Pedestrian Road Safety Audit

Bel Pre Road
From Beaverwood Lane to Georgia Avenue

November 2015

STV Incorporated
7125 Ambassador Road, Baltimore, Maryland 21244

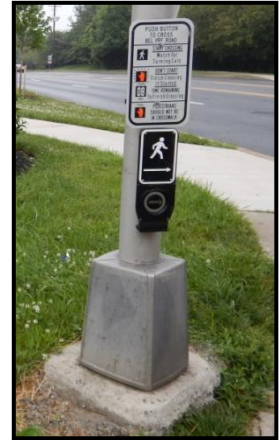
- **Accessible Pedestrian Signals (APS):** Accessible pedestrian signals are provided at each of the study area's signalized intersections, though one intersection is missing the required education signs. Accessible pedestrian signals provide direction through audible and tactile signals which help pedestrians with hearing and visual impairments to cross the street safely.

Accessible Pedestrian Signal and Education Sign

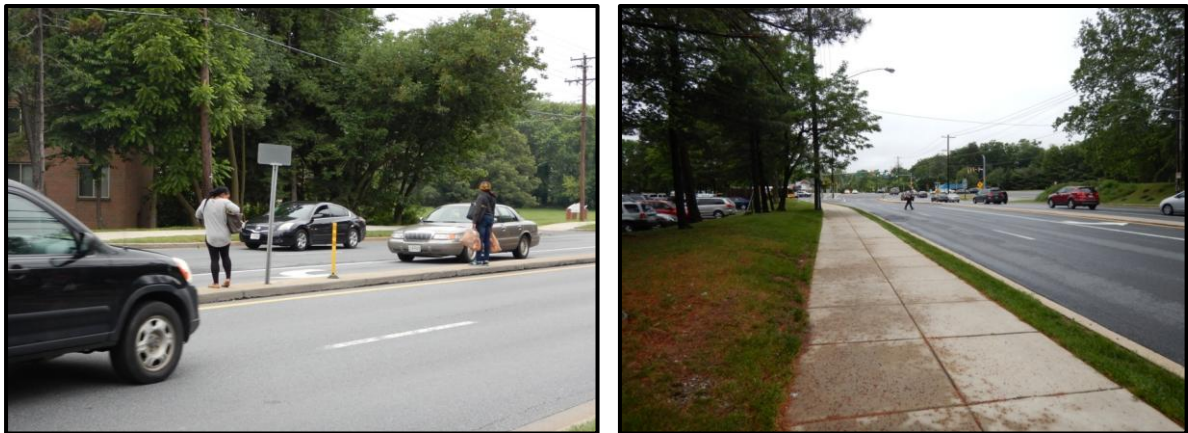
Figure 10: Examples of Pedestrian-Vehicle Conflicts

Pedestrian-vehicle conflicts are comprised of turning movement conflicts at intersections, unsignalized midblock crosswalks, and nearby access points. At multiple locations along the corridor, the locations of the bus stops along Bel Pre Road create potentially unsafe conditions by either blocking pedestrian sight lines when buses stop or by encouraging pedestrians to cross Bel Pre Road at uncontrolled and unmarked locations. The audit team recommends that bus stops be relocated further from major intersections and median improvements be constructed to deter pedestrians from crossing at potentially unsafe locations.

Left: Pedestrians stand in small median to cross near Homecrest Road. Right: Pedestrian crosses midblock to access bus stop near Georgia Avenue.

Safety Issue	Suggestion(s)
Pedestrian Vehicle Conflicts	<ul style="list-style-type: none"> ▪ Coordinate with MCDOT – Transit Services Division to determine the feasibility of relocating the Ride On bus stop further south along the northbound approach of the intersection at Bel Pre Road and Connecticut Avenue to avoid busses blocking the channelized right turn lane. (ST) ▪ Evaluate the feasibility of installing a crosswalk along the west leg of the intersection of Bel Pre Road at Homecrest Road. (ST) ▪ Consider restriping the eastbound two-way left turn lane to a dedicated left turn storage bay along the eastbound approach of the intersection of Bel Pre Road at Beaverwood Lane. (I) ▪ Ensure appropriate levels of enforcement of posted speed limits. (I) ▪ Consider increasing the size of the triangular island and relocating the crosswalk and ADA curb ramps to improve sight distance while maintaining ADA accessibility on the southwest corner of Bel Pre Road at Connecticut Avenue. (LT) ▪ Coordinate with the Transportation Management Section (TMS) to evaluate the need for a signal head along the southbound approach of the intersection of Bel Pre Road at Beaverwood Lane. (LT) ▪ Evaluate the feasibility of installing context sensitive non-traversable barrier along the median at uncontrolled midblock locations where pedestrians were observed crossing. (LT)

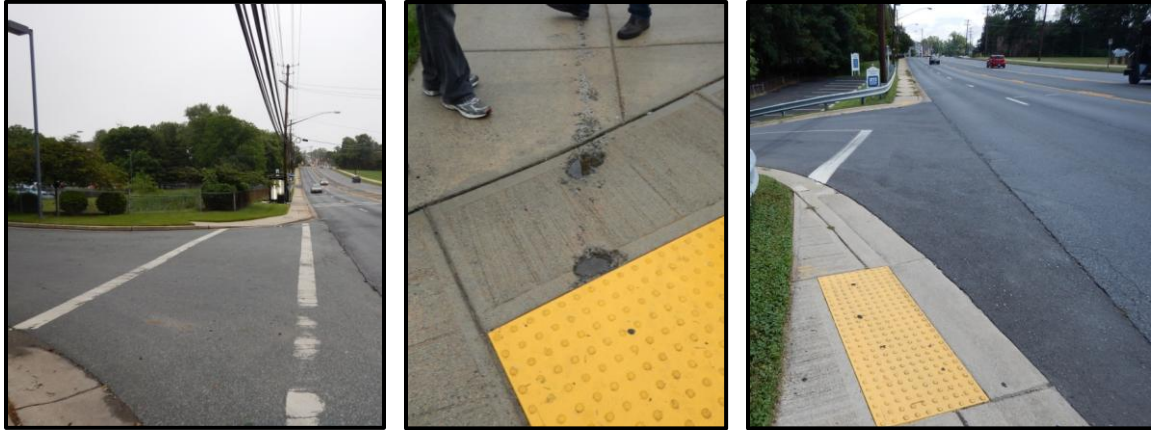
Figure 11: Examples of Pedestrian Facility Issues

A number of issues related to pedestrian facilities were observed during the audit. Examples include missing detectable warning surfaces, damaged sidewalks, faded crosswalks, and the ADA compliance of various facilities. Further, the existing pedestrian ramps at some intersections are not aligned correctly and direct pedestrians into the center of the intersection.

Left: Crosswalk is faded. Center: Damaged Sidewalk. Right: Pedestrian ramp is not aligned with pedestrian crossing path.

The audit team identified a number of suggestions to improve the condition of the existing pedestrian facilities including, but not limited to, the installation of detectable warning surfaces on all pedestrian ramps and cutouts at the unsignalized crossings, and restriping all pavement markings for crosswalks along Bel Pre Road. Additionally, ADA compliance should be verified at all existing pedestrian ramps and pedestrian push buttons.

Pedestrian Facility Issues	<ul style="list-style-type: none"> ▪ Consider relocating the pedestrian warning sign along the northbound approach of the intersection of Bel Pre Road at Connecticut Avenue closer to the intersection and relocating the existing fire and rescue sign. (ST) ▪ Relocate the newspaper bins on the south side of Bel Pre Road near Homecrest Road to maintain full width of the shared use path. (ST) ▪ Consider restriping all faded crosswalk markings with ladder markings. (ST) ▪ Consider restriping all faded stop lines. (ST) ▪ Consider installing crosswalk and stop line markings where applicable. (ST) ▪ Consider installing missing Accessible Pedestrian Signal (APS) education signs. (ST) ▪ Reprogram APS voice operation to ensure consistency throughout the corridor (ST). ▪ Consider installing Detectable Warning Surfaces (DWS), where necessary, to comply with ADA requirements (ST).

Safety Issue	Suggestion(s)
Pedestrian Facility Issues (Continued)	<ul style="list-style-type: none"> ▪ Consider updating all “Stop Here for Pedestrians” signs with the graphic sign that includes the “Stop” symbol. (ST) ▪ Evaluate the feasibility of relocating all pedestrian warning signs that are blocked by adjacent structures so they are easily visible to approaching drivers. (ST) ▪ Repair the fallen pedestrian warning sign east of the Winchester School driveway. (ST) ▪ Work with the Transit Services Division to evaluate the feasibility of relocating nearby Ride On bus stops closer to midblock crossings so that stopped busses load and unload on a level surface and block the crosswalk. (ST) ▪ Replace the vandalized “AHEAD” plaque (W16-9P) on the south side of Bel Pre Road just west of Grand Pre Road. (ST) ▪ Evaluate the guardrail for potential repair at the Winchester School driveway. (ST) ▪ Raise the height of the Two Way Left Turn sign east of Bel Pre Road at Homecrest Road. (ST) ▪ Consider installing guardrail between the sidewalk and storm water retention area on the northeast corner of the intersection of Bel Pre Road at Connecticut Avenue. (I) ▪ Assess the condition of damaged sidewalk and determine the feasibility of repairs. (I) ▪ Consider relocating pedestrian push buttons to conform to ADA standards. (LT) ▪ Determine the feasibility of reconstructing sidewalk ramps to align with adjacent crosswalks and comply with ADA requirements. (LT) ▪ Evaluate the ADA compliance of cutouts in the pedestrian refuges at all unsignalized midblock crossings. (LT) ▪ Coordinate with PEPCO and WSSC to determine the feasibility of relocating utility poles and fire hydrants to maintain the full-width of the shared use path and sidewalk. (LT)

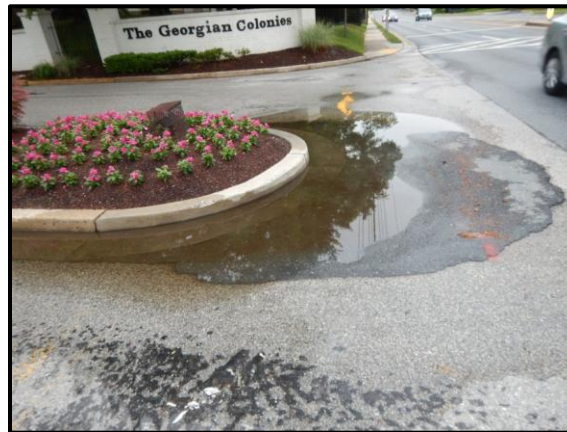
Figure 12: Example of Drainage Conditions

Drainage issues were observed during the audit, including ponding on multiple side streets within the pedestrian path.

Water pools in the pedestrian crossing area.

The audit team recommends that the feasibility of surface improvements or median improvements be reviewed at Dunsinane Drive and Tynewick Drive to prevent the formation of standing water.

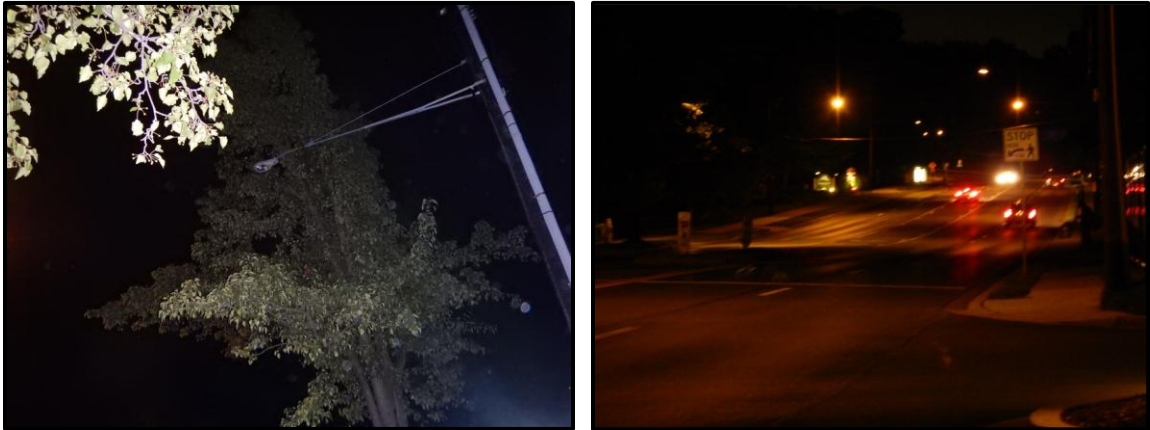
Figure 13: Example of Lighting Conditions

While the majority of pedestrian crashes occurred under daylight conditions, observations during dark conditions indicated that visibility along the corridor, particularly at the unsignalized midblock crosswalks, is low at night due to limited lighting. During the audit, multiple light fixtures were observed as non-functioning and have been reported for repair. The audit team performed an evaluation of street lighting and determined that additional street lighting is necessary.

Left: Light not functioning. Right: Lighting insufficient at midblock crosswalk.

The audit team recommends considering the feasibility of an actuated lighting system at the midblock crosswalks due to the sporadic use of these crosswalks at night.

Lighting	<ul style="list-style-type: none"> ▪ Inspect street lighting throughout the corridor and repair or replace as necessary. (ST) ▪ Trim trees blocking luminaires. (ST) ▪ Determine the feasibility of additional lighting at the unsignalized midblock crossing locations where lighting is insufficient. (LT)
Maintenance	<ul style="list-style-type: none"> ▪ Trim the foliage blocking pedestrian warning signs. (ST) ▪ Trim the foliage along and above the sidewalk and shared use path. (ST) ▪ Coordinate with PEPCO to determine the feasibility of relocating utility line wires blocking the signal heads for the southbound approach at the intersection of Bel Pre Road at Homecrest Road. (LT)
Drainage	<ul style="list-style-type: none"> ▪ Determine the feasibility of constructing drainage improvements in the pedestrian crossings at Dunsinane Drive and Tynewick Drive. (LT) ▪ Determine the feasibility of modifying the medians at Dunsinane Drive and Tynewick Drive so as to not impede the pedestrian crossing area or to extend through the pedestrian crossing path. (LT)

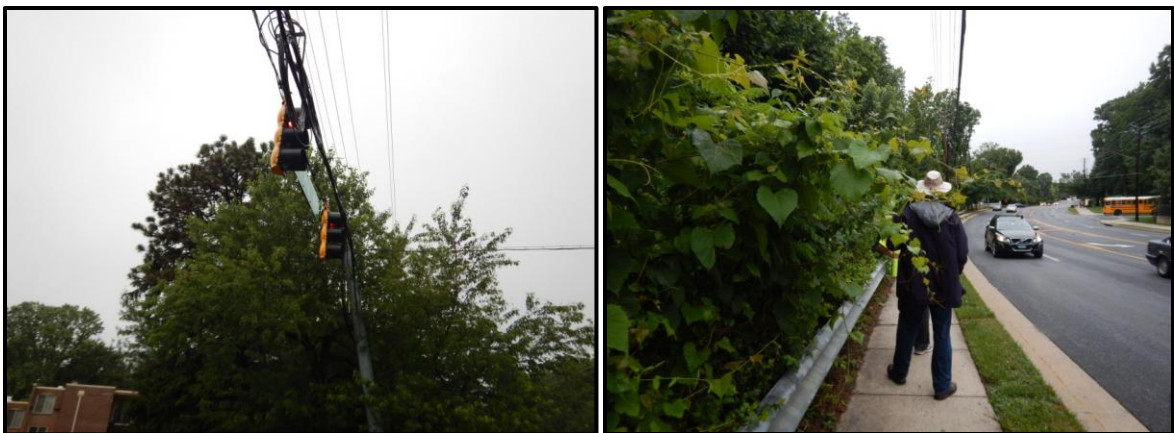
Figure 14: Examples of Maintenance Issues

A number of conditions were observed that may detract from pedestrian safety and that could be resolved through maintenance improvements. Such issues include overgrown vegetation reducing effective sidewalk width or overhead space, blocking pedestrian signage or vehicular signals, and obstructing lighting throughout the corridor.

Left: Overhead utility lines block vehicular signal head at Homecrest Road. Right: Overgrown vegetation impedes the sidewalk.

The audit team recommends that all overgrown vegetation should be trimmed or removed to increase the effective sidewalk widths and allow all signage and signals to be seen or accessed. Tree trimming should be coordinated with the utility company as several trees along the corridor have been marked for removal.
