Pedestrian Road Safety Audit

Rockville Pike (MD 355)

Hubbard Drive to Halpine Road - Rockville
Montgomery County, Maryland

July 2011

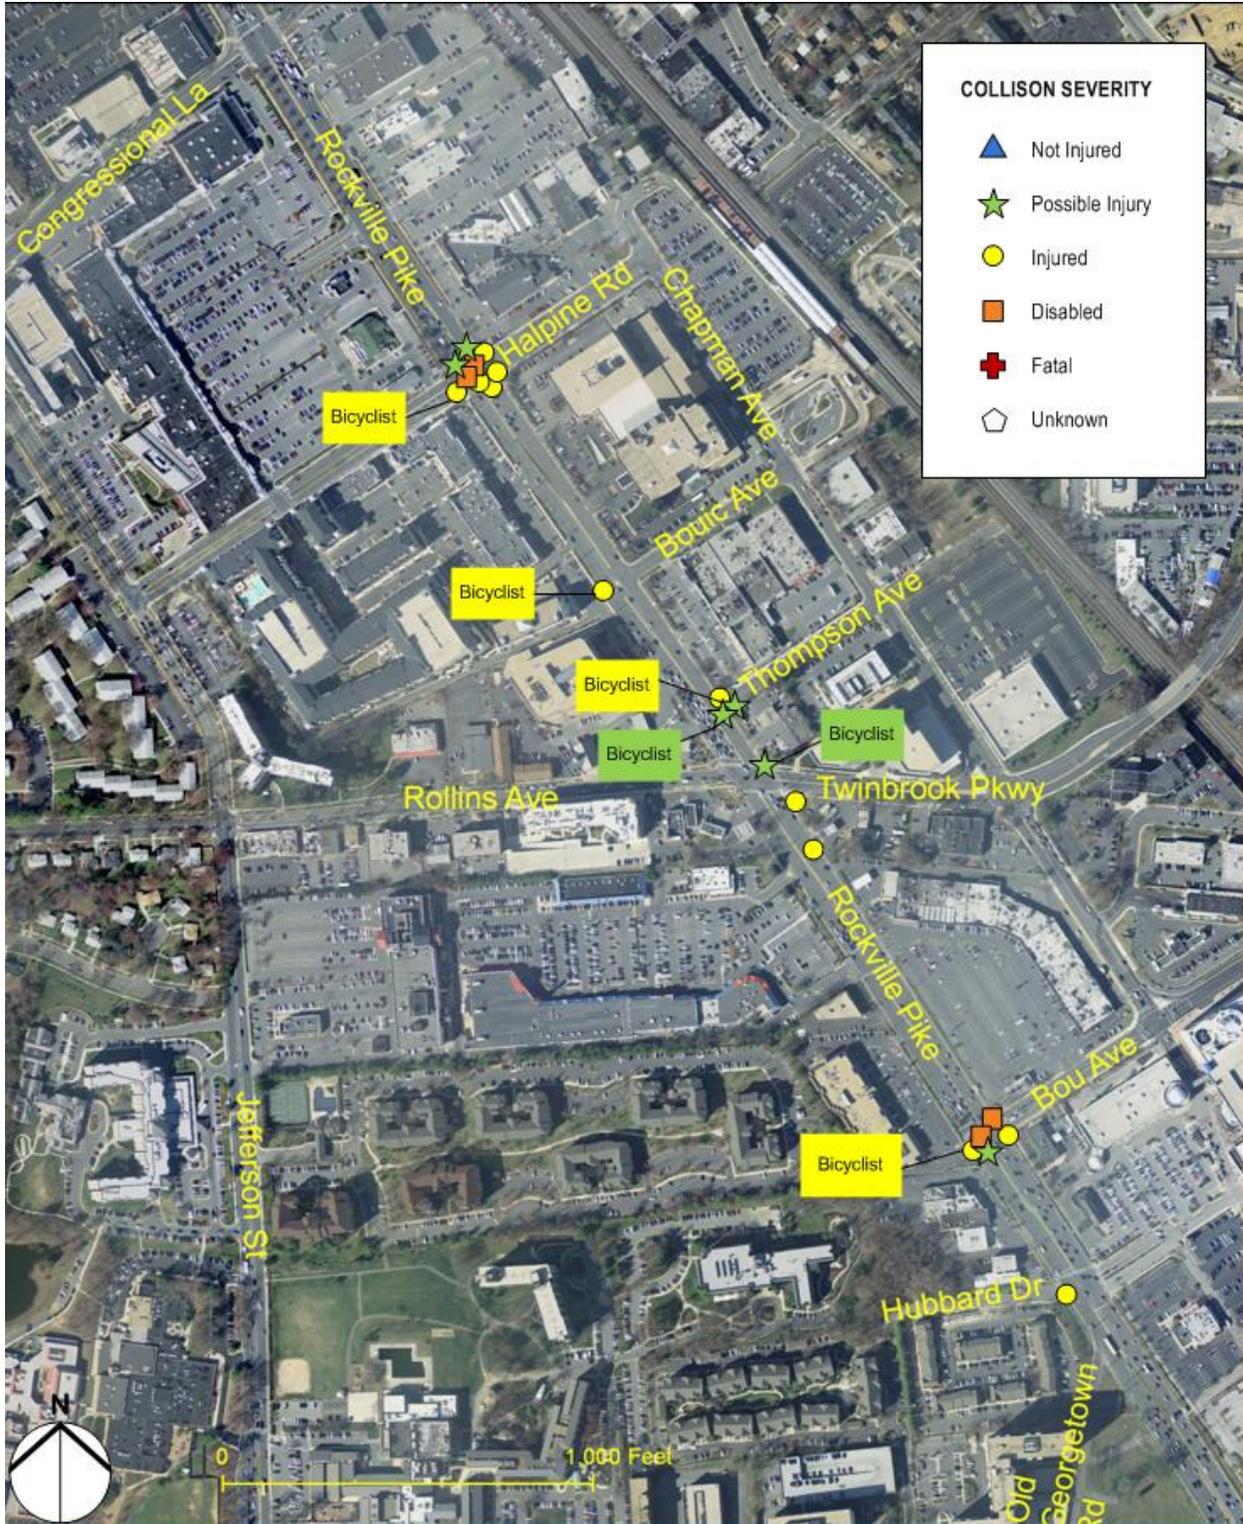
Figure 2: Rockville Pike Pedestrian and Bicycle Crashes (2003 – 2007)

A review of all collision records collected by Montgomery County allowed the PRSA team to identify the location of all reported pedestrian/bicyclist crashes within the corridor (Figure 2). Between 2003 and 2007, 139 vehicular crashes, 16 pedestrian crashes, and 6 bicyclist crashes were reported in the study area (Figure 3).

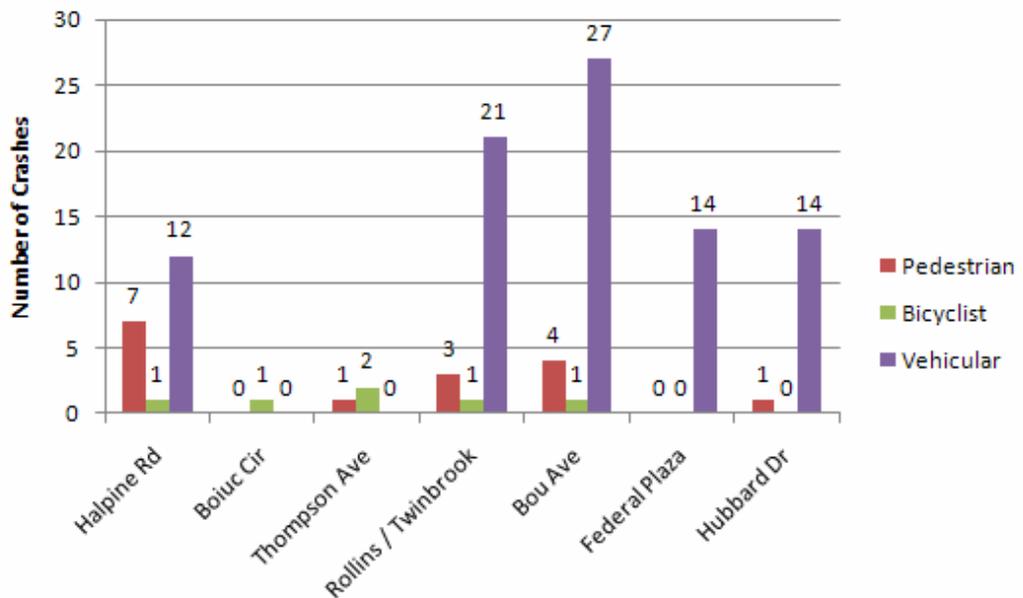
Figure 4: Intersection-Related Crash Frequency by Intersection (2003 – 2007)

The Rockville Pike/Halpine Road intersection experienced seven pedestrian/bicyclist crashes, which was the highest number among all intersections. The second highest collision frequency occurred at the Rockville Pike/Bou Avenue intersection, where five pedestrian/bicyclist crashes occurred (Figure 4).

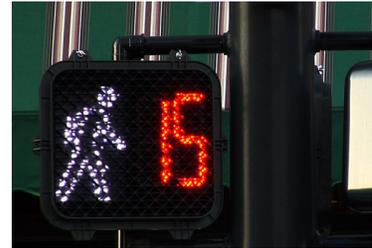
Photo of a countdown signal
