SUBJECT: **Briefing** – Washington Suburban Sanitary Commission (WSSC) – River Road Water Main Break Forensic Report Findings

**FORENSIC INVESTIGATION OF 66-INCH PCCP WATER
TRANSMISSION MAIN FAILURE ON DECEMBER 23, 2008
8500 RIVER ROAD, BETHESDA, MONTGOMERY COUNTY, MD**

**CONDUCTED FOR:
WASHINGTON SUBURBAN SANITARY COMMISSION
LAUREL, MARYLAND**

**CONDUCTED BY:
RICHARD O. LEWIS, P.E.
LEWIS ENGINEERING AND CONSULTING, INC.
GAINESVILLE, FLORIDA**

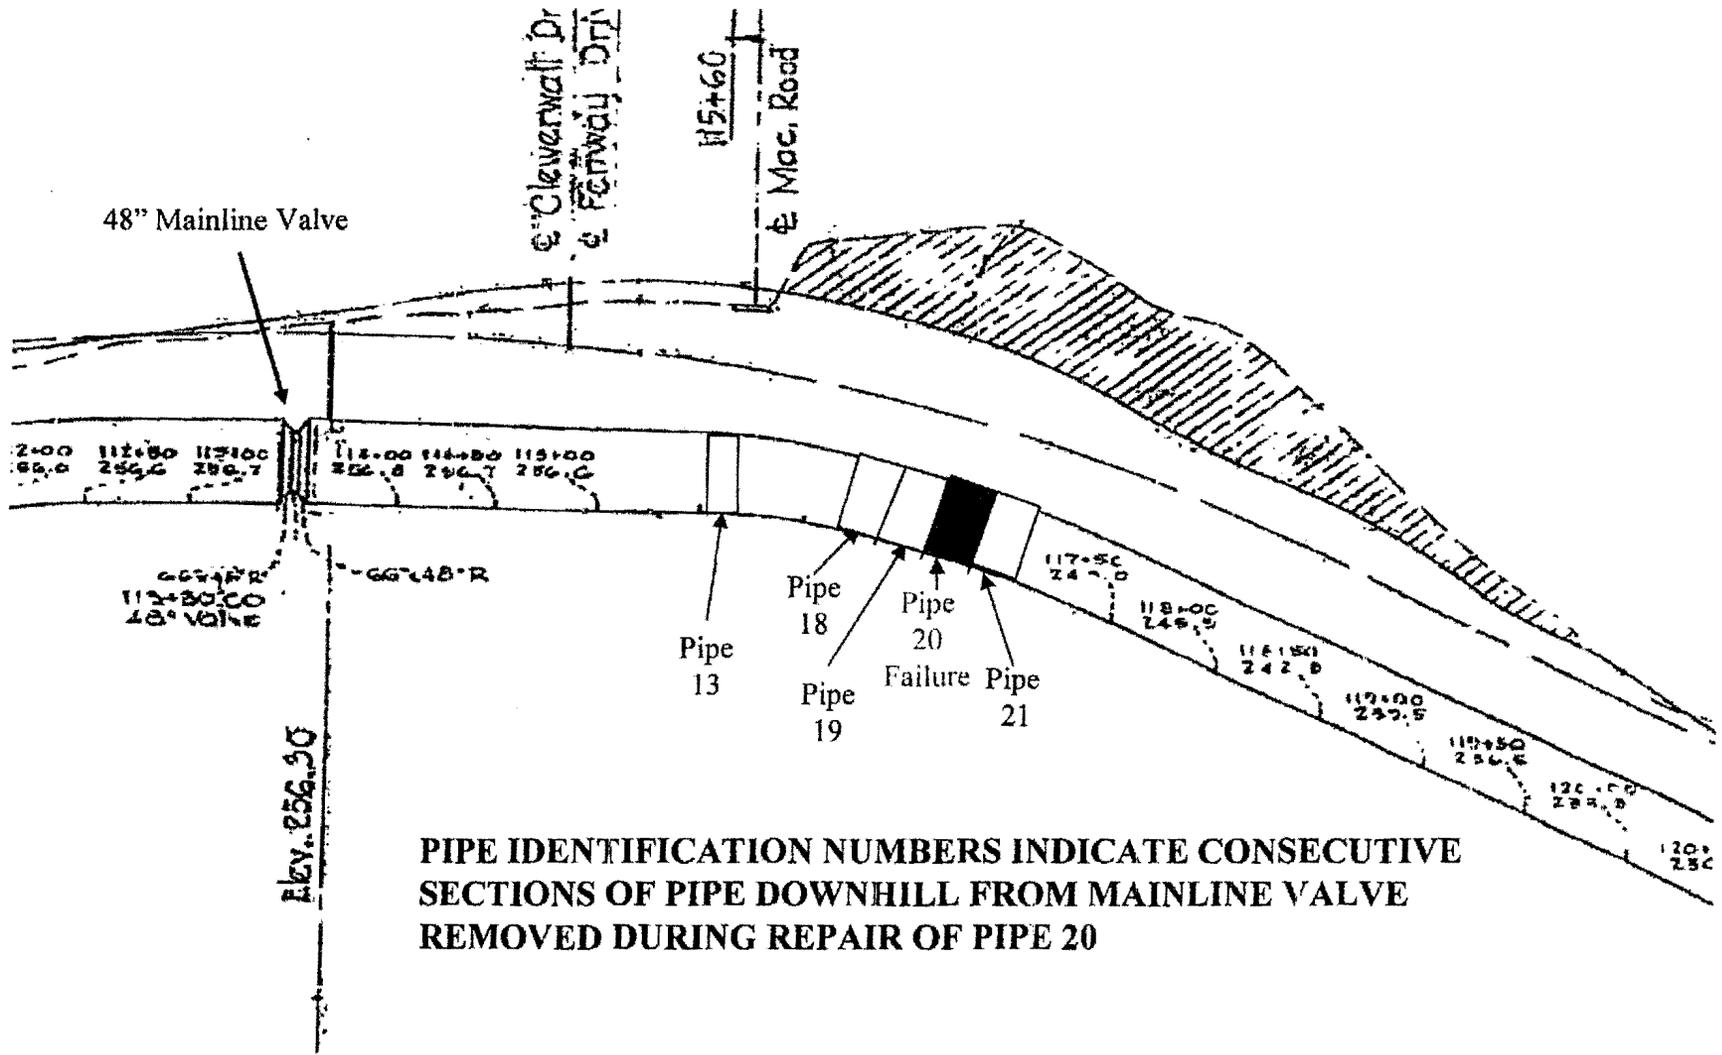
EXCERPTED PORTION OF PROJECT PROFILE DRAWING FOR 66-INCH PCCP RIVER ROAD WATER MAIN

**PIPE IDENTIFICATION NUMBERS INDICATE CONSECUTIVE
SECTIONS OF PIPE DOWNHILL FROM MAINLINE VALVE
REMOVED DURING REPAIR OF PIPE 20**
