Northwest Branch

3.4 Dumont Oaks Stream Restoration

3.4.1 Introduction

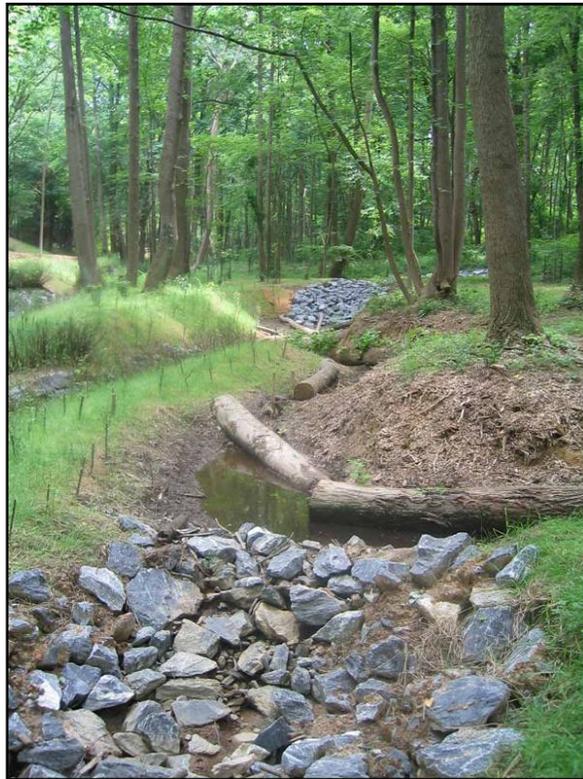
Figure 3.4.1 – Dumont Oaks Stream Restoration in 2004, picturing log veins and streambank stabilization

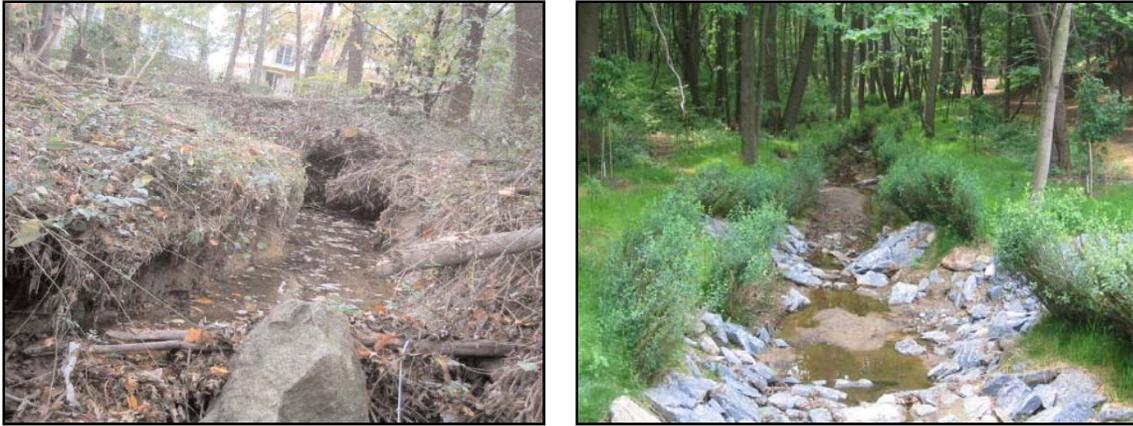
Over time, the Dumont Oaks stream channel down-cut and became entrenched and eroded, undercutting trees and causing damage to private property. Headcuts formed and migrated upstream. Habitat features required for healthy benthic populations were limited, and silt accumulating in the Dumont Oaks stormwater management pond from upstream erosion required frequent dredging and maintenance.

Figure 3.4.6 – Dumont Oaks Stream Restoration Before (2001) and After Restoration (2004)

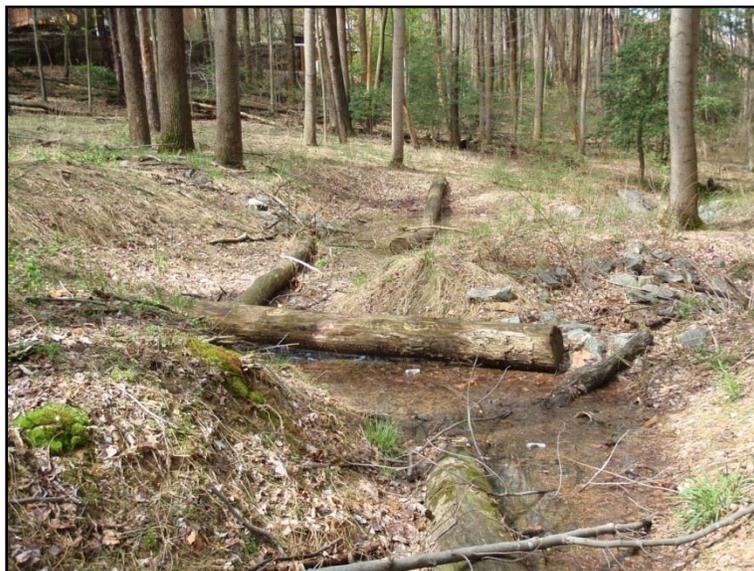
Prior to the creation of the vernal pool at this site, the landscape consisted of a forested slope and adjacent stream valley (*Figure 3.4.11*). Since floodplain species searches indicated various wetland obligate species in the Northwest Branch watershed stream valley, the County was confident the restoration of a wetland would attract these various wetland-dependent species to this area.

Figure 3.4.11 – Looking West at Created Vernal Pool at Site NWDO102 with Surface Water Present (2009)

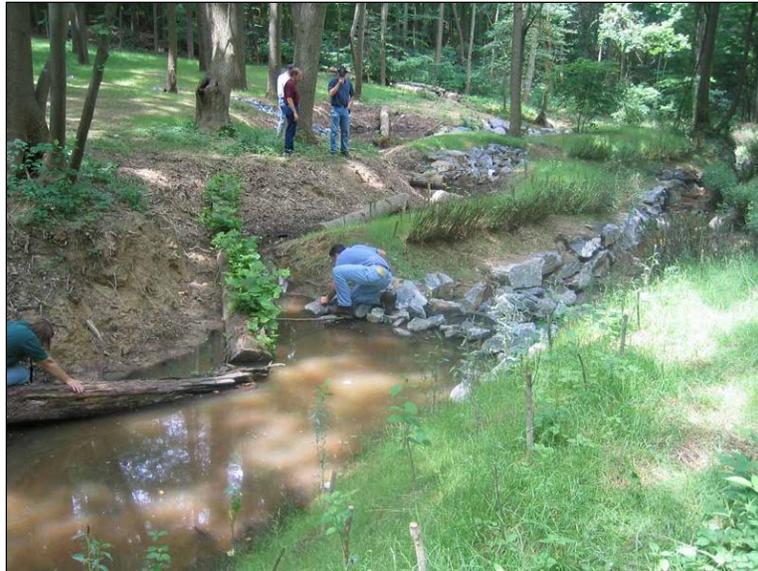
A total of 115 trees and shrubs were planted in association with the 2004 restoration (**Figure 3.4.16**). These plantings were subsequently monitored in 2005, 2007, and 2009. In 2005, plantings were counted in 107, four-foot radius plots. Eight of the plots contained acceptable trees (7.48 percent). However, the majority of the trees and shrubs counted were not planted, and were dominated by *Lindera benzoin* (spicebush). In 2007, the planting area had sparse woody plantings, with over half of the observed trees in 2007 found dead. This area included 18 percent acceptable woody plants.

Figure 3.4.16 – Site NWDO012 in 2004 After Plantings were Installed

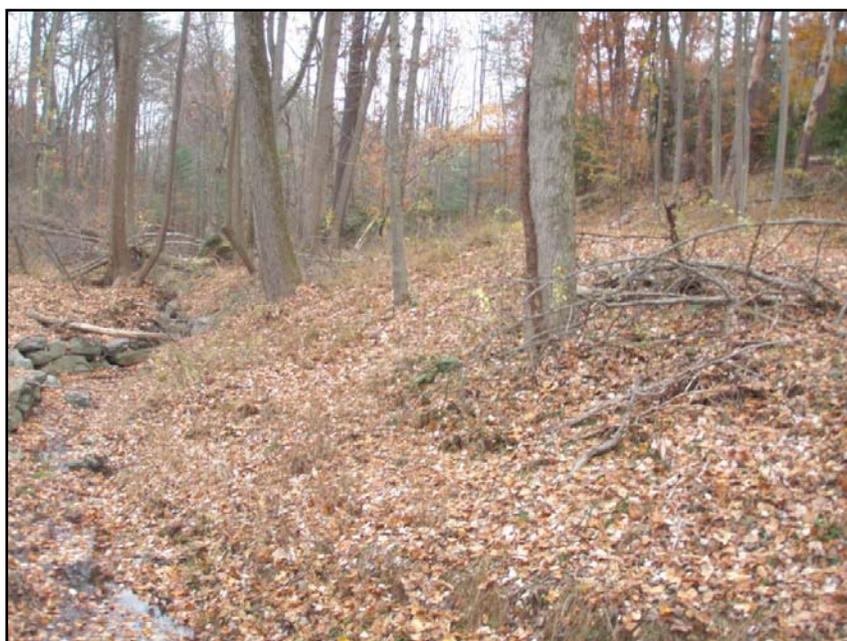
The overall success rate across all of these zones was 34 percent. **Figure 3.4.17** shows an image of the reforestation in 2009, with very few plantings evident. The most successful species planted site-wide included *Quercus palustris* (pin oak), *Quercus rubra* (northern red oak), *Acer rubrum* (red maple), *Betula nigra* (river birch), and *Ilex opaca* (American holly). Plants that fared poorest overall were *Carpinus caroliniana* (American hornbeam) and *Platanus occidentalis* (American sycamore), as well as most of the planted shrub species.

Figure 3.4.17 – Site NWDO102 Botanical Planting Area in 2009, with Very Few Plantings Pictured

In 2009, the overall success rate of the planted material across all zones was 34 percent. Planting Zones A through D showed greater than 50 percent mortality during the 2009 botanical monitoring, whereas planting zone E had 59 percent survival of planted material. It is unclear what factors contributed to the high planting mortality, since invasive species were not pervasive in the botanical zones and no evidence of deer was present in 2009. However, deer are common in this floodplain; therefore, it is likely that young or small plantings may have been browsed by deer prior to 2009, causing the high mortality numbers. It appears that most of the planted trees were 0.5 inch caliper. These individuals may have been too small to withstand the stress of potential deer browse or dry periods. The individuals that were counted in 2009, however, generally had larger caliper sizes than what were planted. The increase in size of the planted individuals is a measure of successful growth and a sign that these trees that have persisted to 2009 are well established. The most successful species planted at this site included pin oak, northern red oak, red maple, river birch, and American holly. Plants that fared poorest overall were American hornbeam and American sycamore, as well as most of the planted shrub species. It is recommended that more trees be planted in this area since so many of the plantings have died and a reestablishment of a forest buffer has not occurred along this project. Larger caliper trees with deer protection or deterrents are also recommended to increase the survival of future plantings.
