3.7 Northwood Stream Restoration

3.7.1 Introduction

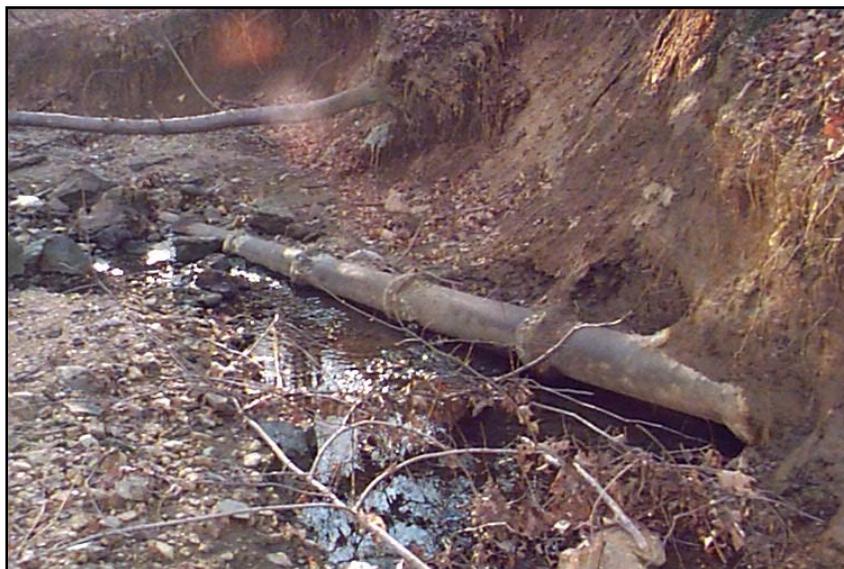
Severe erosion below the concrete flume located at the top of the project limits created a large scour pool that lacked aquatic habitat and the stream banks were actively eroding during every storm event (**Figure 3.7.8**). Washington Suburban Sanitary Commission (WSSC) infrastructure was exposed due to the actively eroding stream bed (**Figure 3.7.2**). Further downstream of the large scour pool there were steep unvegetated streambanks with various non-native vegetation (mostly English Ivy) smothering the native forest. Actively eroding outfall channels were also present along the restoration project where the street runoff from a storm event immediately discharges into the stream (**Figure 3.7.3**). Throughout the project limits, aquatic habitat was limited and mostly consisted of an overwidened stream channel with a shallow water depth that did not provide good aquatic habitat.

Figure 3.7.2 – Exposed WSSC Sewer Line within the Northwood Tributary in 2001 Before Restoration

Instream structures included rock and log vanes, which direct water away from unstable streambanks, and form downstream scour pools that provide good habitat for fish. Rock cross vanes also function as grade control, which slow the erosive process of stream down-cutting (*Figure 3.7.6*). Instream structures were also used to protect exposed WSSC infrastructure.

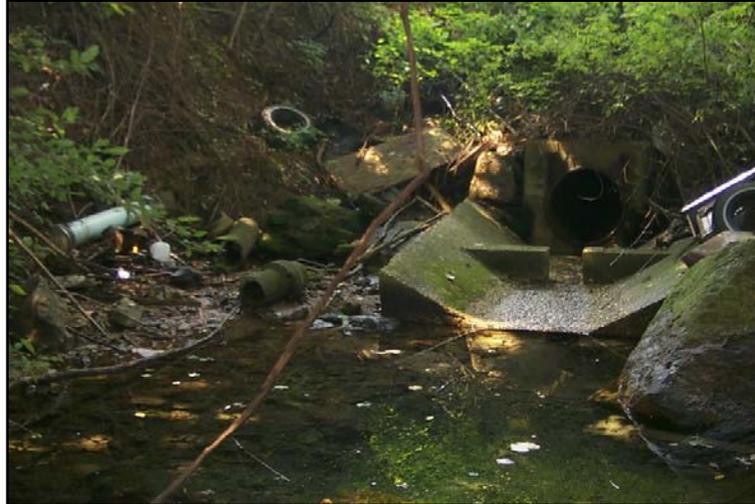
Figure 3.7.3 – Eroded Outfall to the Northwood Tributary in 2001 Before Restoration

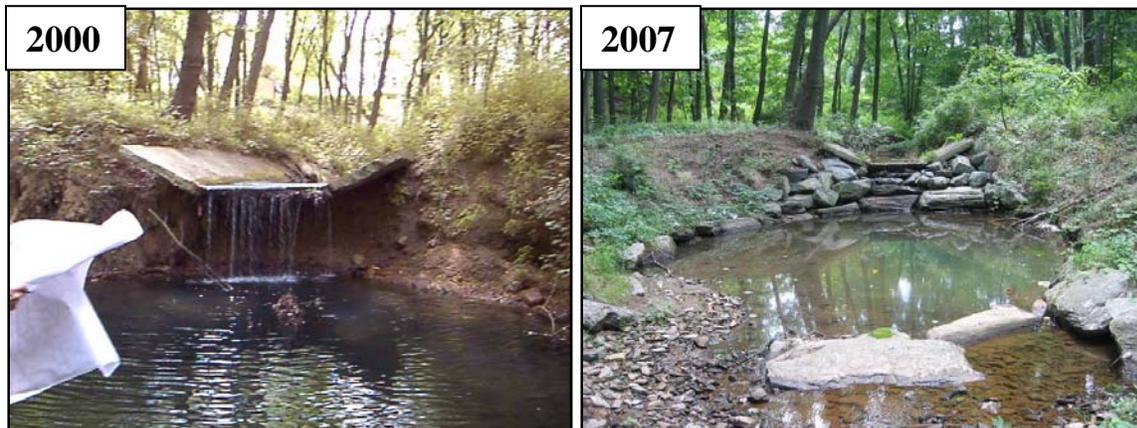
Figure 3.7.4 – Northwood Stream Restoration Before and After Restoration

At the upper end of the project limits, a large step pool system was installed to provide stability and bring habitat back into the large scour pool that formed immediately below the concrete flume (***Figure 3.7.4***). Imbricated rock was installed along eroding streambank slopes, protecting the stream channel from further damage. The slopes above the imbricated walls were planted with native trees and shrubs to further stabilize the streambanks (***Figure 3.7.5***).

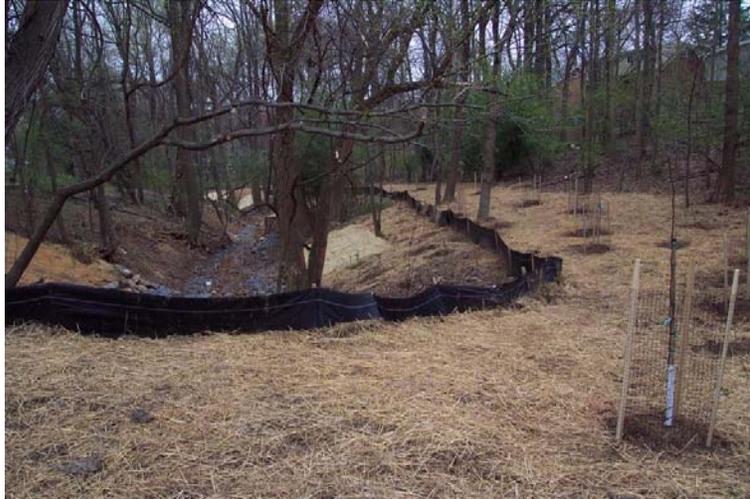
Figure 3.7.5 – Streambank and Riparian Plantings at Northwood Tributary just after Restoration in 2003

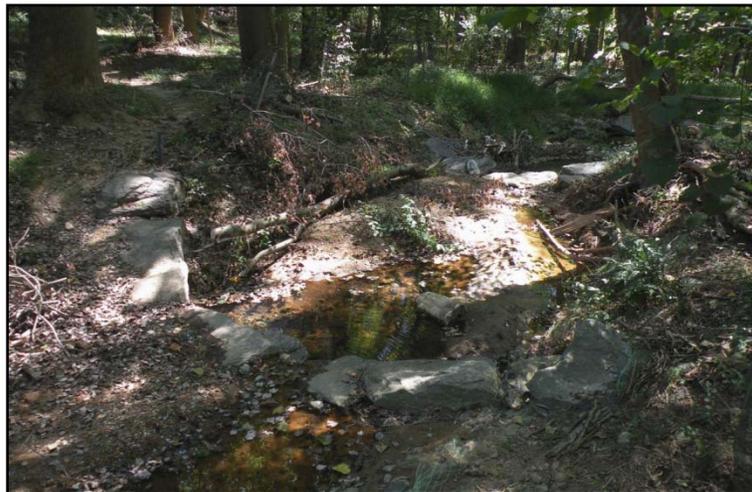
Figure 3.7.6 – Rock Cross Vane at Northwood Tributary in 2010
