## 3.21 Sycamore Creek Stream Restoration

### 3.21.1 Introduction

#### *Subwatershed facts*

#### *Project Facts*

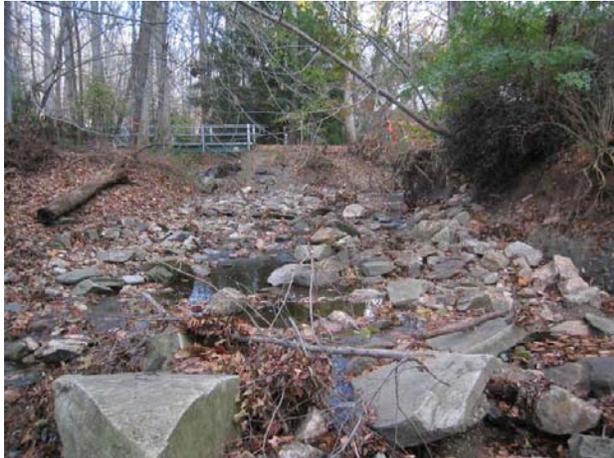
***Figure 3.21.1 – Sycamore Creek Prior to Restoration, Picturing Bank Erosion, Undercut Trees, and Overwidened Stream Channel***

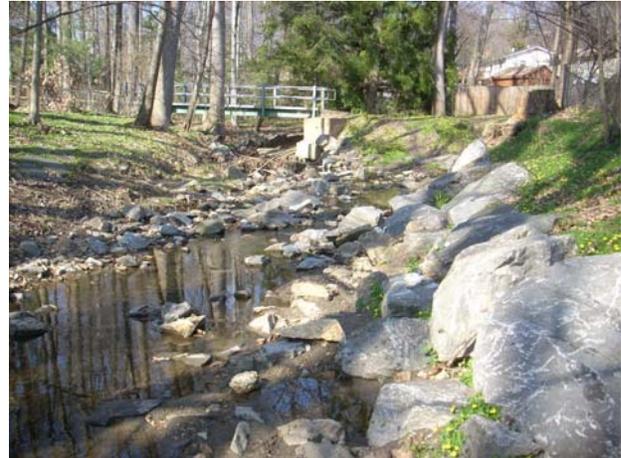
***Figure 3.21.2 – Sycamore Creek Post Restoration, Picturing Stabilized Banks, and Normalized Channel Reach***

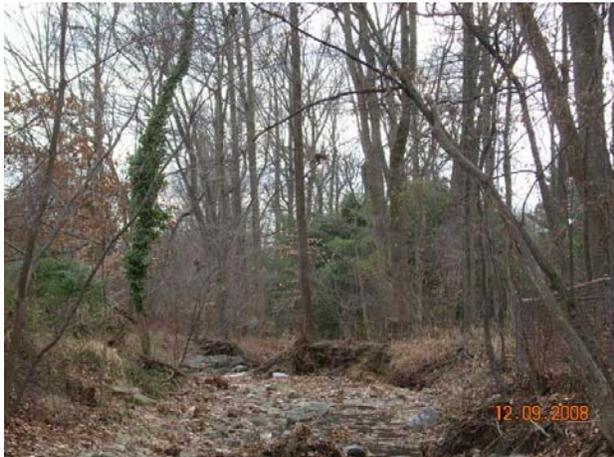
***Figure 3.21.3 – Sycamore Creek Prior to Installation of Log Vanes***

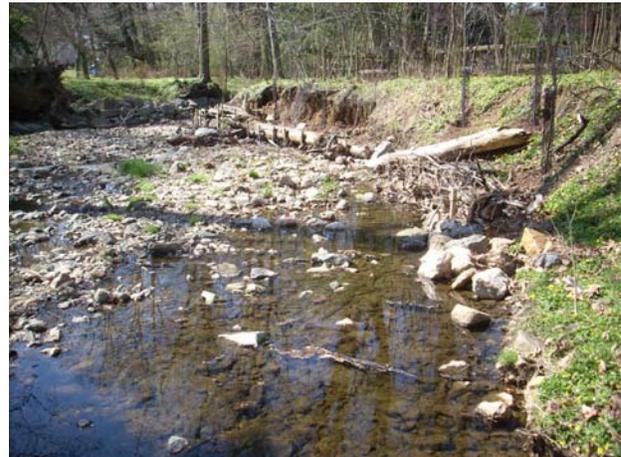
***Figure 3.21.4 – Sycamore Creek Post Restoration, Picturing Log Vanes to Stabilize Banks***

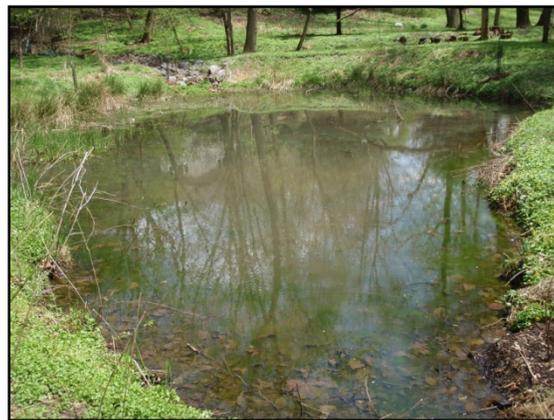
**Figure 3.21.37 – Vernal Pool 1 at LRSB101B in April 2009, showing lesser celandine surrounding the vernal pool and algae within**

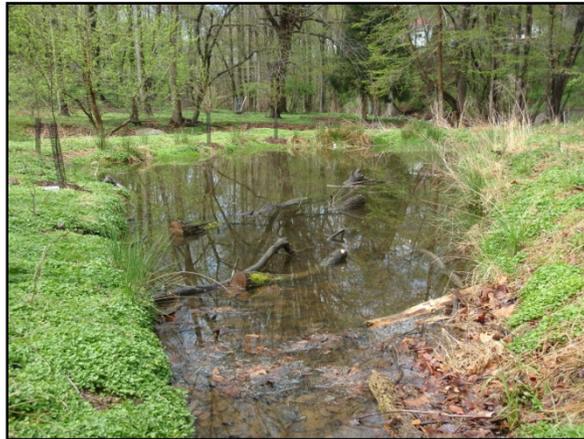
65 feet long by 26 feet wide. Emergent, herbaceous vegetation was found growing, primarily at the downstream end of the vernal pool and included softstem bulrush, and water lily or *Sagittaria sp.* (arrowhead) (**Figure 3.21.38**). Common rush and lesser celandine were found growing on the banks. Logs and a few smaller tree limbs were also observed in the vernal pool and were noted as potential attachment sites for egg masses. Three *Ambystoma maculatum* (spotted salamander) egg masses were found within the pool (**Figure 3.21.39**). *Pseudacris crucifer crucifer* (spring peepers) were heard calling from the pool and one adult was observed outside the pool. Two *Plethodon cinereus* (Eastern red-backed salamanders), in the leadback phase, were found under logs during the search around the perimeter of the vernal pool (**Figure 3.21.40**).

**Figure 3.21.38 – Vernal Pool 2 at LRSB101B in 2009, showing lesser celandine and softstem bulrush**

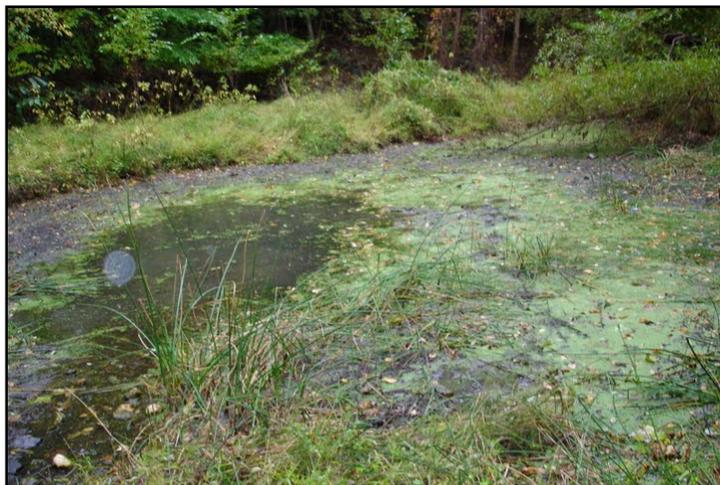
Wetland 1 is a palustrine emergent wetland and lies upstream of Wetland 2. On the day of the assessment in October 2009, 40 percent of the wetland area was inundated with approximately four inches of water and 60 percent of the area was saturated. Dominant emergent species observed were softstem bulrush, common rush, and *Leersia oryzoides* (rice cutgrass) (*Figure 3.21.41*). None of the planted species appear to have survived, however a few volunteer trees and shrubs were found growing around the edge of the wetland, including: *Asimina triloba* (pawpaw), *Betula nigra* (river birch), and *Cephalanthus occidentalis* (common buttonbush). Four of the six river birch were found dead and had *Polygonum perfoliatum* (Asiatic tearthumb) climbing on them, and one *Hamamelis virginiana* (American witchhazel) was found dead. Asiatic tearthumb and Nepalese browntop occupied approximately two percent of the wetland area and may be a concern for the future success of this wetland. The density of wetland plant species was fairly low, at 25 percent. The expected growth of the existing vegetation was also low due to stress caused by invasive species and deep water that limits potential habitat. Overall, Wetland 1 scored 66.5 out of 100. Soils in the wetland were determined to be hydric; however, they were thin, sandy, and underlain by solid rock. These conditions were not optimal for plant growth. Wetland functional gains were also determined to be low, with the wetland providing only minor wetland functions.

**Figure 3.21.41 – Wetland Vegetation at Wetland 1, LRSB101B, common rush pictured**

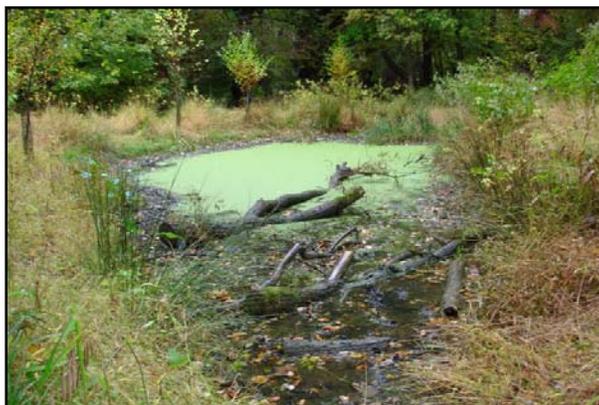
Wetland 2 is a smaller palustrine emergent wetland located downstream of Wetland 1. On the day of the 2009 assessment, Wetland 2 was 90 percent inundated with approximately three inches of water and ten percent saturated. Dominant emergent species included: common rush, rice cutgrass, Nepalese browntop, softstem bulrush, and *Pontederia cordata* (pickerelweed) (**Figure 3.21.42**). Seventy-five percent of the vegetated cover was comprised of native wetland vegetation and seven percent was occupied by Nepalese browntop. Several healthy river birches planted by DEP were found growing on the wetland edge. Hydric soils were evident in the wetland, although no redoximorphic features were present in the profile. Very little mineral soil existed within the profile, which was underlain with rock. A sandy clay layer appeared to be creating a perched wetland condition at Wetland 2.

The total score for Wetland 2 was 73.25 out of 100. This site scored higher than Wetland 1 because it had a higher percent cover of emergent vegetation, which created a more habitable condition for obligate vernal pool species and other wildlife.

**Figure 3.21.42 – Wetland Vegetation at Wetland 2, LRSB101B, common rush, rice cutgrass, Nepalese browntop, and duckweed (light green floating vegetation) pictured**

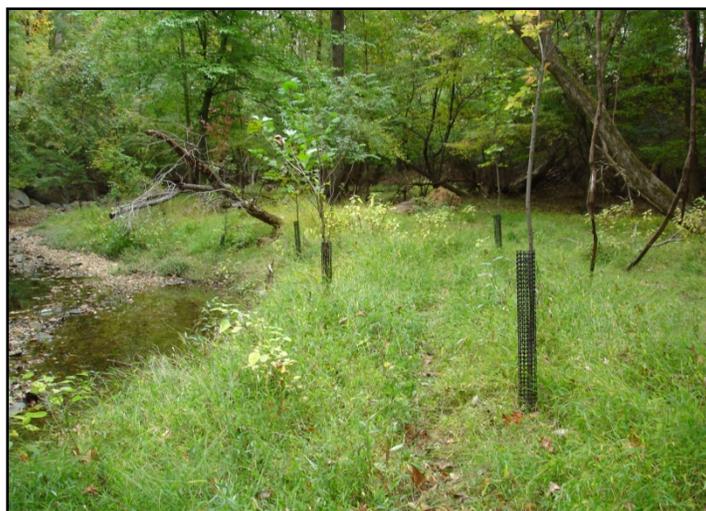
The survival rate of planted trees in Zone 10 (20.1-20.5, 20.8) was 23 percent (**Figure 3.21.43**). All of the shrubs planted in this zone died. Six species of trees were found growing in this zone and accounted for a total of 30 trees, with survival rates for these six species ranging from 40 to 100 percent (**Table 3.21.15**). One volunteer redbud tree was also observed. Eleven percent of the observed trees were dead at the time of the vegetation survey, 43 percent appeared healthy, and the remaining 46 percent were alive, but were not considered healthy. The range of caliper size of the trees counted in 2009 was between 0.5 and 1.25 inches. The trees planted for the project ranged from 0.5 to one inch caliper, suggesting that the growth of these trees has not been substantial. Browsing and rubbing by deer significantly affected some of the trees, and Nepalese browntop was present throughout much of the zone. Fifteen tree and shrub species that were planted were not encountered in 2009.

**Figure 3.21.43 – Botanical Reforestation at LRSB101B, Planting Zone 10, showing American sycamore plantings**
