# Connecticut Avenue (MD 185) Pedestrian Road Safety Audit Montgomery County, Maryland

Prepared For:  
Department of Transportation  
Montgomery County, Maryland

**Vanasse Hangen Brustlin, Inc.**  
Silver Spring, Maryland

**December 2011**

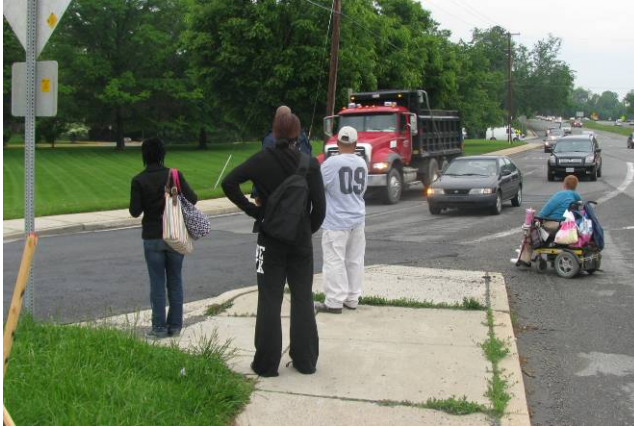
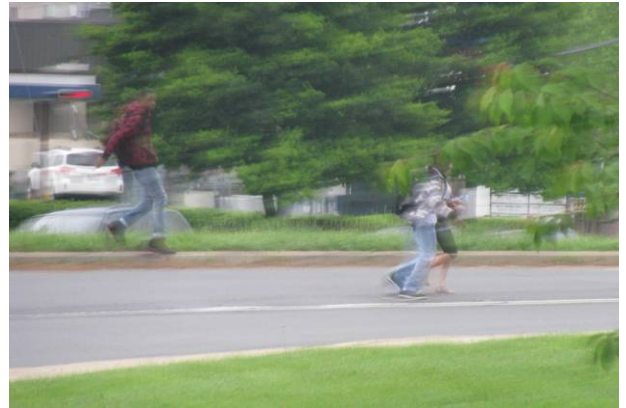
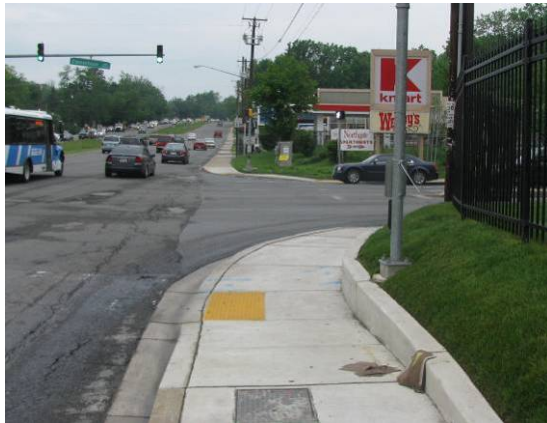
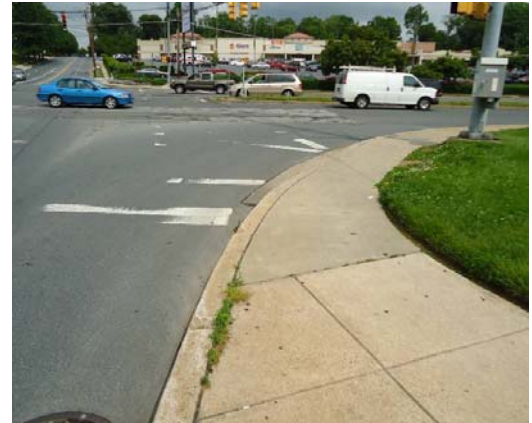
**Pedestrian-Vehicle Conflicts** – Pedestrian-vehicle conflicts, not including those involving uncontrolled midblock crossings, are comprised of turning movement conflicts and conflicts at marked unsignalized crosswalks. They were observed most frequently along Connecticut Avenue at Georgia Avenue and Aspen Hill Road. A combination of factors including frequency of turning movements, pedestrian volume, vehicle speeds, signal phasing/timing settings, and sight line limitations contributed to conflicts.

**Pedestrian-vehicle conflicts were observed at a free-flow right-turn ramp (upper left and upper right). Visual limitations at a right-turn (lower left) and wide corner radii contribute to conflicts.**

| Safety Issue | Suggestions |
|---|---|
| <b>Pedestrian-Vehicle Conflicts</b> | <ul style="list-style-type: none"> <li>▪ Consider signage and pavement markings to improve driver awareness of pedestrians and reduce turning movement conflicts at intersections and marked crossings. (ST)</li> <li>▪ Consider implementing lead pedestrian interval (LPI) phasing for pedestrian signals. (ST)</li> <li>▪ Explore pedestrian signal timing modifications. (ST)</li> <li>▪ Consider evaluating appropriate levels of enforcement to deter turning movement violations. (ST)</li> <li>▪ Consider installing, upgrading, or relocating crosswalks, compliant with MDSHA standards. (I)</li> <li>▪ Consider installing rumble strips or striping narrower lanes to reduce vehicle speeds. (I)</li> <li>▪ Determine the feasibility of relocating potential curbside obstructions to improve driver sight lines. (I)</li> <li>▪ Consider working with the Transportation Management Section to determine the operational impacts of protected phasing for left turns, where appropriate. (I)</li> <li>▪ Determine feasibility of geometric roadway improvements to reduce pedestrian crossing distances, improve pedestrian refuge spaces, or reduce corner radii. (LT)</li> <li>▪ Consider evaluating the need for signal controls at unsignalized intersections in the study area. (LT)</li> </ul> |

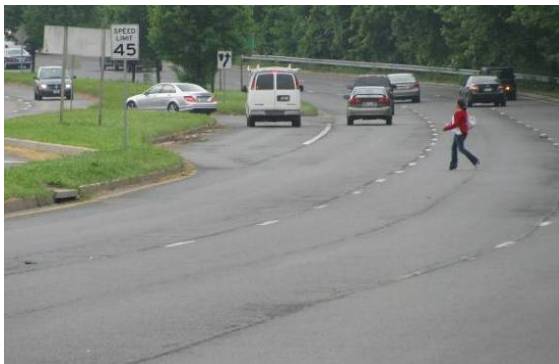
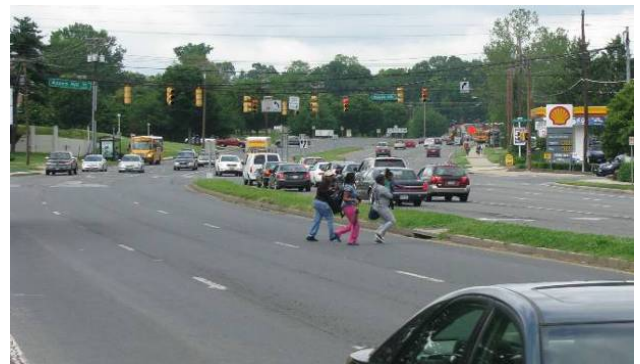
**Uncontrolled Midblock Crossings** – Uncontrolled midblock crossings are prevalent throughout the study area and were identified as one of the primary contributing factors to pedestrian collisions. Pedestrians were frequently observed running across Connecticut Avenue to avoid oncoming traffic and walking along or waiting in medians. The locations of compatible land uses, locations of bus stops, signal cycle lengths, the distances between marked crossings, and pedestrian impatience all contribute to uncontrolled midblock crossings. Pedestrian warning signage, which increases driver awareness of pedestrian activity, is limited within the study area.

**Uncontrolled midblock crossings are prevalent on Connecticut Avenue**

| Safety Issue | Suggestions |
|---|---|
| <b>Uncontrolled Midblock Crossings</b> | <ul style="list-style-type: none"> <li>Consider installing signage to improve driver awareness of pedestrians. (ST)</li> <li>Consider pedestrian signal upgrades, including accessible/audible pedestrian signals and countdown pedestrian signals (APS/CPS), extended pedestrian signal timings, and LPI phasing to make signalized crossings more convenient relative to midblock crossings. (ST)</li> <li>Consider working with Transit Services to determine the feasibility of relocating or consolidating bus stops. (I)</li> <li>Consider working with MDSHA to pursue installing a non-traversable barrier to deter uncontrolled midblock crossings. (I)</li> <li>Consider working with adjacent property owners to modify access permits and close undesigned pedestrian access points to block pedestrian desire lines at uncontrolled midblock locations. (I)</li> <li>Consider working with community groups, public agencies, and property owners to provide a designated location for day labor congregation further from pedestrian conflict areas. (I)</li> <li>Consider working with adjacent property owners to close selected driveways to limit pedestrian exposure. (LT)</li> </ul> |

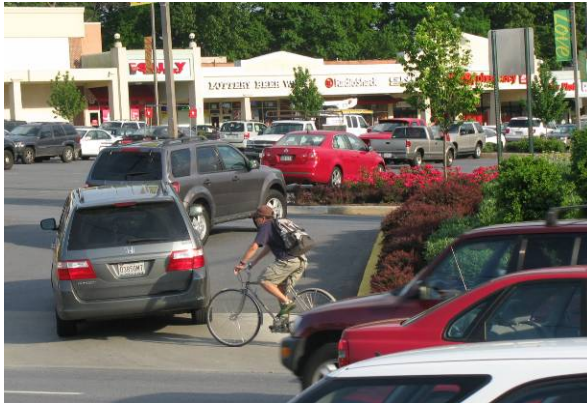
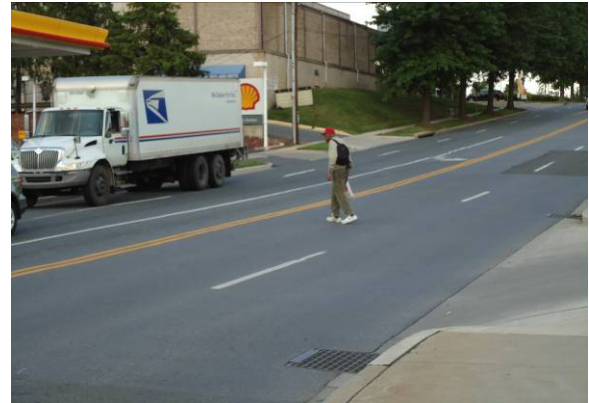
**Access Conflicts** – The presence of many driveways in study area leads to conflicts between pedestrians walking on sidewalks and vehicles entering and exiting commercial properties. In the vicinity of the Connecticut Avenue/Georgia Avenue and Connecticut Avenue/Aspen Hill Road intersections, in particular, commercial driveways tend to be numerous and closely-spaced. On high speed and volume facilities, like Georgia Avenue, vehicles entering access points have also contributed to rear-end vehicle crashes or run-off-road crashes by drivers attempting to avoid rear-end crashes.

**Pedestrian and bicyclist activity near the Aspen Hill Shopping Center driveway on Aspen Hill Road**

| Safety Issue | Suggestions |
|---|---|
| <b>Access Conflicts</b> | <ul style="list-style-type: none"> <li>Consider installing crosswalks across driveways to increase driver awareness and expectation of pedestrians. (I)</li> <li>Consider evaluating the need for signal controls at unsignalized intersections in the study area. (LT)</li> <li>Consider turn restrictions for vehicles exiting driveways. (LT)</li> <li>Explore opportunities for future redevelopment to consolidate access points and reduce pedestrian exposure to turning vehicles. (LT)</li> <li>Explore working with adjacent property owners to consolidate driveways. (LT)</li> <li>Determine the feasibility of constructing narrower curb cuts at driveways. (LT)</li> </ul> |

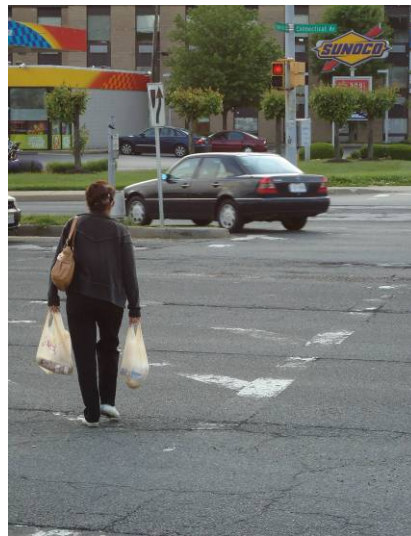
**Pedestrian Compliance with Signals** – Pedestrians were frequently observed violating pedestrian signals. Relatively long pedestrian wait times, significant transit activity, and pedestrian impatience contribute to the reluctance to cross during the pedestrian walk phase.

**Pedestrian crossing during Connecticut Avenue during Don't Walk and exclusive left-turn phase**

| Safety Issue | Suggestions |
|---|---|
| <b>Pedestrian Compliance with Signals</b> | <ul style="list-style-type: none"> <li>▪ Review traffic signal controller settings and modify pedestrian signal timings to comply with MUTCD guidance, if necessary. (ST)</li> <li>▪ Work with MDSHA to pursue installing APS/CPS equipment. (I)</li> <li>▪ Consider community-based educational efforts and enforcement strategies. (I)</li> </ul> |

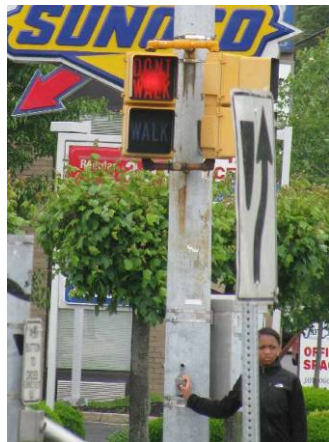
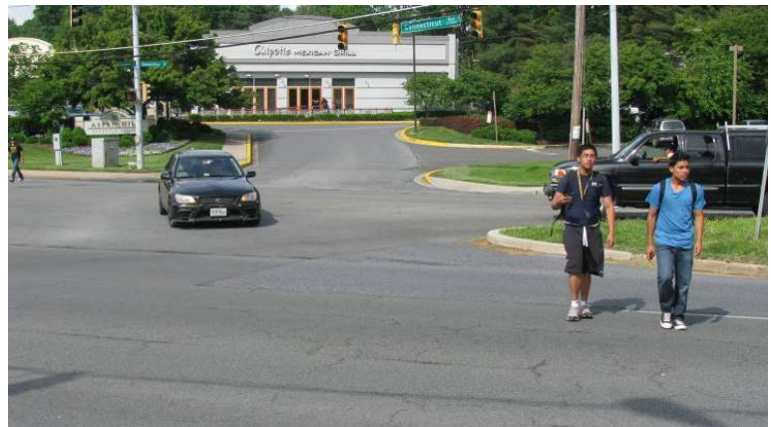
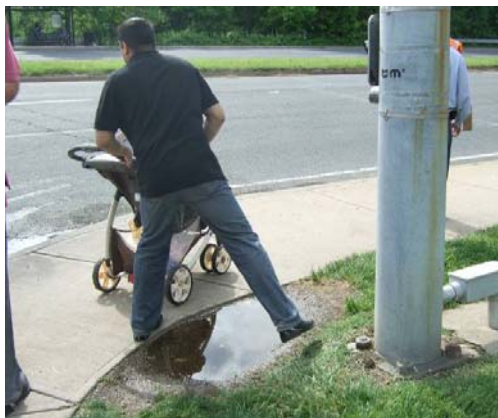
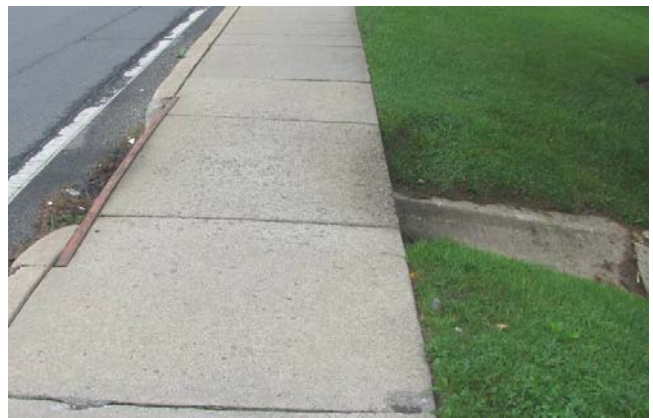
**Pedestrian Facility Limitations** – Several issues concerning the sidewalk design, continuity of pedestrian facilities, and pedestrian accessibility were observed. These issues include substandard and deteriorating pedestrian signal equipment, inaccessible push-button locations, the lack of push-button signage and indications, poor median surface conditions, misaligned curb ramps, narrow effective sidewalk widths, the lack of pedestrian buffers, discontinuous sidewalks, the lack of sidewalks along some pedestrian desire lines, foliage obstructing sidewalks, narrow pedestrian landings, and exposed drainage structures posing safety concerns for pedestrians.

**Pedestrian facilities limitations along Connecticut Avenue include substandard pedestrian signal equipment (upper left), an absent crosswalk (upper right), an inaccessible push button (lower left), and an exposed drainage structure (lower right).**

| Safety Issue | Suggestions |
|---|---|
| <b>Pedestrian Facility Limitations</b> | <ul style="list-style-type: none"> <li>▪ Consider implementing lead pedestrian interval (LPI) phasing. (ST)</li> <li>▪ Consider extending pedestrian signal timings to reduce pedestrian exposure. (ST)</li> <li>▪ Consider installing pedestrian crossing signage. (ST)</li> <li>▪ Trim foliage obstructing sidewalks. (ST)</li> <li>▪ Consider installing detectable warning surfaces at wheelchair ramps. (ST)</li> <li>▪ Consider installing new landscaping or street furniture to close openings in landscaping along commercial frontage. (ST)</li> <li>▪ Consider installing crosswalks across driveways to increase driver awareness and expectation of pedestrians. (I)</li> <li>▪ Work with MDSHA to pursue installing APS/CPS equipment. (I)</li> <li>▪ Consider installing, upgrading, or relocating crosswalks, compliant with MDSHA standards. (I)</li> <li>▪ Work with property owners to ensure barriers protect pedestrians from exposed drainage structures. (I)</li> <li>▪ Work with Transit Services Division to explore relocating bus stops further from the roadway to increase sidewalk width. (I)</li> <li>▪ Determine feasibility and constructability of median improvements at intersections including level landing areas, accessible push buttons, and refuge from turning vehicles. (I)</li> <li>▪ Consider reconstructing wheelchair ramps to properly align them with crosswalks. (I)</li> <li>▪ Consider the feasibility of reconstructing curb and gutter in the vicinity of a wheelchair ramp to eliminate water ponding. (I)</li> <li>▪ Determine feasibility of expanding pedestrian landing areas. (LT)</li> <li>▪ Consider widening sidewalks and constructing grass buffers between the sidewalk and roadway, where absent. (LT)</li> </ul> |

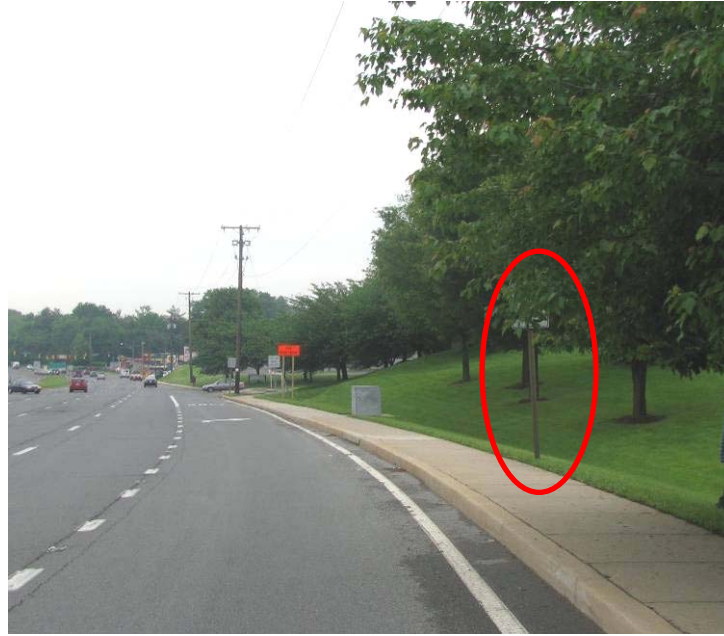
**Maintenance** – The PRSA team observed a number of conditions that may contribute to pedestrian safety issues and that could be resolved through maintenance actions. These issues included missing crosswalks, water ponding, missing signage, signage and sidewalks obstructed by foliage, and faded or deteriorating pavement markings.

**Tree canopy obstructs driver visibility of speed limit sign (circled) on southbound Connecticut Avenue.**

| Safety Issue | Suggestions |
|---|---|
| <b>Maintenance</b> | <ul style="list-style-type: none"> <li>▪ Trim tree canopies to improve visibility of signage and remove obstructions on sidewalks. (ST)</li> <li>▪ Consider restriping all crosswalks and stop bars during next roadway resurfacing project or sooner. (I)</li> <li>▪ Determine the operational impacts of installing No Turn on Red signs at selected locations. (I)</li> <li>▪ Consider installing turning arrow pavement markings and lane use signage to define proper lane use where appropriate. (I)</li> </ul> |
