# Pedestrian Road Safety Audit

Fenton Street

From Cameron Street to Wayne Avenue

STV Incorporated

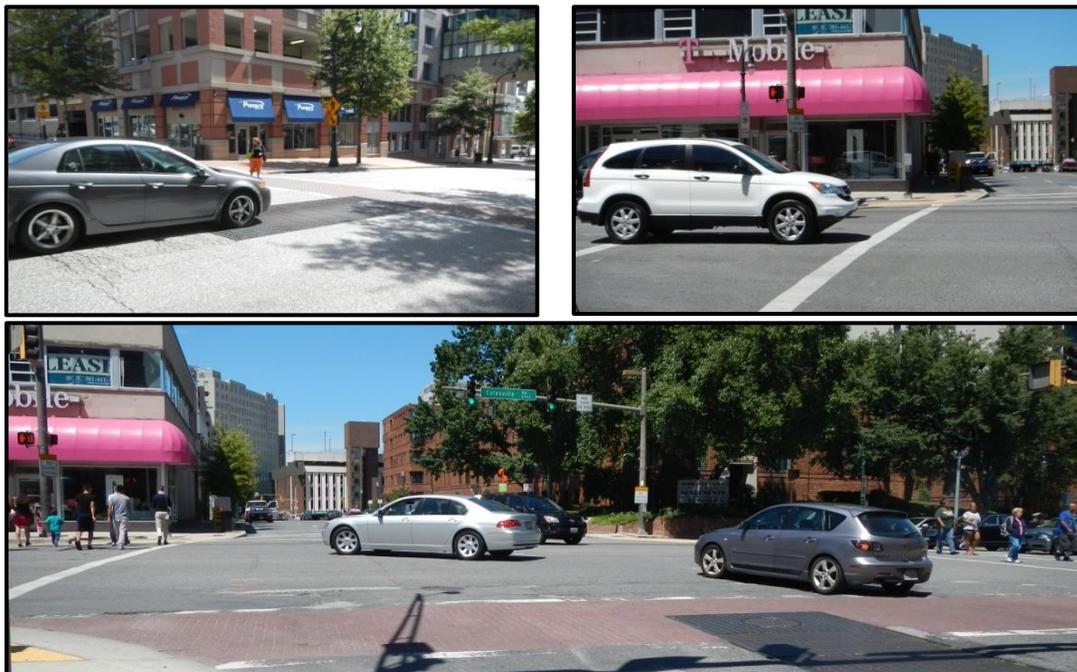
Figure 12: Pedestrian-Vehicle Conflicts

Pedestrian-vehicle conflicts, not including those involving uncontrolled midblock crossings, are comprised of turning movement conflicts at intersections and nearby access points. In many locations, drivers appeared to place more focus on finding acceptable gaps in traffic to make their maneuver than on potential pedestrian and bicycle activity. Vehicles were also observed stopping too close to the intersection and blocking crosswalks at many locations. At the intersection of Fenton Street at Wayne Avenue, queues from the eastbound approach occasionally extend past the Whole Foods Entrance, and pedestrians were observed weaving through the queued vehicles to cross Fenton Street at the Whole Foods Entrance crosswalk. At the unsignalized intersections of Roeder Road and the Whole Foods Entrance, motorists were also observed not yielding to pedestrians in the marked crosswalks. A combination of other factors including frequency of turning movements, pedestrian volume, vehicle speeds, signal phasing/timing settings, and sight distance limitations also contribute to conflicts.

Upper-left: Vehicle failing to yield to pedestrian in marked crosswalk.  
Upper-right: Vehicle stopped at intersection, blocking the crosswalk.  
Bottom: East- and westbound left-turning traffic conflict with pedestrians in crosswalks.

The PRSA team identified a number of suggestions to reduce pedestrian-vehicle conflicts. Such improvements include:

- Installing signage and stop bars to improve driver awareness of pedestrians at intersections
- Installing signage to direct left turning vehicles to yield to pedestrians

- Relocating any bus stops that currently cause buses to block crosswalks when loading or unloading
- Installing flex-posts at unsignalized intersections to prevent street parking that may impede the visibility of pedestrians

- Relocating any bus stops that are blocked by existing street parking or prohibit street parking
- Installing signage where grates and pavers are present along the sidewalk to warn pedestrians of possible slippery conditions

- Considering potential geometric roadway improvements to reduce pedestrian crossing distances, improve pedestrian refuge spaces, and/or reduce vehicle turning speeds, particularly between Colesville Road and Wayne Avenue

- Evaluating and coordinating signal improvements with MDSA, such as traffic signal reconstruction to improve signal head visibility and signal phasing modifications to better serve the pedestrian traffic

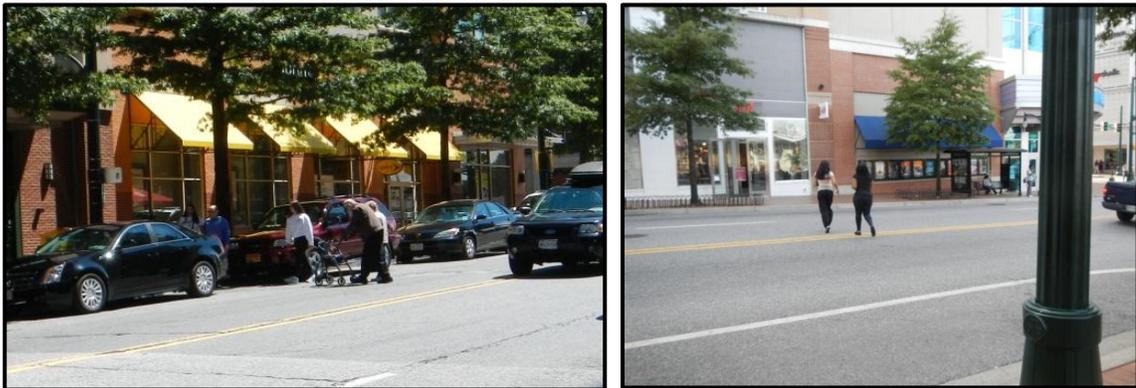
#### **Figure 13: Uncontrolled Midblock Crossings**

Pedestrians were observed crossing at unmarked midblock locations throughout the study area. These uncontrolled midblock crossings were identified as a contributing factor to five of the 21 pedestrian crashes. The location of various land uses, location of bus stops, distances between marked crossings, signal cycle lengths, pedestrian impatience, and the lack of street furniture or planter boxes to channelize pedestrians contribute to midblock crossings.

**Left: Pedestrian crossing midblock between Whole Foods Driveway and Wayne Avenue.  
Right: Pedestrians crossing midblock near the Regal Movie Theater.**

The audit team recommends combining and extending the landscaping along Fenton Street to discourage midblock crossings. Further, it is recommended that the feasibility of relocating midblock bus stops closer to intersections be evaluated in order to reduce midblock crossings.

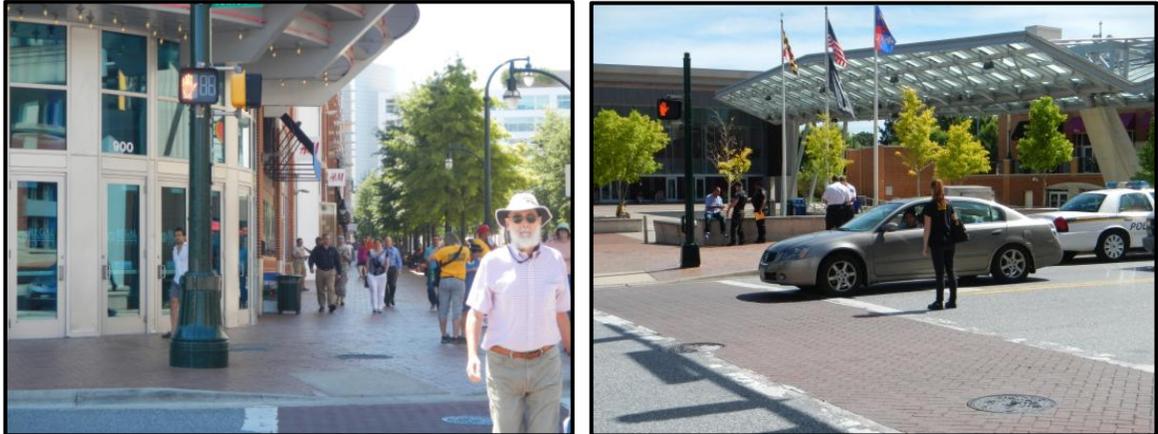
**Figure 14: Limited Pedestrian Compliance with Signals**

Pedestrians were frequently observed disregarding pedestrian signals at locations throughout the study area. In many instances, pedestrians were observed crossing during the Don't Walk intervals. Observations during the PRSA indicated that the existing pedestrian clearance intervals may be shorter than recommended by guidance from the 2011 Maryland Manual on Uniform Traffic Control Devices (MdMUTCD), which may also contribute to the disregard of pedestrian signals.

**Left: Pedestrian violating the pedestrian signal at the intersection of Fenton Street at Ellsworth Drive. Right: Pedestrian violating the pedestrian signal at the intersection of Fenton Street at Ellsworth Drive.**

In order to improve pedestrian compliance with signals, the PRSA team recommends modifying signal phasing at select signalized intersections as well as verifying the adequacy of pedestrian signal timings to accommodate the heavy demand, and adjusting timings as necessary. Also, it is recommended that community-based educational efforts be considered in conjunction with ensuring that appropriate levels of enforcement are provided to deter pedestrians from disregarding signals.

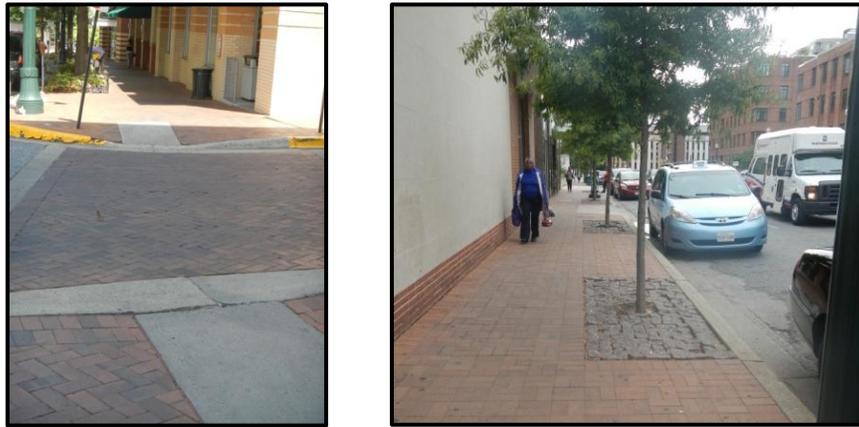
### **Figure 15: Pedestrian Facility Limitations**

A number of issues related to pedestrian facilities were observed during the audit. Examples include a lack of detectable warning surfaces, narrow crosswalks, narrow effective sidewalk widths caused by non-traversable tree pits, and crosswalk skew at the intersection of Fenton Street at Cameron Street. Further, accessible pedestrian signals in select locations had either vandalized or missing pedestrian education signage, and a number of push button mounting heights did not appear to comply with Americans with Disabilities Act (ADA) requirements.

**Left: Sidewalk ramps at Whole Foods Driveway are narrow and lack detectable warning surfaces. Right: Tree pits between Colesville Road and Cameron Street are not traversable.**

It is recommended that sidewalk ramps be reconstructed, vandalized signage be replaced, pedestrian education signs be installed where necessary, push button heights be adjusted to conform to MdMUTCD requirements, and brick-covered tree pits be replaced with traversable grates or landscaped planters. It is also recommended that crosswalks be widened to accommodate the high volume of pedestrians crossing at signalized intersections. Objects that currently block sidewalks should also be removed to provide a clear path of travel without obstructions.

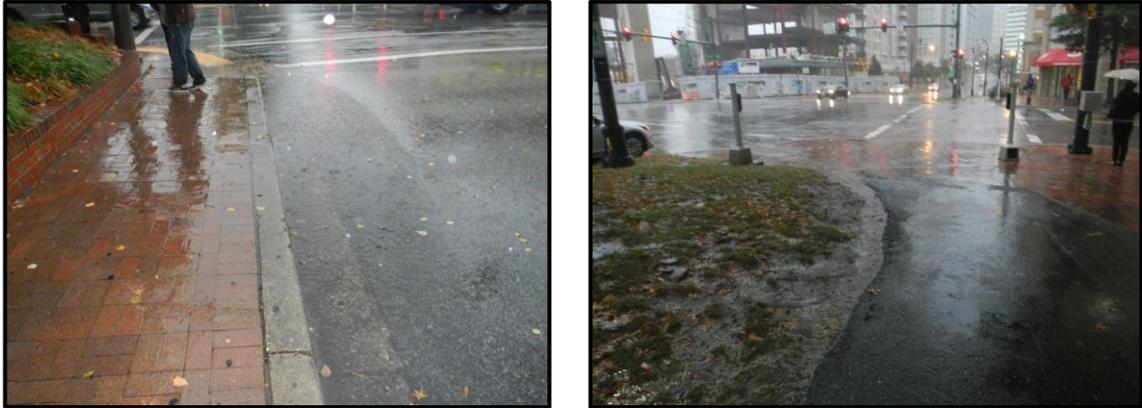
**Figure 16: Drainage Conditions**

A number of drainage issues were observed during the audit, including ponding at several intersections. A downspout at the intersection of Fenton Street at Colesville Road discharged water into the intersection and stormwater collected along the hiker-biker trail near the intersection of Fenton Street at Wayne Avenue was observed pouring into the intersection. Further, the Whole Foods Roof discharged water onto the sidewalk adjacent to the Whole Foods Driveway, leading to slippery sidewalk conditions.

**Left: Ponding near the intersection of Fenton Street at Colesville Road. Right: Drainage along the hiker-biker trail discharging into the intersection of Fenton Street at Wayne Avenue.**

In order to improve drainage conditions, the PRSA team recommends coordinating with local business owners to modify or relocate rain gutters and drainage pipes to prevent stormwater from pouring onto the sidewalks. It is expected that the resurfacing project currently planned for Fenton Street will improve the existing ponding issues along the corridor.

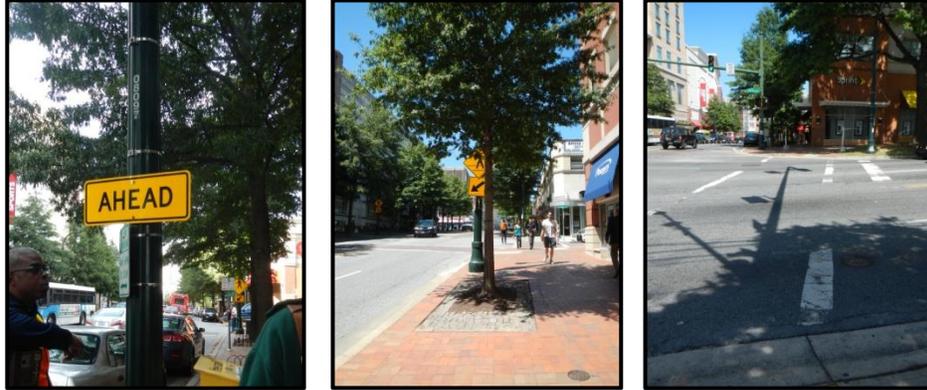
**Figure 17: Maintenance Issues**

A number of conditions were observed that may contribute to pedestrian safety issues and that could be resolved through maintenance improvements. Such issues include deteriorating pavement markings, missing, faded or non-retroreflective signage, and overgrown vegetation.

**Left: Advance pedestrian crossing sign is missing near the Whole Foods Driveway. Middle: Pedestrian crossing sign is blocked by trees. Right: Crosswalk pavement markings have deteriorated at the intersection of Fenton Street at Wayne Avenue.**

The safety concerns listed above can be improved with periodic maintenance measures including replacing faded signage when necessary, trimming overgrown vegetation around signal heads, restriping faded and missing pavement markings and crosswalks, and replacing missing or vandalized advance pedestrian crossing signs. The “STOP” sign at the driveway entrance on the south side of Fenton Street, between Cameron Street and Colesville Road, should conform to MdMUTCD requirements.
