# Pedestrian Road Safety Audit

## University Boulevard (MD 193) and Colesville Road (US 29)

Montgomery County, Maryland

**July 2011**

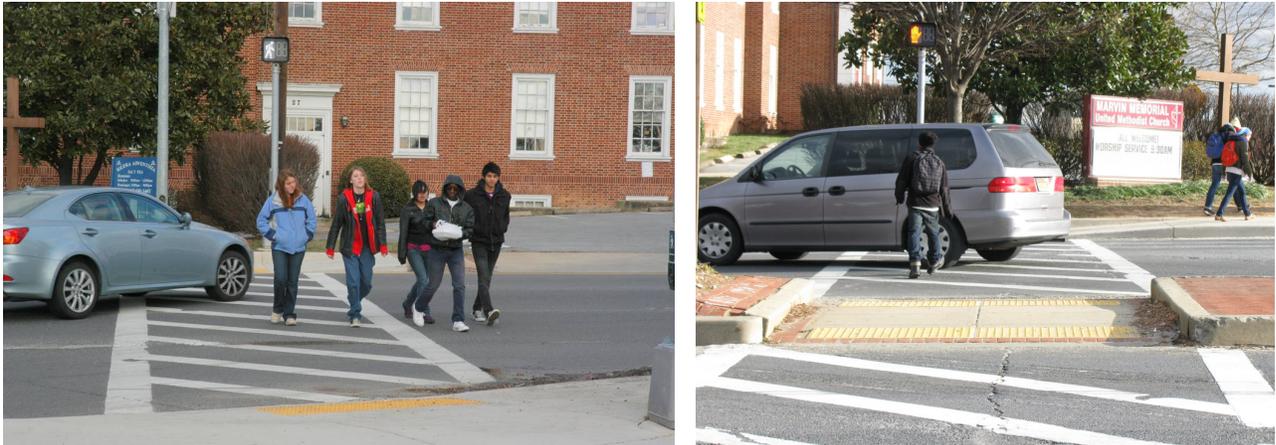
**Figure 10: Pedestrian Conflicts with Turning Vehicles**

**Pedestrian-Vehicle Conflicts** – Most pedestrian conflicts in the study area occur as pedestrians cross Colesville Road or University Boulevard. The relatively high traffic volumes, the distance to cross four or more lanes, and significant pedestrian activity in the study area lead to relatively high exposure levels for pedestrians in the area. Pedestrians were also observed violating pedestrian signals routinely. Possible contributing factors include long pedestrian wait times and long signal timings.

**Both right and left-turning traffic was observed to conflict with pedestrians at the Colesville Road/University Boulevard EB intersection. These conflicts may deter students from crossing at crosswalks.**

Safety Issue	Suggestions
<b>Pedestrian - Vehicle Conflicts</b>	<ul style="list-style-type: none"> <li>▪ Consider signage to improve driver awareness of pedestrians and reduce turning movement conflicts at intersections. (ST)</li> <li>▪ Evaluate pedestrian signal timing. (I)</li> <li>▪ Determine the feasibility of geometric roadway improvements to reduce pedestrian crossing distances or improve pedestrian refuge spaces. (I)</li> <li>▪ Remove or relocate obstructions in sidewalk. (ST)</li> <li>▪ Ensure appropriate levels of enforcement. (LT)</li> </ul>

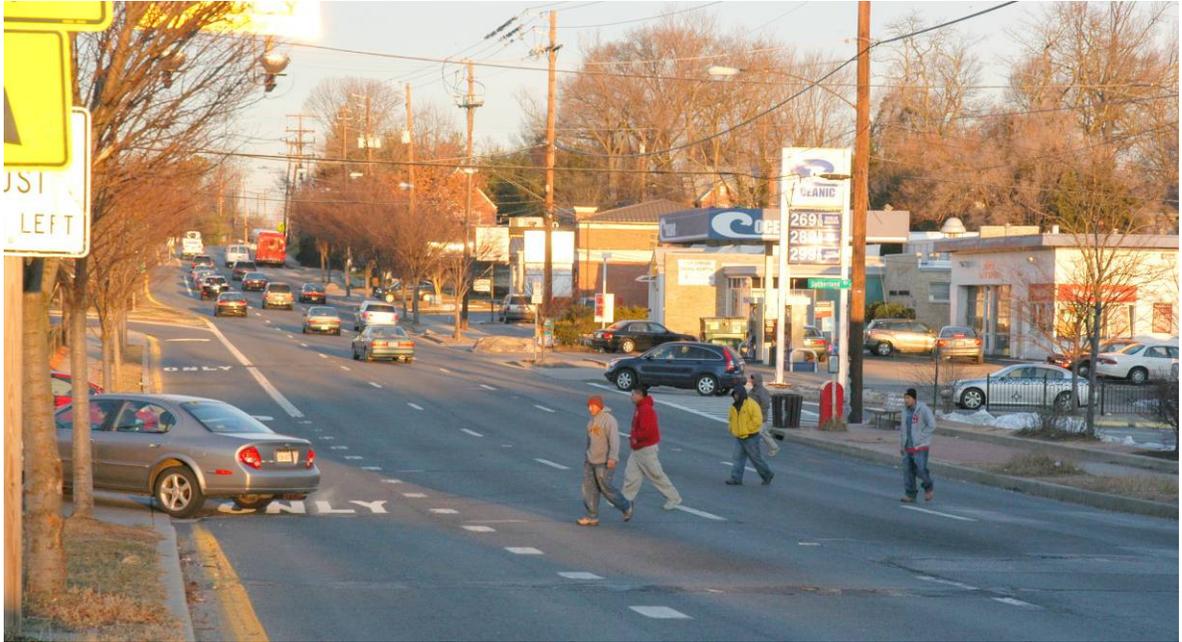
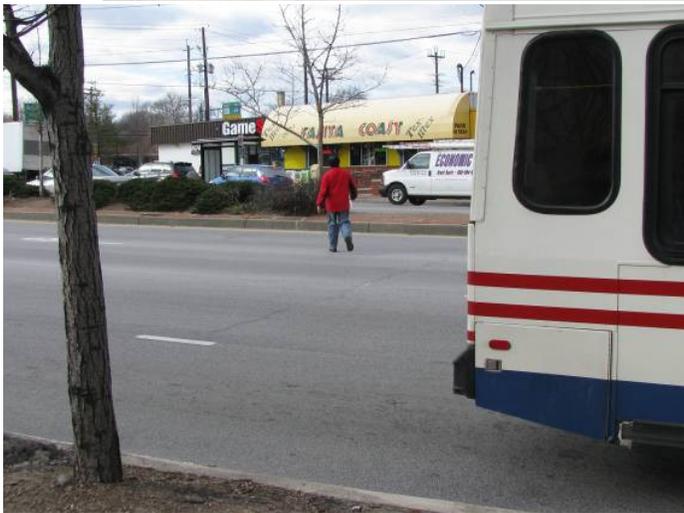
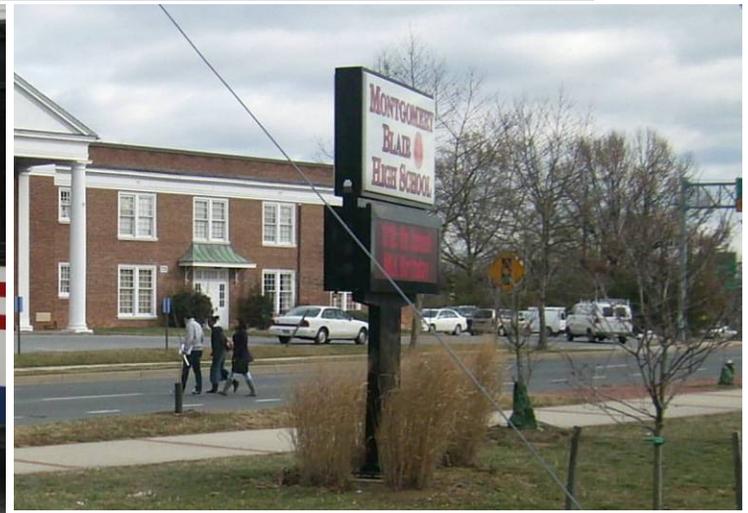
### Figure 11: Uncontrolled Mid-block Crossings

**Uncontrolled Mid-block Crossings** – Uncontrolled mid-block crossings refer to pedestrians crossing roadways at locations away from intersections and without a designated crossing treatment, such as a crosswalks or pedestrian signal. Uncontrolled mid-block crossings are prevalent throughout the corridor and were identified as one of the primary contributing factors to pedestrian collisions in the study area. Possible causes of uncontrolled mid-block crossings are the locations of various land uses, including the Blair High School and various commercial land uses, on all sides of the intersection and within the parcels between University Boulevard EB and WB. Additionally, the locations of bus stops may contribute to uncontrolled mid-block pedestrian crossing activity.

Multiple people cross University Boulevard WB between McDonald's and the bus stop near Sutherland Road (top). A pedestrian crosses the Colesville Road northbound lanes (north of University Boulevard WB) to the median after disembarking from a bus (lower left). High school students cross University Boulevard EB from the brick pavers in front of the high school (lower right).

Safety Issue	Suggestions
<b>Mid-block Crossings</b>	<ul style="list-style-type: none"> <li>▪ Consider signage to improve driver awareness of pedestrians. (ST)</li> <li>▪ Determine the feasibility and constructability of installing median or roadside barriers to deter mid-block crossings. (I)</li> <li>▪ Consider streetscape features and improvements to impede pedestrians from crossing at mid-block locations. (I)</li> <li>▪ Work with MDSHA to designate this area as a school zone and installing signage, flashing beacons, and pavement markings.</li> <li>▪ Implement a pedestrian education program. (LT)</li> <li>▪ Ensure appropriate levels of enforcement and perform targeted enforcement. (ST)</li> <li>▪ Identify potential mid-block locations to conduct a pedestrian warrant study for a signalized or high-visibility pedestrian crossing. (I)</li> <li>▪ Post additional speed limit signs where appropriate. (I)</li> </ul>

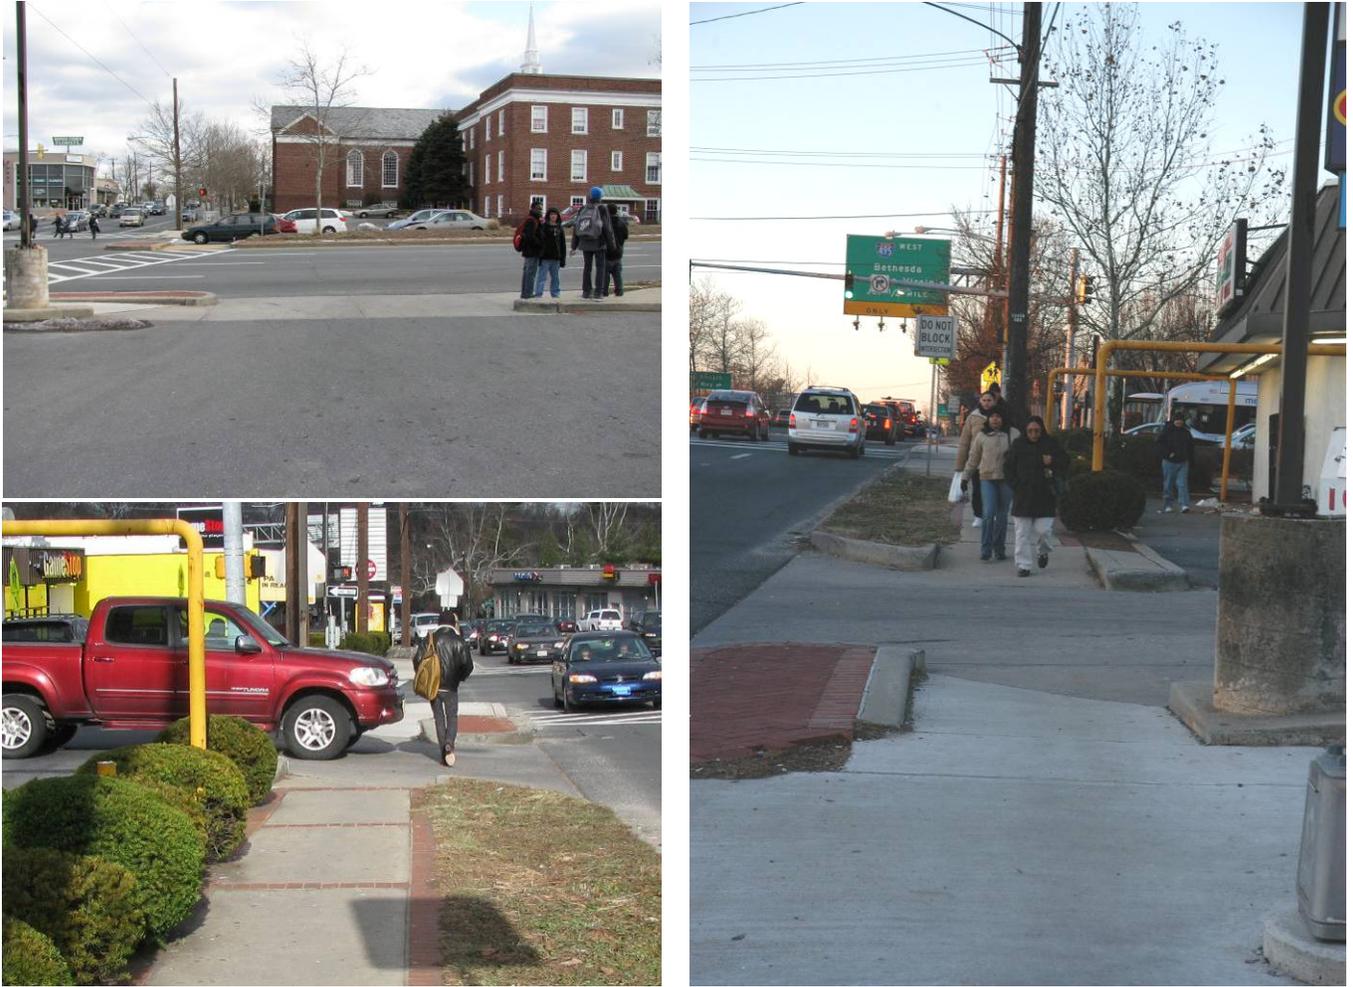
Figure 12: Commercial Driveway on Colesville Road

**Conflicts at Driveway Locations** – Commercial land uses throughout the study area contribute to significant turning movements at driveways. Driveways can introduce conflicts between pedestrians and motorists, often as a result of drivers watching for other vehicles rather than pedestrians. Closely spaced driveways increase opportunities for conflict between pedestrians and vehicles and can deter pedestrians from walking on sidewalks, in order to avoid conflicts with vehicles.

No pedestrian warning or entry prohibition signage is provided at the commercial driveway (upper left). Curbing along the wheel chair ramps (right) and vegetation at the back of sidewalk (lower left) tend to encourage pedestrians to cross in front of waiting vehicles. The crash data for this location suggests drivers are more focused on gaps in traffic than pedestrians on the sidewalk.

<b>Unmarked Crossing Locations</b>	<ul style="list-style-type: none"> <li>▪ Install high-visibility crosswalks at locations where markings should be provided or where existing crosswalks are faded. (ST)</li> </ul>
<b>Driveway Access Conflicts</b>	<ul style="list-style-type: none"> <li>▪ Consider pavement markings, such as stop bars, to discourage vehicle encroachment on pedestrian crossing paths. (ST)</li> <li>▪ Consider signage to improve driver awareness of pedestrian activity and reduce conflicts at driveways. (ST)</li> <li>▪ Work with the business community to pursue physical modifications to driveways and sidewalks to reduce conflicts at driveways. (LT)</li> <li>▪ Explore the use of different paving materials on or along sidewalks at conflict areas to delineate pedestrian pathways. (I)</li> <li>▪ Remove vegetation that limits pedestrian-vehicle visibility. (I)</li> </ul>
<b>Adverse Signage Placement or Condition</b>	<ul style="list-style-type: none"> <li>▪ Re-posting signage at standard heights and distances from the roadway. (ST)</li> <li>▪ Replace missing signage. (ST)</li> <li>▪ Relocate obstructed traffic control signage or remove obstructions. (ST)</li> <li>▪ Re-orient pedestrian crossing signage to ensure visibility by pedestrians. (ST)</li> <li>▪ Upgrade outdated signage. (ST)</li> <li>▪ Assess potential sight line obstructions when vegetation is in full bloom. (I)</li> </ul>

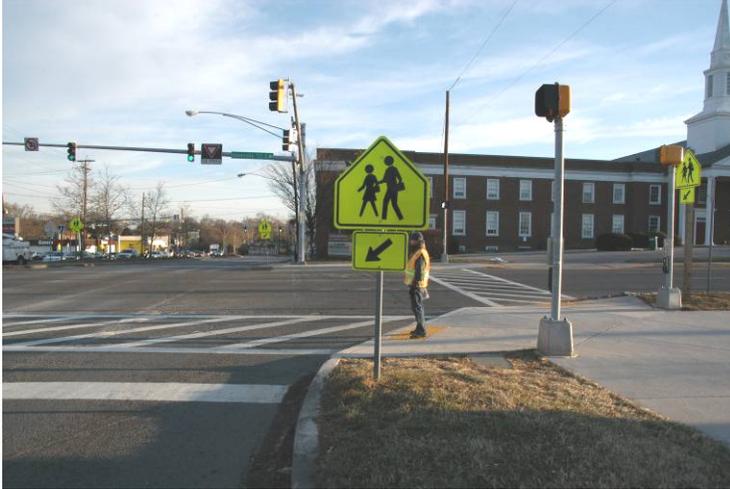
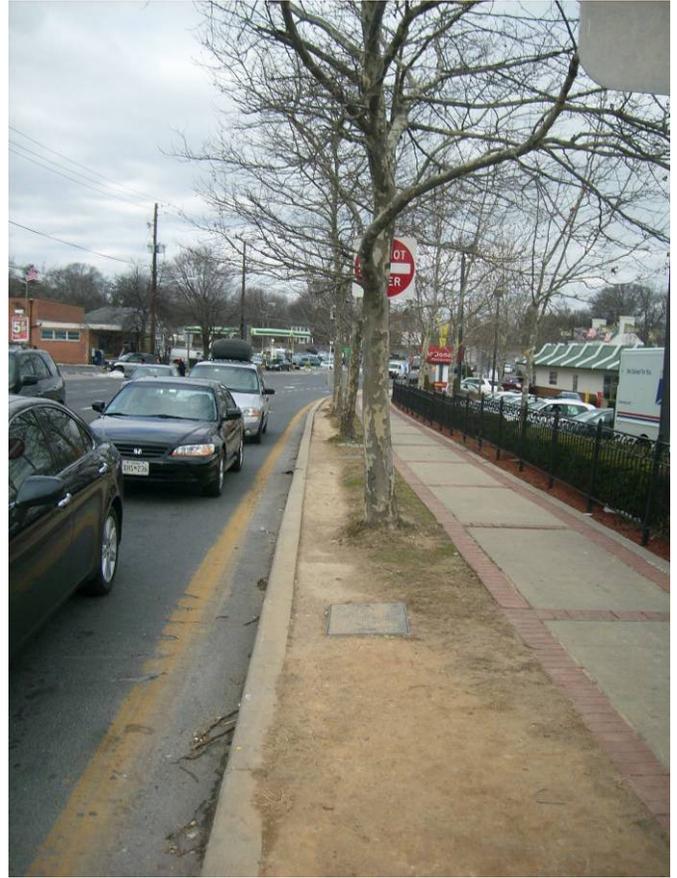
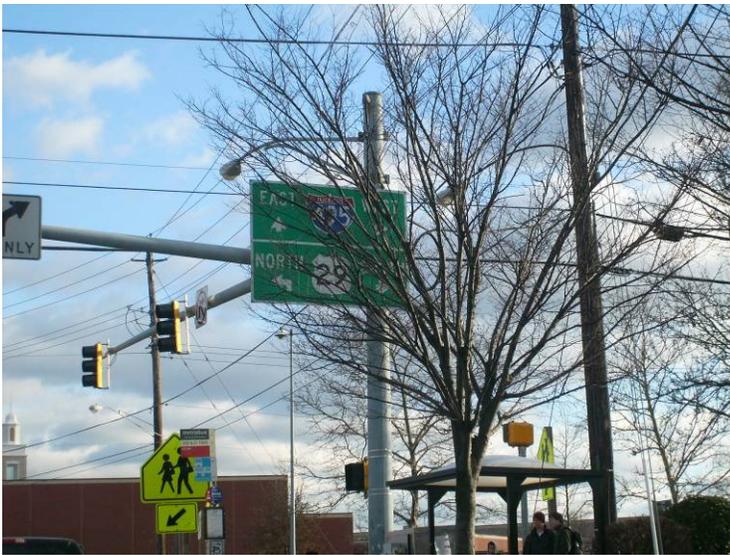
### Figure 13: Signage Obstructions

**Adverse Signage Placement or Condition** – A number of traffic control and warning signs are posted in locations that obstruct vehicle sight lines or are blocked by vegetation. Additionally, some signs were observed to be missing, faded, or worn.

Photos from the Colesville Road at University Boulevard EB intersection (clockwise from upper left): Pedestrian warning signage at the SE corner is posted too low and close to roadway, potentially blocking driver sight lines of waiting pedestrians. Do Not Enter sign on west leg is blocked by a tree. Vegetation on the SW corner partially obstructs eastbound driver views of the overhead directional signage, even in winter.

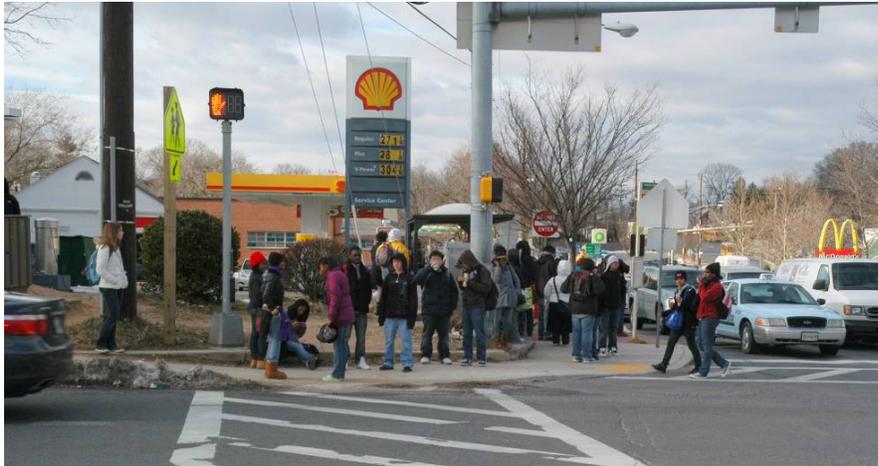
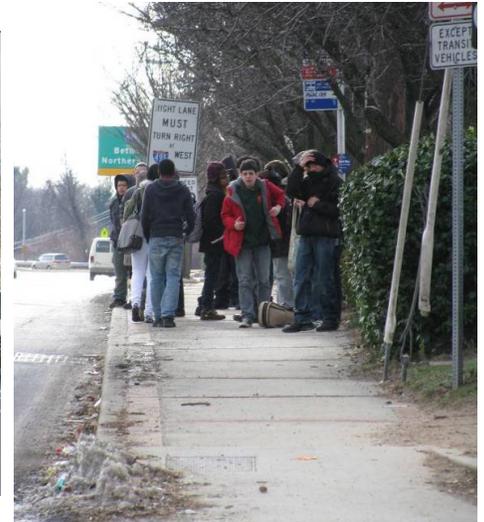
**Figure 14: Bus Stop Crowding and Sight Obstructions**

**Limited Bus Stop Waiting Area** – Significant crowding was observed at a number of bus stops in the study area during periods of peak activity. The crowding at these locations contributes to pedestrians standing very close to roadways and traffic traveling at relatively high speeds. Pedestrians were observed standing in unexpected places, having difficulty passing on the sidewalks (leading to unexpected pedestrian routes on the roadway or private property), and obstructing driver sight distance.

**Large groups of pedestrians waiting for transit buses along Colesville Road and University Boulevard (left) leave little or no room for pedestrians to pass along the sidewalk and obstruct visibility of the south leg crosswalk for right-turning vehicles. Pedestrians occupy the entire sidewalk and stand close to traffic traveling in excess of 45 mph on southbound Colesville Road, south of University Boulevard EB (right).**

<b>Limited Bus Stop Waiting Areas</b>	<ul style="list-style-type: none"> <li>▪ Coordinate with Transit Services to pursue expanding pedestrian landings and bus stop waiting areas; and installing additional bus shelters at locations with relatively high ridership. (LT)</li> </ul>
<b>Maintenance</b>	<ul style="list-style-type: none"> <li>▪ Repair defective pedestrian signals. (ST)</li> <li>▪ Report non-functioning street lighting to PEPCO for repair. (ST)</li> </ul>
