Piney Branch Road (MD 320) Pedestrian Road Safety Audit

Montgomery County, Maryland

April 2011

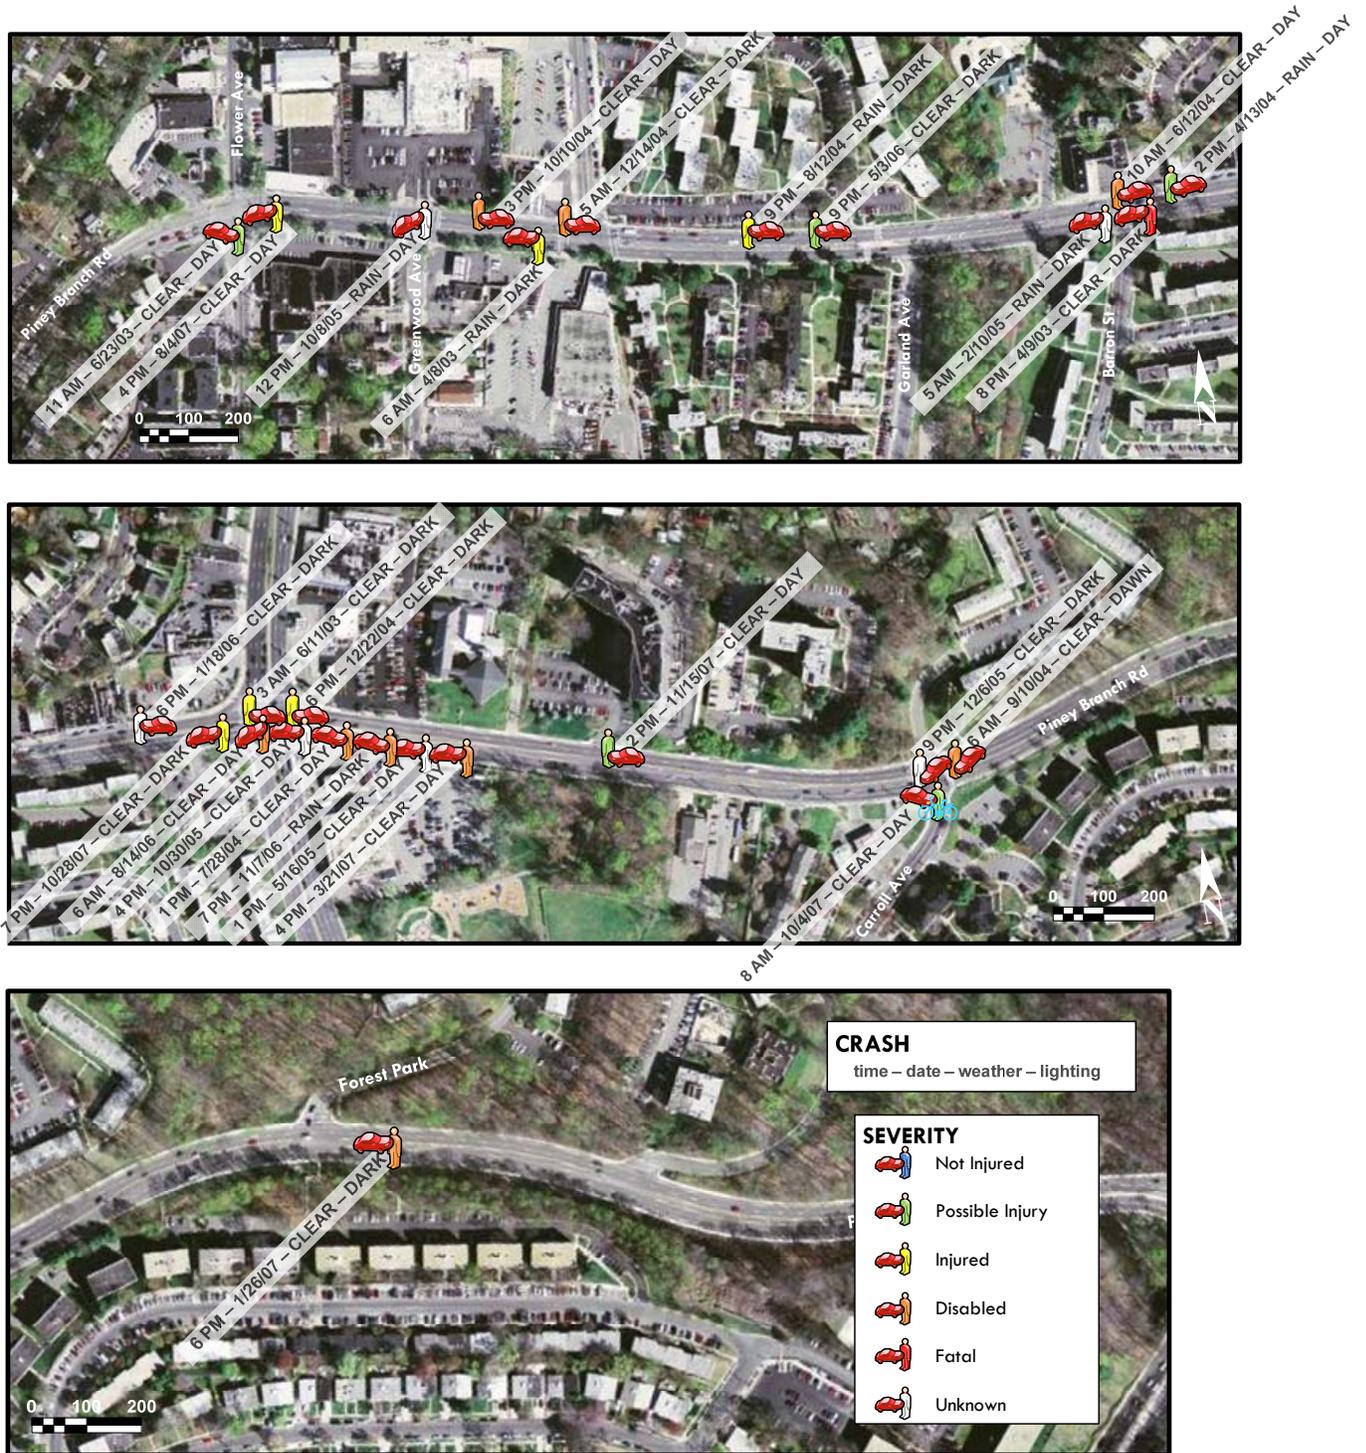
Figure 4: Pedestrian Crashes 2003-2007

There was one fatal crash reported in 2004 at the intersection of Piney Branch Road and Barron Street. The locations with the highest number of pedestrian and bicycle related crashes in descending order are the intersection of Piney Branch Road and University Boulevard, the area north of University Boulevard between the Panam Latino Market/LA Market Entrances, and the intersection of Piney Branch Road and Barron Street. All pedestrian and bicycle related crashes in the study area are illustrated on an aerial diagram in Figure 4.

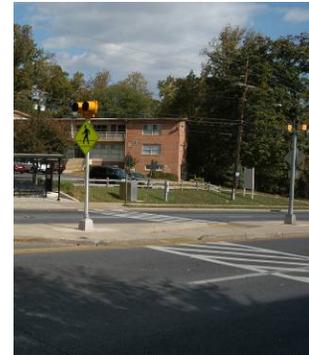
- *Continuous sidewalks:* Sidewalks within the corridor are continuous and provide a designated space for pedestrians in the corridor.
- *Mid-block crosswalk with raised concrete median and flashing beacons at Garland Avenue:* A pedestrian refuge with flashing beacons was installed just south of Garland Avenue. The median provides disabled access with detectable warning surfaces, and warning signs facing northbound and southbound traffic. The pedestrian path in the median has a “Z” configuration that allows pedestrians to have better visibility of conflicting vehicular traffic by being required to turn and face oncoming traffic before crossing from the median to the curb.

Mid-block Crossing with Flashing Beacons

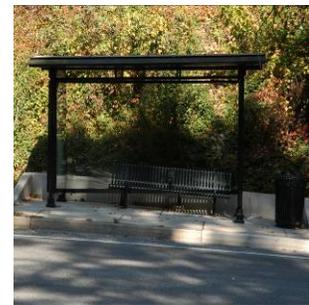
- *Enhanced bus stop shelters:* Most of the bus stop locations have enhanced bus stop shelters, with lighting and seating. Lighting is pending at a few of the bus shelters due to utility issues that are currently being addressed.

Enhanced Bus Shelter
