Pedestrian Road Safety Audit

Randolph Road From Hunters Lane to Selfridge Road

March 2018

Montgomery County
Department of Transportation

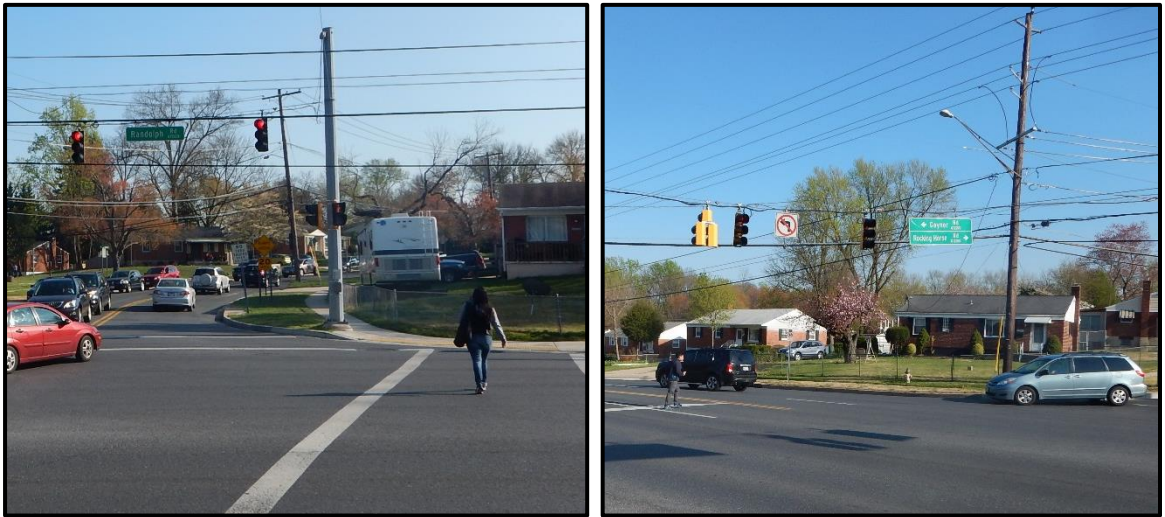
Figure 12: Examples of Pedestrian-Vehicle Conflicts

At multiple locations along the corridor, pedestrians were observed crossing outside of marked crossings or during the Don't Walk phase of the pedestrian signal. Additionally, the locations of the speed cameras may not be optimal for reducing vehicular speeds where pedestrian volumes are highest. The audit team recommends coordination with the MCDOT Pedestrian Safety Coordinator to increase pedestrian education about where and when to cross. Additionally, the audit team recommends reevaluating the location of the eastbound portable speed camera just east of the midblock crosswalk near Hunters Lane and installing an additional speed camera for westbound vehicles just west of Selfridge Road. The audit team also recommends evaluation of geometric and signal changes to reduce conflicts.

Left: Pedestrian crosses during Don't Walk phase. Right: Pedestrian crosses outside of marked crosswalk.

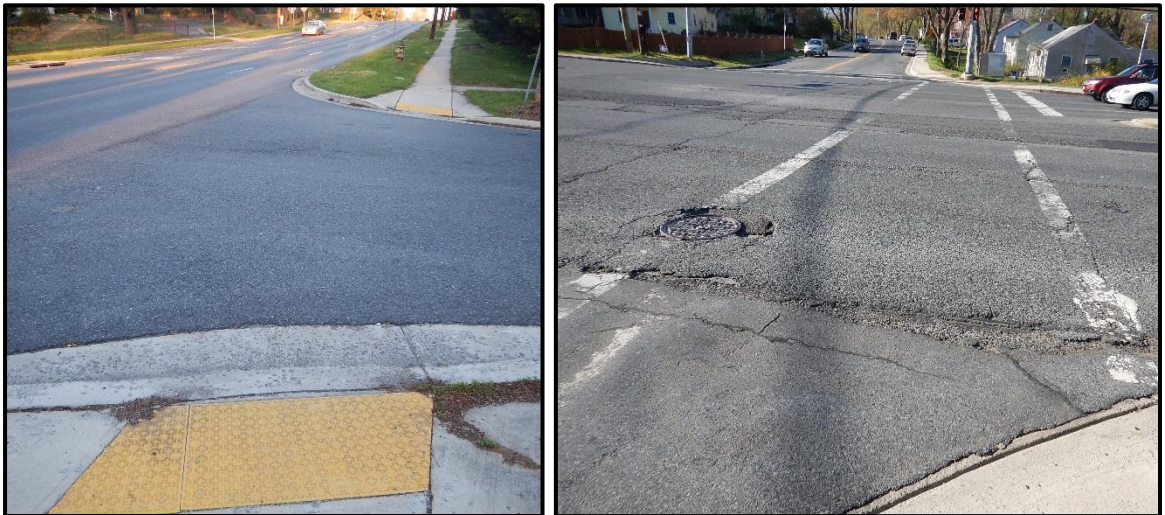
Figure 13: Examples of Pedestrian Facility Issues

A number of issues related to pedestrian facilities were observed during the audit. Examples include a lack of crosswalk markings across side-streets, faded crosswalks, and no Accessible Pedestrian Signals (APS) at some intersections.

Left: No marked crosswalks across side streets. Right: Crosswalk markings are faded.

The audit team identified a number of suggestions to improve the condition of the existing pedestrian facilities including, but not limited to, the installation of crosswalks across all side-streets, restriping pavement markings for crosswalks and stop bars along Randolph Road, evaluation of increasing sidewalk width, and installing APS where applicable.

Pedestrian Facility Issues	<ul style="list-style-type: none"> Consider installing or restriping stop bars and crosswalks, where applicable, across the side streets at unsignalized intersections. (ST) Consider installing pedestrian warning signs (W11-2), and upgrading existing signs to fluorescent yellow, along the north and south sides of Randolph Road, where applicable. (ST) Consider relocating the pavement markings and signage associated with the midblock crosswalk further from the crosswalk to meet standards. (ST) Consider replacing missing or damaged pedestrian signal visors where applicable. (ST) Consider restriping faded crosswalk markings and updating crosswalk markings to ladder markings at signalized intersections, where applicable. (ST) Consider installing high visibility ladder crosswalk markings across Randolph Road at the Rocking Horse Road/Gaynor Road intersection. (ST) Consider installing APS education signs and removing outdated education signs where applicable. (ST) Work with the Transit Services Division to evaluate the feasibility of consolidating or relocating bus stops along the corridor. (ST) Consider relocating the midblock crosswalk to the unsignalized intersection of Hunters Lane to improve driver expectancy and sight distance. (LT) Evaluate the feasibility of relocating utility poles or signal poles currently impeding the sidewalk. (LT) Consider installing Accessible Pedestrian Signals (APS) where applicable. (LT) Evaluate the pedestrian crossing times at the signalized intersections to ensure that the Flashing Don't Walk interval meets standards. (LT) Evaluate the feasibility of widening sidewalk along the corridor to provide a minimum of five feet of walkable space. (LT)

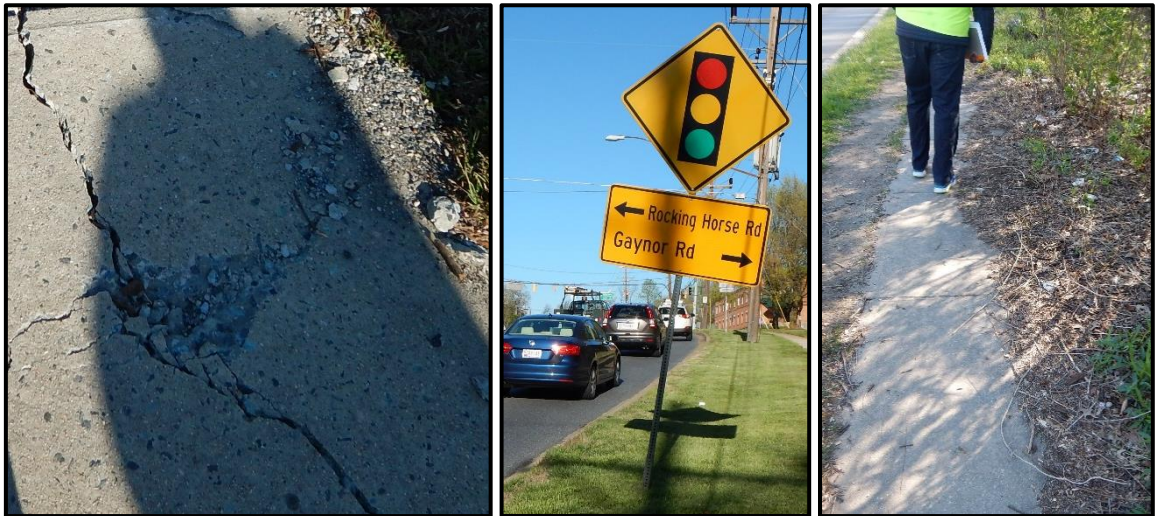
Figure 14: Examples of Maintenance Issues

A number of conditions were observed that may contribute to pedestrian safety issues and that could be resolved through maintenance improvements. Such issues include signs that are damaged and sidewalk that is damaged or overgrown with vegetation.

Left: Damaged sidewalk on the north side of Randolph Road. Center: Sign is leaning east of Rocking Horse Road. Right: Overgrown vegetation greatly reduces sidewalk width.

The audit team recommends that all damaged or missing signs be replaced and that all foliage along the sidewalk be trimmed to maintain the full available width of walkable space. The condition of the sidewalk should be assessed along Randolph Road and the feasibility of repairs should be evaluated.

Maintenance	<ul style="list-style-type: none">▪ Trim the foliage along and above the sidewalk. (ST)▪ Replace all damaged signage throughout the study area. (ST)▪ Consider replacing the mast arm signal heads on westbound Randolph Road approaching Dewey Road with LED signal heads. (LT)▪ Assess the condition of damaged sidewalk and determine the feasibility of repairs. (LT)
Lighting	<ul style="list-style-type: none">▪ Inspect street lighting throughout the corridor and repair or replace as necessary. (ST)▪ Determine the feasibility of additional street lighting at locations where pedestrians cross Randolph Road. (LT)
