Pedestrian Road Safety Audit

East Gude Drive
From Calhoun Drive to Southlawn Lane

May 2015

Montgomery County
Department of Transportation

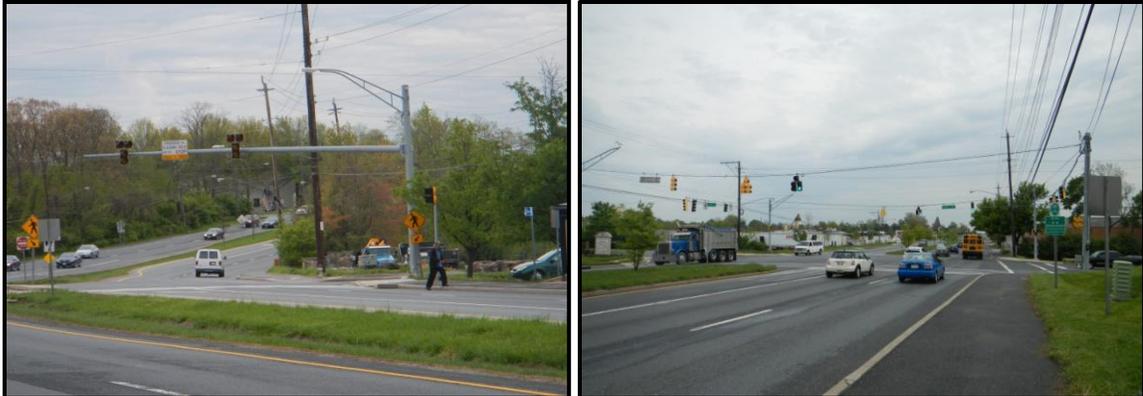
Figure 11: Examples of Non-Compliance with Signals and Signing/Marking

Pedestrians were observed crossing at the modified HAWK signal without using the push-button. Additionally, pedestrians were observed crossing outside of the marked sidewalk due to the location of the bus stops on the north and south sides of East Gude Drive near the modified HAWK signal. Motorists appeared to be confused by the modified HAWK signal as the north- and southbound approaches stop independently and motorists did not usually come to a complete stop during the flashing red indication. Observations during the audit indicated that the existing pedestrian clearance intervals at some intersections may be shorter than recommended by guidance from the 2009 MUTCD, which may lead to pedestrians starting to cross during the Flashing Don't Walk indication.

During the audit, motorists were observed ignoring the existing lane configuration pavement markings on the southbound approach at Calhoun Drive and the eastbound approach at Dover Road. At locations where compliance with lane use is low, lane use signs should be installed and pavement markings should clearly indicate the lane use on the approach to reduce confusion.

Left: Pedestrian crossing at the modified HAWK signal without activation and outside of the crosswalk.
Right: Lane configurations are not supported by lane use signs on the eastbound approach at Dover Road.

The audit team identified a number of suggestions to improve compliance and understanding at the modified HAWK signal. During the stakeholder meeting, the MCCH representatives were unaware that a push button must be activated for each stage of the crossing. The audit team recommends coordinating with the MCCH to implement a pedestrian safety program for its clients. As of the date of this report, coordination is underway between the MCCH staff and the Montgomery County Pedestrian Safety Coordinator. In addition, it is suggested the use of an alternative mode of operation be considered to

reduce pedestrian and driver confusion. Police enforcement to target drivers that do not comply with the modified HAWK signal should be considered, as well.

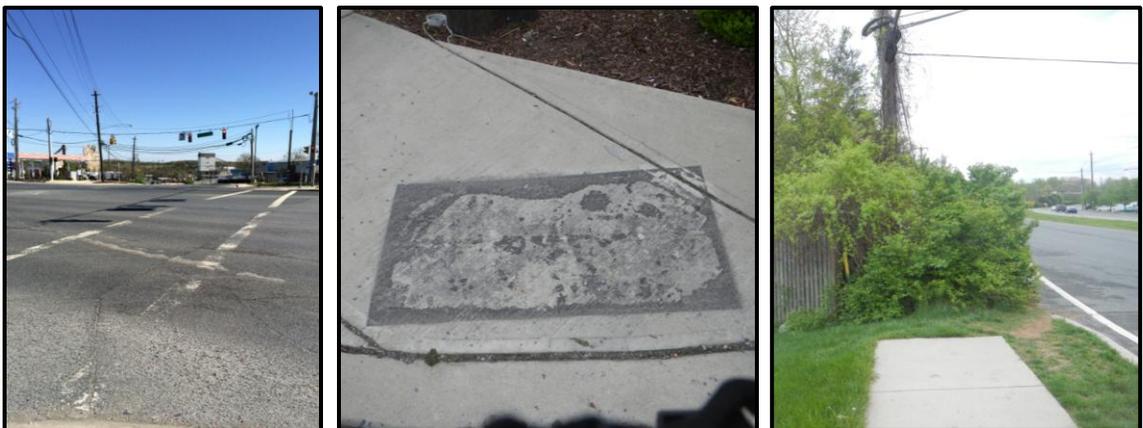
Figure 12: Examples of Pedestrian Facility Issues

A number of issues related to pedestrian facilities were observed during the audit. Examples include a lack of detectable warning surfaces, missing sidewalks, faded crosswalks, and insufficient crossing times. Further, the existing pedestrian ramps at some intersections are not aligned correctly and direct pedestrians into the center of the intersection, and did not appear to comply with ADA requirements.

Left: Crosswalk at E Gude Drive at Southlawn Lane is faded. Center: Missing Detectable Warning Surface near Liberty Gas Station. Right: Sidewalk ends prior to the MCCH driveway.

The audit team identified a number of suggestions to improve the condition of the existing pedestrian facilities including, but not limited to, the installation of detectable warning surfaces on all pedestrian ramps and high-visibility pavement markings for crosswalks along East Gude Drive. Additionally, ADA compliance should be verified at all existing pedestrian ramps and the adequacy of pedestrian signal timings should be verified, as well. The sections of missing sidewalk, particularly near high pedestrian generators such as the MCCH, should be constructed to ensure connectivity of the pedestrian network.

Pedestrian Facility Issues	<ul style="list-style-type: none"> ▪ Install Detectable Warning Surfaces (DWS), where necessary, to comply with ADA requirements. (ST) ▪ Replace crosswalk pavement markings that are faded and difficult to see. (ST) ▪ Verify the adequacy of pedestrian signal timing and adjust as necessary to comply with 2011 MdMUTCD guidance. (ST) ▪ Verify that all curb ramps and driveways are ADA compliant. (ST) ▪ Consider installing gas main covers that are mounted flush with the trail surface. (ST) ▪ Consider installing shared-use signage along the Millennium Trail. (ST) ▪ Consider installing shared-use crosswalk markings for the Millennium Trail crosswalks. (ST) ▪ Evaluate the possible need for additional pedestrian signal heads. (I) ▪ Consider reconstructing sidewalk ramps to align with adjacent crosswalks and comply with ADA requirements. (LT) ▪ Install push buttons with APS. (LT) ▪ Consider reconstructing medians to provide a pedestrian refuge area, if feasible and evaluate the need for push-buttons in the median. (LT) ▪ Install the missing sections of sidewalk along the corridor. (LT) ▪ Consider building shelters at bus stops where applicable. (LT) ▪ Consider geometric modifications at some intersections to reduce crossing distances. (LT) ▪ Install the missing section of sidewalk along the northern side of East Gude Drive between the shelters' driveway and Executive Wholesale Tire. (LT) ▪ Consider installing a buffer along the Millennium Trail where feasible. This could include installing a context-sensitive, non-traversable buffer and/or utilizing excess median width to shift existing travel lanes and increase shoulder width to allow for a grass buffer to be installed. (LT)

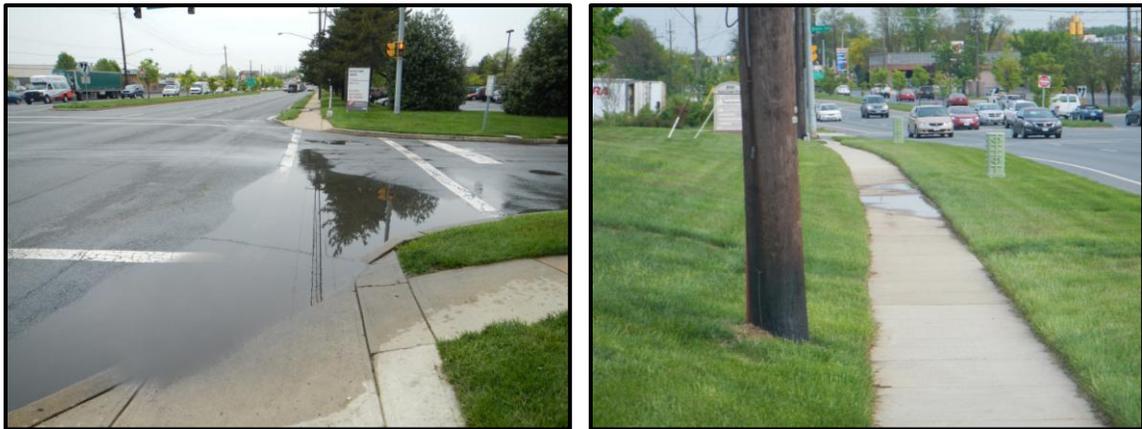
Figure 13: Examples of Drainage Conditions

A number of drainage issues were observed during the audit, including ponding at several intersections. Water was also observed ponding on the Millennium Trail, which may deter pedestrians or cyclists from using the trail during or after inclement weather.

Left: Ponding near the intersection of E Gude Drive at Calhoun Drive.
Right: Water ponds along the sidewalk between the MCCH and Dover Road.

The audit team recommends that surface improvements be considered along East Gude Drive and the Millennium Trail to prevent the formation of standing water.

Drainage Conditions	<ul style="list-style-type: none"> ▪ Consider surface improvements at intersections and along the Millennium Trail where water pooling occurs. (LT)

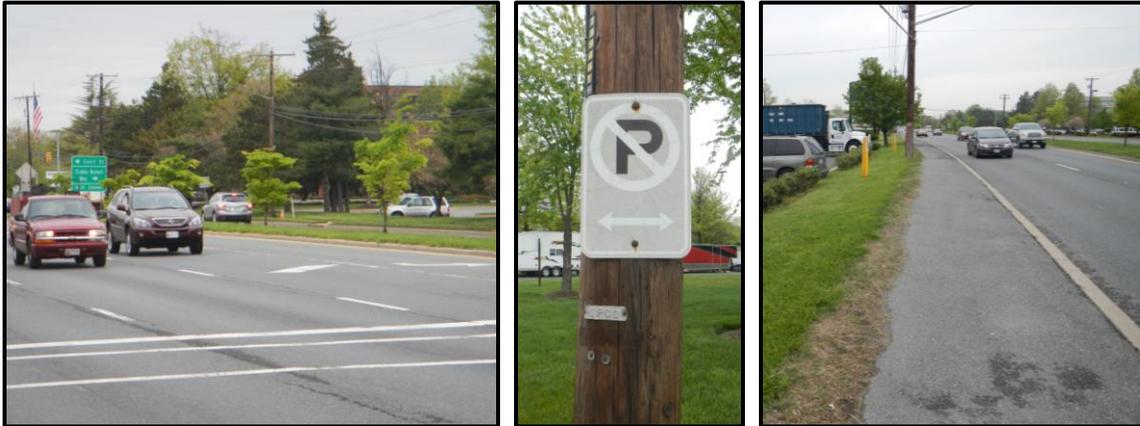
Figure 14: Examples of Maintenance Issues

A number of conditions were observed that may contribute to pedestrian safety issues and that could be resolved through maintenance improvements. Such issues include deteriorating pavement markings, missing, faded or non-retroreflective signage, and overgrown vegetation. Additionally, multiple pedestrian signal heads along the corridor were observed to be nonfunctioning.

Left: Lane drop pavement marking arrows near Calhoun Drive are faded. Center: Sign is faded and is non-retroreflective. Right: Overgrown vegetation on the Millennium Trail reduces the effective trail width.

The audit team recommends that all signage and pavement markings be replaced or updated to meet the 2011 Maryland Manual on Uniform Traffic Control Devices (MdMUTCD) standards. In addition, overgrown vegetation should be trimmed or removed to increase the effective sidewalk widths and allow all signage and signals to be seen or accessed.
