# SCHOOL-RELATED CRASH REVIEW

**Location:** Bushey Drive, North of Minden Road

**Crash Date:** January 10, 2024

**Local Case No.:** 240001460

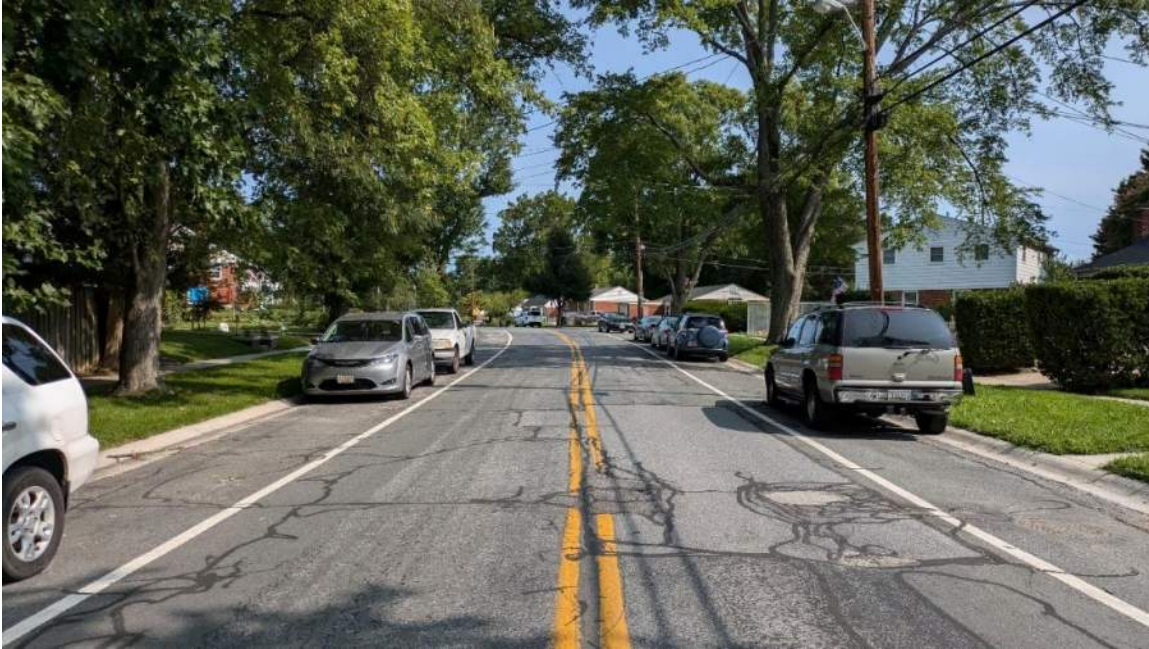
On Wednesday, January 10, 2024, at approximately 8:53 AM, a motorist traveling southbound along Bushey Drive struck a student walking along southbound Bushey Drive. The student was walking in the roadway. The collision occurred approximately 75 feet north of the intersection with Minden Road. Weather conditions were cloudy, the roadway surface was wet, and it was daylight. The student suffered minor injuries.

**Photo 1. Bushey Drive looking north towards Elby Street. Approximate crash location.**

1. Coordinate with elementary school staff to encourage students to use existing sidewalk facilities.
2. Consider conversion of the Bushey Drive at Elby Street intersection to all-way stop control due to poor sight lines resulting from roadway curvature and vehicular speeds. This intersection is one block south of Sargent Shriver ES and less than one block from the crash location.

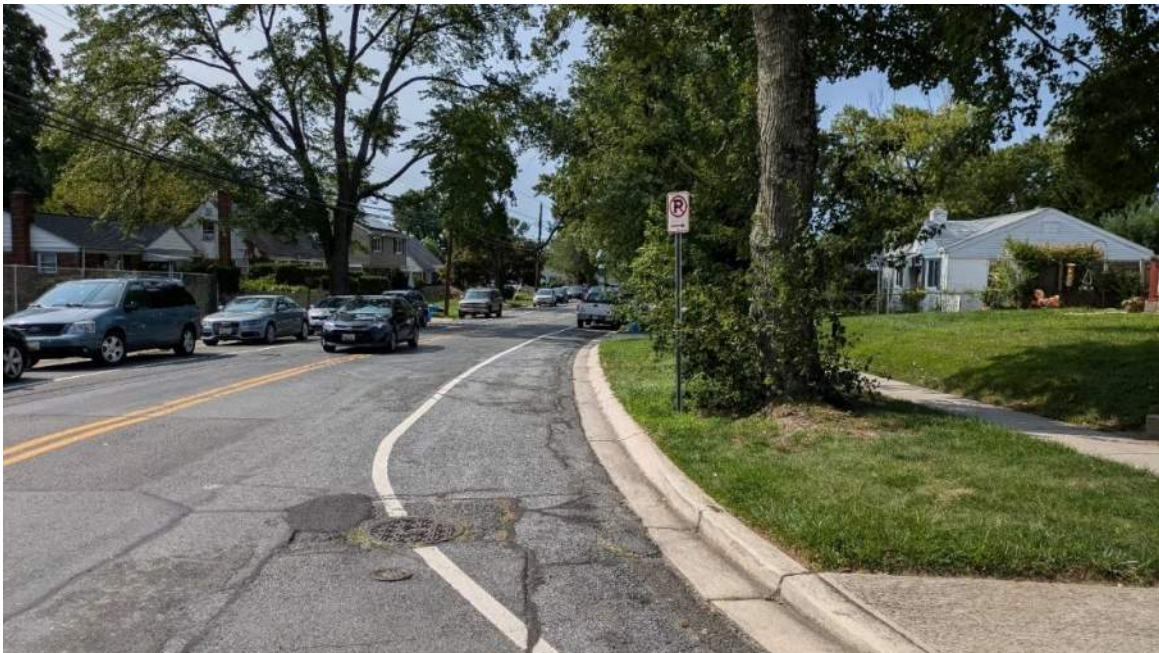
**Photo 2. Limited sightline due to on-street parking and horizontal curve looking south along Bushey Drive from Elby Street intersection.**

3. Consider quick-build or curb line modifications at Bushey Drive intersections with Elby Street and Minden Road to “daylight” the intersections and provide better sight lines. Daylighting will open sight lines approaching the intersections, shorten crossings, physically prevent motorists from parking unlawfully, and promote traffic calming by narrowing the travel ways.

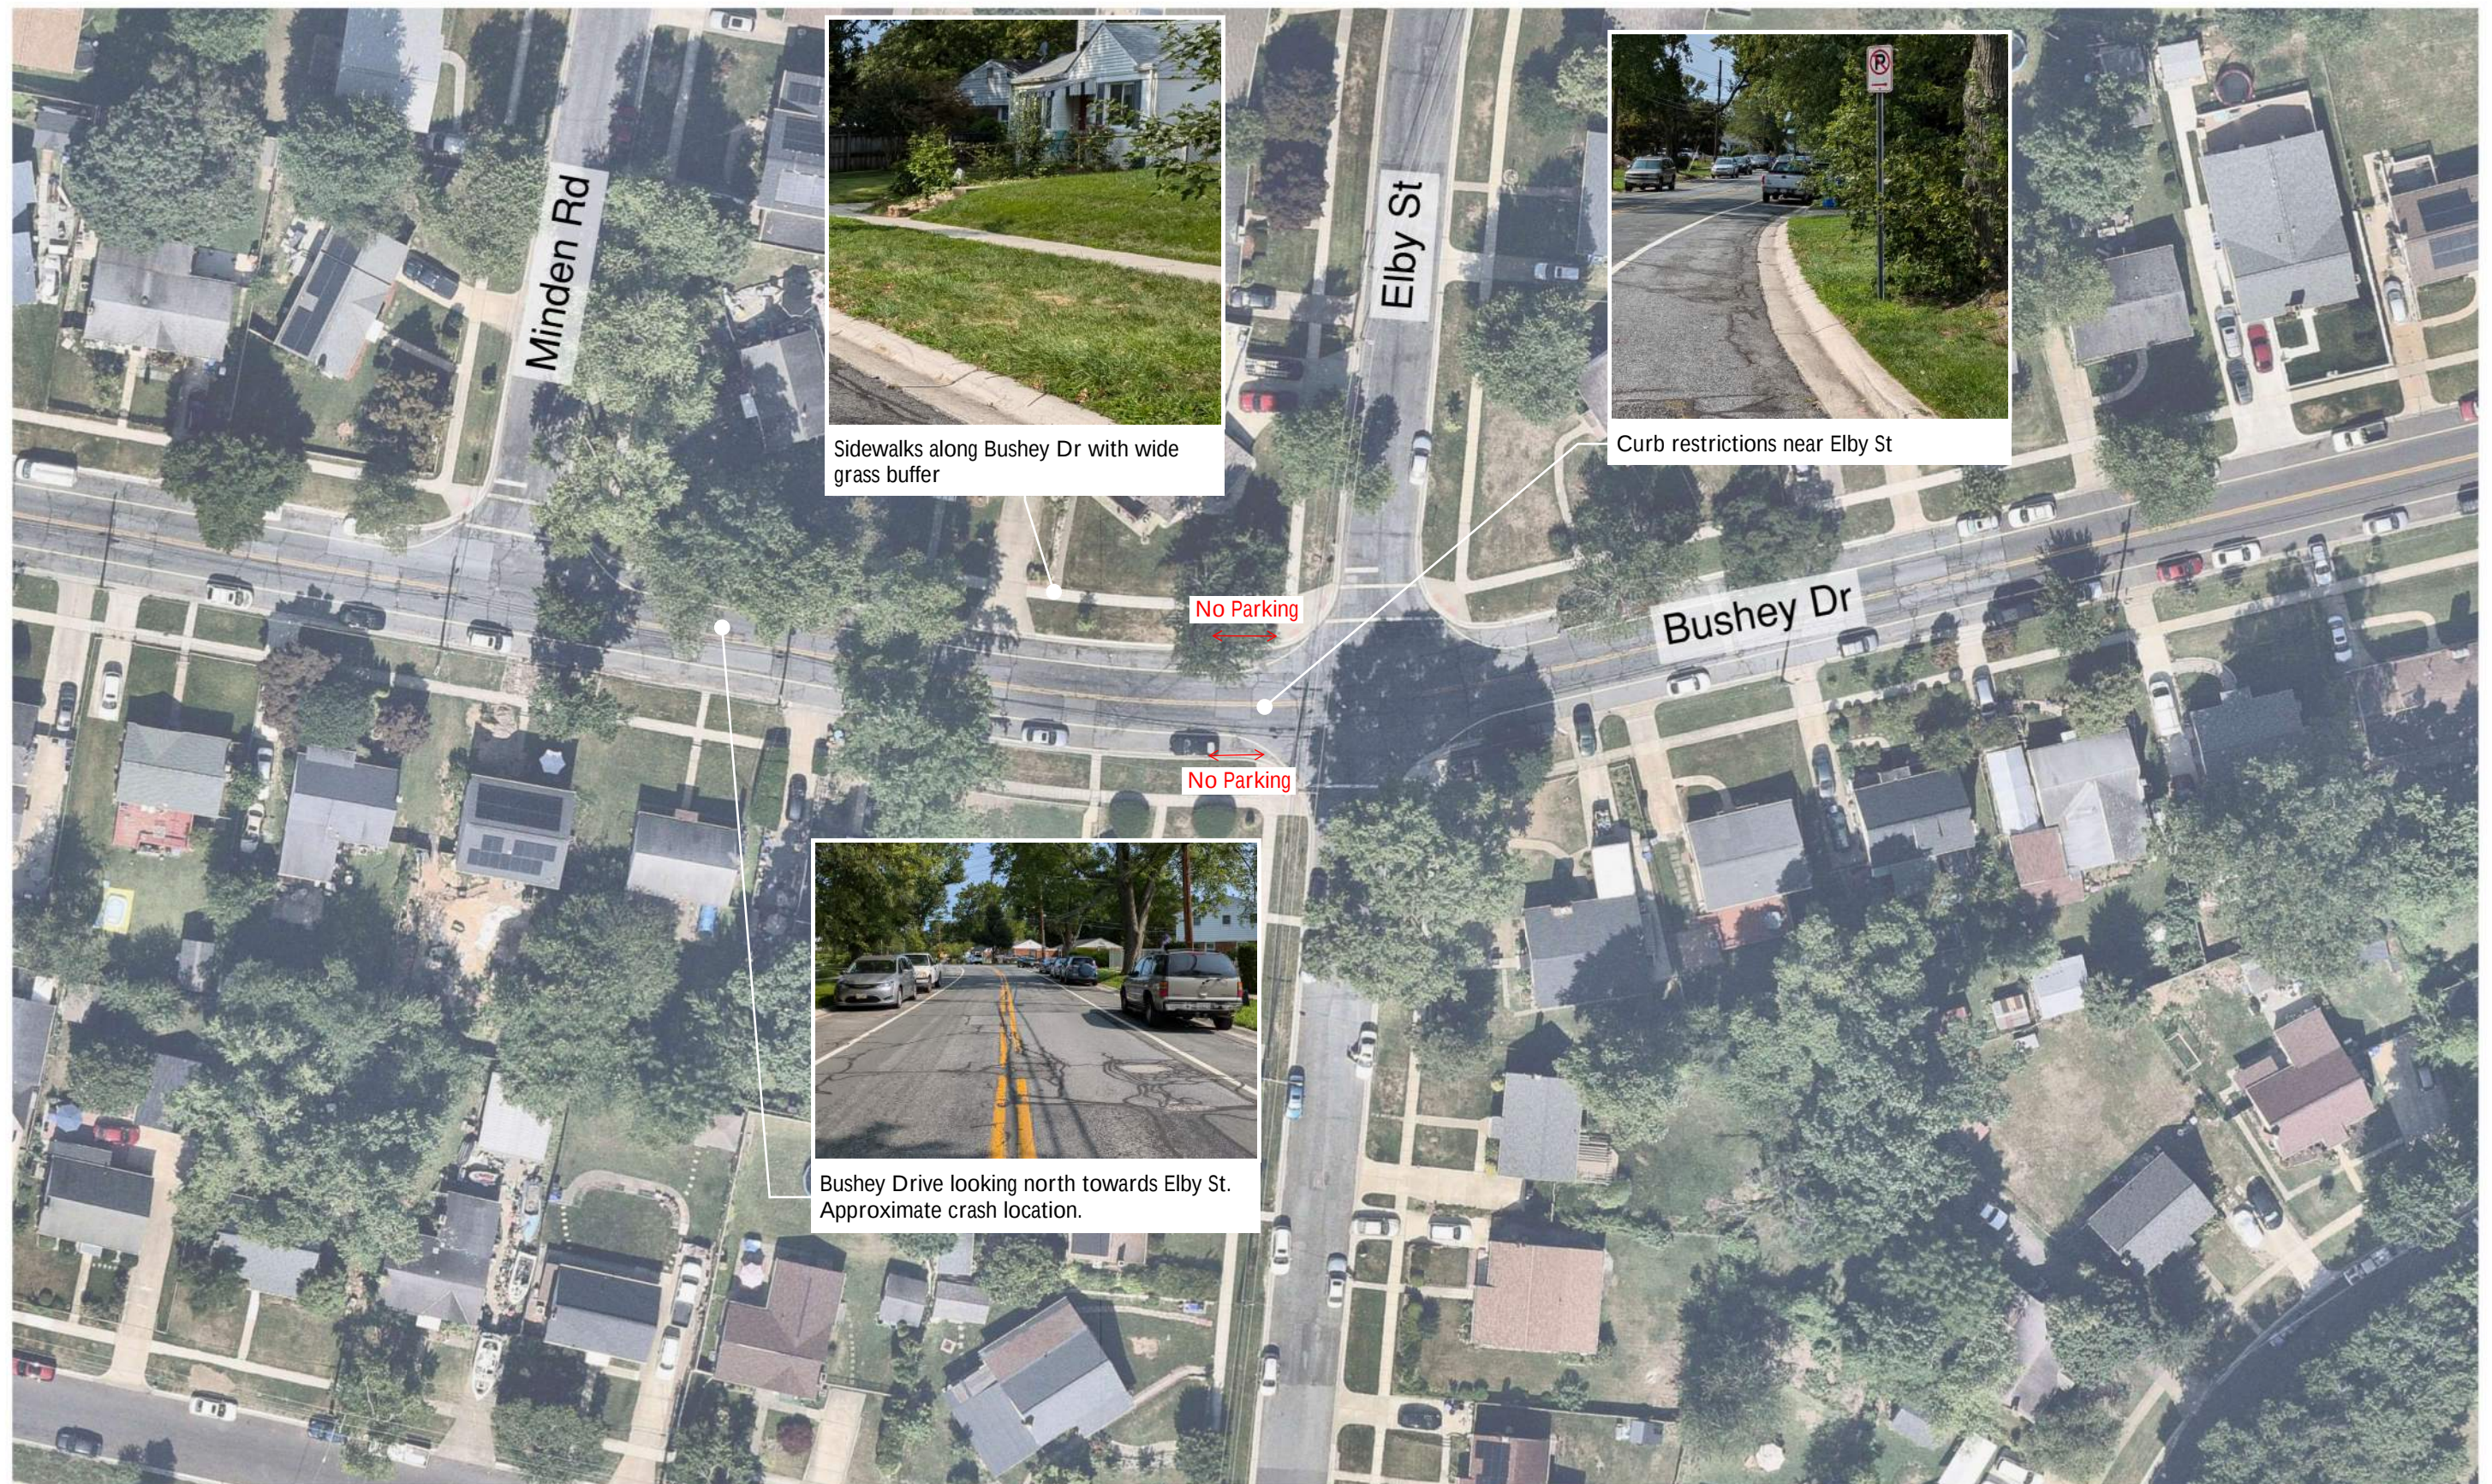
Figure 1 - Bushey Drive Corridor Observations

The Bushey Drive corridor was evaluated to identify potential infrastructure, maintenance activities, and road user behaviors that contribute to increased safety risk at and in the vicinity of the school-related crash location. The Bushey Drive corridor was reviewed between Randolph Road to the south and Elby St to the north. There is a horizontal curve along this segment near Elby Street approaching the location where the incident occurred. This curve constrains lines of sight and observations. Please refer to **Figure 1** for additional information.

Field observations were performed on Wednesday, August 21, 2024, at 12pm. Weather conditions were clear, and the roadway surface was dry. There was low pedestrian activity due to the time of day and the fact that school was not in session. Vehicles were observed rolling through (not coming to a full stop) stop signs at both Elby Street and Minden Road. Additionally, vehicles were observed traveling faster than was appropriate for conditions and crossing over the double yellow centerline along Bushey Drive between Elby St and Minden Road where the crash occurred. Vehicles crossing over the double yellow centerline may be due to the lane widths (10 feet) in conjunction with eight-foot wide, on-street parking facilities in both directions along Bushey Road. On-street parking was consistent along the corridor, which reduces sight lines at intersections, driveways, and along curves through the corridor. Pavement markings are in fair condition.

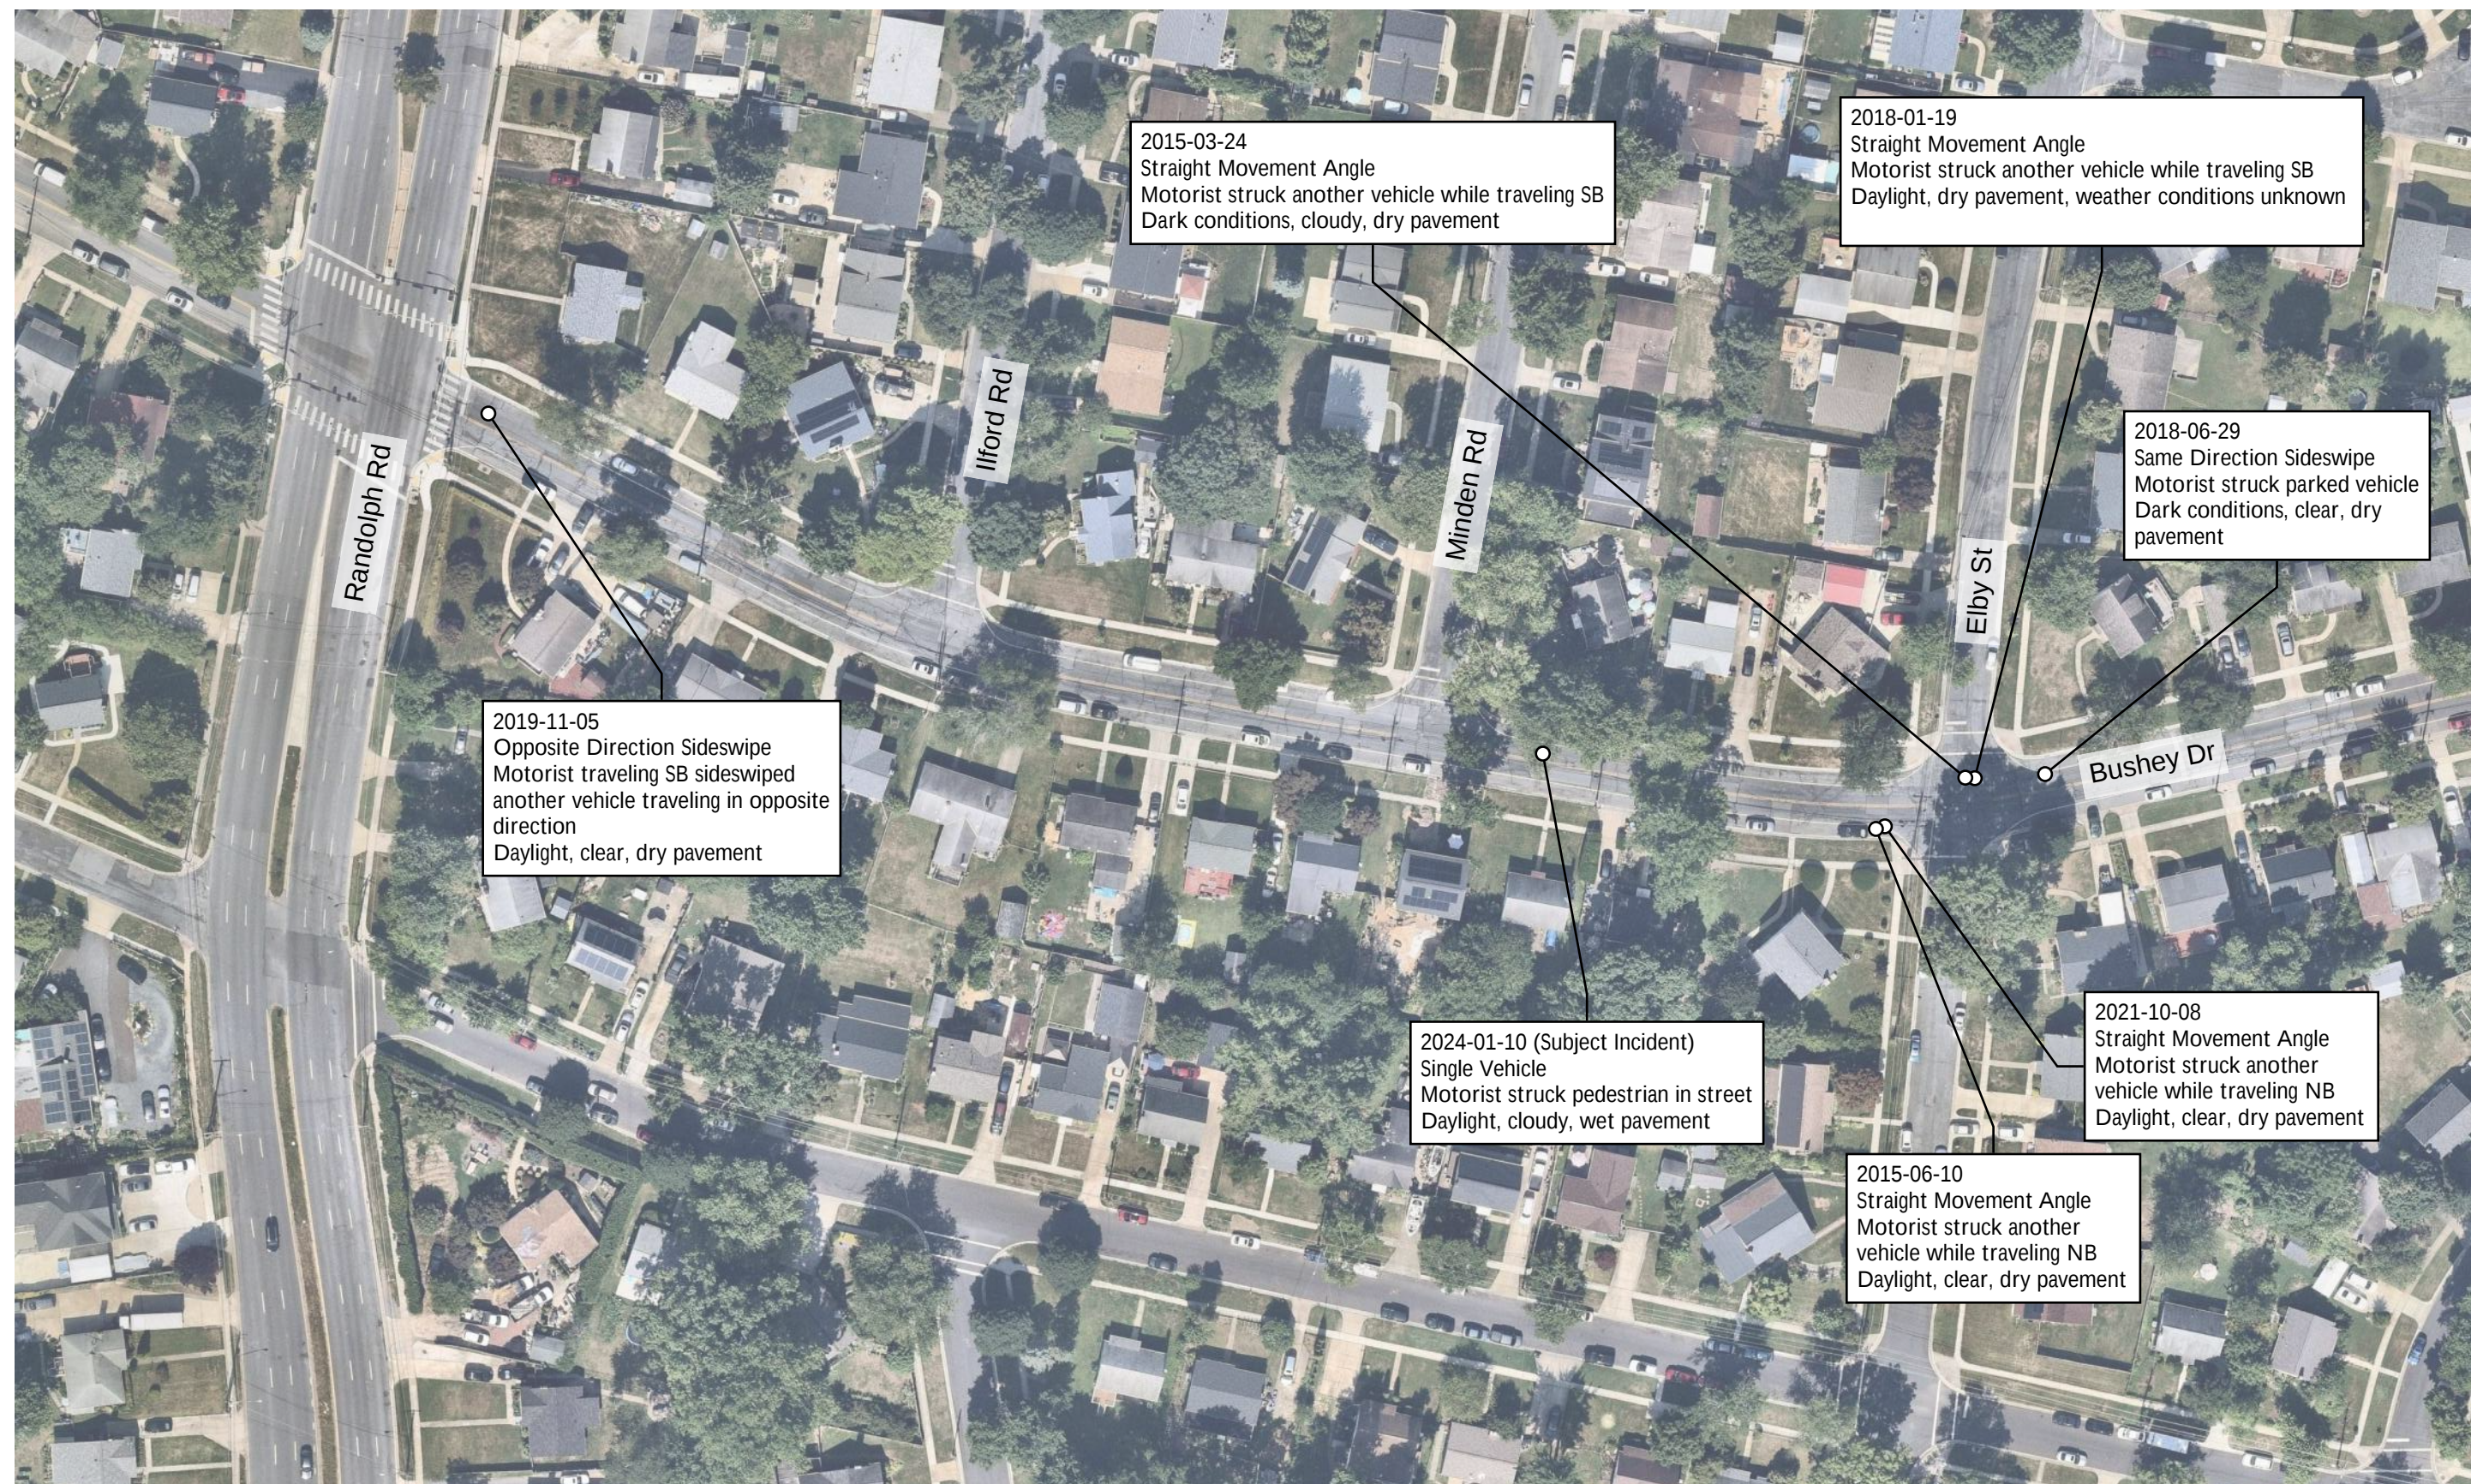
Figure 3 - Crash History (2015-2024)

Crash data obtained from dataMontgomery provides information for seven (7) incidents along Bushey Drive between March 2015 and September 2024. Five (5) incidents occurred at the intersection of Bushey Drive and Elby Street, one block south of the subject crash location. The other two (2) crashes occurred along Bushey Drive near the intersections at Randolph Road and Minden Road, including the subject incident. Four (4) of the crashes were classified as a straight movement angle collision and two (2) were sideswipes. The incidents and locations are illustrated on **Figure 3**.
