SCHOOL-RELATED CRASH REVIEW

Location: Rippling Brook Drive at Bel Pre Elementary School

Crash Date: May 23, 2024

Local Case No.: 240024489

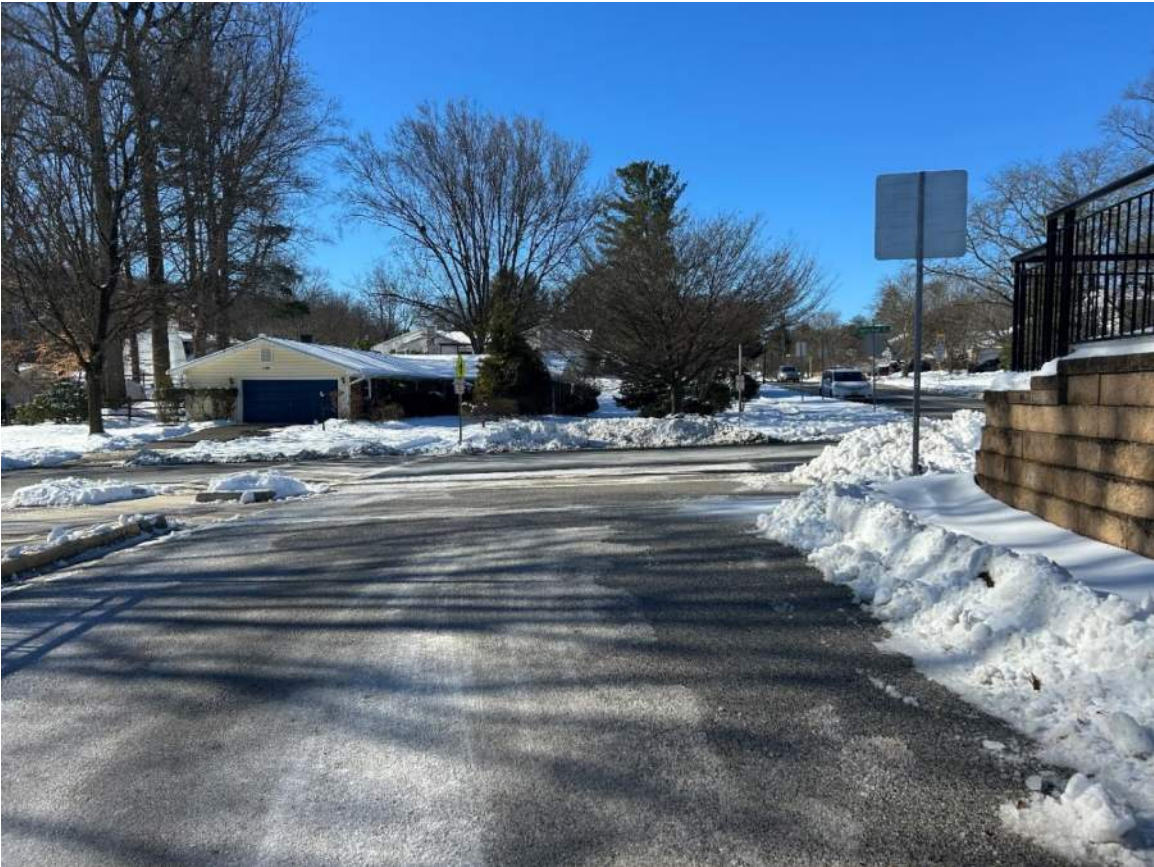
Field observations were performed on Thursday, January 9, 2025, at 12:30 PM. Weather conditions were clear, and the roadway surface was dry. Snow was observed covering portions of the on-street parking aisles on both sides of the road along Hewitt Avenue and Rippling Brook Drive. On-street parking was consistent along both roads. There was minimal pedestrian and vehicular activity due to the time of day. Rippling Brook Drive slopes downhill in the southbound direction, and a large retaining wall next to the driveway at the incident location restricts sight distance for both pedestrians and cyclists attempting to cross the driveway.

Photo 1. Looking west from driveway towards Rippling Brook Drive. Approximate crash location.

1. Upgrade crosswalk markings to continental style for all crossings in the vicinity.
2. Coordinate with MCPS to install signing and pavement markings that direct motorists to travel one way through the school site.

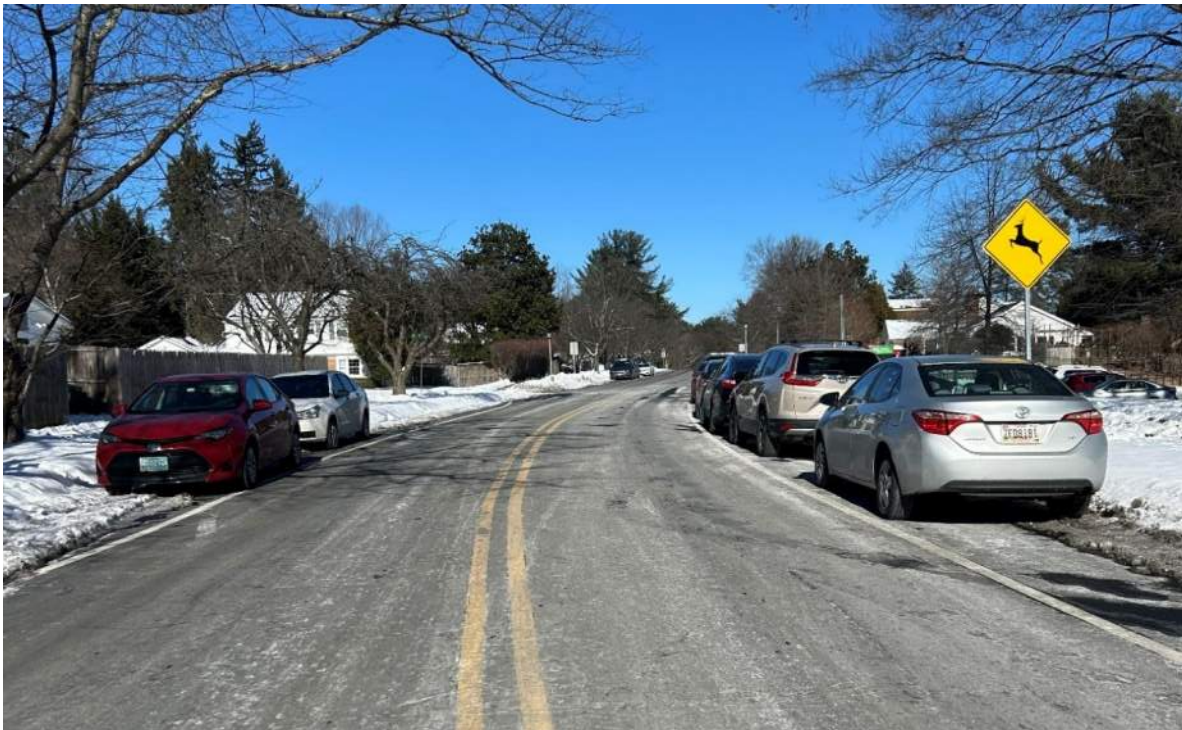
Photo 2. Limited sightline due to crest vertical curve looking north along Rippling Brook Drive towards Blair Stone Lane.

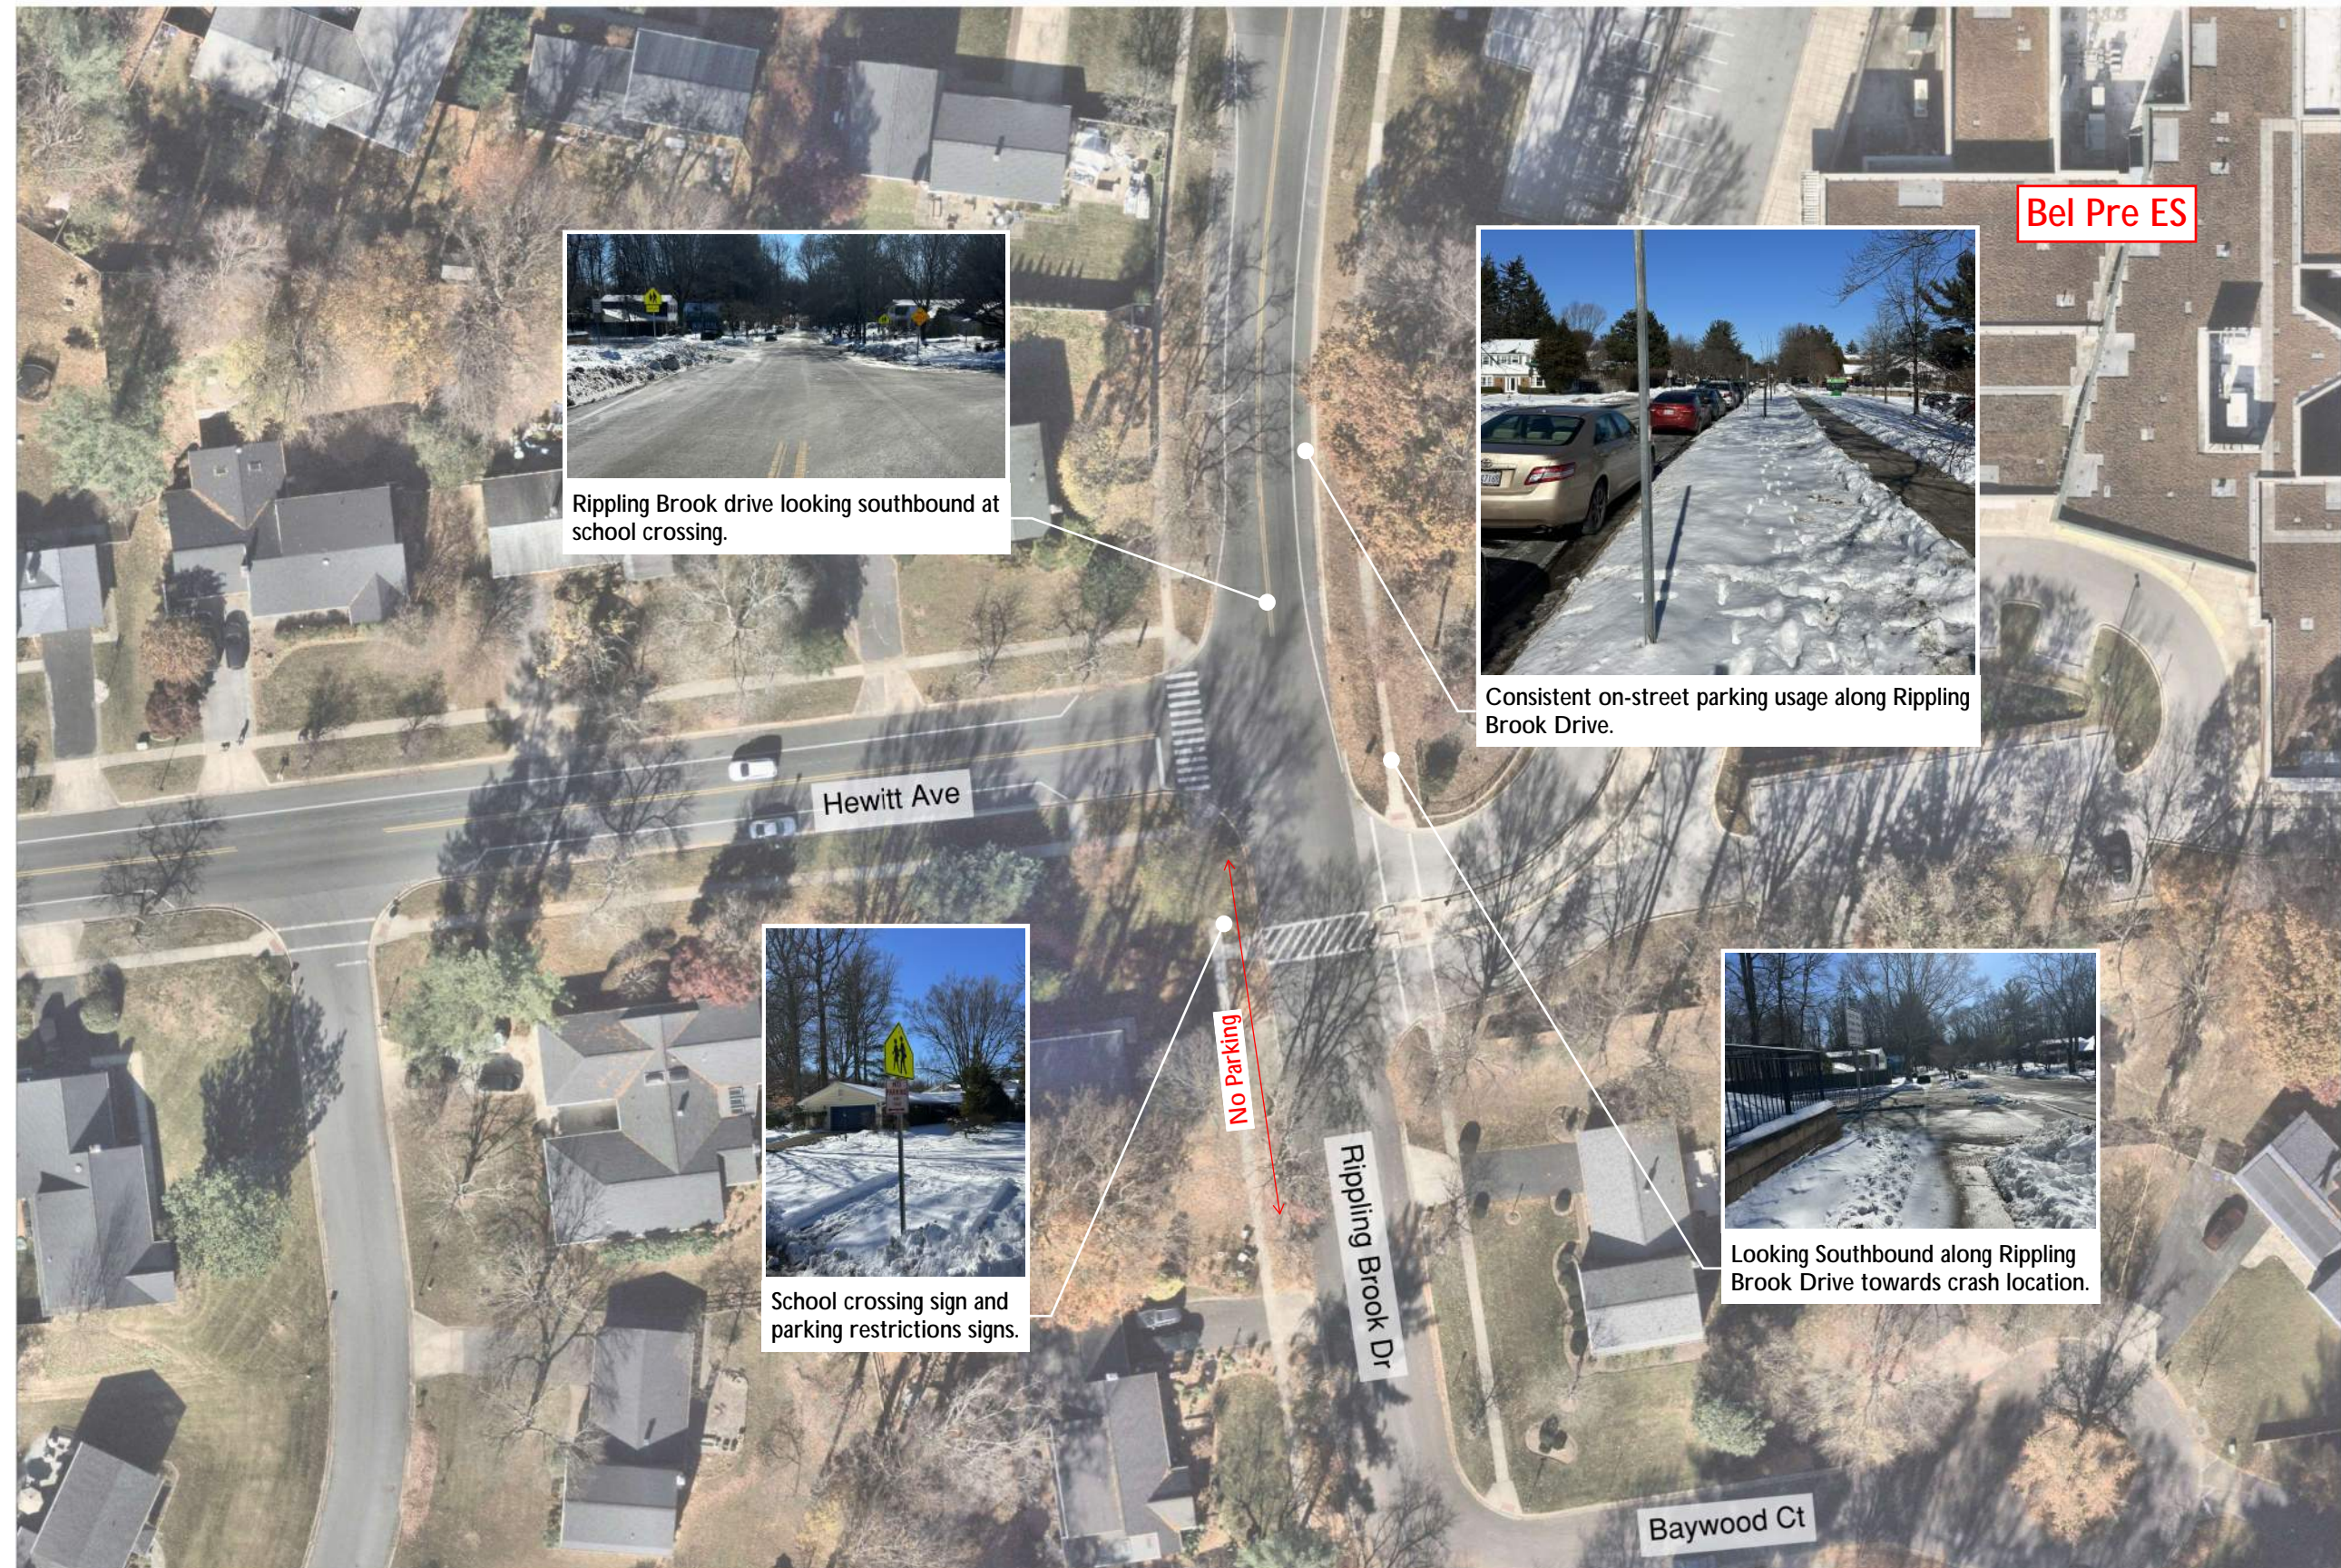
Figure 1 - Rippling Brook Drive Corridor Observations

Rippling Brook Drive is classified as a neighborhood connector, is approximately 30 feet wide, and is oriented in the north-south direction. Rippling Brook Drive is approximately a $\frac{3}{4}$ -mile long corridor starting at Bel Pre Road to the north and terminating at Baywood Court to the south. At the crash location, Rippling Brook Drive has buffered sidewalks on both sides of the street, on-street parking, and speed humps.

The posted speed limit along Rippling Brook Drive is 25 mph. A Montgomery County RideOn bus stop exists in the southbound direction at Hewitt Avenue. There is also a bus stop along Hewitt Ave eastbound at the intersection with Rippling Brook Drive. Multiple school-related signs exist along the corridor, including school zone signing and "Fines Double" plaques.

The Rippling Brook Drive corridor was evaluated to identify potential infrastructure, maintenance activities, and road user behaviors that contribute to increased safety risk at and in the vicinity of the school-related crash location. The Rippling Brook Drive corridor was reviewed between the school driveway just north of Blair Stone Lane to the north and Baywood Court to the south. Please refer to **Figure 1** for additional information.

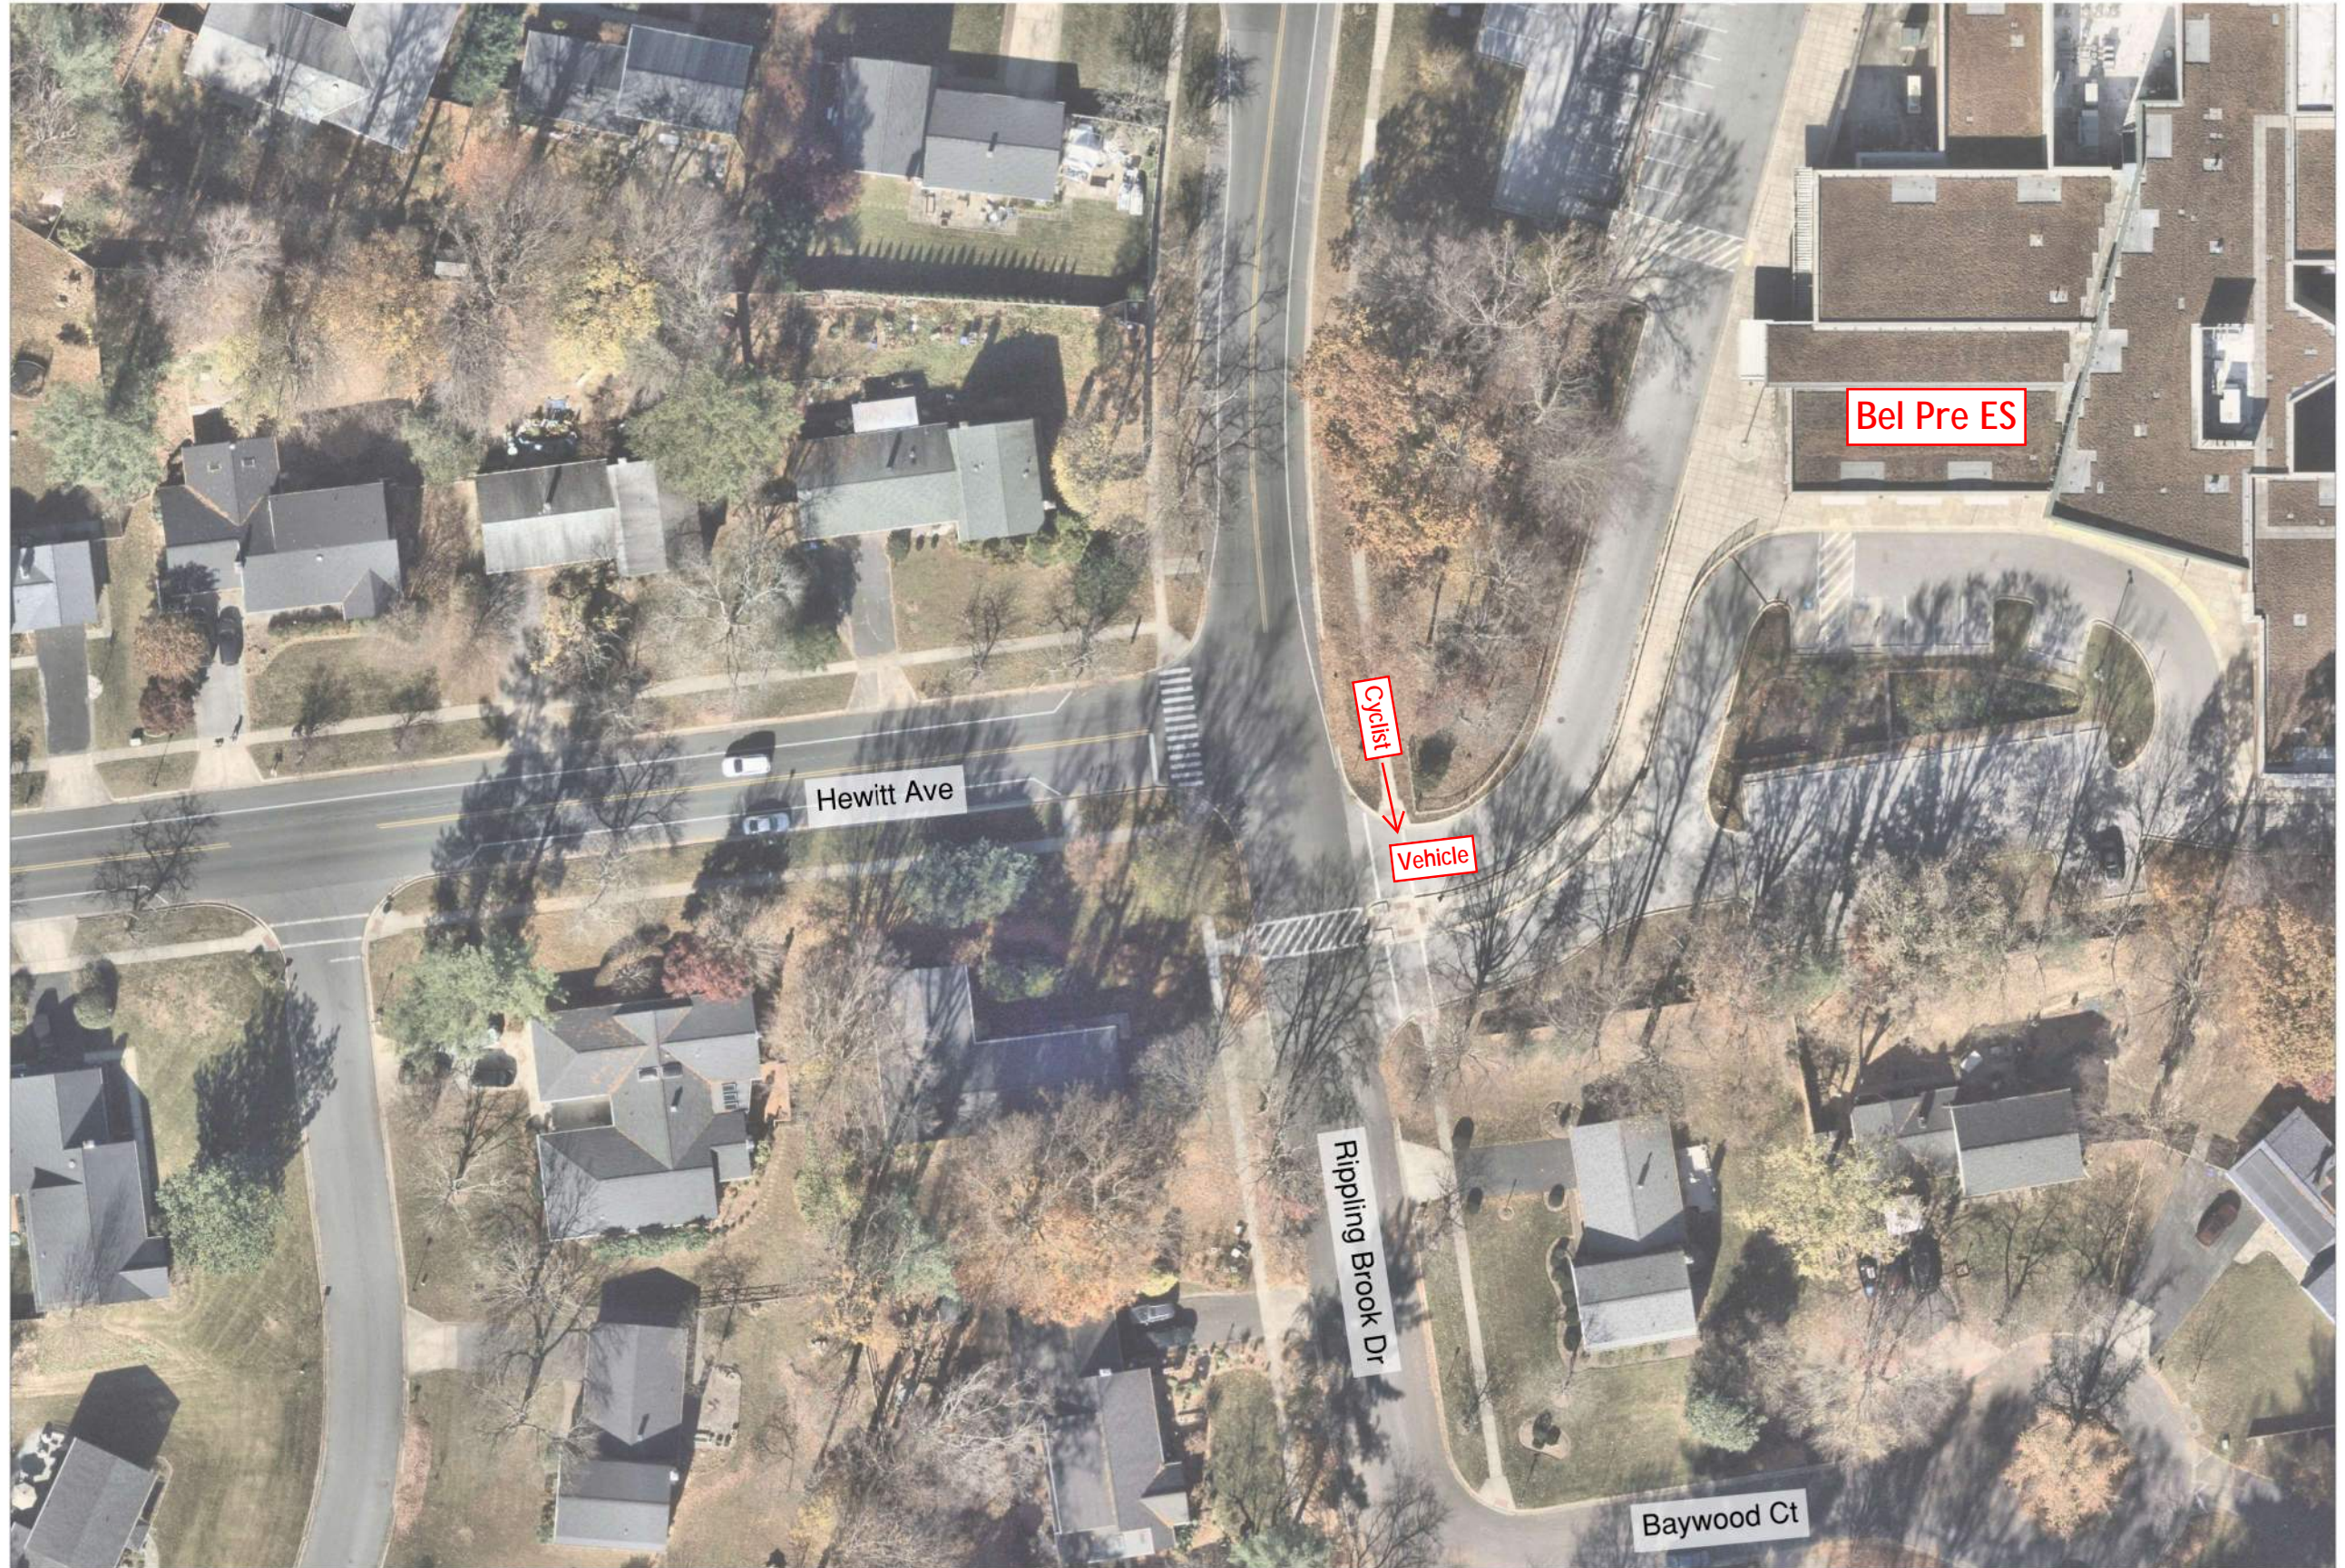
Figure 2 - Crash Diagram

On Thursday, May 23, 2024, at approximately 5:45 PM, a motorist was exiting the school driveway and was stopped in the crosswalk when a bicyclist traveling southbound along the sidewalk adjacent to Rippling Brook Drive collided with the vehicle. According to the crash report, the bicyclist suffered minor injuries. Daytime weather conditions were clear, and the roadway surface was dry.

Figure 2 illustrates the crash location and direction of cyclist and vehicle travel.

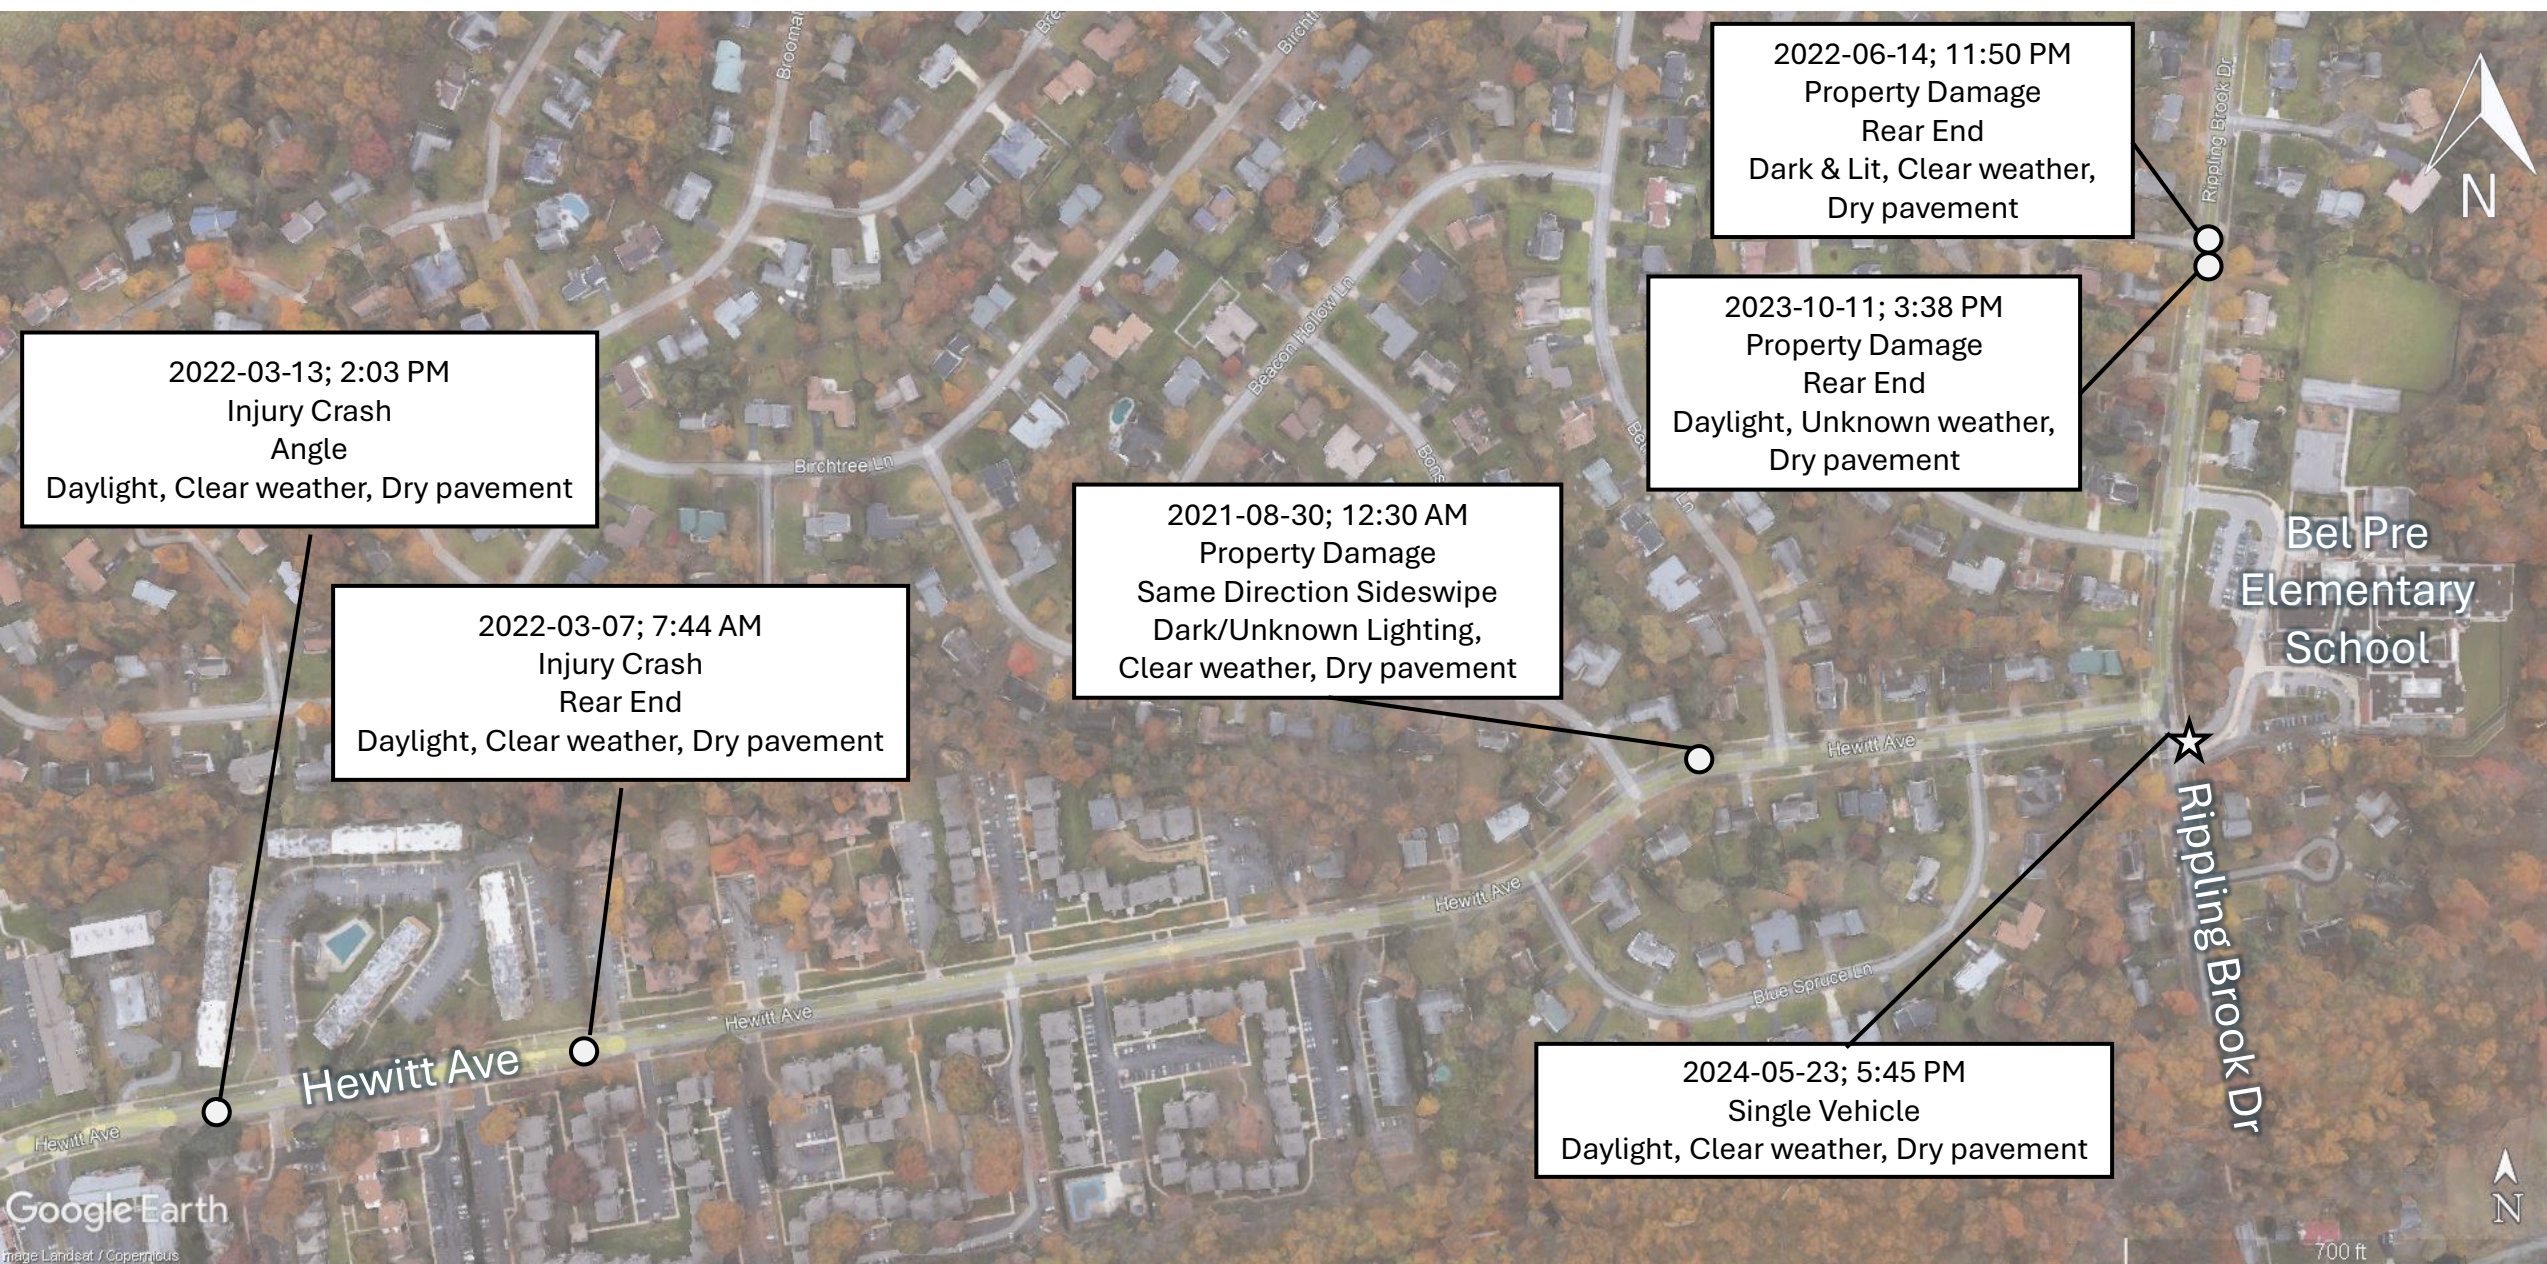
Figure 3 – Crash History (2021-2023)

Crash data obtained from dataMontgomery indicates that five (5) incidents occurred within the vicinity of the crash site between January 2021 and December 2023. Three (3) crashes occurred along Hewitt Avenue within 3,100 feet of Rippling Brook Drive. Two (2) crashes occurred along Rippling Brook Drive within 750 feet of the crash site. The five (5) crashes reported near the Rippling Brook Drive and ES driveway intersection included two (2) injury crashes, three (3) property damage crashes, and the crash type consisted of three (3) rear end collisions, one (1) sideswipe collision, and one (1) angle collision. There were no pedestrian or bicycle-related crashes. All crashes occurred along a dry surface, and two (2) crashes occurred in the dark. The incidents are illustrated on **Figure 3**.
