# SCHOOL-RELATED CRASH INFRASTRUCTURE REVIEW

**Location:** Stedwick Road  
**Crash Date:** October 25, 2024  
**Crash Time:** 3:00 PM  
**Local Case No.:** 240051147  
**Review Date:** July 25, 2025

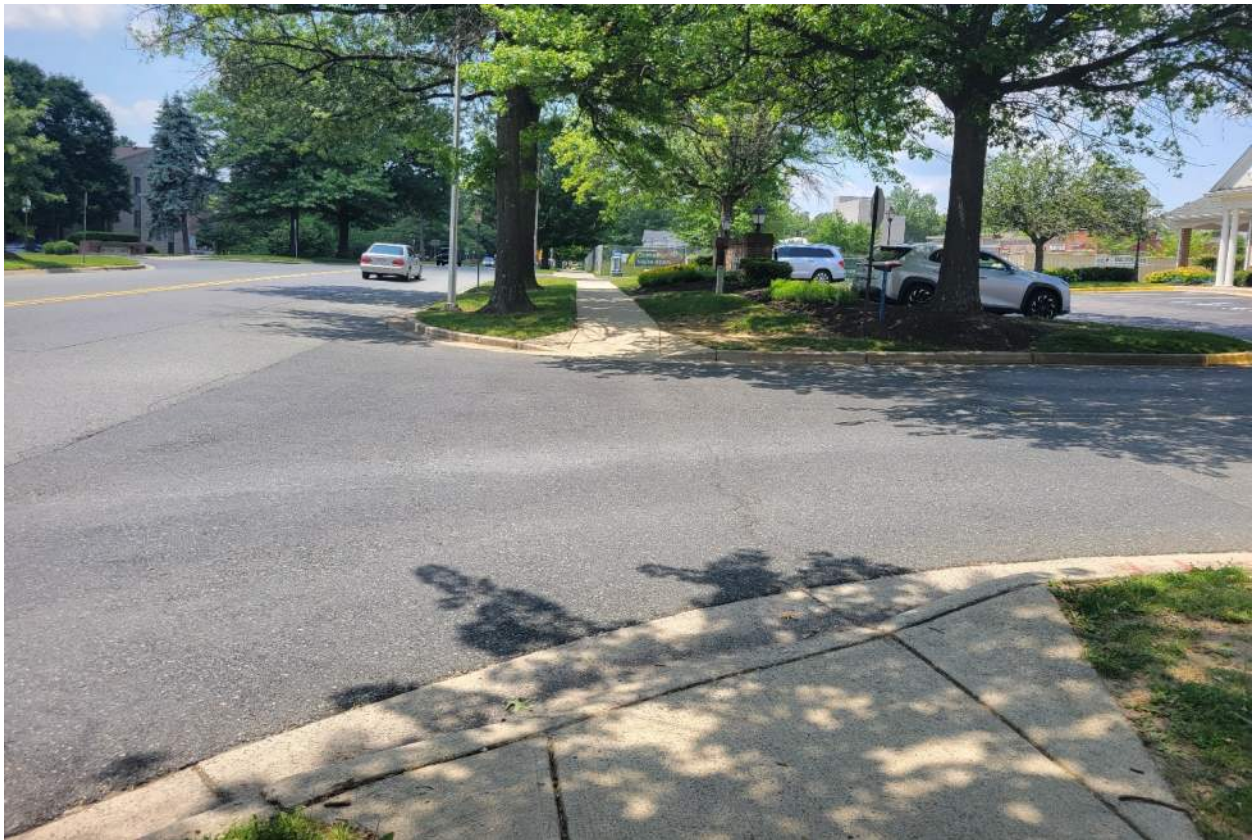
**Photo 1. Taken from northeast corner looking westbound along Stedwick Rd. No pavement markings or detectable warning surfaces on ramps**

1. Recommend painting a stop bar for the southbound approach.
2. Update landing area on the northeast and northwest corner to include DWS.

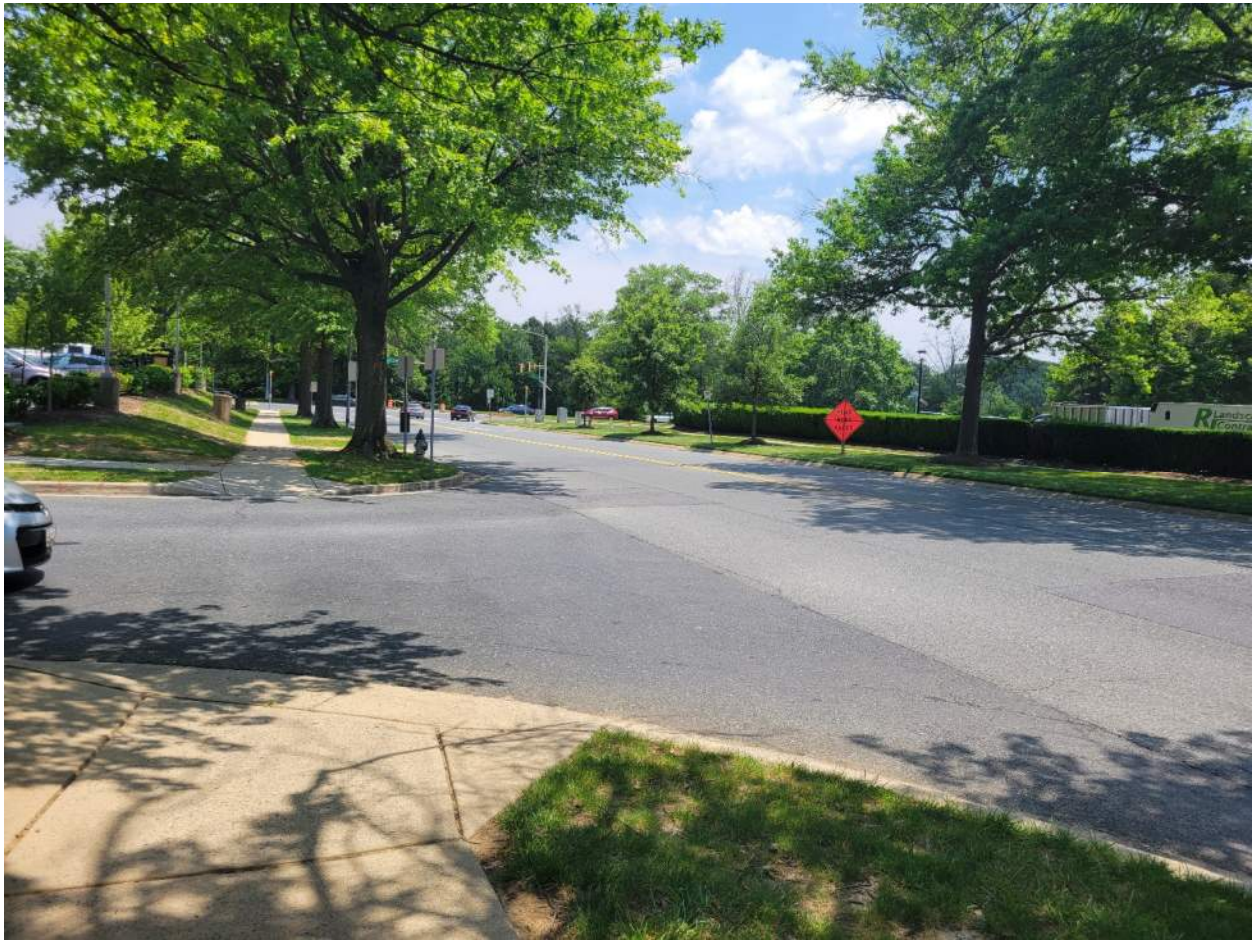
**Photo 2. Taken from northwest corner looking eastbound along Stedwick Rd. No pavement markings or detectable warning surfaces on ramps.**

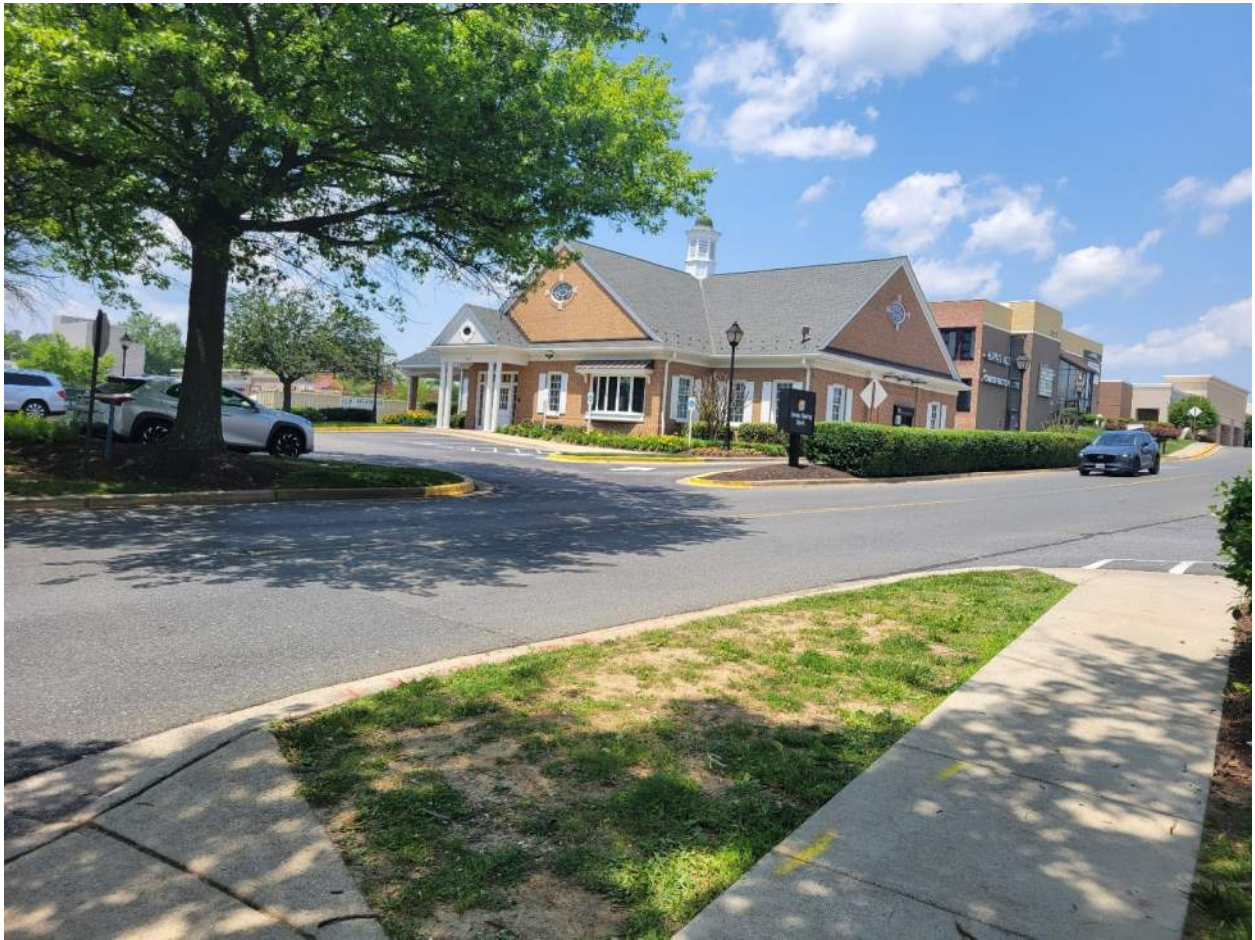
Photo 3. Taken from northwest corner looking north along driveway. Tree casts shadow over approach. Approximately crash location.

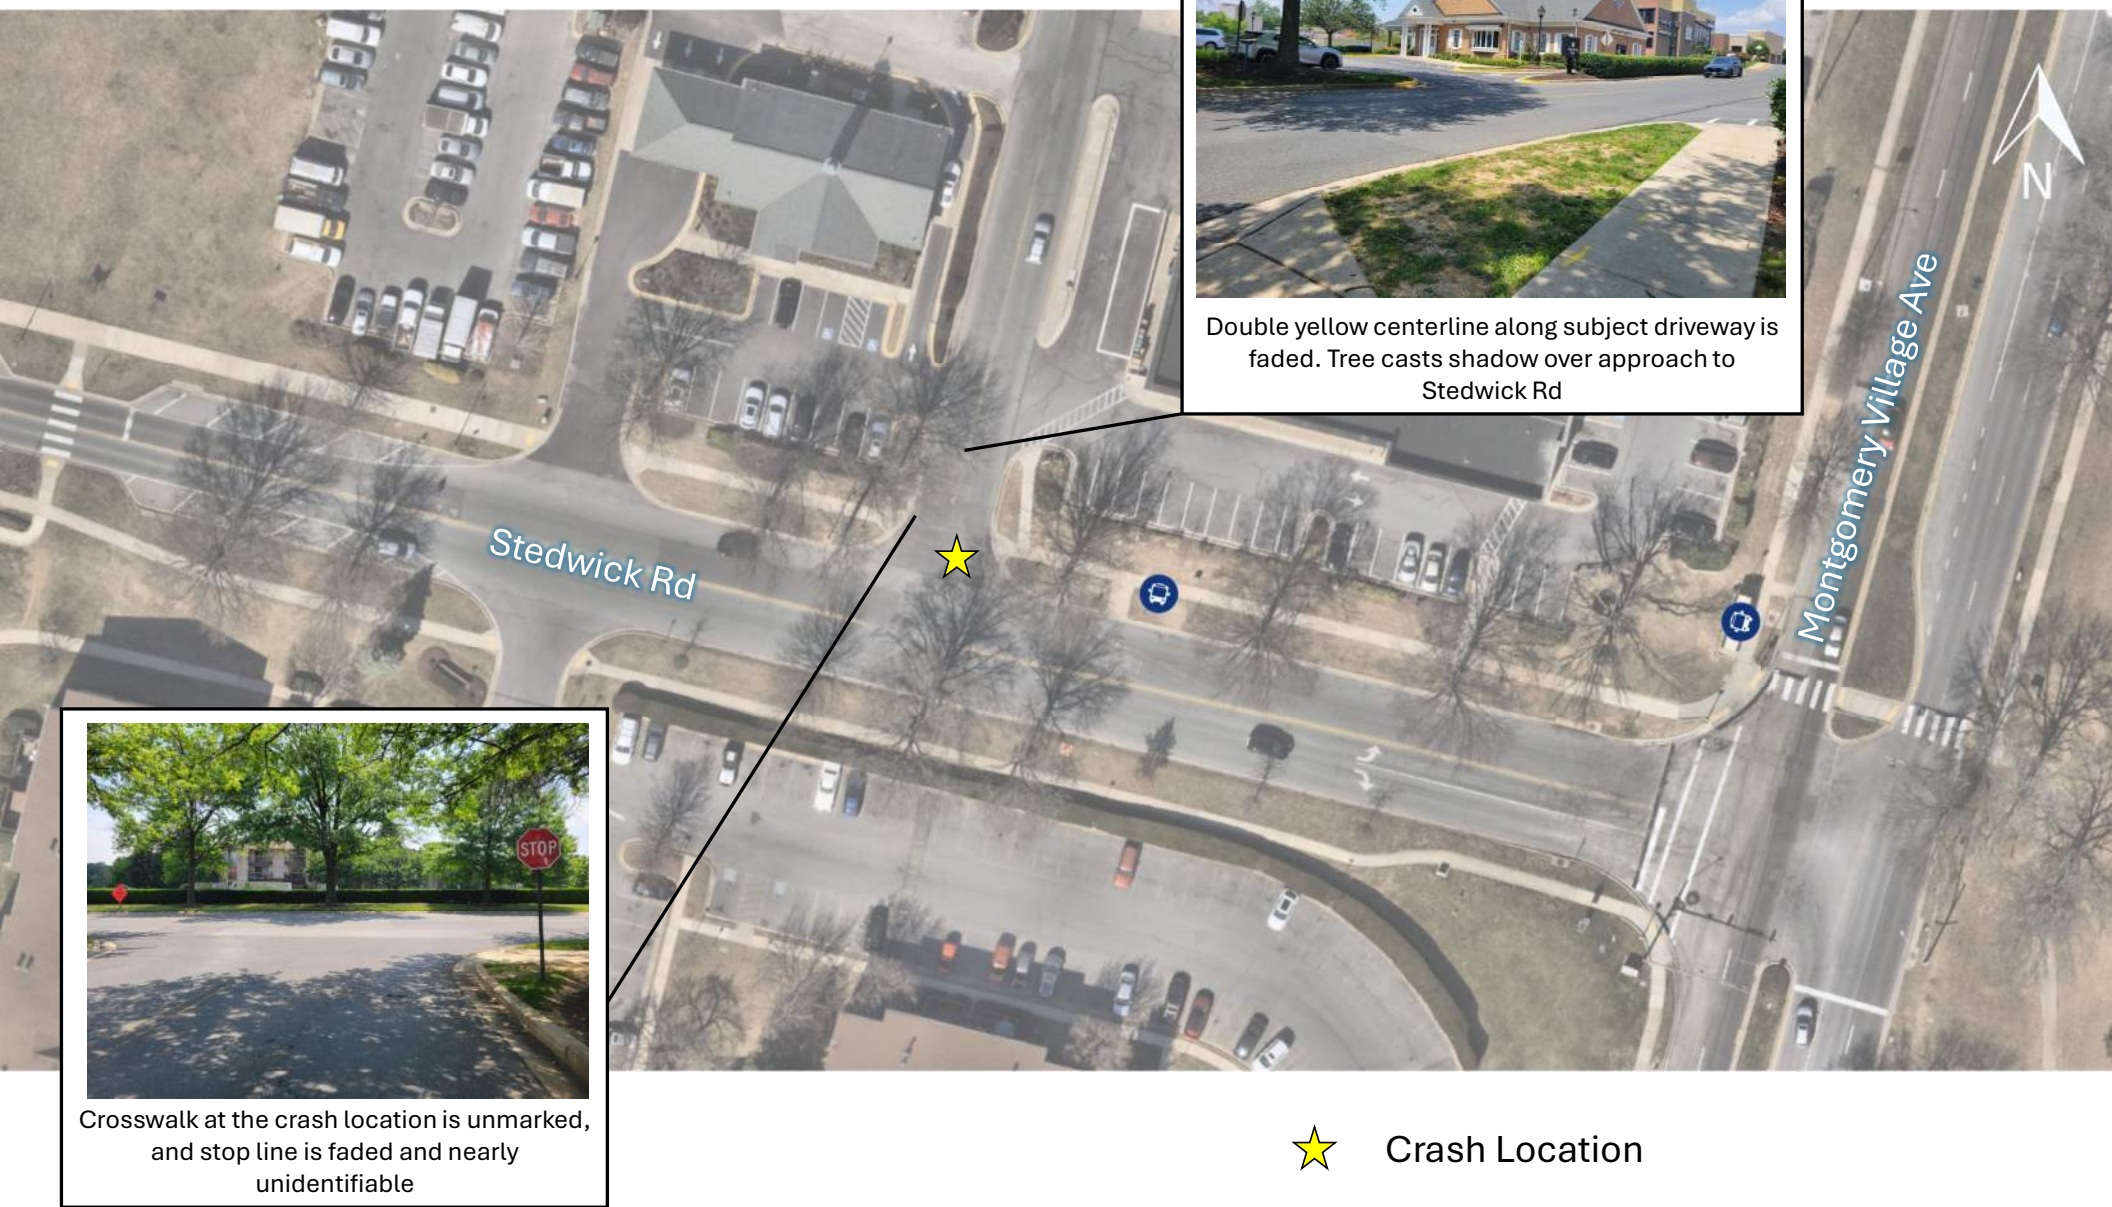
Figure 1 – Stedwick Road at Driveway 300 Feet West of Montgomery Village Avenue Observations

Double yellow centerline along subject driveway is faded. Tree casts shadow over approach to Stedwick Rd

Crosswalk at the crash location is unmarked, and stop line is faded and nearly unidentifiable

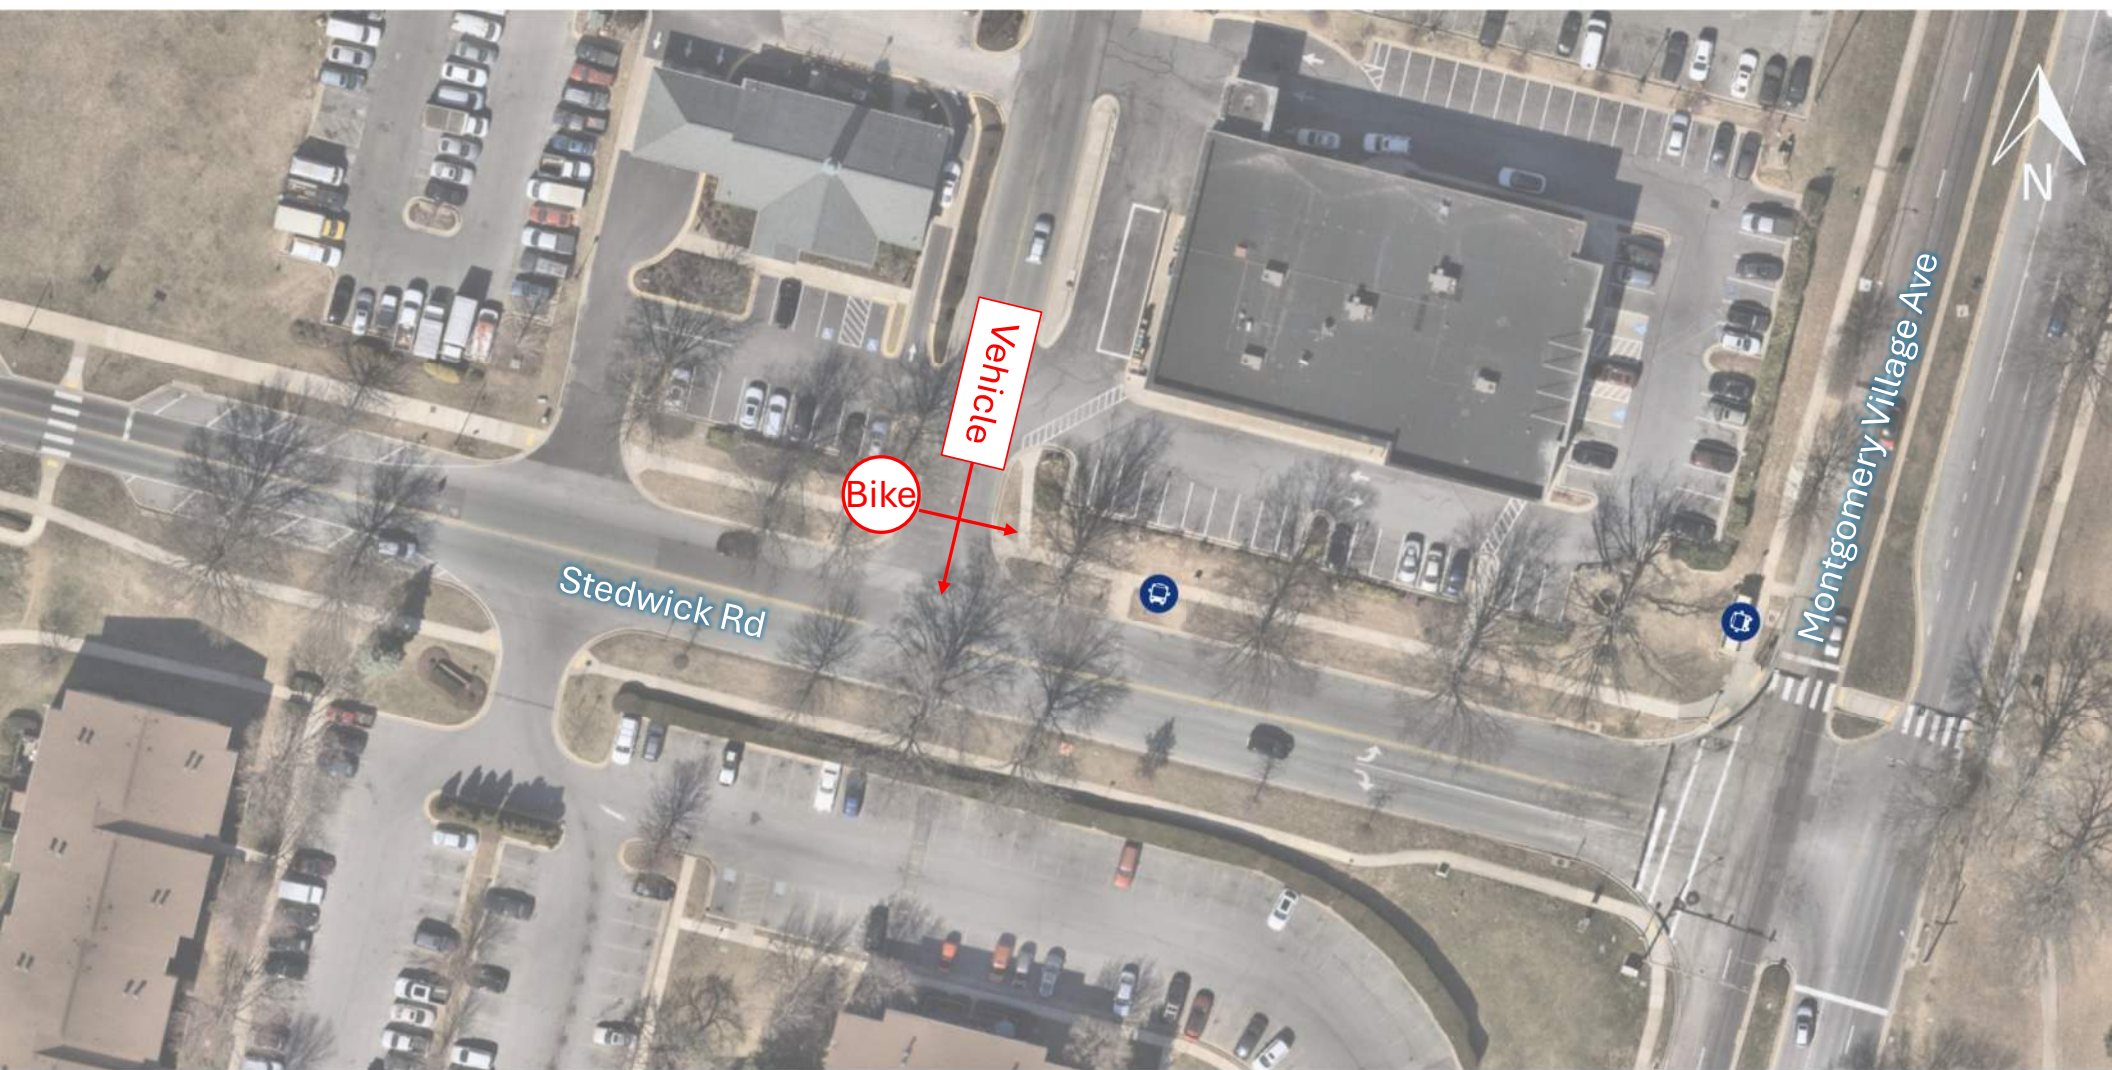
Figure 2 – Crash Diagram

On Friday, October 25, 2024, at approximately 3:00 PM, a motorist was traveling southbound along the driveway approximately 300 feet west of Montgomery Village Avenue when it collided with a bicyclist crossing the driveway, traveling parallel to Stedwick Road. The crash report indicated the subject location did not occur at a crosswalk. The crash report indicated that the bicyclist was unharmed and was at fault for failing to yield right-of-way. It was daylight when the crash occurred, weather conditions were clear, and the roadway surface was dry.

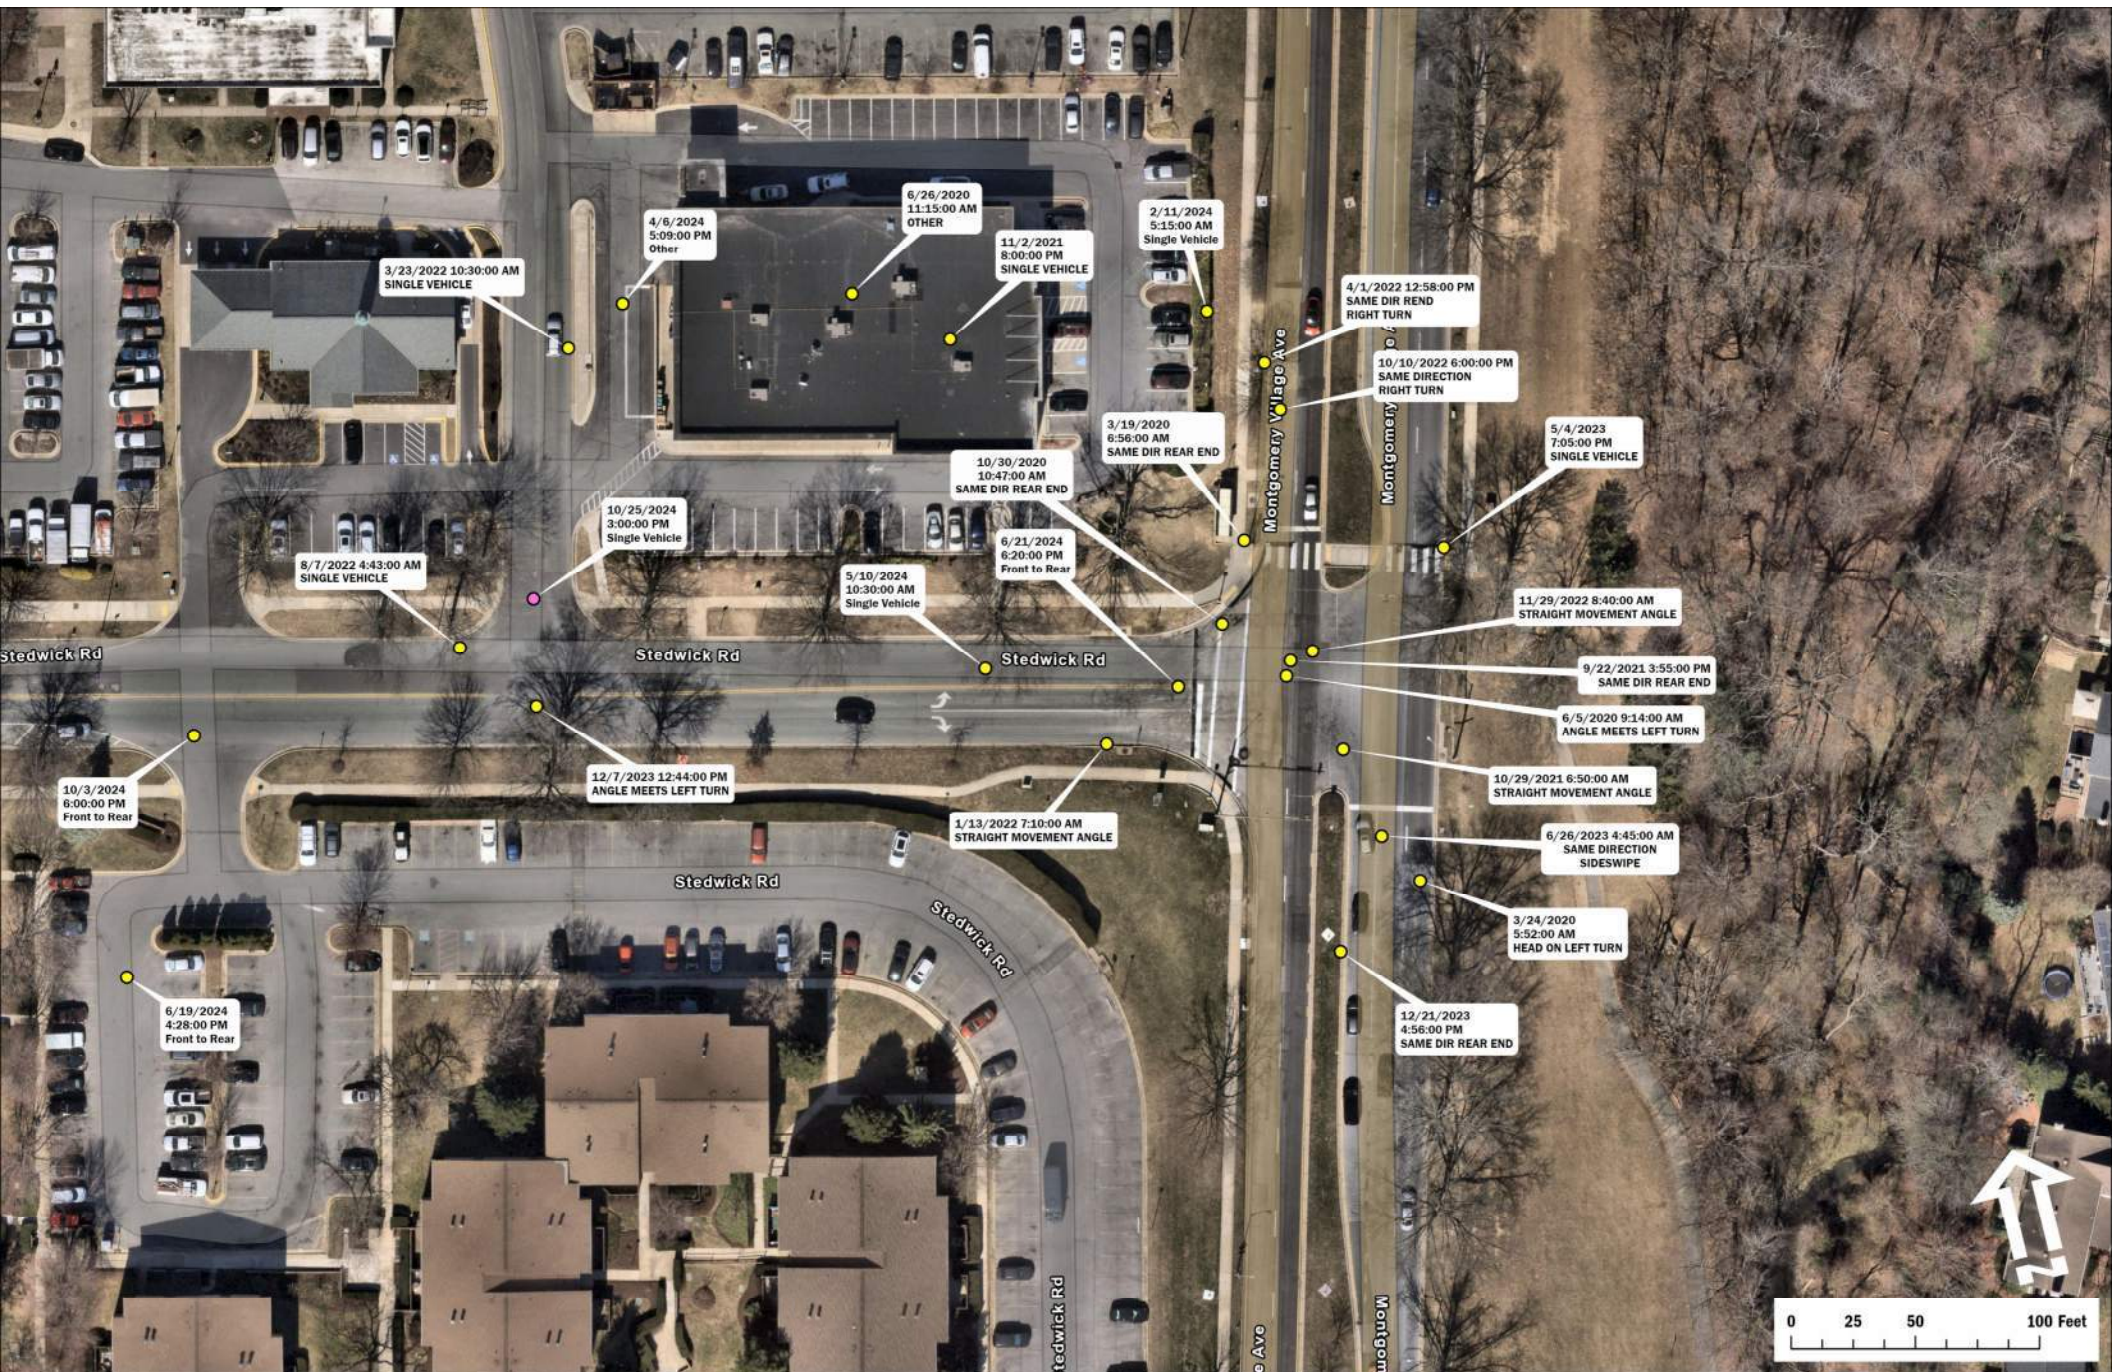
Figure 3a (east) – Crash History (2020-2024)

The remaining 32 crashes occurring within the study area, including 15 crashes at Montgomery Village Ave, one (1) at the driveway located approximately 125 feet to the west, one (1) within 50 feet of the unsignalized marked crosswalk, eight (8) at Mills Choice Rd, and seven (7) within nearby parking lots. These crashes include 13 injury crashes and 19 property damage crashes. The collision types include 10 rear end collisions, five (5) single vehicle collisions, five (5) angle collisions, four (4) collisions classified as “other”, three (3) head on collisions, two (2) right-turn collisions, one (1) left-turn collision, one (1) sideswipe collision, and one (1) rear to side collision. Of the 32 crashes occurring outside of the study location, 13 crashes occurred in the dark/dawn, and 14 crashes occurred along a wet or unknown surface.
