# SCHOOL-RELATED CRASH INFRASTRUCTURE REVIEW

**Location:** Sangamore Road at Overlea Road

**Crash Date:** November 1, 2024

**Review Date:** July 18, 2025

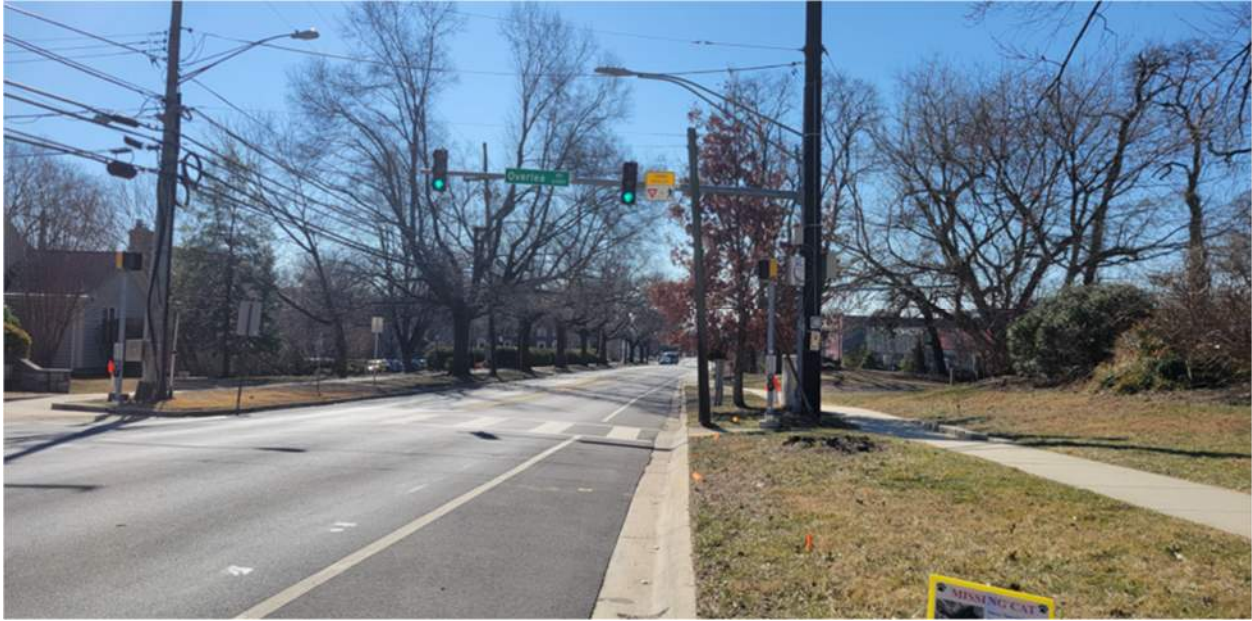
**Photo 1. Taken from northwest corner looking southbound along Sangamore Road at the north leg crossing. Approximate crash location.**

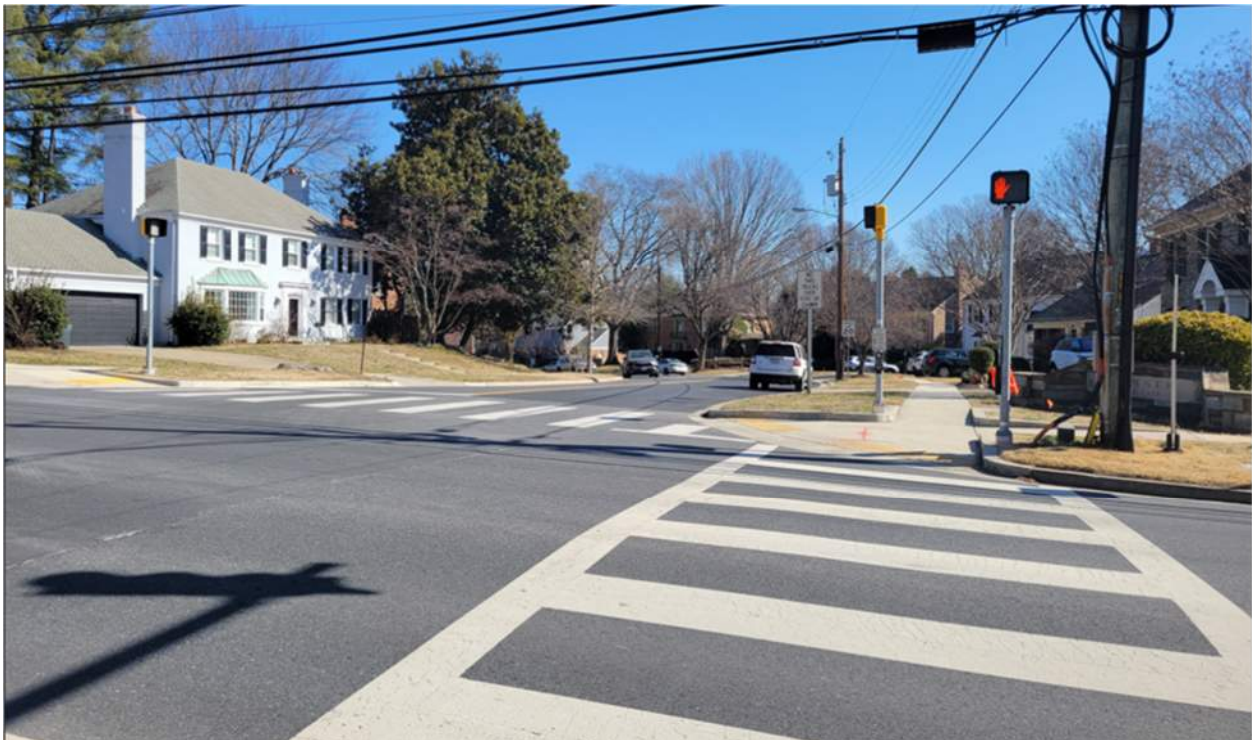
**Photo 2. Taken from the southwest corner looking eastbound along Overlea Road.**

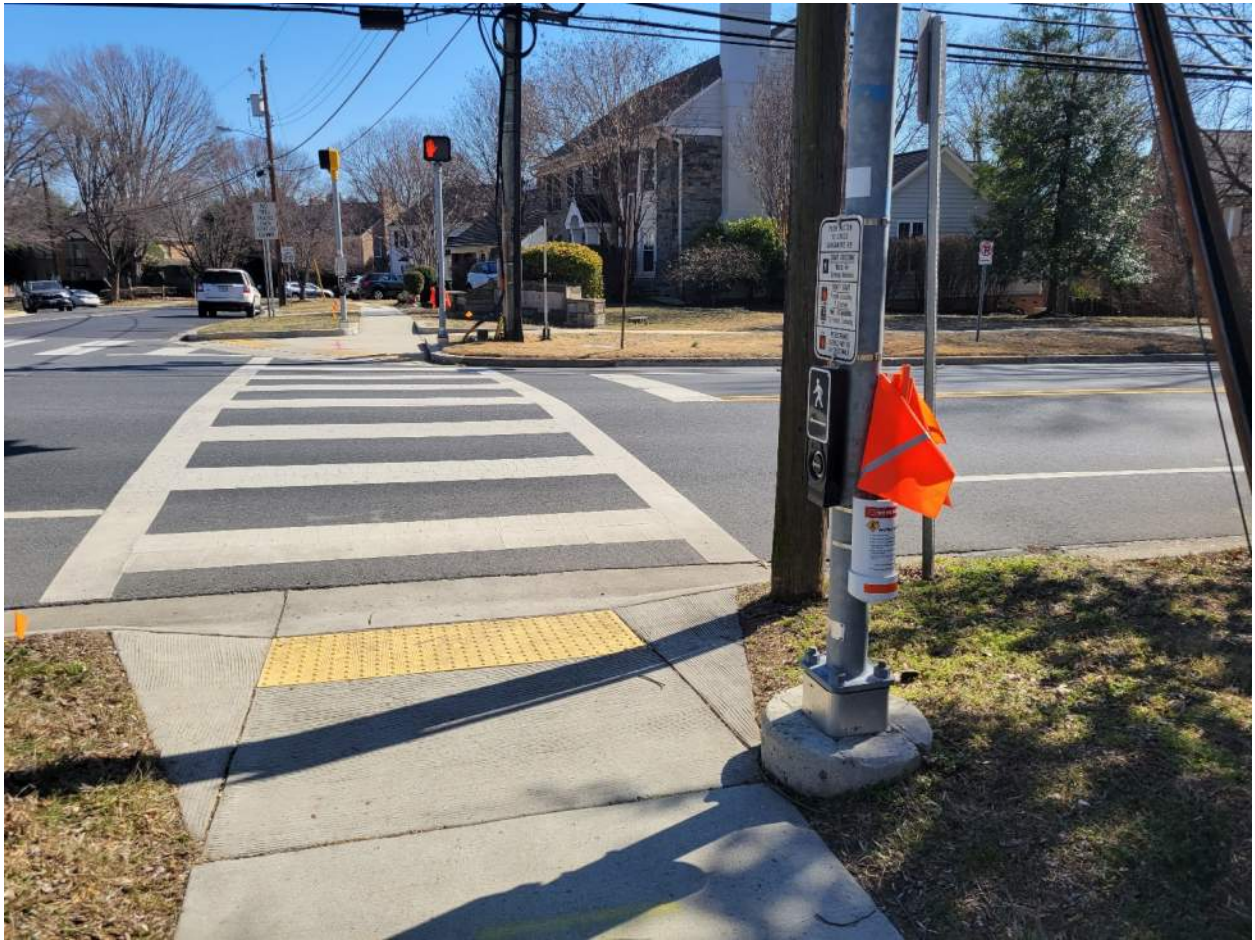
Pedestrian facilities are ADA compliant at the corners of the intersection, with DWS and pedestrian signals. The crosswalks are continental at the north and west leg and ladder bar markings on the south leg. Along the south leg crossing, there are fluorescent orange flags that children can carry as they cross the street to alert motorists of their presence. It is likely that a concerned resident placed these flags here. Photo 3 shows the flags on either side of the south leg crossing.

Photo 3. Fluorescent orange flags for south leg crossing

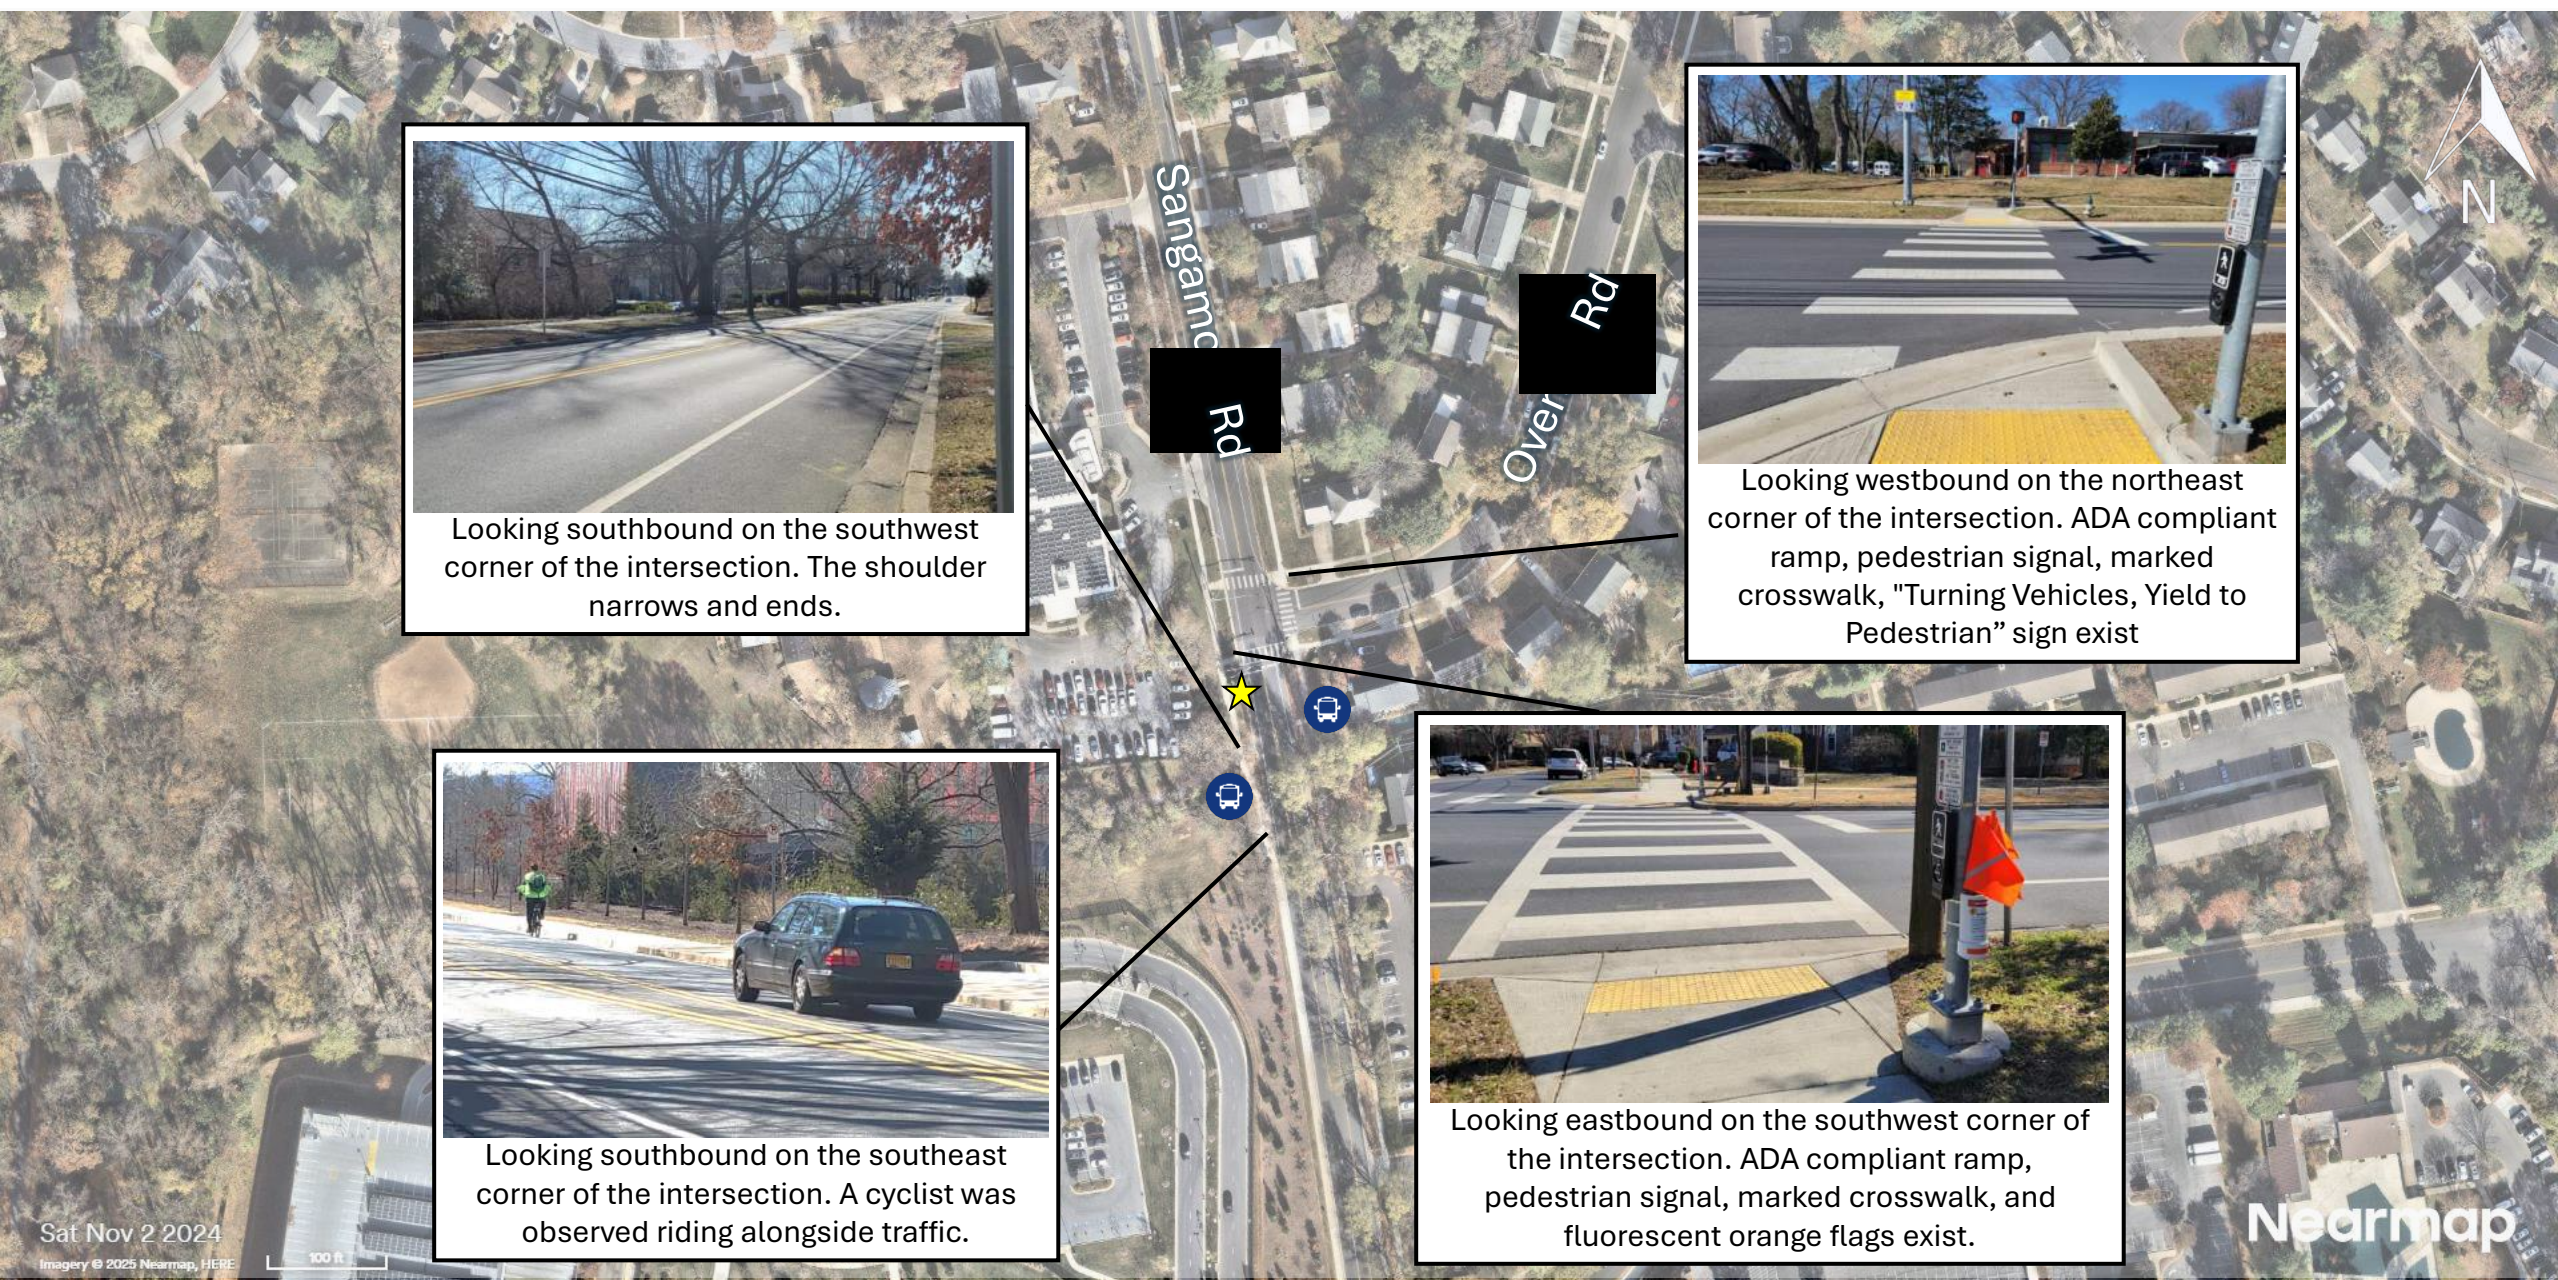
Figure 1 – Overlea Rd at Sangamore Rd Observations

Field observations were performed on Monday, March 3, 2025, at approximately 10 AM. Weather conditions were clear, and the roadway surface was dry. Pedestrian and vehicular activity was consistent during the observation period. Both Sangamore Road and Overlea Road are signalized and have permissive left-turn phases. Pedestrian phases crossing Sangamore Road are actuated with a 12 second crossing time. Crossing Overlea Road, phases are also actuated with a 12 second crossing time. The existing pedestrian signals are Accessible Pedestrian Signals (APS). APS provide auditory cues that indicate the roadway is safe to cross. At the northbound approach, there is a “No Right Turn from 3:00 PM to 4:00 PM, Monday through Friday” sign for the right turn onto Overlea Road. At all the approaches, there are “Turning Vehicle, Yield to Pedestrians” signs located on the masthead signal arms. A gradual

vertical curve exists along Sangamore Road, sloping downward in the southbound direction, and upward in the northbound direction. In the southbound direction, after the intersection, the shoulder narrows rapidly to nothing; the shoulder on the northbound approach is nonexistent until just before the intersection. There is currently no signage to inform motorists of bicyclist usage of the roadway.

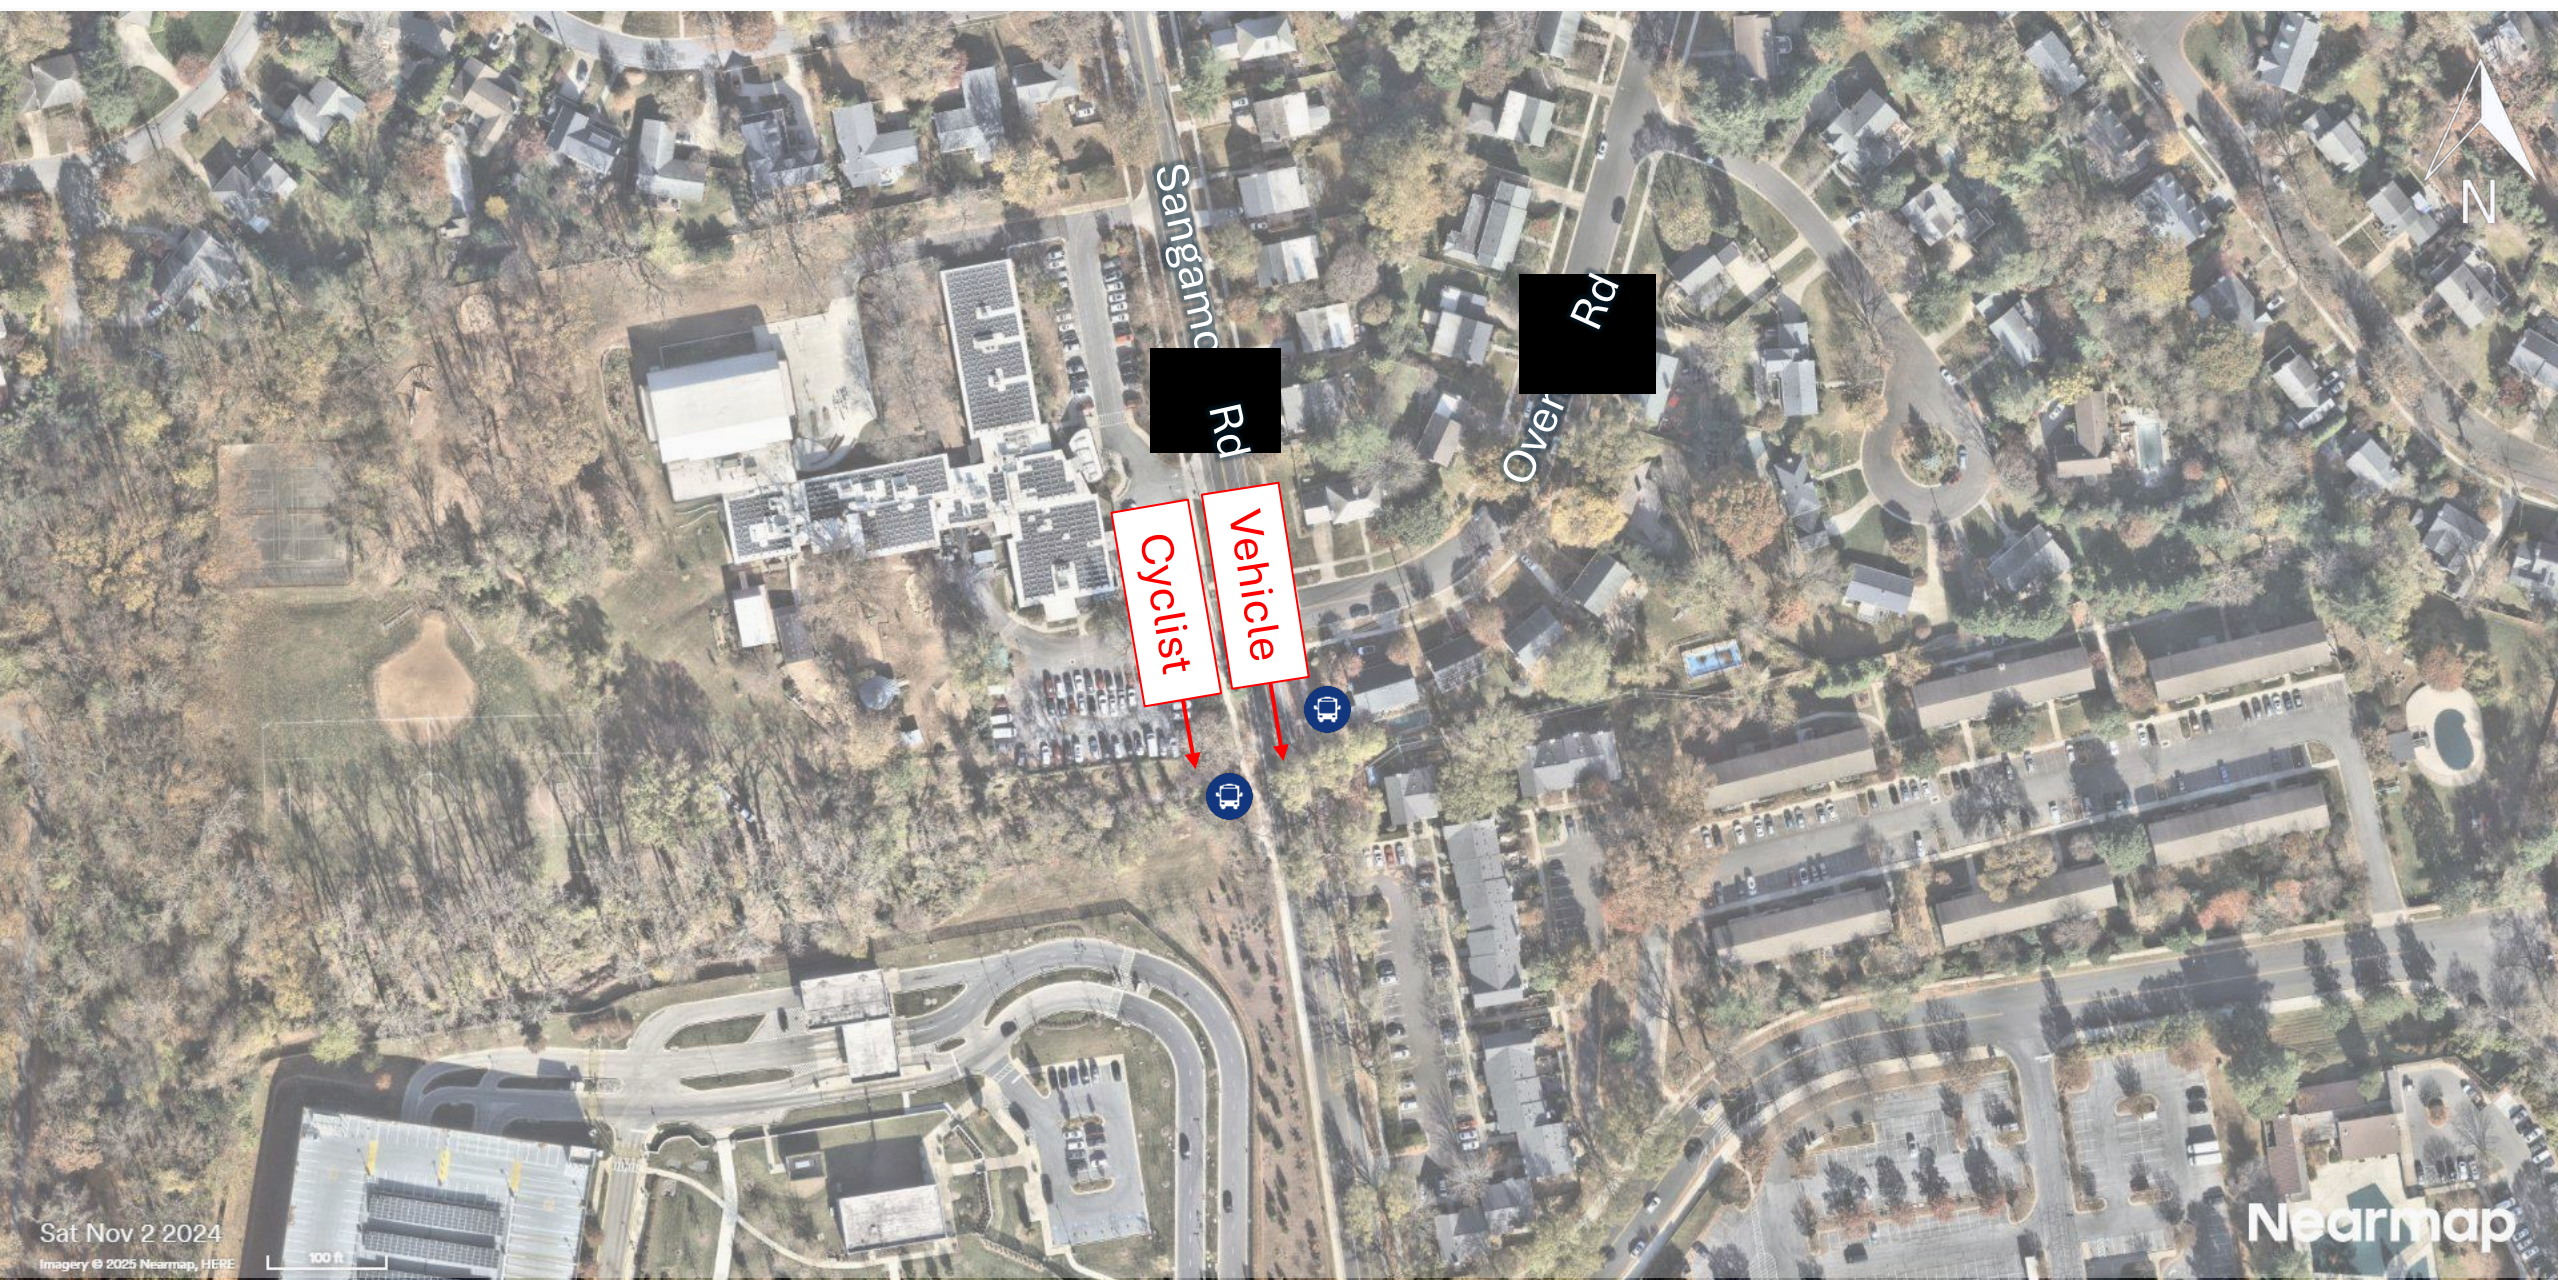
Figure 2 – Crash Diagram

On Friday, November 1, 2024, at approximately 3:15 PM, a motorist was traveling southbound Sangamore Road near the signalized intersection with Overlea Road. A cyclist was traveling southbound in the shoulder and passed the motorist in the travel lane and the motorist struck the cyclist. The crash report indicated that the bicyclist suffered minor injuries. Daytime weather conditions were clear, and the roadway surface was dry.

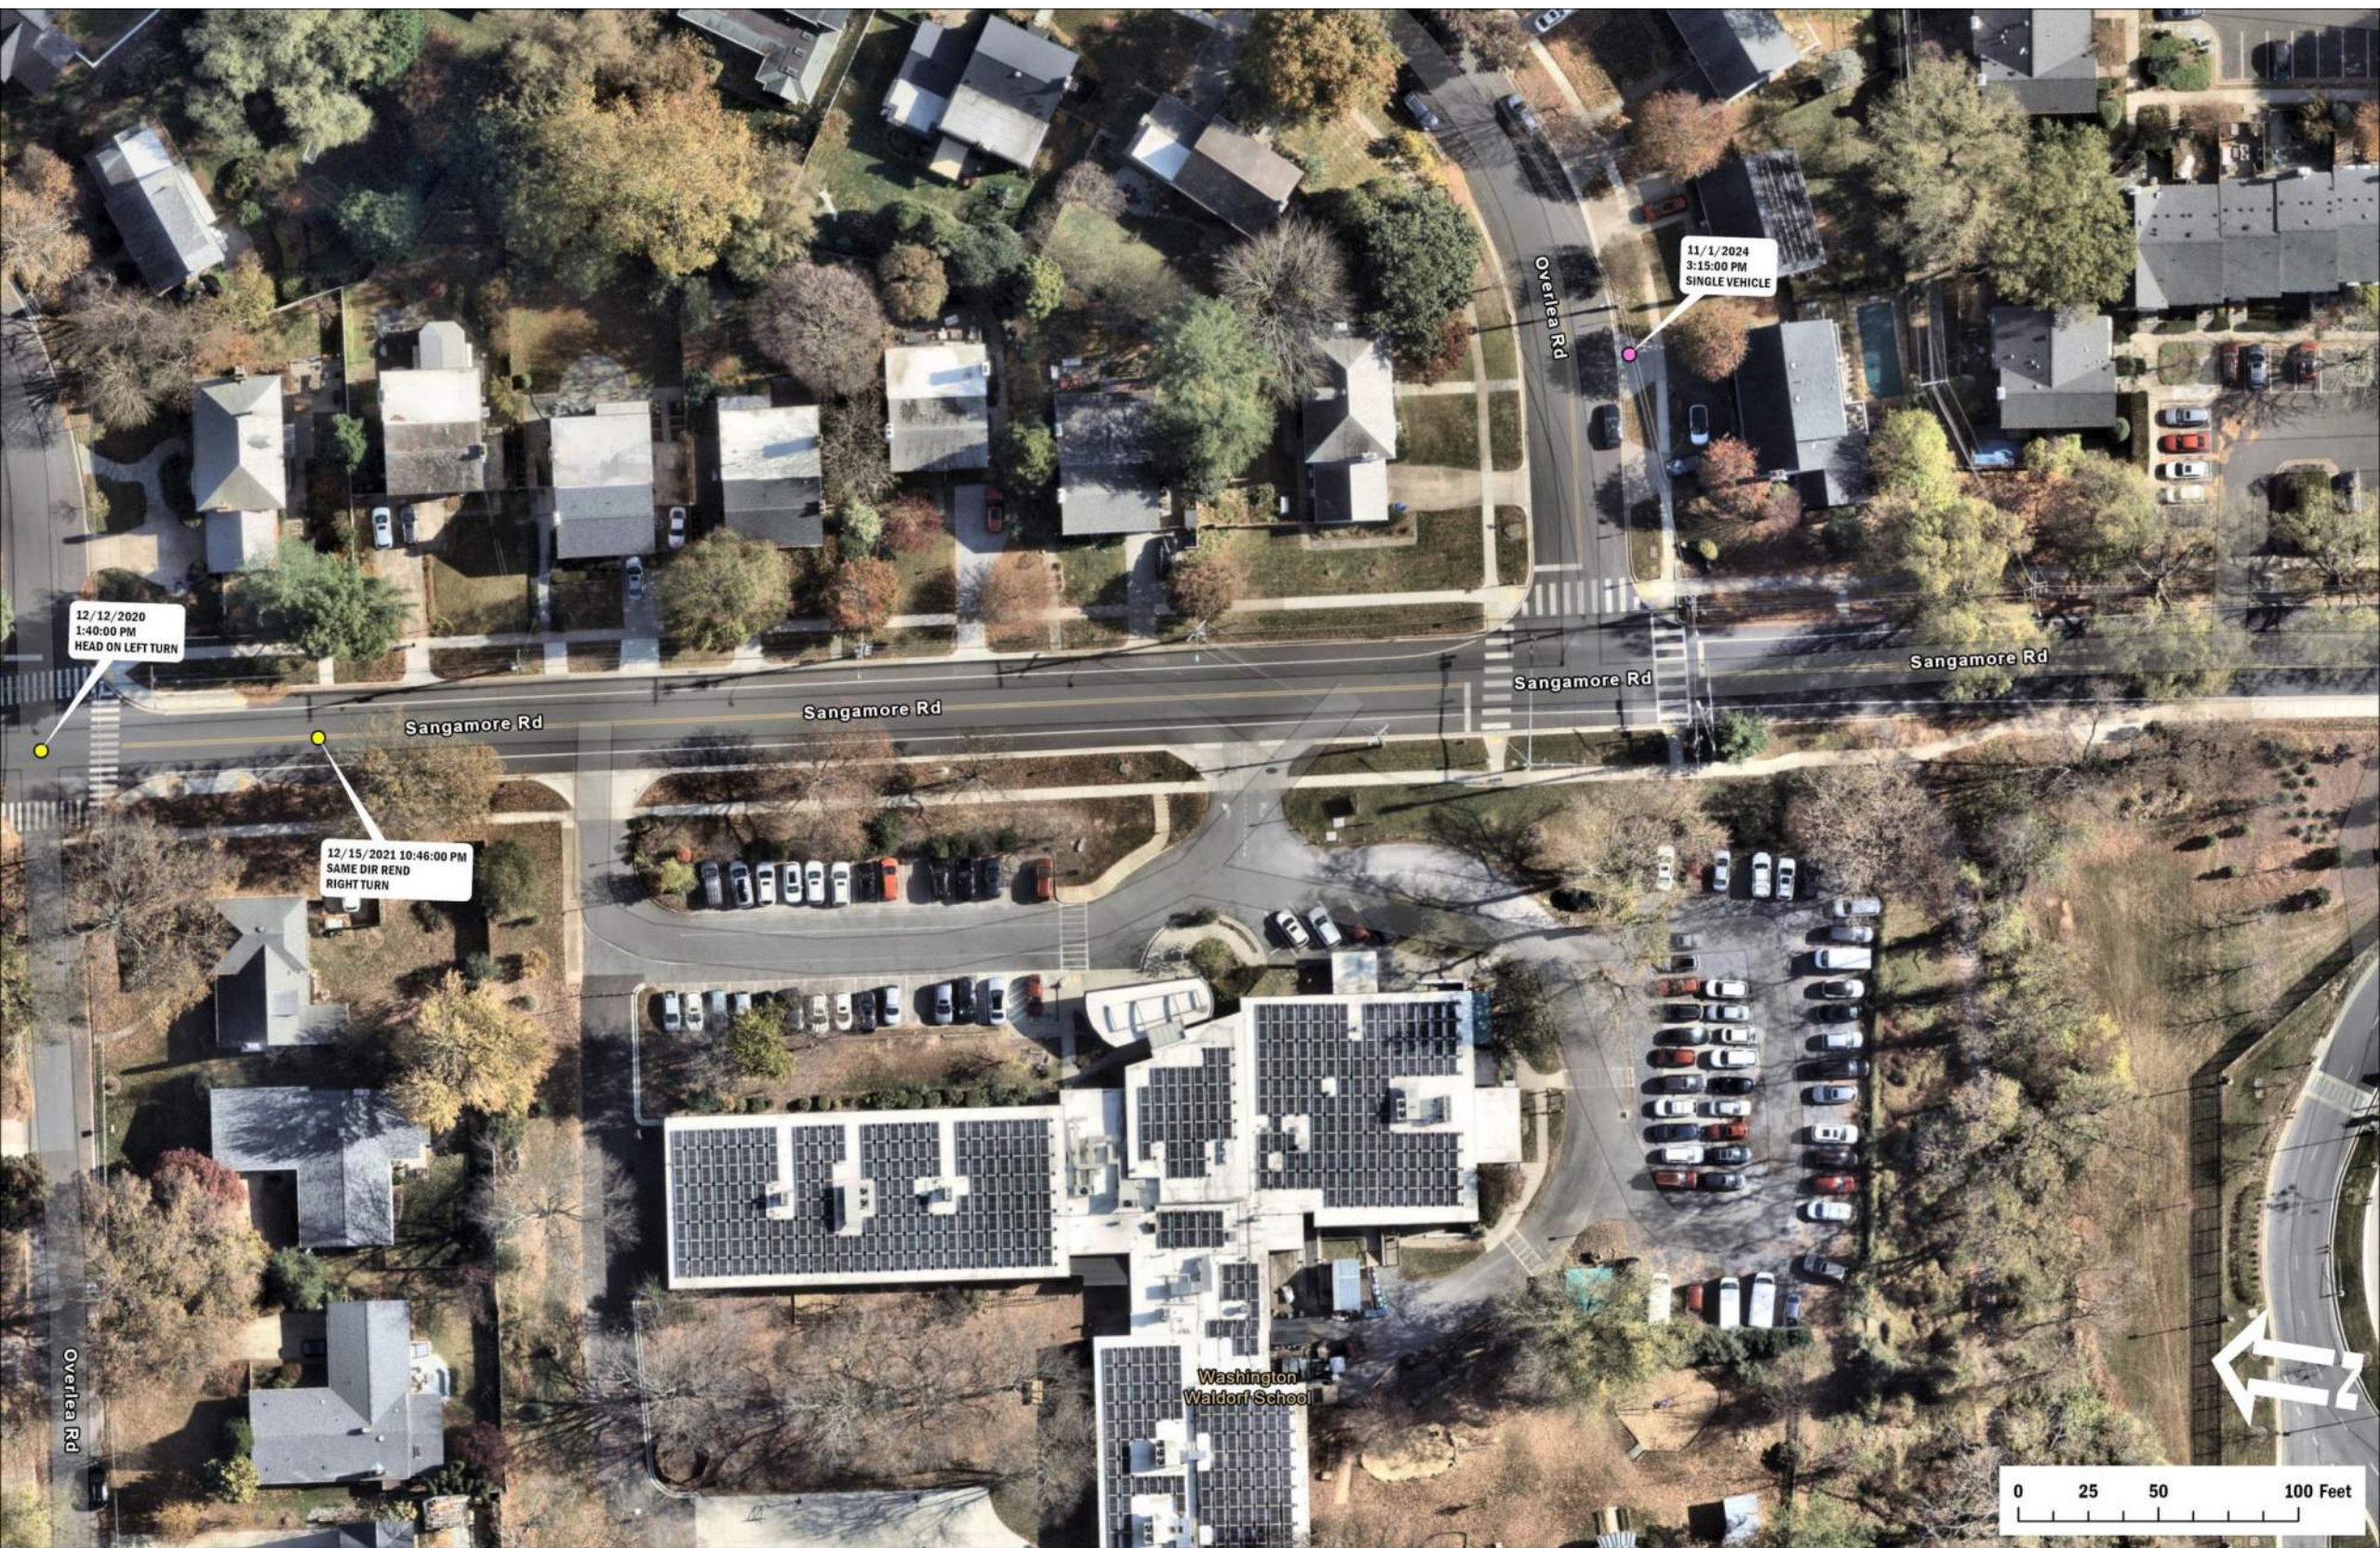
Figure 3 – Crash History (2020-2024)

Crash data obtained from dataMontgomery indicates that three (3) incidents occurred within the vicinity of the crash site between January 2020 and December 2024. Of these three (3) incidents, only one (1) occurred at or near the signalized intersection of Sangamore Road and Overlea Road, the subject crash incident. These three (3) crashes included two (2) injury crashes and one (1) property damage crashes, and the crash type consisted of one (1) left turn collision, one (1) right turn collision, and one (1) single vehicle collision. There was one (1) pedestrian-related crash and one (1) non-motorist crash. The pedestrian-related crash occurred at the northern intersection of Sangamore Road and Overlea Road/Corewood Lane during dry pavement conditions and during the day. All remaining incidents occurred during dry pavement conditions and one (1) occurred in the dark/dusk.
