# SCHOOL-RELATED CRASH INFRASTRUCTURE REVIEW

**Location:** Dayton Street at Windham Lane

**Local Case No.:** 240060012

**Review Date:** July 18, 2025

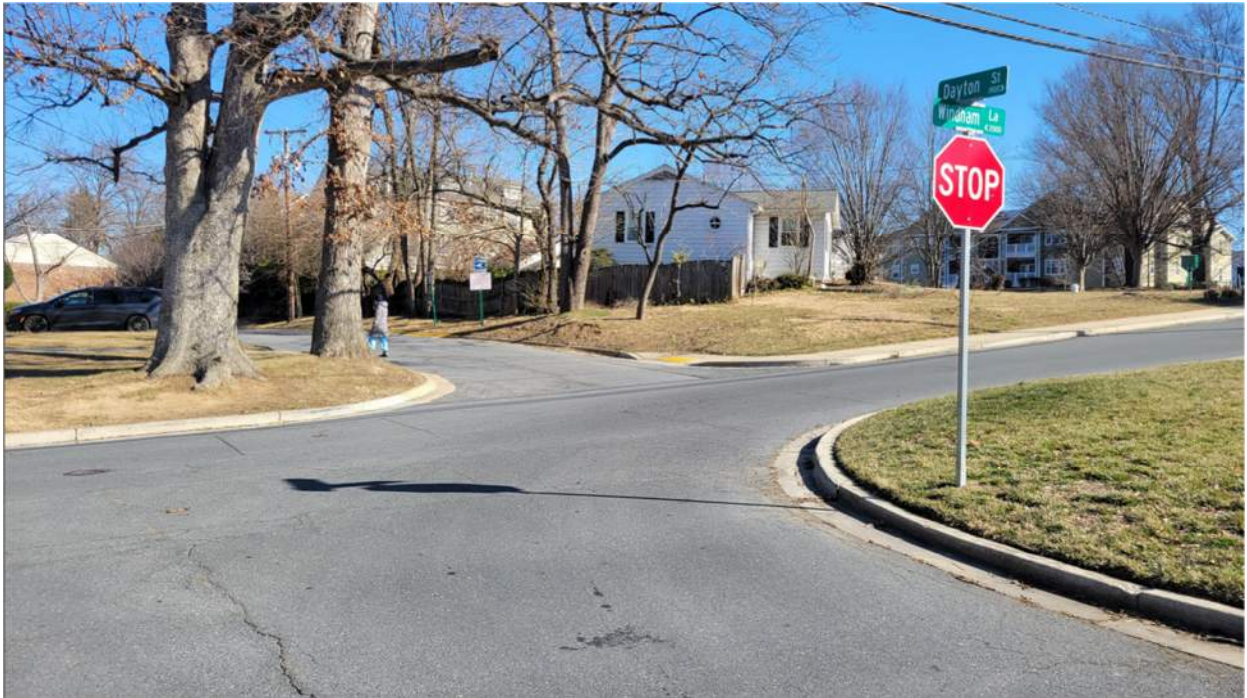
**Photo 1. Taken from southwest corner looking eastbound along Windham Lane.**

**Approximate crash location.**

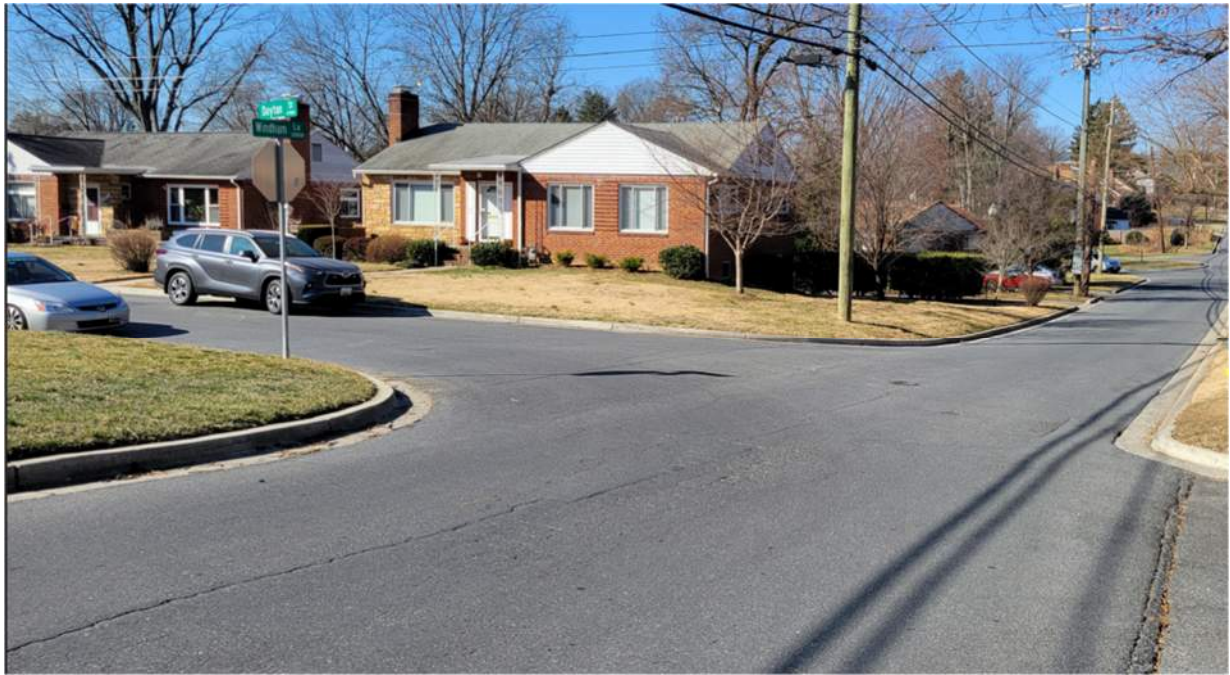
**Photo 2. Intersection view from northeast corner.**

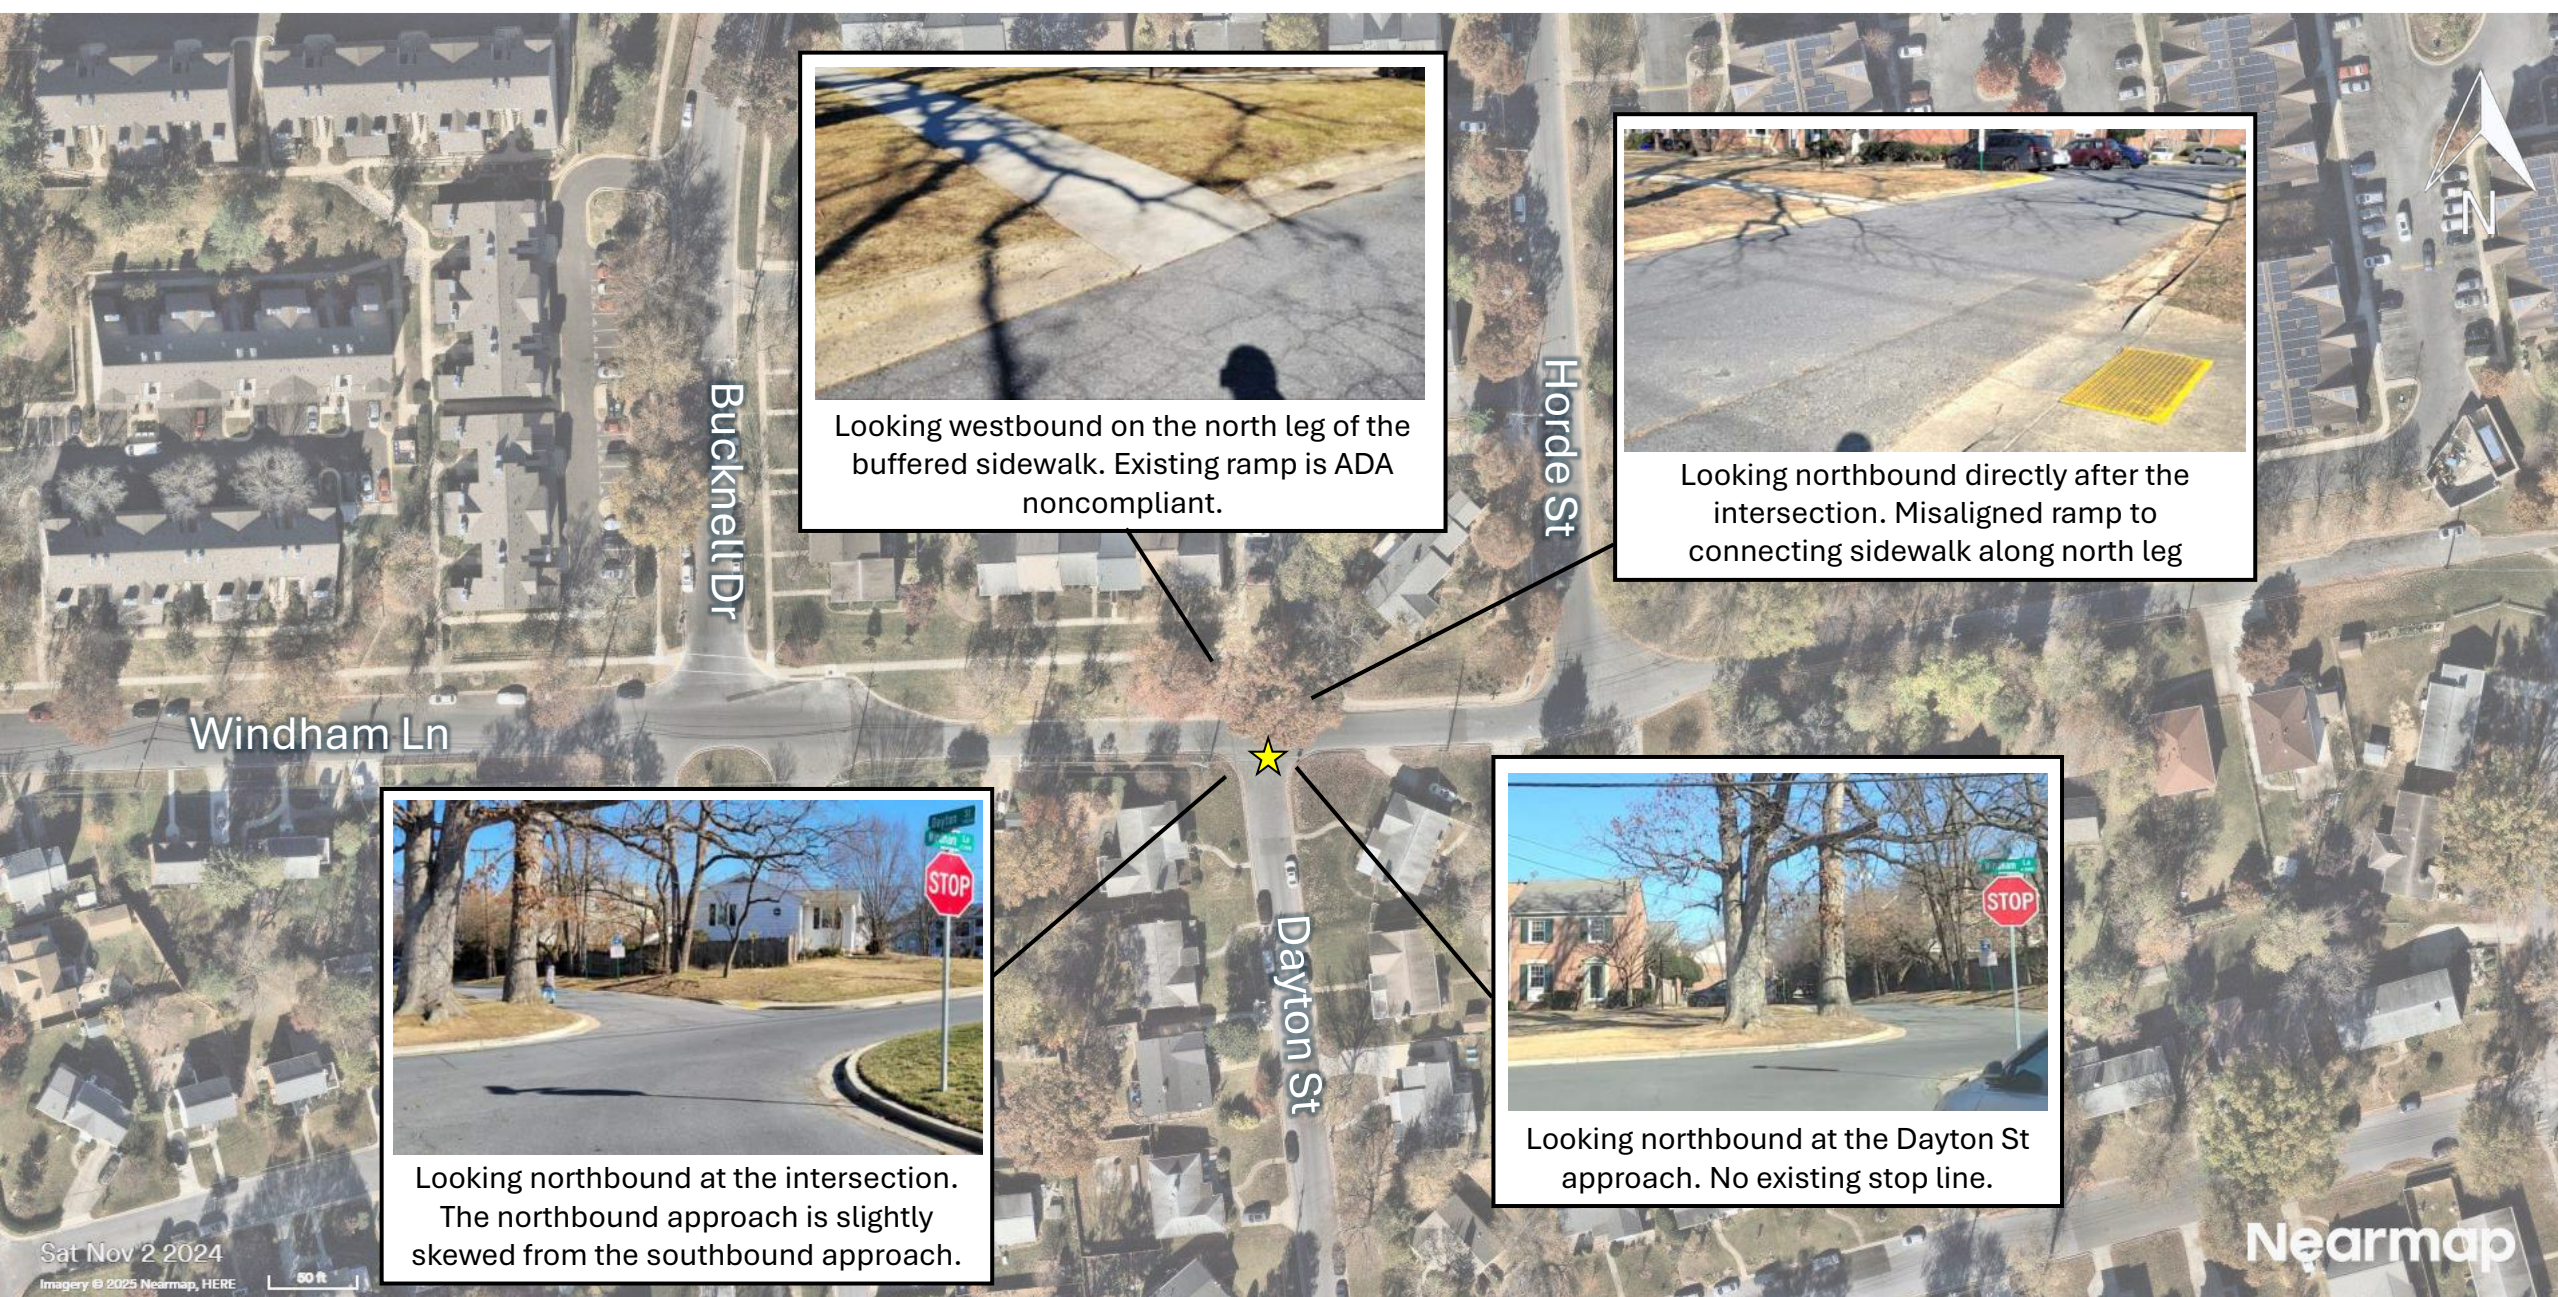
Figure 1 – Dayton St at Windham Ln Observations

Pedestrian facilities at the corners of the intersection are not compliant and the ramps are missing. No marked crossings exist at this intersection.

Field observations were performed on Monday, March 3, 2025, at approximately 10 AM. Weather conditions were clear, and the roadway surface was dry. Pedestrian and vehicular activity was low during the observation period. There are no existing pavement markings across the intersection. On the north leg, there is a sidewalk and an existing ADA compliant ramp that is misaligned to the connecting sidewalk landing area crossing Dayton Street. The sidewalk is not buffered to the east of Dayton Street, while the sidewalk to the west of Dayton Street is buffered. The intersection is not aligned in the northbound and southbound directions along Dayton Street. On-street parking was utilized along Dayton Street reducing sight lines at intersections, driveways, and along curves at the intersection approach.

1. Recommend painting a stop bar for the northbound approach.
2. Update landing area on the northwest corner to include DWS.
3. Consider re-aligning the existing ADA ramp to the landing area on the northwest corner.

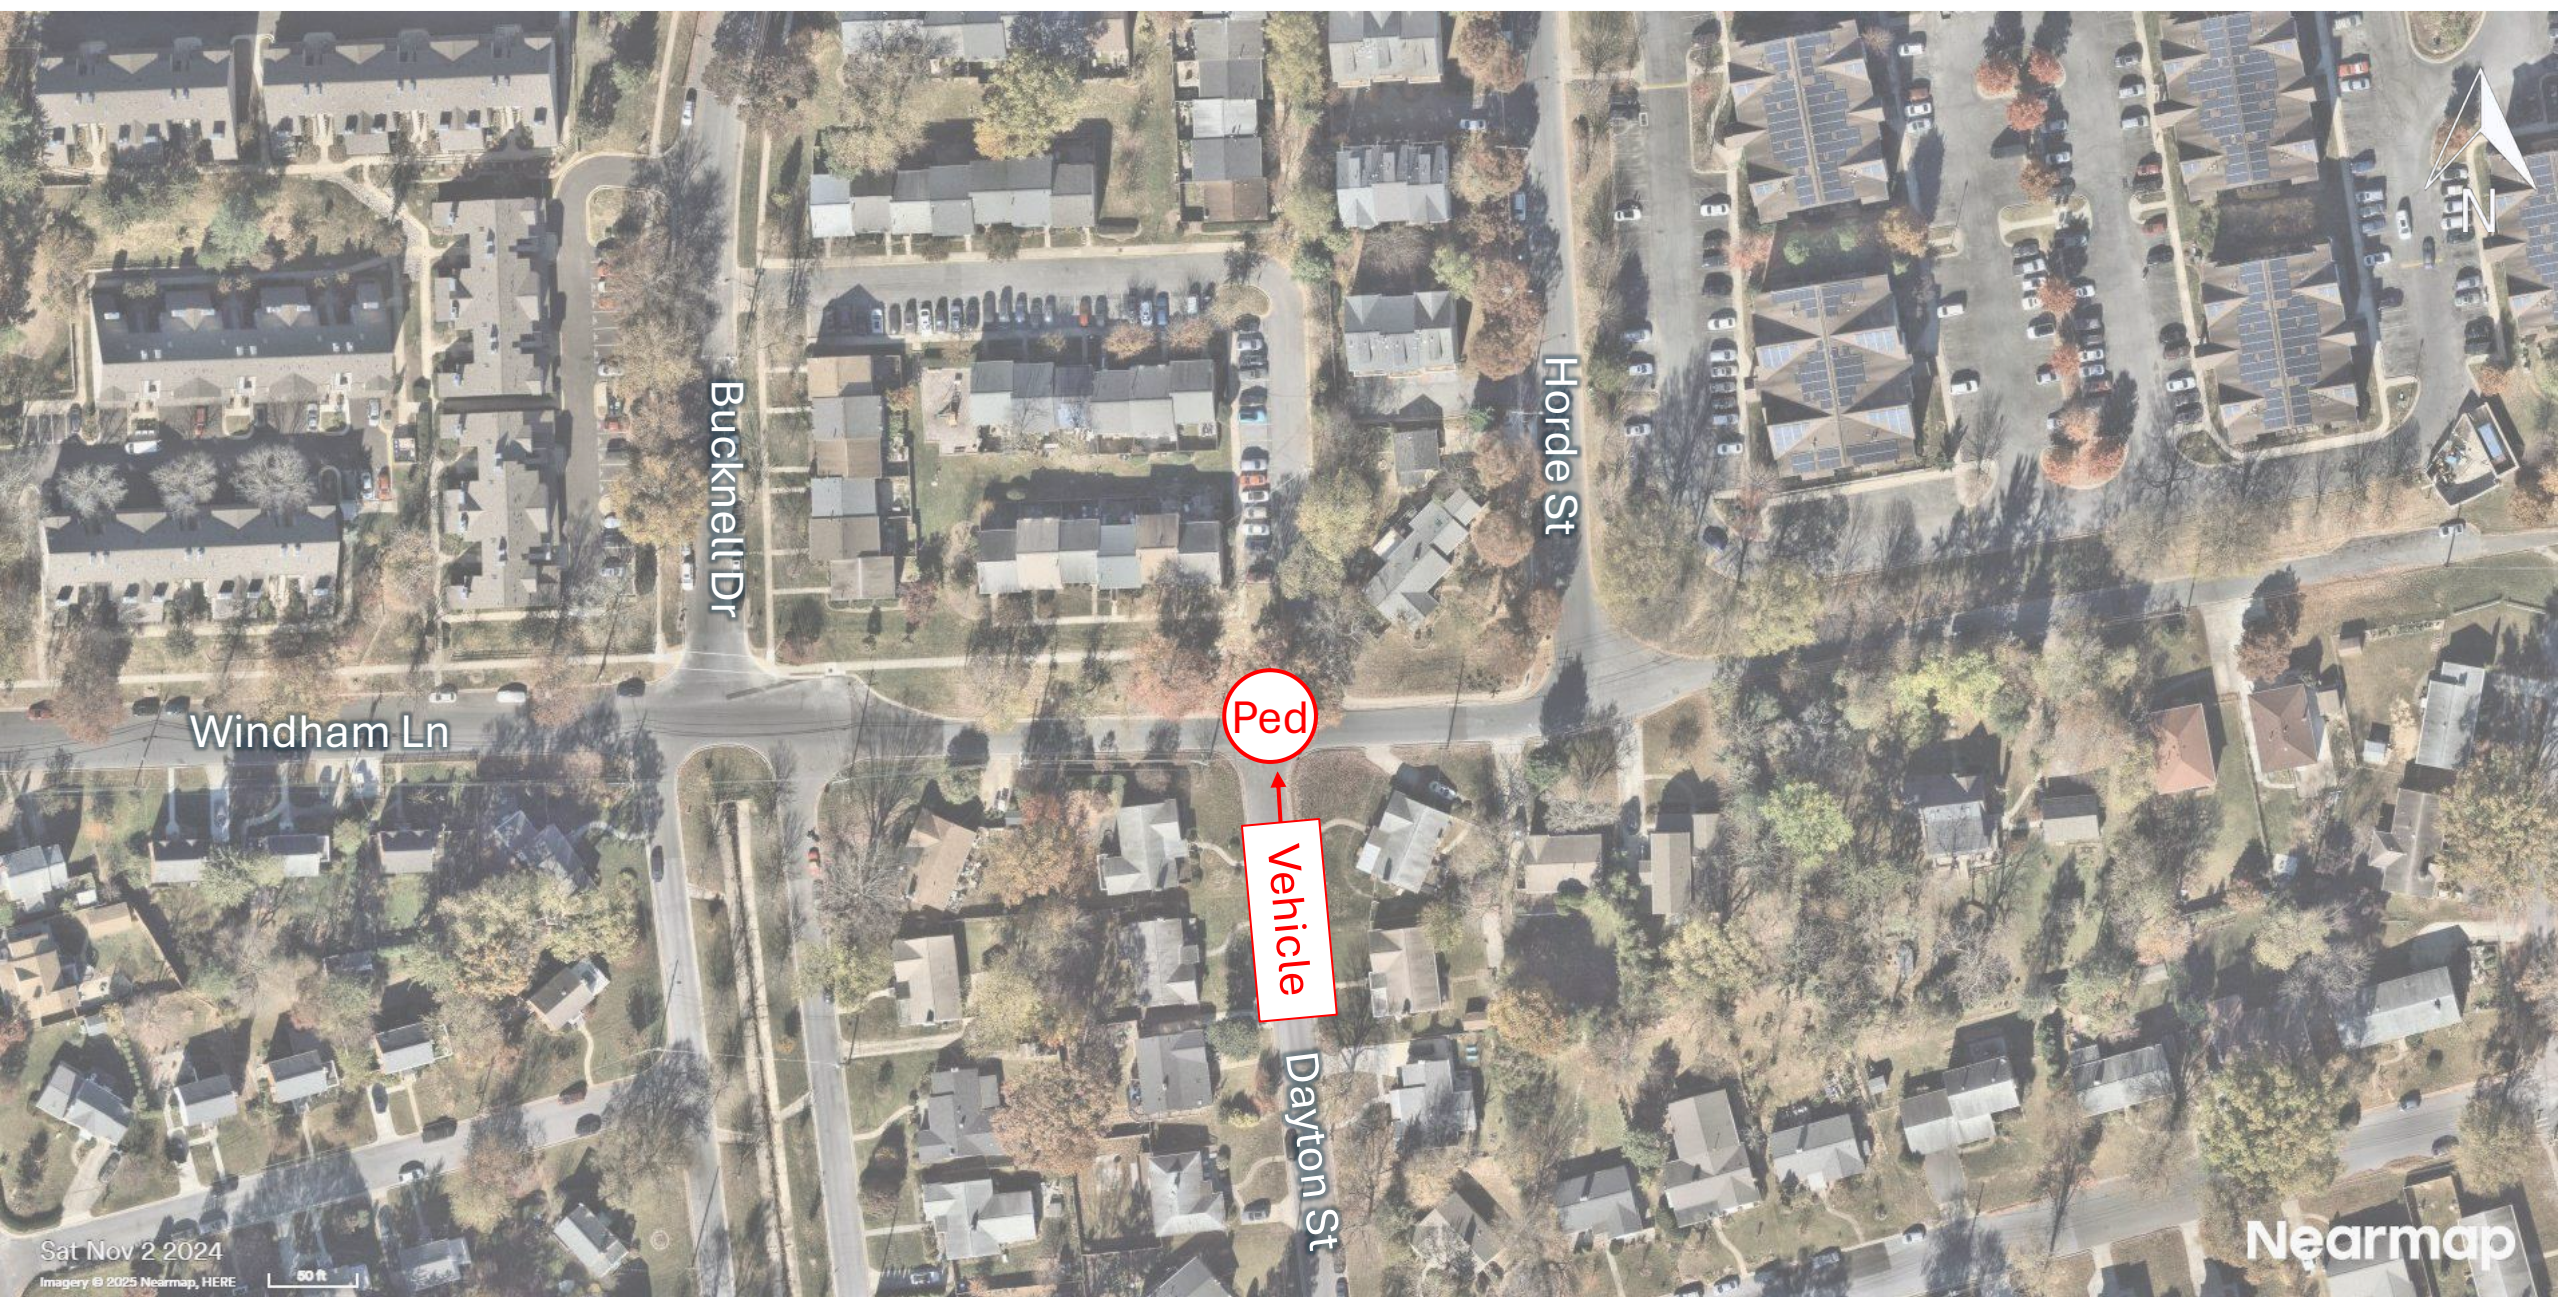
Figure 2 – Crash Diagram

On Monday, December 16, 2024, at approximately 6:40 AM, a school bus was traveling northbound along Dayton Street when it struck a pedestrian running toward it. The crash report indicated the subject location occurred within an unmarked crosswalk. The school bus was making a left turn, and the rear of the vehicle likely swung out and hit the student chasing after the bus on foot. The motorist was unaware of the collision and left the scene, no witnesses or video footage was available. The crash report indicated that the pedestrian suffered minor injuries. It was dark when the crash occurred, weather conditions were clear, and the roadway surface was dry.

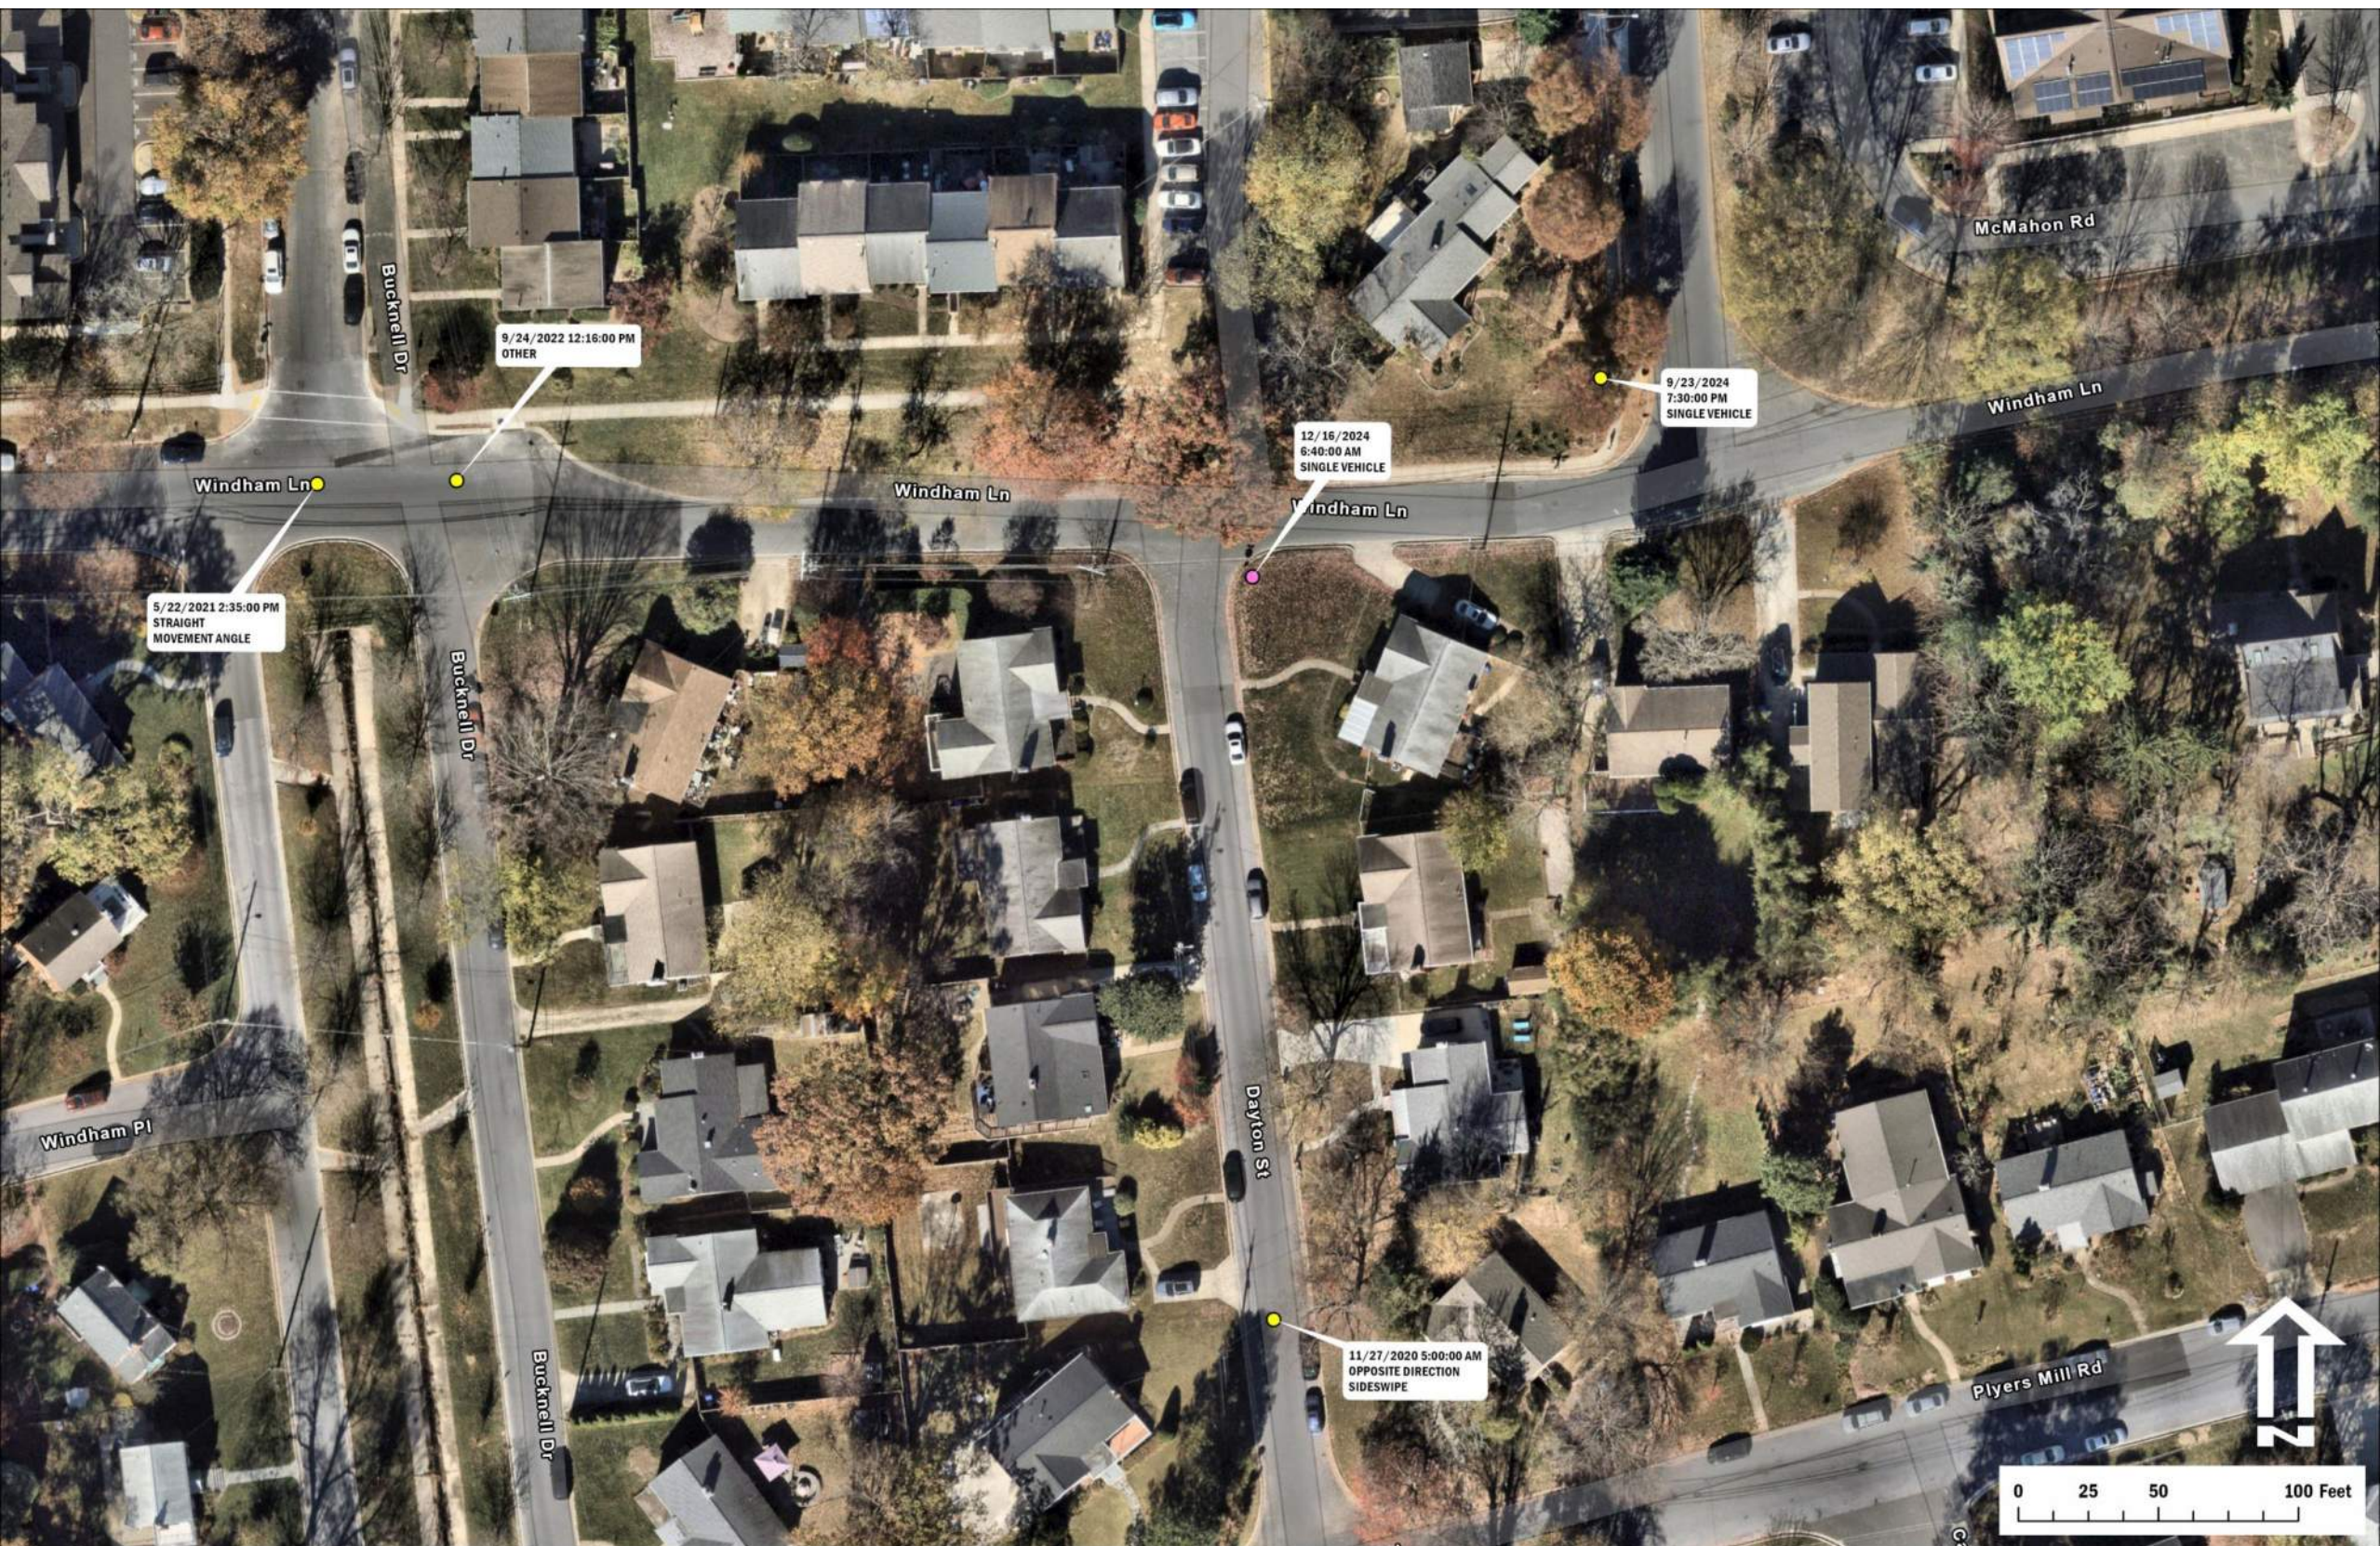
Figure 3 – Crash History (2020-2024)

Crash data obtained from dataMontgomery indicates that five (5) incidents occurred within the vicinity of the crash site between January 2020 and December 2024. Of these five (5) incidents, one (1) crash occurred within 150 feet of the intersection of Dayton Street and Windham Lane, the subject crash incident. The four (4) other crashes occurred at nearby locations. The five (5) crashes reported included three (3) injury crashes, two (2) property damage crashes, and the crash type consisted of one (1) angle collision, one (1) sideswipe collision, two (2) single vehicle collisions, and one (1) classified as “other”. There was only one (1) pedestrian-related crash. Two (2) of the collisions occurred during dry conditions, three (3) of the incidents were not specified, and two (2) occurred in the dark/dusk. The incidents are illustrated on **Figure 3**.
