# SCHOOL-RELATED CRASH INFRASTRUCTURE REVIEW

**Location:** Middlebrook Road at Century Boulevard

**Crash Date:** December 20, 2024

**Local Case No.:** 240060840

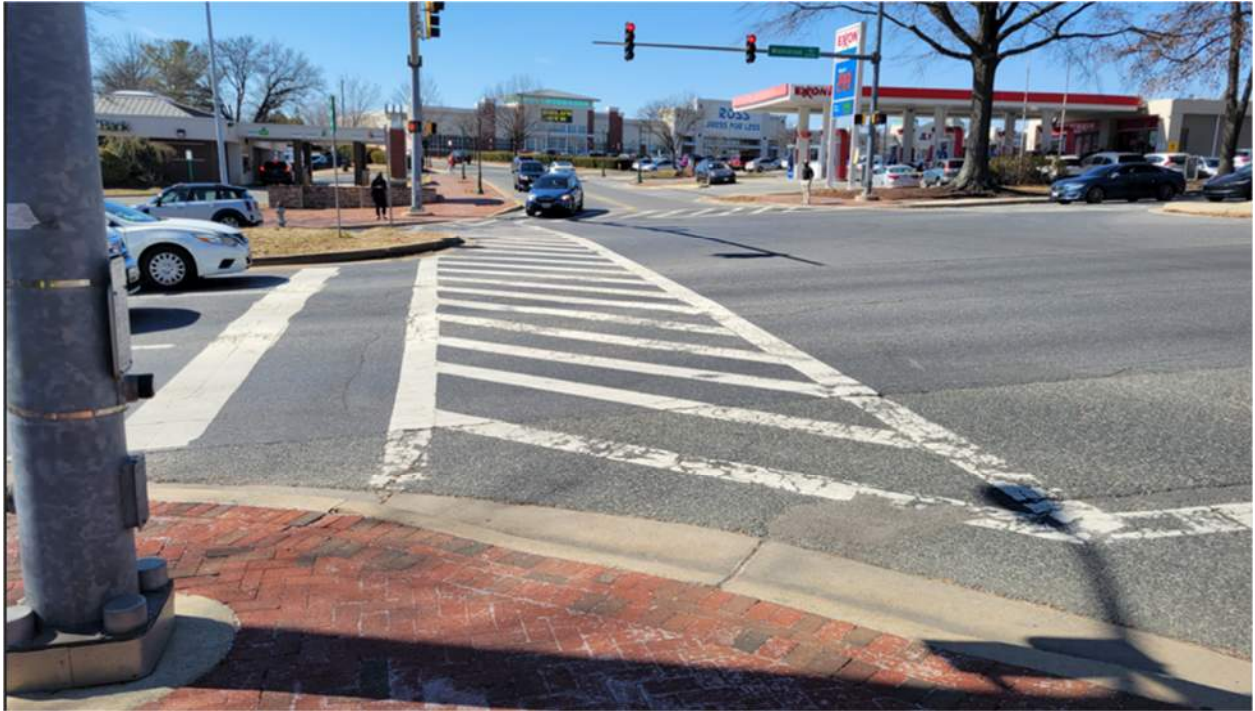
**Photo 1. Taken from southeast corner looking westbound along Century Blvd at the south leg crossing. Approximate crash location.**

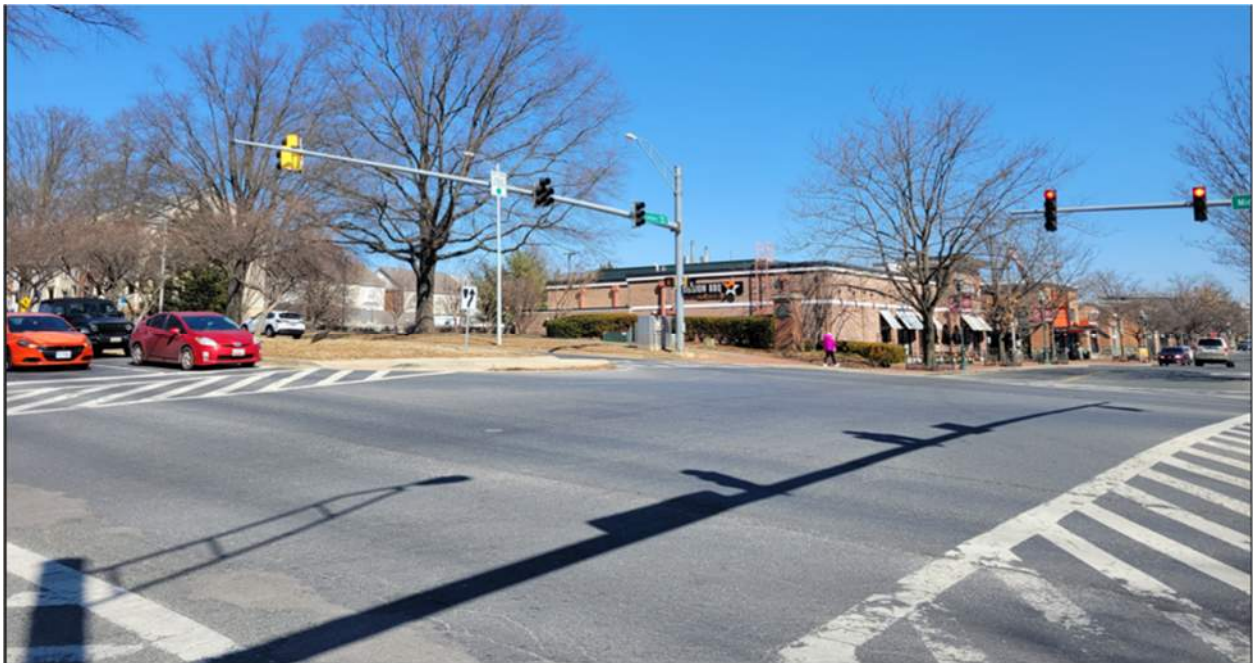
Pedestrian facilities at the corners of the intersection are not compliant with American's with Disabilities Act (ADA), and include missing and improperly angled ramps at the corners of the intersection. The crosswalks are diagonally hatched, and a pedestrian refuge island is installed on the north leg.

**Photo 2. Intersection view from southwest corner.**

- Update the traffic signal to include properly configured APS
- Install ADA-compliant pedestrian ramps and continental crosswalks at each leg of the intersection.

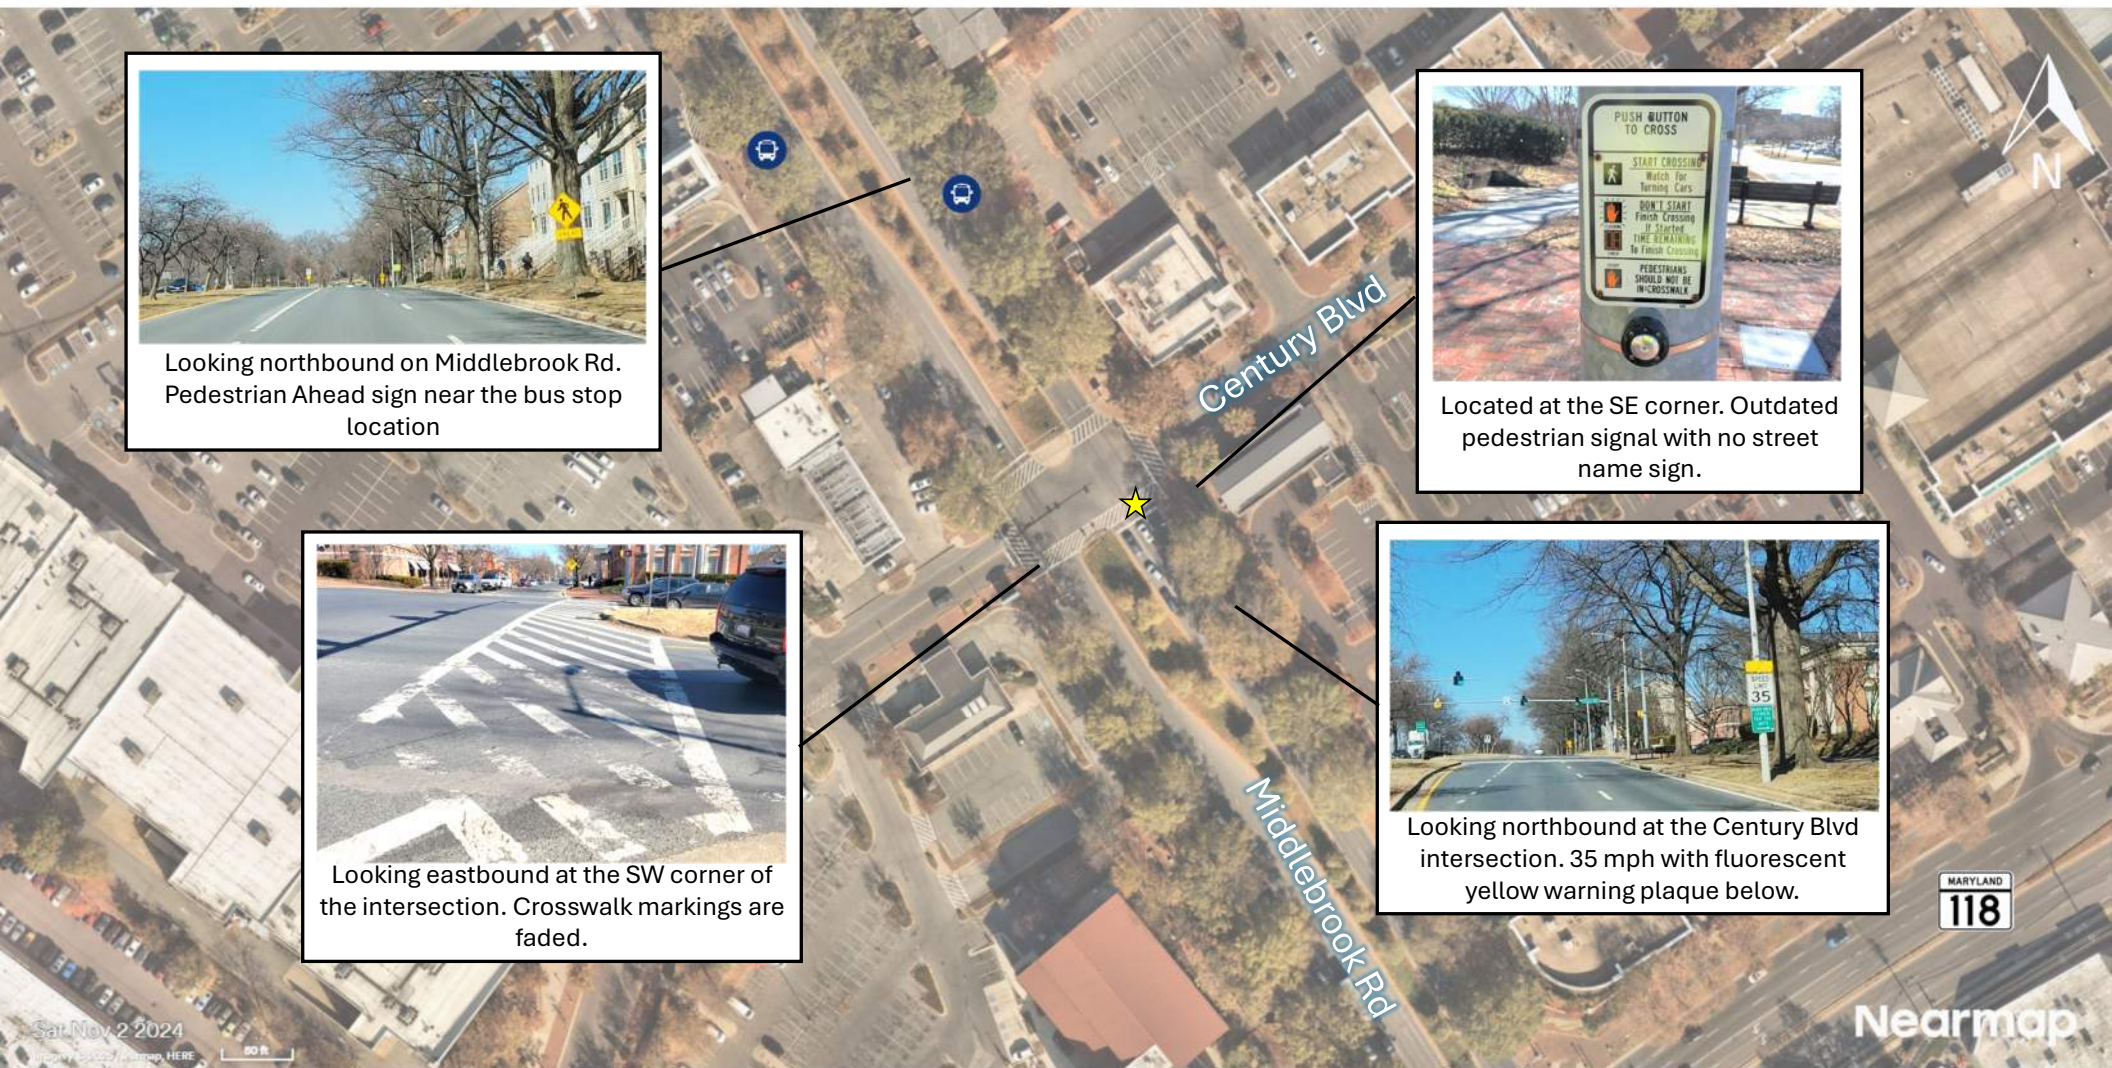
Figure 1 – Middlebrook Rd at Century Blvd Observations

Refer to **Figure 1** in the attachments for additional details on the Middlebrook Road segment.

The Middlebrook Road corridor was evaluated to identify potential infrastructure, maintenance activities, and road user behaviors that contribute to increased safety risk at and in the vicinity of the school-related crash location. The Middlebrook Road corridor was reviewed between Father Hurley Boulevard to the north and MD 119 (Great Seneca Highway) to the south. Please refer to **Figure 1** for additional information.

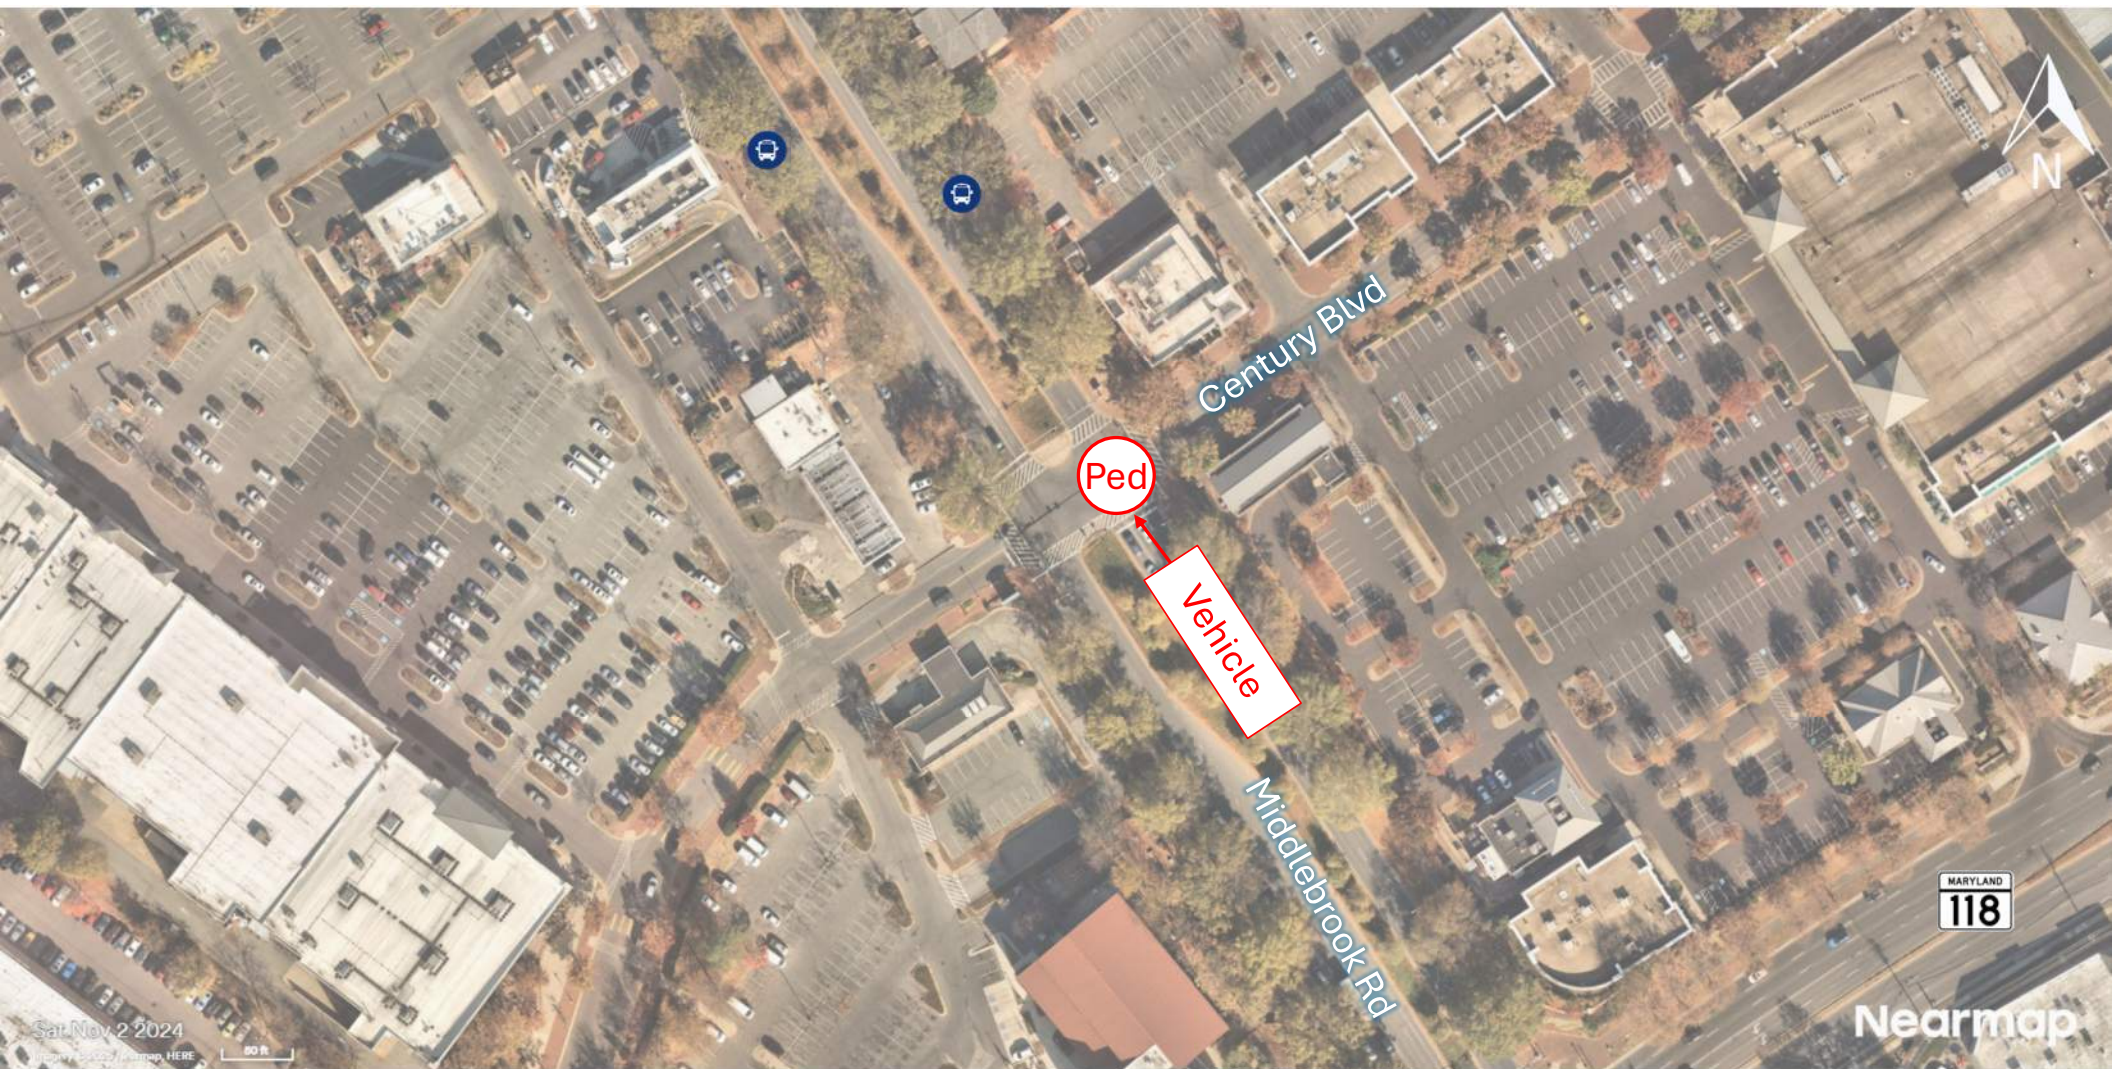
Figure 2 – Crash Diagram

On Friday, December 20, 2024, at approximately 11:38 AM, a pedestrian was traveling over Middlebrook Road when a motorist traveling southbound on Middlebrook Road struck the pedestrian. The crash report indicated the subject location occurred within an unmarked crosswalk. The crash report indicated that the pedestrian suffered minor injuries. Daytime weather conditions were snowy, and the roadway surface was wet.

**Figure 2** illustrates the crash location and direction of pedestrian and vehicle travel.

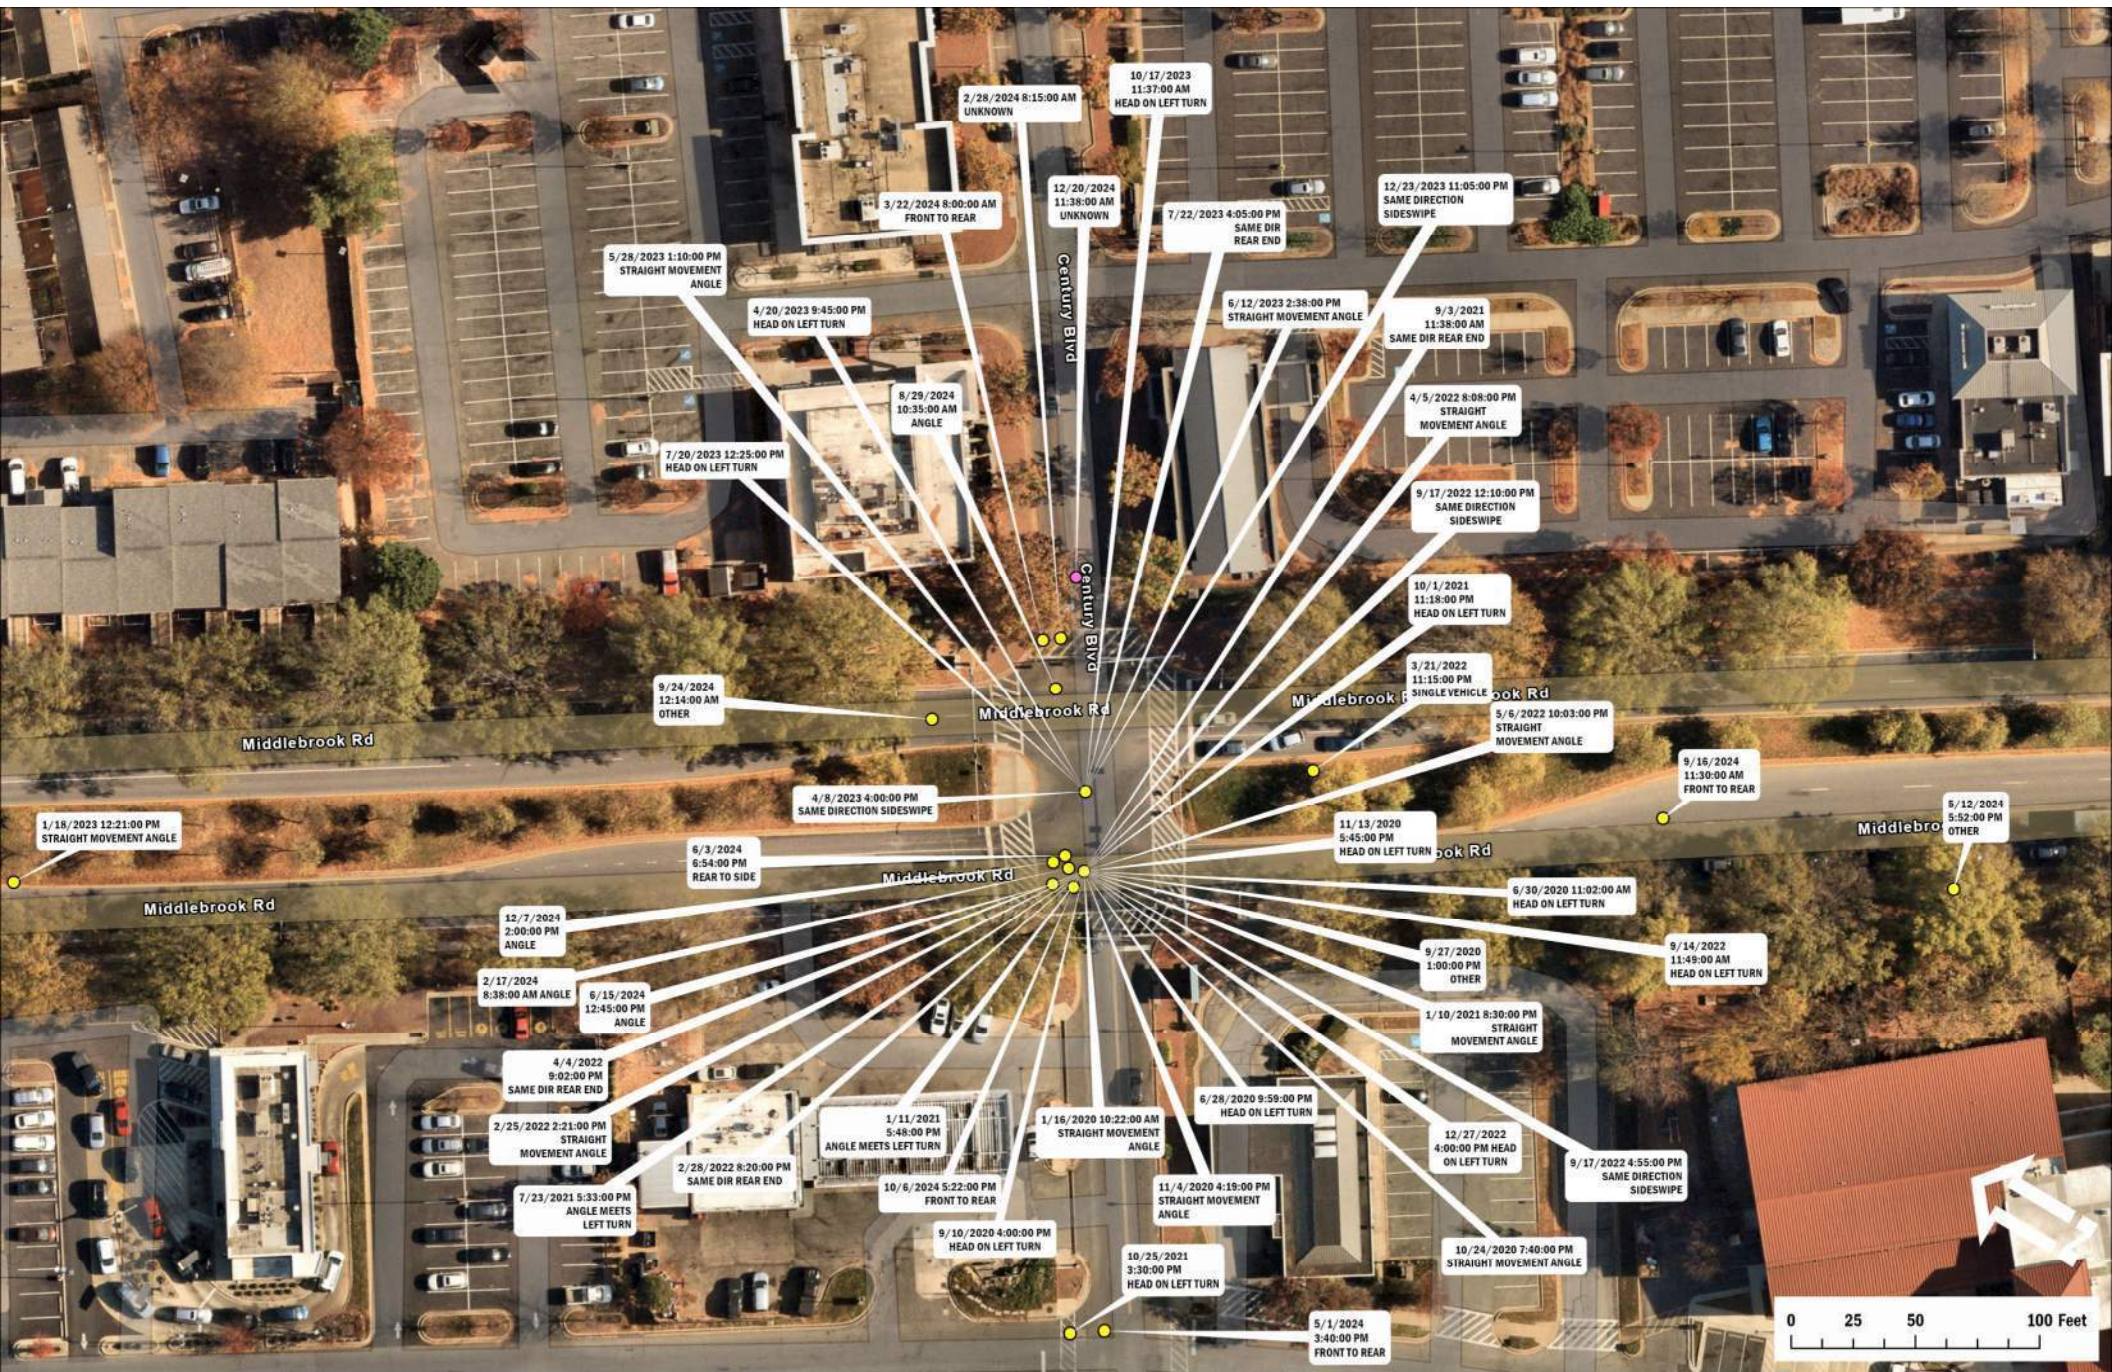
Figure 3 – Crash History (2020-2024)

Crash data obtained from dataMontgomery indicates that 46 incidents occurred within the vicinity of the crash site between January 2020 and December 2024. Of these 46 incidents, 41 crashes occurred at or near the signalized intersection of Century Boulevard and Middlebrook Road, the subject crash incident. These 41 crashes included 24 injury crashes, 17 property damage crashes, and the crash type consisted of 15 angle collisions, 10 head on collisions, seven (7) rear end collisions, four (4) sideswipe collisions, one (1) single vehicle collisions, two (2) classified as “other”, and two (2) classified as “unknown”. Eight (8) of the incidents occurred during wet pavement conditions and 13 occurred in the dark/dusk. There were two (2) pedestrian-related crashes; one (1) is the subject crash and the other pedestrian crash resulted in an injury crash occurring in the daylight during clear weather conditions. The subject intersection crashes are summarized in the chart below.

The five (5) other crashes occurred at points not at the subject intersection of Middlebrook Road and Century Boulevard, including north of the intersection along Middlebrook Road, south of the intersection along Middlebrook Road, or east of the intersection within the parking lot. There were five (5) injury crashes and one (1) property damage crash, with two (2) rear end collisions, one (1) angle collision, one (1) head on collision, and one (1) classified as “other”. All five (5) collisions occurred in daylight and along a dry surface with clear or cloudy weather conditions.

All incidents are illustrated on Figure 3.
