SCHOOL-RELATED CRASH INFRASTRUCTURE REVIEW

Location: Observation Dr at Royal Crown Dr
Crash Date: March 17, 2025
Crash Time: 9:36 AM
School Name: William B. Gibbs Jr. Elementary School
School Walkshed Boundary (☒ **Inside** ☐ **Borderline** ☐ **Just Outside**)
Local Case No: 250011609
Review Date: October 10, 2025

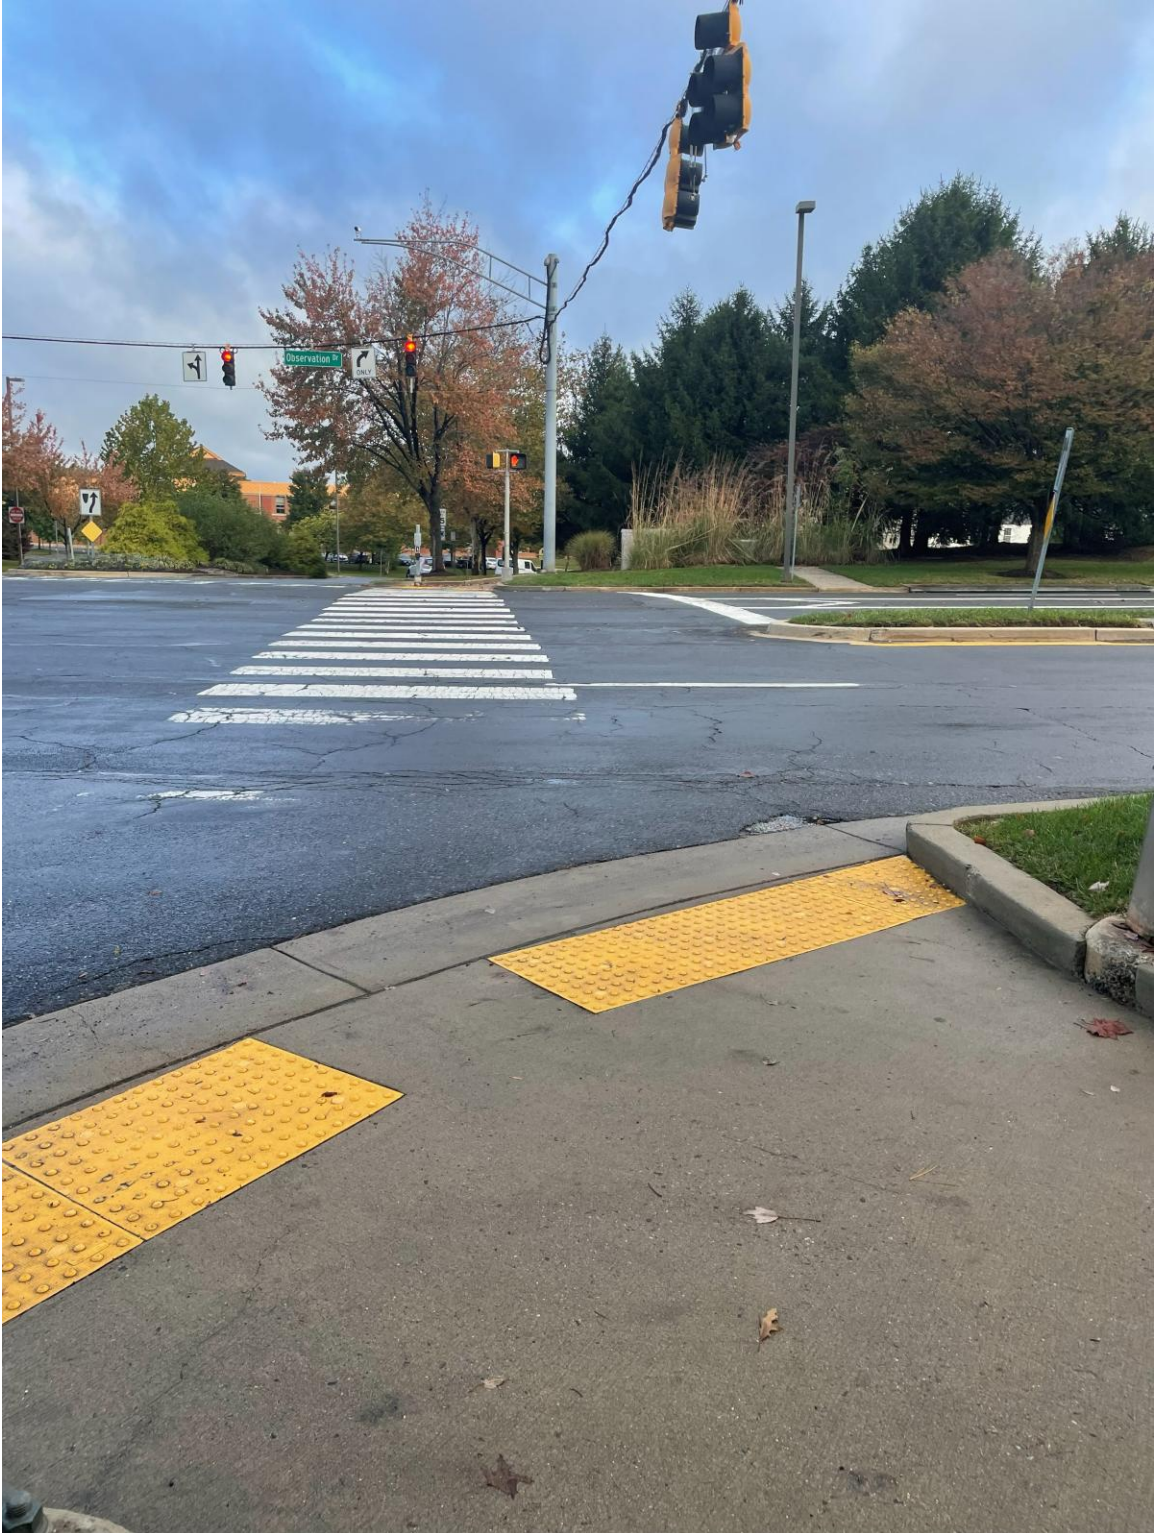
On Monday, March 17, 2025, at approximately 9:36 AM, a pedestrian was in the crosswalk on the east leg of the Observation Drive at Royal Crown Drive intersection when a motorist making a southbound left turn from Royal Crown Drive onto Observation Drive struck the pedestrian. The crash report indicated the crash occurred within a marked crosswalk. The pedestrian suffered a possible injury. The driver was found at fault for failing to yield right-of-way. Daytime weather conditions were clear, and the roadway surface was dry.

Figure 1A: East Leg Crosswalk, Facing North, where Crash Occurred

1. Restripe continental crosswalk markings on the north, south, and east legs of the intersection.

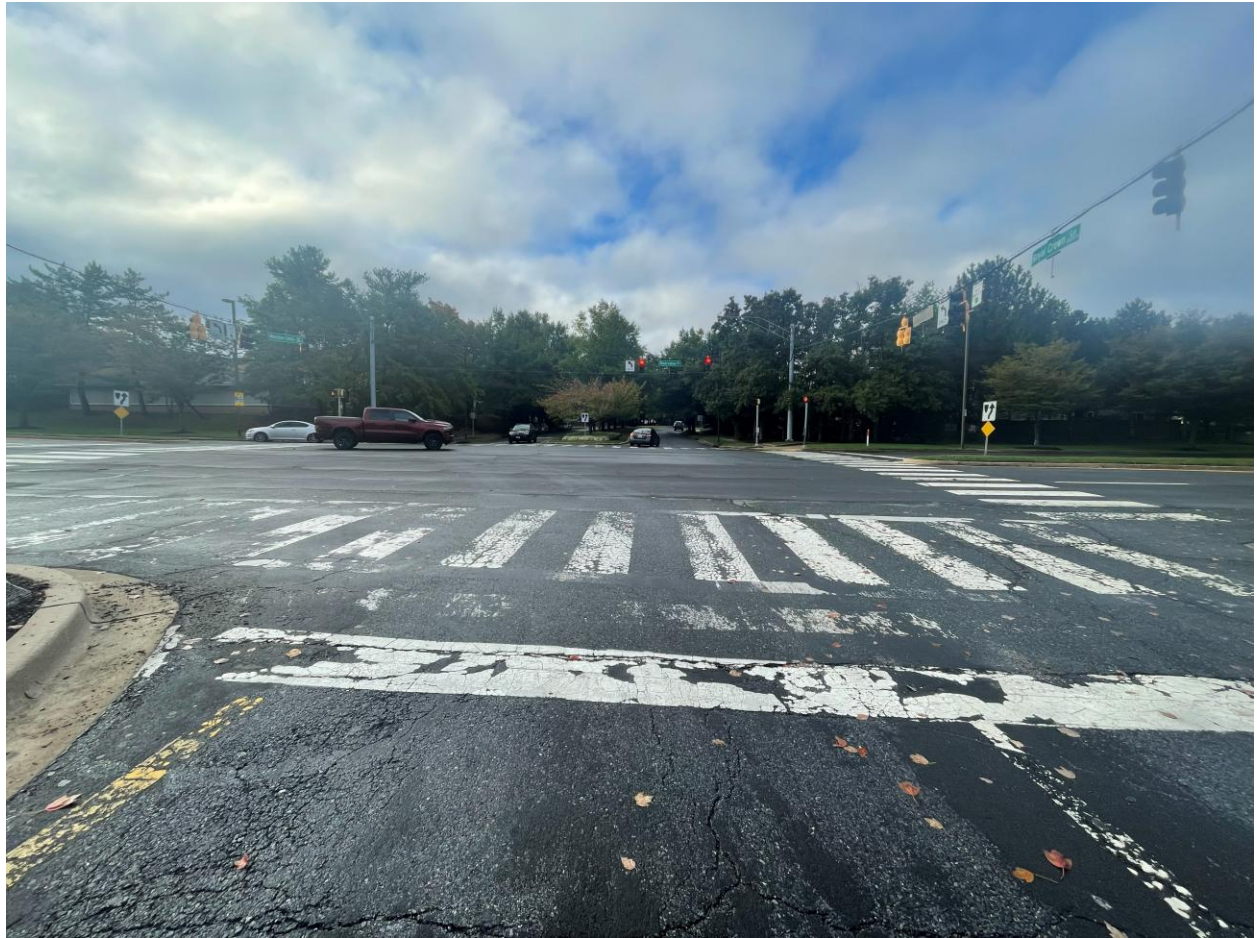
Sight lines for southbound left turning vehicles are unobstructed. Based on field observations, the primary issue appears to be that southbound left turning vehicles grow impatient due to the quantity of pedestrians utilizing the east leg crosswalk as it utilizes the full green phase for the sidestreet movement.

Figure 1B: View for Southbound Left Turning Vehicles

1. Consider installing R10-15L “Turning Vehicle Yield to Pedestrians” signs for the southbound approach.
2. Consider installing S1-1 “School Crossing” signs for the east leg crosswalk.

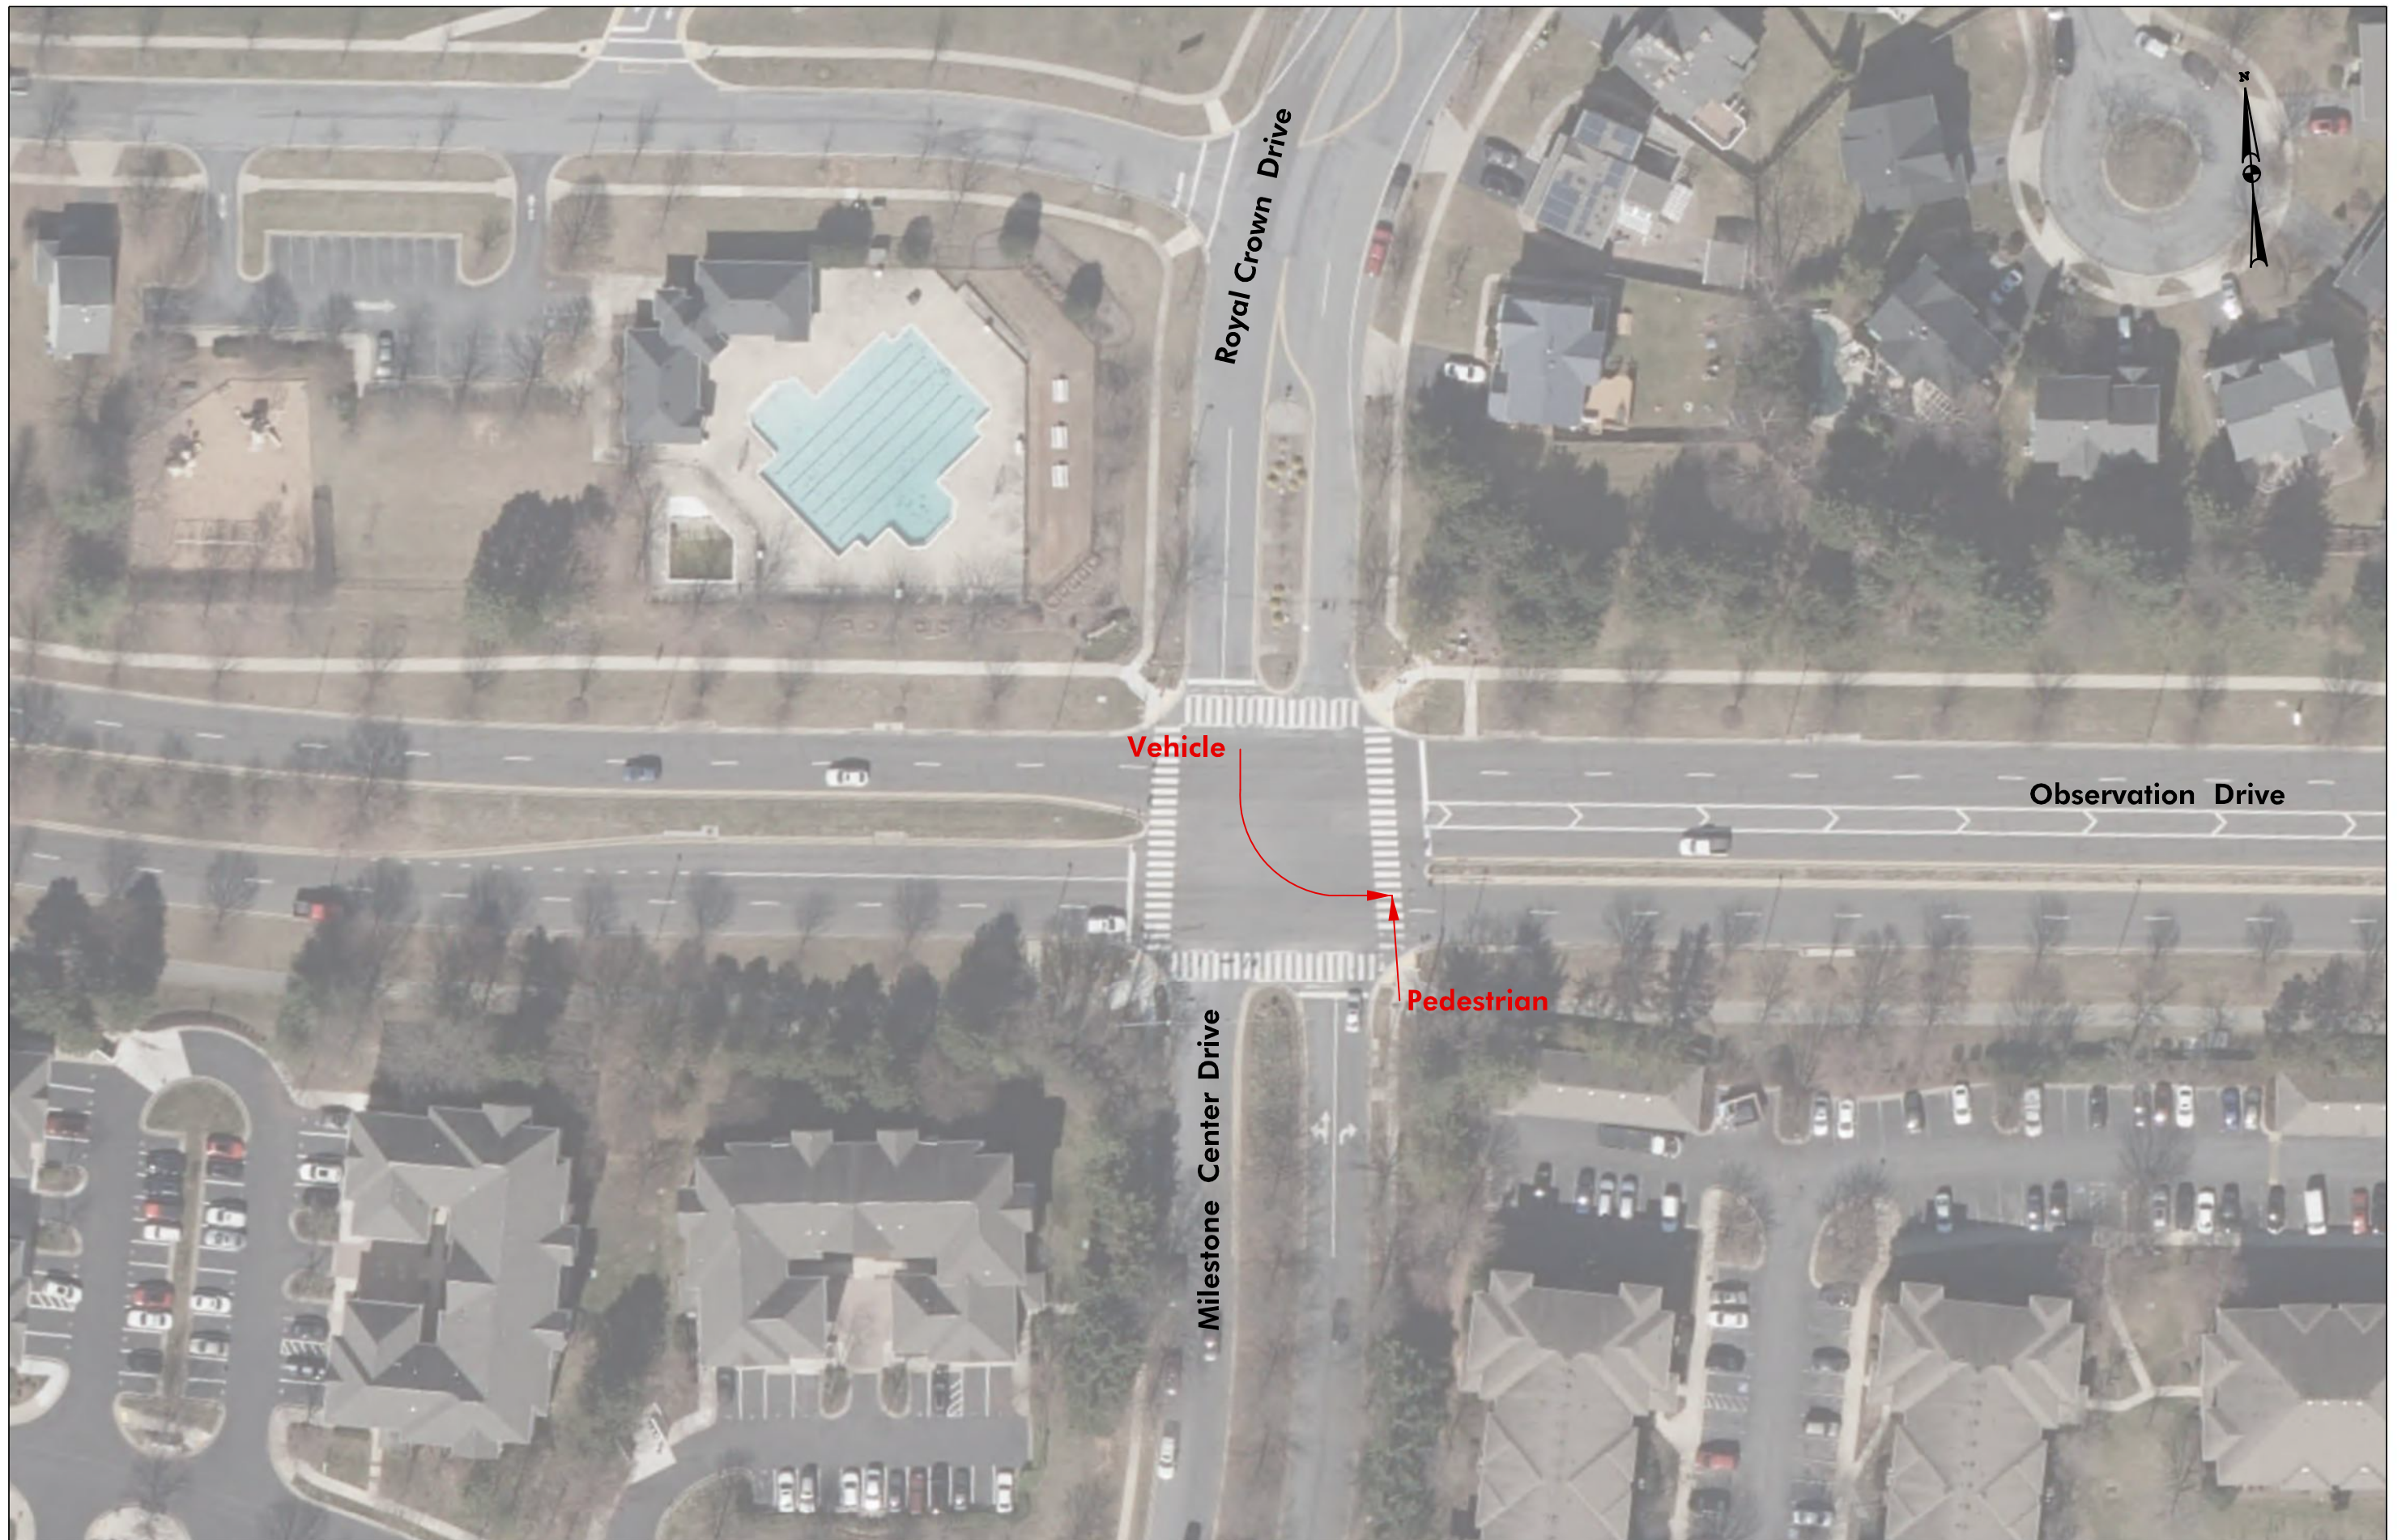
Figure 2 – Crash Diagram

Figure 2 illustrates the crash location and direction of pedestrian and vehicle travel.

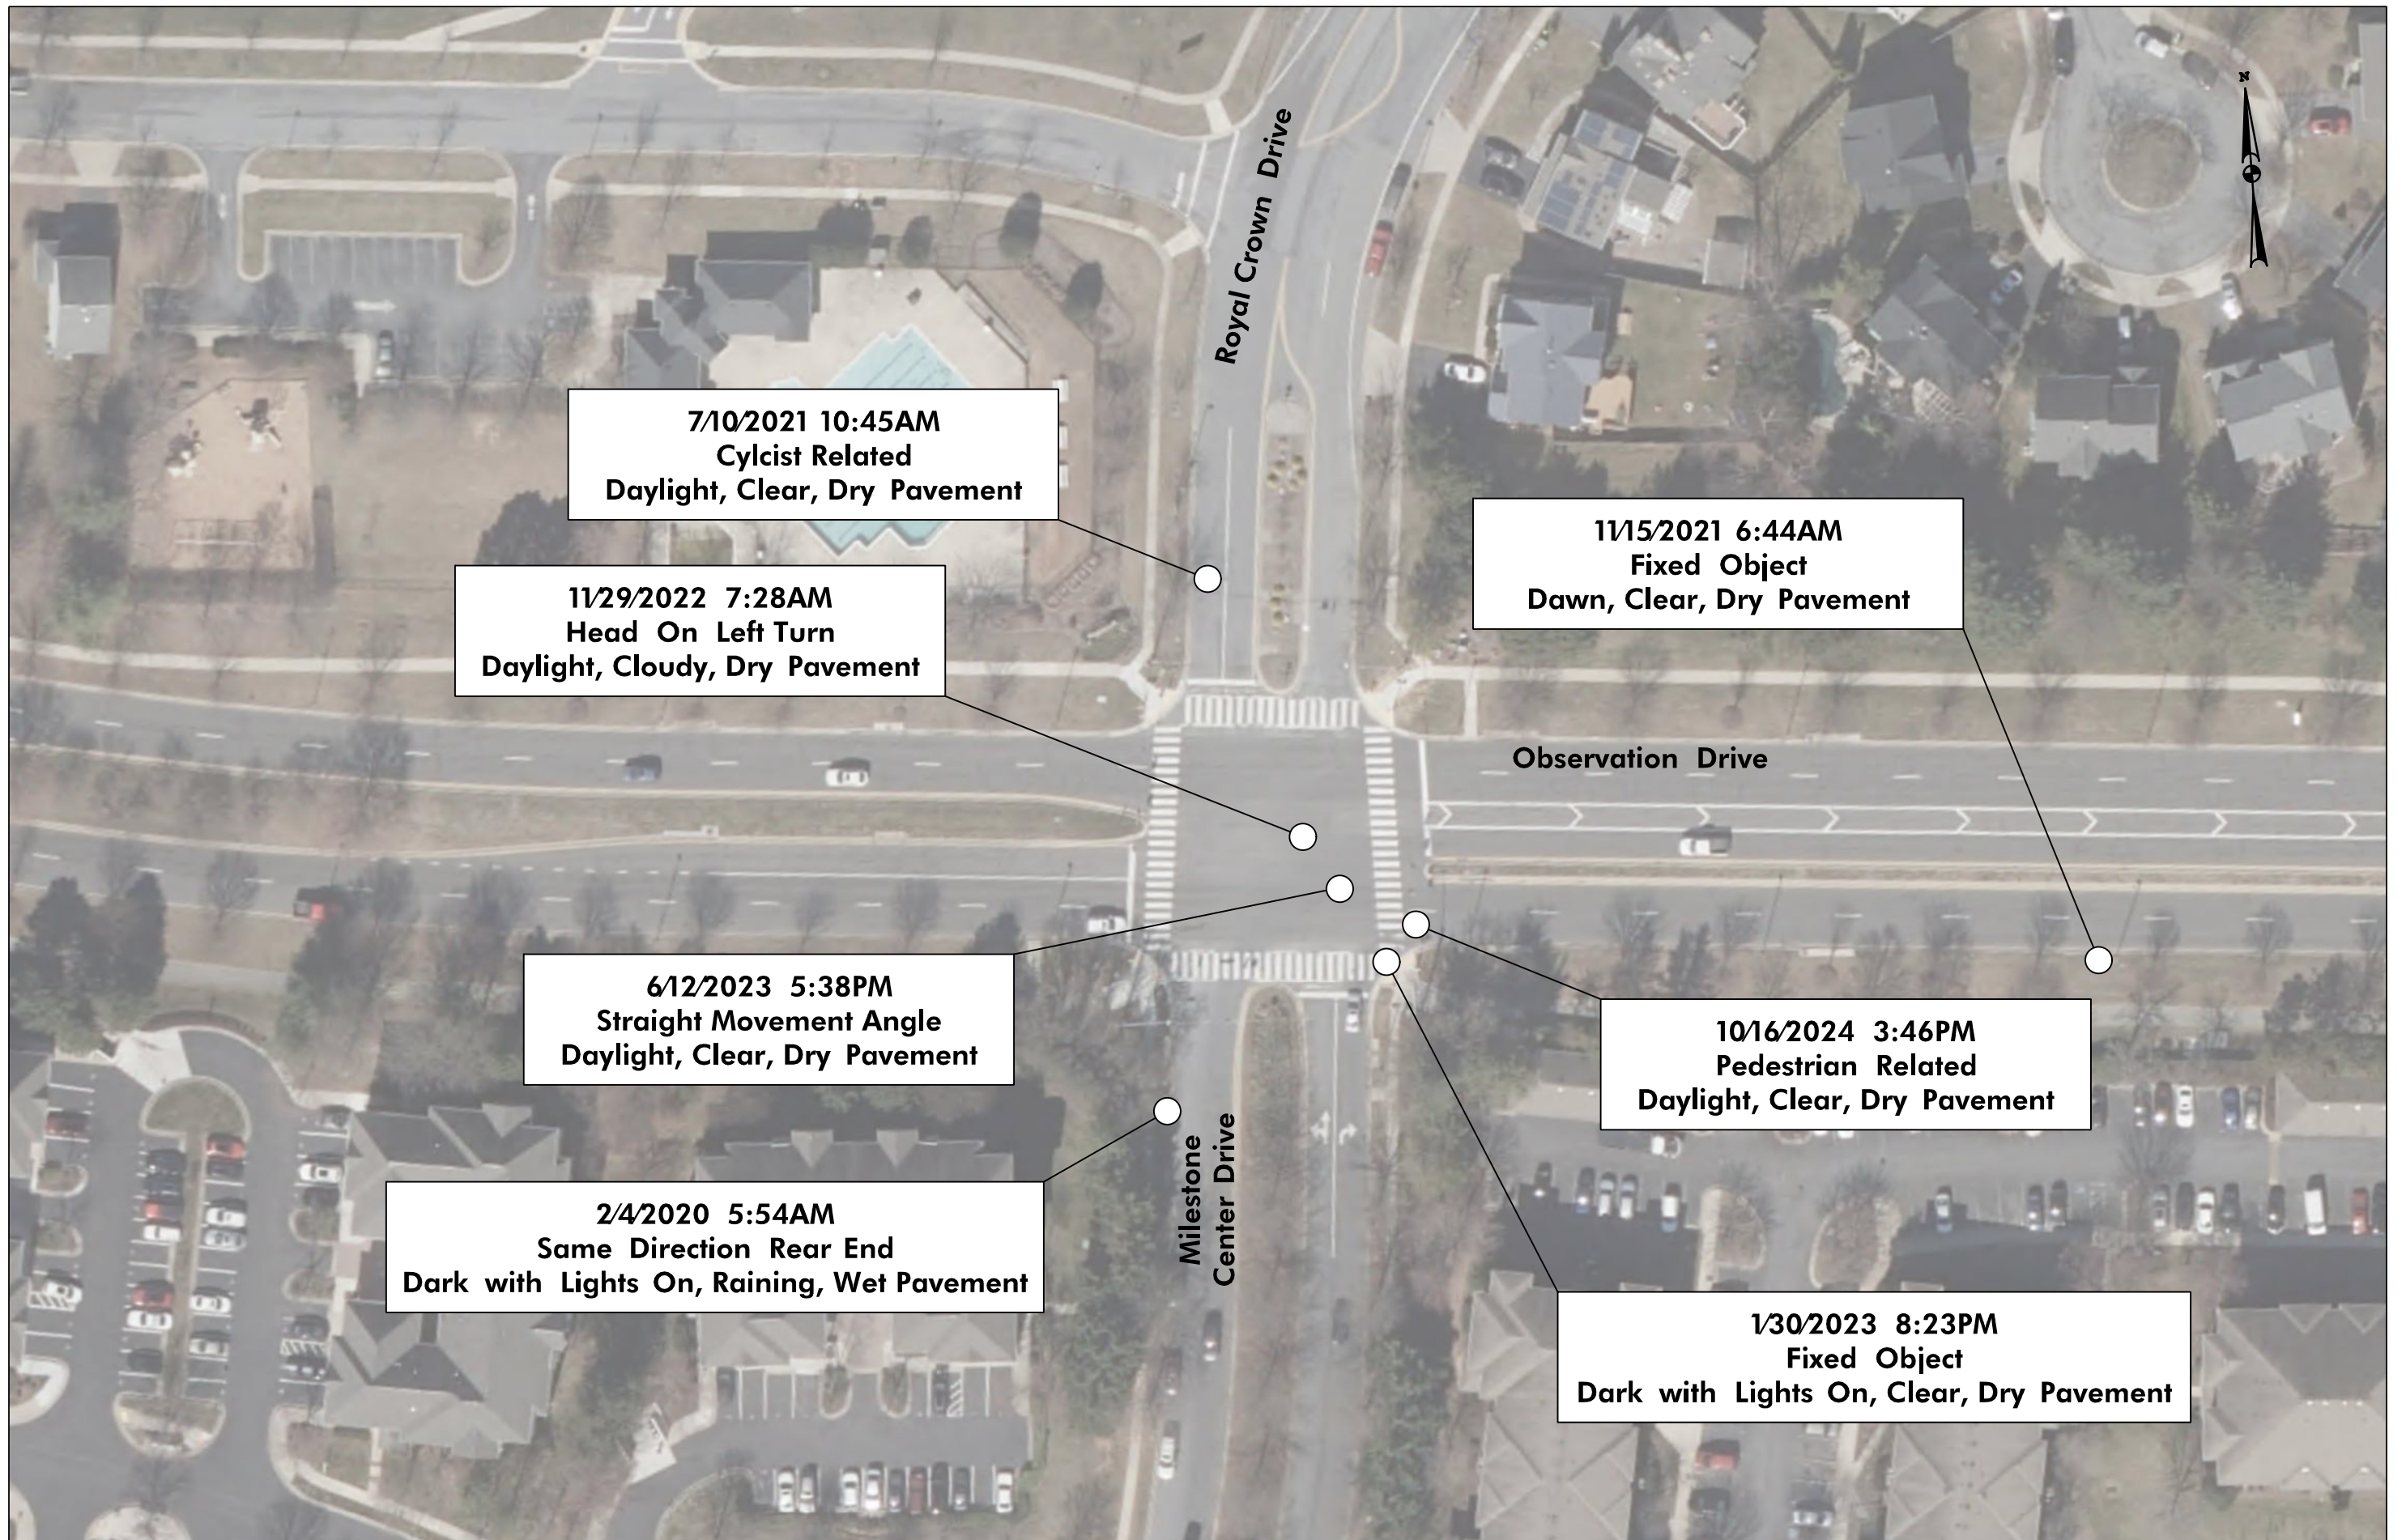
Figure 3 – Crash History (2020–2024)

- Total Crashes (Last 5 Years): 7
- Pedestrian/Bicycle Involved: 2
- Student-Involved Crashes: 0
- Crashes During School Hours: 1
- Recurrent Patterns (Time/Type): None
