SCHOOL-RELATED CRASH INFRASTRUCTURE REVIEW MONTGOMERY COUNTY DEPARTMENT OF TRANSPORTATION (MCDOT)

• Location: Woodcrest Drive at Melinda Lane

• Crash Date: August 28, 2025

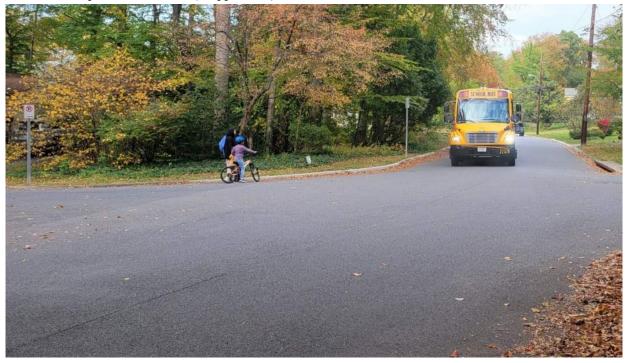
School child on bicycle and parent walking at the intersection yielding to school bus

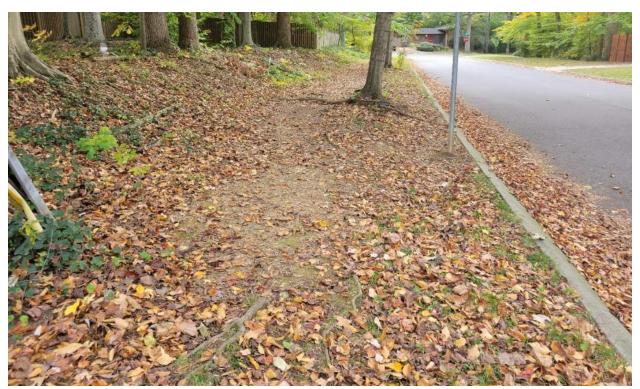
Because the elementary and middle school are within the walkshed, school children and parents were observed to walk at the intersection within the drop-off and pick-up time periods, most notable between 3:30 PM and 4:00 PM. There were numerous pedestrians observed walking within the roadway or within the nearest property because sidewalks are not available. There is a worn path in the southeast corner where pedestrians were observed to be comfortable walking.

Pedestrian path along east side of south leg

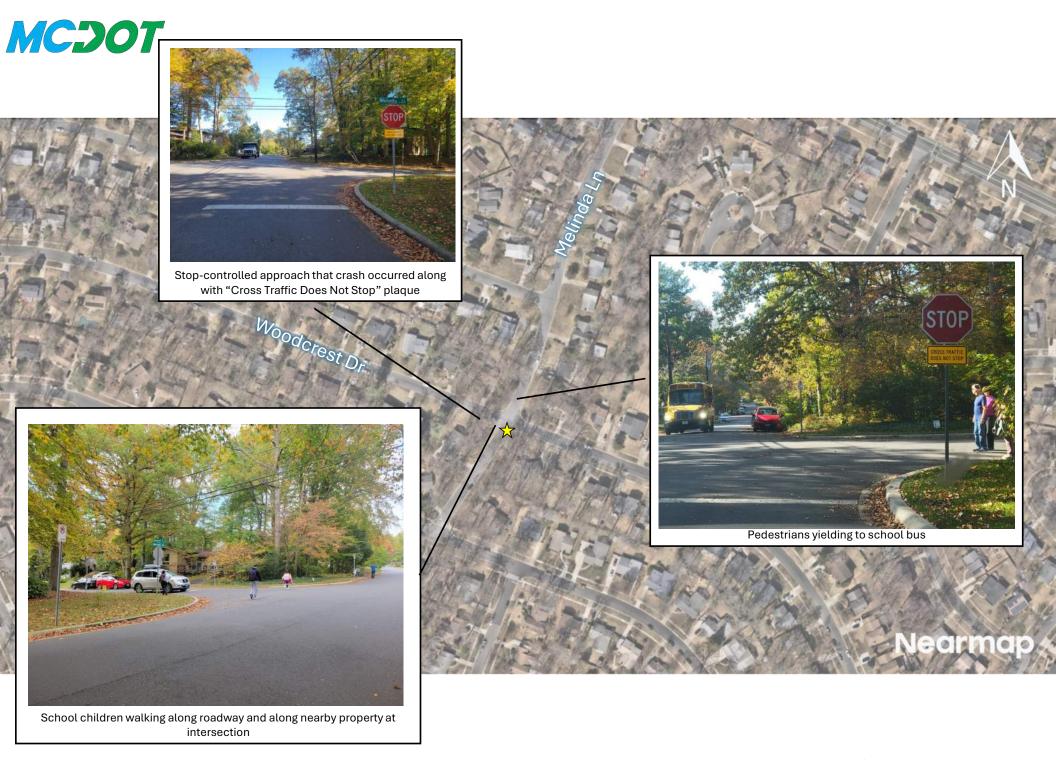
Figure 1 – Woodcrest Dr at Melinda Ln Intersection Observations

There is a "Cross Traffic Does Not Stop" plaque along the stop-controlled approaches.

• Engineering Improvements: Consider installing ADA-compliant pedestrian ramps, continental crosswalks, and continuous sidewalk along Melinda Lane from Bel Pre Road to Barkwood Drive and on Woodcrest Drive from Melinda Lane to Nadine Drive.

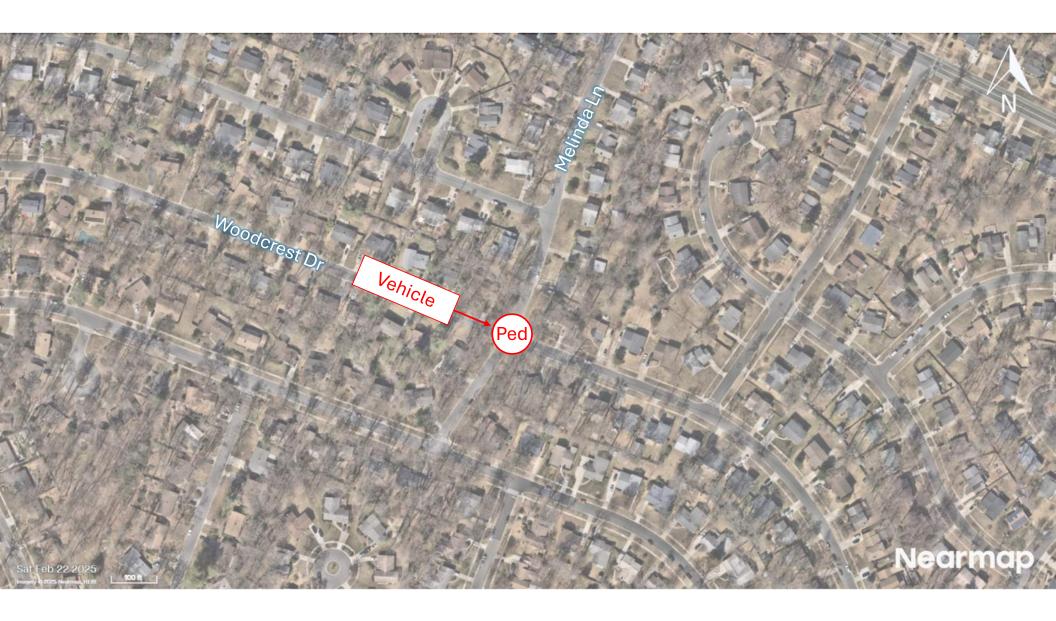
Figure 2 – Crash Diagram

On Friday, August 29, 2025, a pedestrian was crossing the subject intersection when the school bus began to drive and the student ran in front and was struck by a school bus. The crash report indicated the pedestrian did not suffer an apparent injury. The weather was clear, and the roadway was dry. Figure 2 illustrates the crash location and the direction of pedestrian and vehicle travel.

There were no obvious infrastructure deficiencies that contributed to this crash. The crash occurred due to driver error.

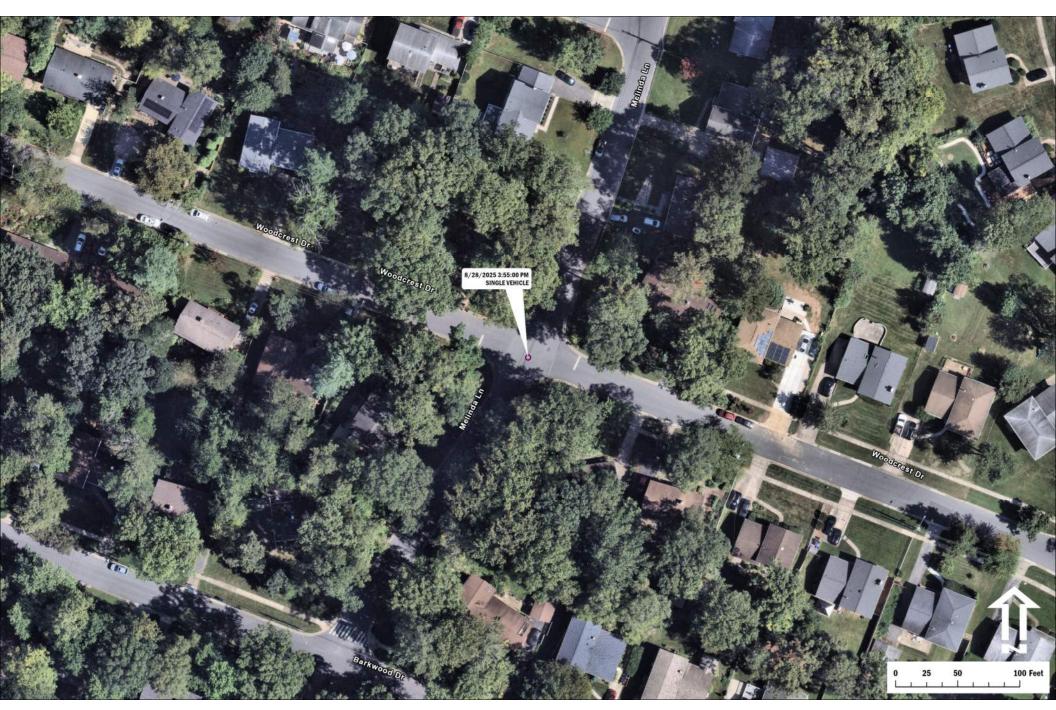
Figure 3 – Crash History (2020-2025)

- Total Crashes (Last 5 Years): Only the subject crash occurred at the subject intersection within the last five years.
 - o Pedestrian/Bicycle Involved: Only the subject crash involved a non-motorist.
 - o Student-Involved Crashes: Only the subject crash involved a student.
 - o Crashes During School Hours: The subject crash occurred during pick-up hours.
 - o Recurrent Patterns (Time/Type): There is no recurring pattern of crashes at the intersection.
