FATAL CRASH REVIEW

Location: Columbia Pike (US 29) and Industrial Parkway
Accident Date/Time: Sunday, October 18, 2020 at approximately 1:09 AM
Local Case No.: 200041049
Police District: District 3
Review Date: Tuesday, October 20, 2020

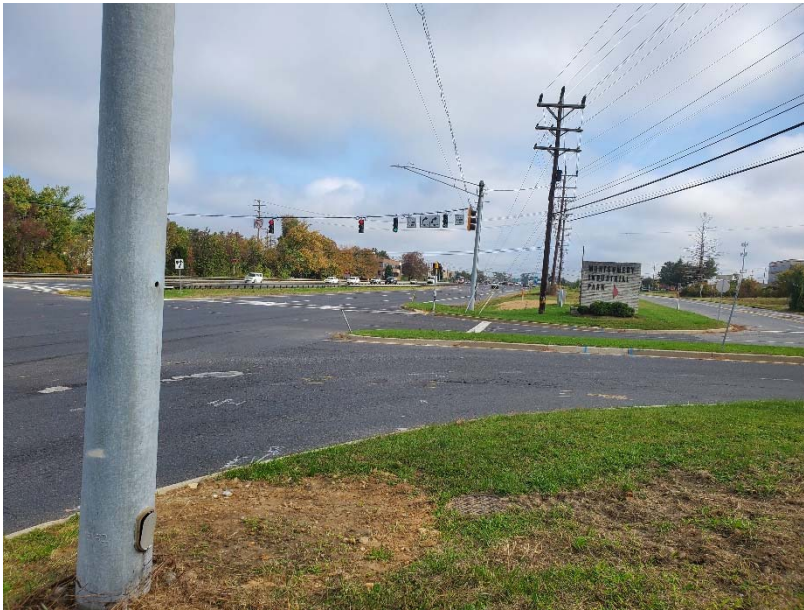
Picture 1: The signal head arrangement of northbound Columbia Pike: two signal heads for the three through lanes and two signal heads for the two right-turn lanes.

1. Generally increasing the visibility of the signal. Adding additional signal heads to have a signal head inline with each through lane on Columbia Pike, as recommended in the MDMUTCD, may make the signal more visible to drivers, particularly at night. Currently the north and southbound through movements on Columbia have the minimum required two signal heads for each three-lane approach.
2. Adding advance warning signing for the signal to improve drivers' awareness that the signal is present, particularly during the day. This may include a standard W3-3 signal ahead sign, possibly supplemented with flashing beacons. Installing a 'Signal Red When Flashing Prepare to Stop' advance sign with flashing beacons coordinated with the signal phase to warn drivers approaching the intersection of the need to pay attention and to slow down as needed.

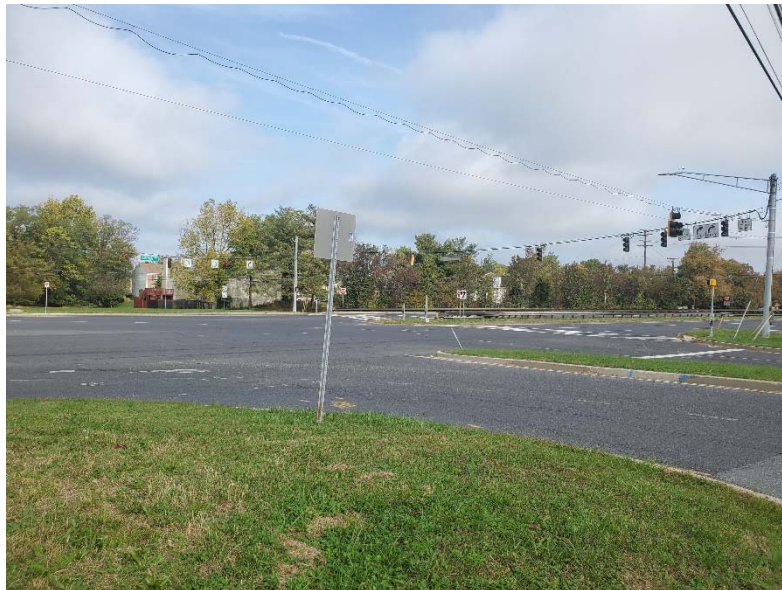
Picture 2: Looking across the west leg, showing the three-section and five-section signal heads for the Industrial Parkway approach and the two three-section ball and two three-section arrow signal heads for the northbound Columbia Pike approach.
