FY2023 School Bus Monitoring System and Stop Safety Review

**MONTGOMERY COUNTY
GOVERNMENT
Final Version
Released January 19, 2024**

Date: January 17, 2024
To: Michael Paylor, PE, PTOE
 Mark Terry
Organization: Traffic Engineering Studies Section, Division of Traffic Engineering and Operations, Montgomery County Department of Transportation
From: Will Wu, PE, PTOE
Project: MCDOT School Bus Stop Evaluations (Contract No. 1082910) – Task 40
Subject: School Bus Stop Observations and Recommendations

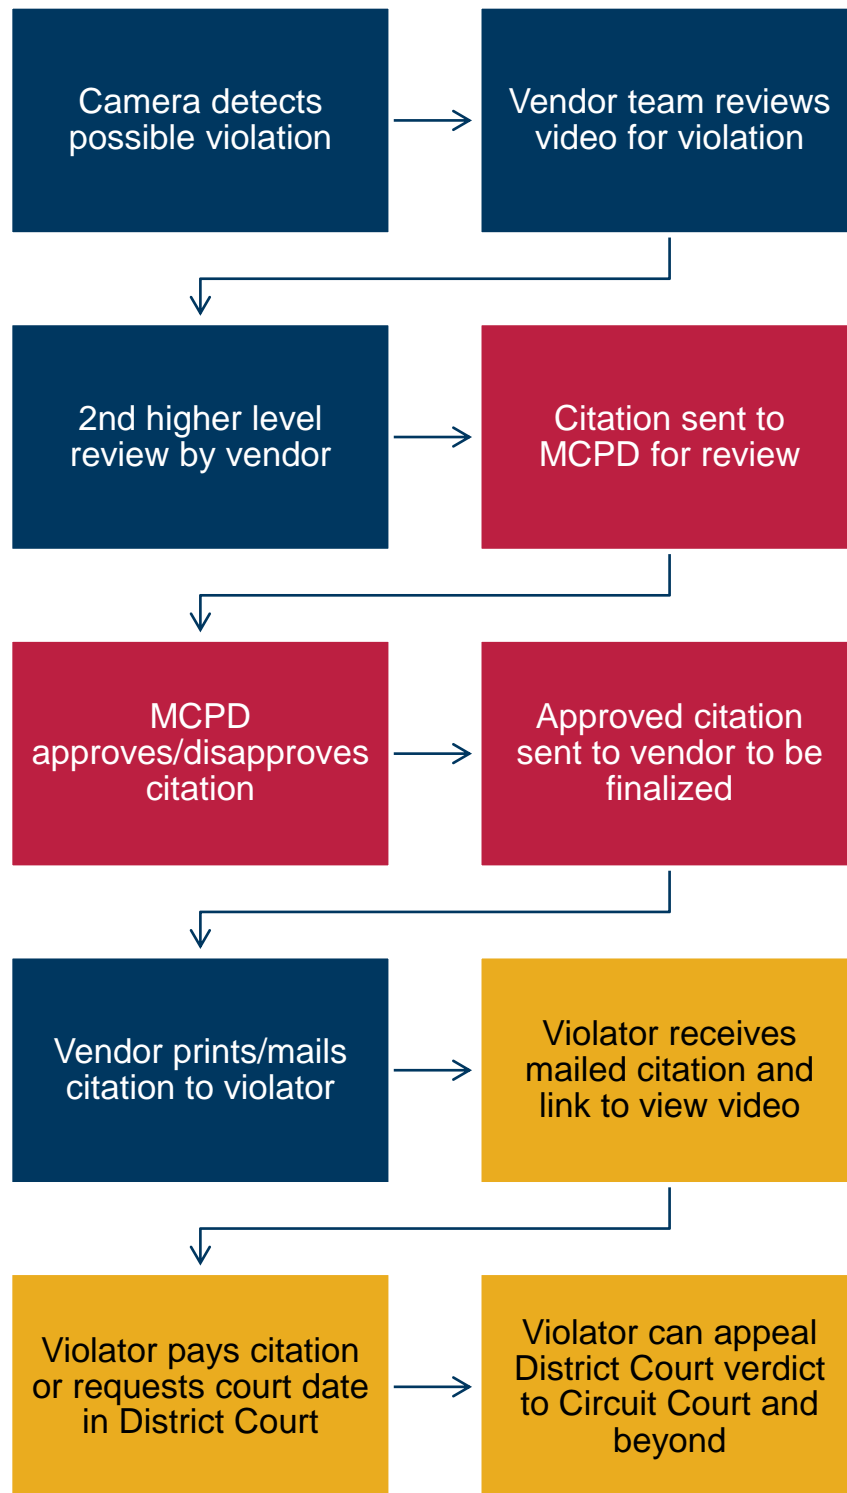
If MCPD reviewers approve the event as a violation, they turn the event into a citation and it gets sent back to the vendor for final creation of the citation. Once approved by MCPD, the final version is sent back to the vendor to be printed and mailed to the violator. This process is legislatively required to be completed within 14 days of the date of the event.

Figure 4 - Flowchart showing how bus stop violations are processed.

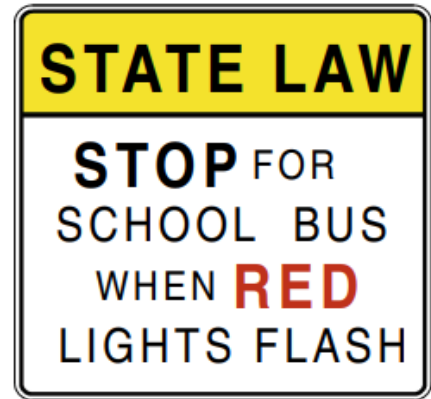
Figure 3. S6-1(2) Sign

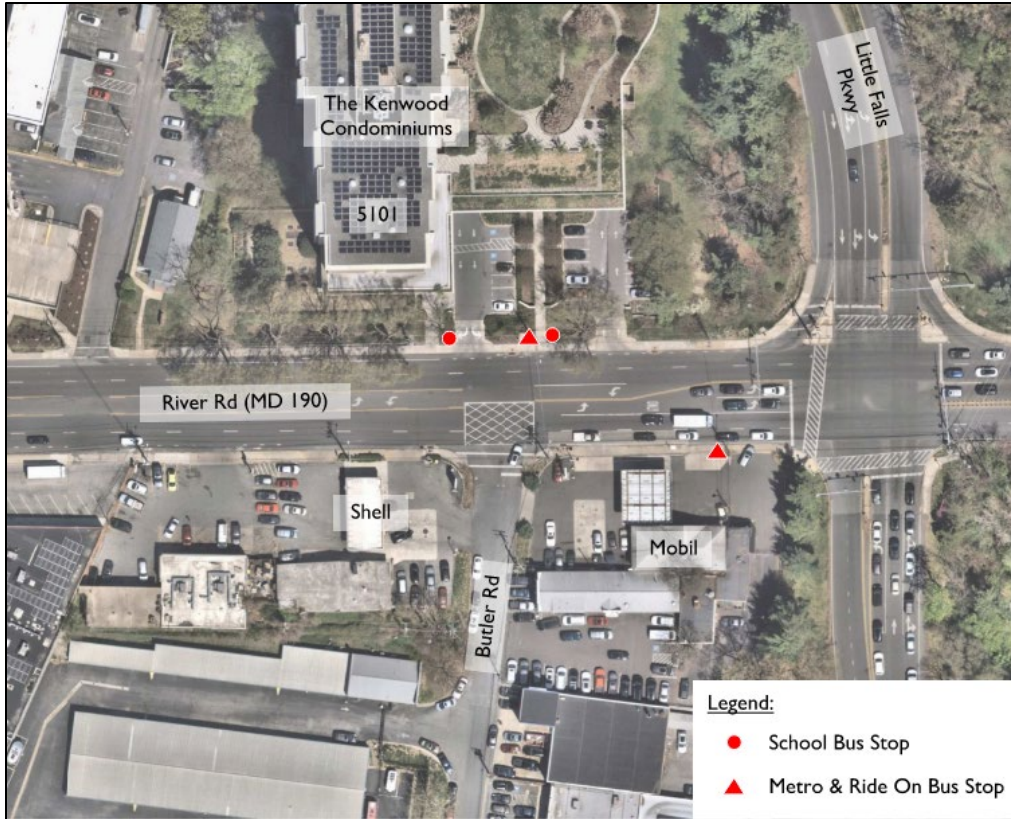
The County-provided information identified the bus stops located along the 5100 and 5200 blocks of River Road (MD 190) in Bethesda, MD. Specifically, the school buses were observed to stop at 5101 River Rd (The Kenwood Condominiums) and the adjacent transit bus stop, as illustrated in **Figure 4**. Notably, these locations coincide with the Metro and Ride On bus stops.

Signalized crossings are present at the intersection of River Road at Little Falls Parkway. Crosswalks are marked, but pavement markings are faded. Pedestrian warning sign assemblies are present for crossings of channelized right turns. Advance warning signs for school bus stops are not present as the school bus stops are visible upstream along River Road.

Figure 4. River Road Bus Stop Locations

Our evaluation findings align with the prior year observations. To enhance safety, we recommend the MDOT SHA refresh the existing crosswalk markings at the signalized intersection with Little Falls Parkway to enhance visibility.

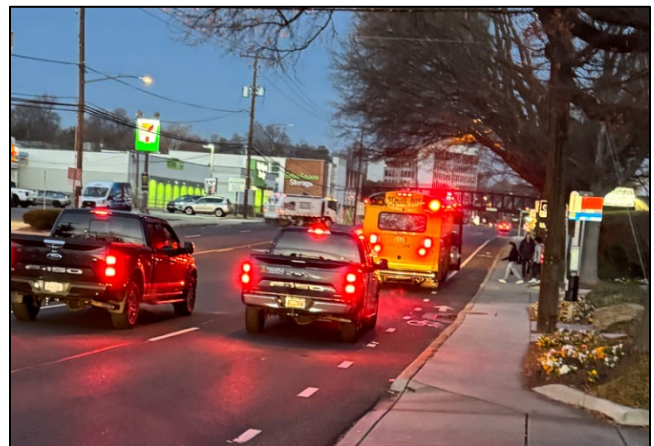
- **Violations:** In the morning, all motorists traveling eastbound and westbound along River Road stopped for the school bus (**Figure 5**). In the afternoon, all motorists traveling in the same direction as the school bus (westbound) stopped as required. Numerous motorists traveling in the opposite direction (eastbound) were observed passing the school bus while red flashing beacons were activated, and the STOP panel was extended.

Figure 5. WB River Road Morning Stop

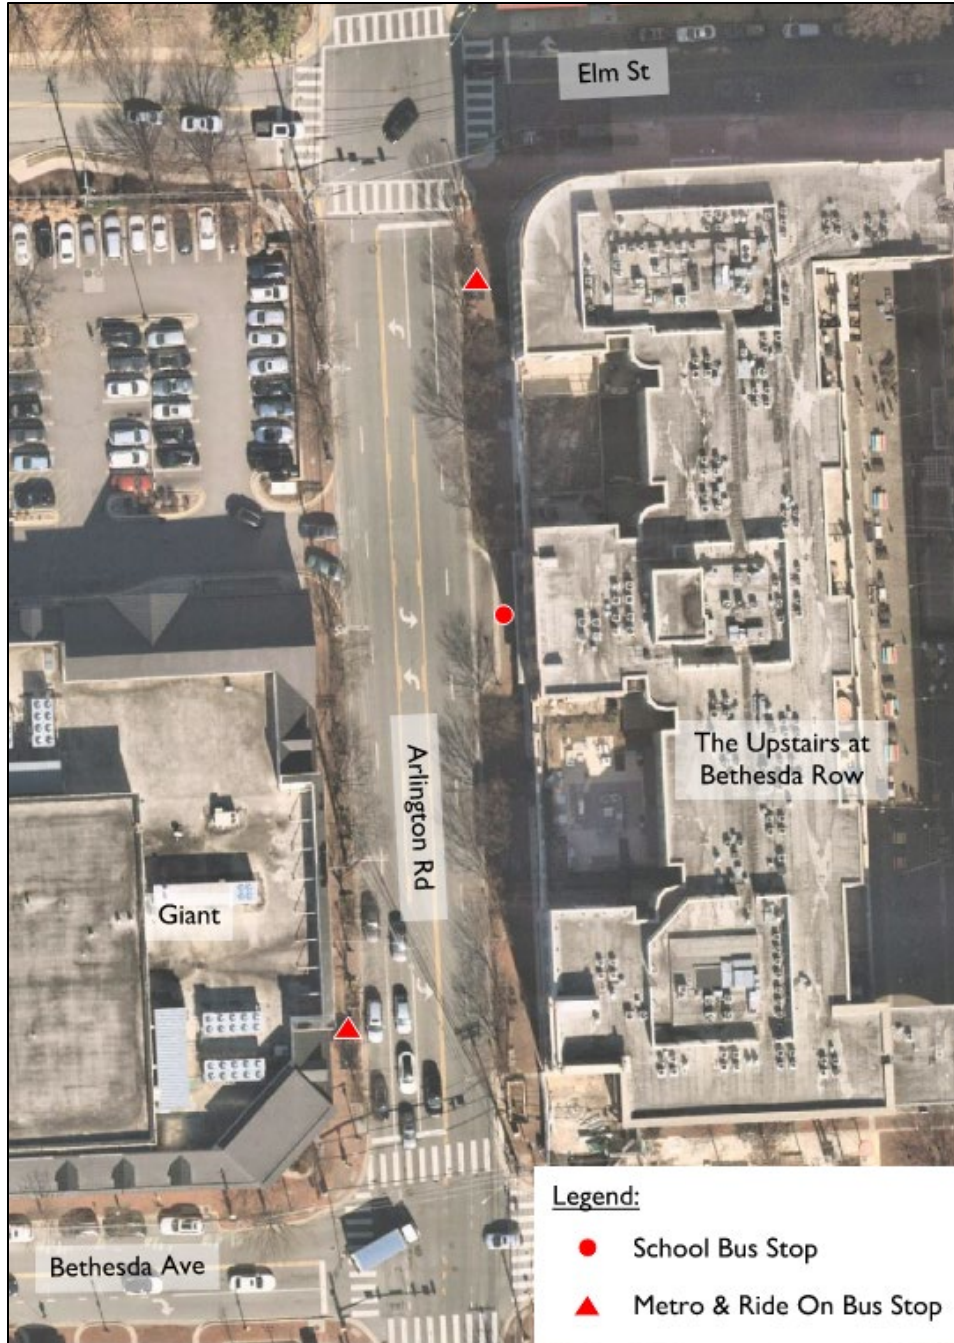
The County-provided information identified the bus stops located along the 7100 Block of Arlington Road in Bethesda, MD. Specifically, the school buses were observed to stop at 7131 Arlington Road (The Upstairs at Bethesda Row), as illustrated in **Figure 6**.

Figure 6. Arlington Road Bus Stop Locations

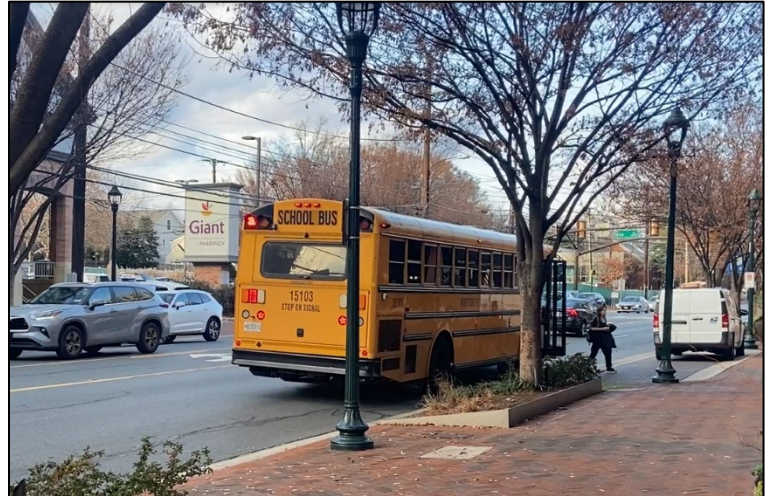
- **Violations:** In the morning and afternoon, several motorists traveling in both directions along Arlington Road were observed passing the school bus while red flashing beacons were activated, and the STOP panel was extended.
- **Pedestrian Crossings:** No students were observed crossing Arlington Road traveling to or from the school bus stops. Although several students were observed alighting the school bus in the afternoon and crossing Bethesda Avenue to points south. The segment has heavy pedestrian activity given the urban core context.
- **Obstructions:** There were no perceived sight distance obstructions for motorists approaching in either direction in the vicinity of the school bus stops.

Figure 7. NB Arlington Road Afternoon Stop

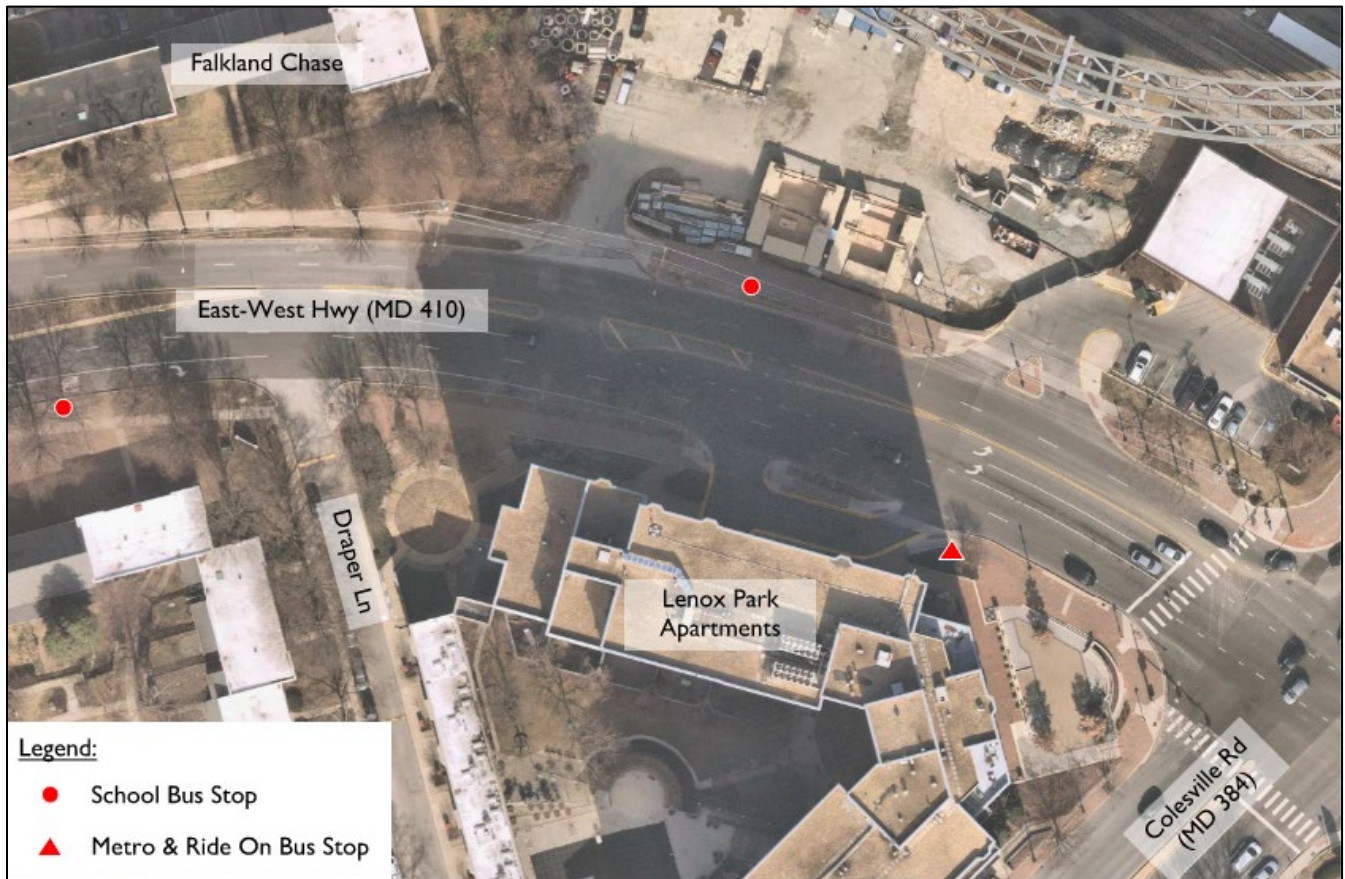
The County-provided information identified the bus stops located along the 1400 Block of East-West Highway (MD 410) in Silver Spring, MD. Specifically, the school buses were observed to stop at 1400 East-West Highway (Lenox Park Apartments), as illustrated in **Figure 8**.

Signalized crossings are present at the intersection of East-West Highway at Colesville Road. Crosswalks include high visibility markings. Advance warning signs for school bus stops are not present.

Figure 8. East-West Highway Bus Stop Locations

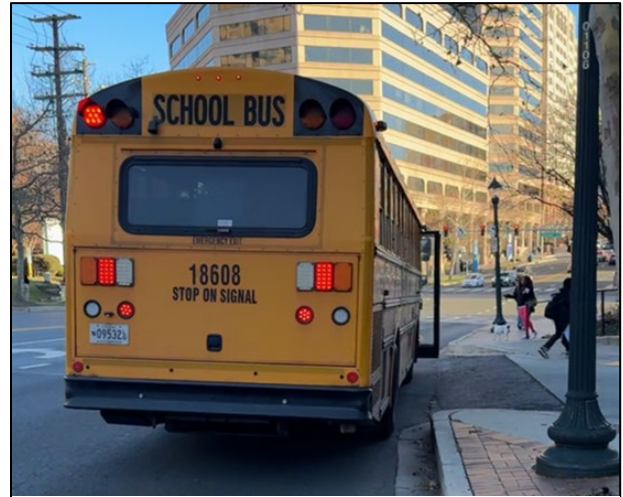
- **Violations:** In the morning and afternoon, motorists traveling in the same direction as the school buses (eastbound) stopped when the school bus red flashing beacons were activated, and the STOP panel was extended. Many motorists traveling in the opposite direction (westbound) did not stop during the morning observations, but fewer passed the school bus in the afternoon.

Figure 9. EB East-West Highway Afternoon Stop

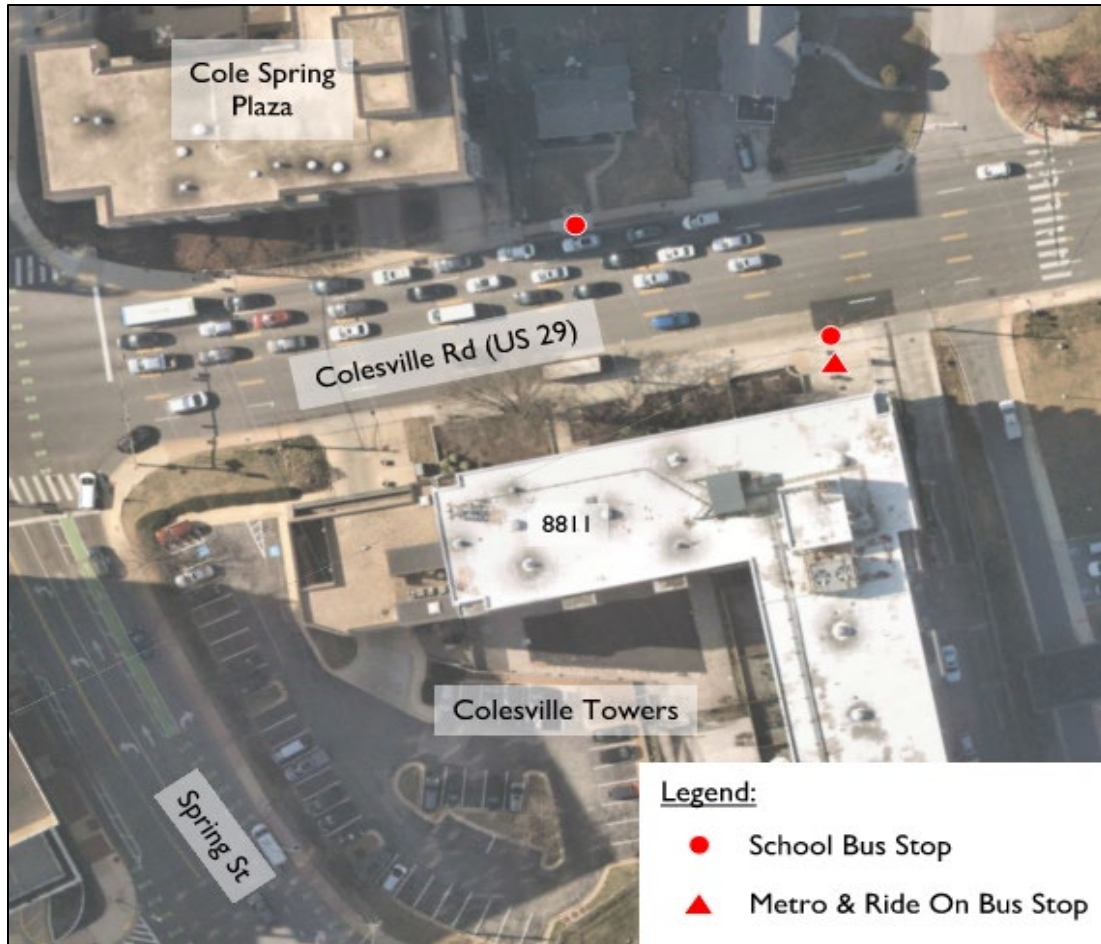
Figure 10. Colesville Road Bus Stop Locations

A midblock crossing is positioned just north of S Noyes Drive, featuring a marked crosswalk visible on the right side of **Figure 10**. This crossing includes double posted pedestrian crossing signs, ADA ramps, and pedestrian ahead signs in advance. However, the crosswalk exhibits fading in some areas.

- 1) Refresh the existing crosswalk markings at the midblock crossing located at S. Noyes Drive to enhance visibility and ensure pedestrian safety.
- 2) Evaluation of the feasibility of upgrading the pedestrian crossing to an enhanced crossing with a Pedestrian Hybrid Beacon (PHB). While students were not observed crossing at this location, enhancing the crossing would benefit pedestrians in the area. This proactive approach aligns with broader safety considerations for the community.

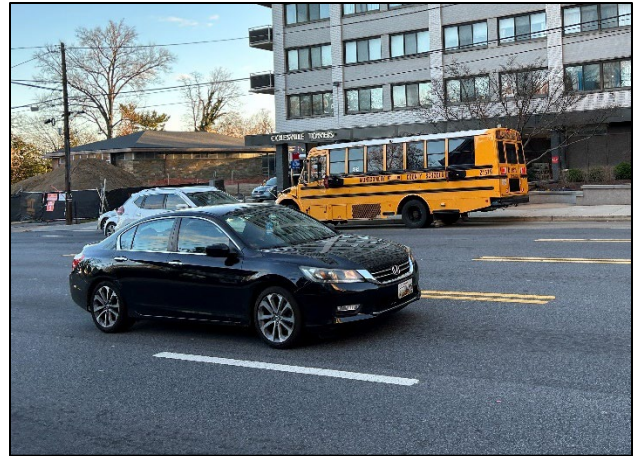
- **Buses Observed:** In the morning, school busses stopped in front of Colesville Towers at 7:34 AM, 8:02 AM, 8:41 AM, and 9:09 AM. One bus stopped in front of Montgomery Arms Apartments at 9:14 AM. In the afternoon, school busses stopped in front of Colesville Towers at 2:43 PM, 4:15 PM, and 4:32 PM. One bus stopped in front of Montgomery Arms Apartments at 4:11 PM.
- **Bus Stops:** Children boarding or alighting from the bus entered directly into the adjacent apartment complex, and no children were observed crossing the streets. Most small children were accompanied by parents or guardians.
- **Violations:** In the morning, all motorists traveling in the same direction as the bus, whether there were 2 or 4 lanes in that direction stopped for the school bus. However, in the opposite direction, nearly every single

motorist violated the bus stop (**Figure 12**), except when traffic was congested at the Spring Street intersection. The number of violations were too numerous to count. Afternoon observations showed a similar pattern but included a few violations in the same direction as the bus when there were four lanes in that direction, and a couple of cars proceeded in the far lane.

Figure 12. NB Colesville Road Afternoon Stop

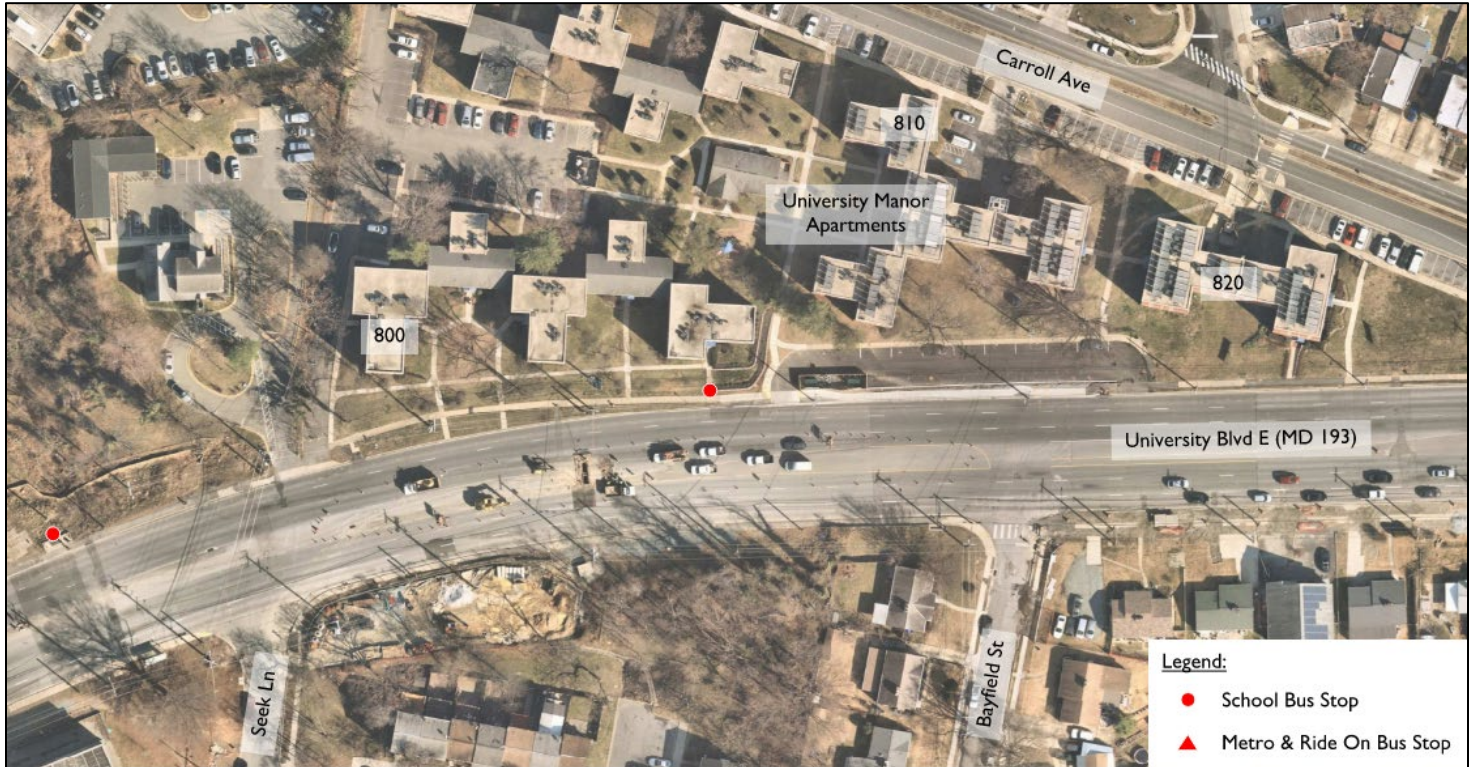
The County-provided information identified the bus stops located along the 800 Block of University Boulevard East in Silver Spring, MD. While school buses were expected in the vicinity of 800, 810, and 820 University Boulevard East, no school buses were observed during the time periods provided by MCPS. The segment is illustrated in **Figure 13**.

University Boulevard East is a 6-lane typical section in the vicinity of the expected school bus stops. However, the roadway and roadsides are both significantly impacted by the ongoing Purple Line construction. The existing condition of traffic control devices was found to be very poor. Lane use assignment was unclear.

Figure 13. University Boulevard East Bus Stop Locations

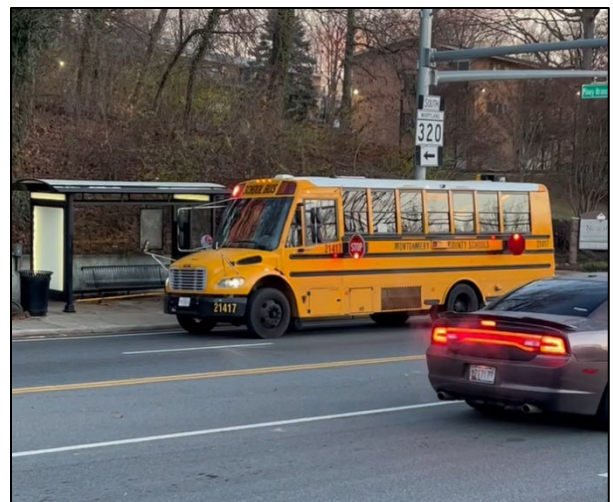
- **Violations:** In the morning and afternoon, several motorists traveling in both directions along Piney Branch Road were observed passing the school buses while red

Figure 15. WB Piney Branch Road Afternoon Stop

flashing beacons were activated, and the STOP panel was extended.

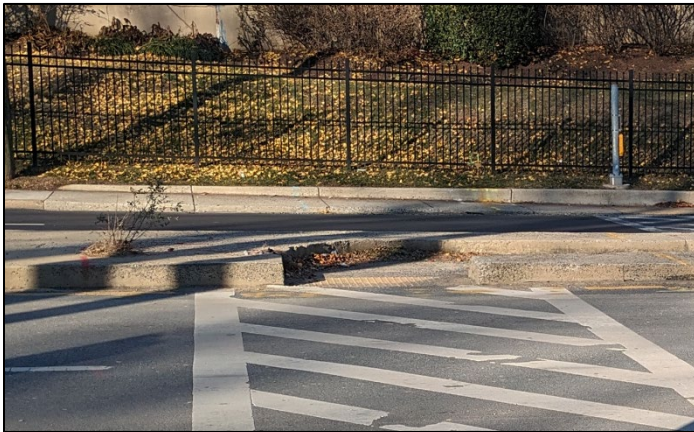
Figure 16. HIB Equipment Damage

- 1) Repair the damage to the existing HIB signal equipment and signing within the midblock crossing island (**Figure 16**).
- 2) Upgrade existing S6-1(2) signs along both sides of Piney Branch Road. (**Figure 17**)

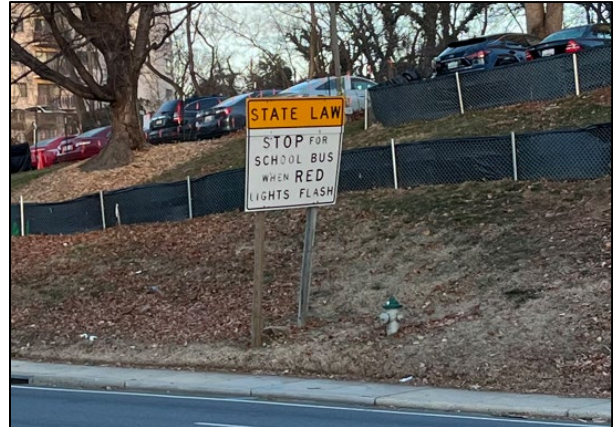
Figure 17. State Law Sign Poor Condition

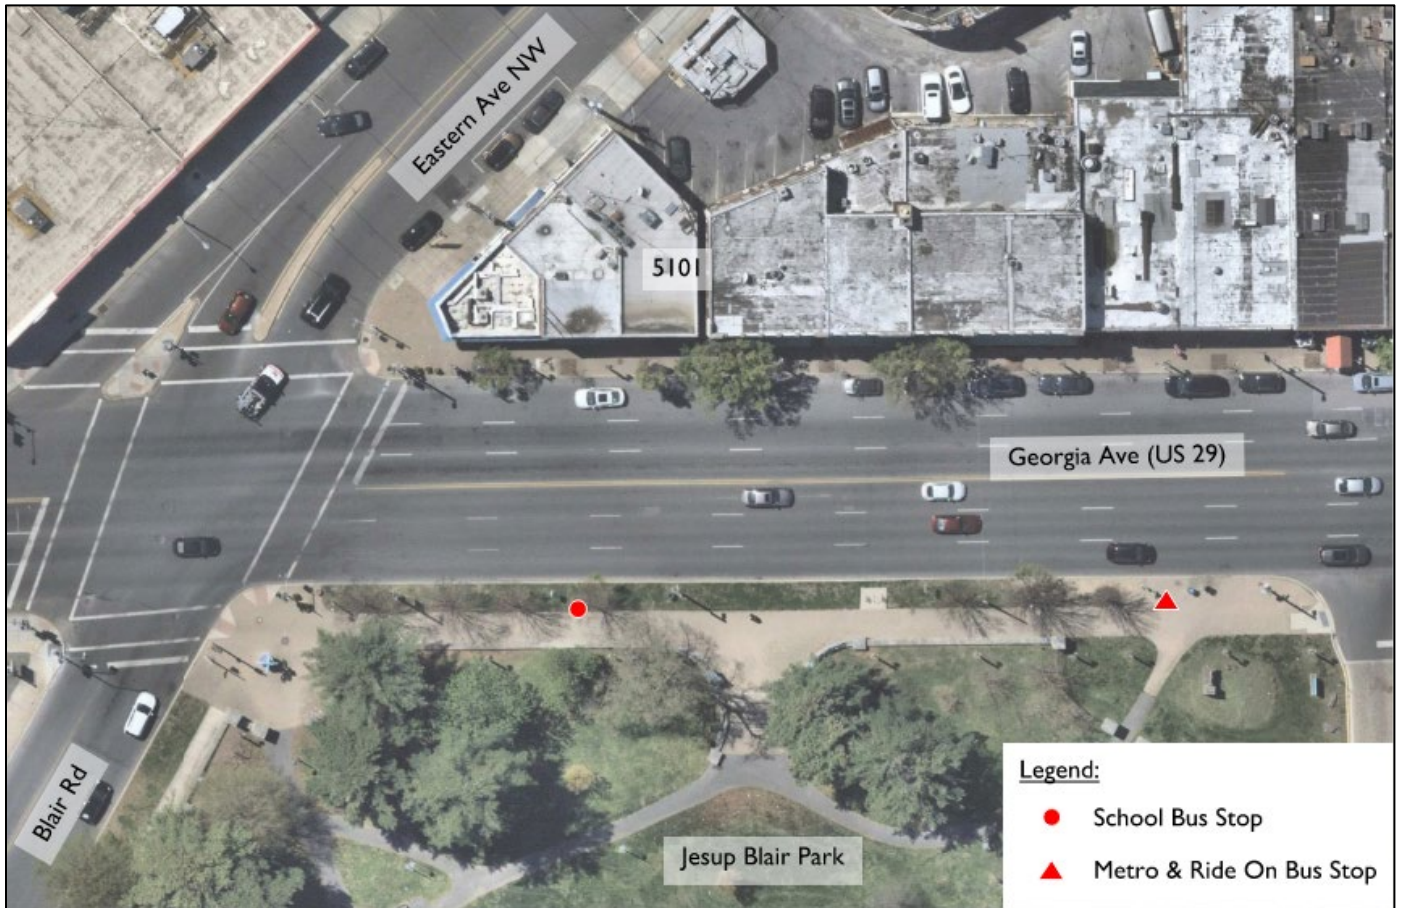
Figure 18. Georgia Avenue Bus Stop Locations

The County-provided information identified the bus stops located along the 7900 Block of Georgia Avenue (US 29) in Silver Spring, MD. Specifically, the school buses were expected to stop near the intersection with Blair Road, as illustrated in **Figure 18**.

Downtown Silver Spring falls within the Urban Core context zone. The immediate vicinity of the school bus stop is characterized by dense retail. High-density residential can be found west and north of the site.

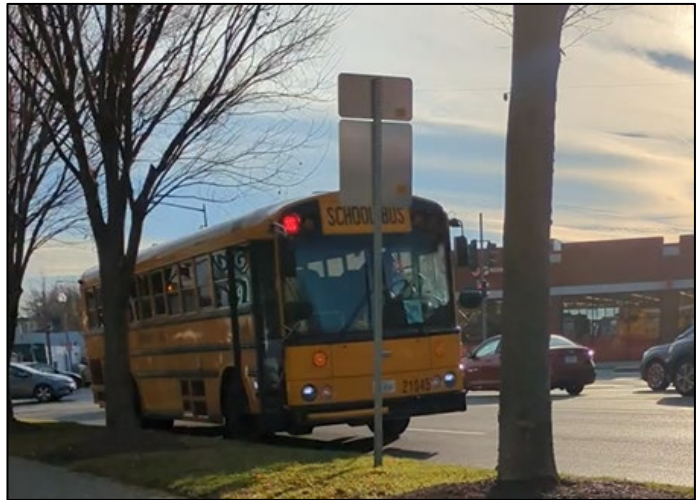
Figure 19. NB Georgia Avenue Afternoon Stop

- **Buses Observed:** In the morning, 1 school bus was observed stopping to pick up school children. The school buses stopped along Jesup Blair Park, north of Blair Road (**Figure 19**). In the afternoon, 1 school bus was observed stopped to drop off school children at the same location.

- **Pedestrian Crossings:** No students were observed crossing Georgia Avenue traveling to or from the school bus stops. The segment has heavy pedestrian activity given the urban core context.

- **Obstructions:** There were no perceived sight distance obstructions for motorists approaching in either direction in the vicinity of the school bus stops.

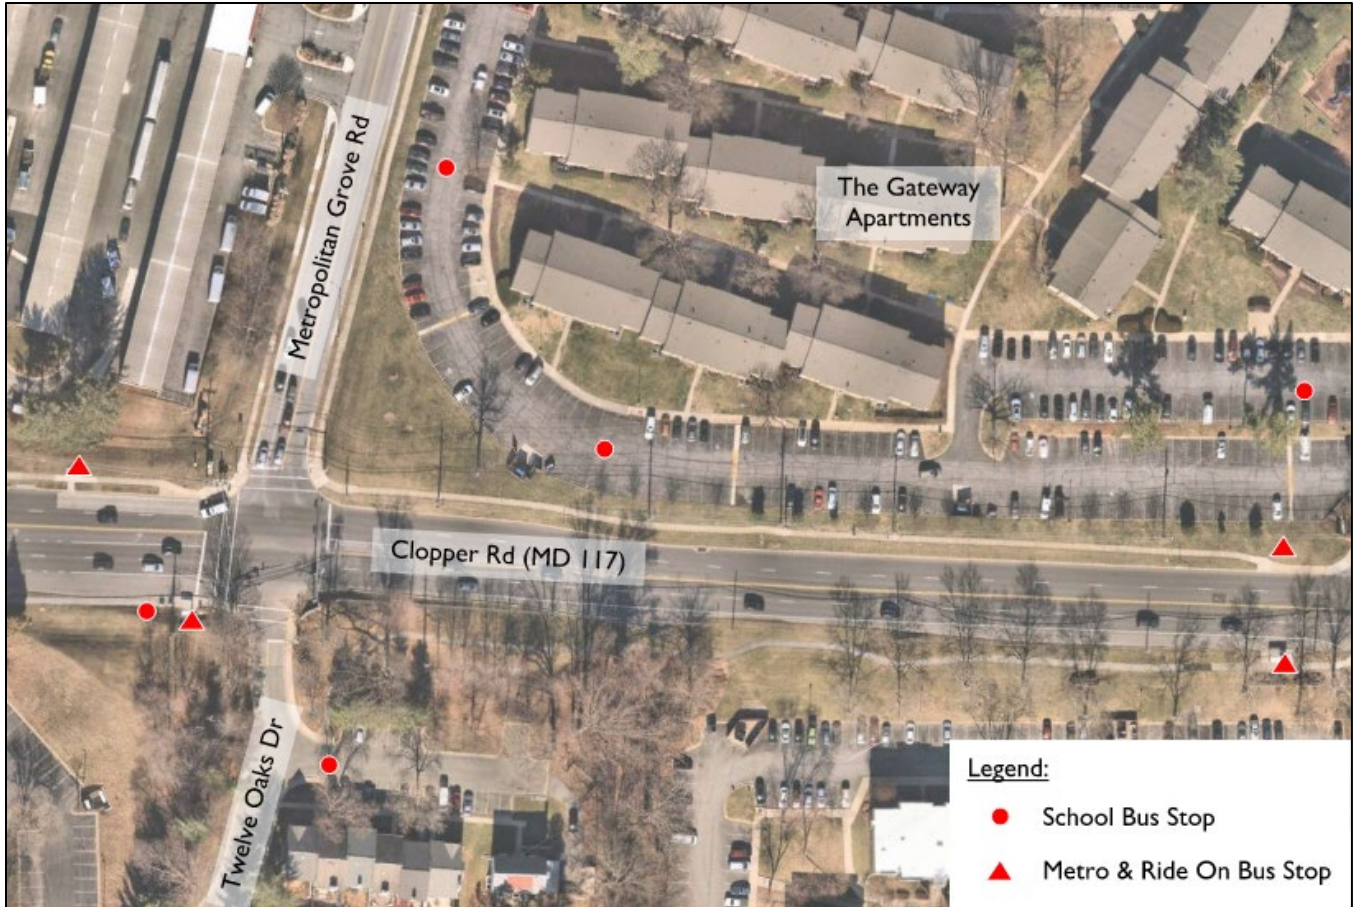
Figure 20. Clopper Road Bus Stop Locations

The County-provided information identified the bus stops located along the 900 Block of Clopper Road (MD 117) in Gaithersburg, MD. Specifically, the school buses were expected to stop at 977 and 983 Clopper Road (Gateway Apartments), Clopper Road at Twelve Oaks Drive, and Metropolitan Grove Road at Gateway Apartments as illustrated in **Figure 20**.

This portion of Gaithersburg falls within the Suburban context zone. The immediate vicinity of the school bus stops is characterized by multifamily residential developments as well as self-storage and office space.

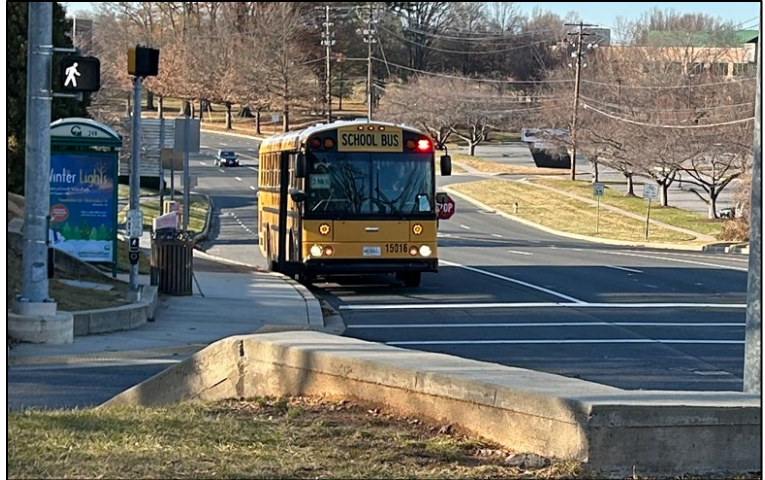
Figure 21. EB Clopper Road Afternoon Stop

- **Buses Observed:** In the morning, 2 school buses were observed stopping to pick up school children along eastbound Clopper Road at Twelve Oaks Drive. The school bus stopped at the transit bus shelter. In the afternoon, 3 school buses were observed stopped to drop off school children at the same location. Several other school buses were observed in the area, but all pulled into the apartment complexes to pick-up and drop-off students.
- **Bus Stops:** Children boarding and alighting the school bus were not observed crossing the streets. Most small children were accompanied by parents or guardians.

- **Violations:** In the morning and afternoon, no motorists traveling in either direction along Clopper Road were observed passing the school bus while red flashing beacons were activated, and the STOP panel was extended. This may be due to signal phasing.
- **Pedestrian Crossings:** No students were observed crossing Clopper Road traveling to or from the school bus stops. School-aged pedestrians using public transit buses were observed crossing Clopper Road at the traffic signal.
- **Obstructions:** The crest vertical curve along Clopper Road may limit sight lines for eastbound motorists approaching a stopped school bus. In the morning, the sunrise was observed to be a significant visual impairment for eastbound motorists.

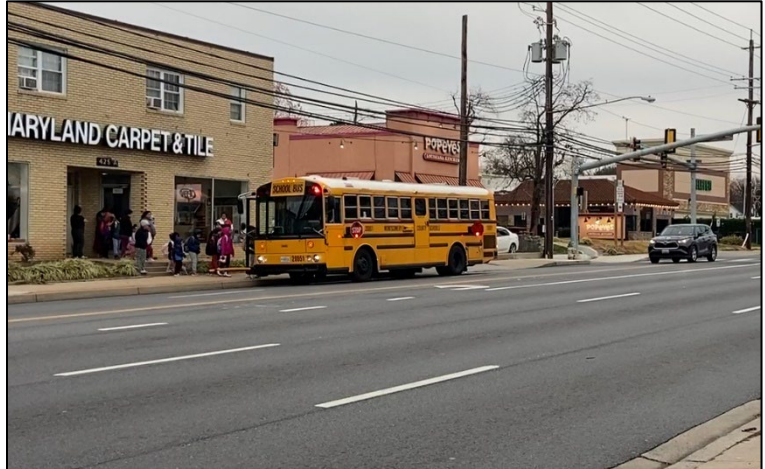
Figure 23. NB N. Frederick Avenue Morning Stop

- **Pedestrian Crossings:** No students were observed crossing N. Frederick Avenue traveling to or from the school bus stops. Other school-aged pedestrians were observed using the sidewalks and crossing the street at several controlled and uncontrolled midblock locations, but were not associated with the school buses.

- **Obstructions:** There were no perceived sight distance obstructions for motorists approaching in either direction in the vicinity of the school bus stops.

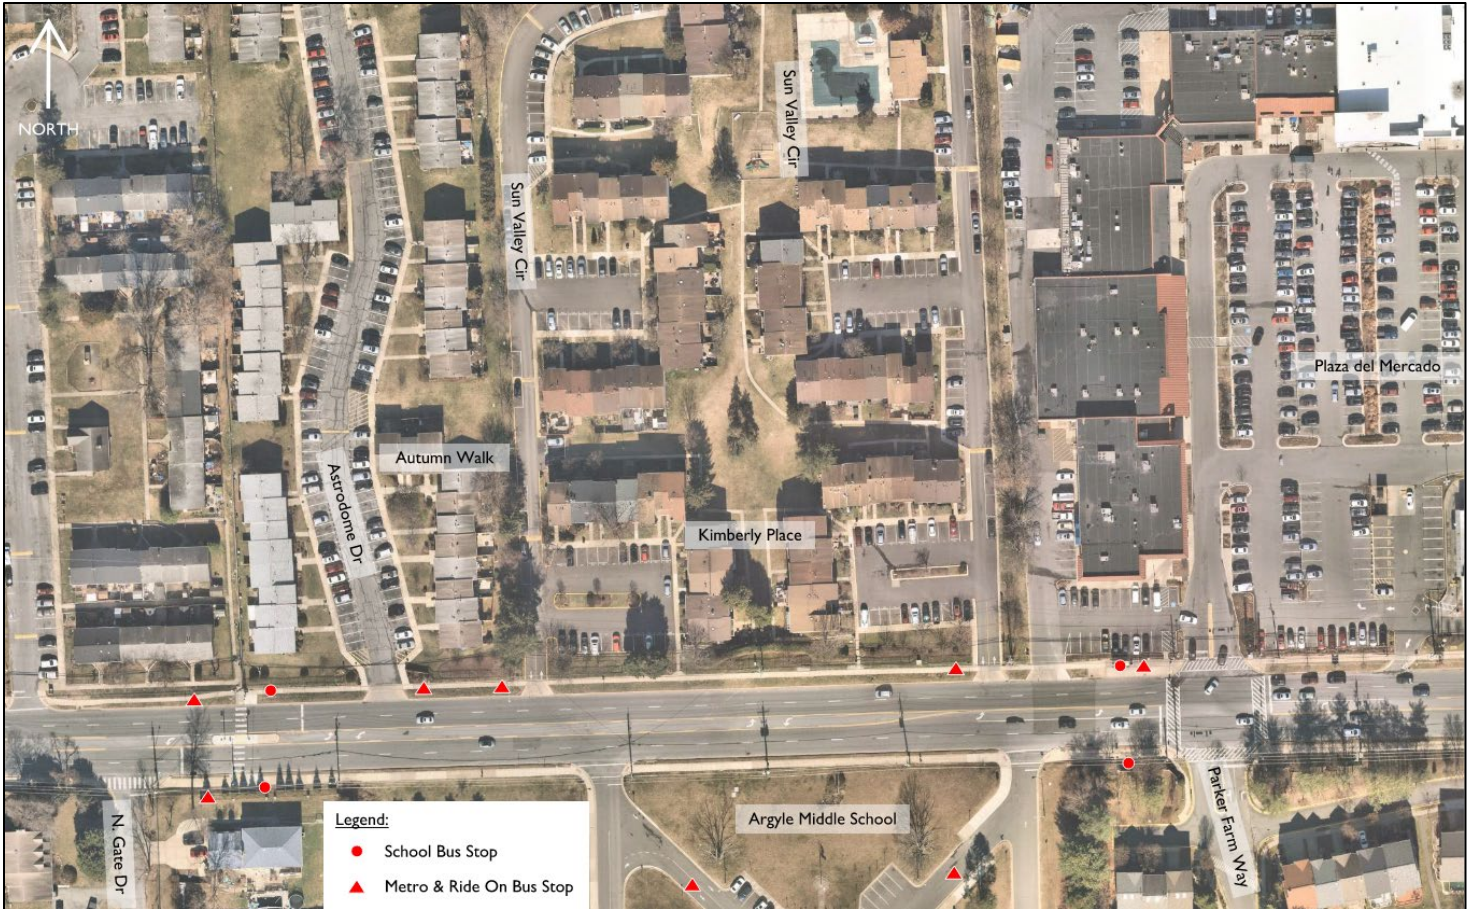
Figure 24. Sun Valley Circle (Bel Pre Road) Bus Stops

The County-provided information identified the bus stops located along the 2300 Block of Sun Valley Circle in Aspen Hill, MD. The school buses were expected to stop along Bel Pre Road at the Sun Valley Circle driveways that provide access to Kimberly as illustrated in **Figure 24**.

Bel Pre Road is a 5-lane typical section in the vicinity of the school bus stops, with two lanes in each direction and a two-way center left turn lane. The posted speed limit is 25 MPH in both directions. The nearest signalized intersections are a full color signal at the intersection with Parker Farm Way / Plaza del Mercado, and a PHB at the midblock crossing between N. Gate Drive and Astrodome Drive.

- **Buses Observed:** 8 school buses were observed stopping to pick up and drop off school children along Bel Pre Road. The locations are illustrated in **Figure 24**, with most locations along westbound Bel Pre Road, and 1 along eastbound near the PHB crossing. There were additional school bus stops in the area that stopped within the Argyle Middle School parking lot and along Sun Valley Circle.

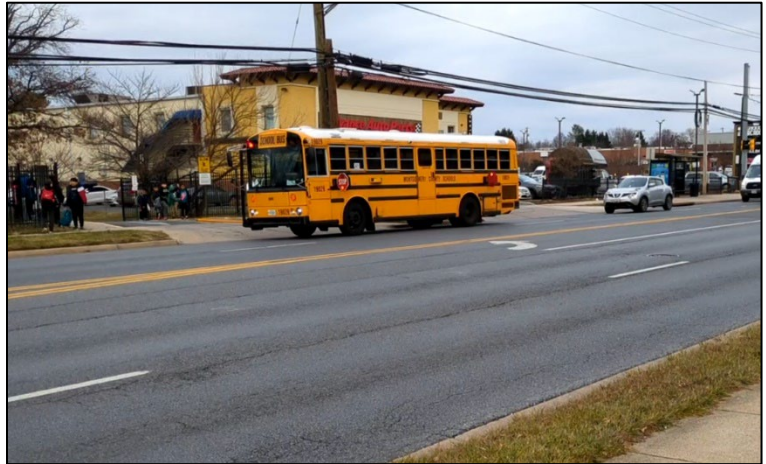
Figure 25. WB Bel Pre Road Afternoon Stop

- **Pedestrian Crossings:** No students were observed crossing Bel Pre Road at uncontrolled locations. In the afternoon, students from the school bus were observed using the PHB crossing properly. In the afternoon, school bus stop times overlapped with Argyle Middle School dismissal. There were many school children observed using sidewalks on both sides of the street, but crossing mostly at the traffic signal at Plaza del Mercado. Many students appeared to be meeting in the shopping center to get picked up by caretakers.

- **Obstructions:** There were no perceived sight distance obstructions for motorists approaching in either direction in the vicinity of the school bus stops.

Our findings align with the previous year observations. Based on the field observations detailed, there are no notable safety concerns pertaining to school bus stop operations at this time, and no infrastructure changes are deemed necessary for these specific school bus stops.

MCDOT is separately evaluating and designing improvements for vulnerable road users along this segment of Bel Pre Road through the Transportation Planning Board's Regional Roadway Safety Program.
