Colesville *Design Study*

Community Meeting
September 17, 2013

Montgomery County
Department of Housing and
Community Affairs

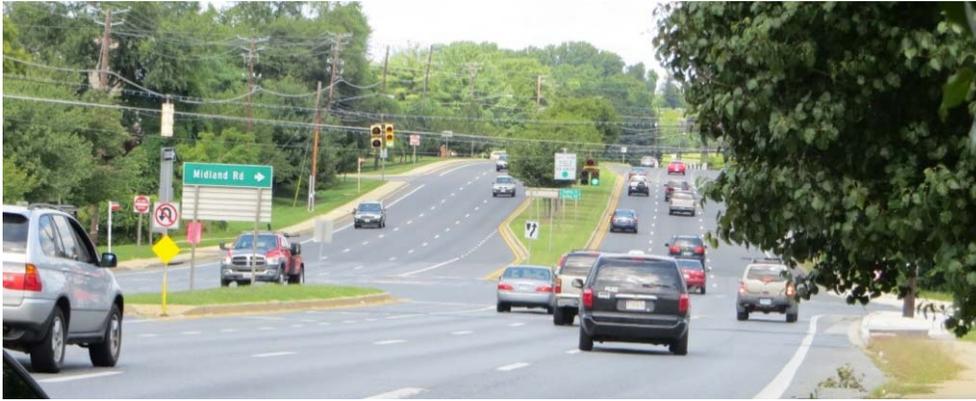
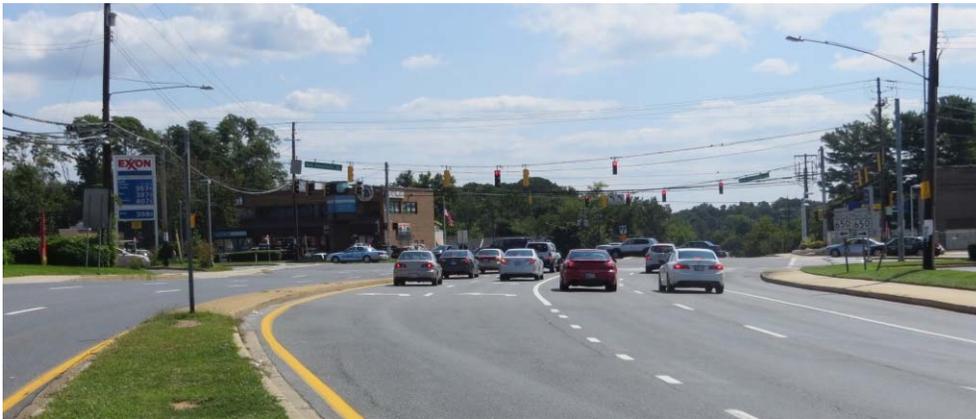
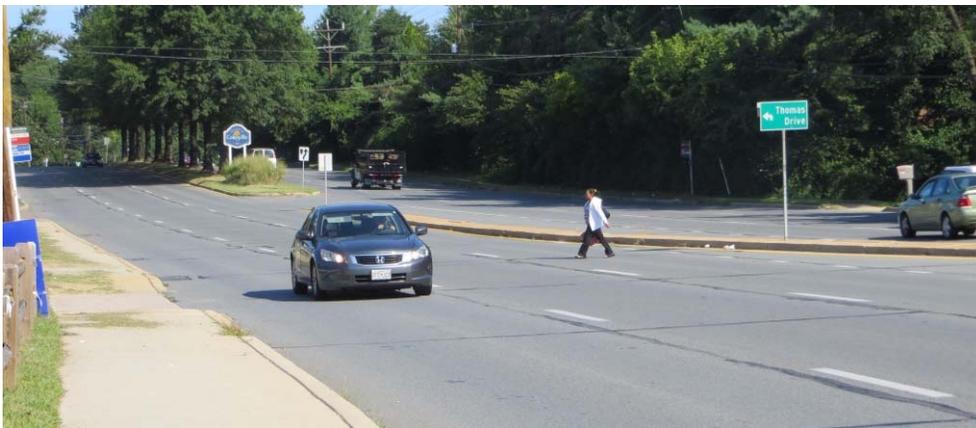
CORRIDOR CHARACTER

- High Vehicular Volume and Traffic
- Limited Vehicular Access to Parcels and Local Streets
- Sidewalks Adjacent to the Curb
- Lack of Pedestrian Comfort
- Limited Pedestrian Crossings
- Overhead Utilities

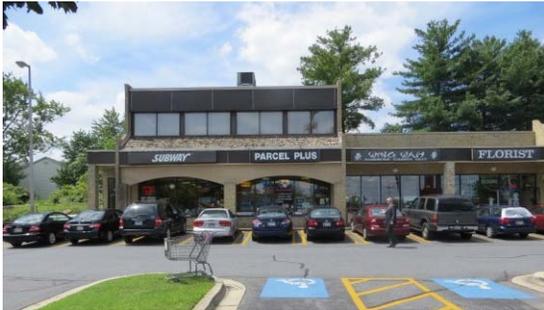
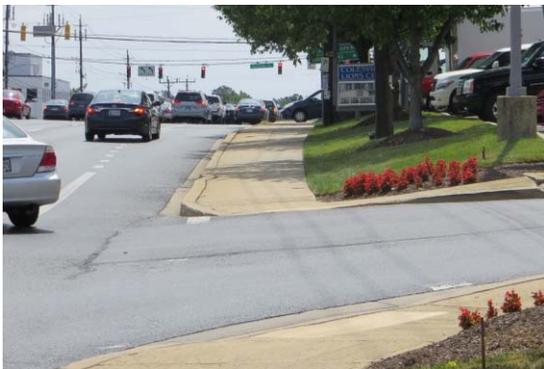
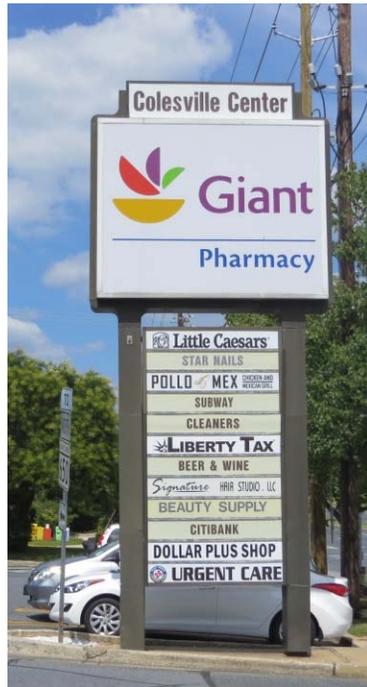
COLESVILLE CENTER [CIRCULATION]

- Multiple Access Points
- Perimeter Sidewalks/Aprons
- Adequate Parking Distribution
- Pathway to Adjacent Neighborhood
- Rear Service

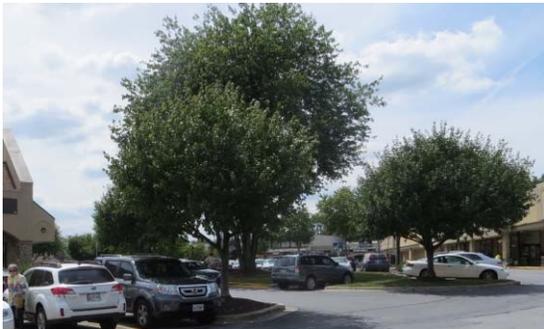
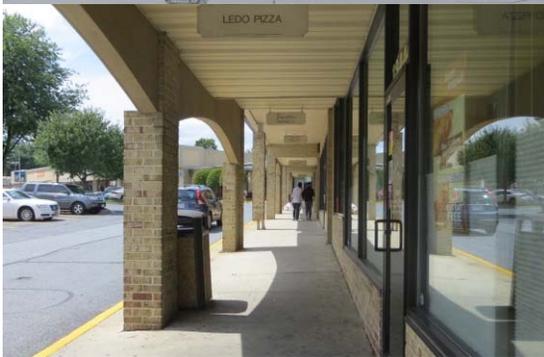
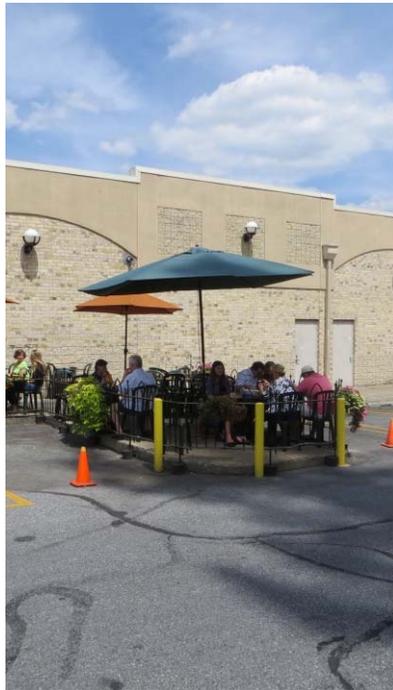
COLESVILLE CENTER [TOPOGRAPHY + DRAINAGE]

- Healthy Tenant Mix
- Outdoor Seating
- Tree Canopy

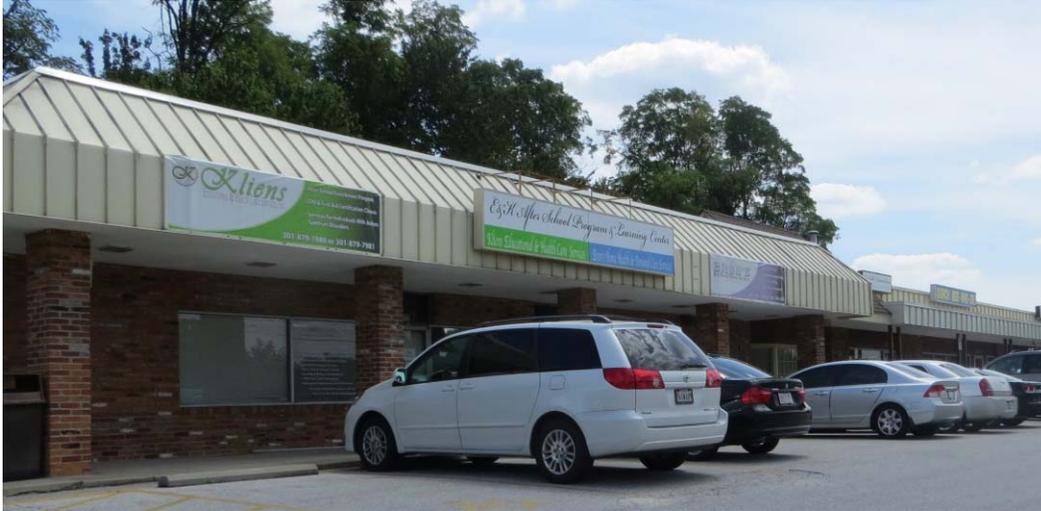
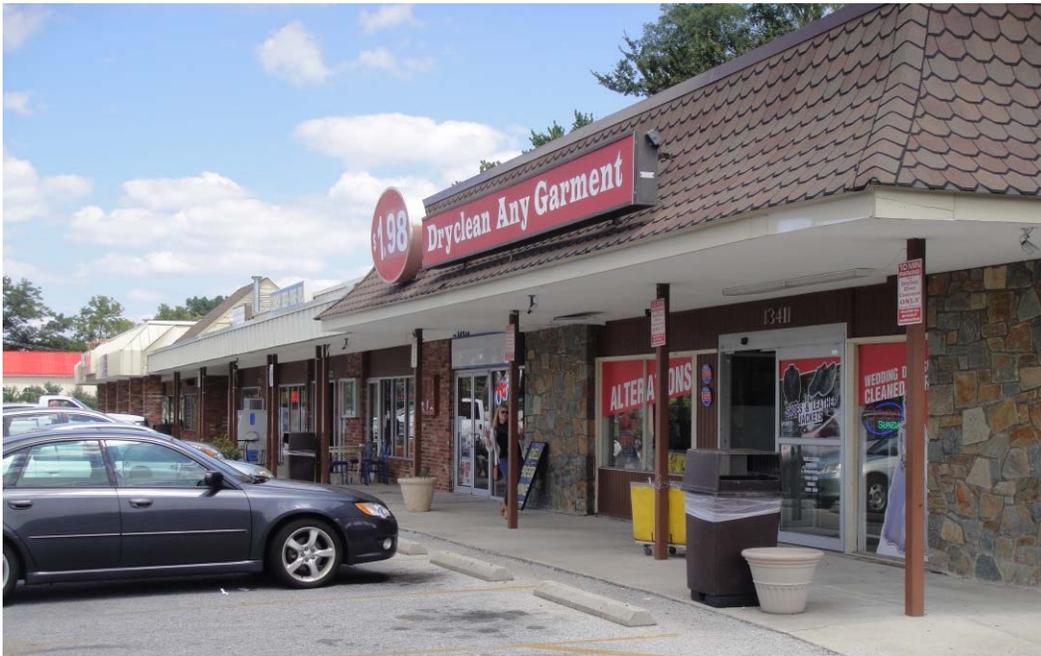
MONTEREY CENTER

Architecture Style

- Circa 1970 Eclectic Strip Retail

Building Characteristics

- Variety of façade materials,
 - predominately masonry, stone and some siding
- Variety of fenestration patterns:
 - fixed metal windows,
 - storefront glazing,
 - various glazed commercial doors
- Decorative shingle and metal mansard
 - roof low over flat roof with downspouts to the rear
- Concealed mechanical systems

Signage

- Variety of Sign types:
 - plastic/vinyl illuminated box signs
 - surface mounted painted plywood,
 - window signs,
 - movable sandwich boards,
 - vinyl lettering

Lighting

- Surface mounted lighting under canopy

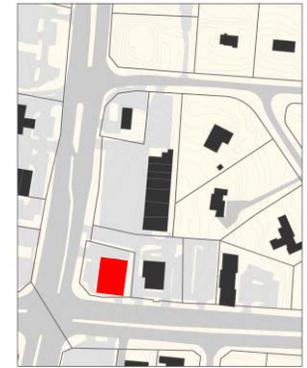
7-ELEVEN

Architecture Style

- Circa 1985 Mid-Century Commercial

Building Characteristics

- Flush masonry walls
- Fenestration patterns:
 - Storefront glazing,
 - Ribbon windows,
 - Glazed commercial doors
- Flat roof with metal-capped parapet with downspouts to the rear.
- Standing seam awning
- Concealed mechanical systems

Signage

- Sign types:
 - Plastic/vinyl illuminated box signs
 - Window mounted signs and vinyl lettering

Lighting

- Recessed can lighting under canopy

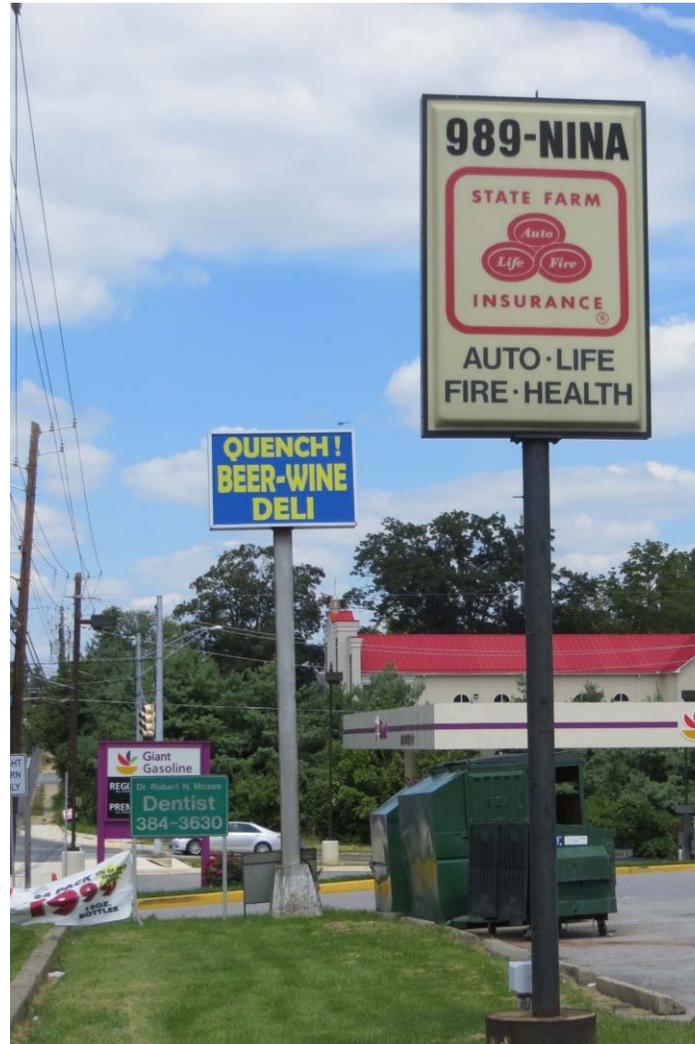
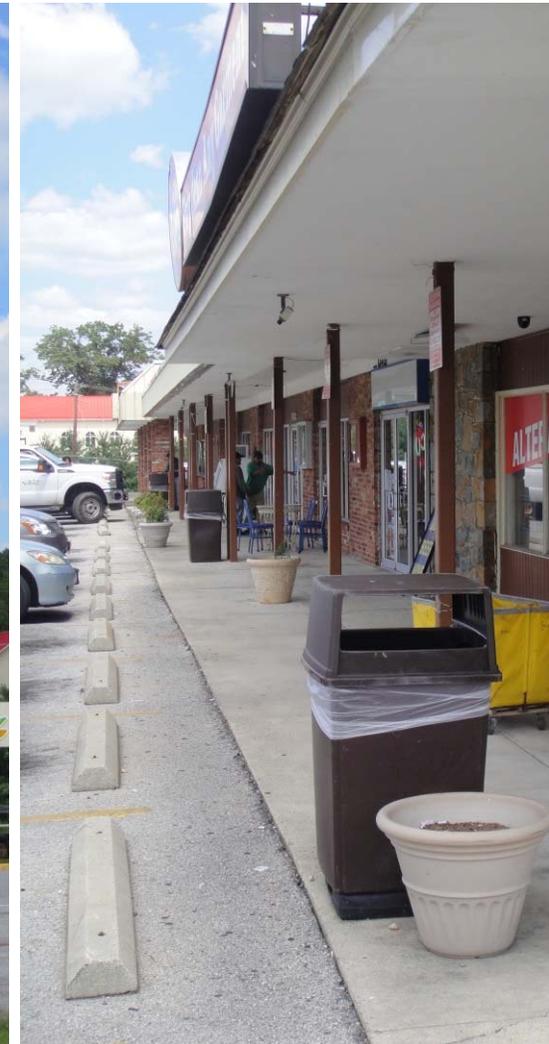
MONTEREY CENTER

- Sufficient parking spaces
- Space for redevelopment and/or expansion
- Space for landscape and stormwater management
- Variety of businesses- retail and services

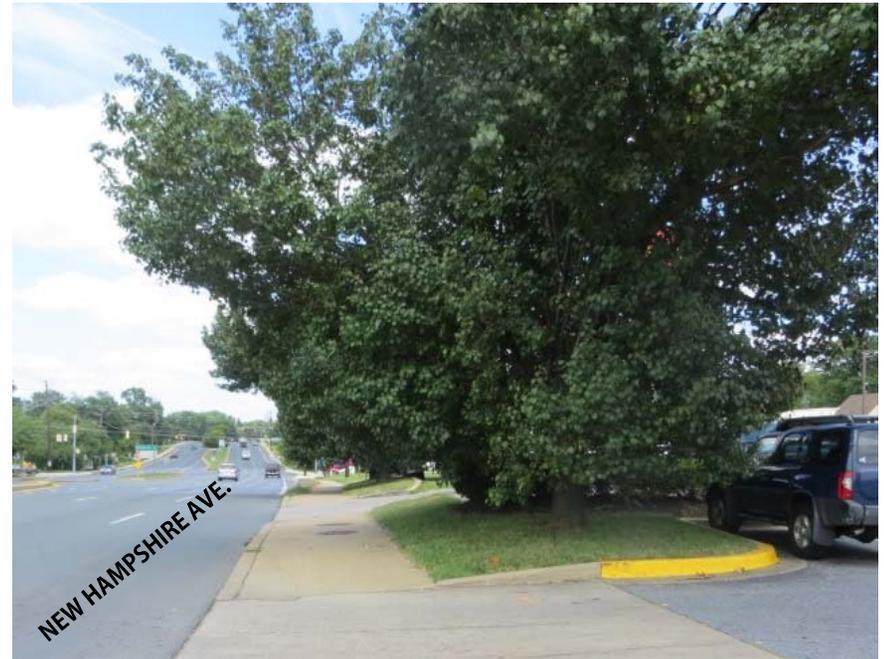
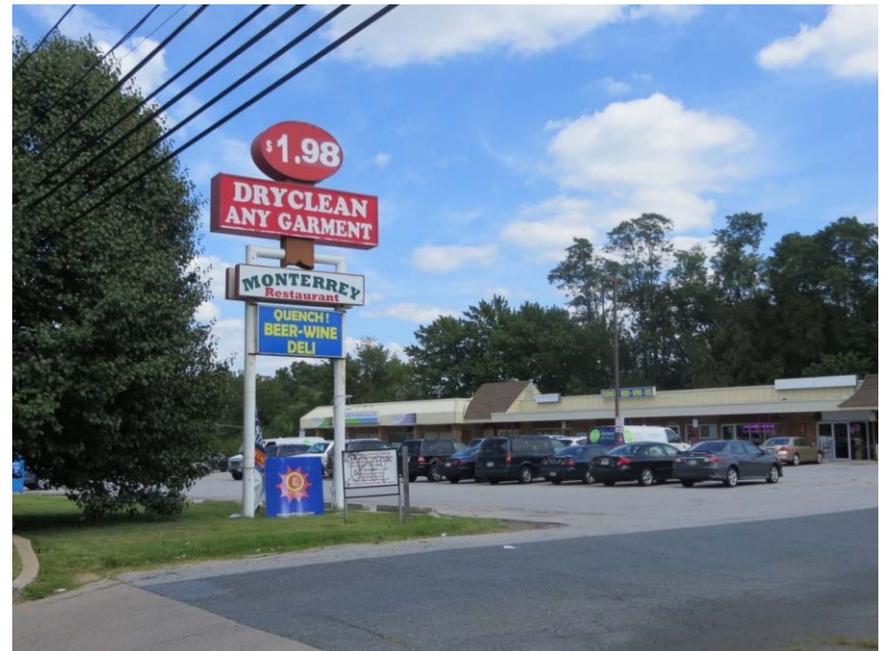
MONTEREY CENTER

- Poor visibility
 - Dense tree canopies along New Hampshire Avenue
 - Imposing mansard canopy roofs project shade on storefronts
 - Storefronts are located far from New Hampshire Avenue
- Limited vehicular access
- Steep access from Midland Road
- Various levels of building maintenance

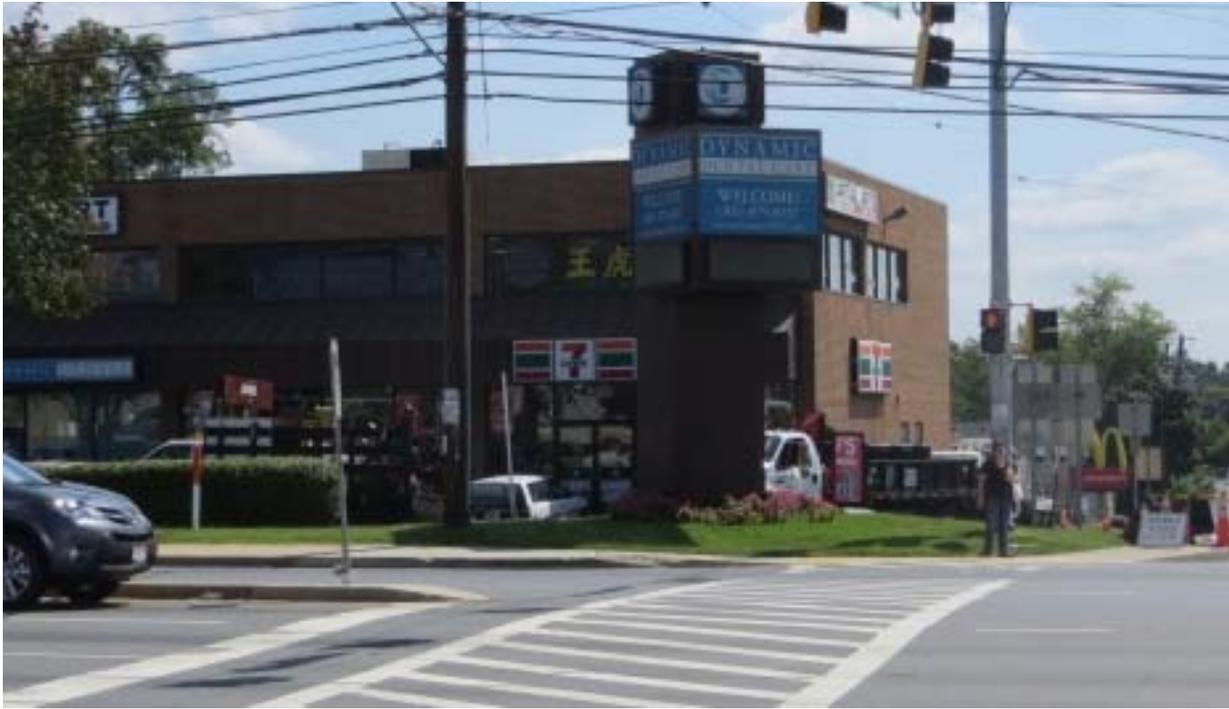
7-ELEVEN [OPPORTUNITIES]

- Highly visible location
- Landscape / gateway opportunity
- Central location to other services and businesses

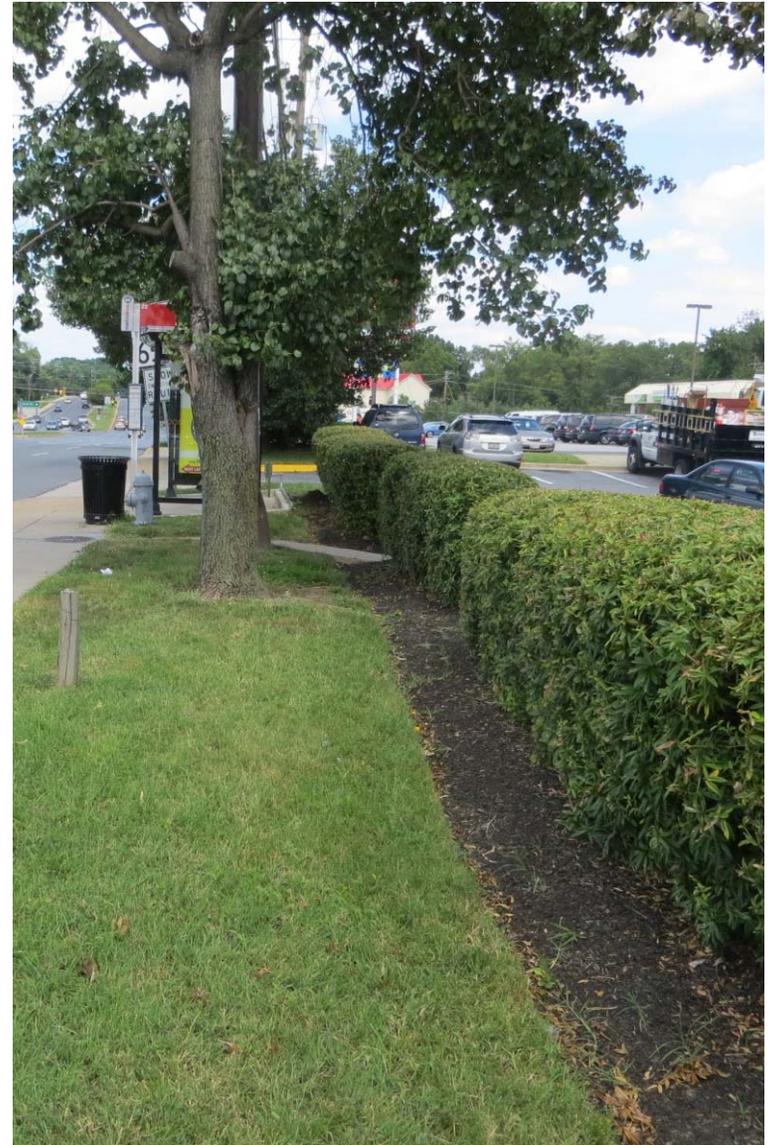
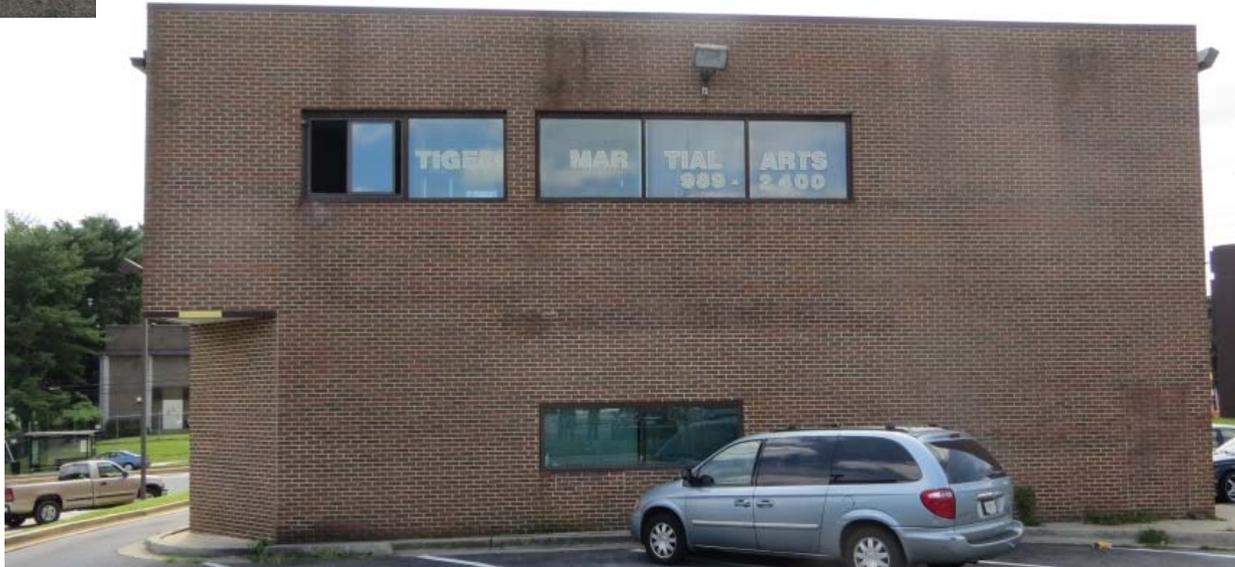
7-ELEVEN

- Limited expansion potential
- Limited vehicular access
- Dense tree canopies along New Hampshire Avenue
- Blank facades on three sides

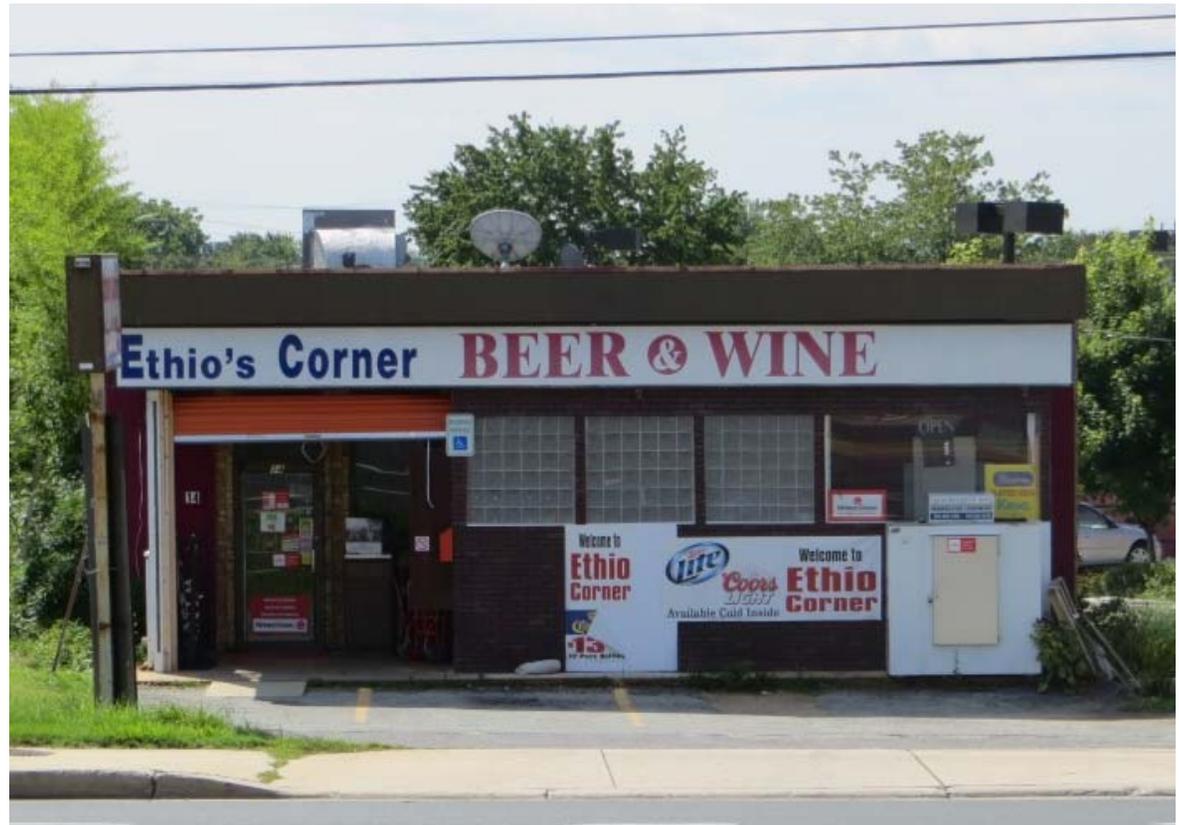
ETHIOS CORNER

Architecture Style

- Circa 1970 Strip-Retail

Building Characteristics

- Flush painted masonry walls
- Fenestration patterns:
 - Storefront glazing,
 - Glassblock,
 - Glazed commercial doors with roll-up security fencing
- Flat roof with small metal-capped parapet with downspouts to the rear.
- Exposed roof-top mechanical systems

Signage

- Sign types:
 - Plastic/vinyl illuminated box sign
 - Vinyl banners
 - Window mounted signs and vinyl lettering

Lighting

- Wall mounted exterior flood lights

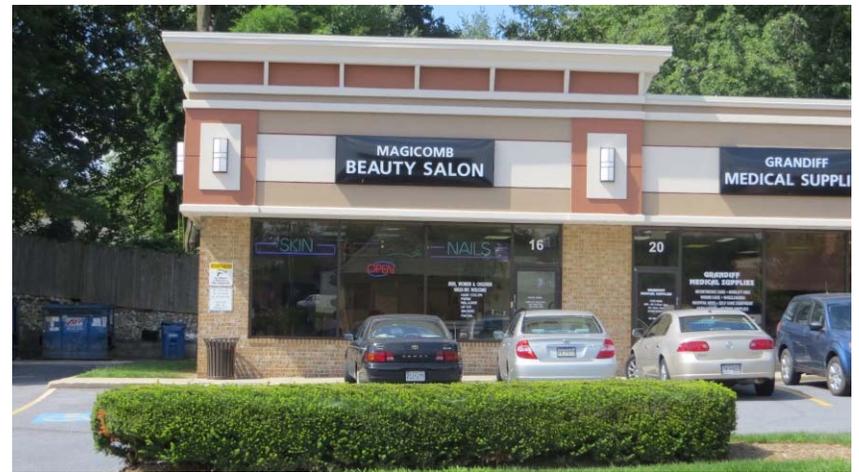
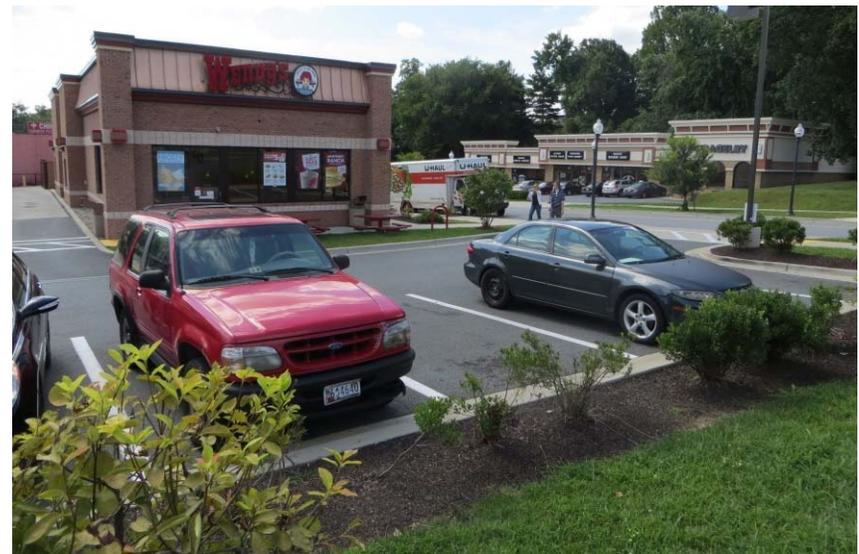
ETHIOS CORNER

- Good diversity of uses, national and local businesses
- Private and public investment
- Vital Way is an appropriately scaled retail street
- Infill opportunity
- Landscape / gateway opportunities

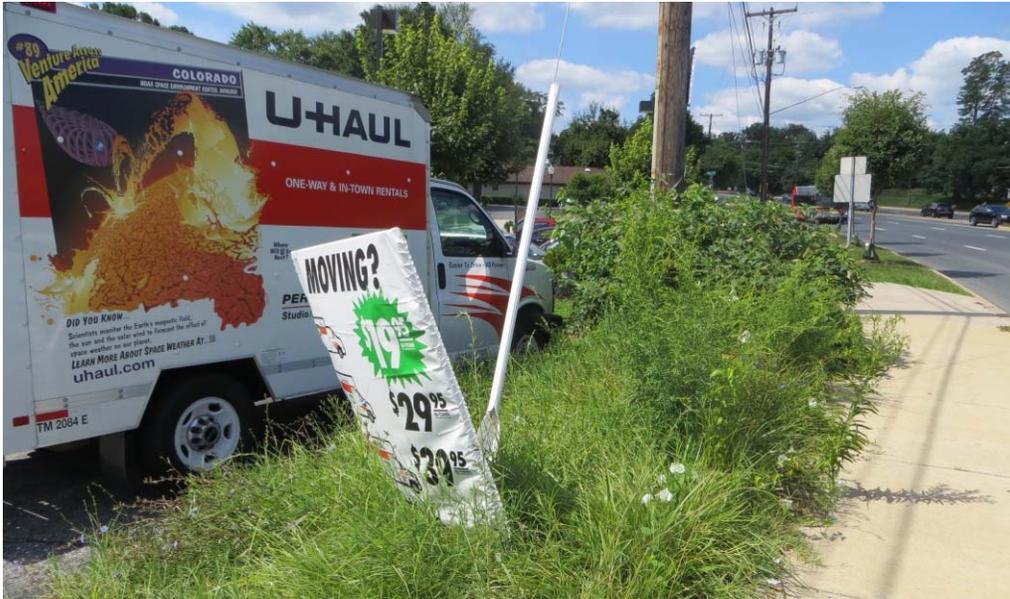
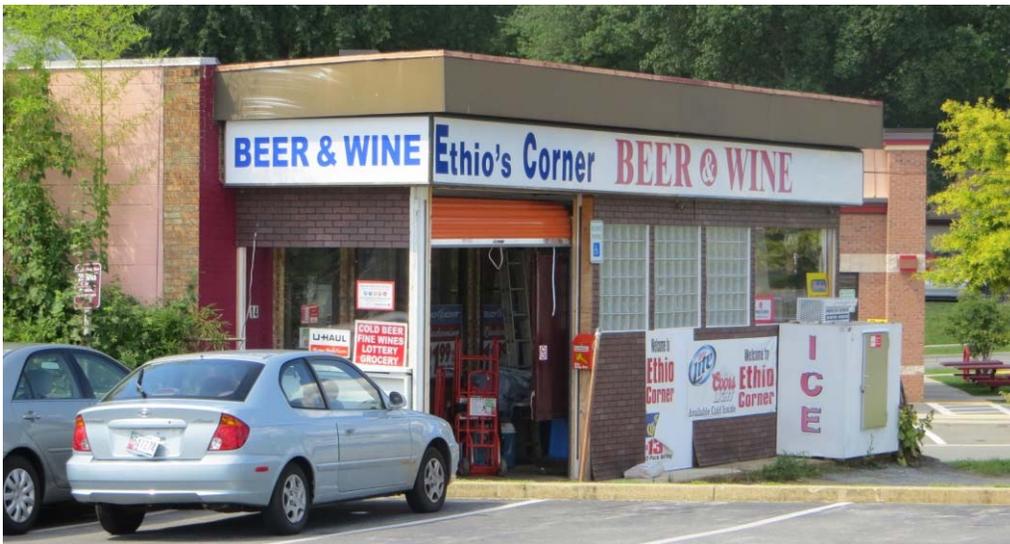
ETHIOS CORNER

- Ethio's Site is a narrow parcel
- Rear service through adjacent parcel
- Limited access and parking space
- Ethio façade is cluttered around entry – ice machine and signage not well maintained.
- Landscape and parking is not well maintained.

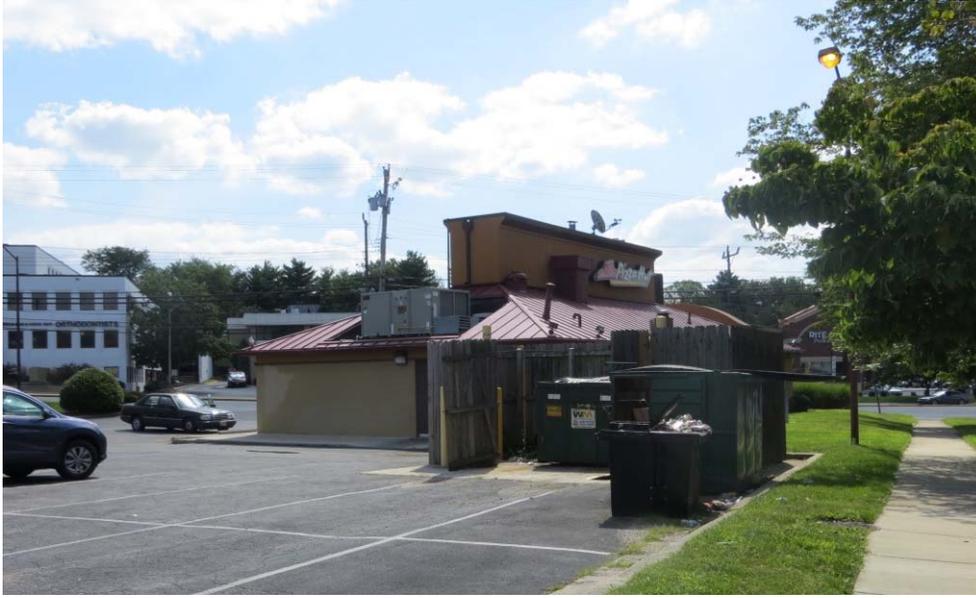
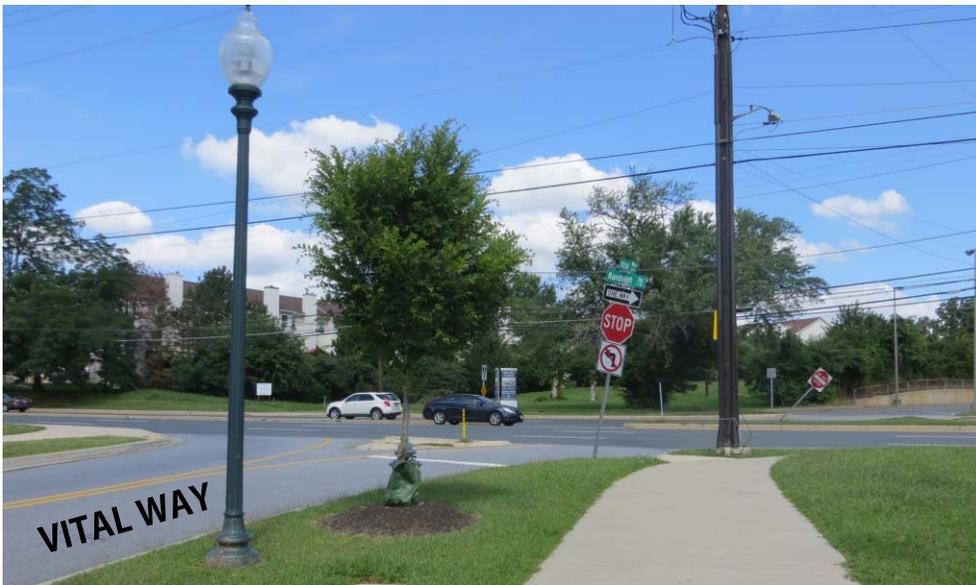
ETHIOS CORNER

- Right-in and right-out to Vital Way
- Abrupt grade changes between parcels
- Blank walls facing public spaces
- Dumpsters are highly visible

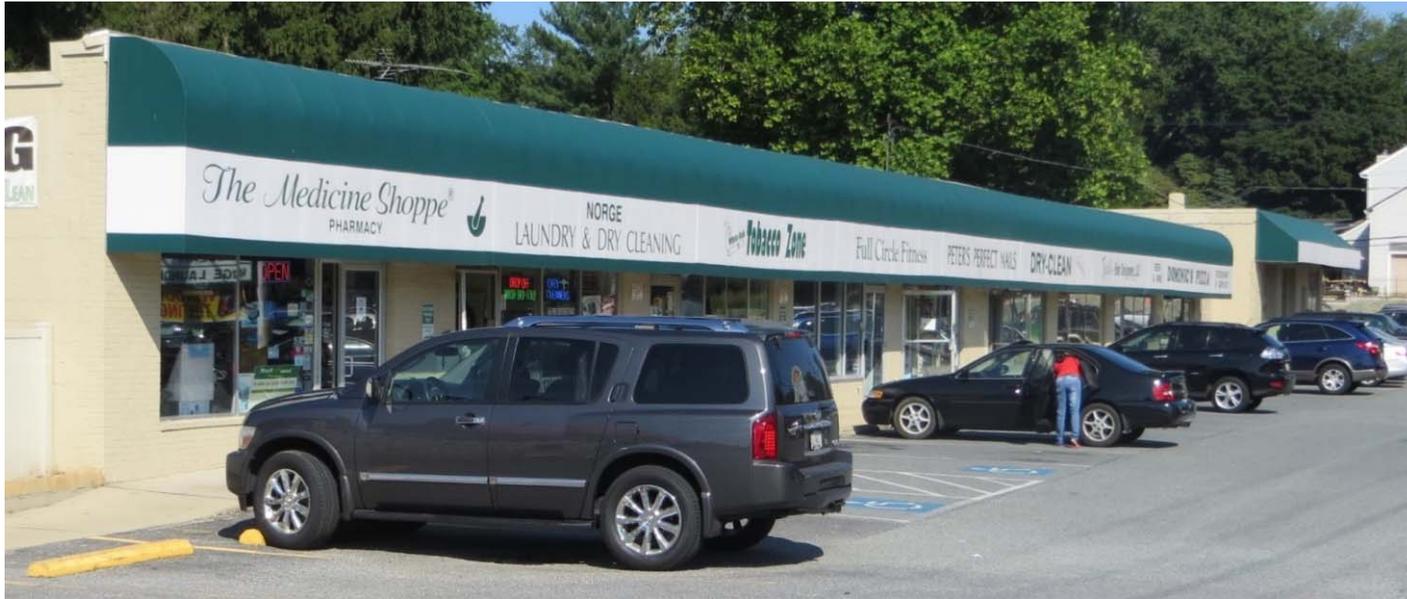
MEADOWOOD CENTER

Architecture Style

- Circa 1950 Strip-Retail

Building Characteristics

- Flush painted masonry walls
- Fenestration patterns:
 - Large storefront glazing
 - glazed commercial doors
 - garage door bays
- Flat roof with downspouts to the rear
- Vinyl awning with business signage
- Window unit Air conditioners along front façade.

Signage

- Sign types:
 - Awning signs
 - window mounted signs
 - Neon signs
 - vinyl lettering

Lighting

- Wall mounted fluorescent tube lights under canopy
- No site lighting

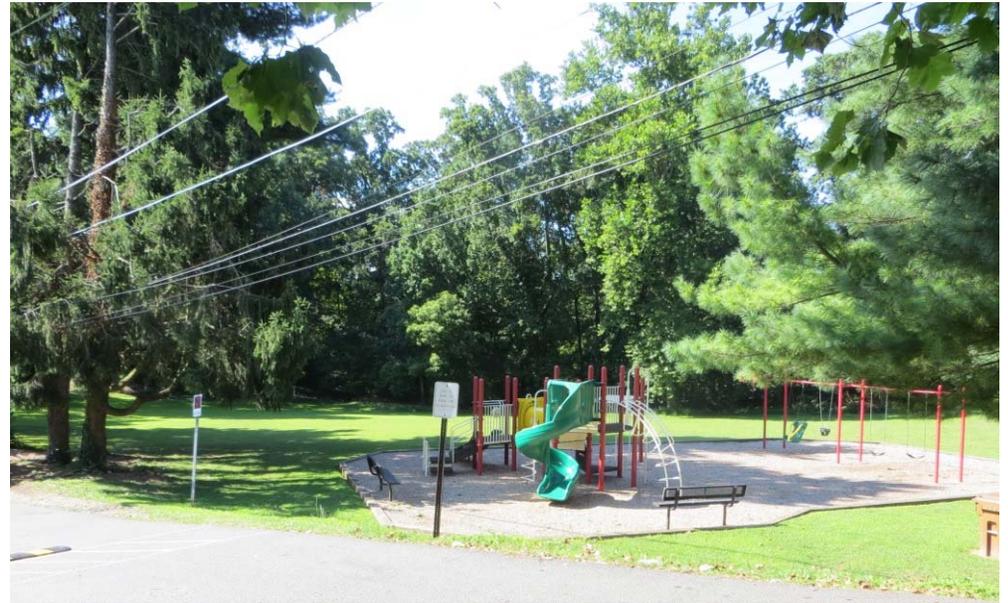
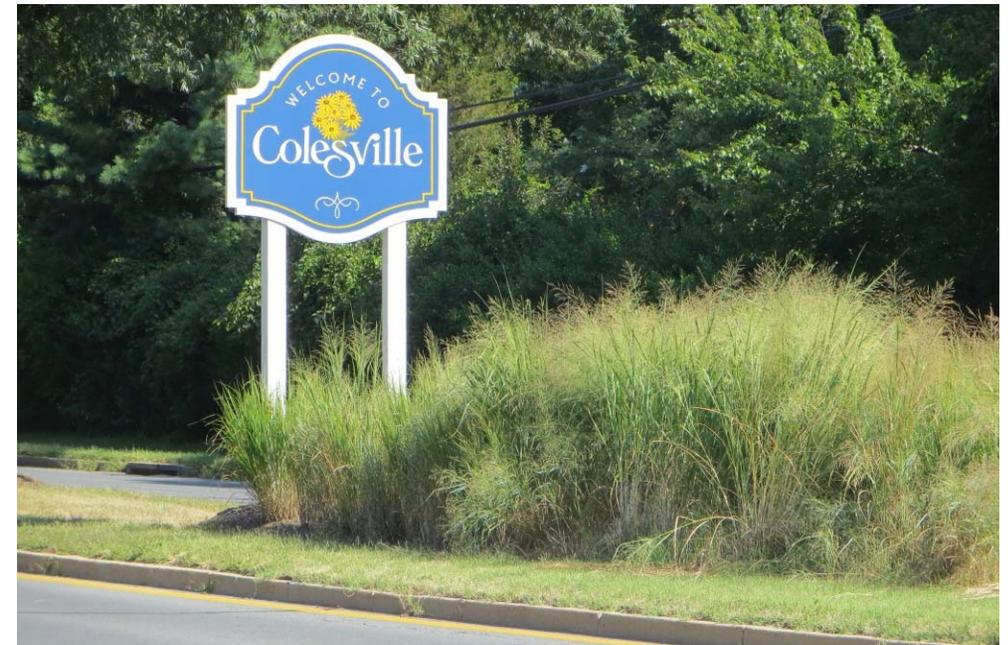
MEADOWOOD CENTER

- Southern gateway opportunity
- Easy access from New Hampshire Avenue
- Proximity to public park
- Space for pedestrian amenities

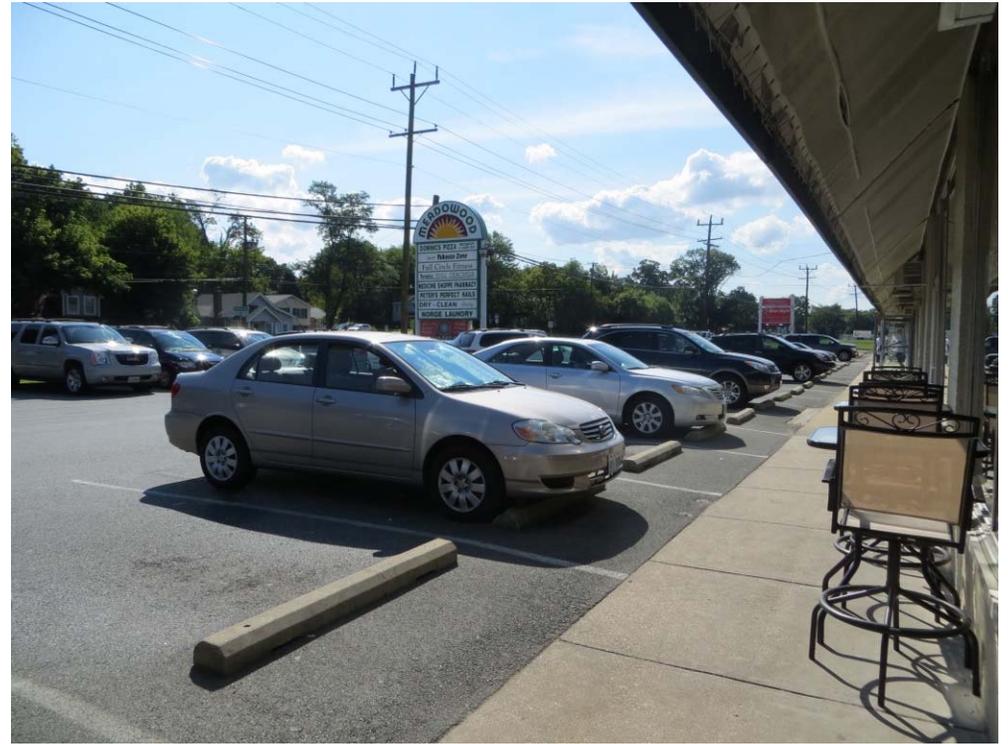
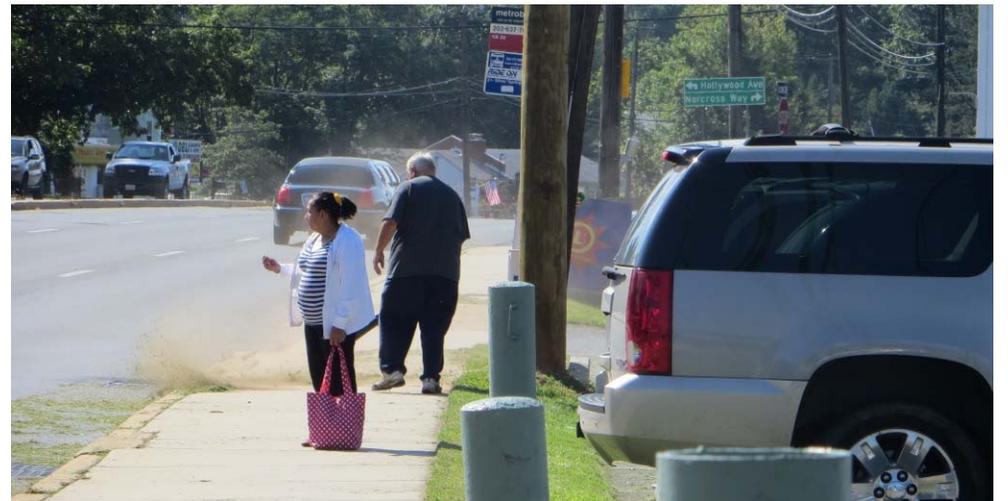
MEADOWOOD CENTER

- Lots of asphalt
- Flush retail sidewalk with parking lot
- Pedestrian desire lines across New Hampshire Avenue
- Limited sidewalk width along New Hampshire Avenue
- Horizontal and monotonous building elevation

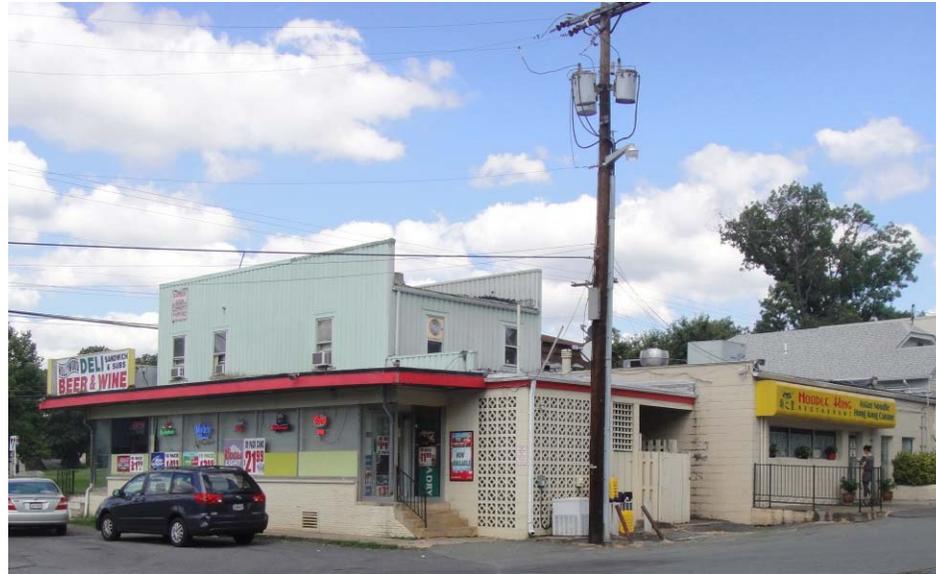
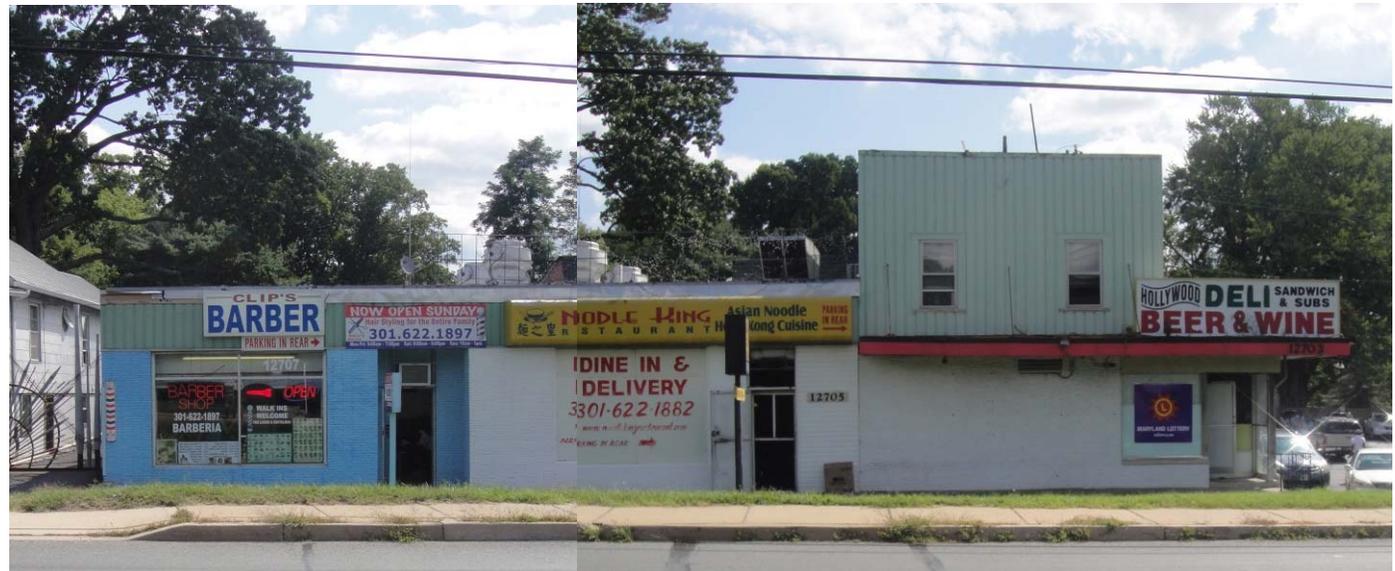
HOLLYWOOD PARK

Architecture Style

- Circa 1950 Strip-Retail

Building Characteristics

- Variety of painted masonry, aluminum siding
- Fenestration patterns:
 - fixed metal windows,
 - sash vinyl windows
 - glazed commercial doors
- Flat roof with downspouts to the rear.
- Exposed roof-top mechanical systems

Signage

- Variety of sign types:
 - plastic/vinyl illuminated box sign
 - vinyl banners
 - window mounted signs and vinyl lettering
 - Neon

Lighting

- Wall mounted exterior flood lights

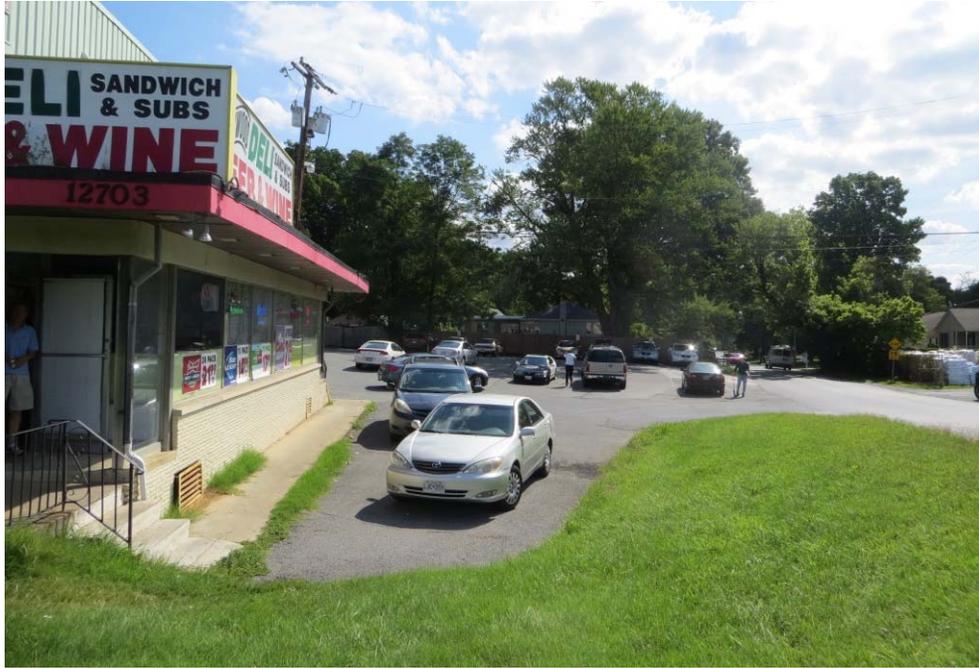
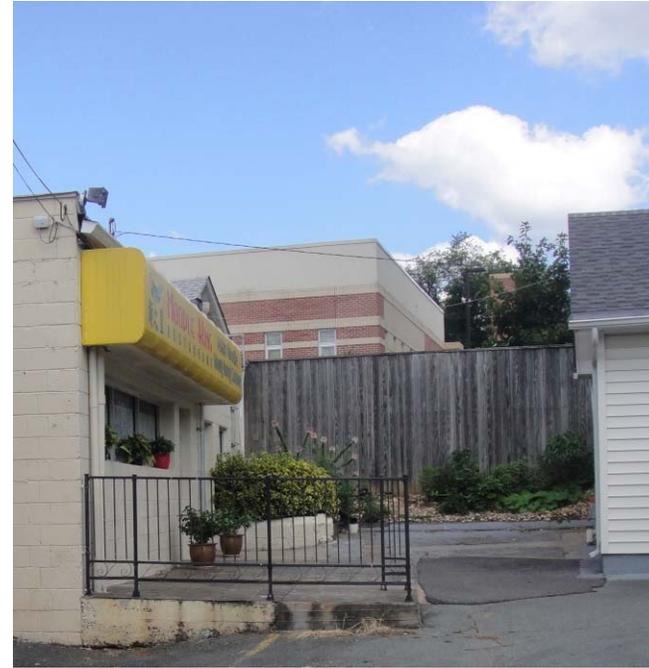
HOLLYWOOD PARK

- Easy access from New Hampshire Avenue
- Parking and services behind businesses
- Outdoor / pedestrian spaces
- Redevelopment

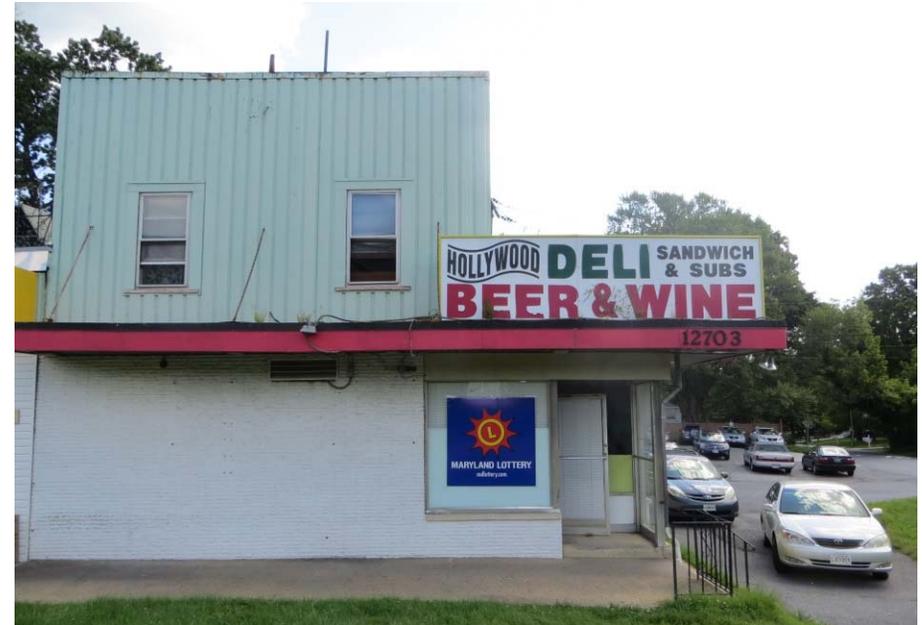
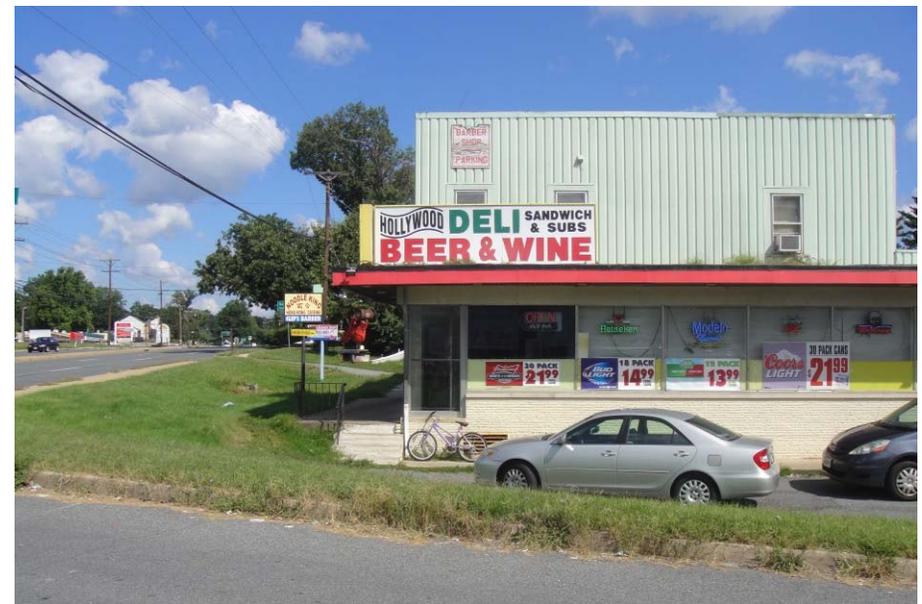
HOLLYWOOD PARK

- Building sits lower than New Hampshire Avenue
- No edge between parking lot and Hollywood Avenue
- Blank walls facing New Hampshire Avenue
- Building appears to have been expanded and/or renovated multiple times without maintaining a consistent look
- Front retailers are not accessible from parking lot
