Final
Report of
Inspection

Project Management
Deficiencies in Constructing
the Paul S. Sarbanes
Silver Spring Transit Center

Report # OIG-14-007

Montgomery County Maryland
Office of the Inspector General

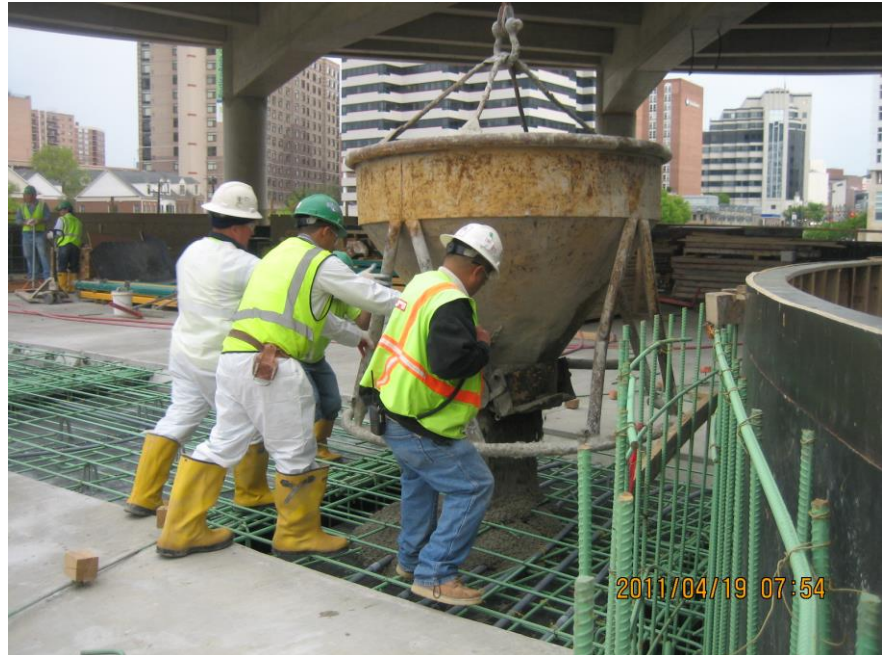
Image 6: West Level 330 Pour Strip Concrete Pour – April 19, 2011

330 level strip was poured in January 2011 while the west strip was poured in April. The level 350 strip was poured in June 2011. The SSTC Pour Strips are substantially wider than the normal industry practice of 3-4 feet. Both pour strips at the 330 level are 760 square foot

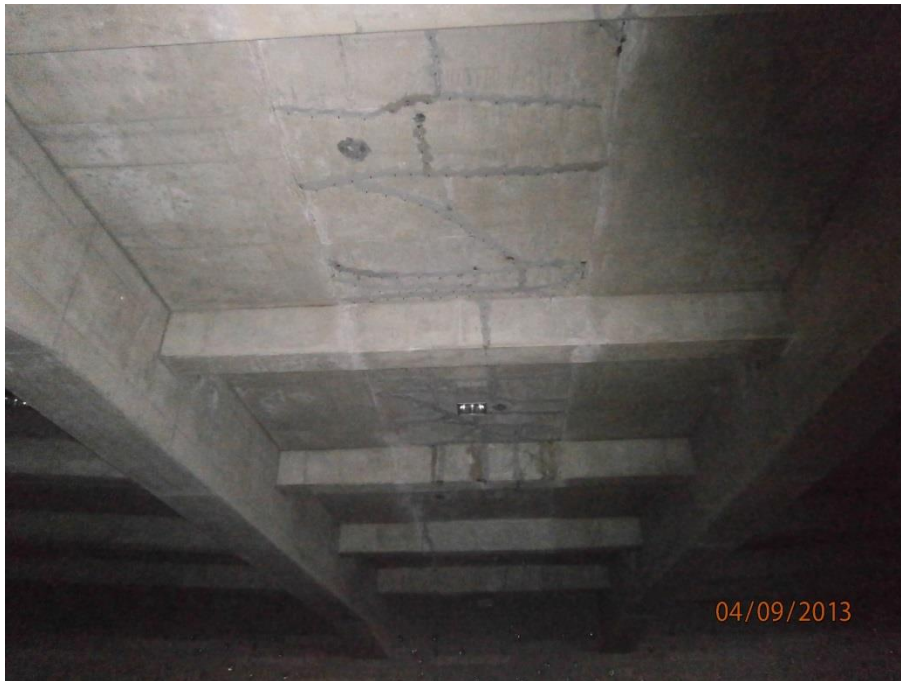
Image 7: Cracking Evident on Underside of Level 330 East Pour Strip – April 9, 2013

rectangles approximately 10' wide and up to 76' in length while the 350 level pour strip is slightly larger at 800 square feet, 20' wide, and 40' Long

The CRWG quickly agreed upon, designed, and implemented corrective actions to strengthen both of the Level 330 pour strips. Those actions were completed by the end of 2013. The CRWG also adopted a plan to fill slab cracks and resolve the slab thickness deficiencies by topping the Level 330 and 350 slabs with a Latex Modified Concrete (LMC) overlay that will be applied once the weather and temperatures permit, and decisions about other remedial actions necessary to address durability issues have been made. As of the mid-April 2014, the CRWG had not agreed upon a remediation plan to address the latter issues.

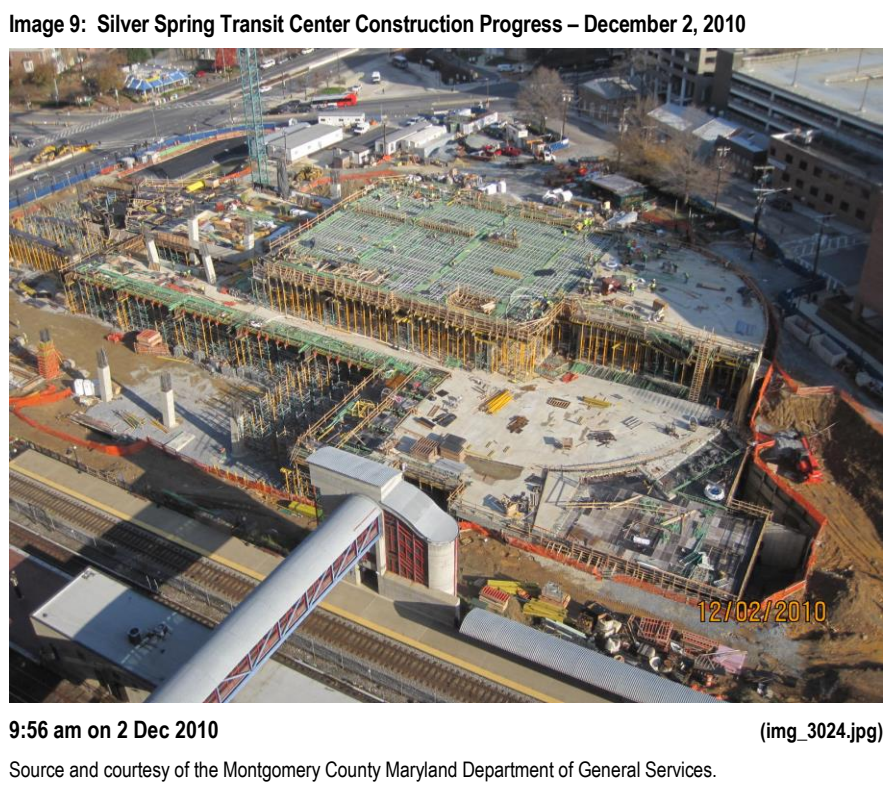
At the point in time of the November PMT meeting, less than half the slab concrete had been placed, and the structure was less than 50 percent complete (see Image 9).⁹⁹ The meeting minutes indicate that the issues were not unusual or unexpected in a complex structure like the SSTC and that the SEOR was working to address each one. Although the construction schedule and completion date were discussed during the meeting, there was no suggestion that these issues might further delay the completion of the SSTC.

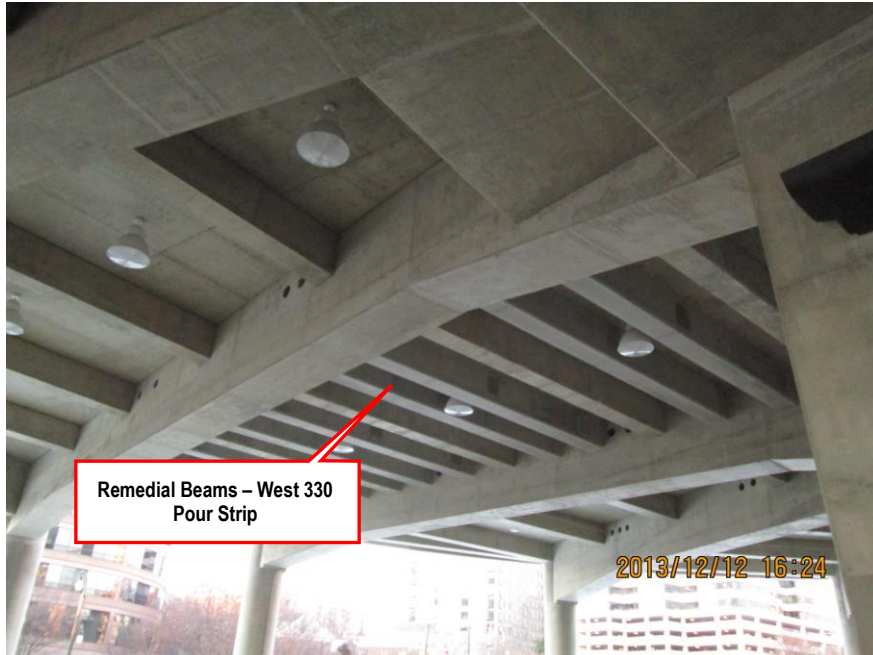
Image 10: Additional Beams for Remediation of Shear and Torsion Deficiencies per KCE and IAC Recommendations

Remedial Beams – West 330
Pour Strip

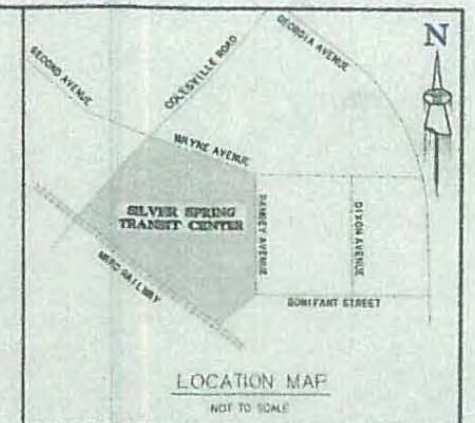
CONCRETE SLAB BETWEEN LEVEL 305 AND 330
 SCALE: 1" = 20'

REPORT OF ASBUILT SURVEY:
 THE SURVEY SHOWN HEREON IS A FORENSIC SURVEY OF THE SILVER SPRING TRANSIT CENTER'S LOWER AND UPPER CONCRETE SLABS BEING BETWEEN FLOORS 305 AND 330 AND FLOORS 330 AND 350, LOCATED IN SILVER SPRING IN MONTGOMERY COUNTY, MARYLAND. THE FIELD SURVEY WAS COMPLETED NOVEMBER 1 THROUGH 8, 2011, UNDER THE DIRECTION OF JOHN H. ADLER III, PROFESSIONAL SURVEYOR AND MAPPER (PSM). THIS SURVEY IS VALID ONLY WHEN THE SIGNATURE AND RAISED EMBOSSED SEAL ARE FOUND AT THE END OF THIS REPORT.
