## 5. Natural Resources

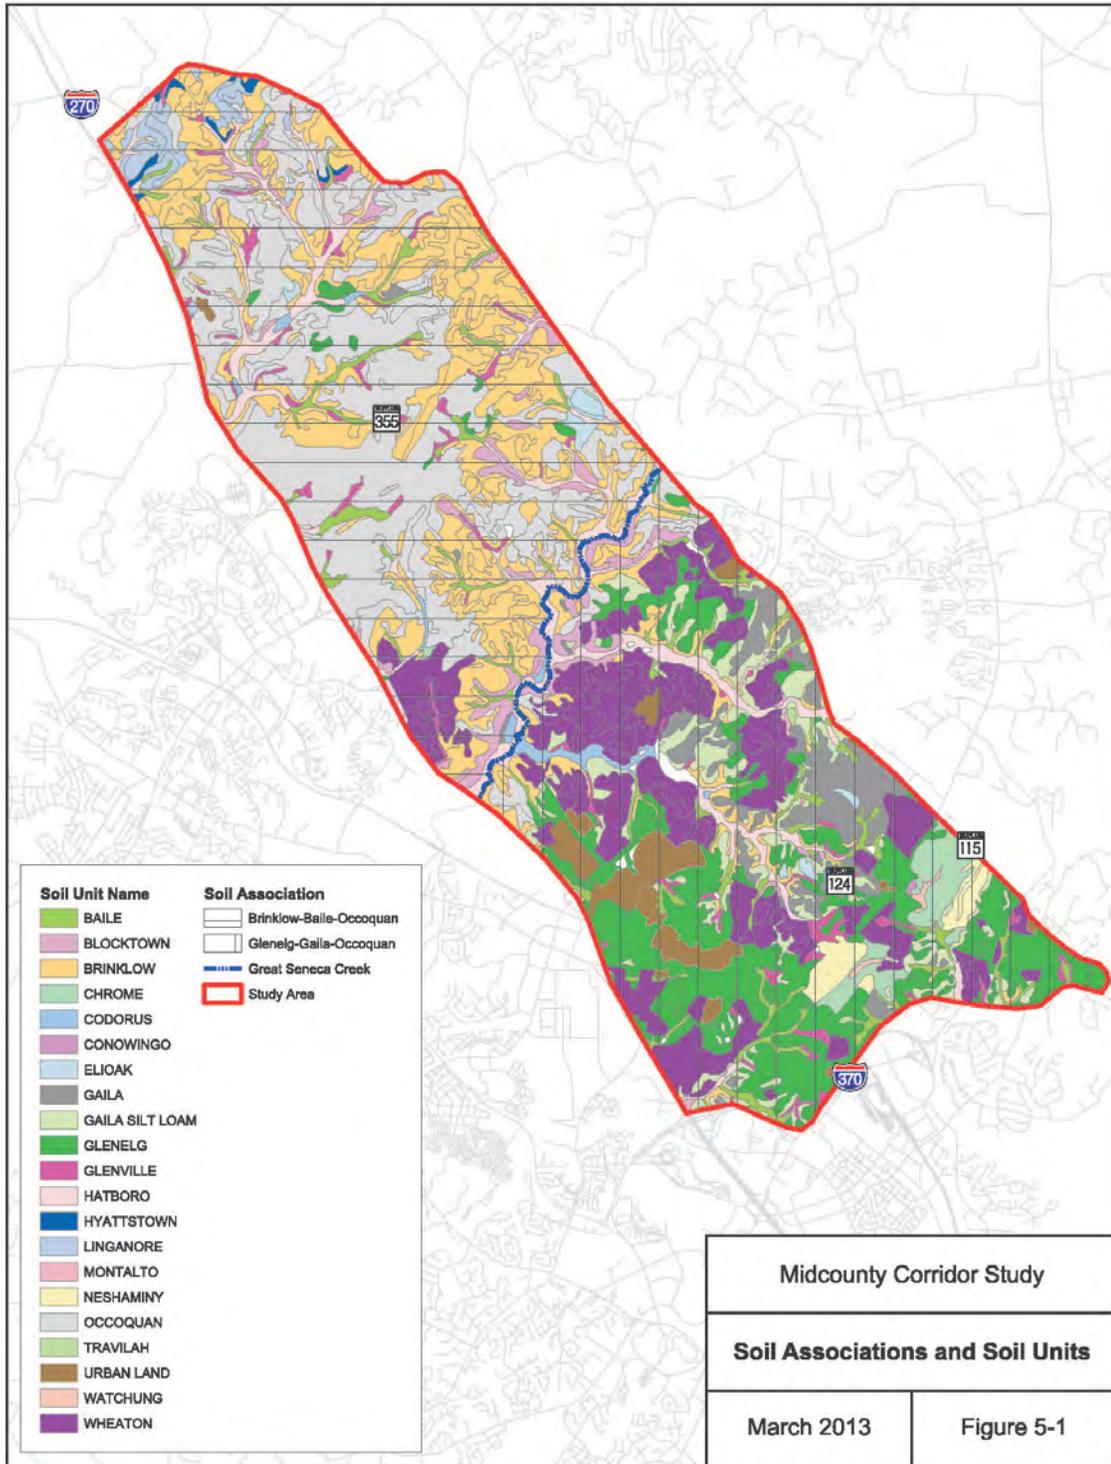
**Figure 5-1: Soil Associations**

Southeast of Great Seneca Creek, the study area lies within the Glenelg-Gaila-Occoquan association, composed of moderately deep to deep, and moderately erodible, well-drained, strongly sloping, micaceous soils. Northwest of Great Seneca Creek, the study area lies within the Brinklow-Baile-Occoquan soil association, composed of shallow to moderately deep, well drained, strongly sloping, channery soils. Both associations are classified as having a fair to good suitability as material for roadway subgrade or fill.

The U.S. Department of Agriculture, Natural Resources Conservation Service (NRCS) in cooperation with the Maryland Agricultural Experiment Station and the Montgomery Soil Conservation District conducted a soil survey of Montgomery County. Excluding the stream channels, the study area includes two soil associations divided at the intersection with Great Seneca Creek (see **Figure 5-1**).

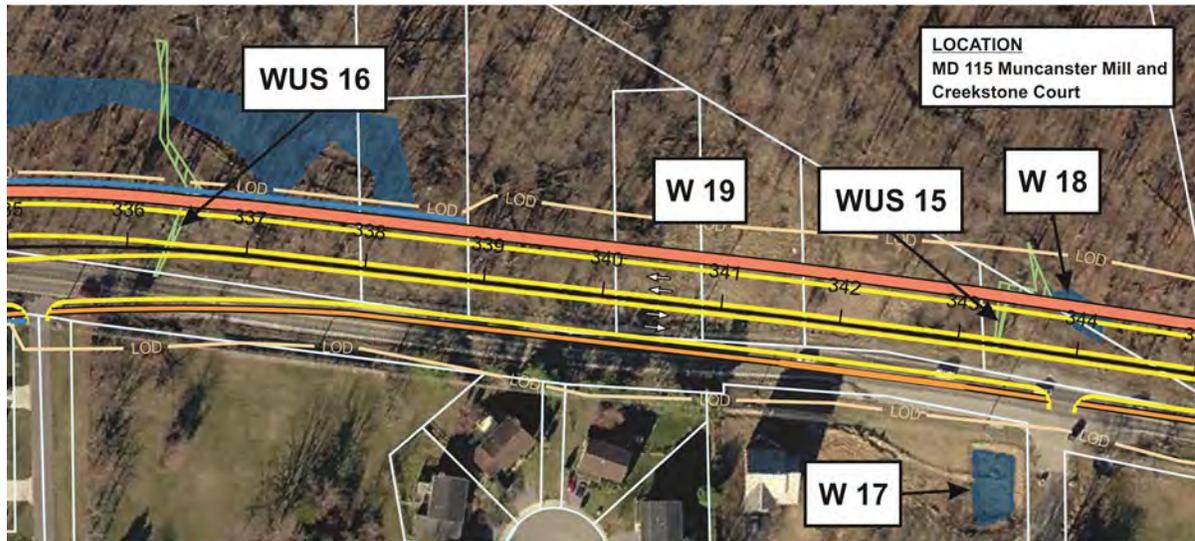
**Figure 5-5: Location WUS 15, WUS 16, W17, W18, W19**

Feature WUS 15 is a perennial RPW (Relatively Permanent Water) originating at a stormwater pond in the Rock Creek watershed. The stream has a natural channel shape, with a width of 3 to 8 feet, a channel depth of 18 to 30 inches, and banks with a 2:1 slope. Channel substrate consists of cobbles, sands, and gravel. The feature has well defined bed and banks, and observed indicators of the ordinary high water mark include disturbed leaf litter, sediment deposition, water staining, presence of litter and debris, sediment sorting, and scour. The forest surrounding WUS 15 is dominated by slippery elm (*Ulmus rubra*), southern arrowwood (*Viburnum dentatum*), blackhaw (*Viburnum prunifolium*), and persimmon (*Diospyris virginiana*). Feature W15 provides limited aquatic habitat due to its small size. Maryland DNR’s Stream Waders collected benthic macro-invertebrate samples at a site (0840-02-2009) downstream of Feature W15 in 2009. The site had a total of 8 macro-invertebrate families, with 4 EPT (Ephemeroptera, Plecoptera, Trichoptera) taxa and 3 Dipteran taxa, resulting in a poor IBI score of 1.57.

Feature WUS 15 was flowing during the April 2011 field review, and is jurisdictional under Rapanos guidance. Fish passage at the road culvert is unnecessary due to the absence of upstream habitat. Impacts to waters here total 113 LF.

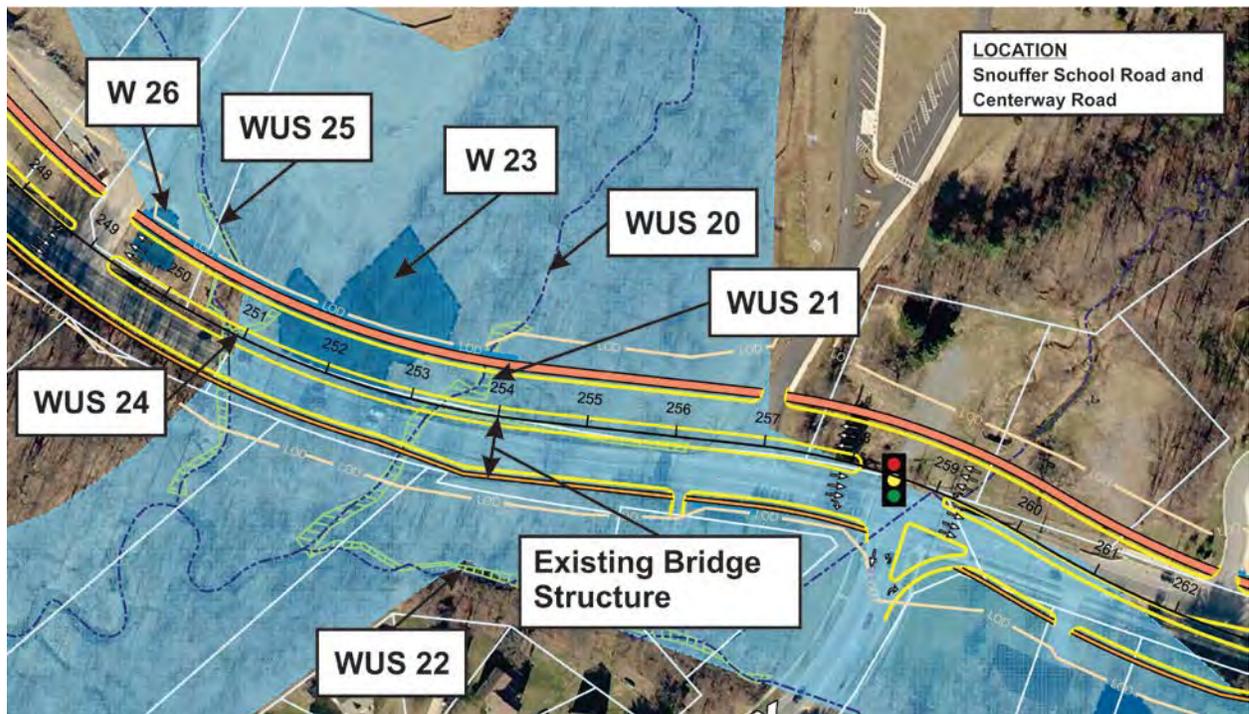
Figure 5-6: Location WUS20, WUS21, WUS22, W23, WUS24, WUS25, W26

Feature WUS 20 is a perennial RPW flowing year round, and is jurisdictional under Rapanos guidance. Even though the downstream sampling site received a poor IBI score, the feature provides adequate habitat for fish and benthic macro-invertebrates due to its perennial flow, variety of substrates, and presence of riffle-pool sequences. Fish passage is presently unimpeded beneath the bridge and would continue to be available beneath a widened bridge. Impacts to waters here total 145 LF.

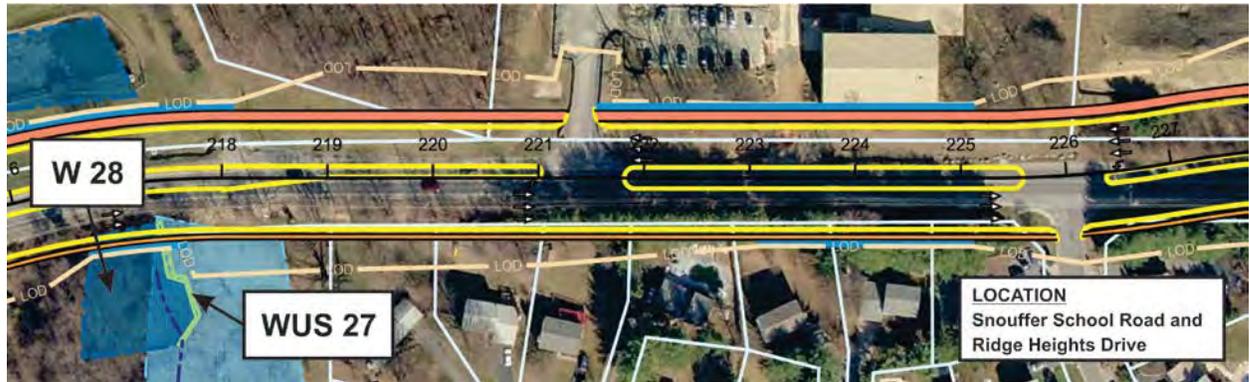
**Figure 5-7: Location WUS 27, W28**

Feature WUS 27 is an unnamed, perennial tributary to Cabin Branch originating at a stormwater pond outfall west of Snouffer School Road and flowing west through a forest in the Hunters Woods Neighborhood Conservation Area. WUS 27 receives drainage from a forested wetland (Feature W28) to the north and exhibits a natural channel shape, with a width of 3 to 6 feet, water depth of 4 to 12 inches, and banks with a 2:1 slope. The channel substrate consists of silts, cobbles, and gravel. The feature has well defined bed and banks, and observed indicators of the ordinary high water mark include: presence of litter and debris, sediment sorting, and scour. The forest surrounding the feature is dominated by red maple, black gum (*Nyssa sylvatica*), and southern arrowwood. Maryland DNR’s Stream Waders collected benthic macro-invertebrate samples at a site (863-4-2001) located ½ mile downstream, just below Goshen Road, in 2001. The site had a total of 9 macro-invertebrate families, with 1 EPT taxon and 2 Dipterans, resulting in a poor IBI score of 1.57. EPT taxa made up only 1.7% of the macro-invertebrates in the sample, indicating unhealthy stream conditions. Despite having a poor IBI score, the feature provides adequate aquatic habitat for a first order stream due to its perennial flow and instream cover.

upstream habitat. An eastward shift in the centerline of Alternative 4 Modified has avoided this stream. There are no impacts to waters at this location.

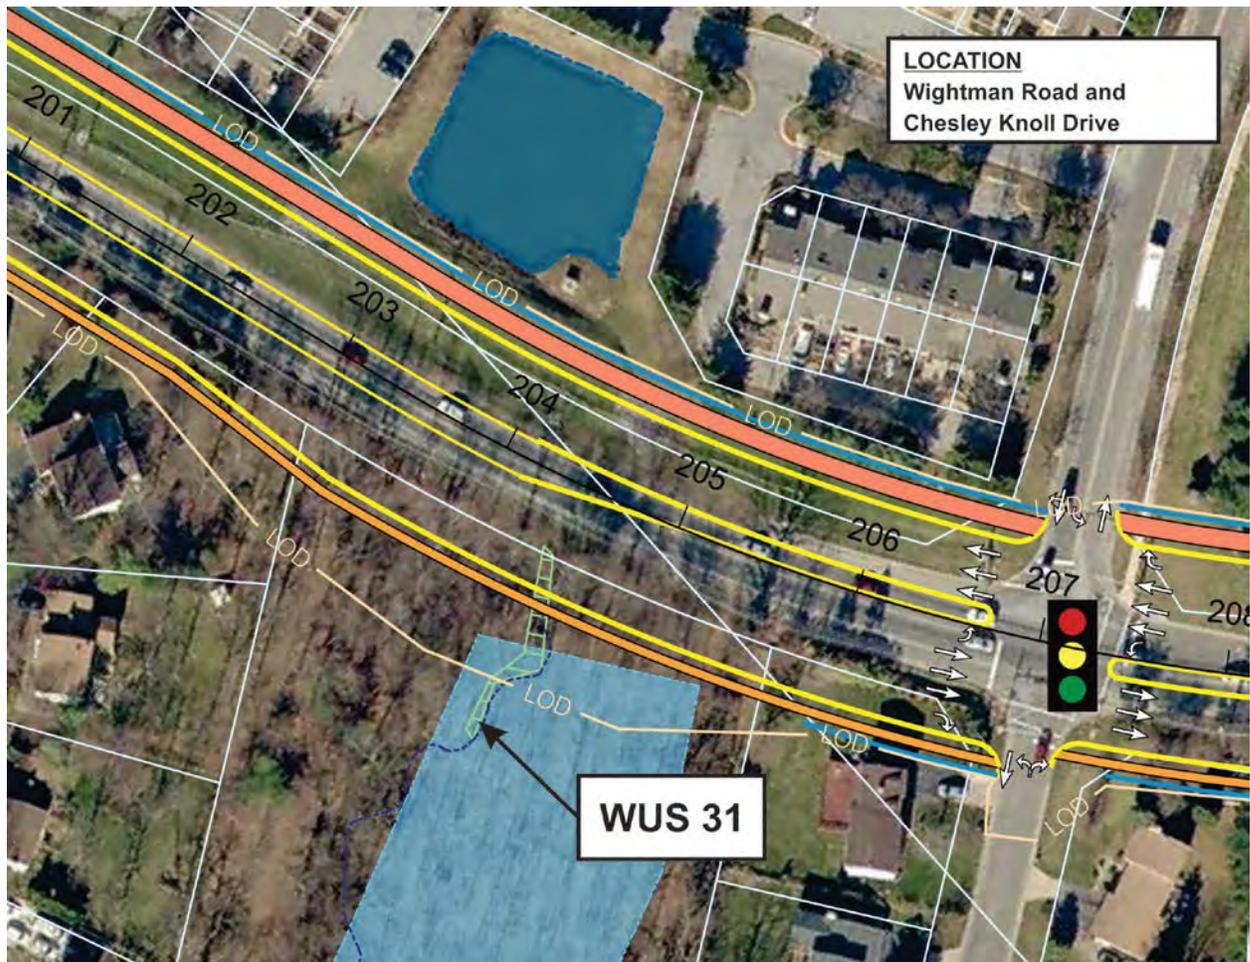
**Figure 5-8: Location WUS 31**

This stream flows southwest through a forest in the Hunters Woods Neighborhood Conservation Area and is dominated by red maple, slippery elm, and southern arrowwood. The stream has a natural channel shape, with a width of 6 to 10 feet, a water depth of 4 to 18 inches, and banks with a 2:1 slope. The banks of WUS 31 are relatively unstable with moderate areas of erosion and channel substrate consisting of silt, cobble, sand, and gravel. The feature has well defined bed and banks, and observed indicators of the ordinary high water mark include: disturbed leaf litter, sediment deposition, water staining, presence of litter and debris, destruction of terrestrial vegetation, and scour.

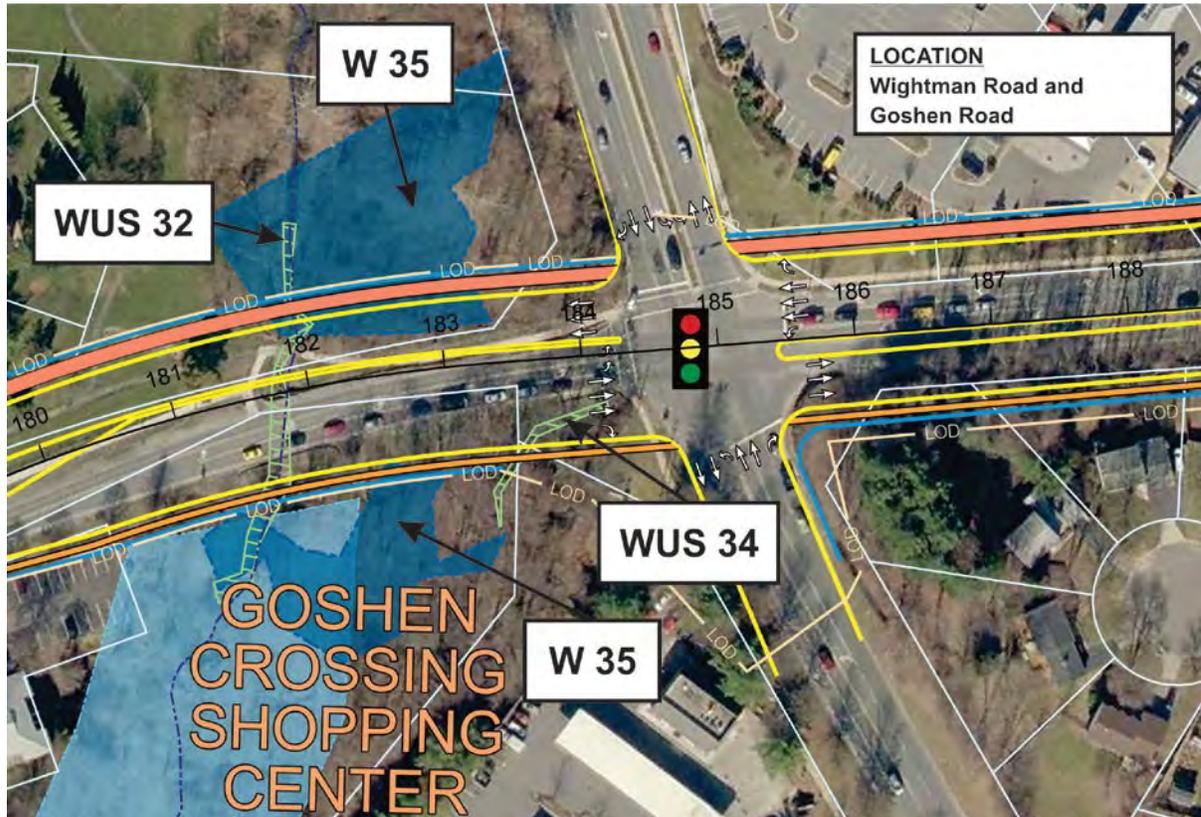
**Figure 5-9: Location WUS 32, WUS 34, W35**

Stained Leaves with secondary indicators including D2: Geomorphic Position and D4: Microtopographic Relief. The soils in W35 meet the requirements of Hydric Soil Indicator F3: Depleted Matrix. Feature W35 is a USACE jurisdictional wetland since it meets the three-parameter definition of a wetland and abuts Feature W32, an RPW flowing year round. Wetland fill impacts here total 5,754 SF.

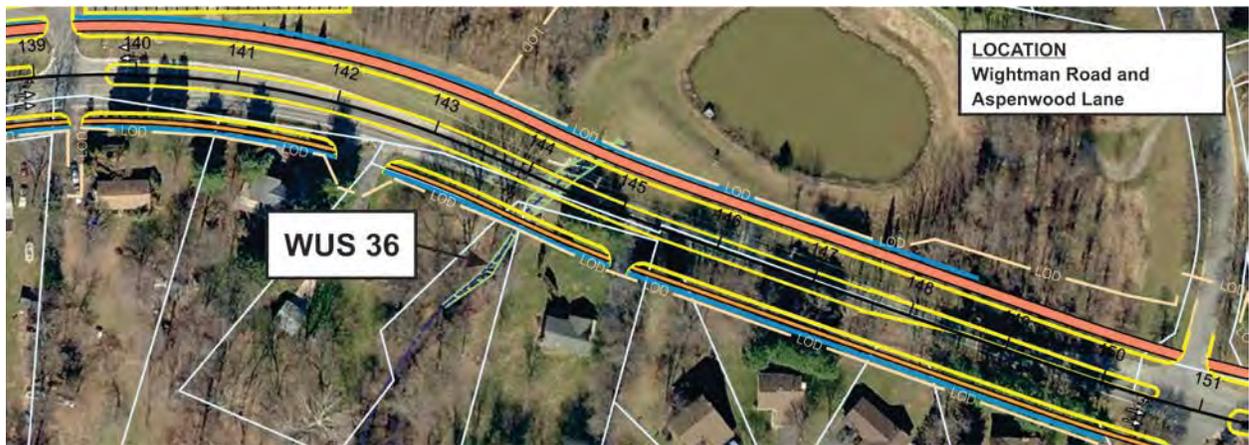
**Figure 5-10: Location WUS 36**

The feature flows west through a rip-rap channel before draining through a twin culvert under Wightman Road. The rip-rap channel ends a short distance downstream of the roadway, where the stream flows through a narrow forested buffer dominated by silver maple, black cherry (*Prunus serotina*), black walnut, and spicebush. The stream has an artificial channel shape, with a width of 5 to 15 feet, a channel depth of 3 to 7 inches, and banks with a 2:1 slope. Channel substrate near the roadway consists of rip-rap; downstream of the roadway WUS 36 transitions to a natural channel shape with cobble, silt, sand, and gravel substrate. The feature has well defined bed and bank, and observed indicators of the ordinary high water mark include: disturbed leaf litter, sediment deposition, presence of litter and debris, and scour. According to the online MBSS interactive map, no biological monitoring records exist for this unnamed tributary. WUS 36 provides limited aquatic habitat due to the altered state of the channel.

The April 2011 field review was not conclusive as to whether WUS 36 flows throughout the entire year. WUS 36 is being categorized as an RPW and considered jurisdictional under Rapanos guidance. Fish passage at the road culvert is unnecessary due to the lack of habitat in the artificial channel upstream of the culvert. Impacts to waters here total 85 LF (Table 5-14).

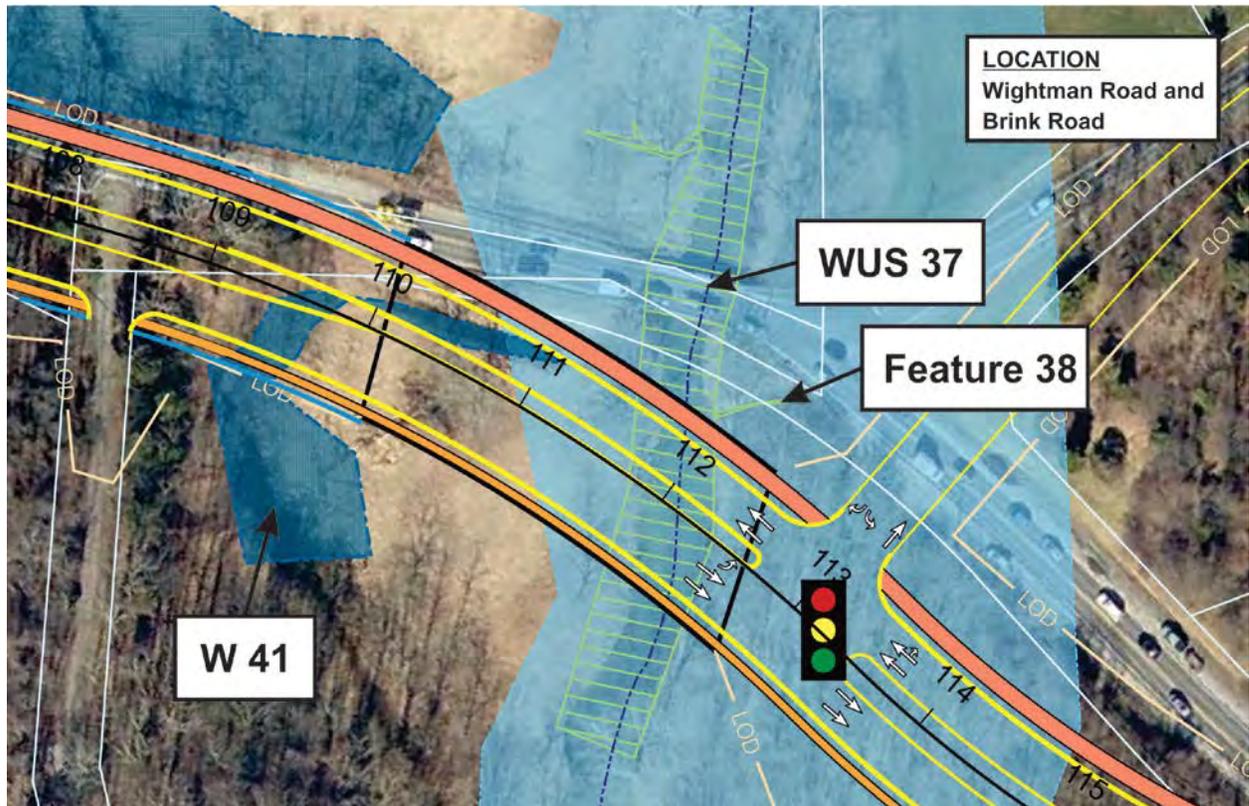
**Figure 5-11: Location WUS 37, Feature 38, W41**

Feature WUS 37 is a section of Great Seneca Creek flowing south-west under a bridge at Brink Road. This section of Great Seneca Creek flows through patchy riparian forest with large open grass areas. This riparian area is dominated by red maple, black walnut, American sycamore (*Platanus occidentalis*), box elder (*Acer negundo*), reed canary grass (*Phalaris arundinacea*), and deer-tongue grass (*Dicanthelium clandestinum*). The banks of Great Seneca are unstable throughout most of the reach, with several areas actively eroding. WUS 37 has a natural channel shape, with a width of 30 feet, a water depth of 6 to 24 inches, and banks with a 1:1 slope.

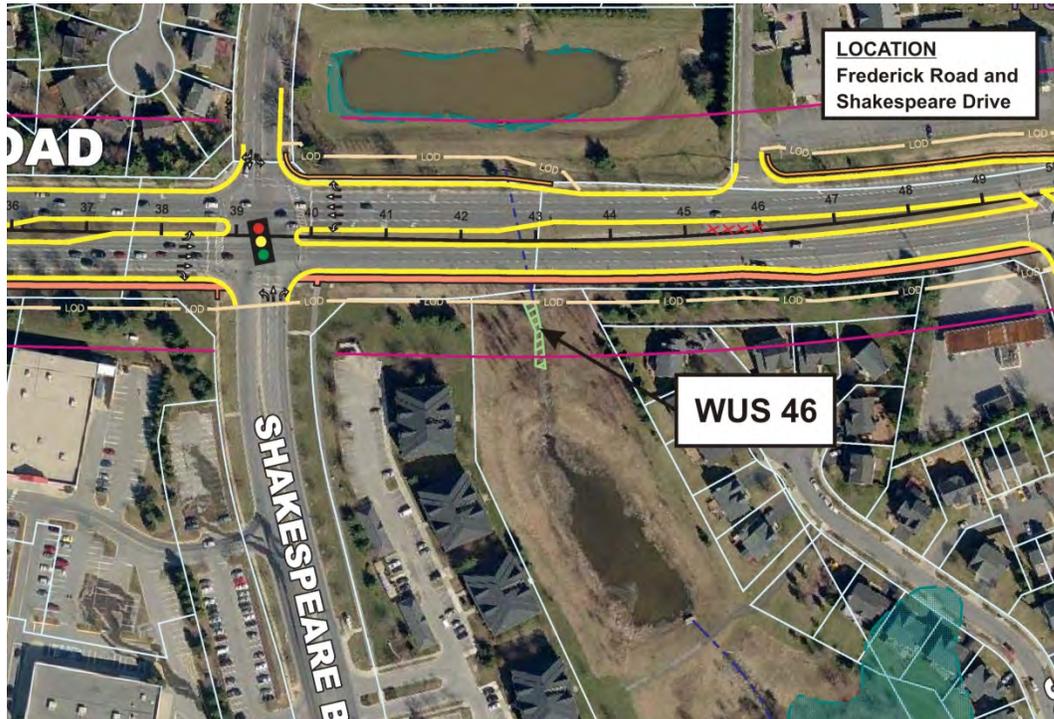
Figure 5-12: Location WUS 46

and gravel. WUS 46 has defined bed and banks, and observed indicators of the ordinary high water mark include: vegetation matted down, bent, or absent, and presence of litter and debris. The feature is surrounded by a thin strip of forest that is dominated by slippery elm, black willow, and Bradford pear (*Pyrus calleryana*). According to the online MBSS interactive map, there are no biological monitoring records for Milestone tributary.

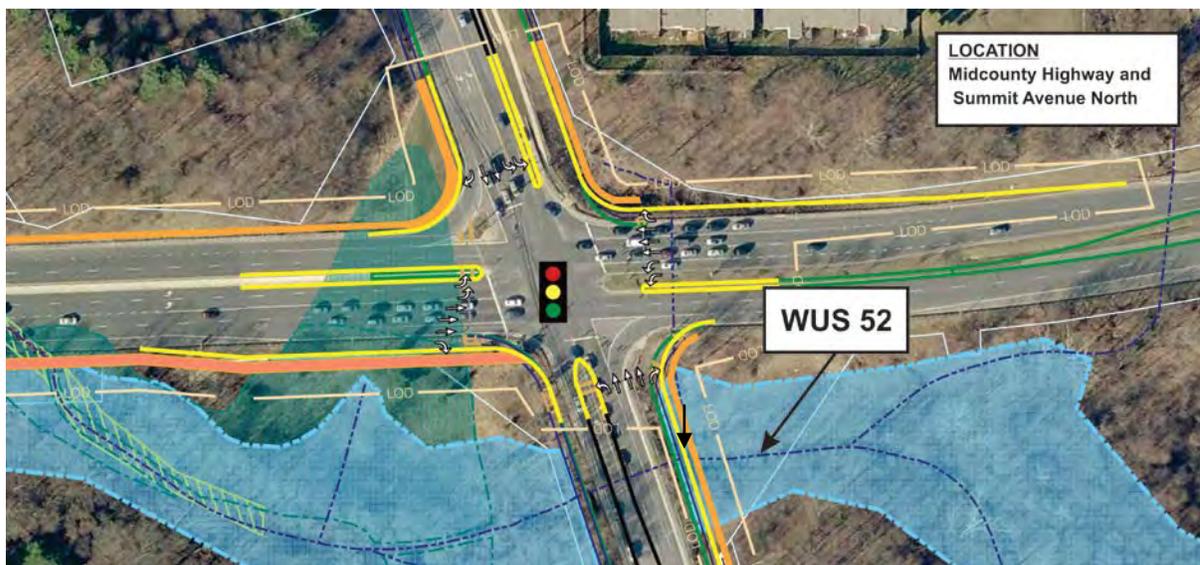
**Figure 5-13: Location WUS 52**

through similar culverts. This reach of Whetstone Run is near the headwaters of the stream. The width varies between 10 to 20 feet, with an average water depth of 1 to 3 feet. Normal flow appears to be contained within the channel and observed ordinary high water marks include matted vegetation, disturbed leaf litter, sediment deposition, water staining, presence of litter and debris and wrack line, and scour. Dominant plants in WUS 52 include sycamore, black willow, box elder, and Japanese stiltgrass (*Microstegium vimineum*). DNR's Maryland Biological Stream Survey collected benthic macro-invertebrate and fish samples from a site (SENE-113-R-2001) upstream of WUS 52 in 2001. The site had a total of 15 macro-invertebrate families, with 2 EPT taxa and 9 Diptera taxa, resulting in a poor IBI score of 1.50. EPT taxa made up only 2.3% of the macro-invertebrates in the sample, indicating unhealthy stream conditions. The site also received a poor fish IBI score of 2.00, with only 4 tolerant fish species. Despite the upstream site's poor IBI scores, the feature still provides adequate habitat for fish and macro-invertebrates due to its perennial flow and stable instream habitat. Fish passage at the feature would be desirable due to the available aquatic habitat upstream of the proposed alignment. If this alternative should ultimately be selected, fish passage would be provided only if the culverts warrant replacement, rather than an extension. The length of impact is estimated to be 10 LF for the construction of new headwalls at Midcounty Highway and 60 LF for the Goshen Road widening.

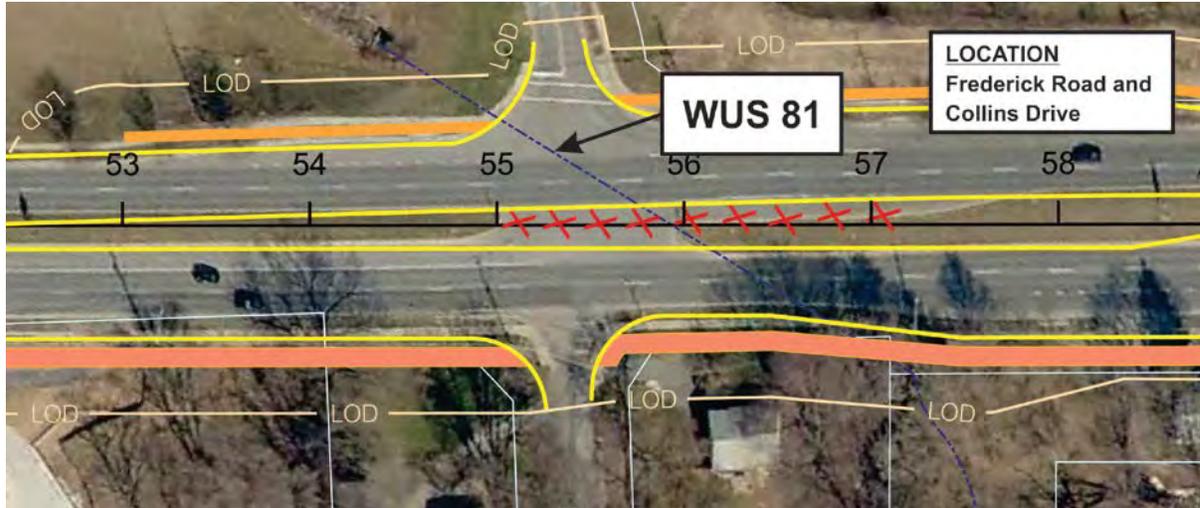
**Figure 5-14: Location WUS 81**

(*Alliaria petiolata*). Observed indicators of the ordinary high water mark include: vegetation matted down, bent, or absent, presence of litter and debris, and scour. The channel would be impacted for a distance of 15 feet.

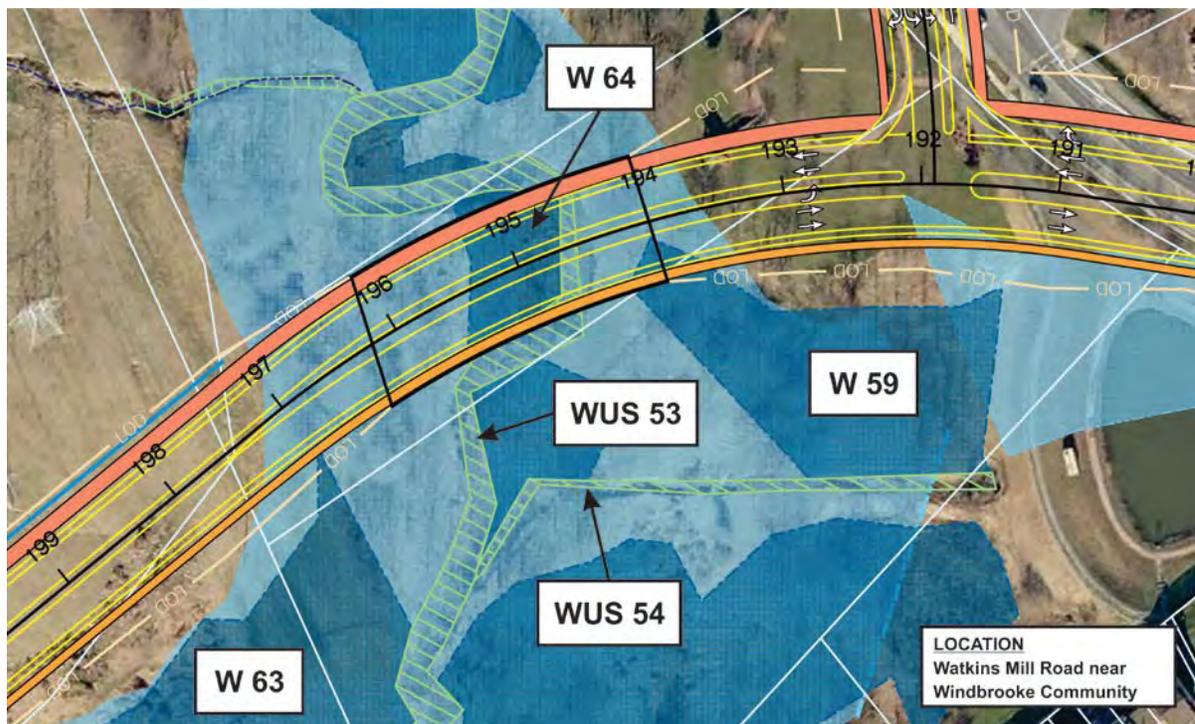
**Figure 5-15: Location WUS 53, WUS 54, W59, W63, W64**

Feature WUS 53, Whetstone Run, is a perennial, meandering and incised channel within the Middle Great Seneca Creek watershed. Feature WUS 53 begins at Lake Whetstone and flows west, crossing under Watkins Mill Road and Game Preserve Road, and continues flowing north to Seneca Creek. The channel has a natural channel shape that varies between 9 to 15 feet in width, water depth is 2 to 3 feet, and banks are often slumping and up to eight feet high. Whetstone Run is extremely incised, with headwall slumping and toe scour with severe erosion. Channel substrate includes silts, sands, gravel, and cobble. WUS 53 is buffered by a fairly wide riparian forest dominated by sycamore, black walnut, black willow, false nettle (*Boehmeria cylindrica*), Japanese stiltgrass, goldenrod (*Solidago* sp.), mile-a-minute (*Persicaria perfoliata*), deer tongue grass, and small carpgrass (*Arthraxon hispidus*).

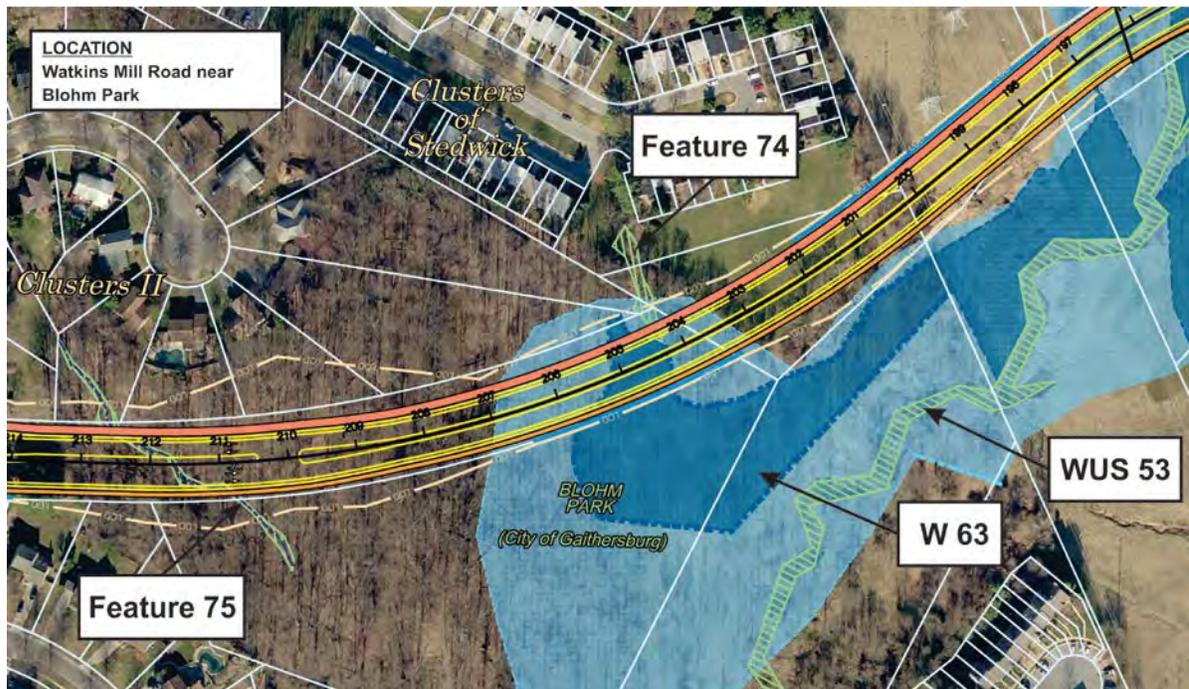
**Figure 5-17: Location WUS 53, W63, Feature 74, Feature 75**

channel has an average width of 2 to 4 feet, an average channel depth of 1 foot, and has been stabilized with riprap. Feature 75 is buffered by a 50' wide riparian forest dominated by tulip poplar (*Liriodendron tulipifera*), box elder, red maple, flowering dogwood (*Cornus florida*), spice bush, and Japanese stiltgrass. Observed indicators of the ordinary high water mark include disturbed leaf litter, the presence of litter and debris, wrack line, and an abrupt change in plant community. Feature 75 is not a USACE jurisdictional waterway since it is a Non-RPW draining uplands. Due to the ephemeral nature of the channel, the feature does not provide aquatic habitat and fish passage is unnecessary. The ephemeral channel would be piped under the alternative.

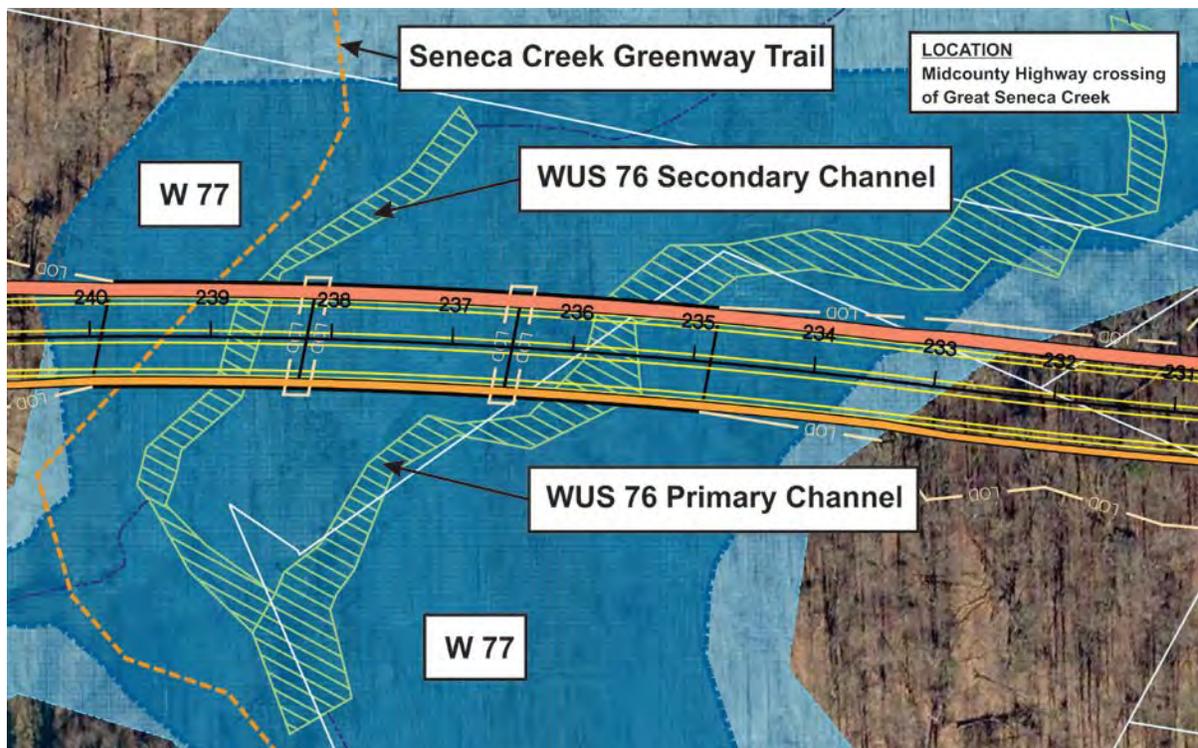
**Figure 5-18: Location WUS 76, W77**

Feature WUS 76, Great Seneca Creek, is a perennial channel within the Middle Great Seneca Creek watershed. The Creek has a primary, active channel and a secondary, flood channel at the Alternative 8 and 9 crossing, after which it flows south for approximately 10 miles before flowing into the Potomac River. Classified as a TNW (Traditional Navigable Water), the creek has an average width of 30 feet, and an average water depth of 1 foot to 6 feet with fairly unstable, eroding banks. Channel substrate includes silts, gravel, and cobbles. The secondary channel is similar to the primary channel in width, depth, and channel substrate yet contained no flow, with pools of standing water at the time of the site evaluation. It appears to function as an overflow channel during storm events. WUS 76 is buffered by a 100'+ wide riparian forest dominated by box elder, red maple, green ash, musclewood (*Carpinus caroliniana*), slippery elm, stinging nettle, Asiatic tearthumb, and Japanese stiltgrass.

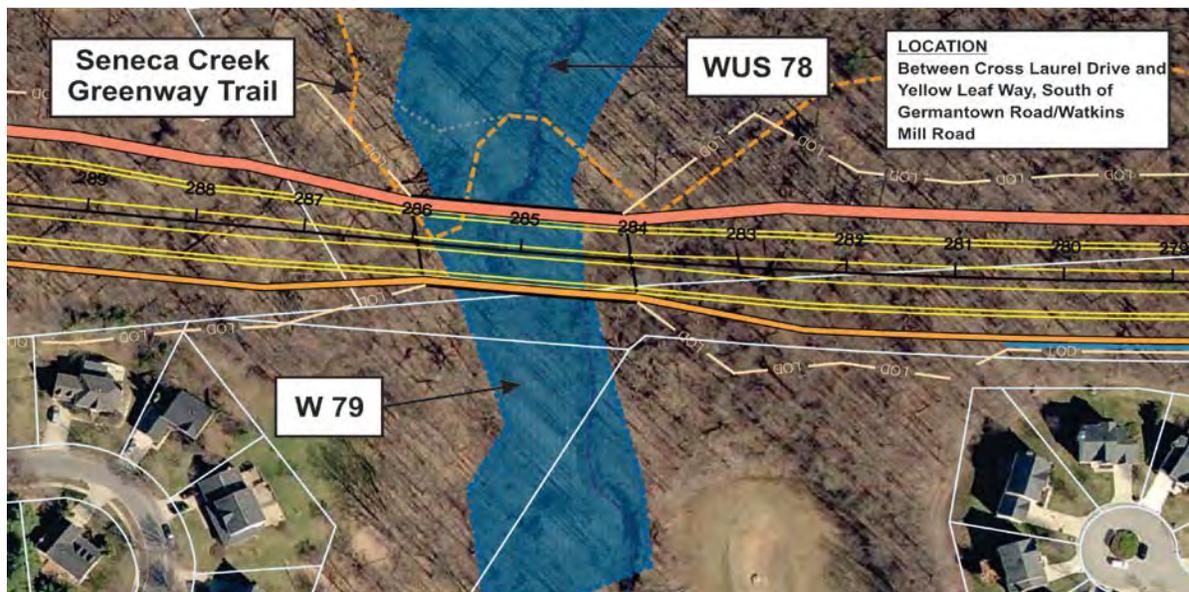
Figure 5-19: Location WUS 78, W79

Feature W79 is a wetland located at the base of a steep slope on one side of the creek. Dominant vegetation includes box elder, red maple, black walnut, riverbank grape, skunk cabbage, stinging nettle, and dotted smartweed. Primary indicators of hydrology include A3: Saturation and B9: Water-Stained Leaves with a secondary indicator including D2: Geomorphic position. Soils in W79 meet the requirements of Hydric Soil Indicator F3: Depleted Matrix. Feature W79 is a jurisdictional wetland since it meets the three-parameter definition of a wetland and is adjacent to Feature W78 (Brandermill Tributary), an RPW flowing year round. Wetland fills would be avoided through bridging and wetland conversion impacts would total 11,425 sf.

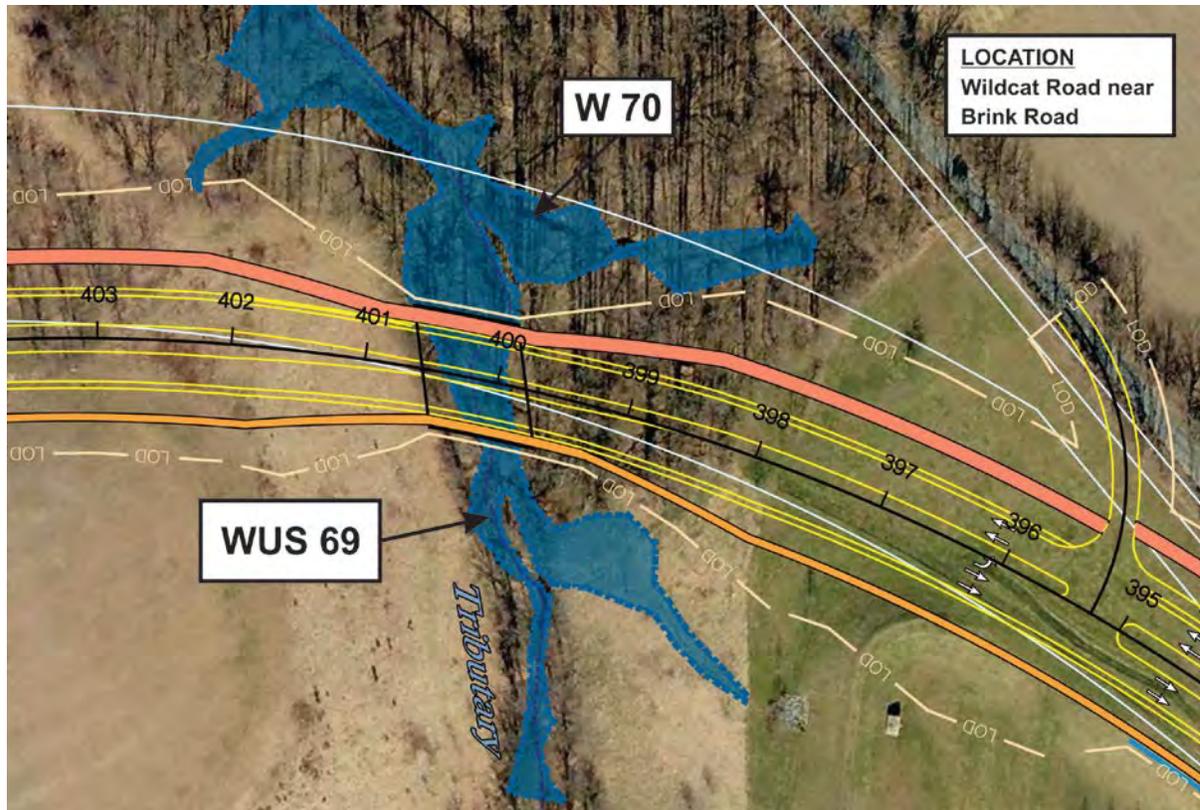
**Figure 5-21: Location WUS 69, W70**

proposed at this location would avoid wetland fill impacts. Wetland conversion impacts of 4,175 SF (0.10 acre) would occur with a proposed bridge. However, based on the July, 2012 field reconnaissance, this feature may no longer be considered a jurisdictional wetland. Following a public hearing, W70 will be revisited with USACE to determine whether W70 continues to be a jurisdictional wetland. If not, the structure type and size will be re-evaluated, since a bridge would not be necessary for wetland avoidance, and fish and wildlife habitat are not sufficient to warrant a bridge for passage.

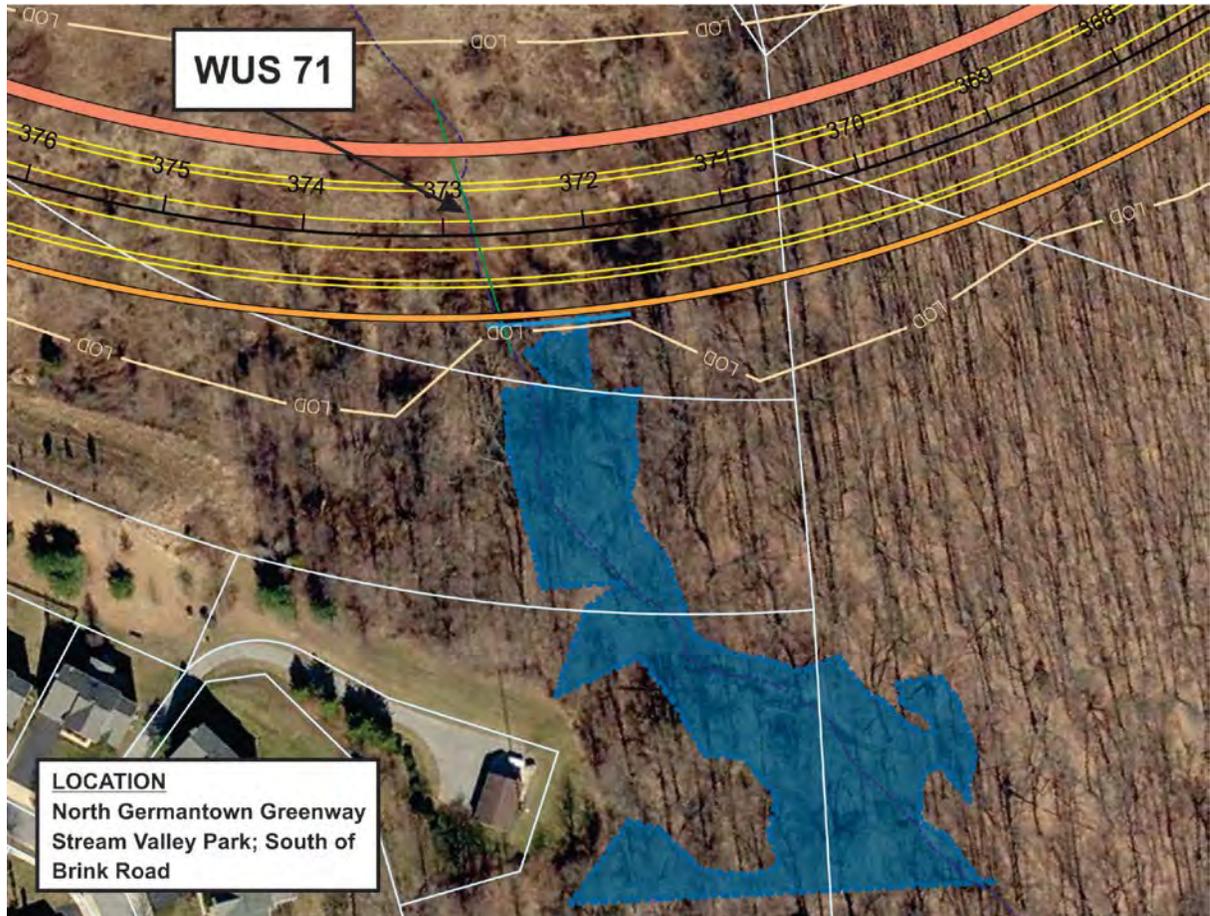
**Figure 5-22: Location WUS 71**

steep slopes along the tributary. Due to the ephemeral nature of the channel, the feature does not provide aquatic habitat, and fish passage is unnecessary. The alignment was adjusted in this area to avoid the forested wetlands abutting WUS 71. Stream impacts here total 229 LF.

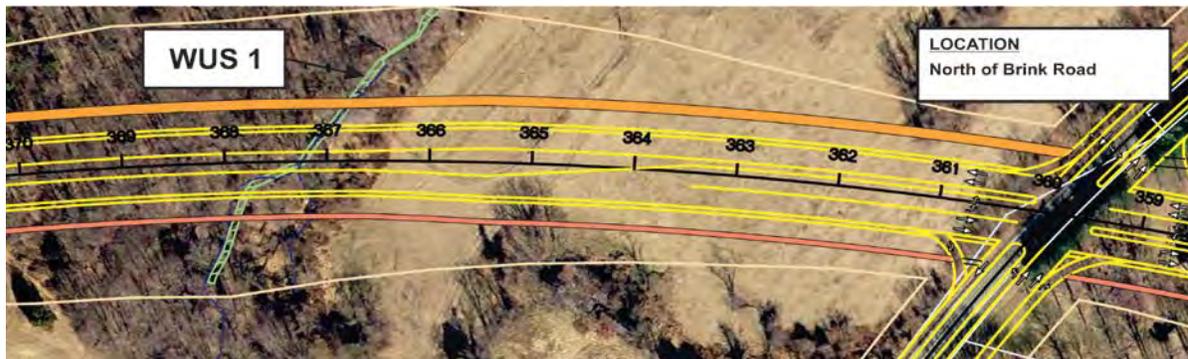
**Figure 5-23: Location WUS 1**

(*Juniperus virginiana*), black cherry, common greenbrier, grape vine, and Christmas fern (*Polystichum acrostichoides*). Observed indicators of the ordinary high water mark include the presence of litter and debris, sediment sorting, and sediment deposition. Feature WUS 1 is a jurisdictional waterway since it is a Relatively Permanent Water (RPW) with abutting wetlands and flows into Great Seneca Creek, a TNW. Stream Waders collected benthic macro-invertebrate samples at a site (860-3-2001) downstream of Feature WUS 1 in 2001. The site had a total of 14 macro-invertebrate families with 10 EPT taxa and 3 dipterans, resulting in a Fair IBI score of 3.00. Ephemeropterans made up 43% of the macro-invertebrates in the sample, indicating healthy stream conditions. Pipe culverts that can accommodate fish passage are necessary at this location due to the high quality habitat available upstream of the proposed alignment. Stream impacts total 229 LF in this area.

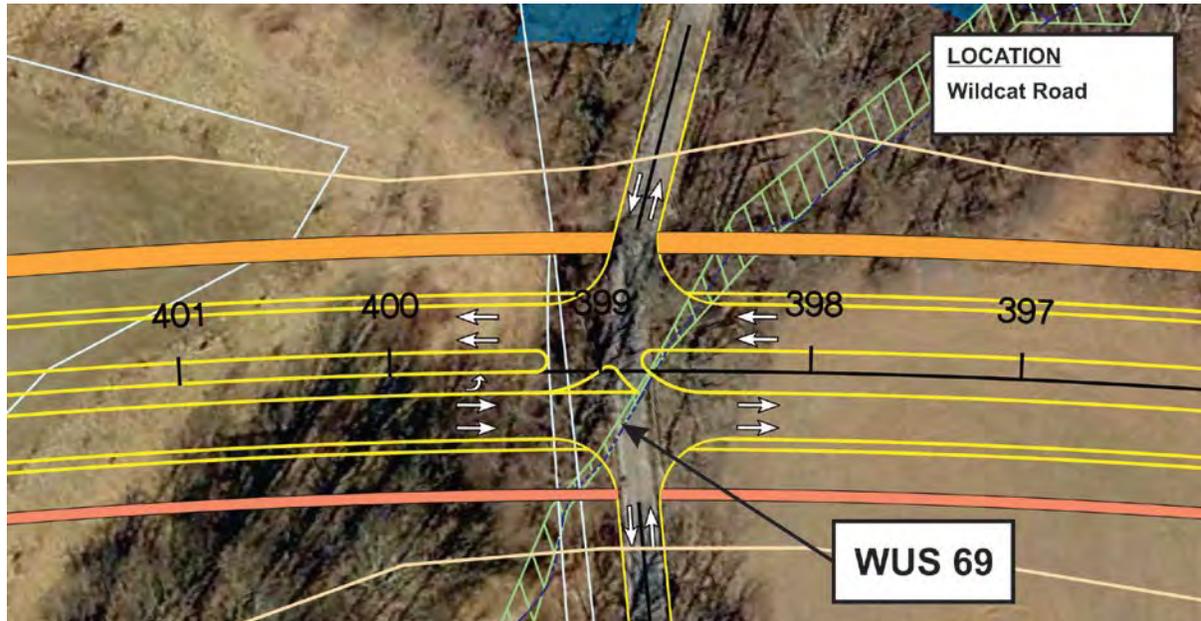
**Figure 5-24: Location WUS 69**

Under Option D, WUS 69 Wildcat Branch Tributary (previously described), would be impacted at a location approximately 900 feet downstream of the crossing proposed under Option A (see **Figure 5-24**). At this location, Wildcat Branch Tributary is currently piped to convey the stream under Wildcat Road. Option D would form an at-grade intersection with Wildcat Road, necessitating the replacement of the existing pipe with a new culvert that would be 165 feet longer.

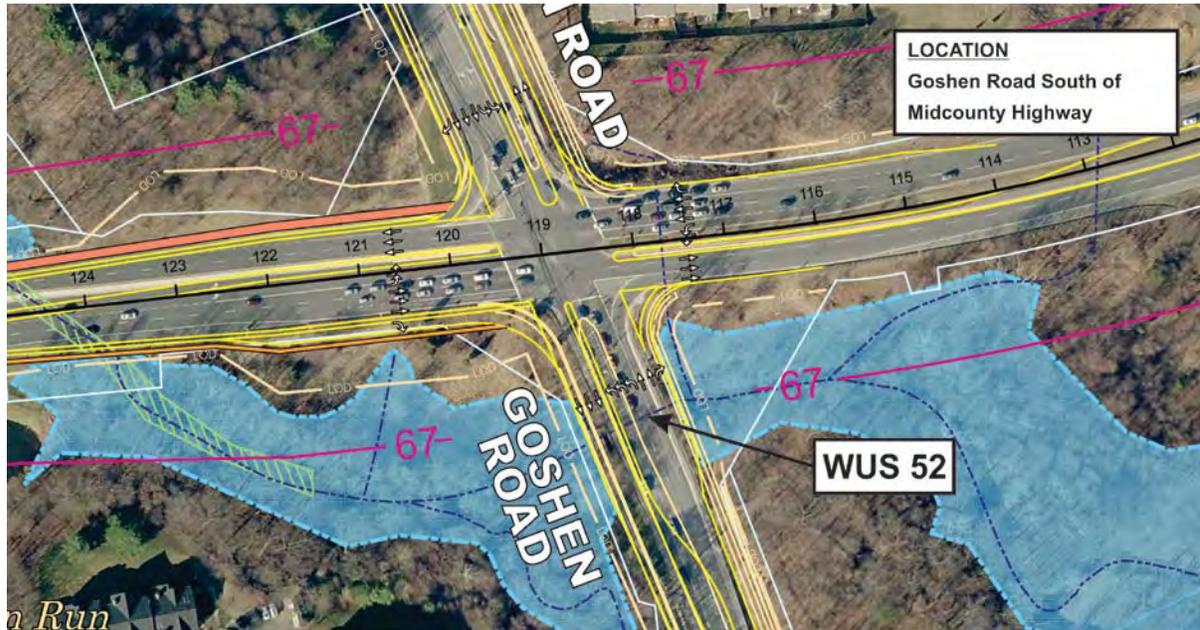
**Figure 5-26: Location WUS 52 under Goshen Road**

WUS 52, (upper Whetstone Run), is located approximately one mile upstream of the previously described Whetstone Run, WUS 53. WUS 52 is classified as an RPW by USACE and is conveyed in a series of pipe culverts under existing Midcounty Highway at Sta 124+50 (see **Figure 5-25**) and under Goshen Road (see **Figure 5-26**). The stream width varies from 10 to 20 feet at Midcounty Highway and 20 to 25 feet at Goshen Road, with an average channel depth of 1 to 3 feet. Normal flow appears to be contained within the channel and observed ordinary high water marks include matted vegetation, disturbed leaf litter, sediment deposition, water staining, presence of litter and debris and wrack line, and scour. Dominant plants in WUS 52 include sycamore, black willow, boxelder, and Japanese stiltgrass. DNR's Maryland Biological Stream Survey collected benthic macro-invertebrate and fish samples from a site (SENE-113-R-2001) upstream of Feature WUS 52 in 2001. The site had a total of 15 macro-invertebrate families, with 2 EPT taxa and 9 Diptera taxa, resulting in a poor IBI score of 1.50. EPT taxa made up only 2.3% of the macro-invertebrates in the sample, indicating unhealthy stream conditions. The site also received a poor fish IBI score of 2.00, with only 4 tolerant fish species. Despite the upstream site's poor IBI scores, the stream still provides adequate habitat for fish and macro-invertebrates due to its perennial flow and stable instream habitat. Fish passage is recommended at the culverts due to the available aquatic habitat upstream of the proposed alignment. If a decision is made during final design to replace the existing pipes, the new culvert would employ measures to facilitate fish passage through the conveyance. High headwalls would be employed to limit the stream impact. The length of impact is estimated to be 10 LF for the construction of new headwalls at Midcounty Highway and 60 LF for the Goshen Road widening.
