## 5. Natural Resources

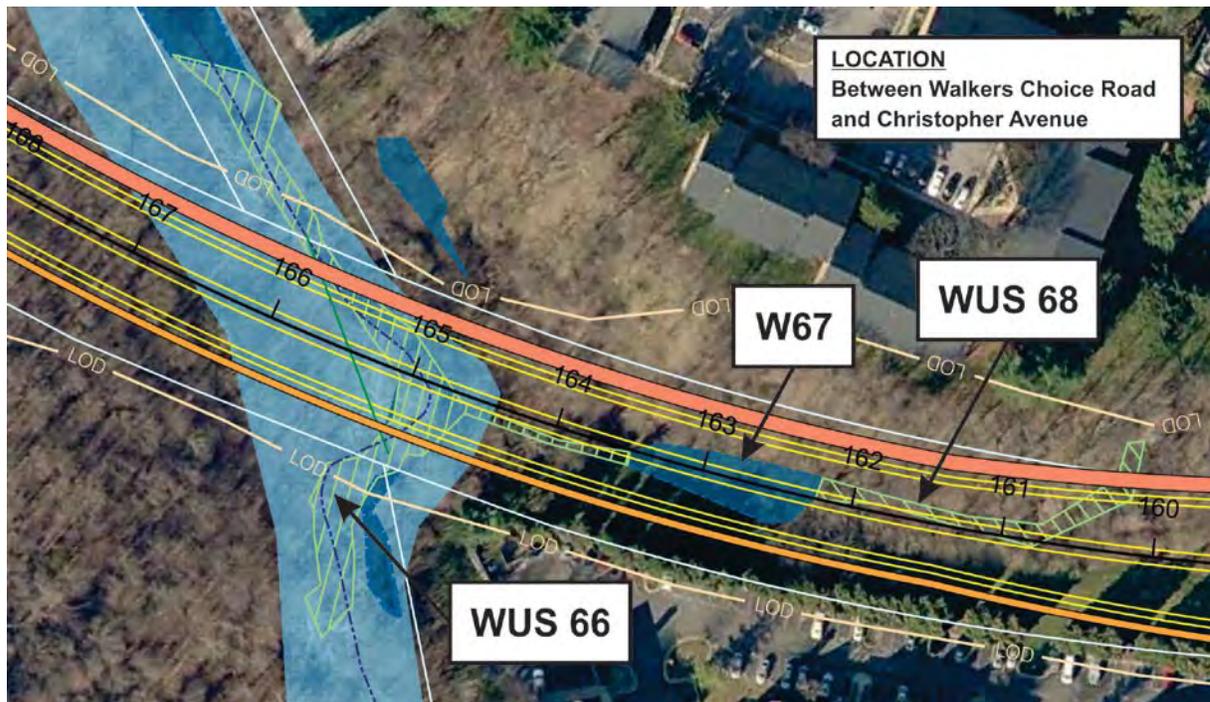
**Figure 5-27: Location WUS 66, W67, WUS 68**

Feature WUS 66, Walkers Run, is a perennial stream and a tributary to Whetstone Run within the Middle Great Seneca Creek Watershed (see **Figure 5-27**). The channel has a natural channel shape is 10 to 15 feet wide, water depth of 2 to 10 inches, with moderate erosion in some areas. Channel side slopes are approximately 3:1 and channel substrate includes sands, gravel, cobble, and riprap. WUS 66 is buffered by a riparian forest dominated by sycamore, box elder, flowering dogwood, grape vine, and multiflora rose. Observed indicators of the ordinary high water mark include sediment deposition, the presence of litter and debris, vegetation matted down, bent, or absent, leaf litter disturbed, destruction of terrestrial vegetation, and scour. Feature WUS 66 is a jurisdictional waterway since it is a Relatively Permanent Water (RPW) with adjacent wetlands and flows into Whetstone Run. There are no DNR or MCDEP biological monitoring records for Walkers Run. The feature provides poor, yet adequate habitat for fish and benthic macro-invertebrates due to its perennial flow and the presence of riffle-pool sequences. Fish passage at the feature is recommended due to the available aquatic habitat upstream of the proposed alignment. The crossing of Walkers Run and its floodplain (Sta 164+50 to 166+50) would be accomplished with a new culvert, using high headwalls to limit the culvert to 150 feet in length. The hydraulic opening of the culvert would be somewhat larger than the 8-foot diameter culvert located immediately upstream under Christopher Avenue. Including the impact associated with construction of the headwalls, Waters of the U.S. impacts at this location would total 186 LF.
