Stormwater Engineering Evaluation – 2016

EA Project No. 14982.01

Topic: Stormwater Engineering Evaluation
Gude Landfill, Montgomery County
Author: William Brooks, P.E., LEED AP BD+C
Date: 4 April 2016

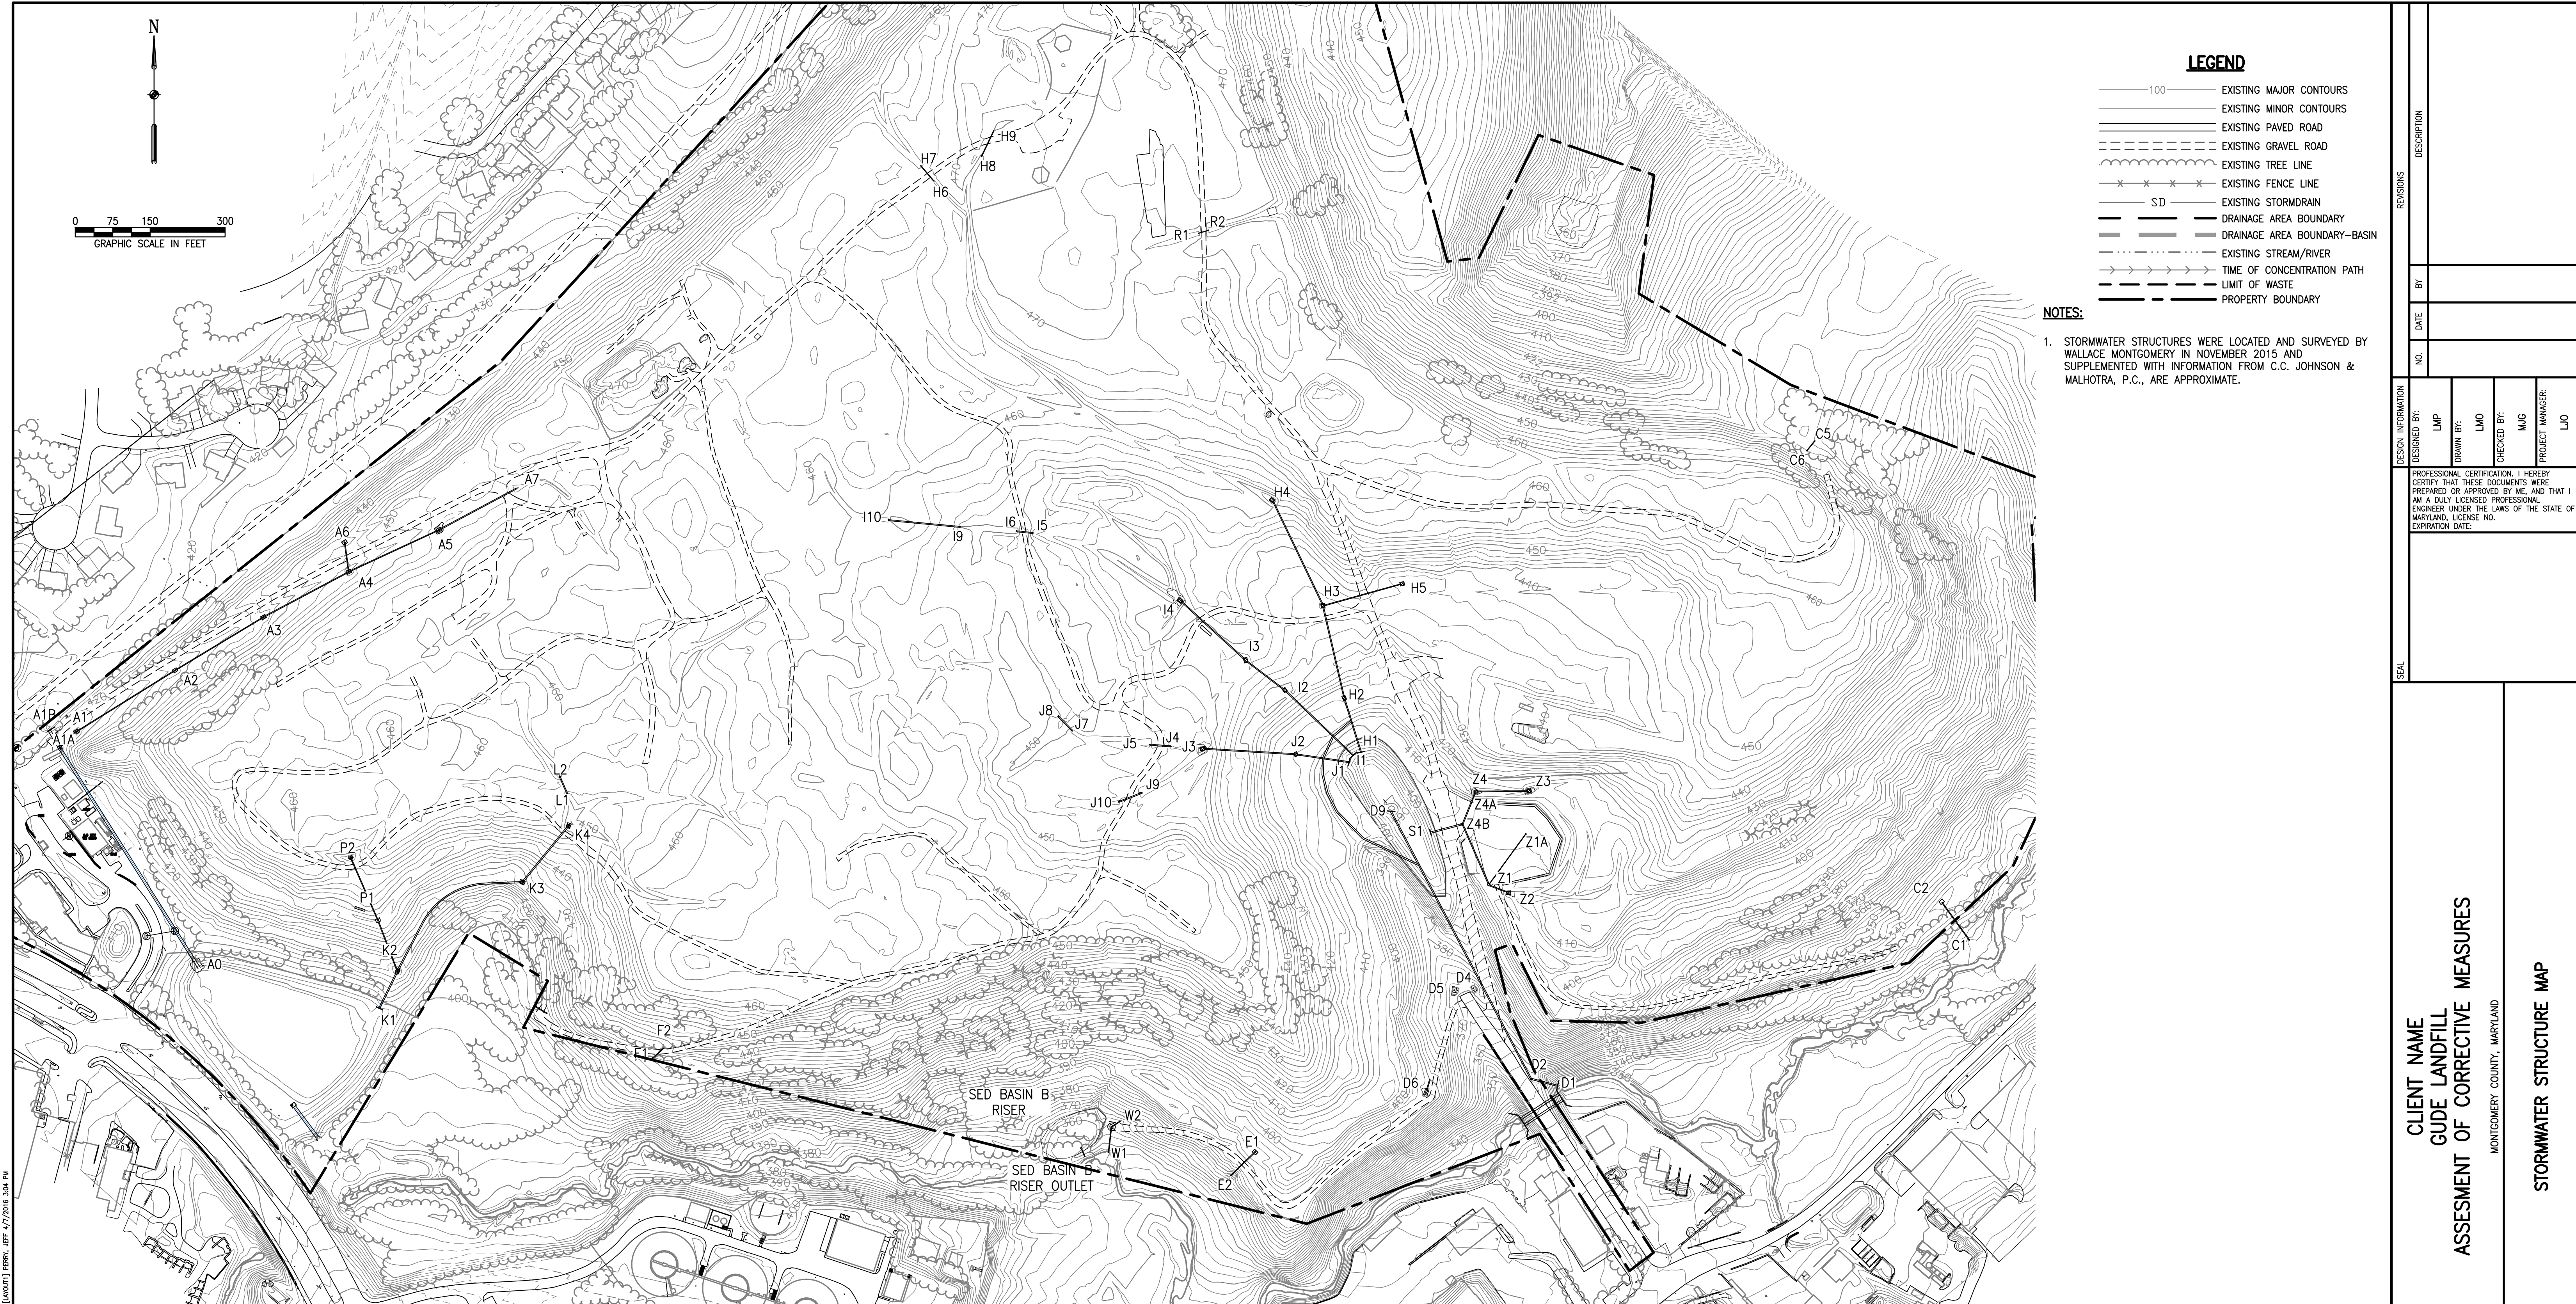
Figure 2: Stormwater Structure Map

As part of the NES, EA performed a condition assessment of the existing site stormwater management infrastructure. As part of the condition assessment, EA created a pre-inspection inventory list of existing site stormwater management infrastructure, which identified more than ninety (90) stormwater management devices from the SCS documents. The inventory included swales, berms, inlet structures, outlet structures, culverts, detention ponds, and sediment basins. During the November 2015 field survey, updated stormwater management infrastructure elevations were obtained. EA utilized this information in addition to the 2015 topographic survey information for hydrologic and hydraulic analysis.

Based on the 2015 survey information, the majority of the storm drain network has settled at approximately the same rate as the surrounding grade. However, the storm drain pipe A6 to A4 has experienced differential settlement which has now resulted in the pipe having a negative slope.

Structures A6 and A4, as well as the eighteen (18) inch high-density polyethylene pipe, have settled such that the pipe does not provide a positive slope for drainage. The structures and pipe should be removed and replaced back to the original design slope as well as minimum surface cover. These two structures should be assessed at least annually (e.g., spring) to determine if additional differential settlement has occurred, and if so assess potential solutions. In addition, the County should continue to perform a semiannual inspection of the visible structures to determine if debris or other impediments may be present to dampen the conveyance of runoff through the storm drain.

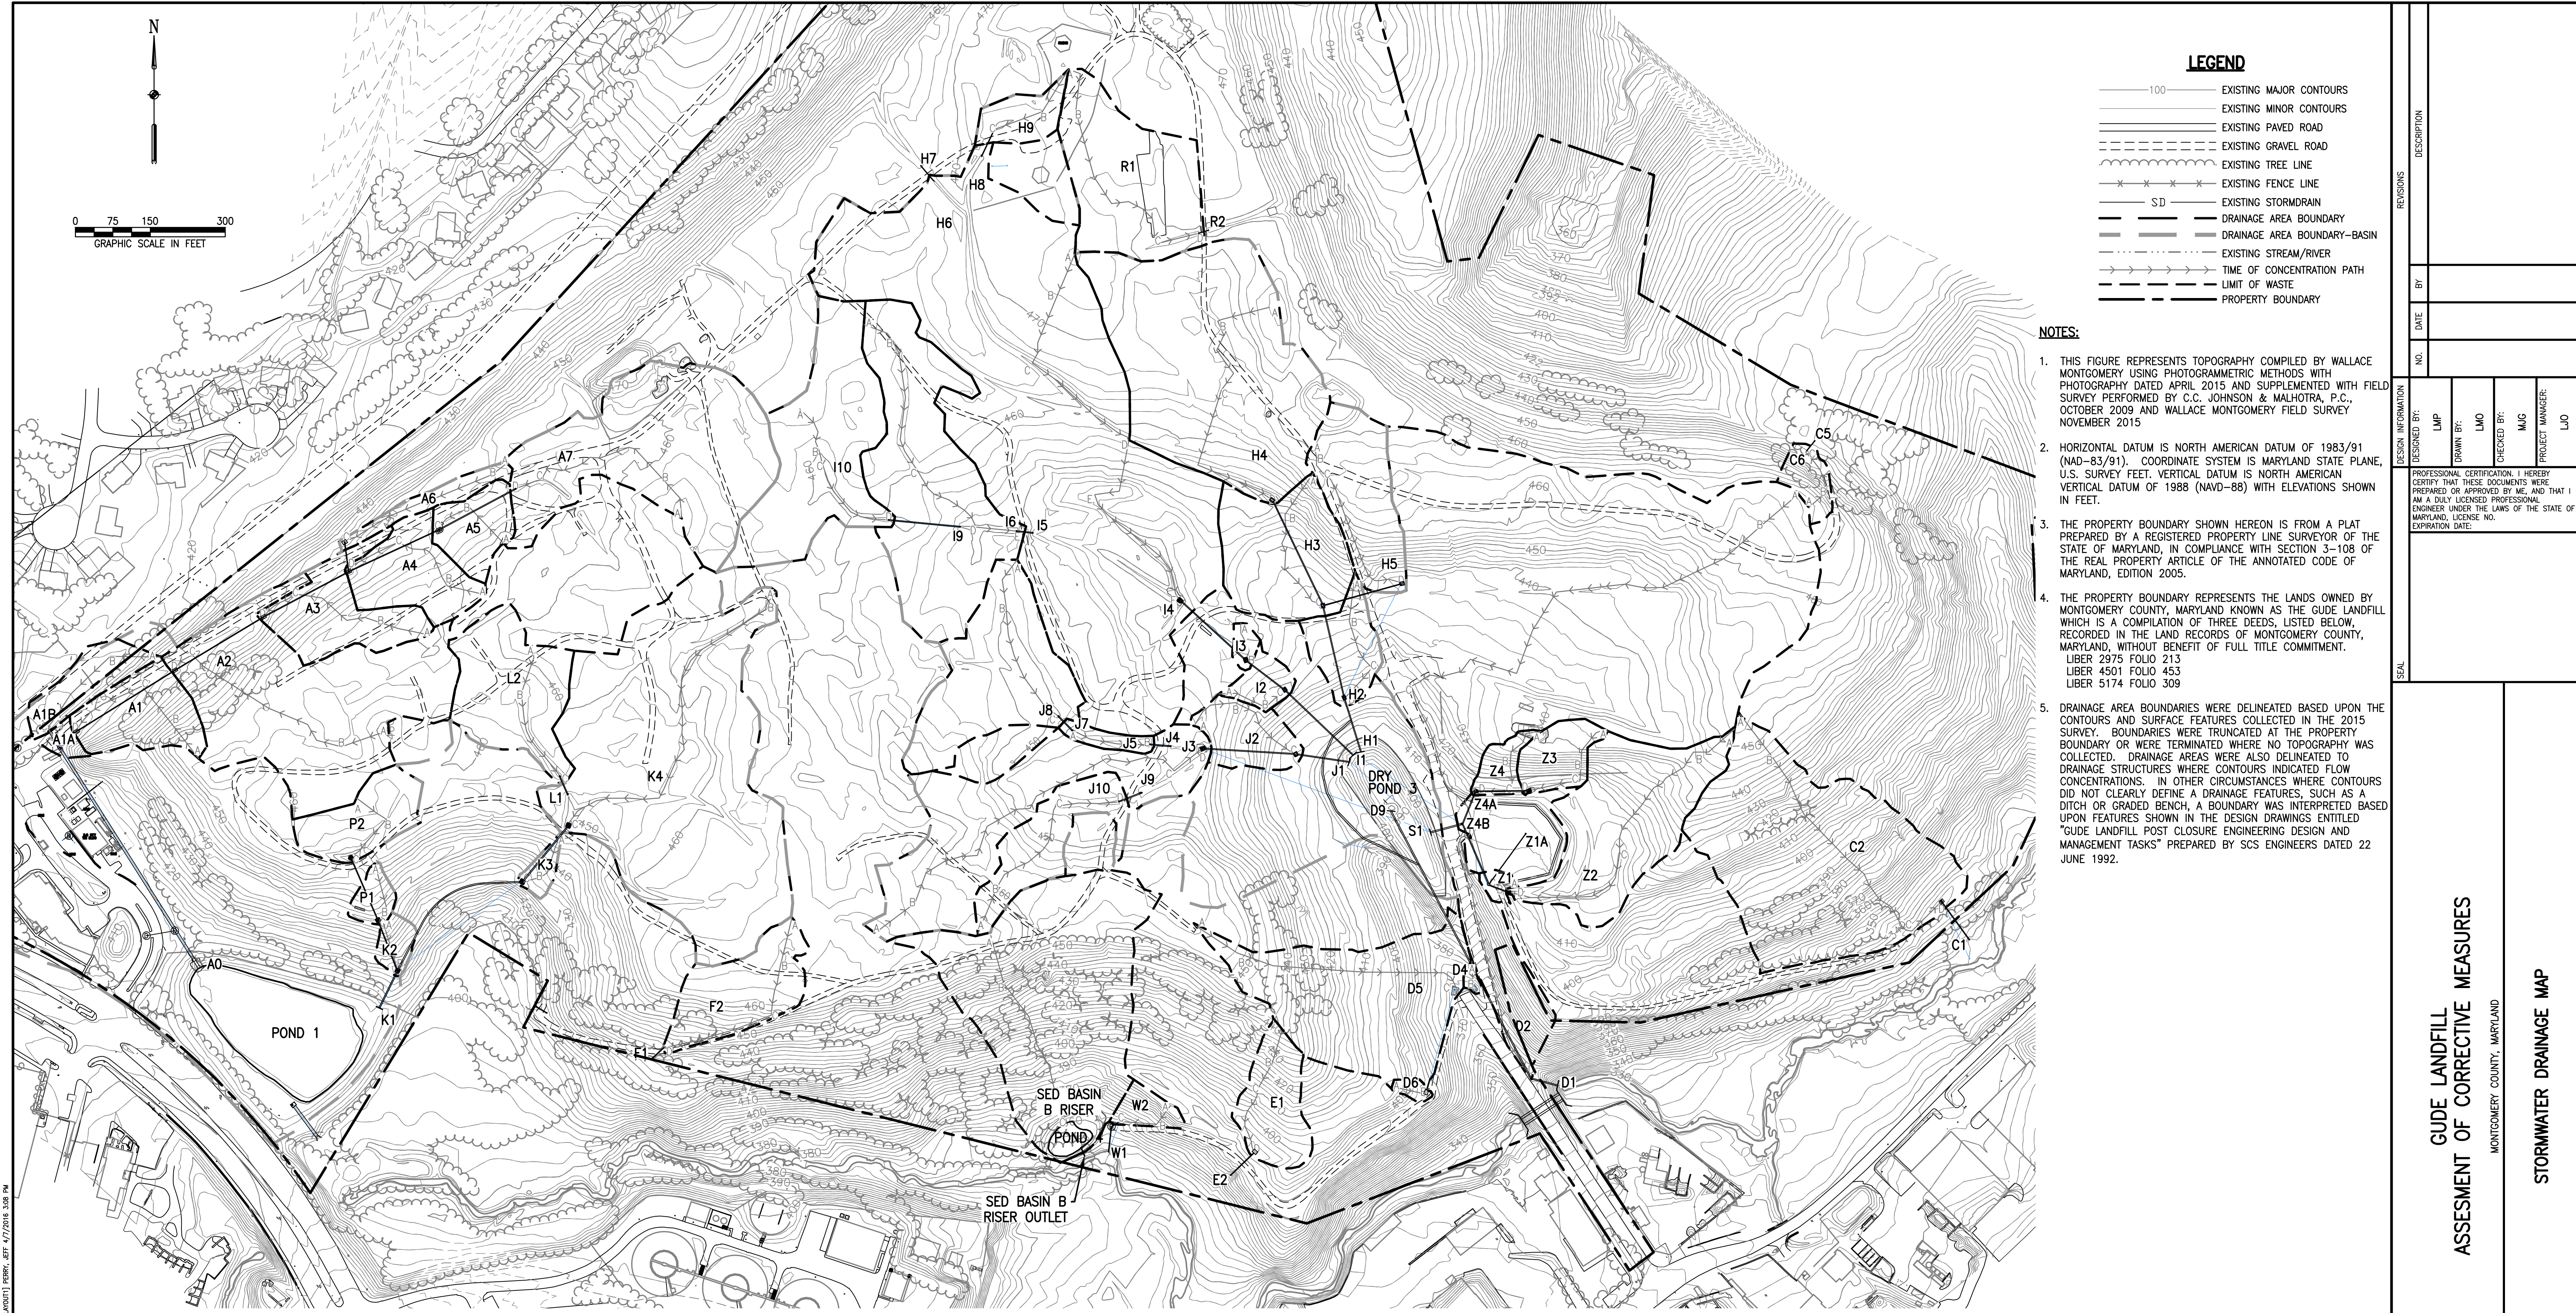
Figure 3: Stormwater Drainage Area Map

EA developed a drainage area map (Figure 3) indicating drainage area boundaries to stormwater management infrastructure based upon the 2015 topographic survey and field run information. These boundaries indicate the catchment areas and flow directions for surface runoff from the cap. The drainage area boundaries were delineated based upon the updated contours and surface features collected in the 2015 survey. Boundaries were truncated at the property boundary or were terminated where no topography was collected. In other circumstances where contours did not clearly define a drainage feature, such as a ditch or graded bench, a boundary was interpreted based upon features shown in the design drawings entitled “Gude Landfill Post Closure Engineering Design and Management Tasks” prepared by SCS Engineers and dated 22 June 1992. Some drainage areas on the cap are captured and conveyed by storm drains that then discharge further downgradient at the Landfill perimeter or into another drainage area.

EA utilized HydroCAD (version 10) to prepare a hydrologic and hydraulic analysis on the runoff to storm drain structures. Peak discharges to structures and pipe capacities were determined. No pond or basin routing was performed. Based on MDE requirements, the design rainfall event analyzed was the twenty-five (25) year, twenty-four (24) hour storm event (six and two one-hundredths [6.02] inches). For the purposes of preparing the hydrologic model, it was assumed all soils would respond to runoff similar to an HSG D. This assumption is supported by the double ring infiltration analysis by Soil and Land Use Technology, Inc., which is included in the revised ACM. The drainage areas received by storm drain structures ranged from six one-hundredths (0.06) acres to eleven and ninety one-hundredths (11.90) acres. For the largest drainage area (eleven and ninety one-hundredths [11.90] acres) and a twenty-five (25) year, twenty-four (24) hour event, the maximum peak discharge rate was fifty-four and one-tenth (54.1) cubic feet per second (cfs) with a controlling discharge rate from the storm drain of approximately fifty-three and two-tenths (53.2) cfs. As a result, temporary ponding will occur at several structures during the rain event until such time the storm drain can convey the runoff. While the received peak discharge rate is greater than that which the storm drain can handle, the calculations show that any ponded water at the inlet will be fully conveyed within twenty-four (24) hours of the twenty-five (25) year rainfall event. For more frequent storms (e.g., one [1] and two [2] year events), the system will either convey the peak discharge rates during the storm event or convey the runoff in a shorter duration.

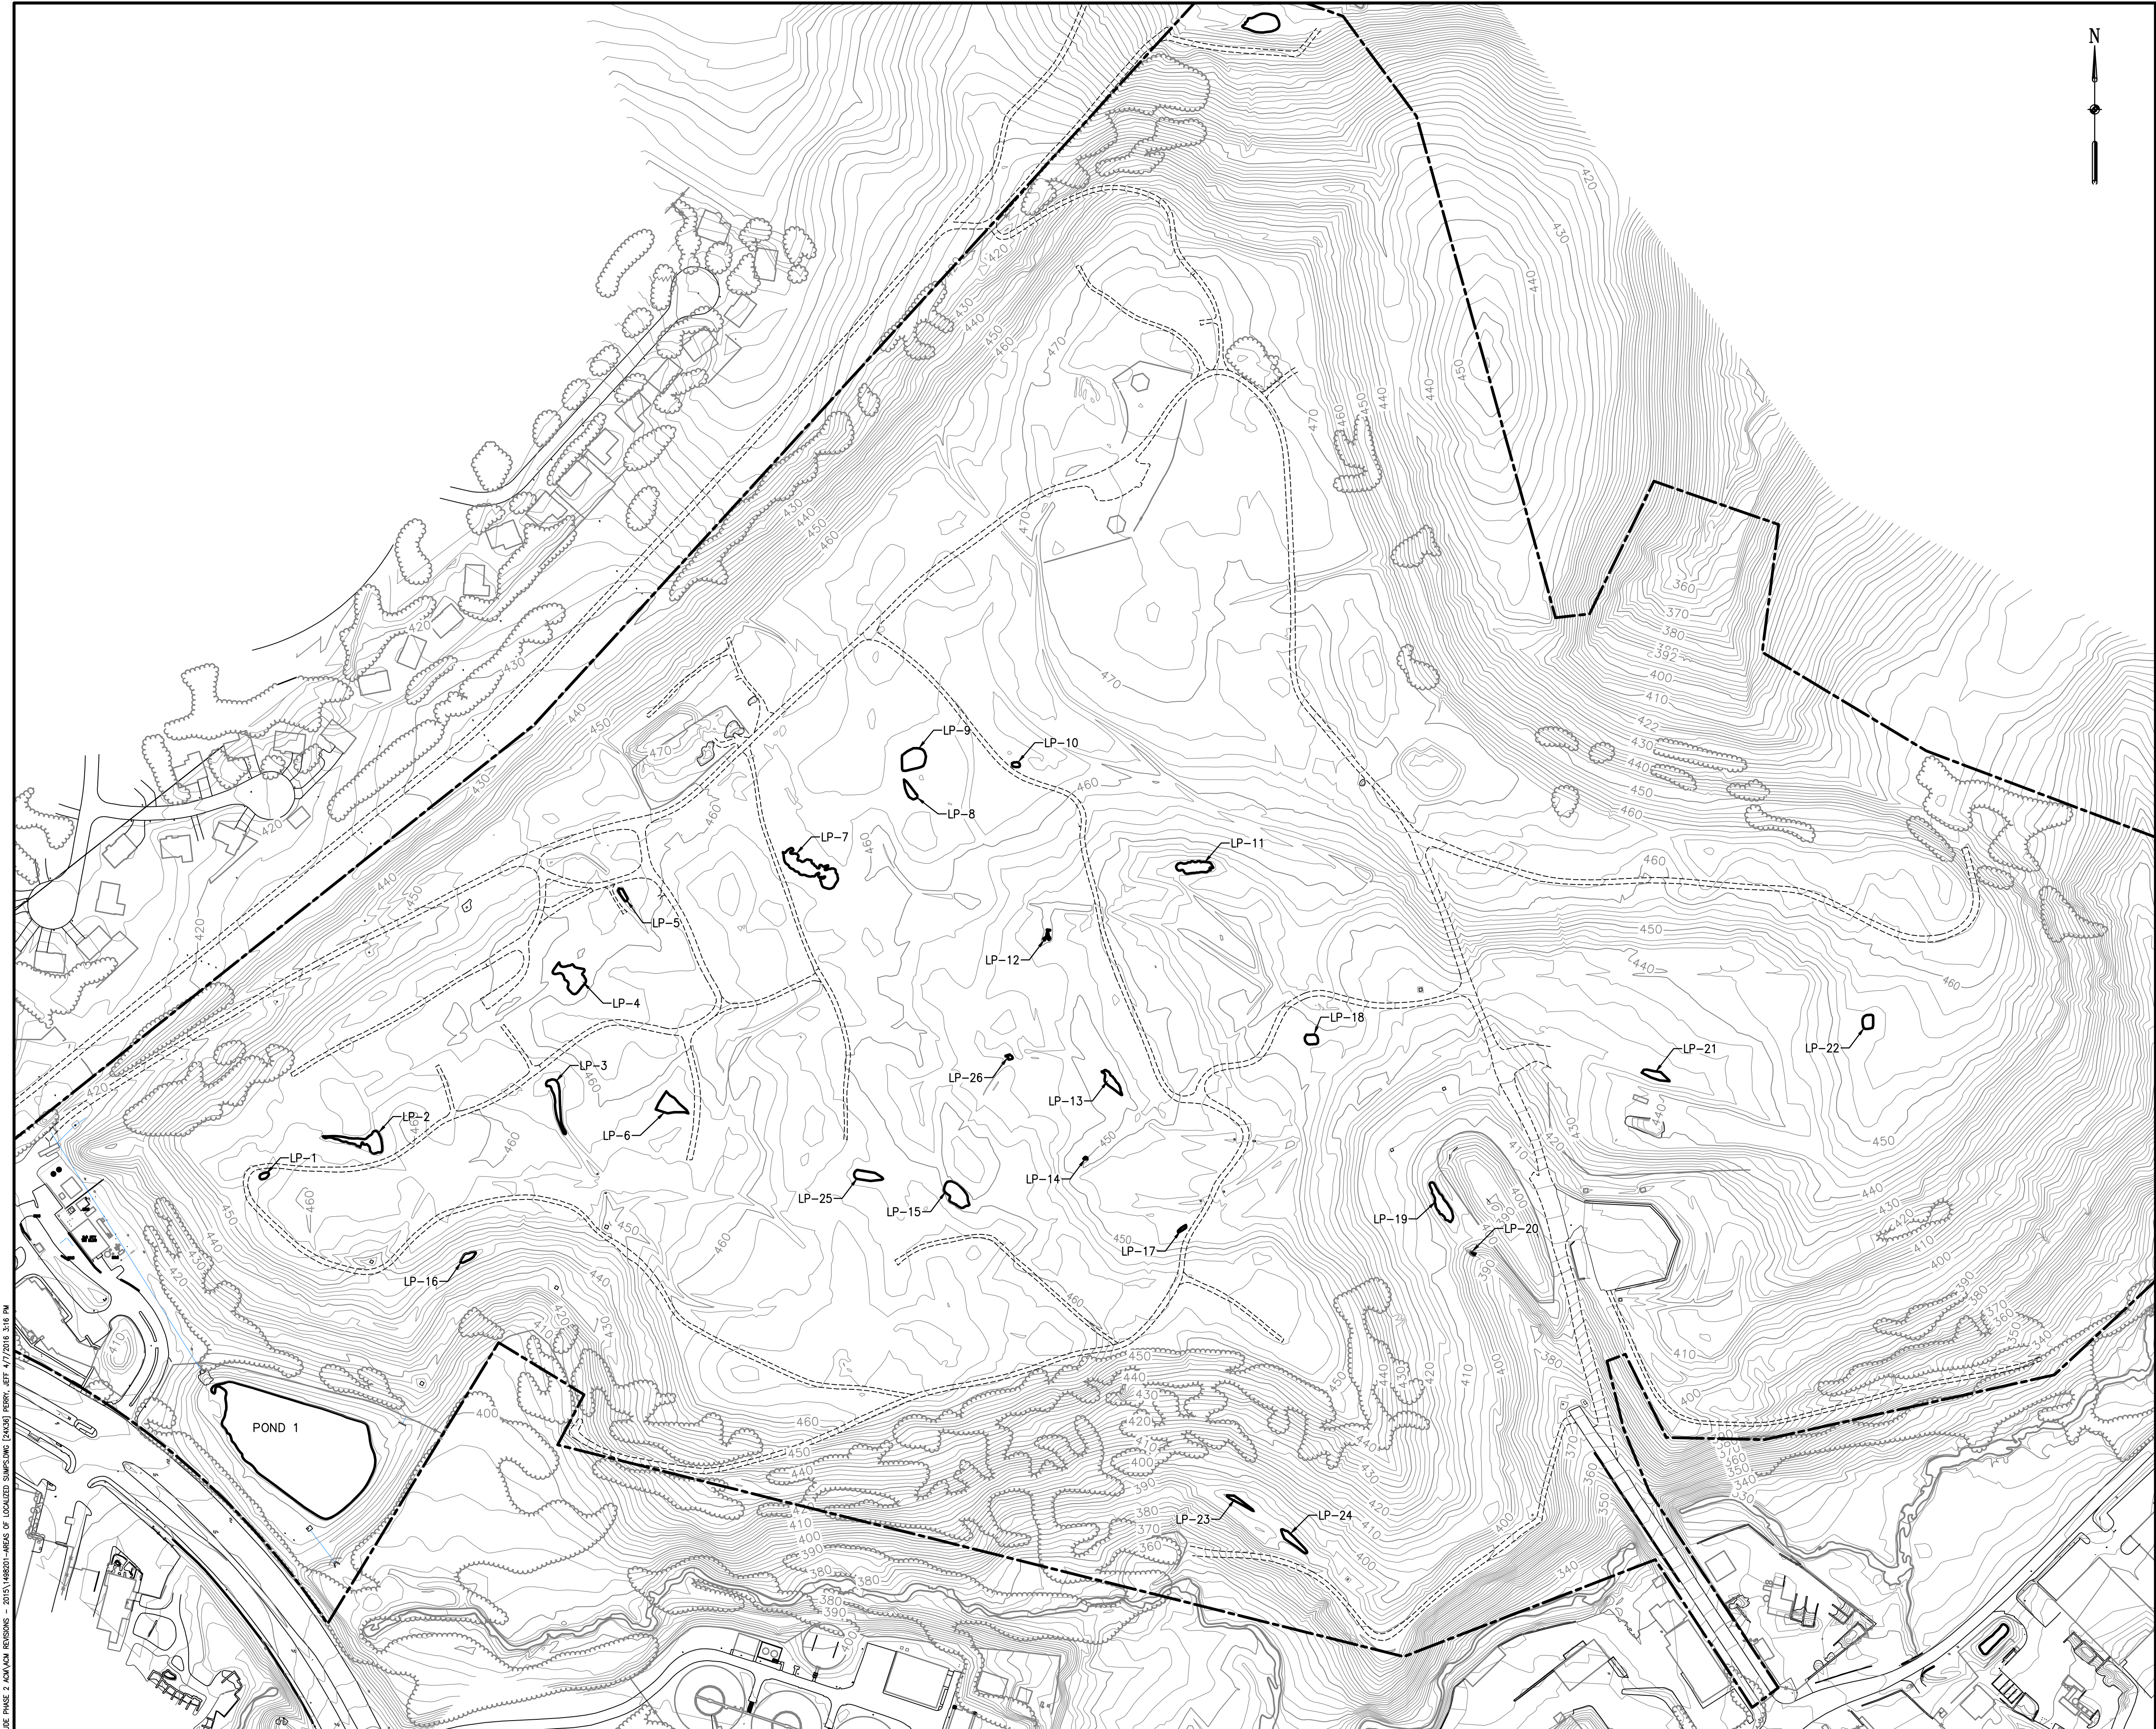
Figure 4: Areas of Localized Sumps

EA performed a comparison between the 2015 topography and the previously obtained 2009 topography. Since 2009, the Landfill has been subject to approximately one (1) to two (2) feet of settlement, with more or less in localized areas, and is shown in Figure 5. As a result of the settlement, there are currently twenty-six (26) localized low points where positive surface drainage is not maintained. These locations are shown in Figure 4 and listed in Table 1 with coordinate values in Maryland State Plane, North American Datum 1983 (NAD 83). The total area of these twenty-six (26) locations is approximately eighteen thousand six hundred sixty-two (18,662) square feet (SF).

Since 1984 the County DEP/DSWS has maintained a landfill maintenance contract to perform site repairs to the Landfill, which is required to correct surface depressions and the resulting ponding of water. Based on the analysis performed above, all localized low points should be filled with low permeability material to an elevation such that positive drainage and a smooth transition with surrounding grade is restored. These areas should be stabilized immediately to minimize erosion. Should it be determined necessary in the field, a pilot channel or minor swale could to be constructed to assist in conveying flow to the nearest storm drain structure. These areas subject to fill should be assessed at least annually in the spring to determine if additional differential settlement has occurred. If additional settlement is observed, additional fill will be warranted.
