**Gude Landfill
Nature and Extent Study Plan
Montgomery County, Maryland**

Department of Environmental Protection
Division of Solid Waste Services
Montgomery County, Maryland

EA Engineering, Science, and Technology, Inc.
15 Loveton Circle
Sparks, Maryland 21152
(410) 771-4950

July 2010

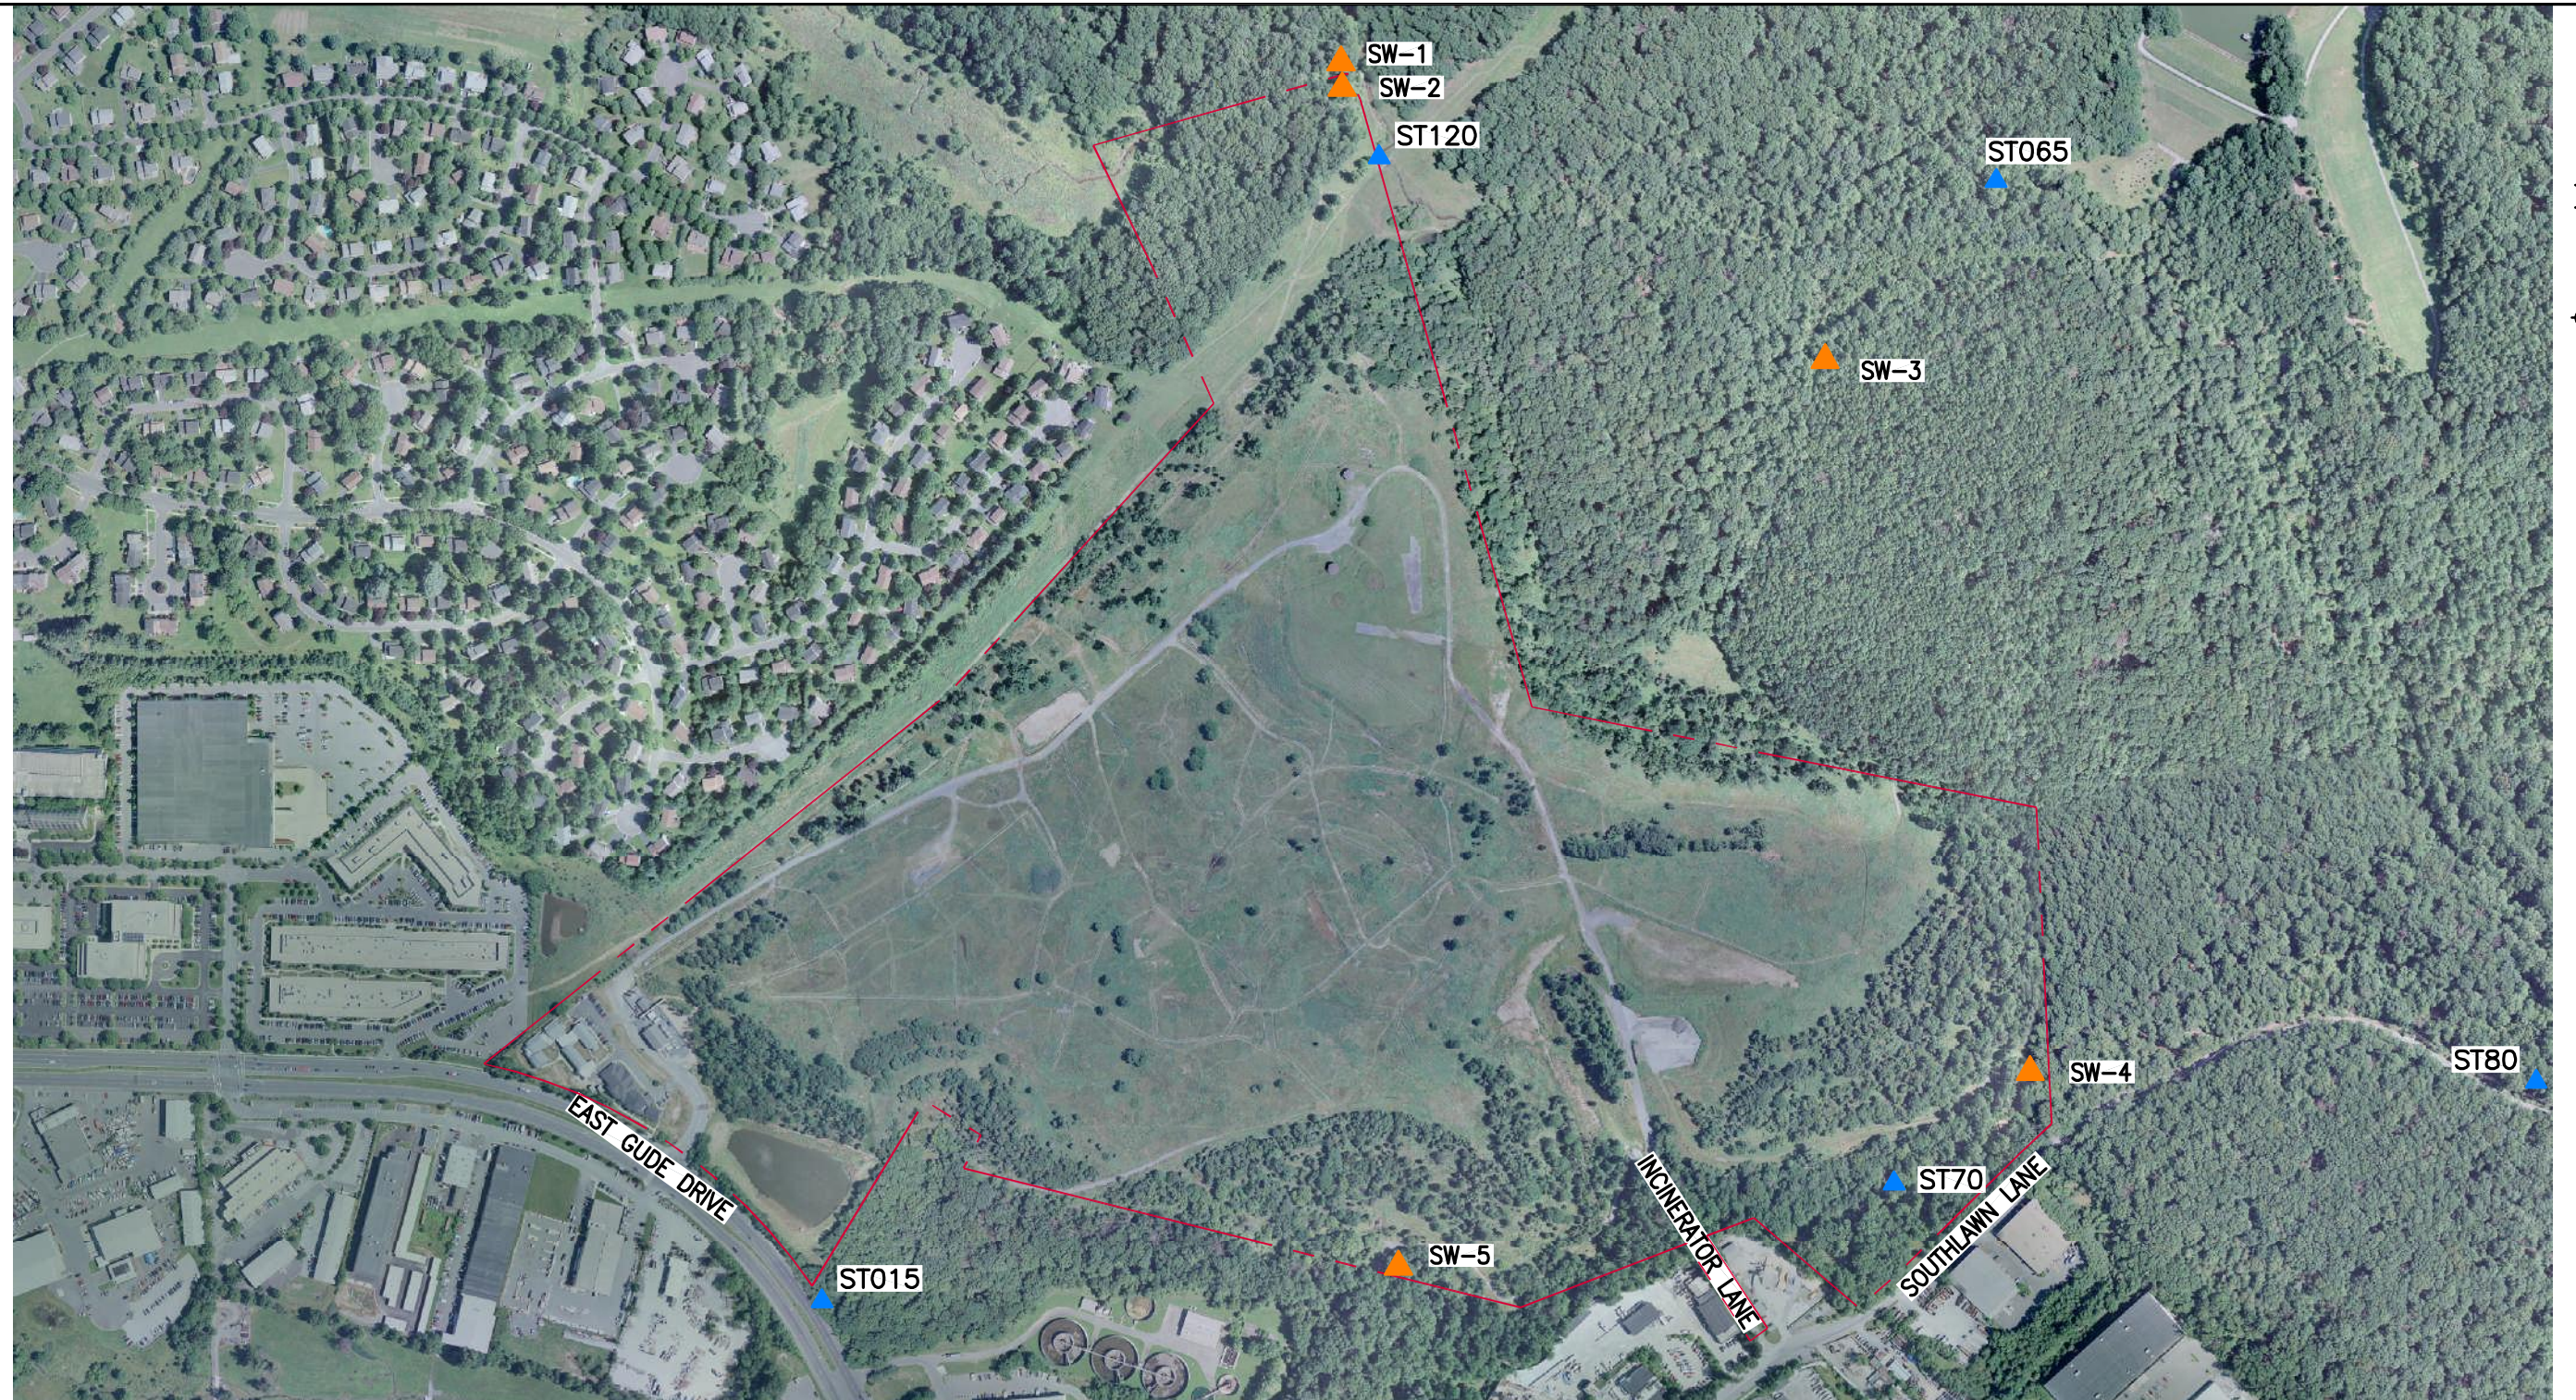
Figure 4-2
PROPOSED SURFACE WATER SAMPLING LOCATION MAP

Ten surface water samples, including five existing surface water sampling locations and five proposed surface water sampling locations, will be collected from offsite streams around the perimeter of the Landfill to monitor the water quality (Figure 4-2).

On 5 November 2009, EA conducted a field review of the five surface water sampling locations (ST015, ST065, ST070, ST080, and ST120). Photographs were taken of each location (Figure 4-2), and the sample location, including surface water flow direction, was described (Appendix F). Surface sampling locations were not previously marked; therefore, each location was staked and coordinates were recorded using a Trimble™ global positioning system (GPS) to ensure a consistent sampling location. Surface water is generally flowing from west to east toward Rock Creek.

The MCLs are criteria established by the U.S. EPA for protection of drinking water. These criteria have been used to determine the constituents of concern for this study. Historical data (2001-present) for the dissolved phase constituents for the five surface water sampling locations (Figure 4-2) are provided in Appendix D.
