Citizen's Forum

Gude Landfill Remediation

September 24, 2009

Keith Ligon, GLCC

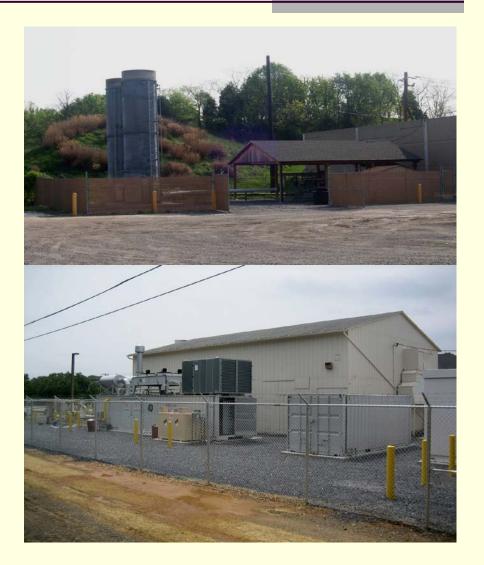
Gude Landfill Landfill Gas Collection System

- Landfill gas is produced as part of waste decomposition
 - Consists primarily of methane (CH₄) and carbon dioxide (CO₂)
 - Controlled via an active collection system (installed 1985) and burned at the Enclosed Flare Station (installed 2005)
 - 40 to 50 vertical extraction wells with horizontal above ground piping scattered around the site
 - 33 vertical gas extraction wells on the northwestern slope property boundary to control migration
 - Former landfill gas to energy power plant beneficially used landfill gas to generate electricity 1985 – 2006 (1.5 – 2.7 MW)
 - New Landfill Gas-to-Energy Facility Operational June 2009 (0.8 MW)

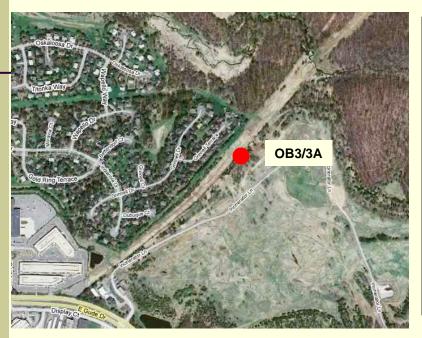
Groundwater Contamination

- Well OB-3/3A closest to Derwood houses
- OB-3 had 97 above EPA Drinking Water limits
- OB-3A had 68 above EPA Drinking Water Limits
- Observed chemicals are contaminants in EPA's Clean Water Act and on Hazardous Waste List

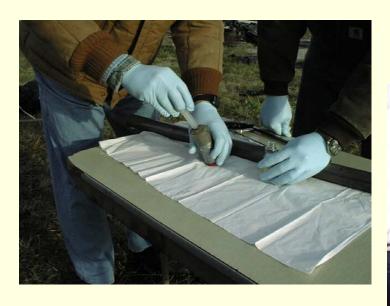
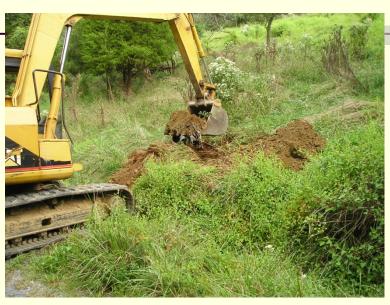
Soil Sampling

- Test pits
 - Soil borings
 - Surface Soil
 - Sediment

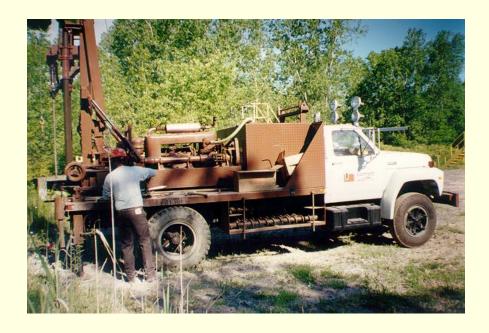
Install Monitoring Wells

- Determine stratigraphy
- Determine direction and velocity of groundwater flow
- Collect soil samples

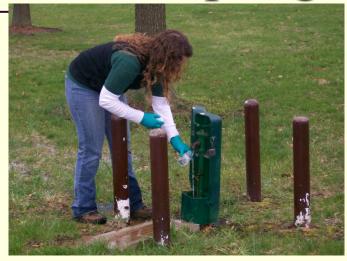
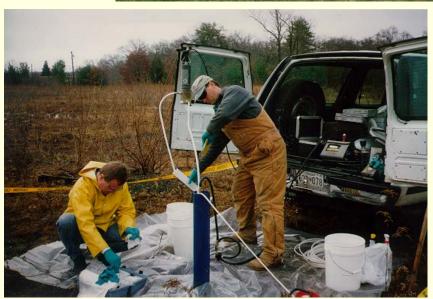
Groundwater Sampling

- Collect general groundwater parameters
- Collect samples for chemical analyses
- Determine groundwater levels and the presence of other non-aqueous fluids

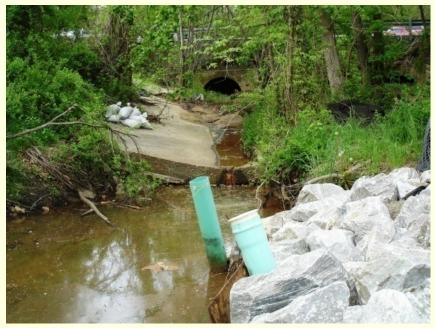
Surface Water Sampling

- Collect water quality parameters
- Collect samples for chemical analyses

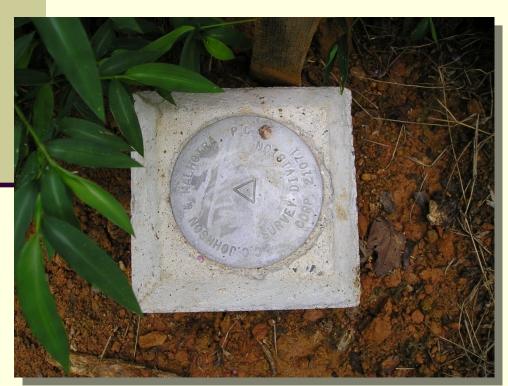
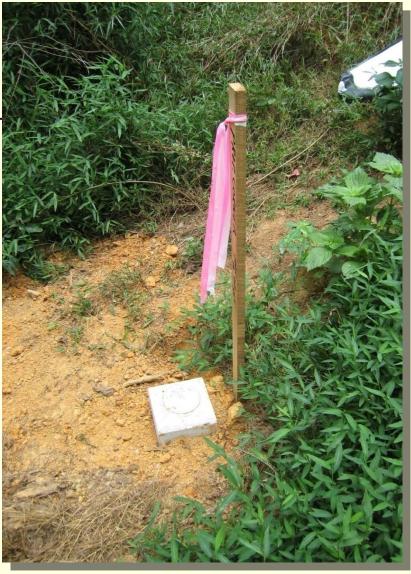
Surveying

- Locations
- © Elevations
- Reference to established datum
