Attachment A

Topographic Survey

TOPOGRAPHIC SURVEY GUDE LANDFILL	
 1" = 150'	
4th Election District	Montgomery County, MD
Sheet 1 of 1	Project No. 218007.0001
Drawn By: DBM	Checked By: EVC
Scale 1"=150'	Date January 30, 2019

Re: Report of Findings – Gude Landfill

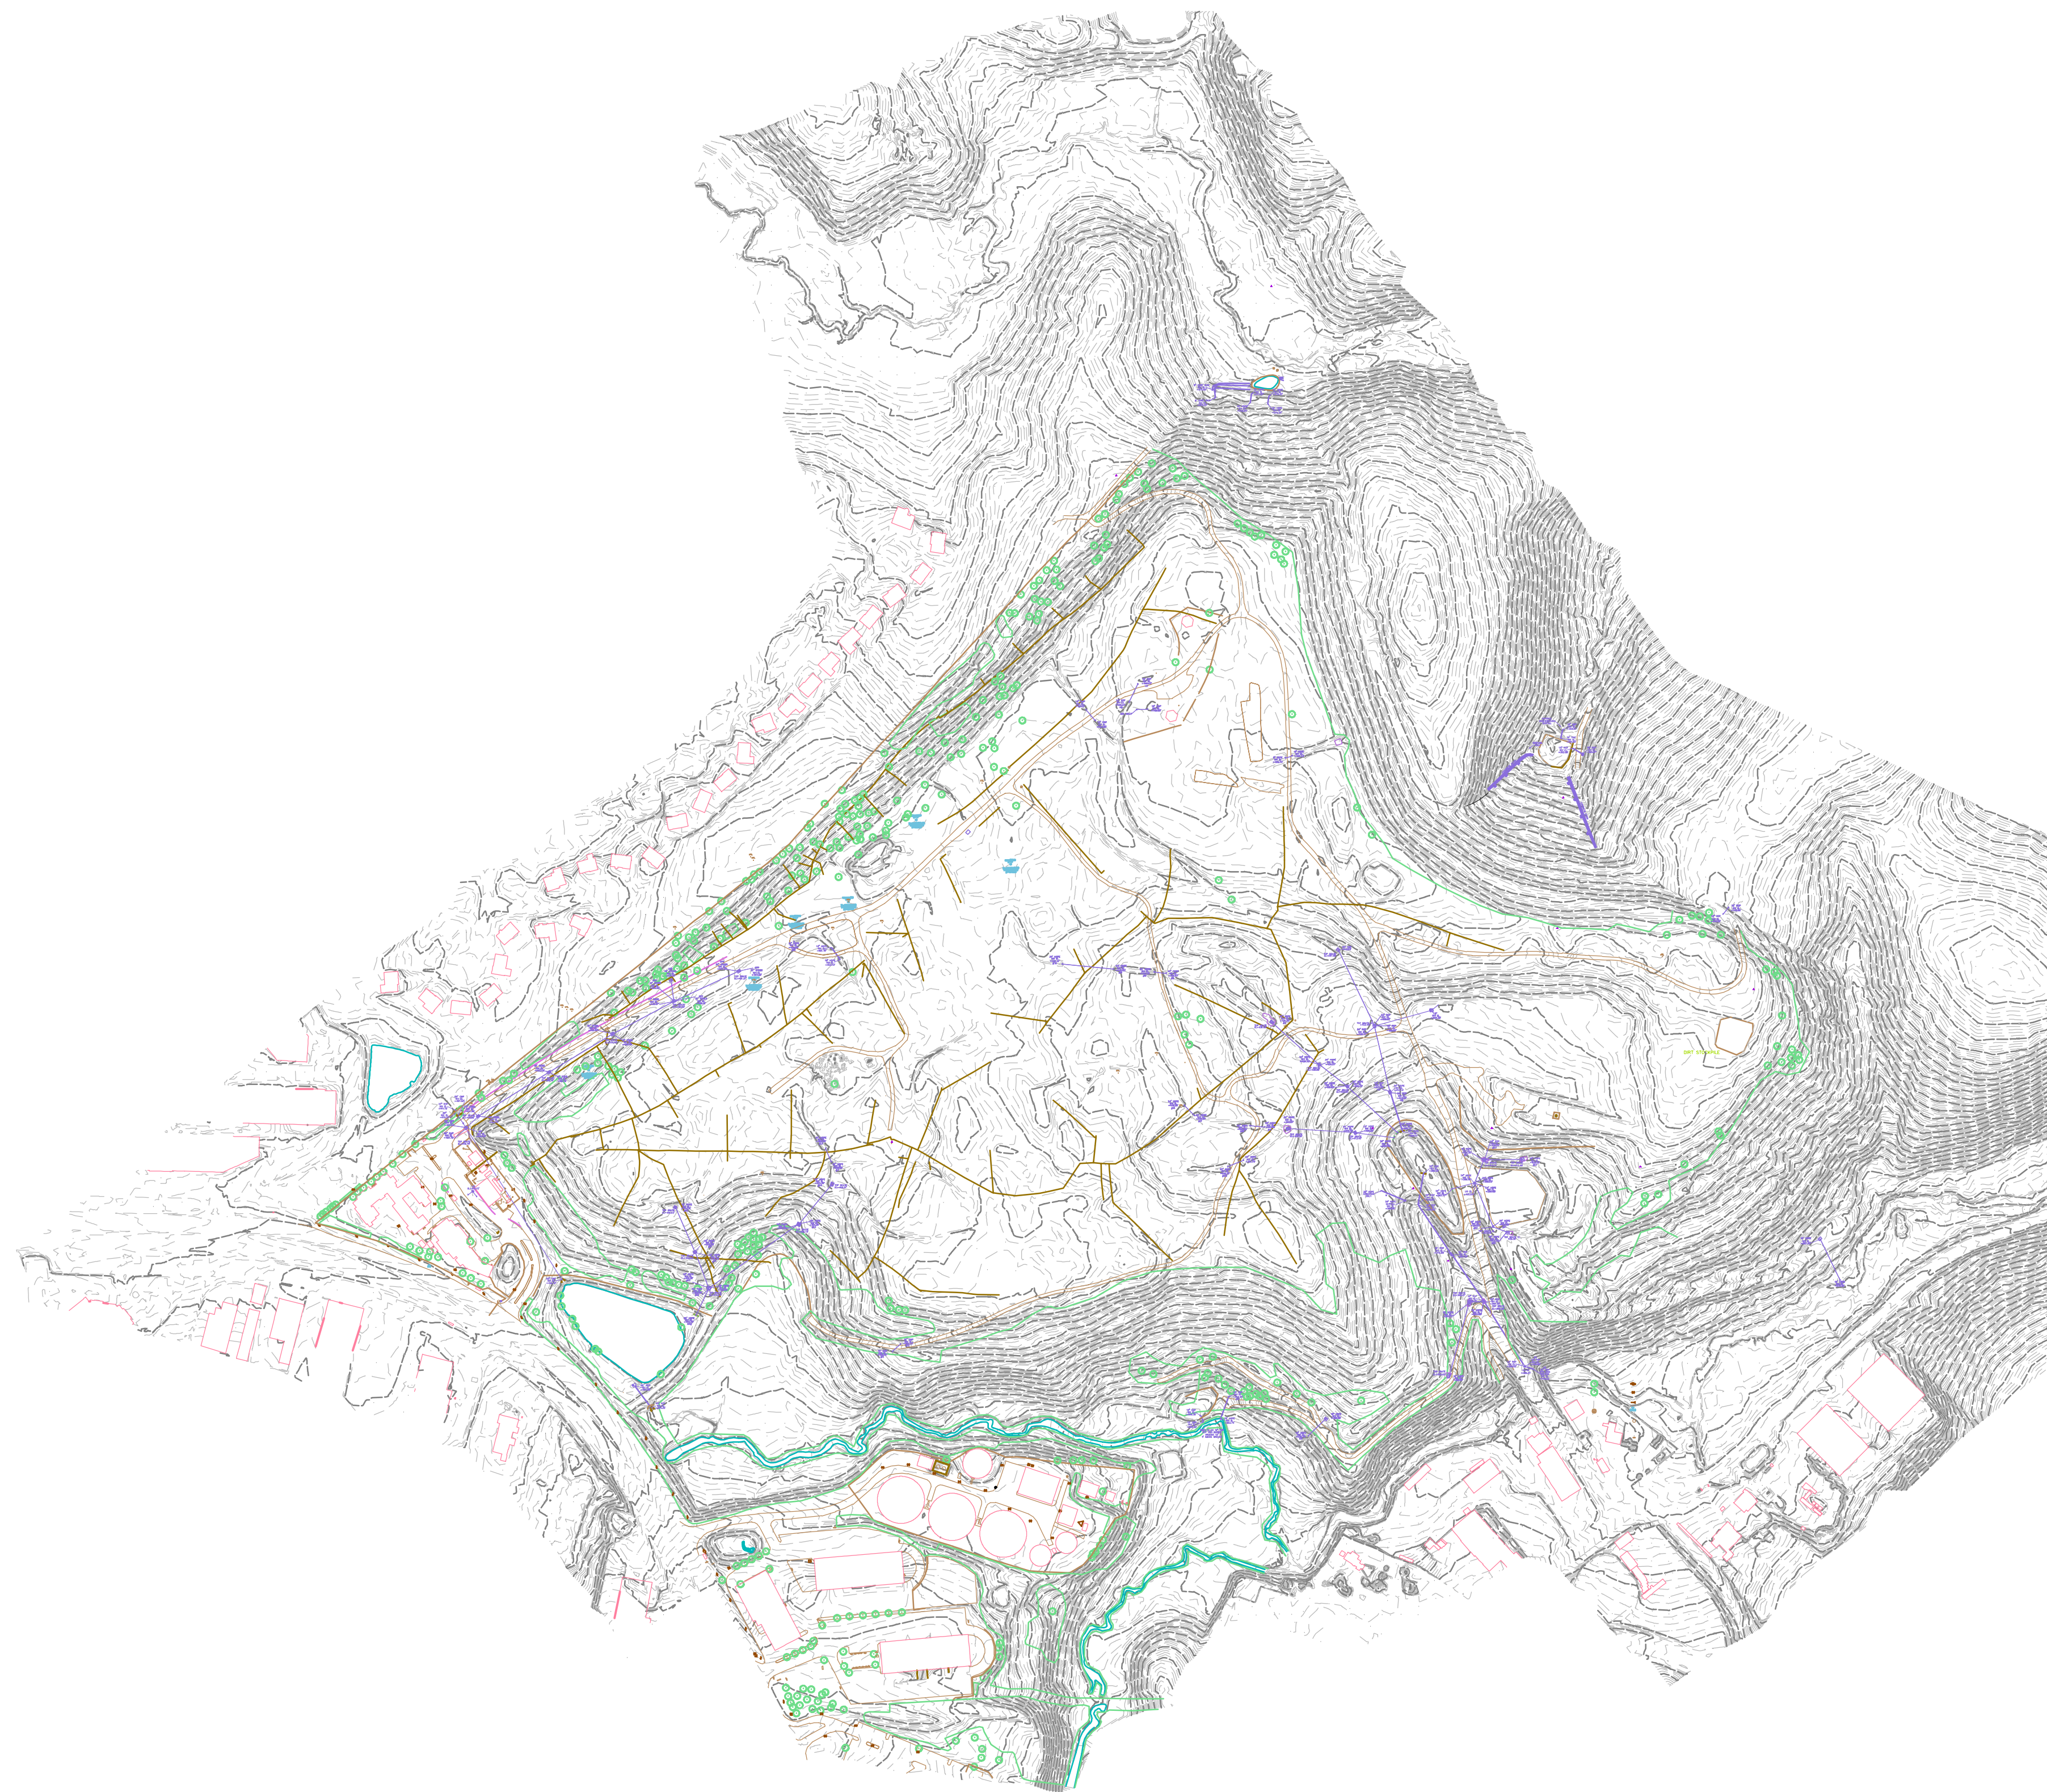
THE TOPOGRAPHICAL SURVEY SHOWN HEREON ARE AN INTERPRETATION OF PHOTOGRAMMETRY AND FIELD RUN SURVEYS COMPLETED ON JAN. 30, 2019, THE UNDERSIGNED WAS IN RESPONSIBLE CHARGE OF THE PREPARATION OF THIS MAP AND THE SURVEYING WORK REFLECTED IN IT. THIS MAP WAS DEVELOPED IN COMPLIANCE WITH THE REQUIREMENTS SET FORTH IN COMAR REGULATIONS 09.13.06.

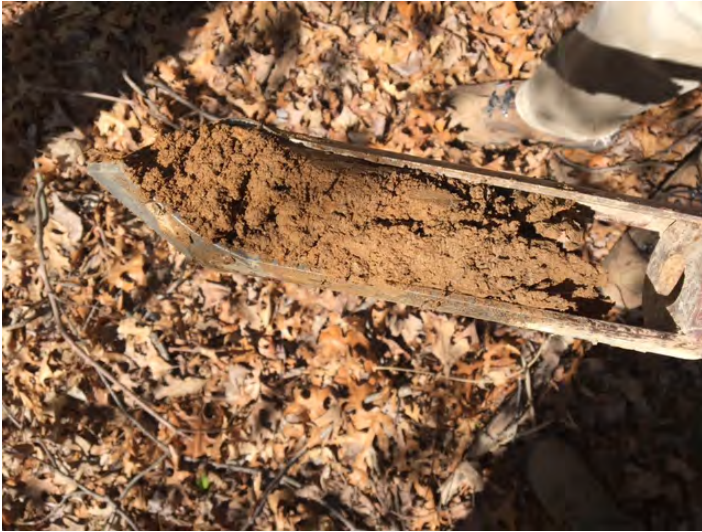
Photograph 9: Upland soil sample typically observed throughout the upland forest slopes.
