Gude Landfill Remediation Project Design Engineer Contract

Wetland Delineation Report

Department of Environmental Protection
Division of Solid Waste Services
Montgomery County, Maryland

January 2019
Version: FINAL
EA Project No. 15646.01

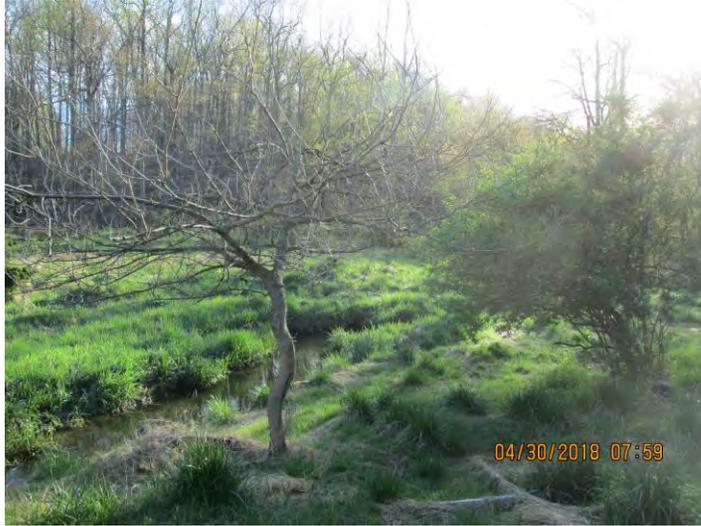
Photograph 1: Stream Channel #1 on the northeast corner of the project site.

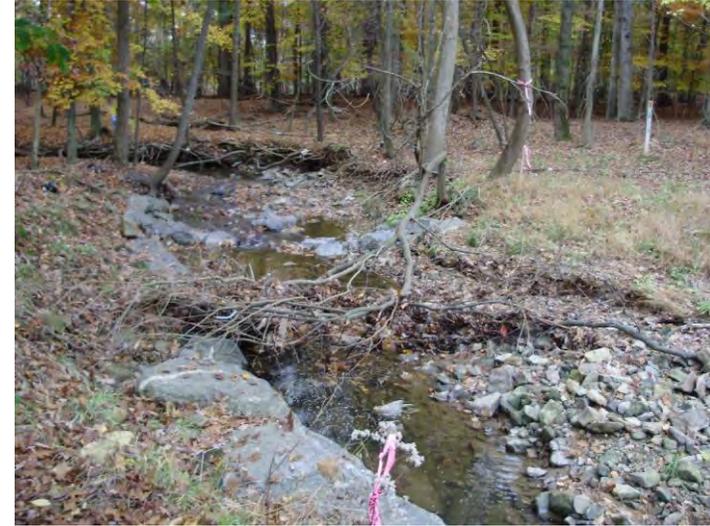
Photograph 2: Upstream portion of Stream Channel #2.

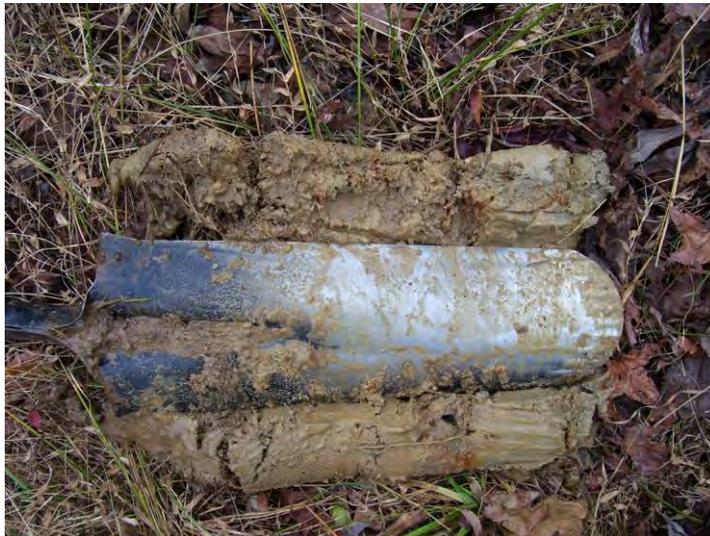
Photograph 3: Hydric Soils within Wetland A.

Wetland A contained predominantly hydrophytic vegetation consisting of red maple (*Acer rubrum*), sweetgum (*Liquidambar styraciflua*) saplings, and black willow (*Salix nigra*) saplings, as well as skunk cabbage (*Symplocarpus foetidus*) false nettle (*Boehmeria cylindrica*), sensitive fern (*Onoclea sensibilis*), soft rush (*Juncus effusus*), sedge species (*Carex* spp.), and arrowleaf tearthumb (*Polygonum sagittatum*). The soil matrix within the wetland area had a chroma value of two (2) or less with mottling of the matrix. Redox features and depletions were observed in soil samples throughout the wetland. Wetland hydrology indicators included saturation in the upper twelve (12) inches, water-stained leaves, and drainage patterns.

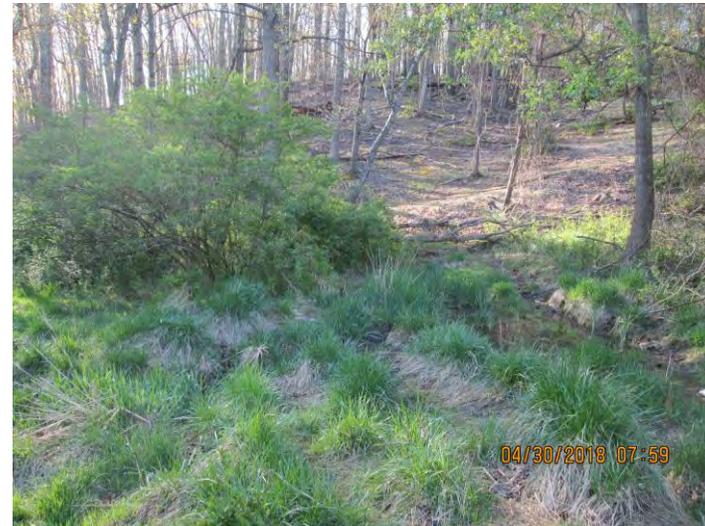
Photograph 4: Overview of Wetland A.

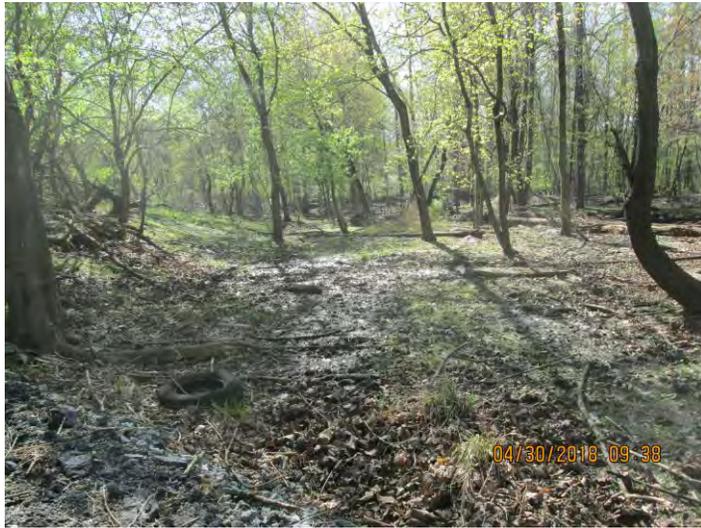
Photograph 5: Overview of Wetland B.

Wetland B contained predominantly hydrophytic vegetation consisting of red maple, sweetgum, and willow oak (*Quercus phellos*), soft rush, sedge species, and arrowleaf tearthumb. The soil matrix within the wetland area had a chroma value of two (2) or less with mottling of the matrix. Redox features and depletions were observed in soil samples throughout the wetland. Wetland hydrology indicators included saturation in the upper twelve (12) inches, water-stained leaves, and drainage patterns.

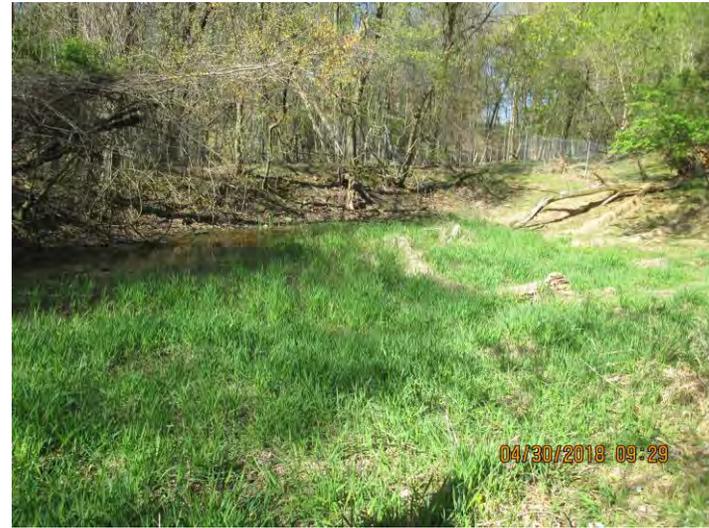
Photograph 6: Overview of Pond #4.

EA personnel identified a fenced pond (referred to as Pond #4 by the County) associated with the stream/wetland system located on the south side of the project site (**Appendix D**). Pond #4 appeared to be a historical sediment basin, and classified as a potential emergent wetland. This pond was located adjacent to Wetland B but appeared to be hydrologically separated by an earthen berm. A deteriorated eighteen (18)-inch corrugated metal pipe was identified at this location and directly connects the pond to Stream Channel #2. This pond was identified as a potentially jurisdictional feature due to its location, directly adjacent to Stream Channel #2, and its location within the floodplain. Furthermore, groundwater was observed in the soil pit during the field effort; the presence of hydrophytic emergent vegetation within the pond as well as larger hydrophytic trees was documented along the pond boundary. Unlike other ponds identified onsite this pond does not appear to have been constructed solely in uplands and, therefore, this pond has potential to be considered jurisdictional.

Pond #4 contained predominantly hydrophytic vegetation consisting of red maple, silver maple (*Acer saccharinum*), and black willow along the edge of the pond, and sensitive fern, soft rush, and sedge species within the central portion of the pond. The soil matrix within the wetland area had a chroma value of two (2) or less with mottling of the matrix. Redox features were observed in soil samples throughout the wetland. Wetland hydrology indicators included inundation and saturation in the upper twelve (12) inches, along with water-stained leaves, and water marks.

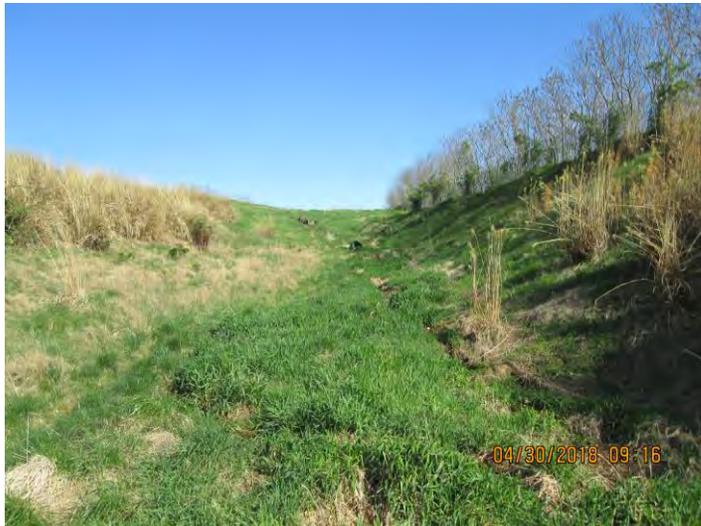
Photograph 7: Overview of Wetland C.

Within the limits of the wetland, EA personnel observed predominantly hydrophytic vegetation species, including soft rush, softstem bullrush (*Schoenoplectus tabernaemontani*), blunt spikerush (*Eleocharis obtusa*), and sedge species. Evidence of observed wetland hydrology included saturated soil within twelve (12) inches of the ground surface and inundation. EA personnel excavated test pits to depths of approximately eighteen (18) inches and observed gleyed or low-chroma soils.

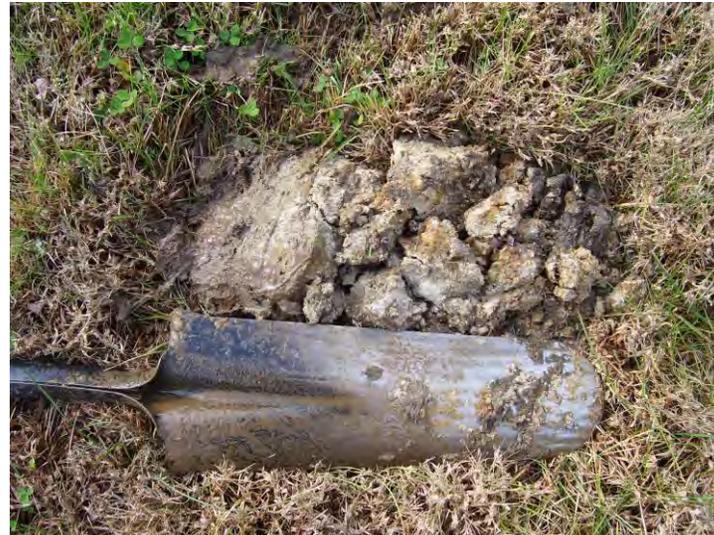
Photograph 8: Wetland C, soil sample.

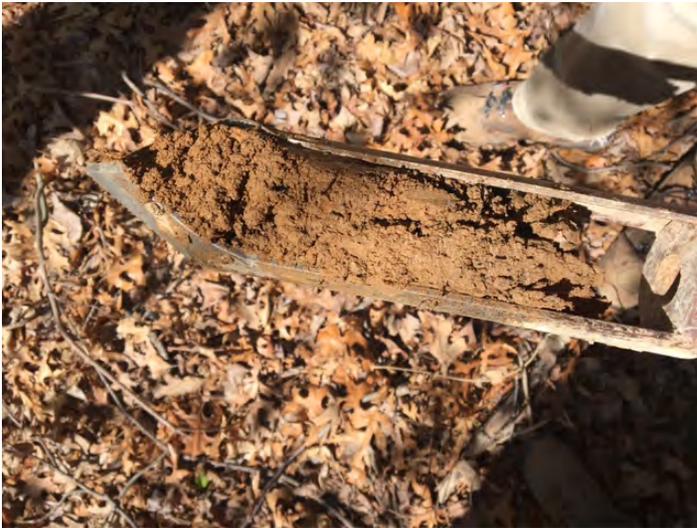
Photograph 9: Upland soil sample typically observed throughout the upland forest slopes.

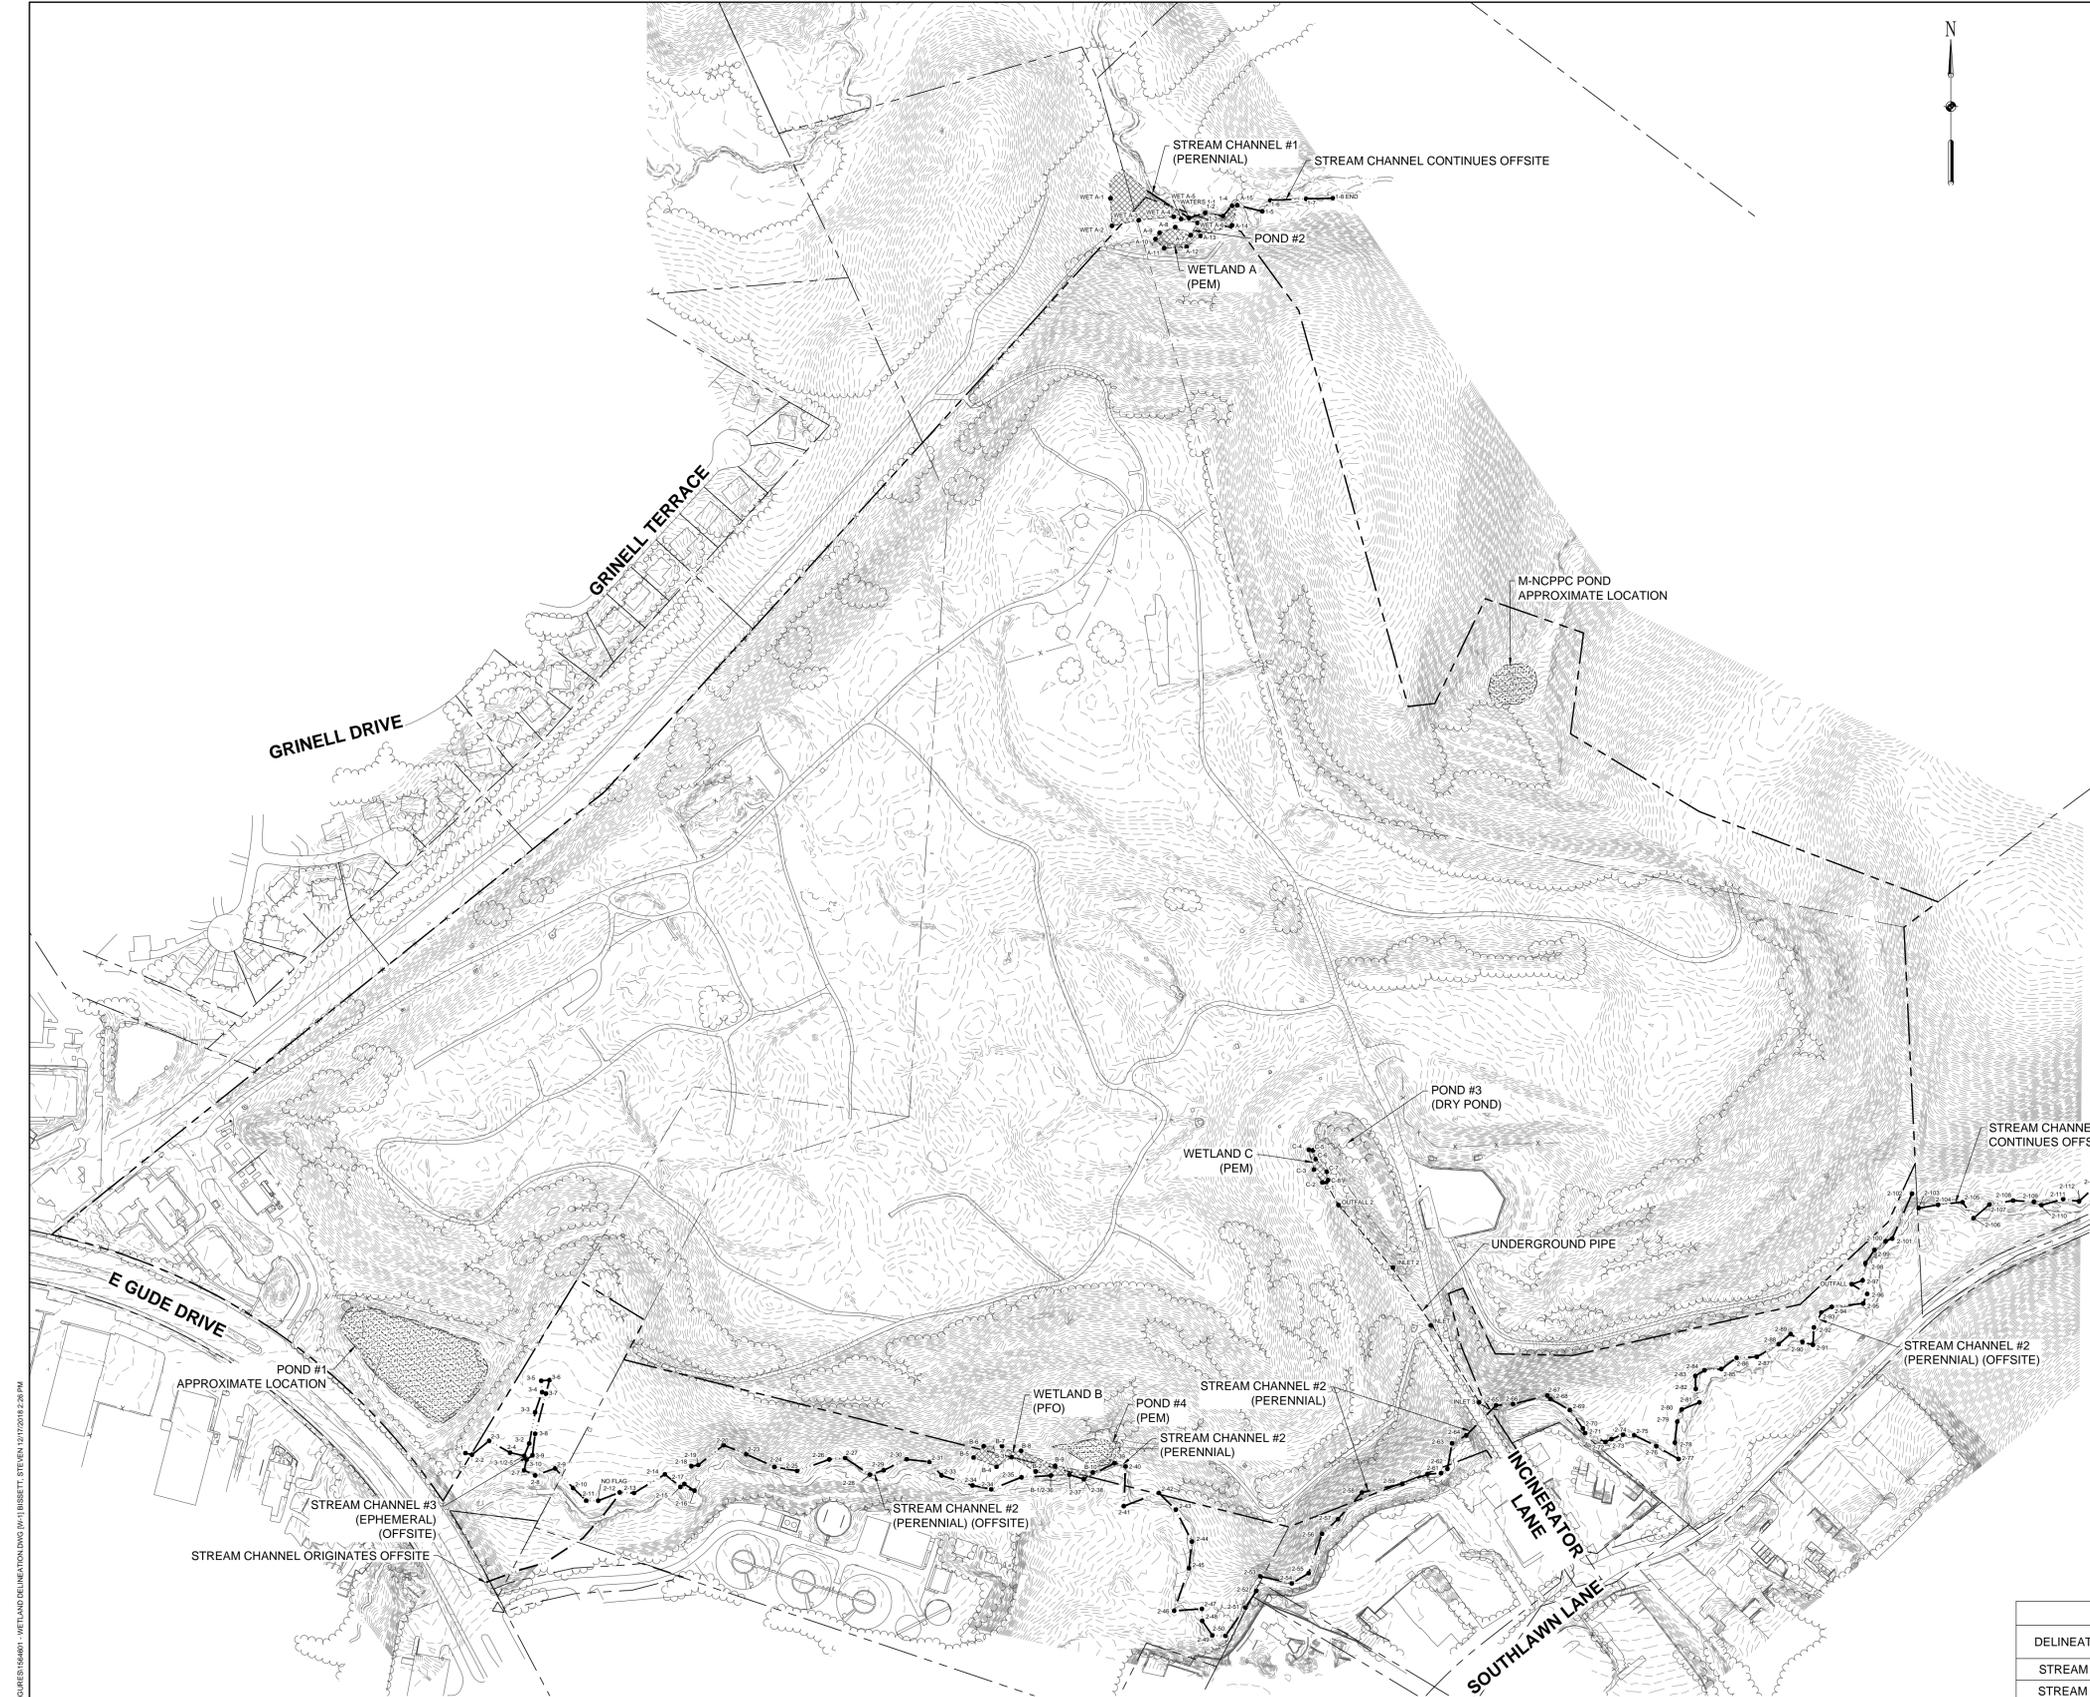
- THE WATERS OF THE U.S. INCLUDING FEDERALLY REGULATED WETLANDS WERE DELINEATED BY EA ENGINEERING ON OCTOBER 28TH, 30TH, AND NOVEMBER 2, 2009. FLAGS WERE LOCATED USING A TRIMBLE GEO XH GLOBAL POSITIONING SYSTEM INSTRUMENT. EA RE-VISITED THE SITE ON MAY 1, 2018 TO VERIFY THE BOUNDARIES AND CONDITIONS OF THE WATERWAYS. SLIGHT REVISIONS TO THE WETLAND BOUNDARIES WERE MADE AND RE-LOCATED USING A TRIMBLE GEO7X GLOBAL POSITIONING SYSTEM INSTRUMENT.

On May 1, 2018, EA's wetland scientists re-visited the site to re-evaluate the wetland and stream boundaries and confirmed very little change to these resources. Slight variations in the wetland and stream boundaries that were observed were re-surveyed and included on the attached Wetland Delineation Map (**Appendix D**).
