Gude Landfill Waste Delineation Study Montgomery County, Maryland

Northeast Maryland Waste Disposal Authority/
Department of Environmental Protection
Division of Solid Waste Services
Montgomery County, Maryland

EA Engineering, Science, and Technology, Inc.
15 Loveton Circle
Sparks, Maryland 21152
(410) 771-4950

January 2010

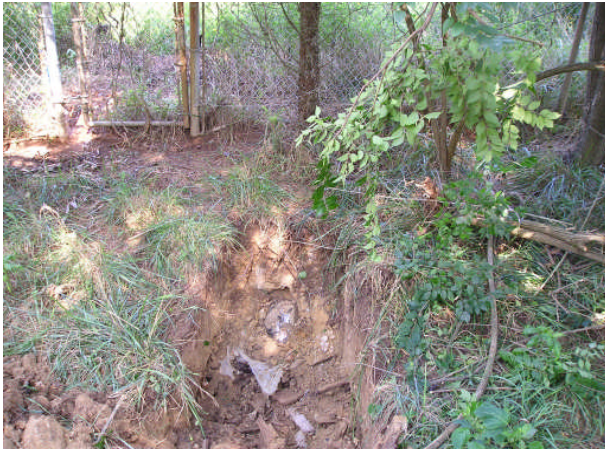
TP-7, Located Along N.W. Landfill Property Boundary

Along the northwest side of the property boundary, there were four locations where the limit of waste was not identified, and it may extend into the gas pipeline right-of-way (TP-7 through TP-10). Waste in this area was fairly shallow, with waste typically encountered one to two feet bgs. The photo of TP-7 illustrates where waste was identified in relation to the property boundary, which is marked by the existing fence.

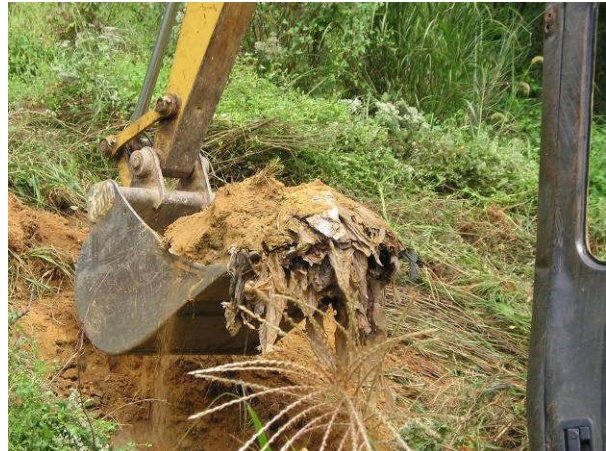
TP-136, Located Along Southern Landfill Property Boundary (Adjacent to WSSC Property)

Along the southern boundary to the west of Incinerator Lane, waste was surficial in nature and extends beyond the Landfill property boundary in several locations (TP-136 through TP-140). Test pitting on WSSC property was not performed because it is unlikely that waste was intentionally buried on this property based on the County's knowledge of the landfilling operations. The photo of TP-136 illustrates typical waste encountered in areas where waste extends onto WSSC property.

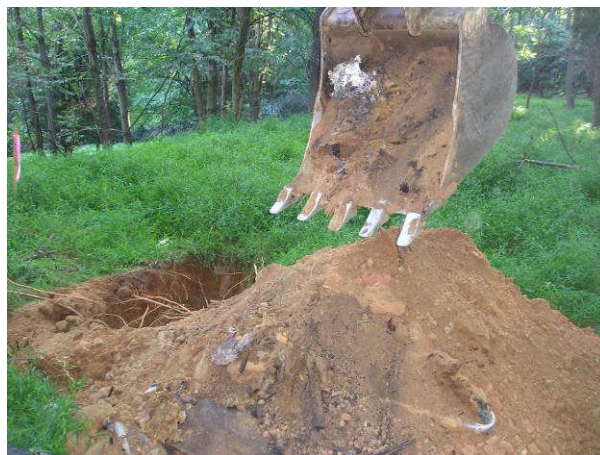
TP-48, Located Along N.E. Landfill Property Boundary

Along the N.E. property boundary, waste was primarily identified as likely extending onto M-NCPPC property (TP-46 through TP-84). Historical aerial photography illustrates that waste was likely placed in this area during the late 1970s (Appendix D). Appendix D is an aerial photo from 1979 with the property boundary overlaid on it. Light areas on the photo represent areas without vegetation where landfilling activities were occurring at the time of the photo. The image illustrates that landfill activities extended beyond the property boundary.

The topography of the N.E. property boundary area also indicates waste was placed beyond the property boundary. The area appears to be graded with a downward slope to facilitate stormwater drainage, which is indicative of waste placement. The majority of the area is vegetated with trees and shrubs, except for the area directly upgradient of an offsite stormwater management pond, which is covered with tall grasses. The pond is fed by two concrete channels set along each side of the open area along the Landfill side slopes, forming a triangular shape. The photo of TP-48 is representative of the test pits performed along the N.E. property boundary.

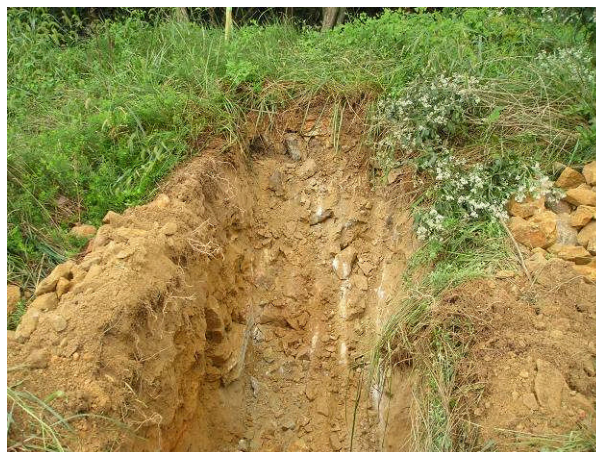
**TP-108, Located on S.E. Landfill Property Boundary
(East of Incinerator Lane)**

Waste was primarily delineated as being on the Landfill property along the N.W., east, and S.E. property boundaries. Waste that was delineated on site primarily followed the property boundary. Waste on the S.E. of the site followed the Landfill access road. Figure 1 shows an approximate limit of waste in green based on the test pit locations where waste was delineated. The photo of TP-108 was taken along a Landfill access road east of Incinerator Lane, where waste was encountered approximately three feet bgs.

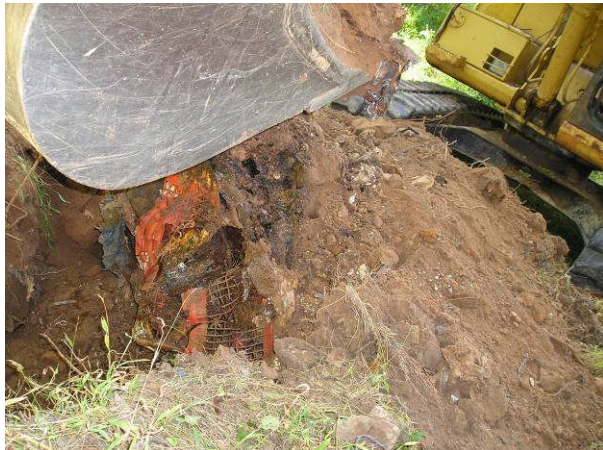
**TP-5A, Located on M-NCPPC Property
(Along N.E. Landfill Property Boundary)**

Test pits on M-NCPPC property were up to eight feet in depth, and waste was encountered at fairly shallow depths ranging from half a foot to three feet bgs. The limit of waste delineated on M-NCPPC property correlates well with the disturbed area seen on the aerial photo shown in Appendix D, with the limit of waste approximately 200 to 250 feet from the Landfill property boundary. Labeled photos of each of the M-NCPPC test pits are provided in Appendix C. Table 4-6 summarizes the test pit locations performed on M-NCPPC property.
