# Georgia Avenue (MD 97) Pedestrian Road Safety Audit Montgomery County, Maryland

Prepared For:  
Department of Transportation  
Montgomery County, Maryland

**May 2011**

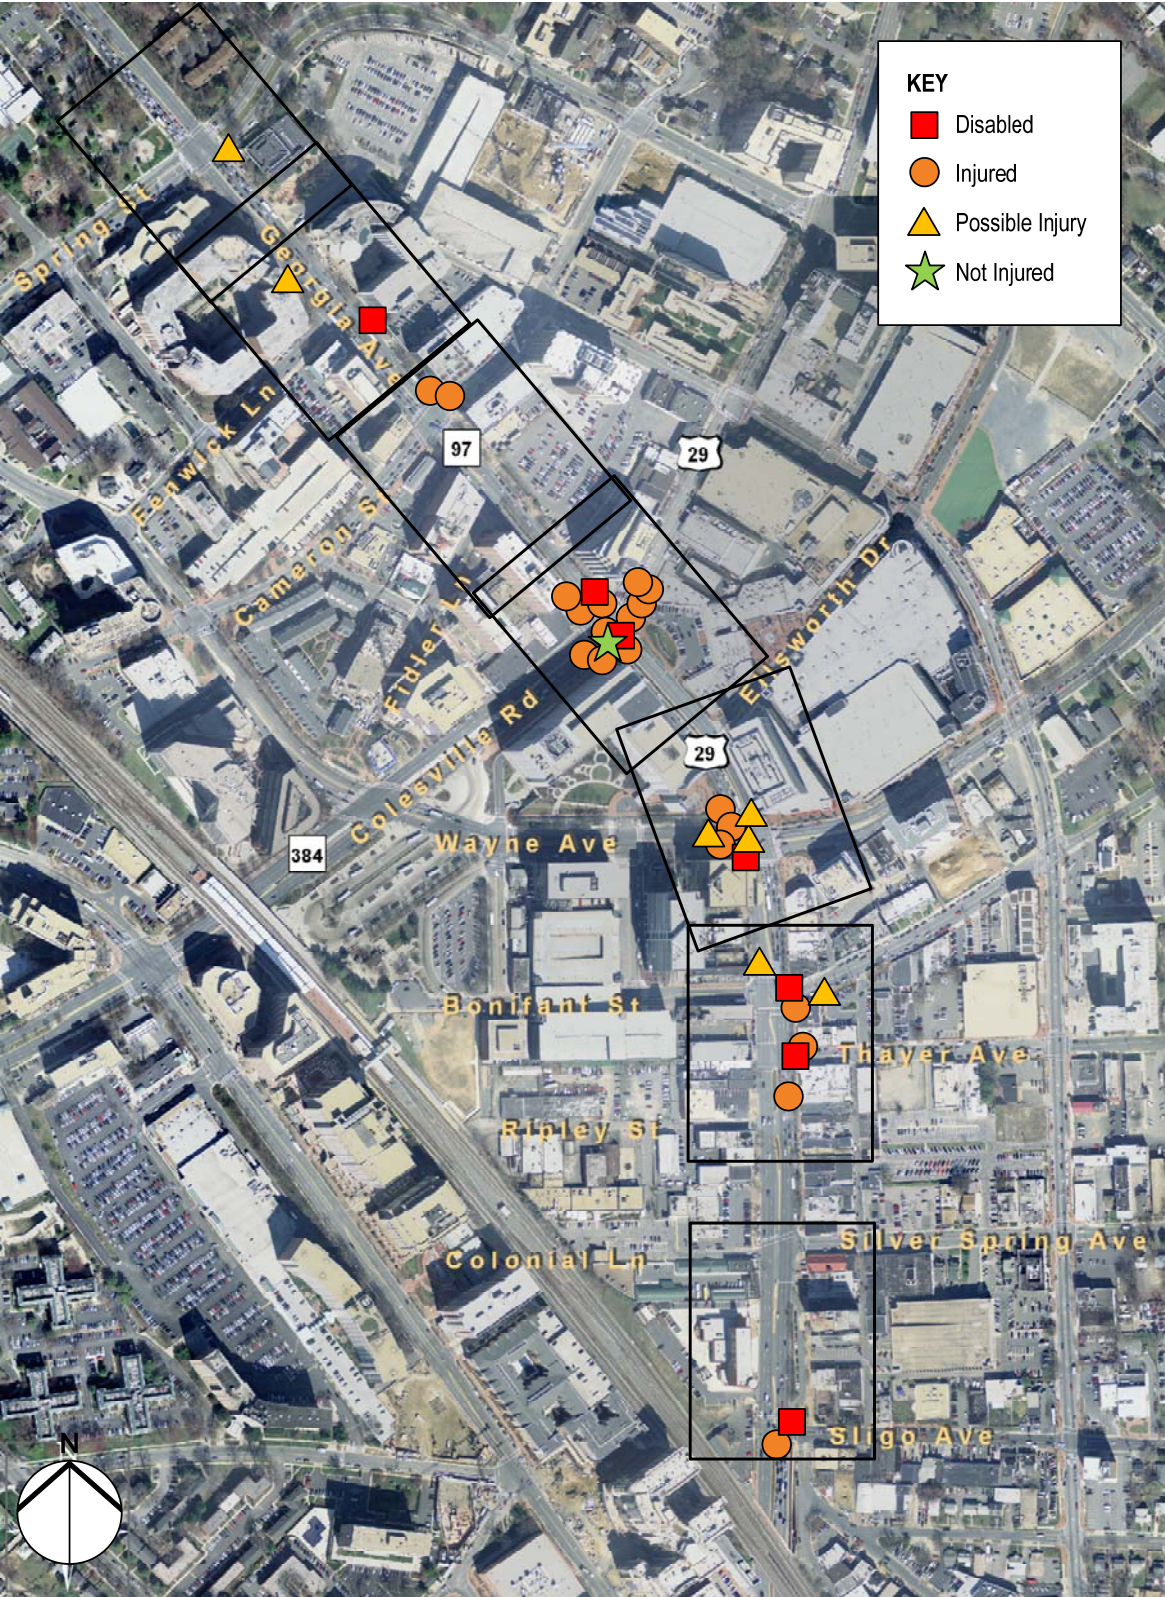
Figure 2: Georgia Avenue Pedestrian and Bicycle Crashes 2003-2007

A review of all collision records collected by Montgomery County Police in the study area during the five-year period from 2003 through 2007 allowed the PRSA team to identify the location of all reported pedestrian crashes within the corridor (Figure 2). Between 2003 and 2007, 506 vehicular crashes, 34 pedestrian crashes, and a single bicyclist crash were reported in the study area. Of the 35 pedestrian and bicyclist crashes between 2003 and 2007, 25 occurred at an intersection and 10 occurred between intersections. Figure 2 shows the location of all crashes along Georgia Avenue within the study period.
