# SCHOOL-RELATED CRASH REVIEW

**Location:** Arlington Road at Edgemoor Lane

**Crash Date:** January 26, 2024

**Local Case No.:** 240004060

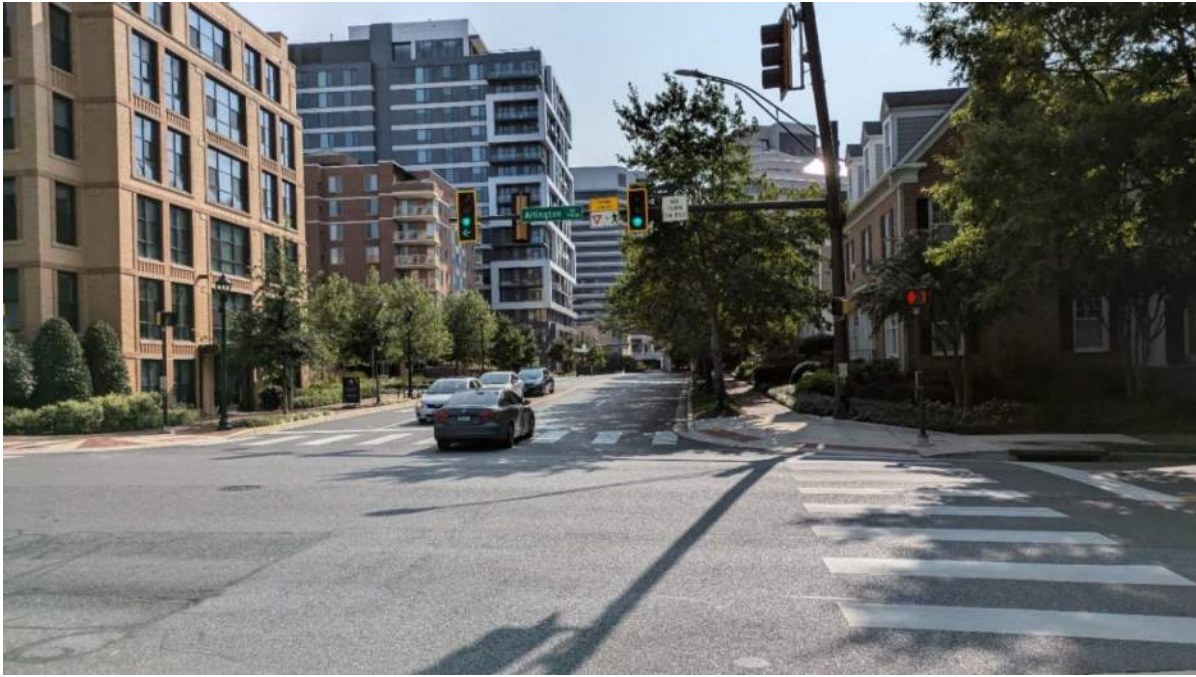
**Photo 1. Looking towards east crossing leg of intersection at Edgemoor Lane where crash took place.**

Based on the crash report, the motorist failed to yield right of way to the pedestrian in the crossing. The following measures were identified as a result of this review:

1. Consider installing centerline hardening to slow left-turning vehicles and increase visibility of pedestrians in the crosswalk.
2. Consider removing split phasing for side streets.
3. Consider replacing the 3’-9’ skips along Arlington Road south of Moorland Lane. They should be 10’-30’ skips.
4. Consider replacing the “school days 25” sign with a standard speed limit sign.

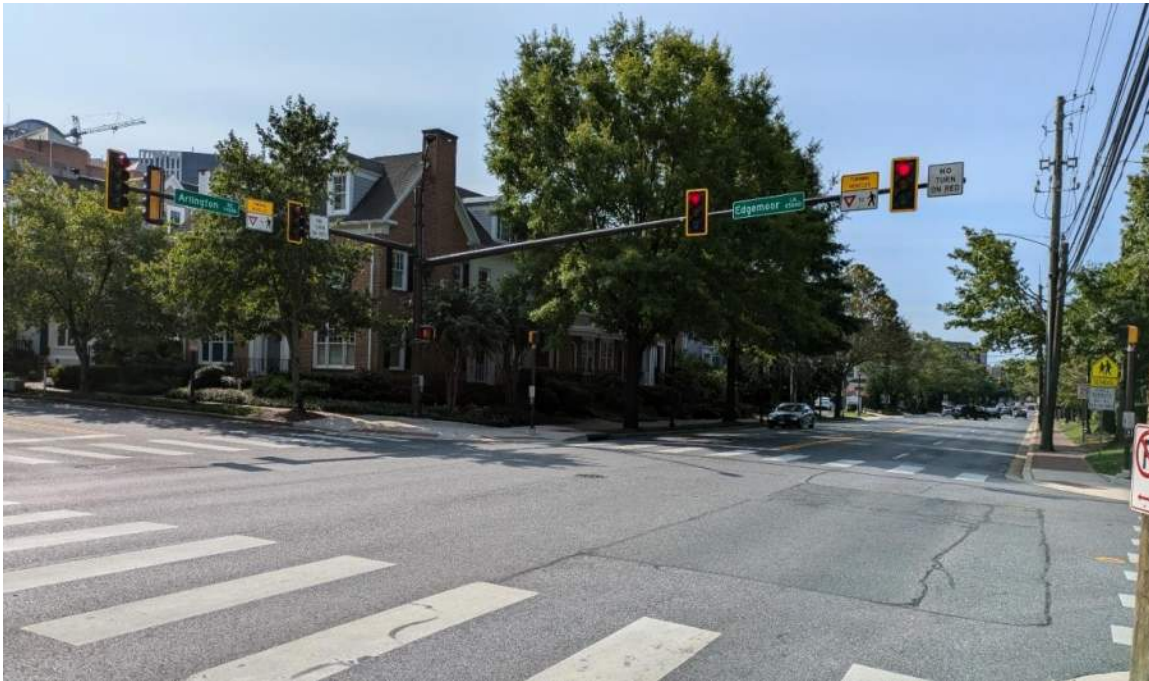
**Photo 2. Southbound Arlington Road signal displays.**

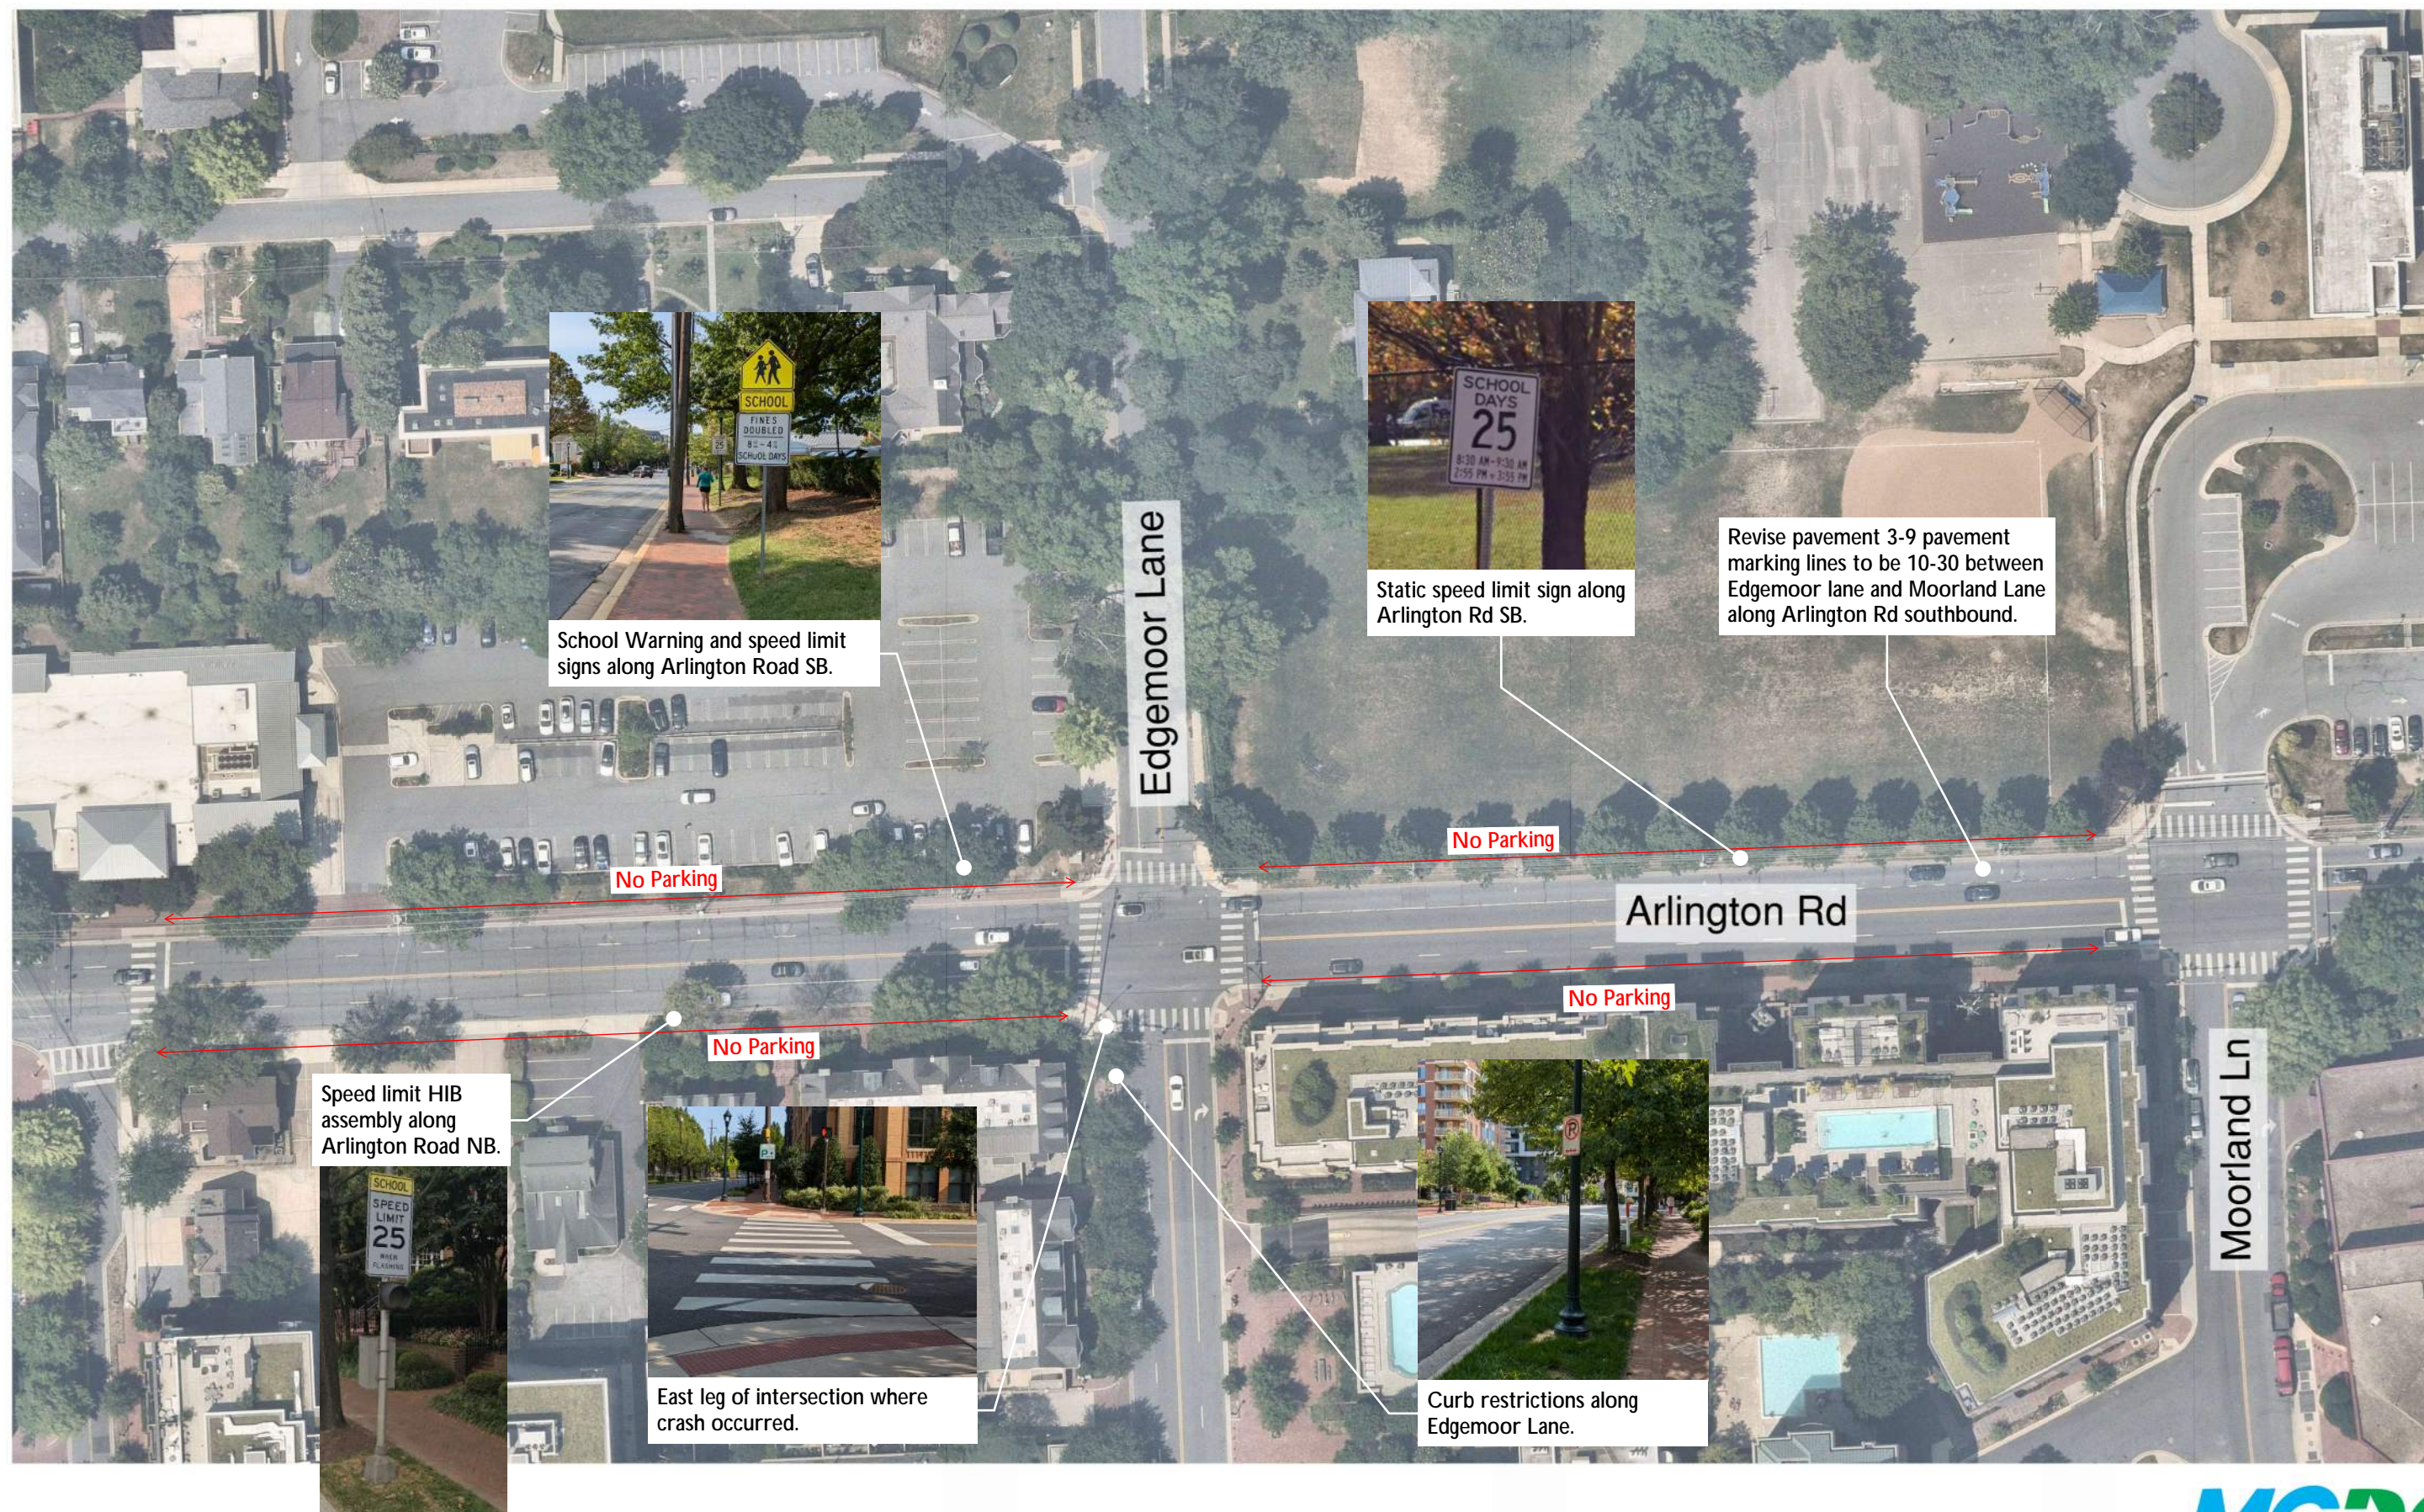
Figure 1 - Arlington Road Corridor Observations

In the southbound direction, Arlington Road has a school flasher/high-intensity beacon (HIB) displaying a posted speed limit of 25 MPH, just south of Old Georgetown Road. Also displayed for southbound traffic is a static, non-standard “School Days 25” speed limit sign north of Moorland Lane. The northbound direction includes a static 25 MPH speed limit sign, located north of Elm Street and south of Montgomery Lane. A school flasher/HIB with a posted speed limit of 25 MPH is installed between Edgemoor Lane and Montgomery Lane. On-street parking is not permitted between Old Georgetown Road and Bethesda Avenue. Refer to **Figure 1** in the attachments for additional details on the Arlington Road segment.

The Arlington Road corridor was evaluated to identify potential infrastructure, maintenance activities, and road user behaviors that contribute to increased safety risk at and in the vicinity of the school-related crash location. The Arlington Road corridor was reviewed at the subject intersection where the crash occurred. Please refer to **Figure 1** for additional information.

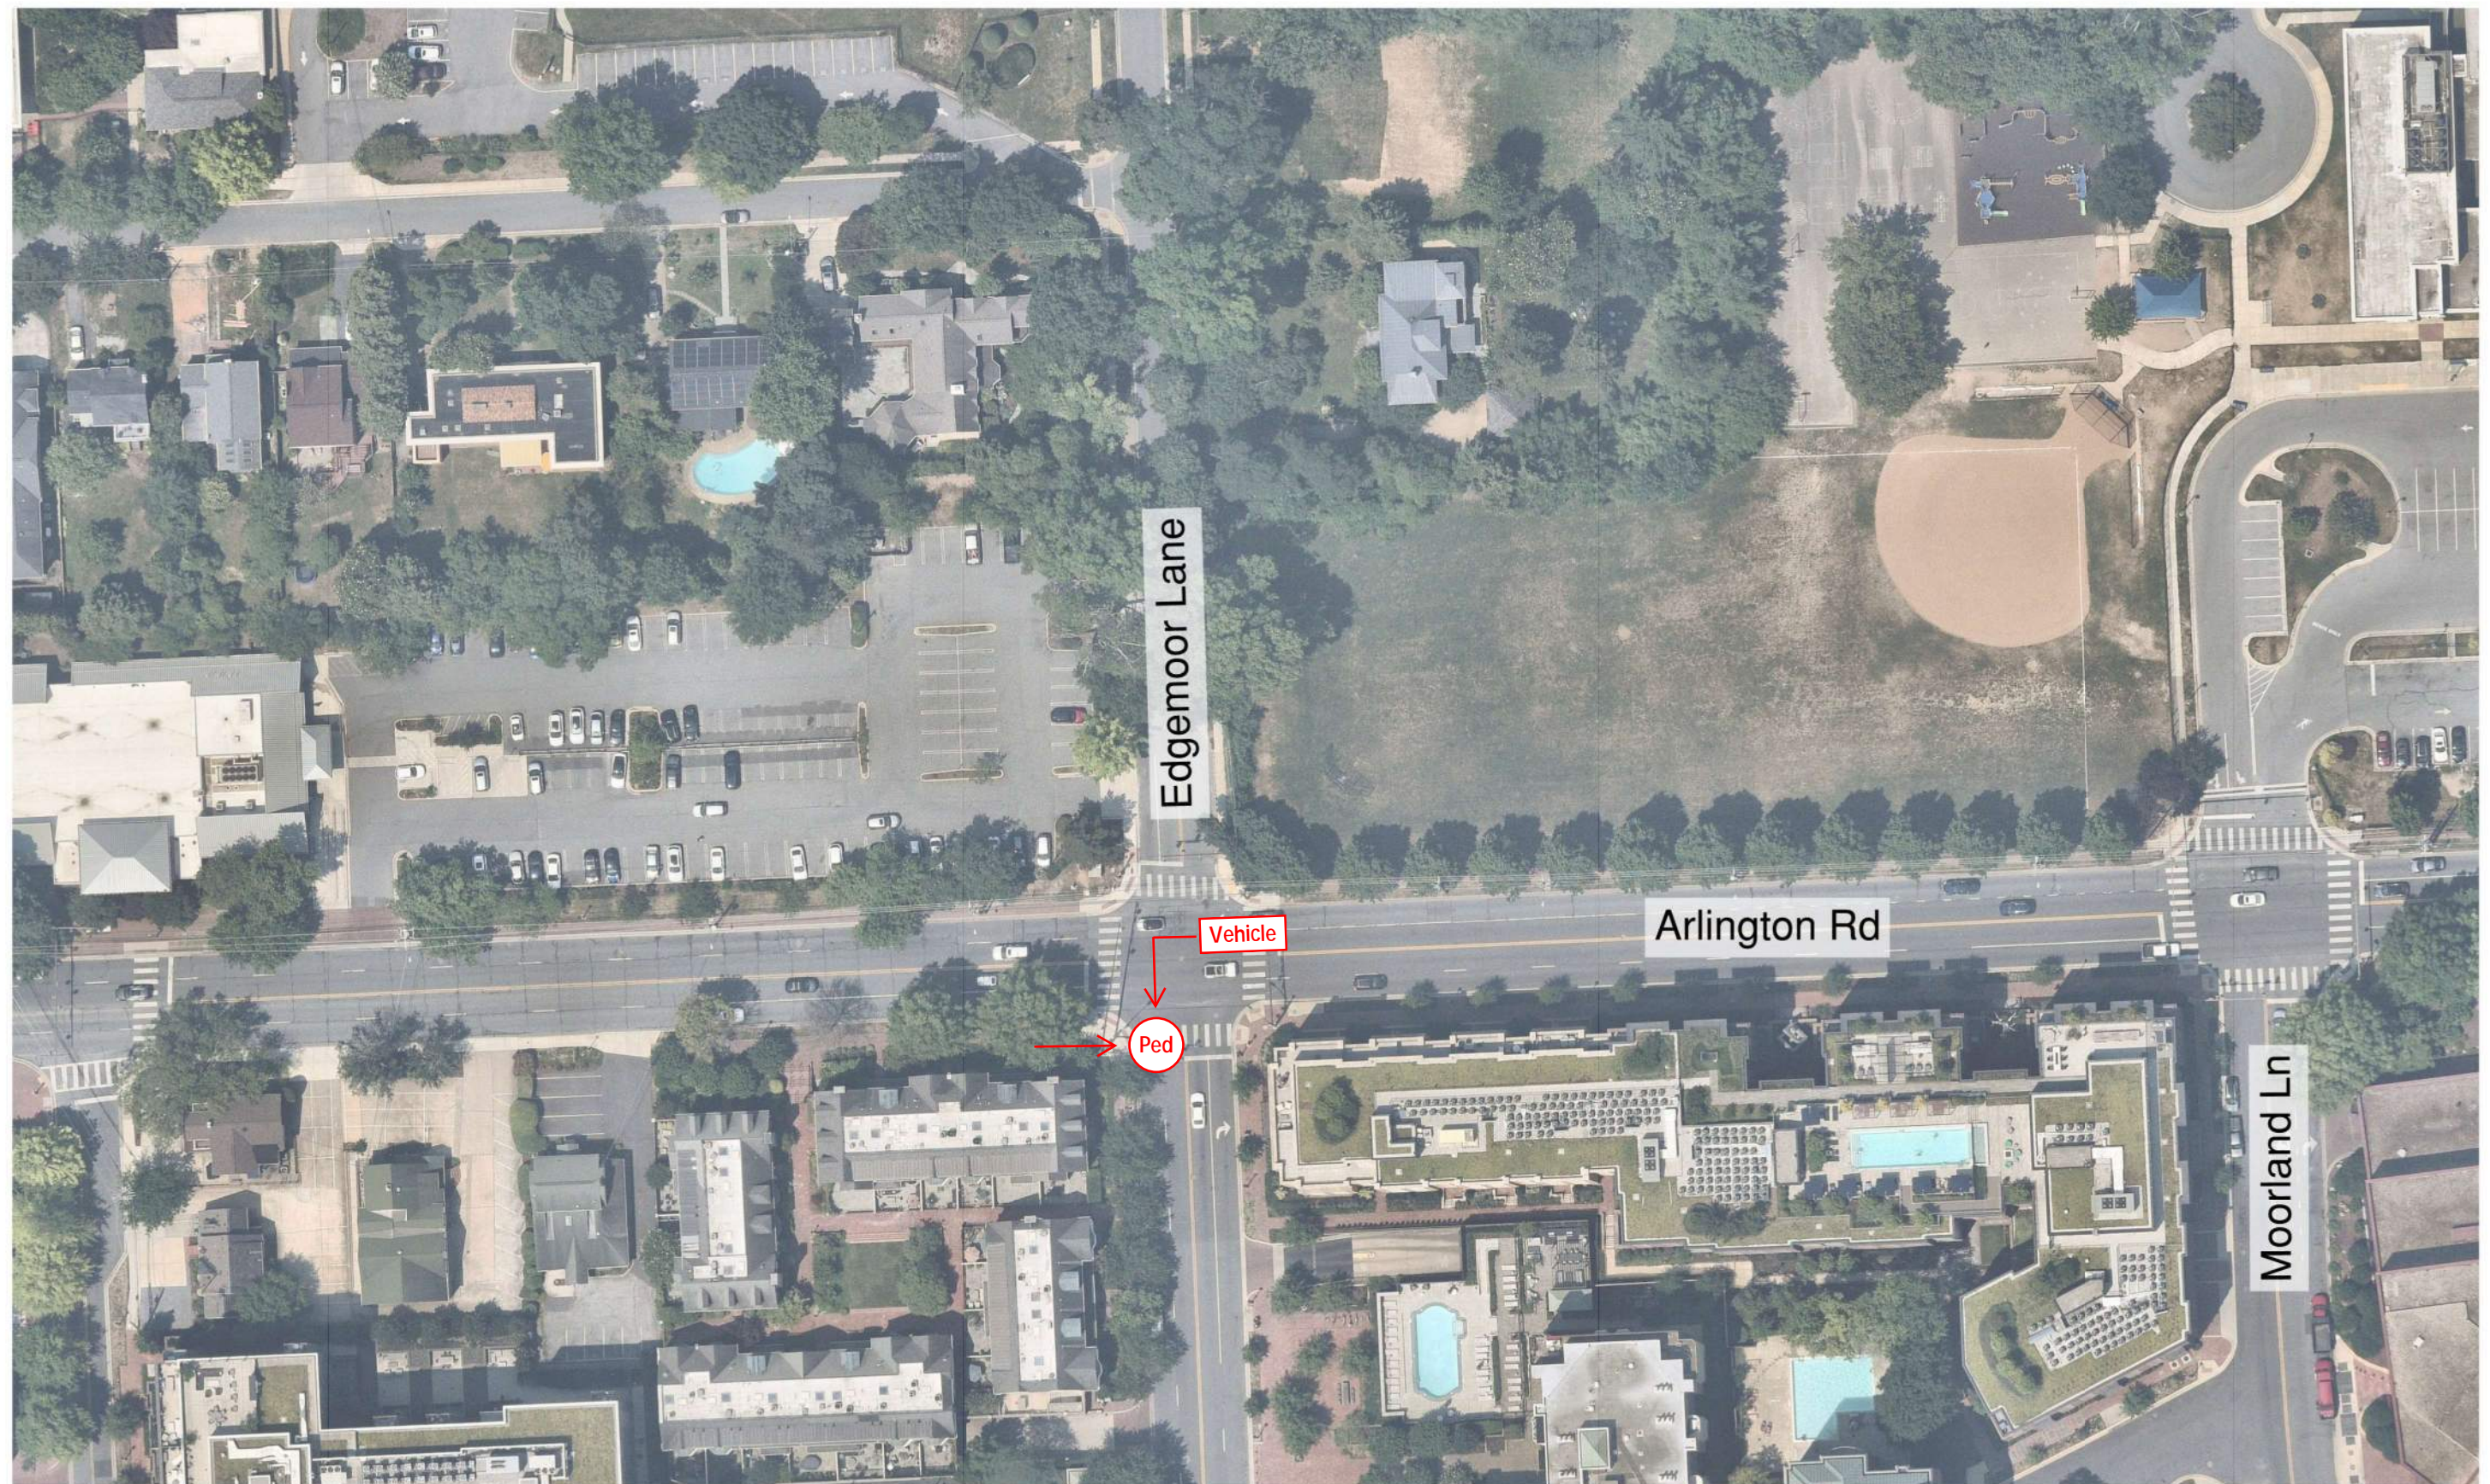
Figure 2 - Crash Diagram

On Friday, January 26, 2024, at approximately 7:33 AM, a pedestrian was traveling northbound along Arlington Road, crossing Edgemoor Lane in the crosswalk with a walk signal. A motorist traveling southbound along Arlington Road, with a green signal, turned left onto eastbound Edgemoor Lane and struck the pedestrian in the crosswalk. The crash report indicated that the motorist failed to yield right of way to the pedestrian. The pedestrian suffered minor injuries. Daytime weather conditions were cloudy, and the roadway surface was wet.

**Figure 2** illustrates the crash location and direction of pedestrian and vehicle travel.
