# SCHOOL-RELATED CRASH REVIEW

**Location:** Wisteria Drive at Walter Johnson Road

**Crash Date:** March 6, 2024

**Local Case No.:** 240010945

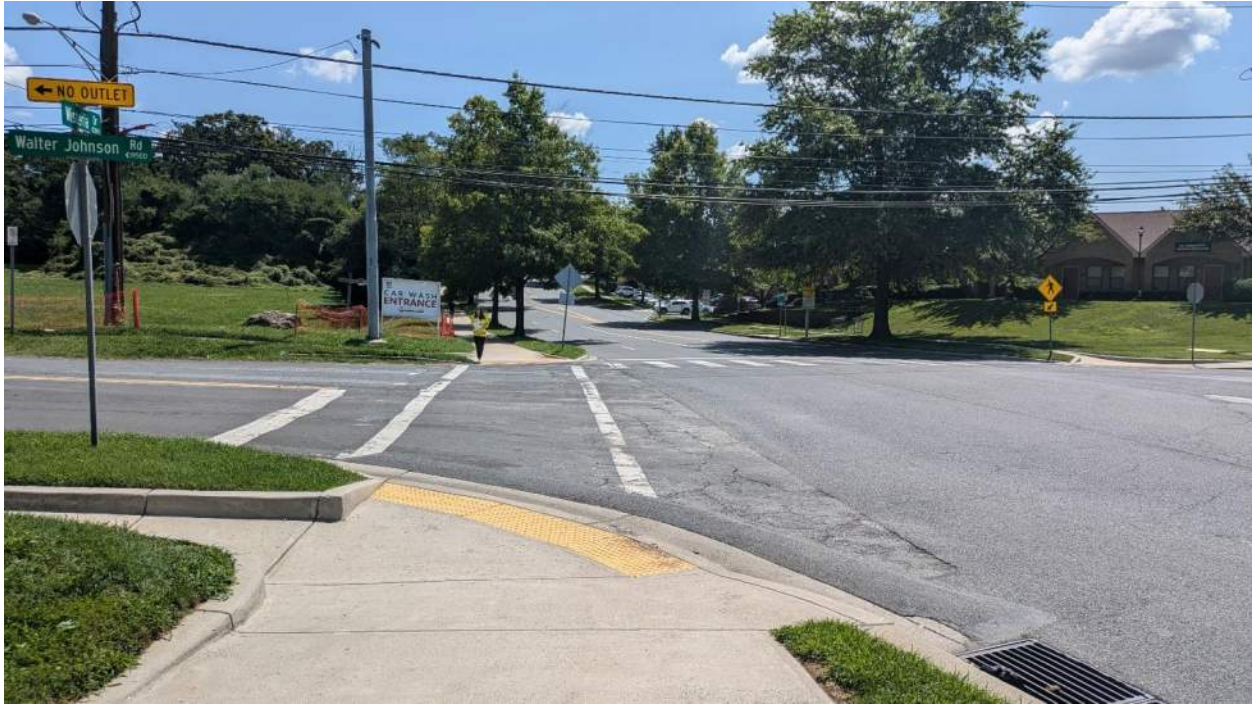
**Photo 1. North leg of intersection where crash occurred, looking south along Wisteria Drive.**

1. Trim trees near subject intersection to improve sightlines for pedestrians and motorists.
2. Consider installing continental crosswalk markings along the north and south legs of the intersection to enhance pedestrian conspicuity.
3. Consider removal of the advanced stop line for uncontrolled crossing on east leg to avoid motorist confusion or shift it 20 feet upstream of the marked crosswalk and supplement with a STOP HERE FOR PEDS sign.
4. Discuss relocation of car wash sign to increase visibility for motorists looking to make a right turn from Walter Johnson Road onto Wisteria Drive westbound. The sign placed within the public right of way limits the sight line to approximately 125 feet.

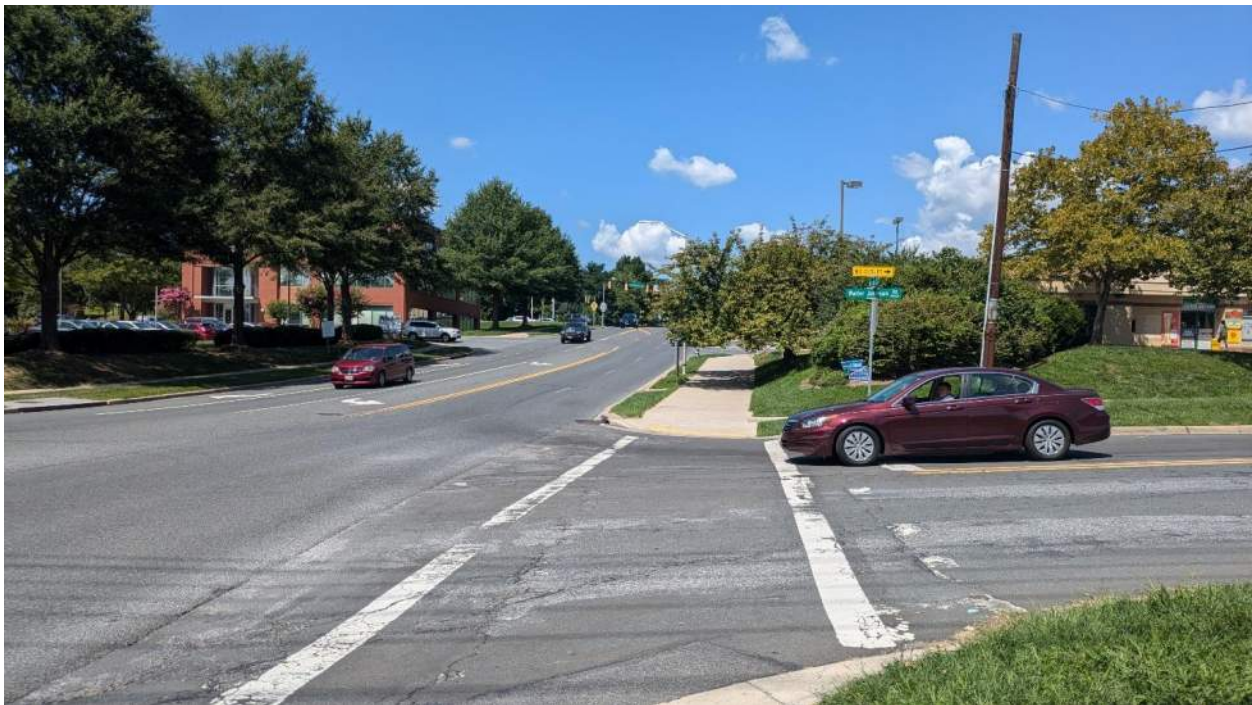
During the observation period, much of the vehicular traffic at the intersection originated from this leg, due to several businesses that exist on this portion of Walter Johnson Road. Foliage and signing obstruct sightlines at the Wisteria Road intersection for traffic turning from the north leg (southbound) of Walter Johnson Road. Reduced sightlines on this approach result in motorists advancing past the stop line and into the crosswalk. Along the east leg crossing, there is an advanced stop line installed which is an atypical application and may cause confusion for motorists traveling westbound along Wisteria Road.

**Photo 2. North leg of intersection where crash occurred, looking north along Wisteria Drive. Motorist can be seen creeping up past stop line before turning due to poor visibility.**

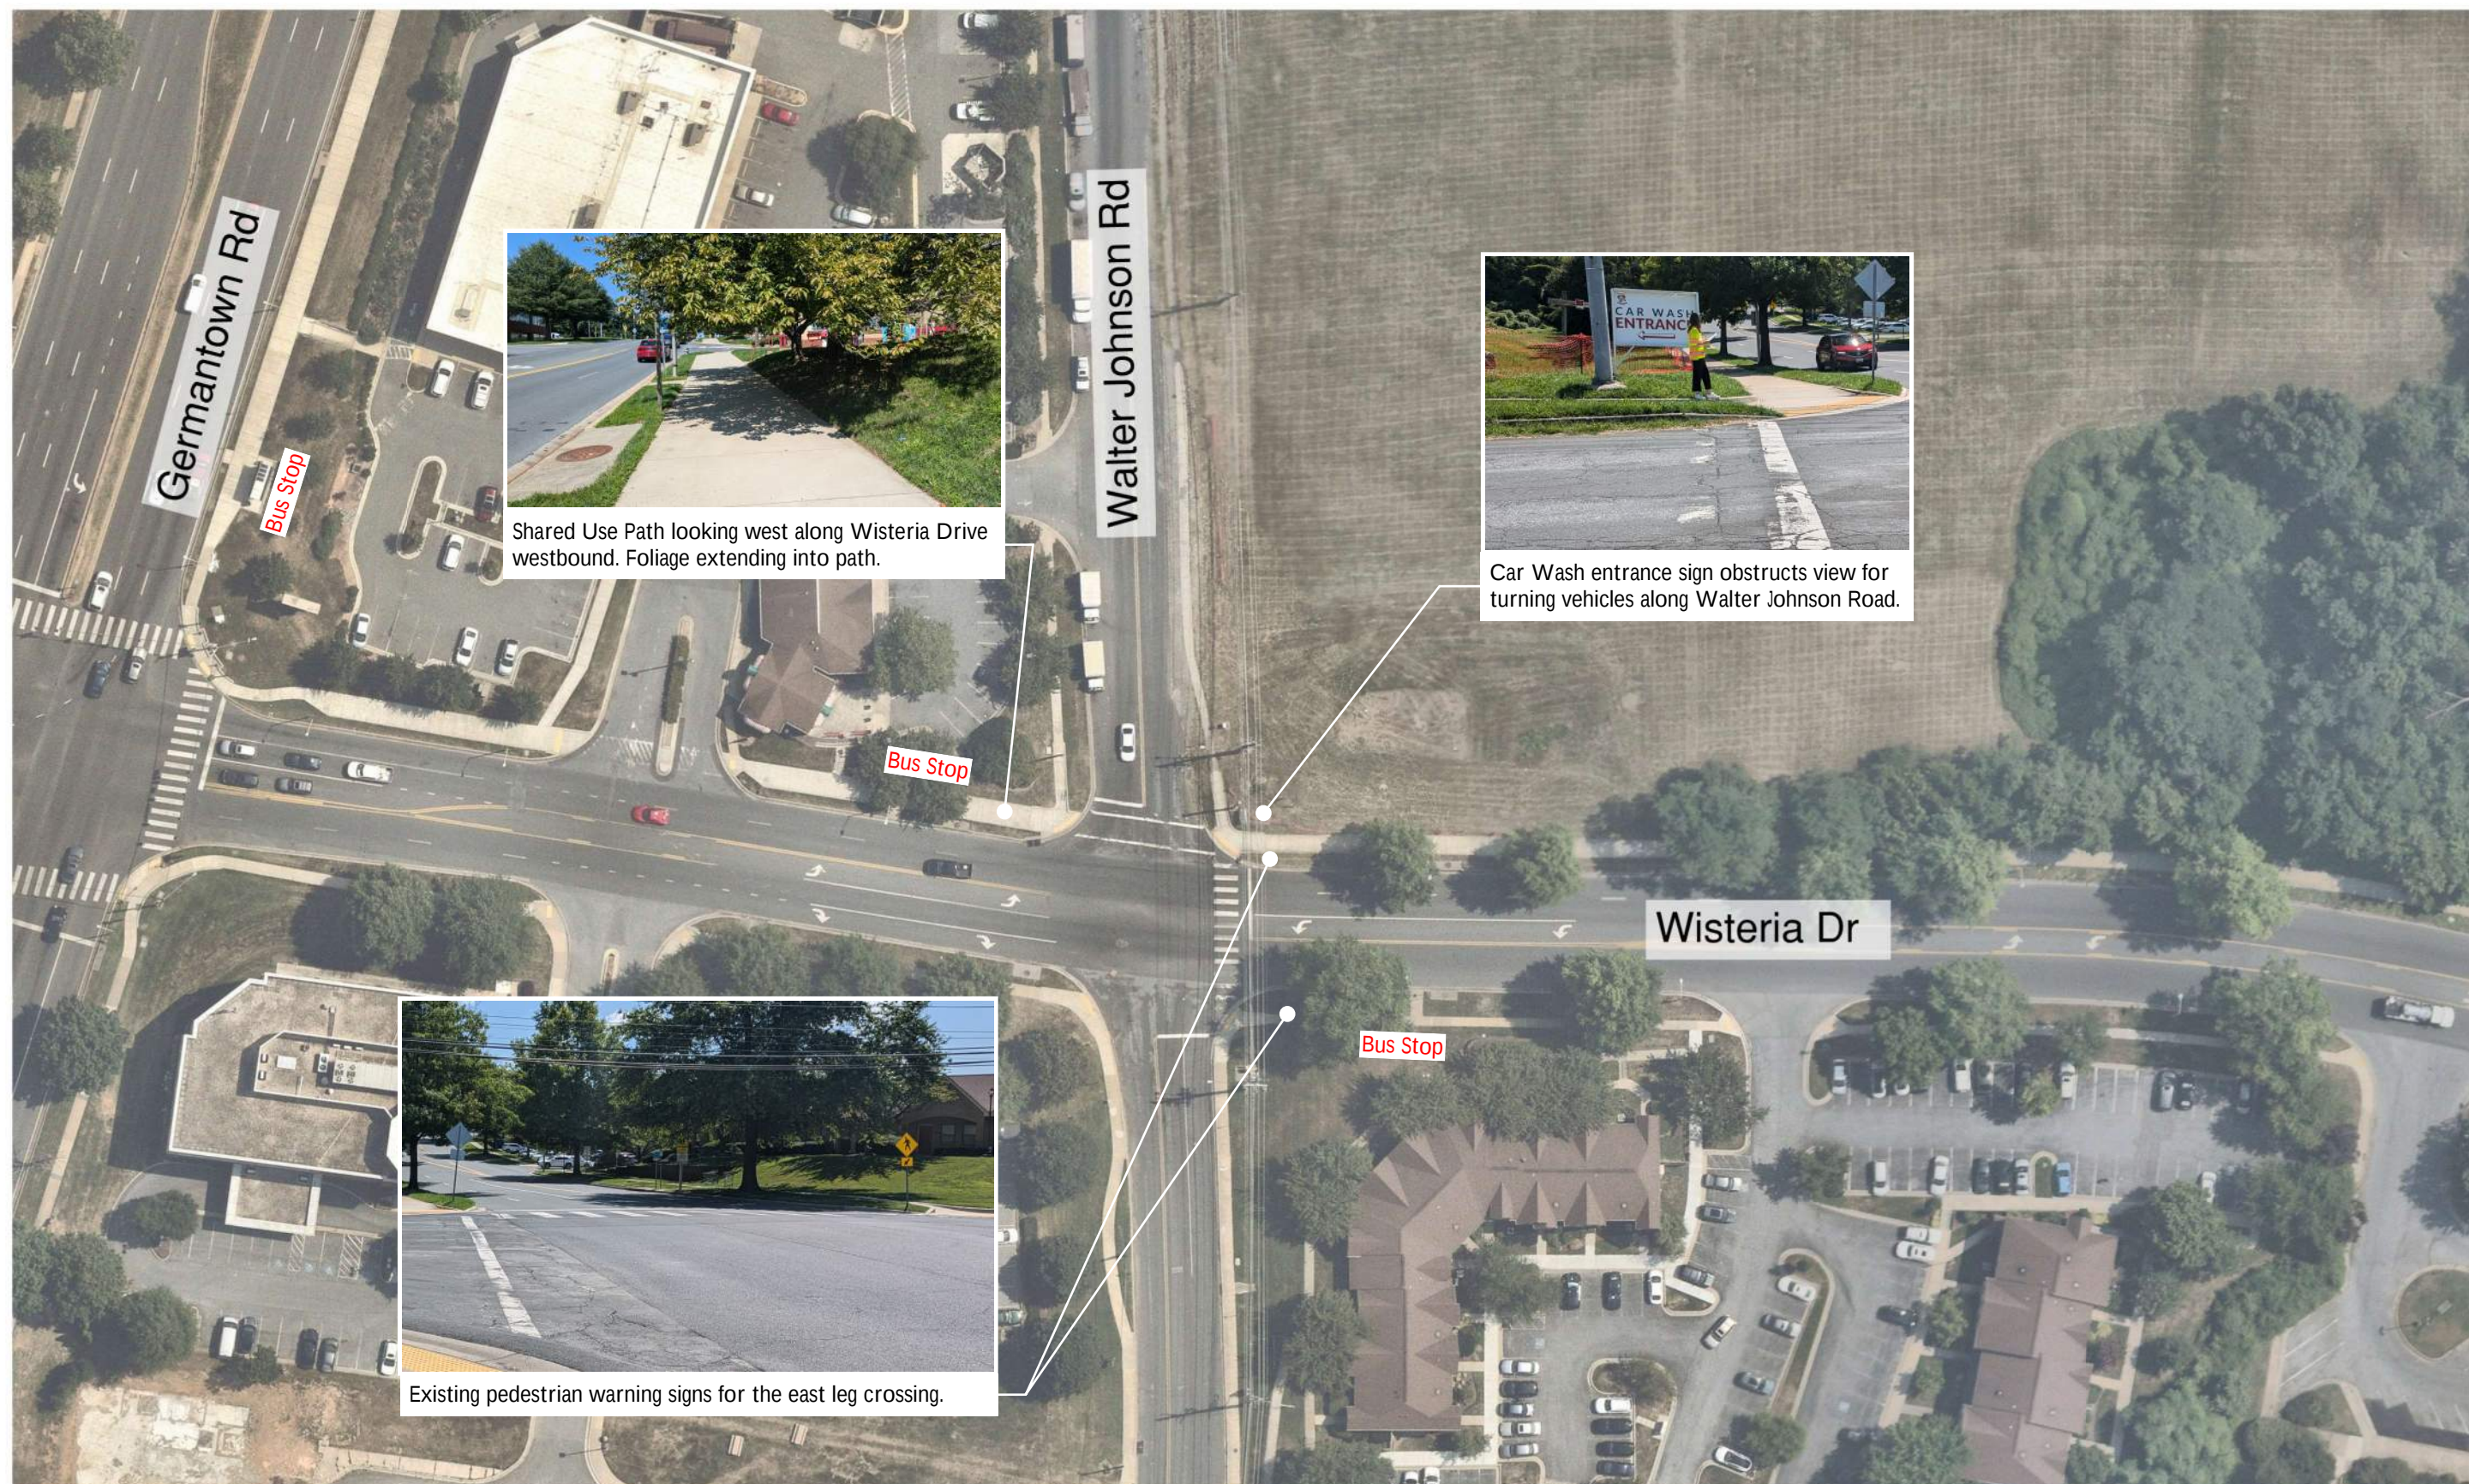
Figure 1 - Wisteria Drive Corridor Observations

Wisteria Drive has a posted speed limit of 30 MPH. On-street parking is not permitted within the vicinity of the high school between Germantown Road and MD 119 (Great Seneca Highway). Refer to **Figure 1** in the attachments for additional details of the Wisteria Drive segment.

The Wisteria Drive corridor was evaluated to identify potential infrastructure, maintenance activities, and road user behaviors that contribute to increased safety risk at and in the vicinity of the school-related crash location. The Wisteria Drive corridor was reviewed at the subject intersection where the crash took place. Please refer to **Figure 1** for additional information.

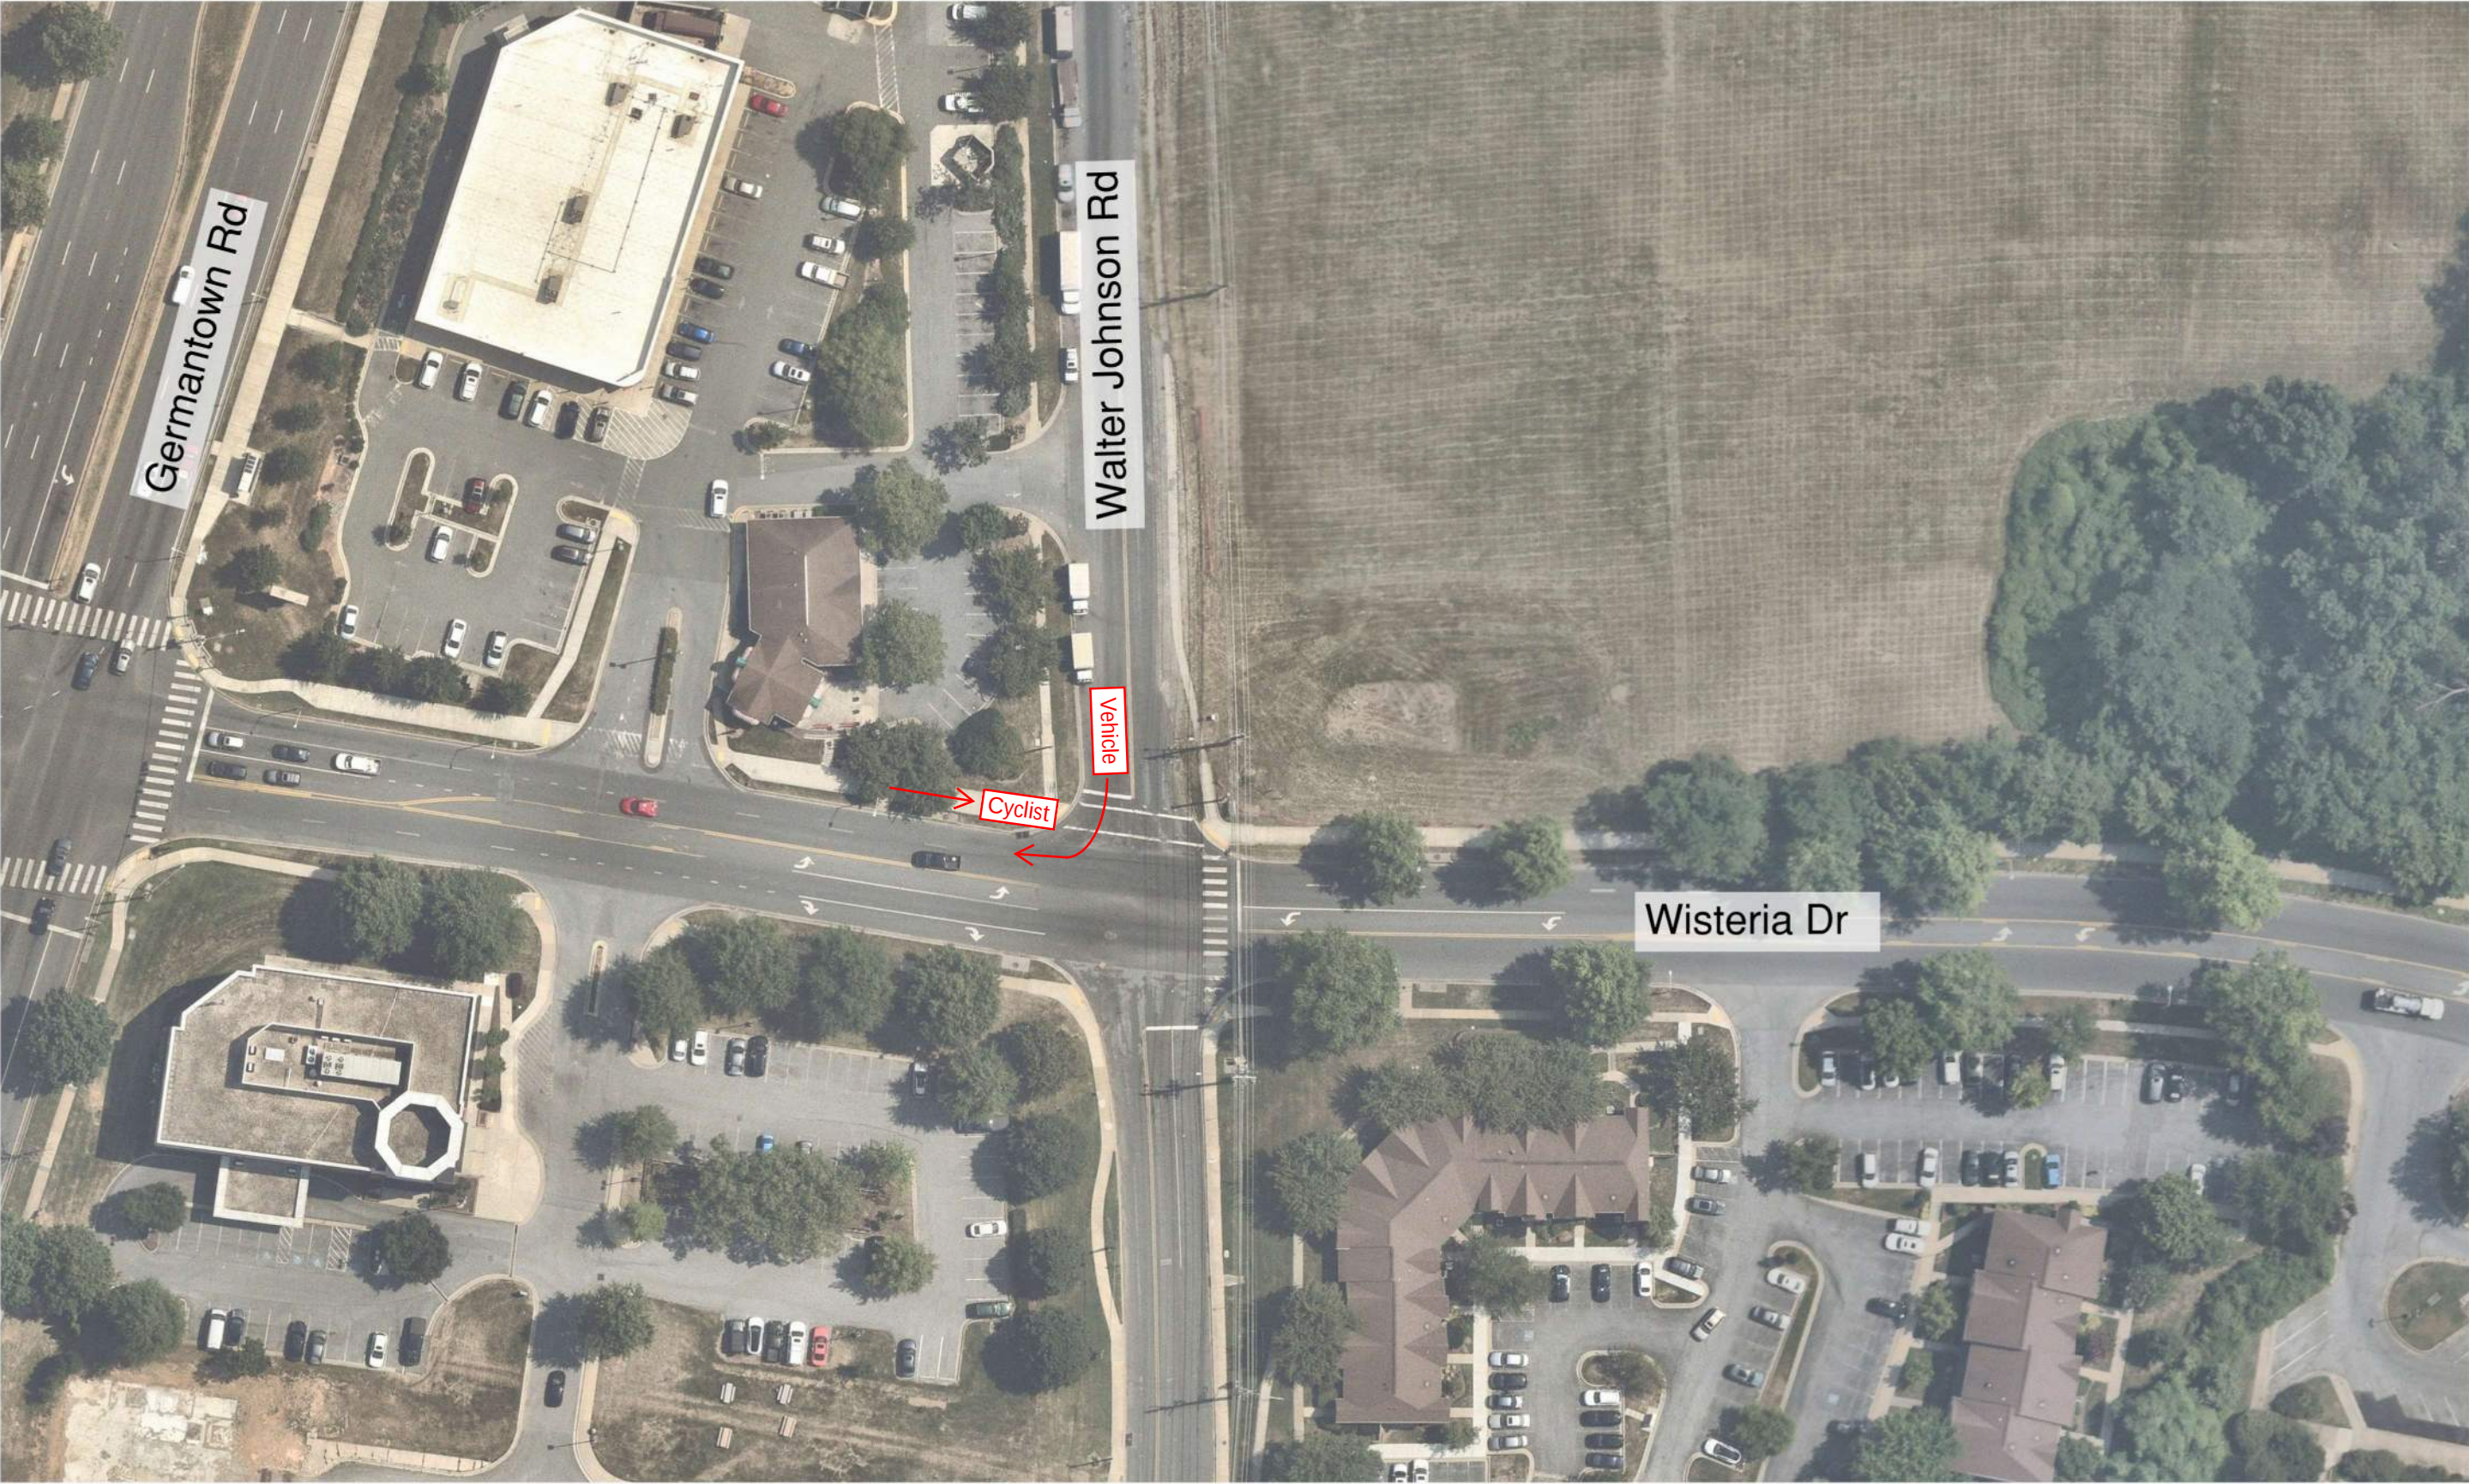
Figure 2 - Crash Diagram

On Wednesday, March 6, 2024, at approximately 4:40 PM, a motorist traveling southbound along Walter Johnson Road stopped at the stop sign at Wisteria Drive, then began turning right on to westbound Wisteria Drive. A cyclist was traveling eastbound on the shared use path on the north side of the street. According to the crash report, the cyclist stated that he saw the vehicle turning left but was not able to brake in time. The cyclist struck the right front corner of the turning vehicle. The crash report indicated the cyclist failed to yield right of way. It was raining at the time of the crash, the roadway surface was wet, and it was daylight. The cyclist suffered minor injuries.

**Figure 2** illustrates the crash location and direction of pedestrian and vehicle travel.

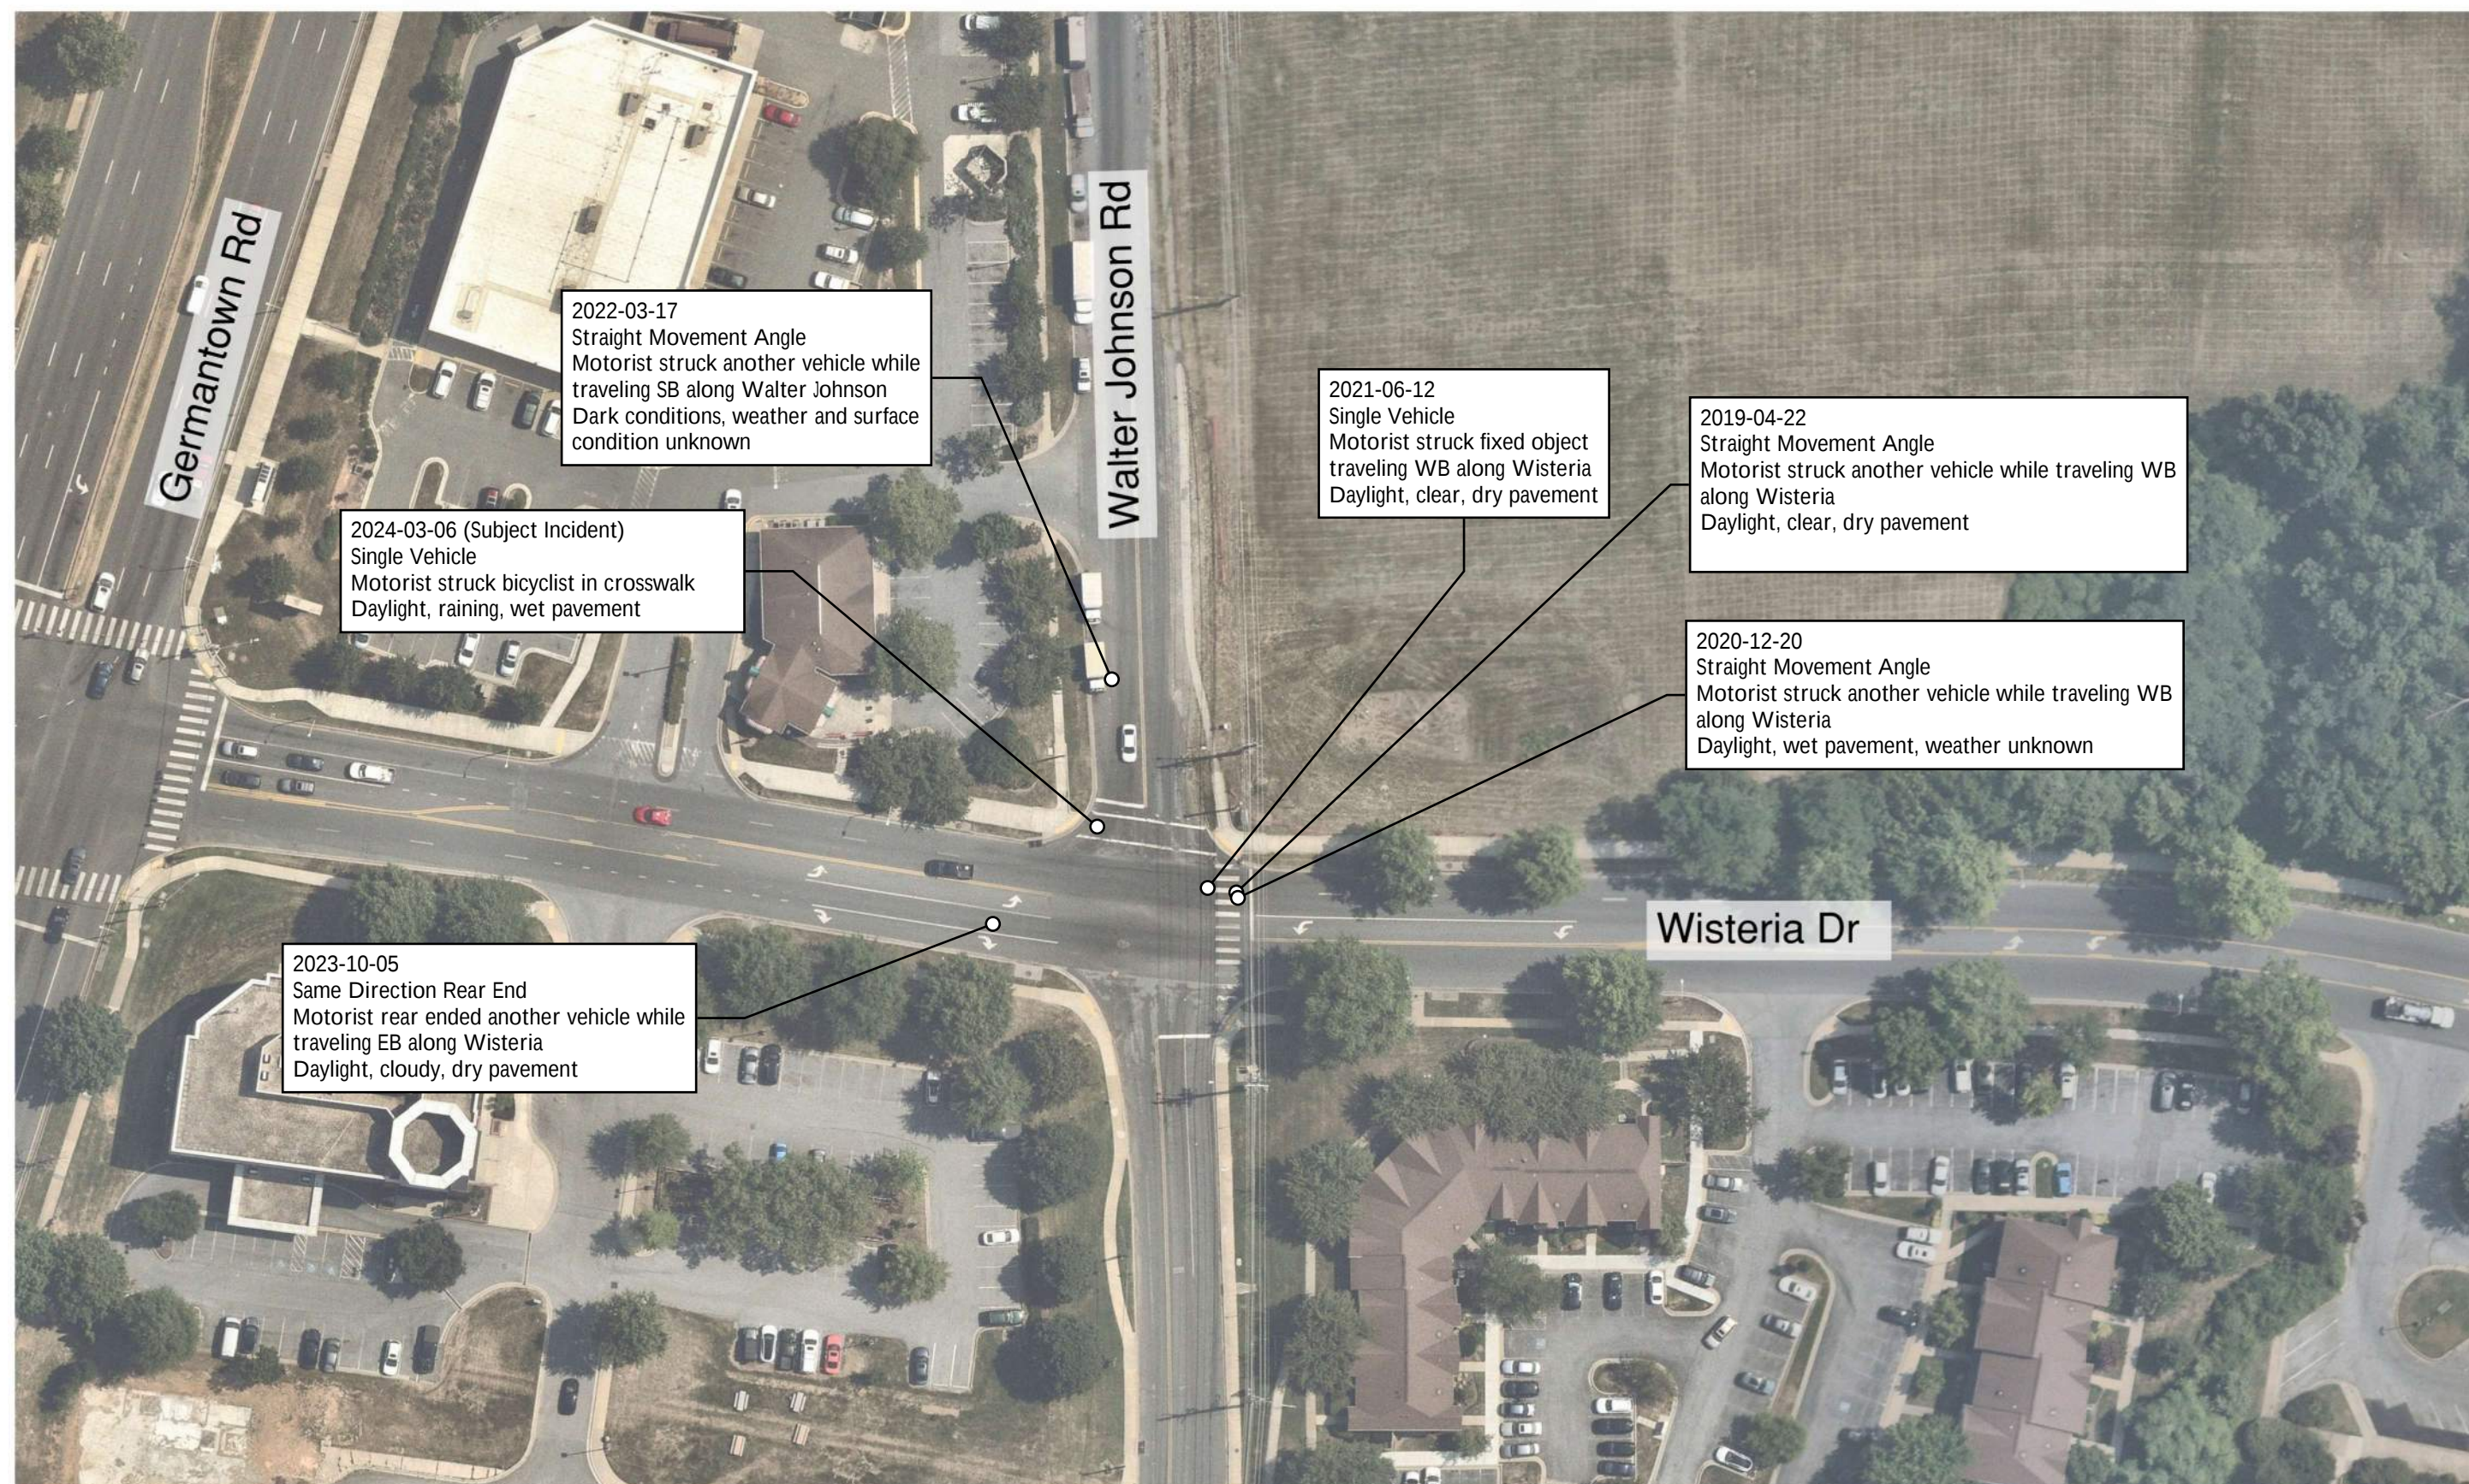
Figure 3 - Crash History (2019-2024)

Crash data obtained from dataMontgomery indicates six (6) crashes occurred at the intersection of Wisteria Drive at Walter Johnson Road between April 2019 and September 2024. Three (3) of the crashes were classified as “straight movement-angle collisions”, two (2) were “single vehicle collisions”, and one (1) was a “same direction rear-end collision”. Of the six crashes noted in the report, four (4) were identified as “property damage only” and two (2) as “injury” crashes, one of which involved a bicyclist. The incidents are illustrated on **Figure 3**.
