# SCHOOL-RELATED CRASH REVIEW

**Location:** Bel Pre Road at the Entrance to Plaza del Mercado Shopping Center (west of Layhill Road)

**Crash Date:** April 29, 2024

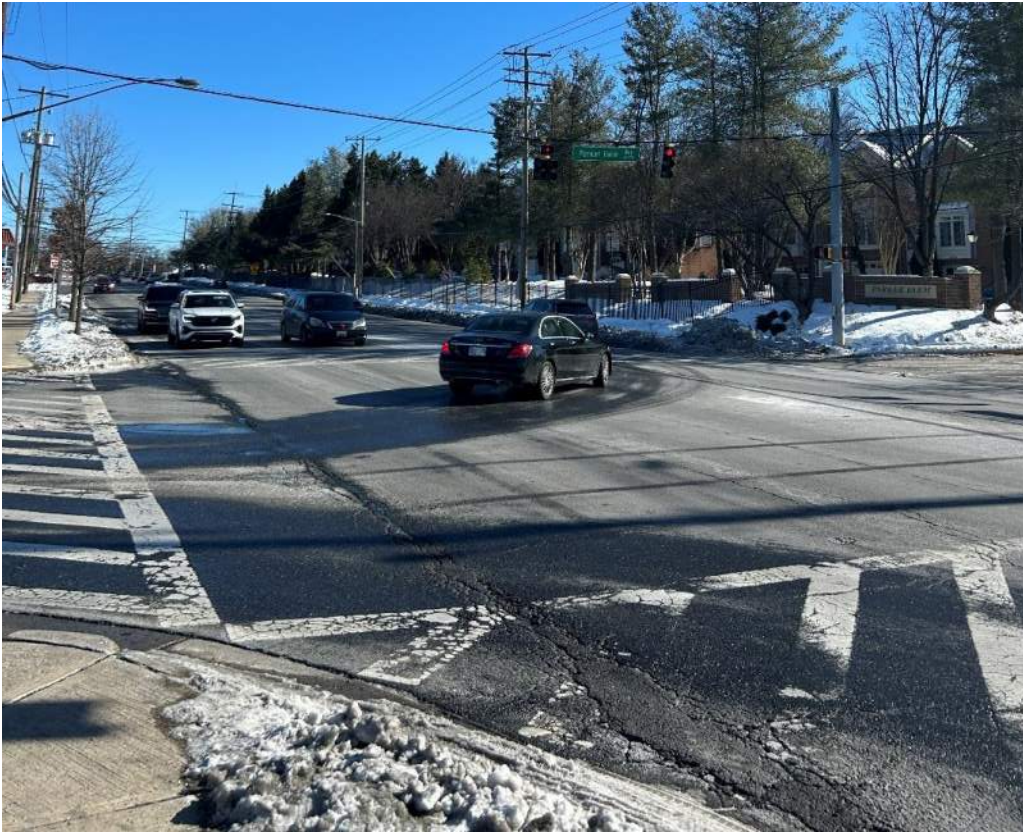
**Photo 1. Taken from the northwest corner looking east along Bel Pre Road. Approximate crash location.**

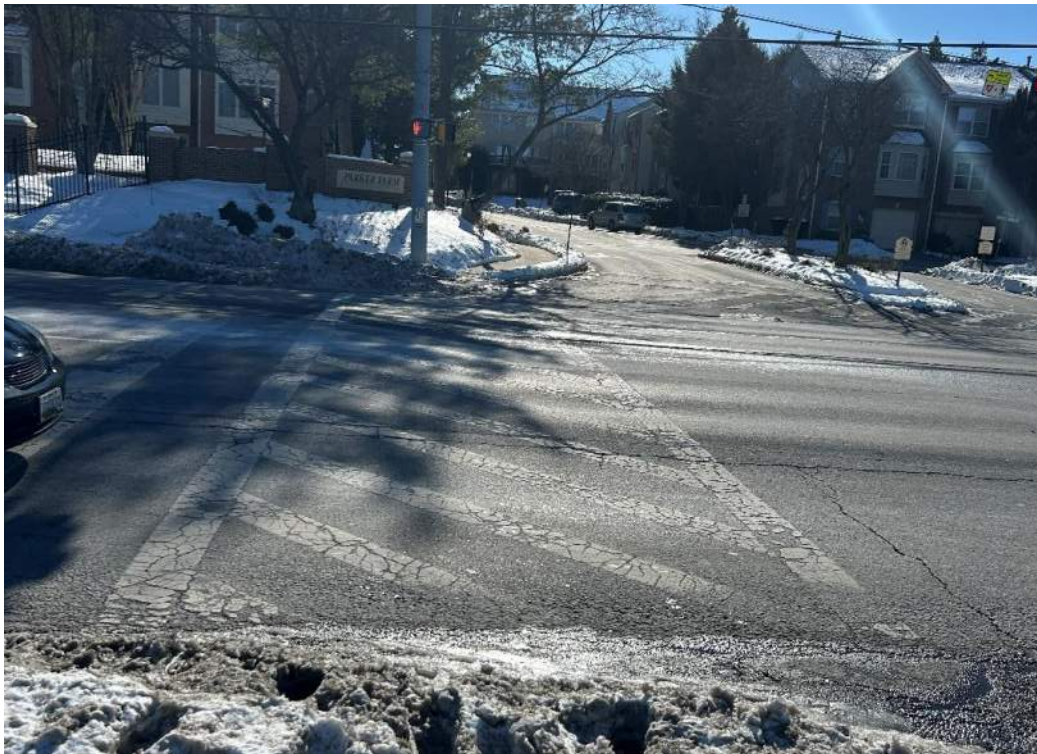
**Photo 2. Taken from the northeast corner looking north. Approximate crash location.**

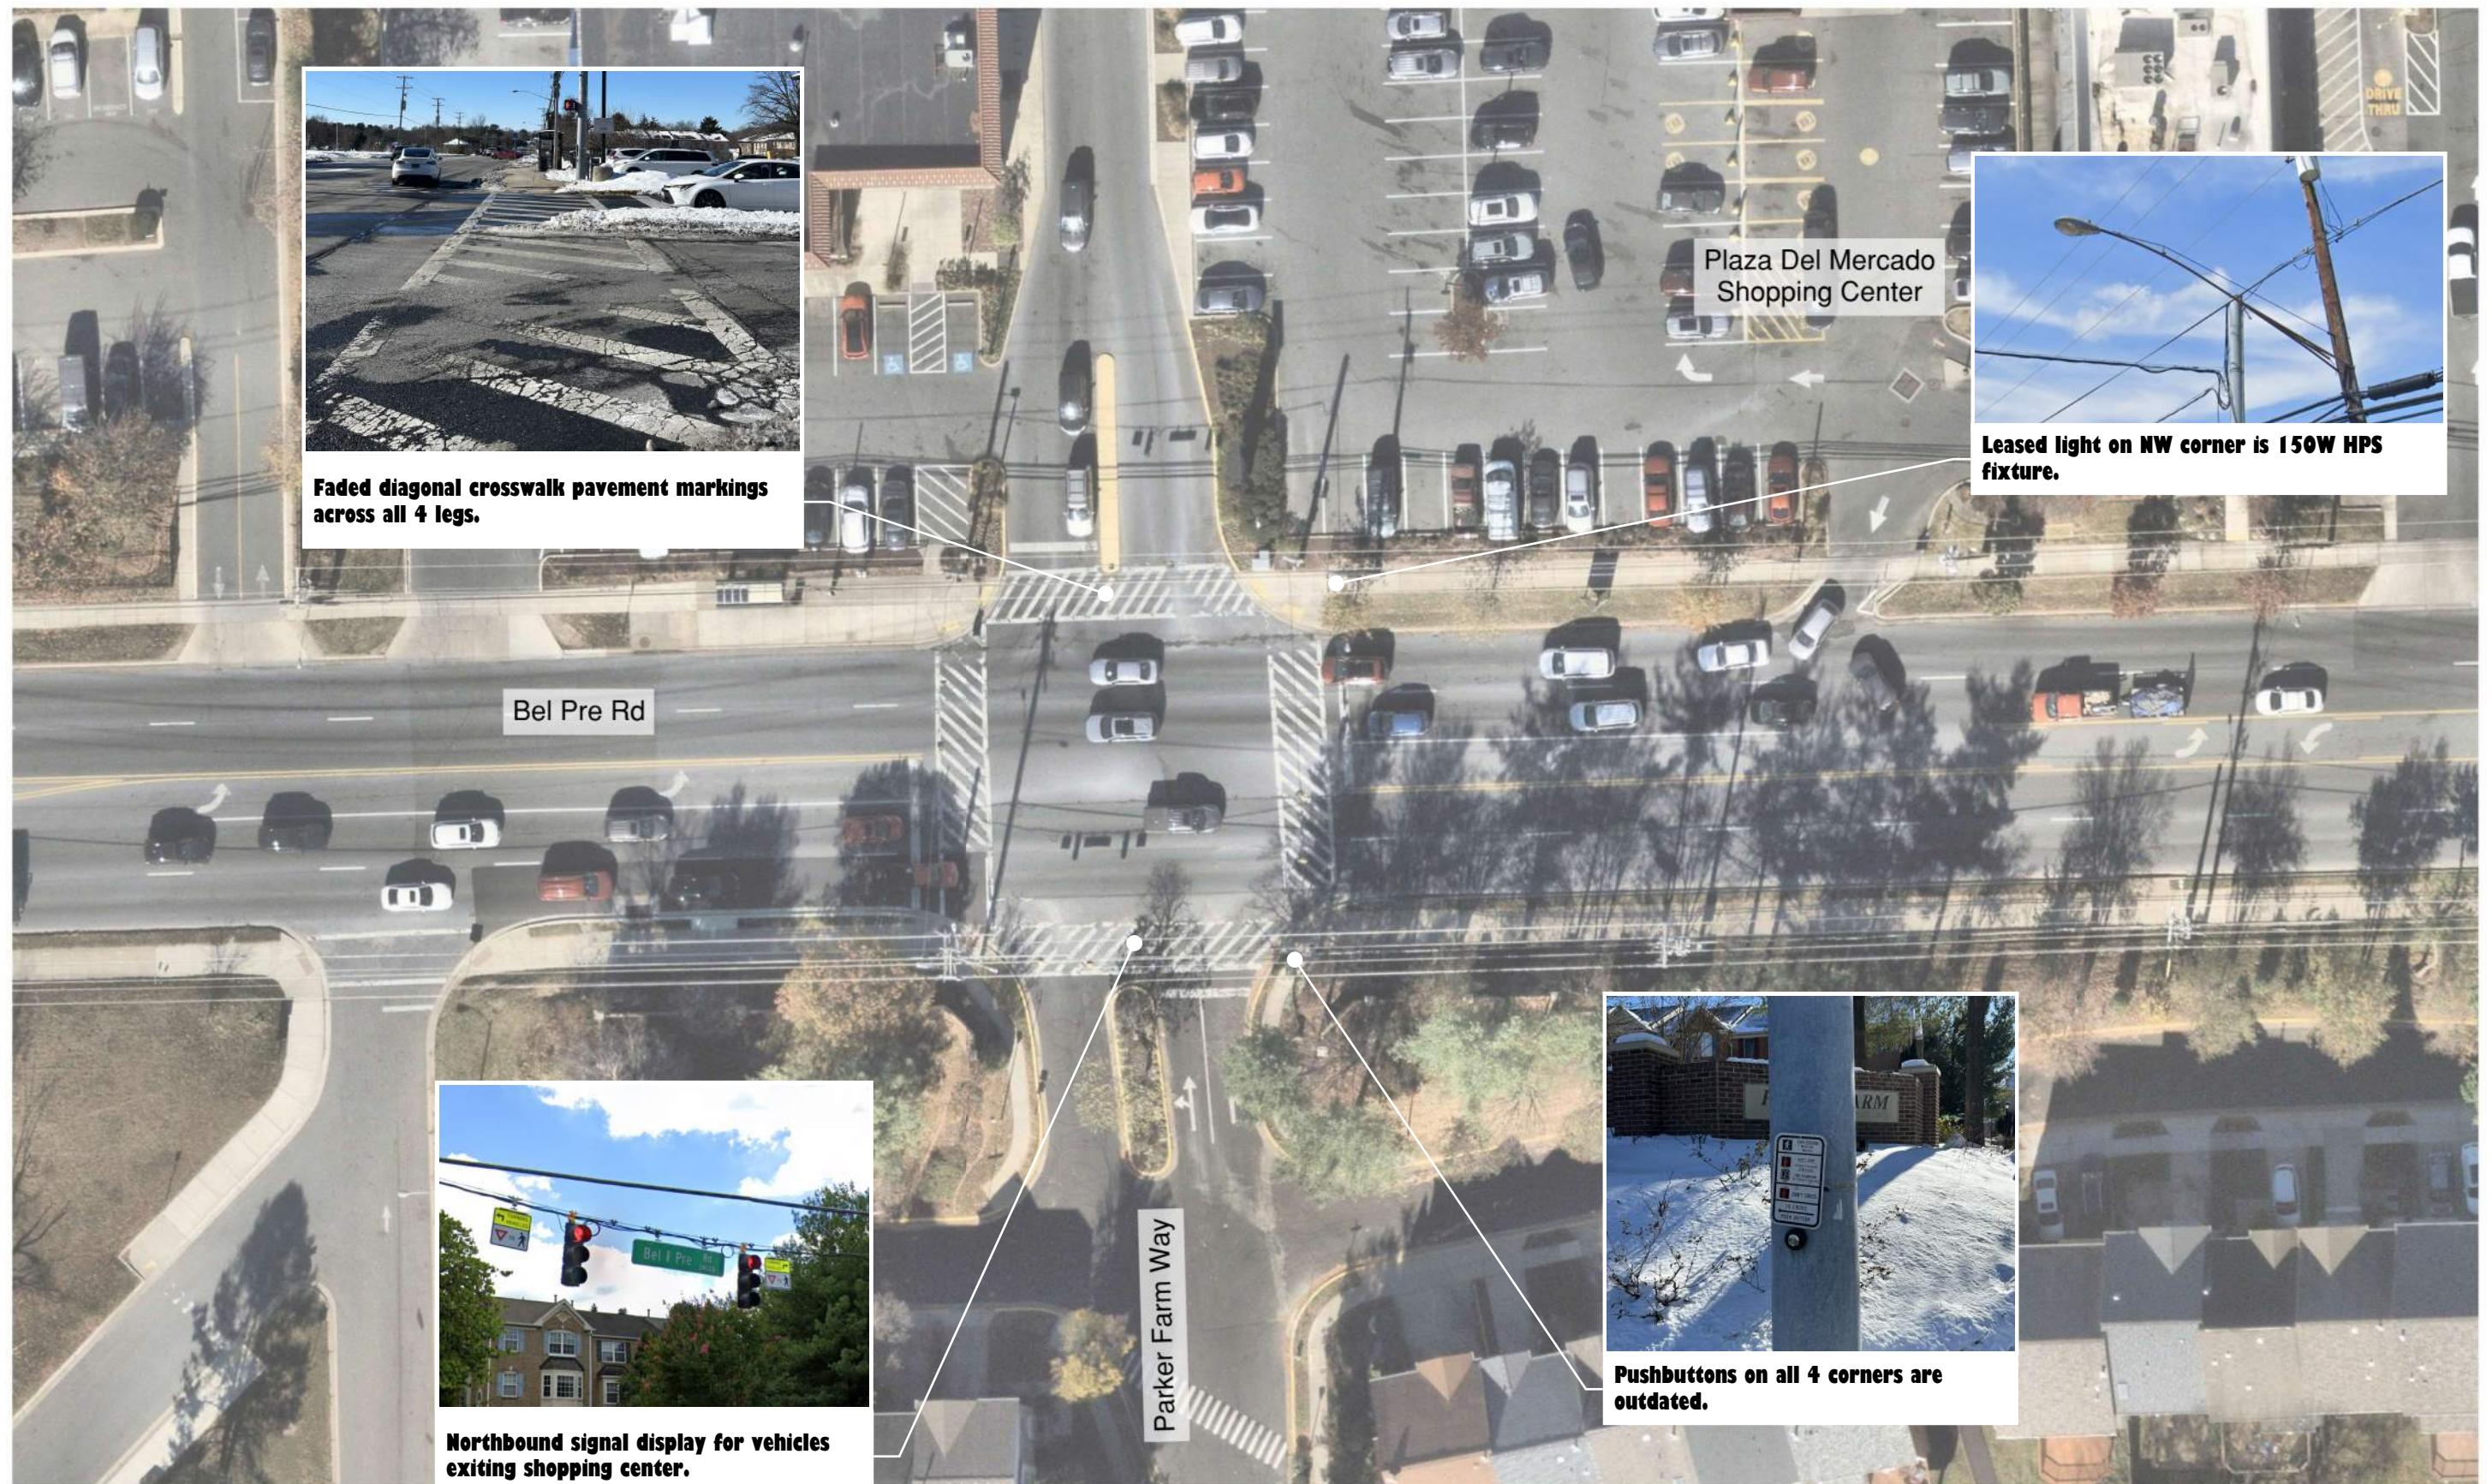
**Figure 1 - Bel Pre Road Corridor Observations**

Refer to **Figure 1** in the attachments for additional details on the Bel Pre Road segment.

The Bel Pre Road corridor was evaluated between Atrodome Drive to the west and Layhill Road to the east, to identify potential infrastructure, maintenance activities, and road user behaviors that contribute to increased safety risk at and in the vicinity of the school-related crash location. Please refer to **Figure 1** for additional information.

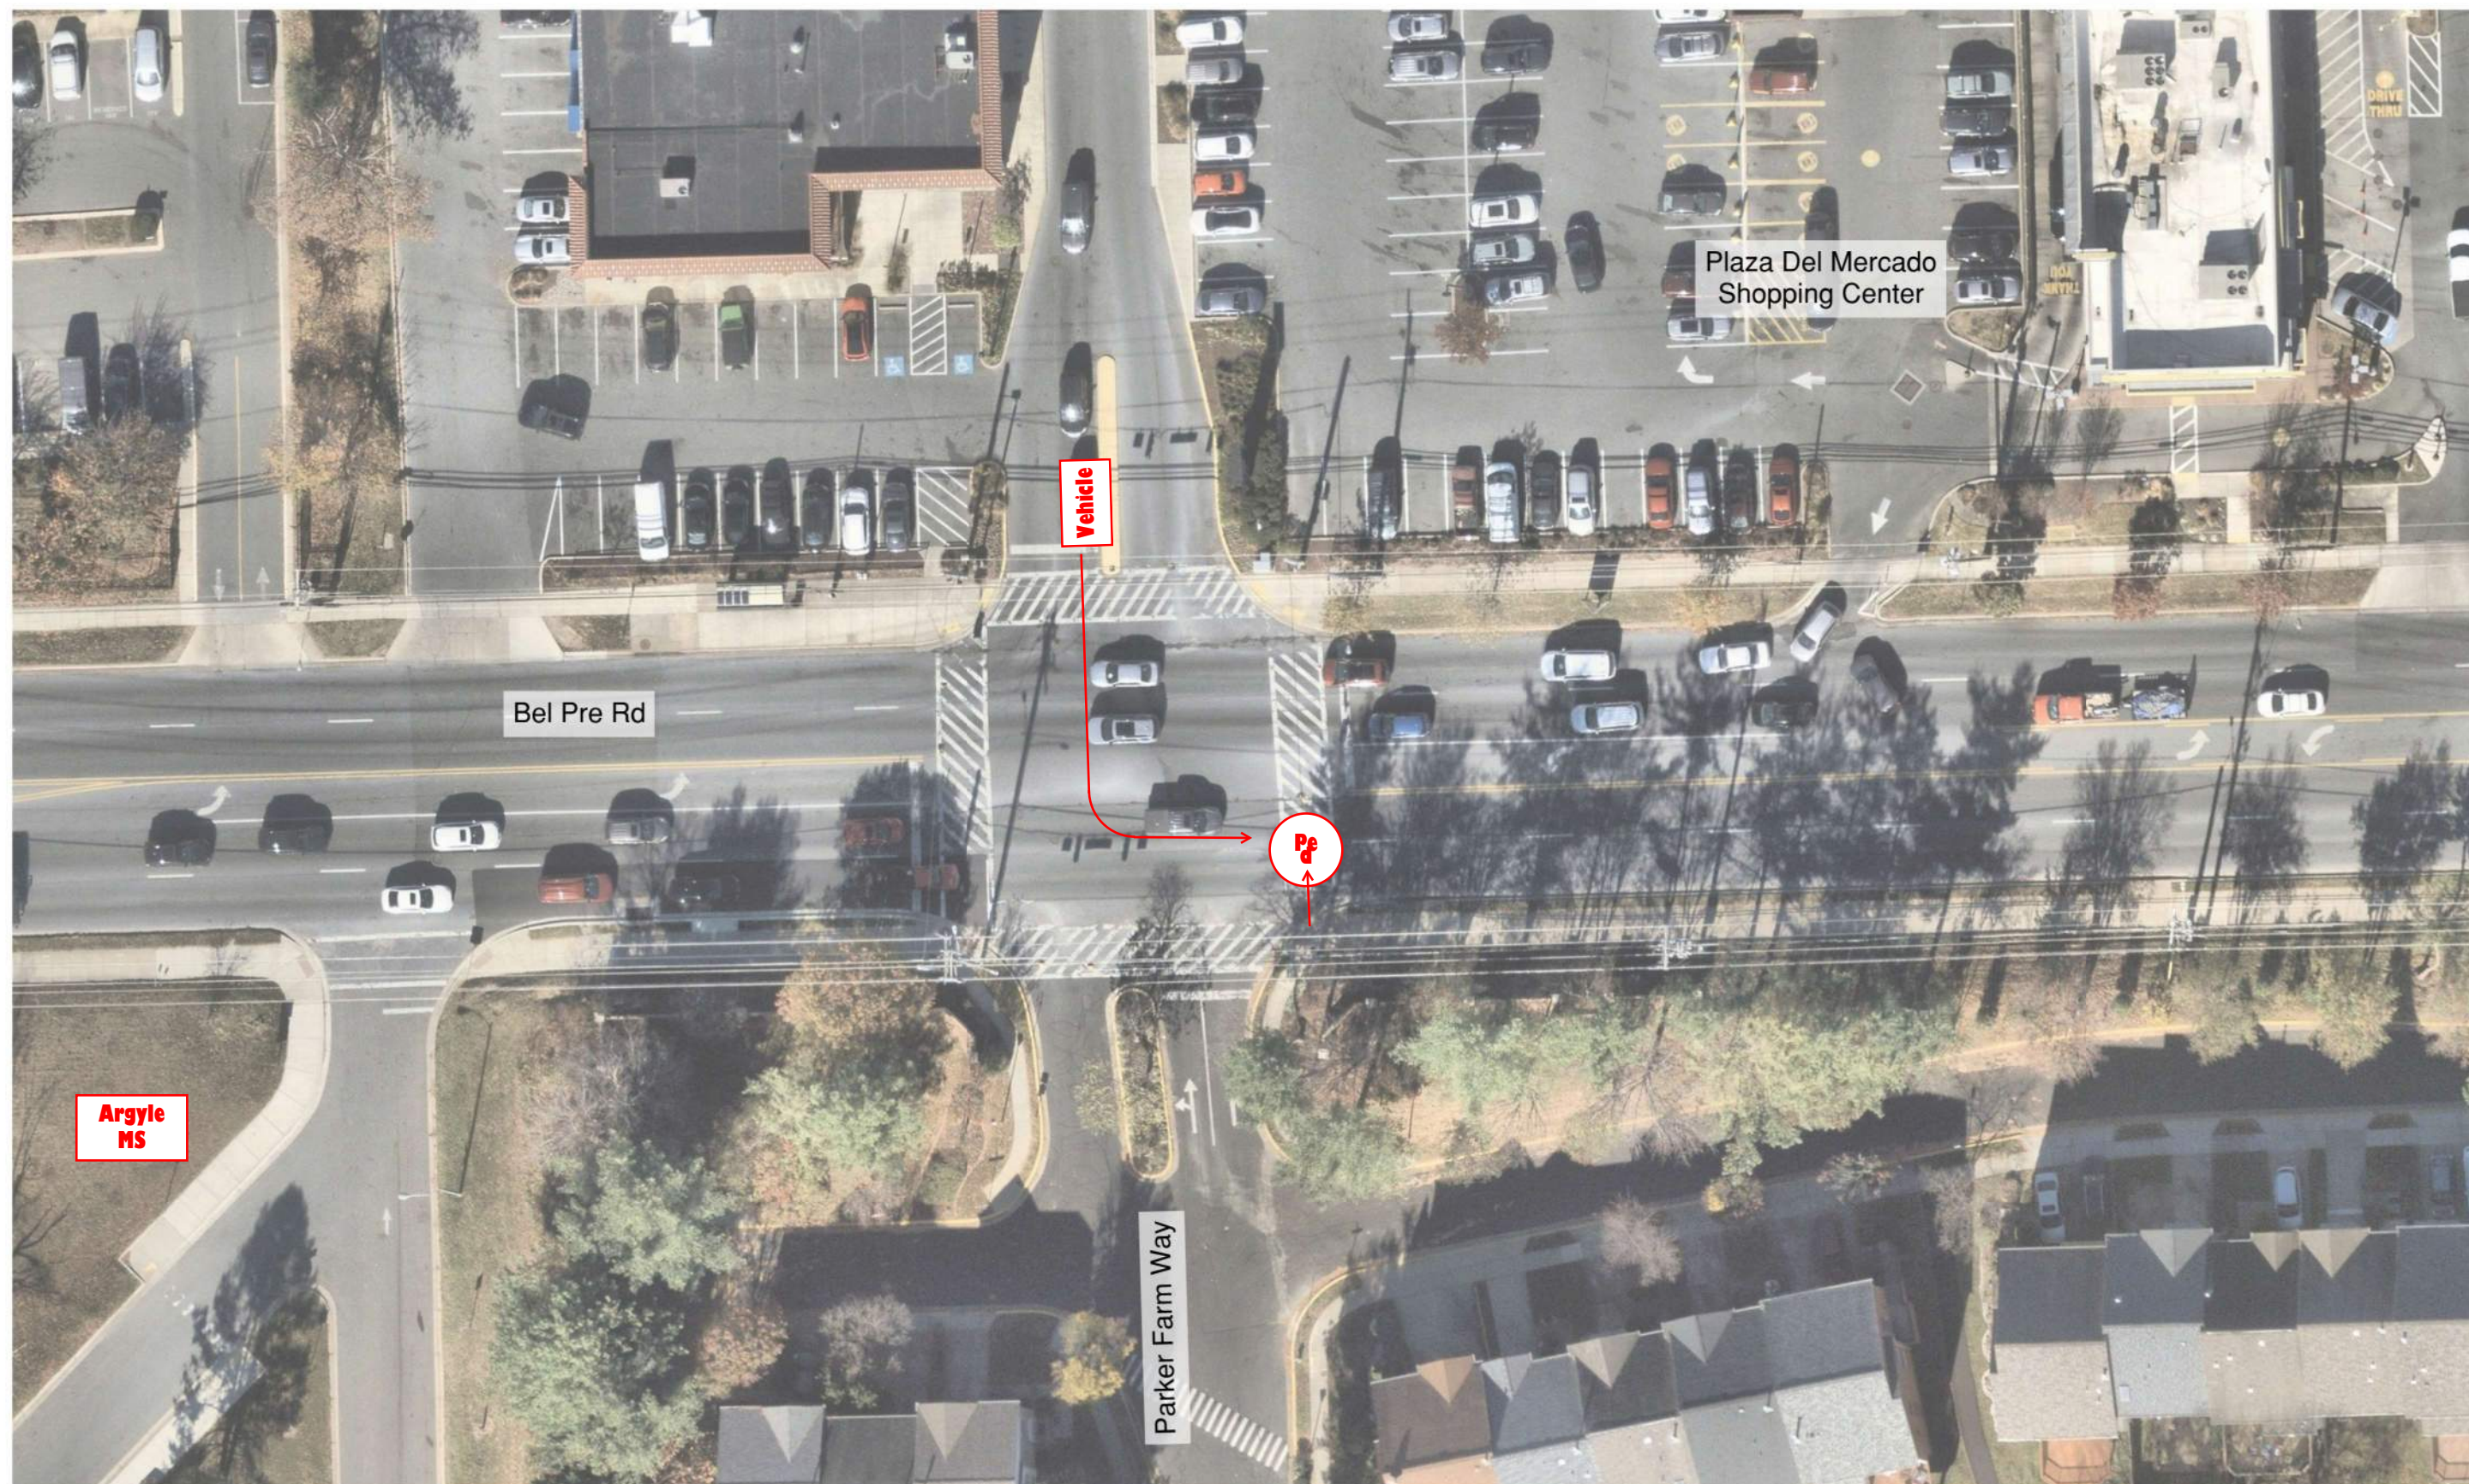
**Figure 2 - Crash Diagram**

On Monday, April 29, 2024, at approximately 7:44 AM, a motorist was making a left turn from the Plaza del Mercado Shopping Center to eastbound Bel Pre Road and struck a pedestrian crossing the east leg of Bel Pre Road from south to north. The pedestrian was in the crosswalk when the motorist collided with the pedestrian. According to the police report, the pedestrian suffered minor injuries. Daytime weather conditions were clear, and the roadway surface was dry.

**Figure 2** illustrates the crash location and direction of cyclist and vehicle travel.
