# SCHOOL-RELATED CRASH REVIEW

**Location:** Woodson Avenue south of Astoria Road

**Crash Date:** May 6, 2024

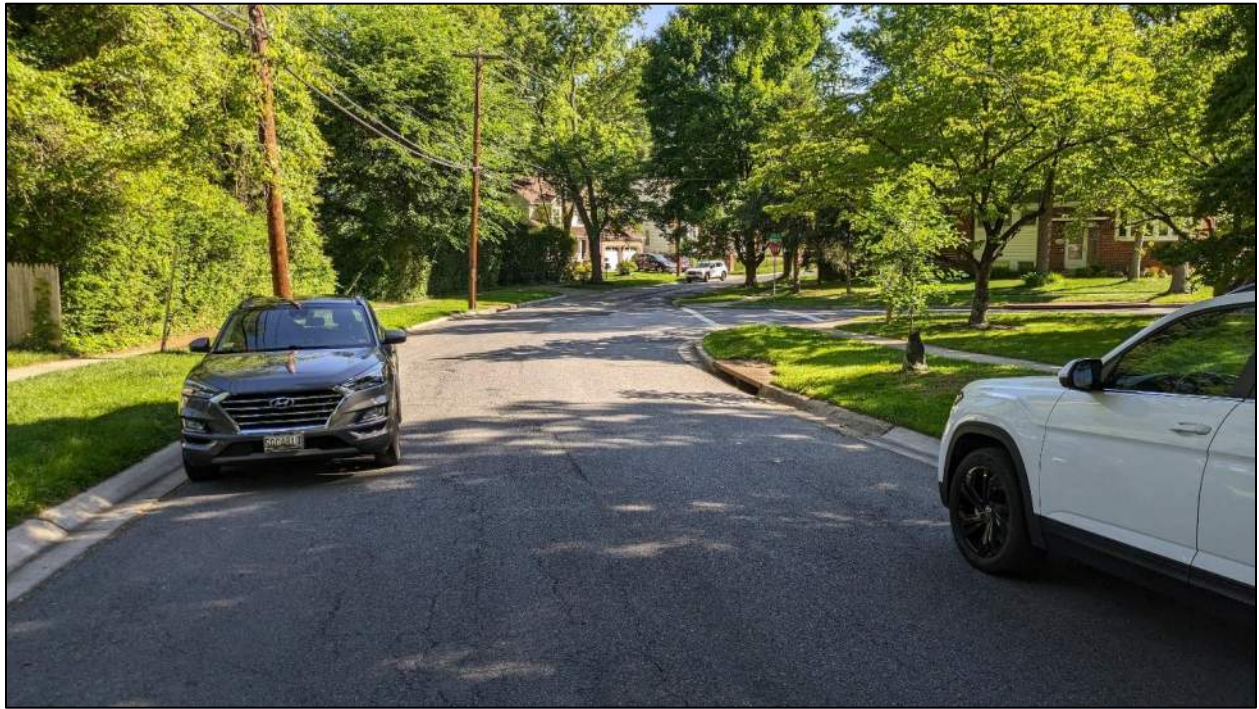
On Monday, May 6, 2024, at approximately 3:49 PM, a motorist traveling southbound along Woodson Avenue collided with two pedestrians/students crossing Woodson Avenue in an easterly direction. The collision occurred approximately 50 feet south of the Woodson Avenue intersection with Astoria Road. The daylight crash occurred during cloudy conditions and the roadway surface was dry. The pedestrians suffered minor injuries.

**Photo 1. Woodson Avenue looking north towards Astoria Road. Approximate crash location.**

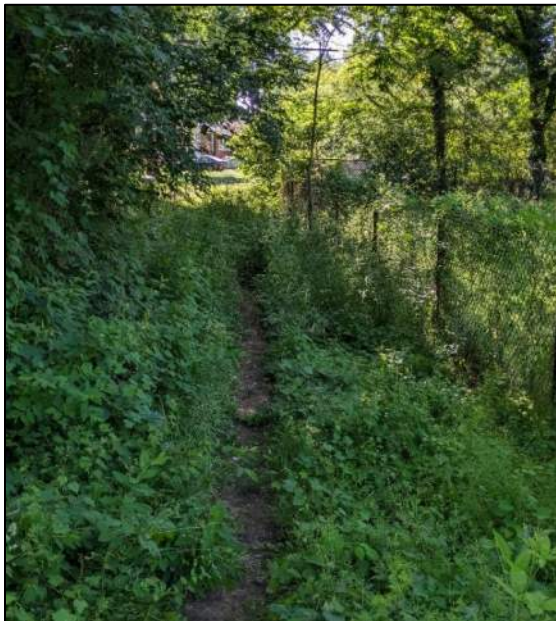
The west lot adjacent to the Woodson Avenue at Astoria Road intersection is owned and maintained by MDOT SHA as a storm water management facility. The facility displays “No Trespassing” signs and includes a chain link boundary fence. A chain link fence also runs behind the W-beam set along northbound MD 185 (Connecticut Avenue). A hole was cut in the chain link fence to provide unauthorized access between MD 185 (Connecticut Avenue) and Woodson Avenue via a worn pathway that follows the northern boundary of the storm water management facility.

During the field review, the student/pedestrian observed using the pathway indicated that many students use this pathway as a shortcut to Albert Einstein HS. All three (3) schools – Rock View ES, Newport Mill MS, and Albert Einstein HS – have walkshed boundaries that span the MD 185 (Connecticut Avenue) corridor. The Rock Creek Palisades Townhomes and bus transit stops create a desire line for crossing MD 185 (Connecticut Avenue) and to provide the most direct walking route to/from Albert Einstein HS. Students traveling to the nearest protected crossing of MD 185 (Connecticut Avenue) add 10 minutes to their trip, each way. The pedestrians/students involved in the subject crash did not use of this shortcut.

**Photo 2. Worn path adjacent to SWM facility.**

1. Consider converting the Woodson Avenue/Astoria Road intersection to all-way stop control. Advance warning signs, crosswalk markings, and ADA ramps should be installed as necessary. This work was completed in winter 2024. See **Photo 6**.
2. Coordinate with MDOT SHA to request the existing chain link fence along the east side of MD 185 (Connecticut Avenue) bounding the storm water management facility be maintained and repaired as needed to discourage use of the cut thru path and midblock crossings of Connecticut Avenue north of Denfeld Avenue.

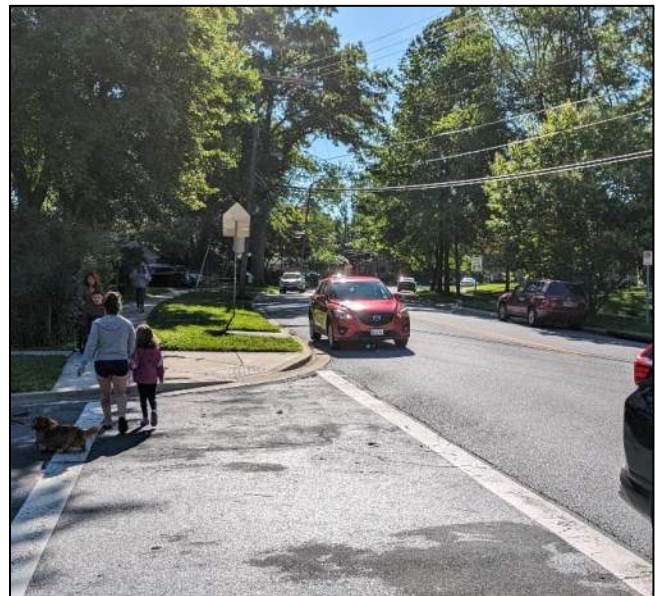
Pedestrian activity was concentrated closer to Denfeld Avenue, where most pedestrians cross MD 185 (Connecticut Avenue) while traveling to/from Rock View ES. Two (2) crossing guards were present at the intersection of MD 185 (Connecticut Avenue) at Denfeld Avenue. Most students were accompanied by adults.

**Photo 3. Pedestrians along Denfeld Avenue.**

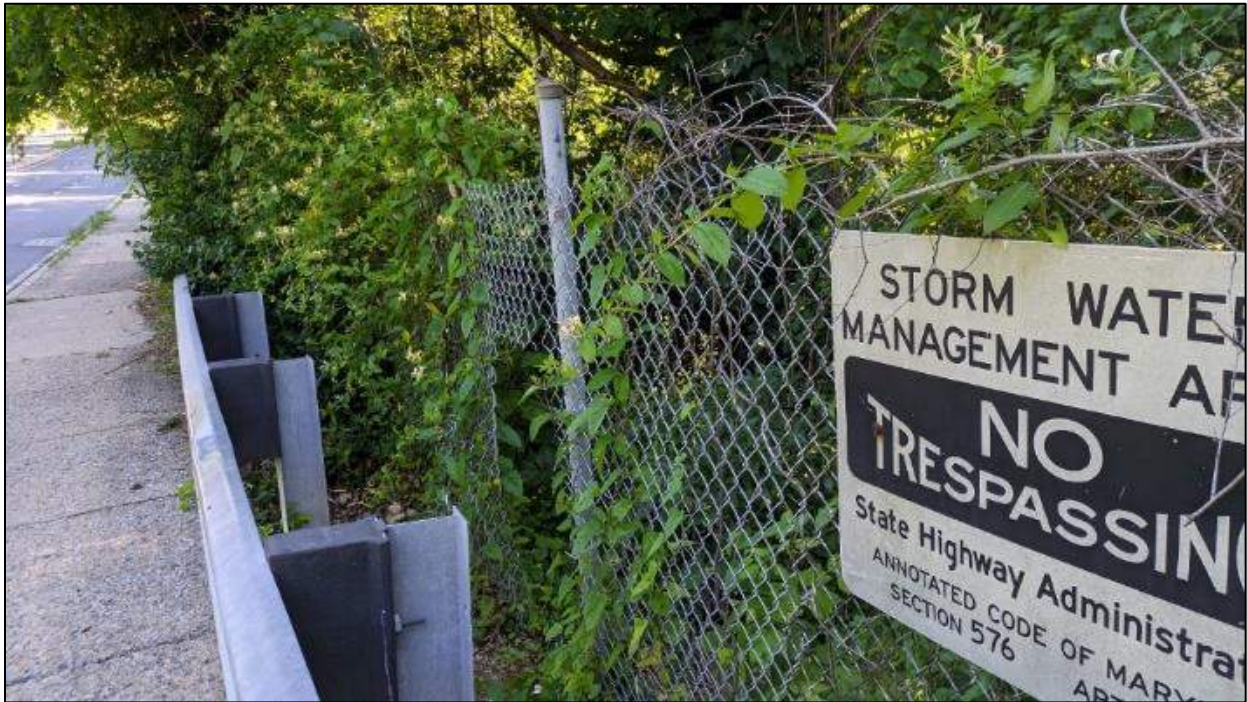
Photo 4. Fence breach along Connecticut Avenue.

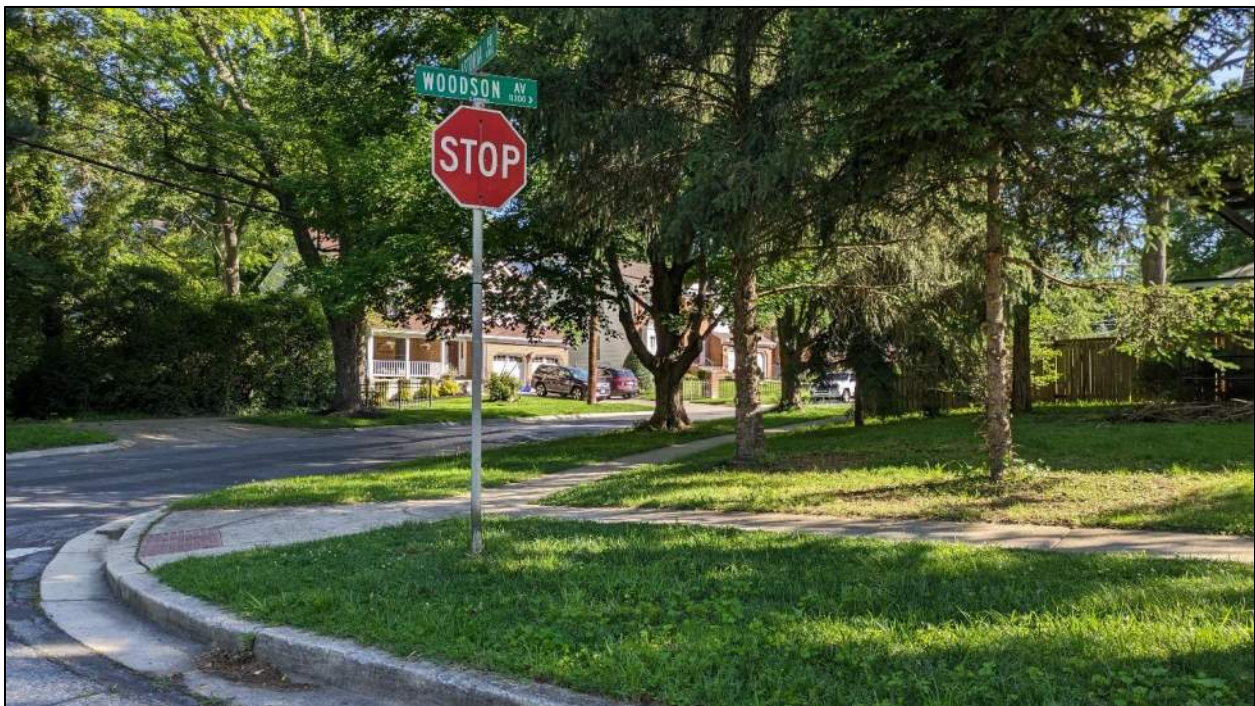
Photo 5. Obstructed sight line for Astoria Road approach looking north up Woodson Avenue.

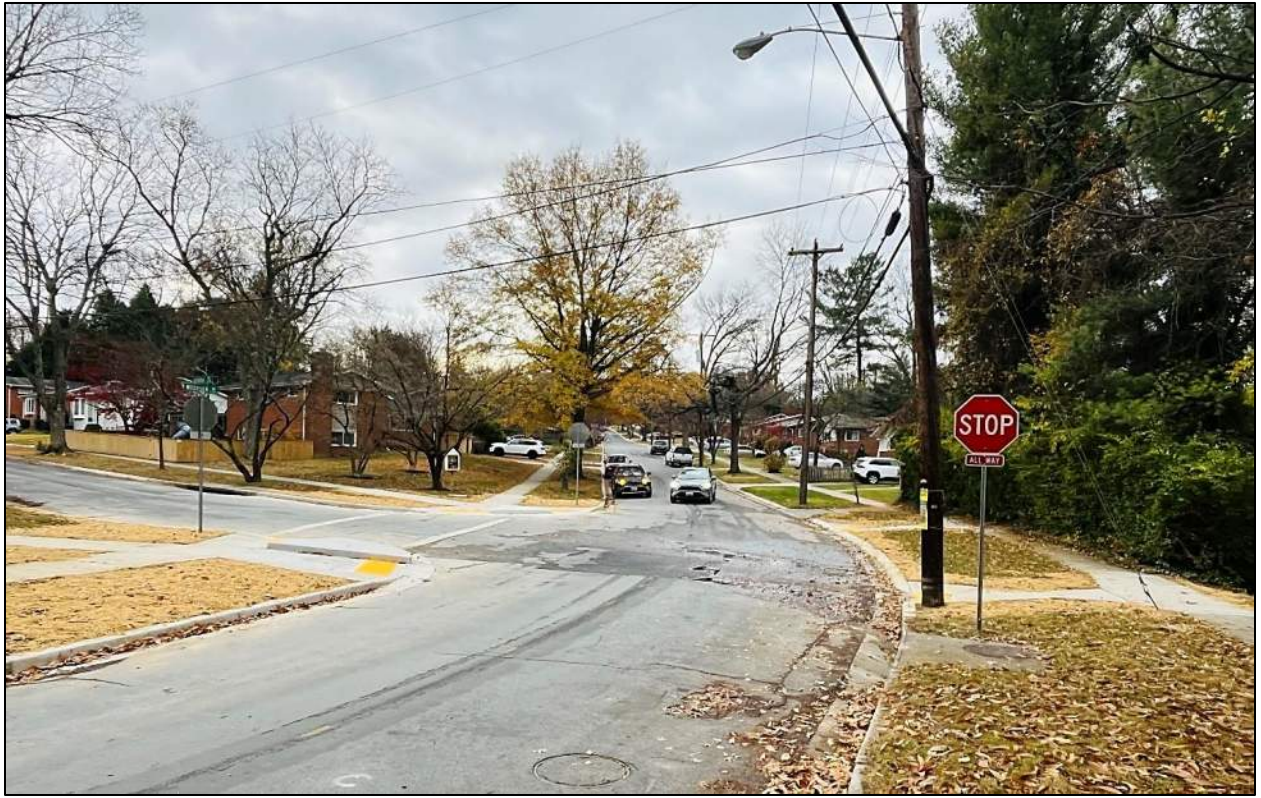
**Photo 6. All-Way Stop Control implemented at the intersection of Woodson Avenue at Astoria Road.**

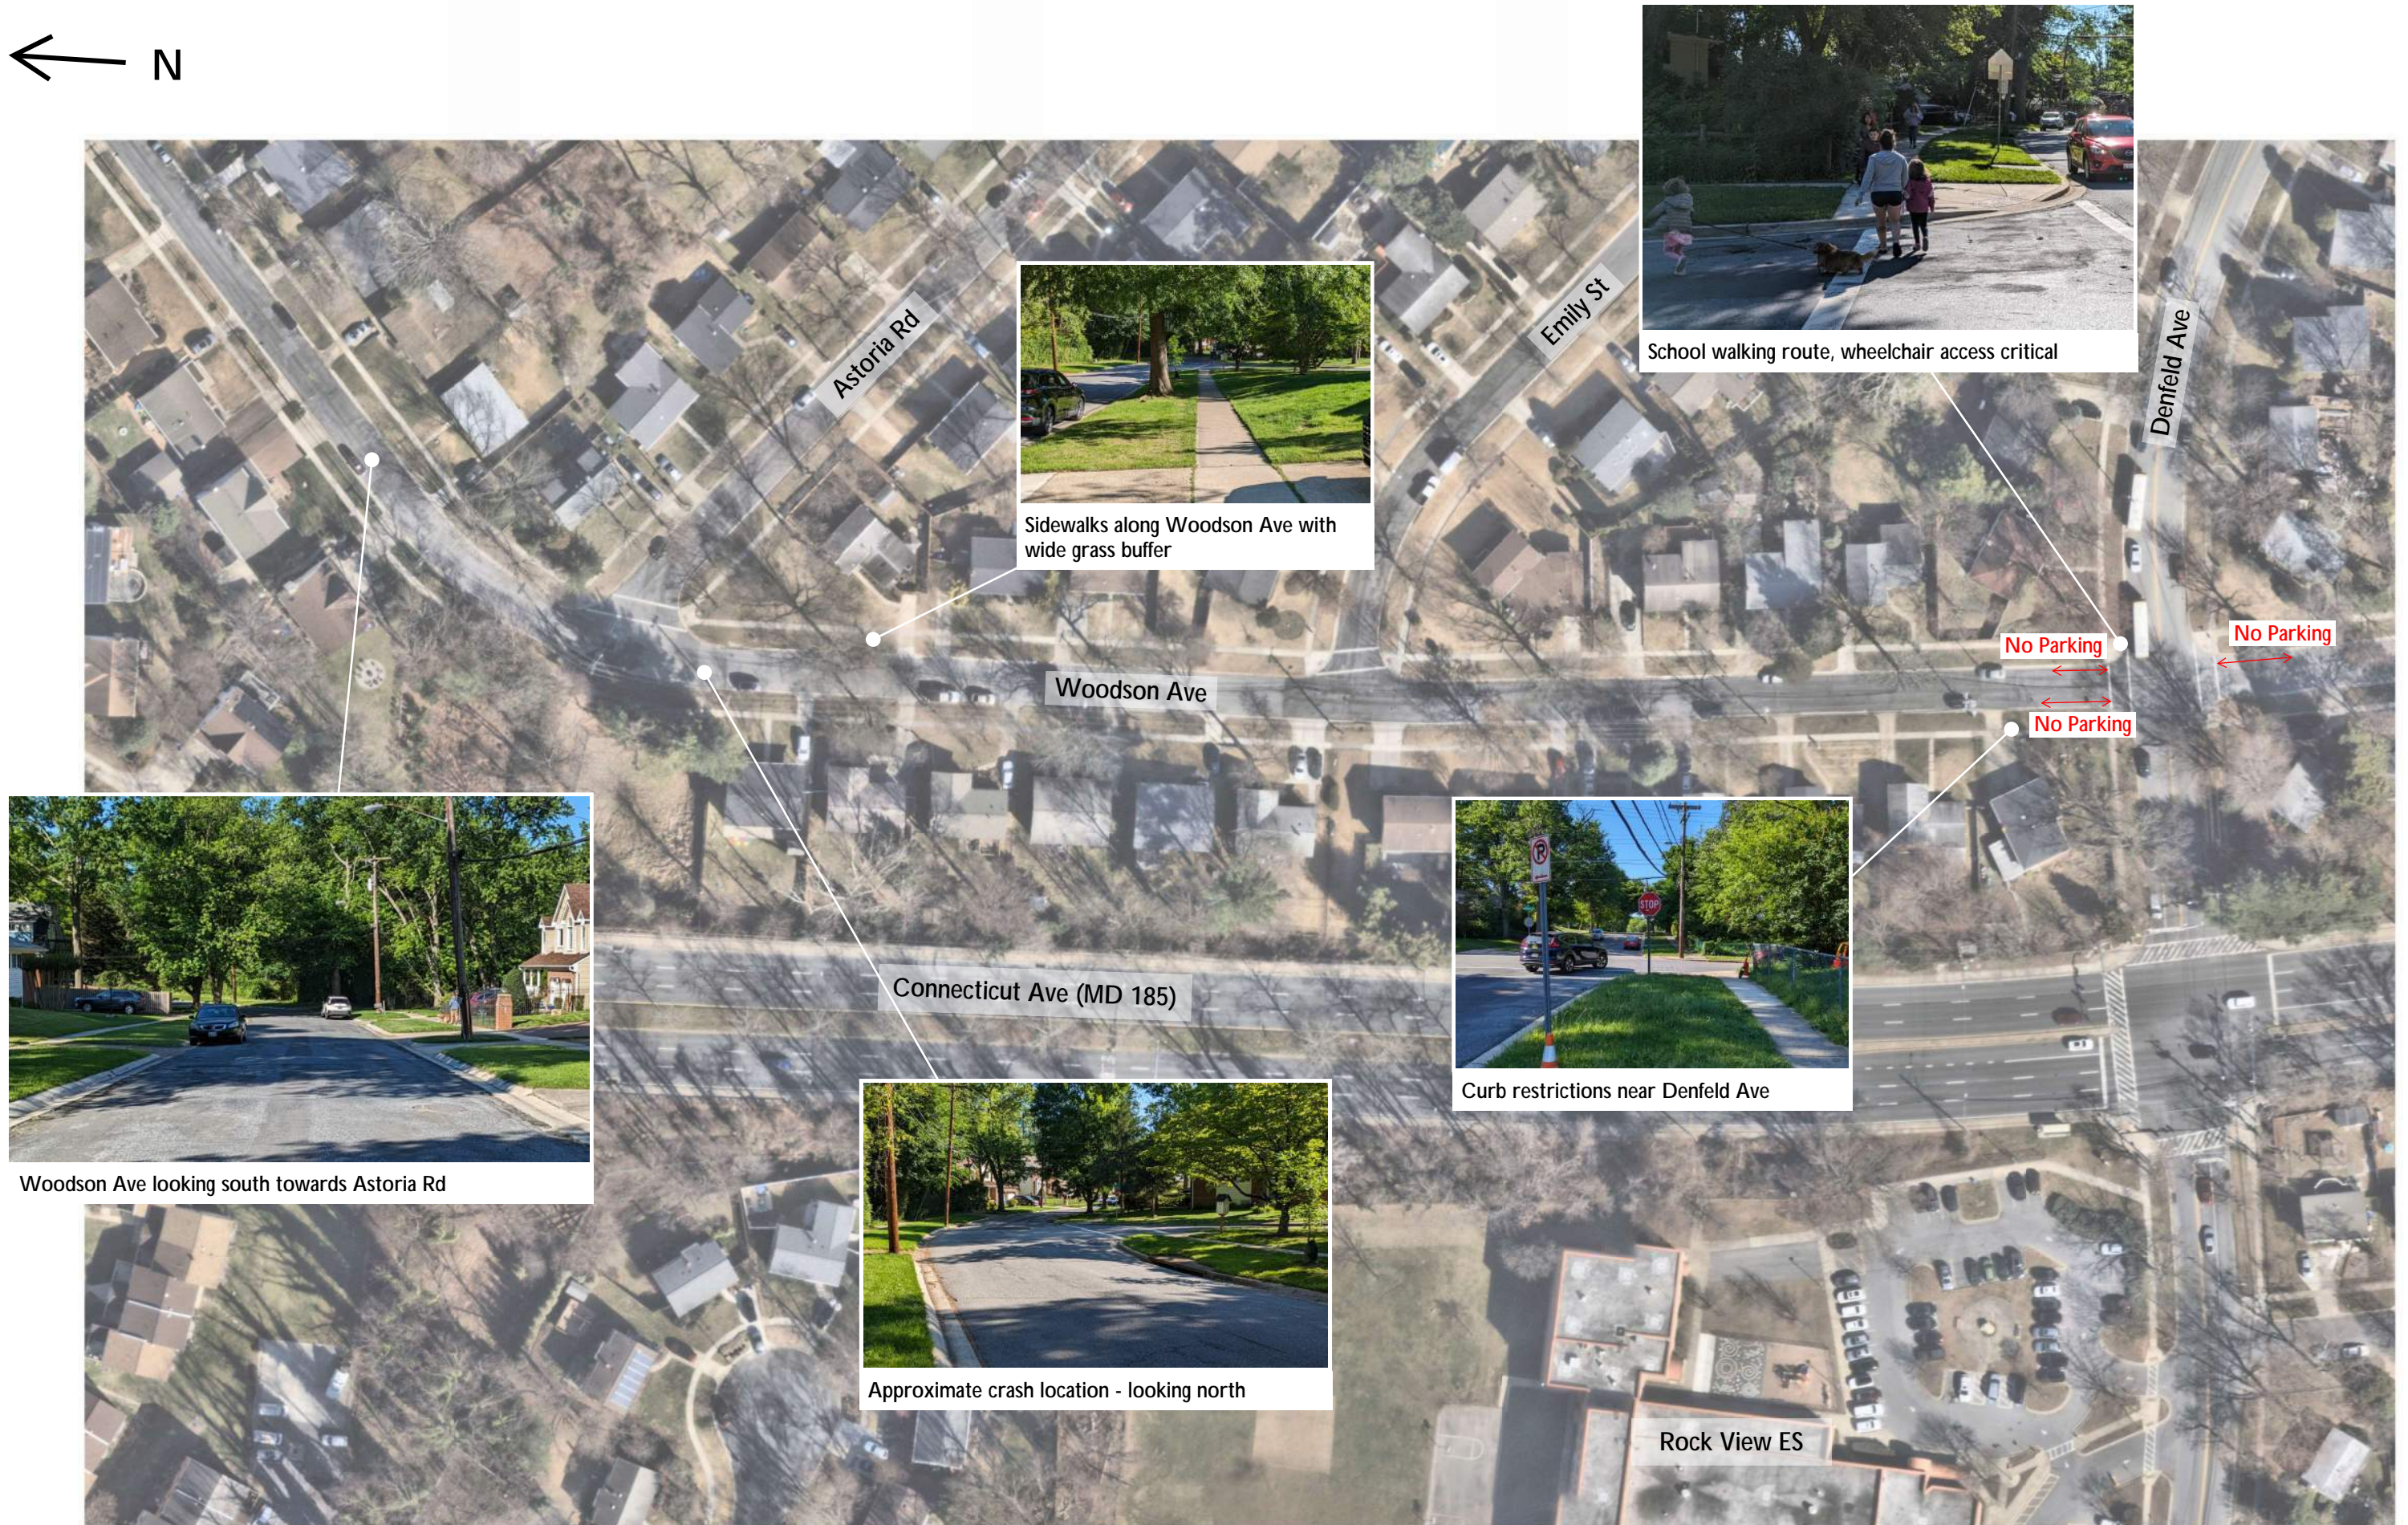
Figure 1 - Woodson Avenue Corridor Observations

Woodson Avenue is a 25-foot-wide “Neighborhood Yield Street” and is generally oriented in the north-south direction. Woodson Avenue has grass-buffered, four-foot-wide sidewalks along both sides of the street. Woodson Avenue is approximately 3,300 feet long, with a speed limit of 25 MPH, between Wexford Drive to the south and Lund Place to the north. On-street parking is permitted along most of the Woodson Avenue segment, except for posted restrictions near the intersection with Denfeld Avenue. Refer to **Figure 1** in the attachments for additional details of the Woodson Avenue segment.

The Woodson Avenue corridor was evaluated to identify potential infrastructure, maintenance activities, and road user behaviors that contribute to increased safety risk at and in the vicinity of the school-related crash location. The Woodson Avenue corridor was reviewed between Denfeld Avenue to the south and Soward Drive to the north. There is one horizontal curve along this segment directly adjacent to the intersection with Astoria Road. The segment also includes sag vertical curve with the low point at Astoria Road. The horizontal and vertical curvature constrain lines of sight and observations show the grade changes result in variable acceleration and deceleration rates by motors traveling the corridor. Please refer to **Figures 1 and 2** for additional information.

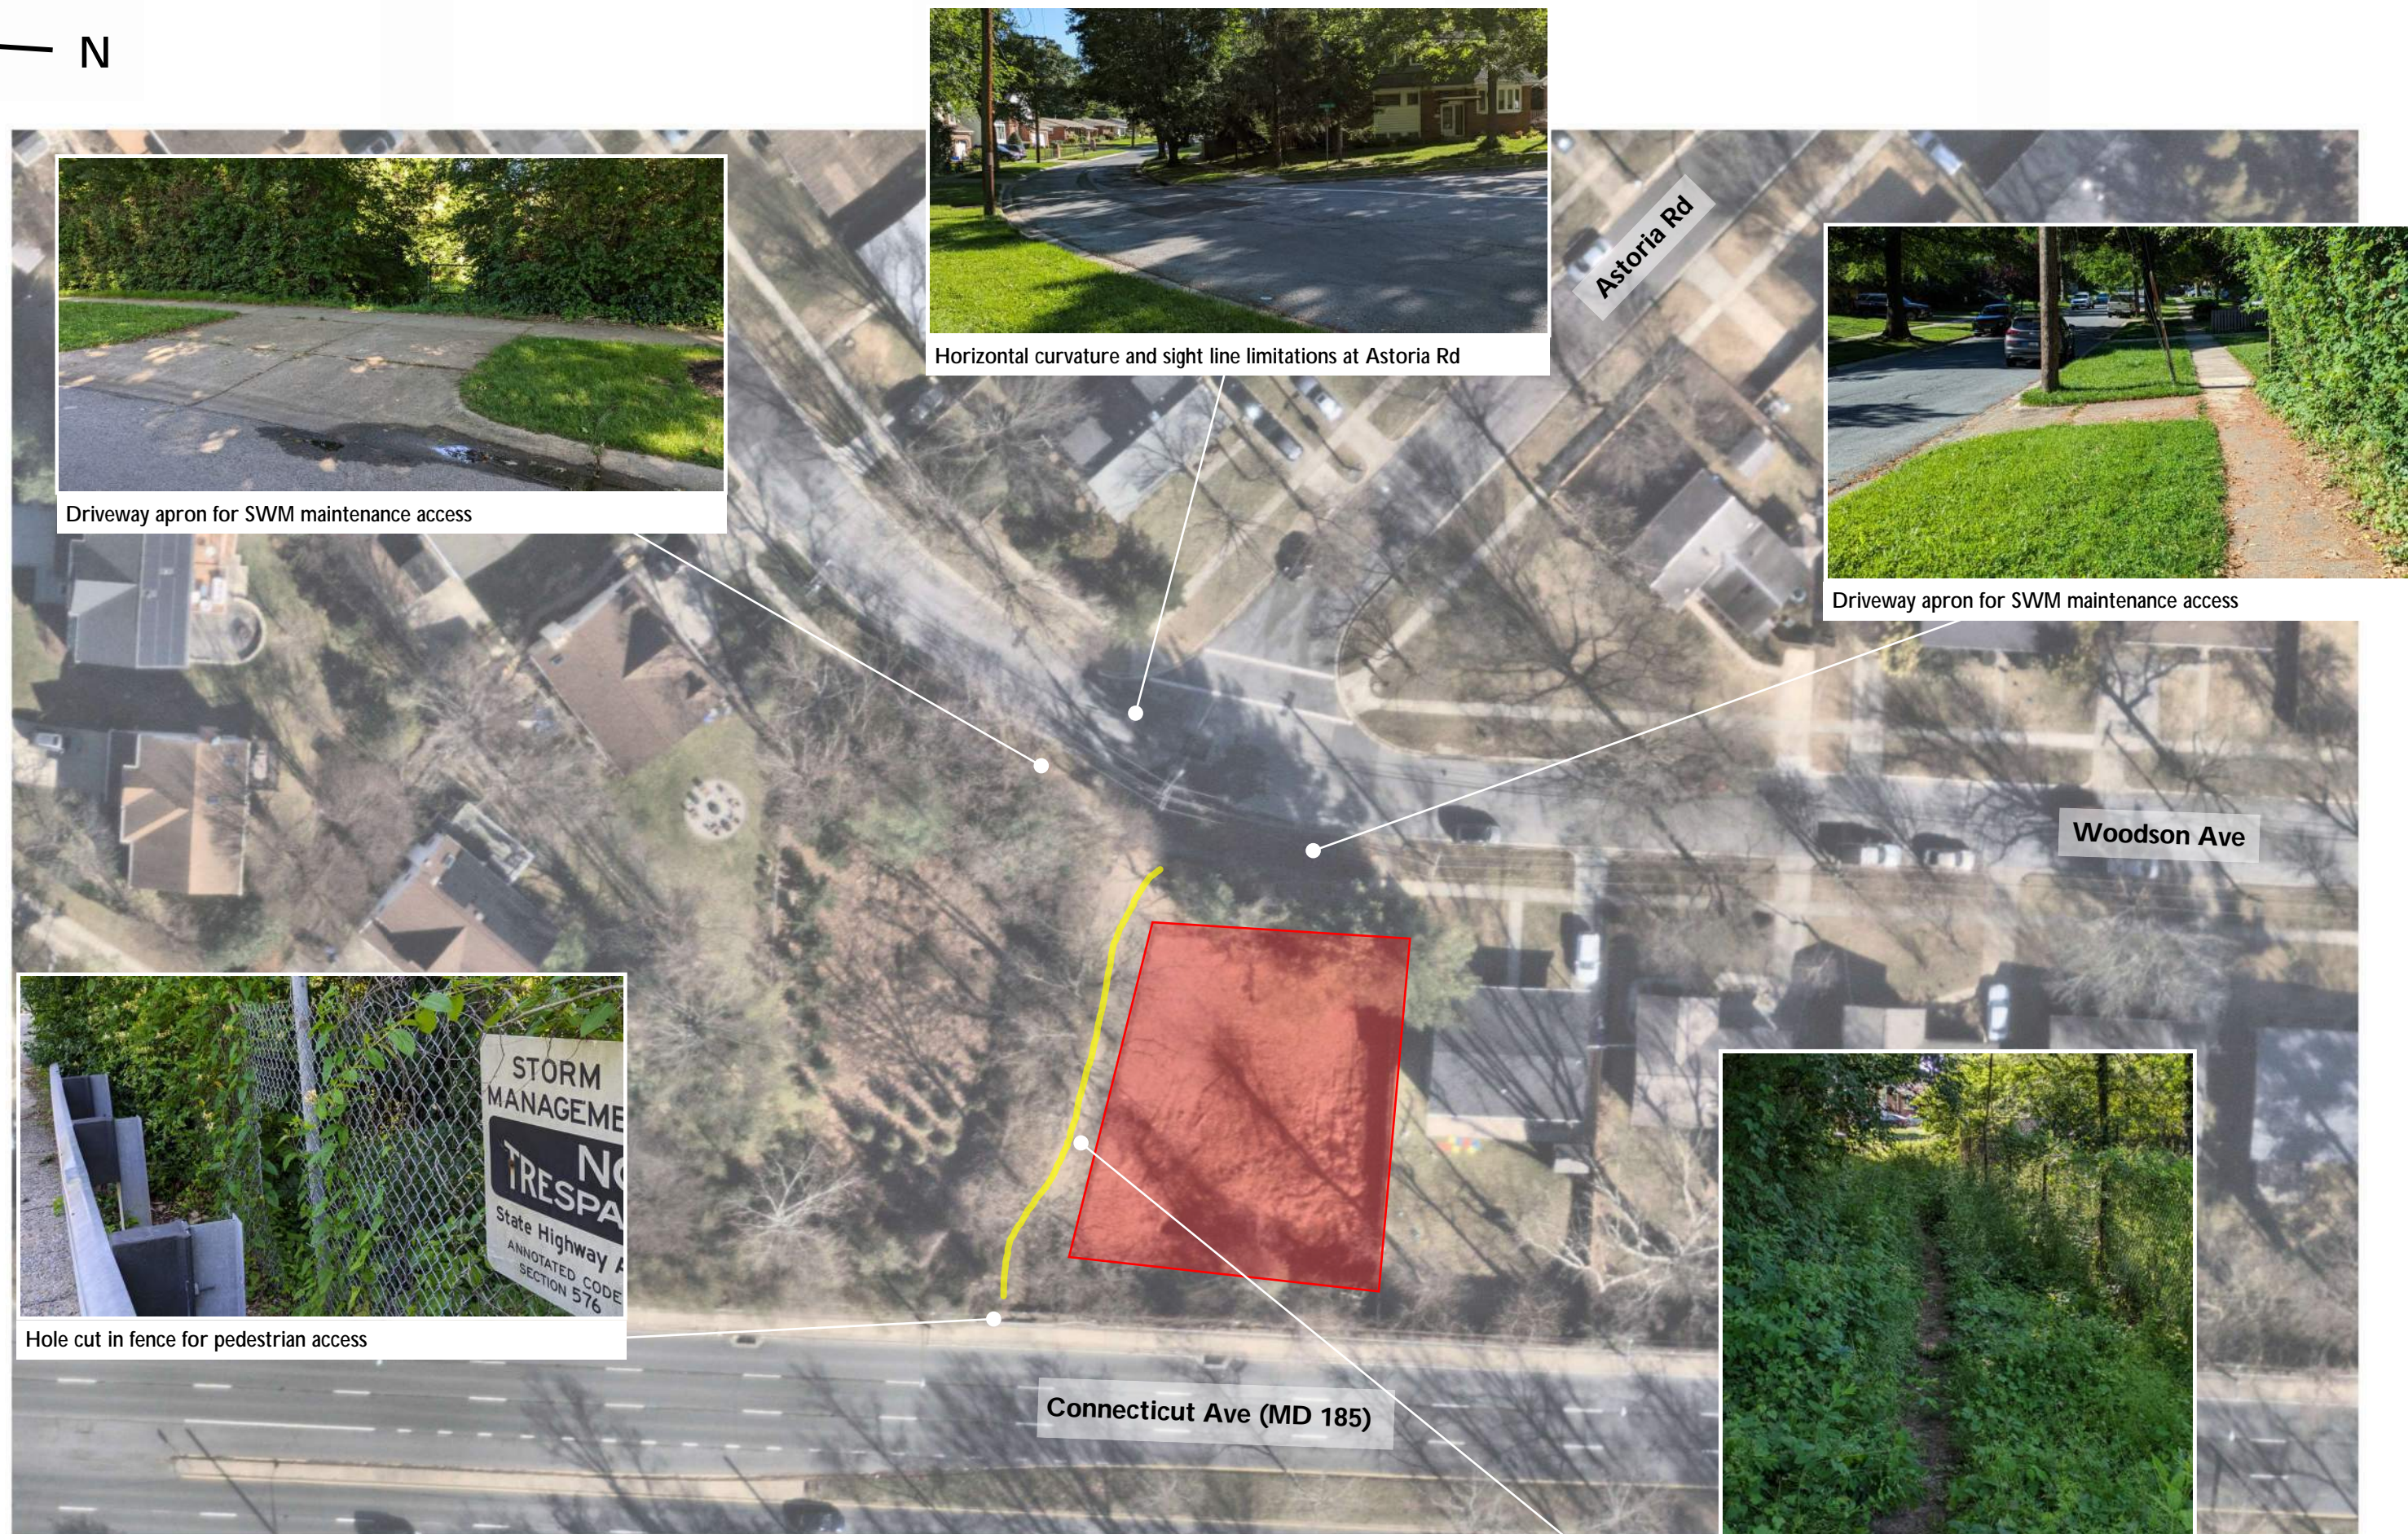
Figure 2 - Woodson Avenue at Astoria Road and Adjacent SWM Facility

Walking path adjacent to SWM facility

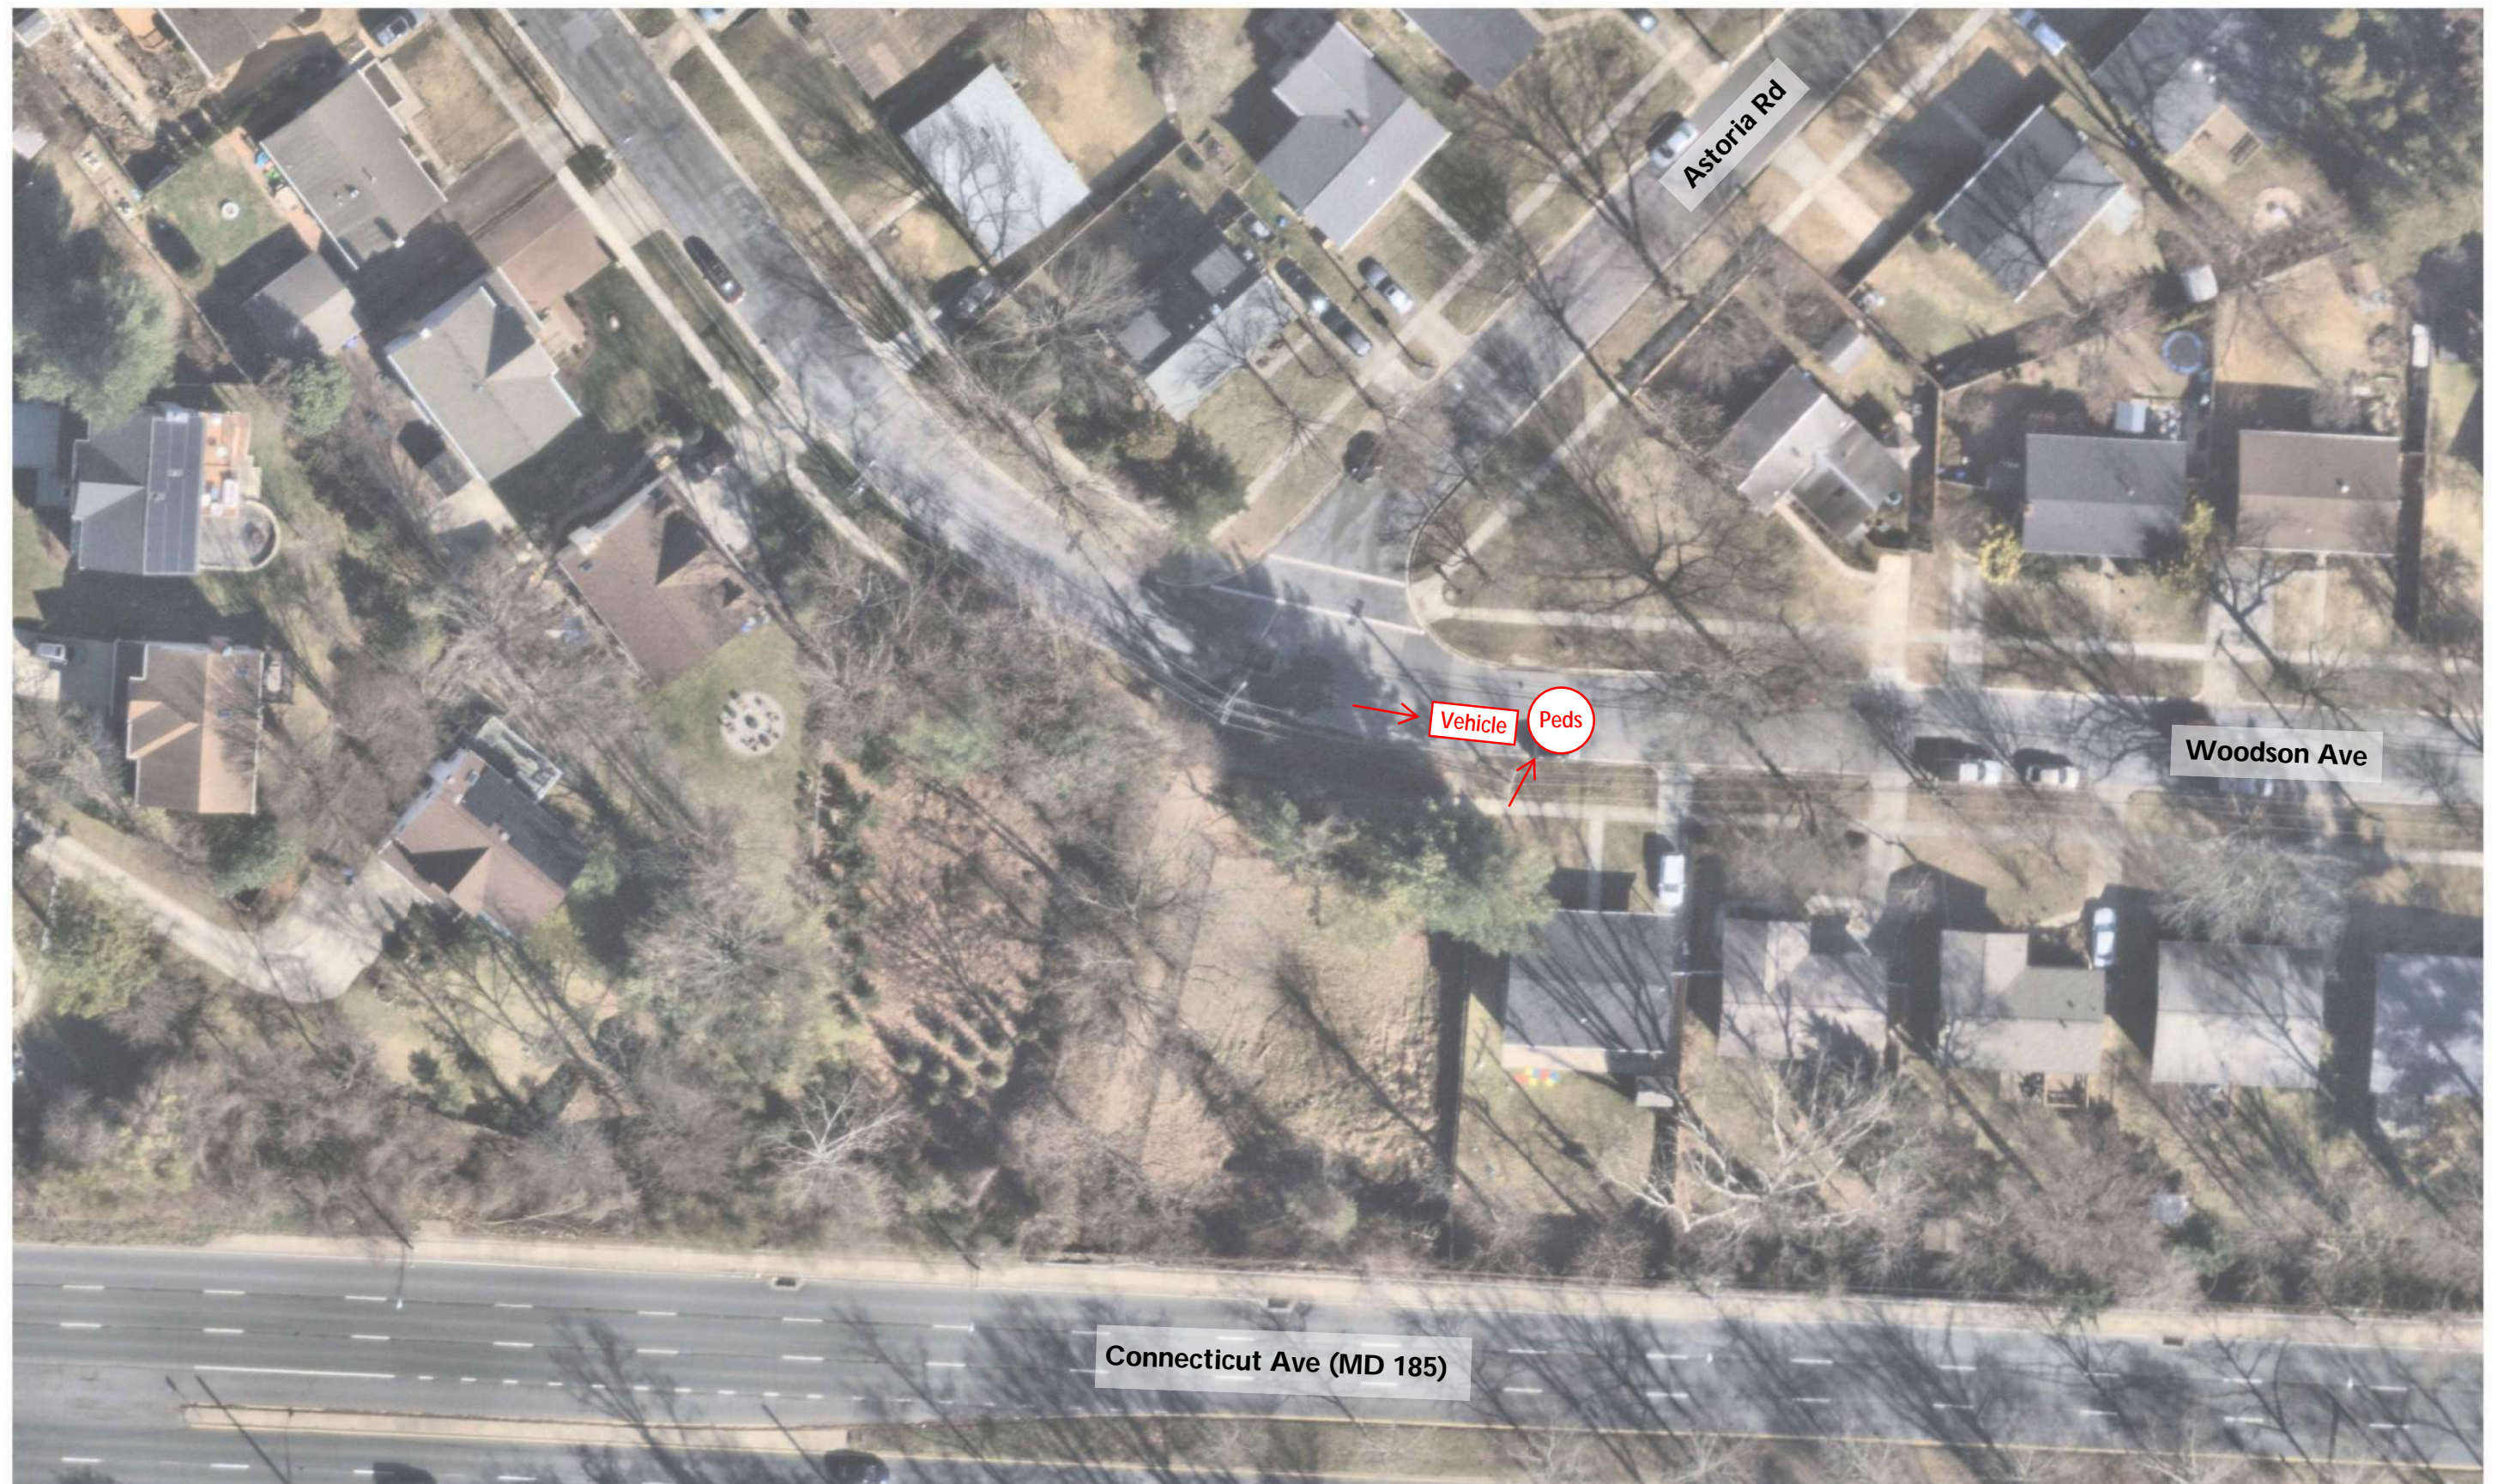
Figure 3 - Crash Diagram

**Figure 3** illustrates the crash location and direction of pedestrian and vehicle travel.
