# SCHOOL-RELATED CRASH REVIEW

**Location:** Wayne Avenue at Fenton Street

**Crash Date:** May 07, 2024

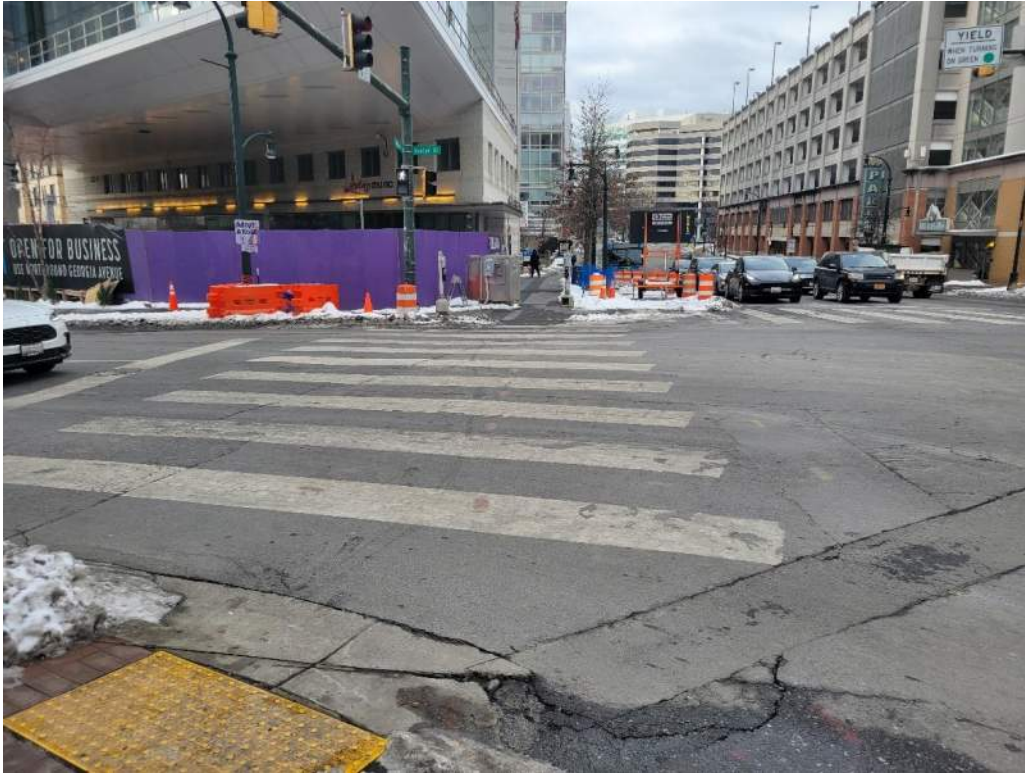
Photo 1. Taken from southeast corner looking westbound along Wayne Avenue at south leg crossing. Approximate crash location.

1. Recommend installing “Turning Vehicles Yield to Pedestrians” signs on signal mast arm displays for all approaches.

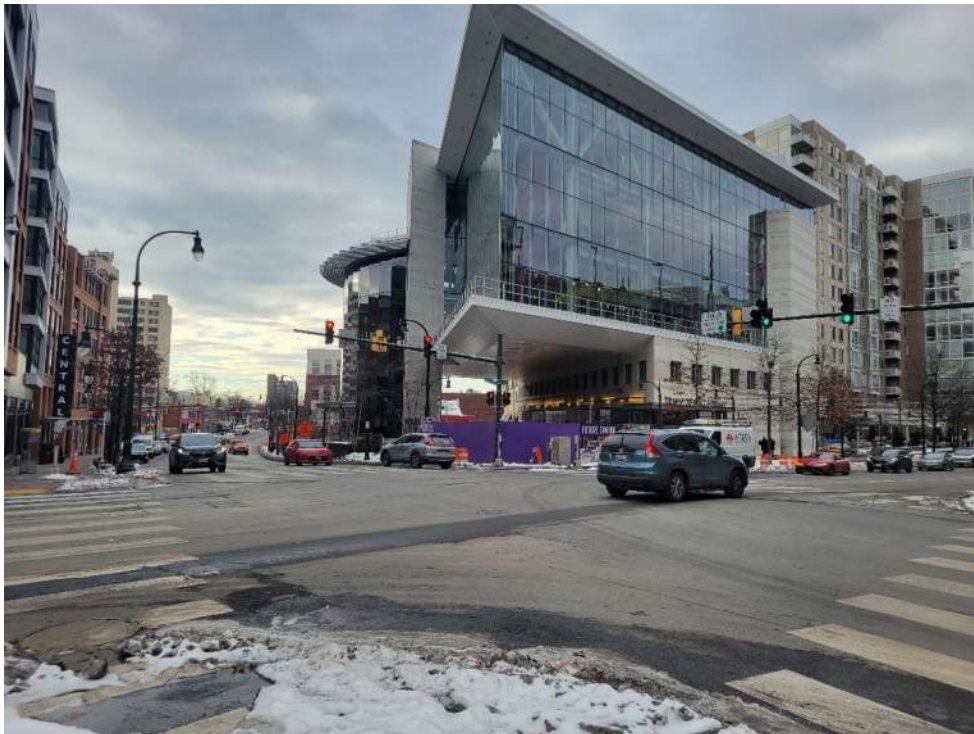
Photo 2. Intersection view from north east corner.

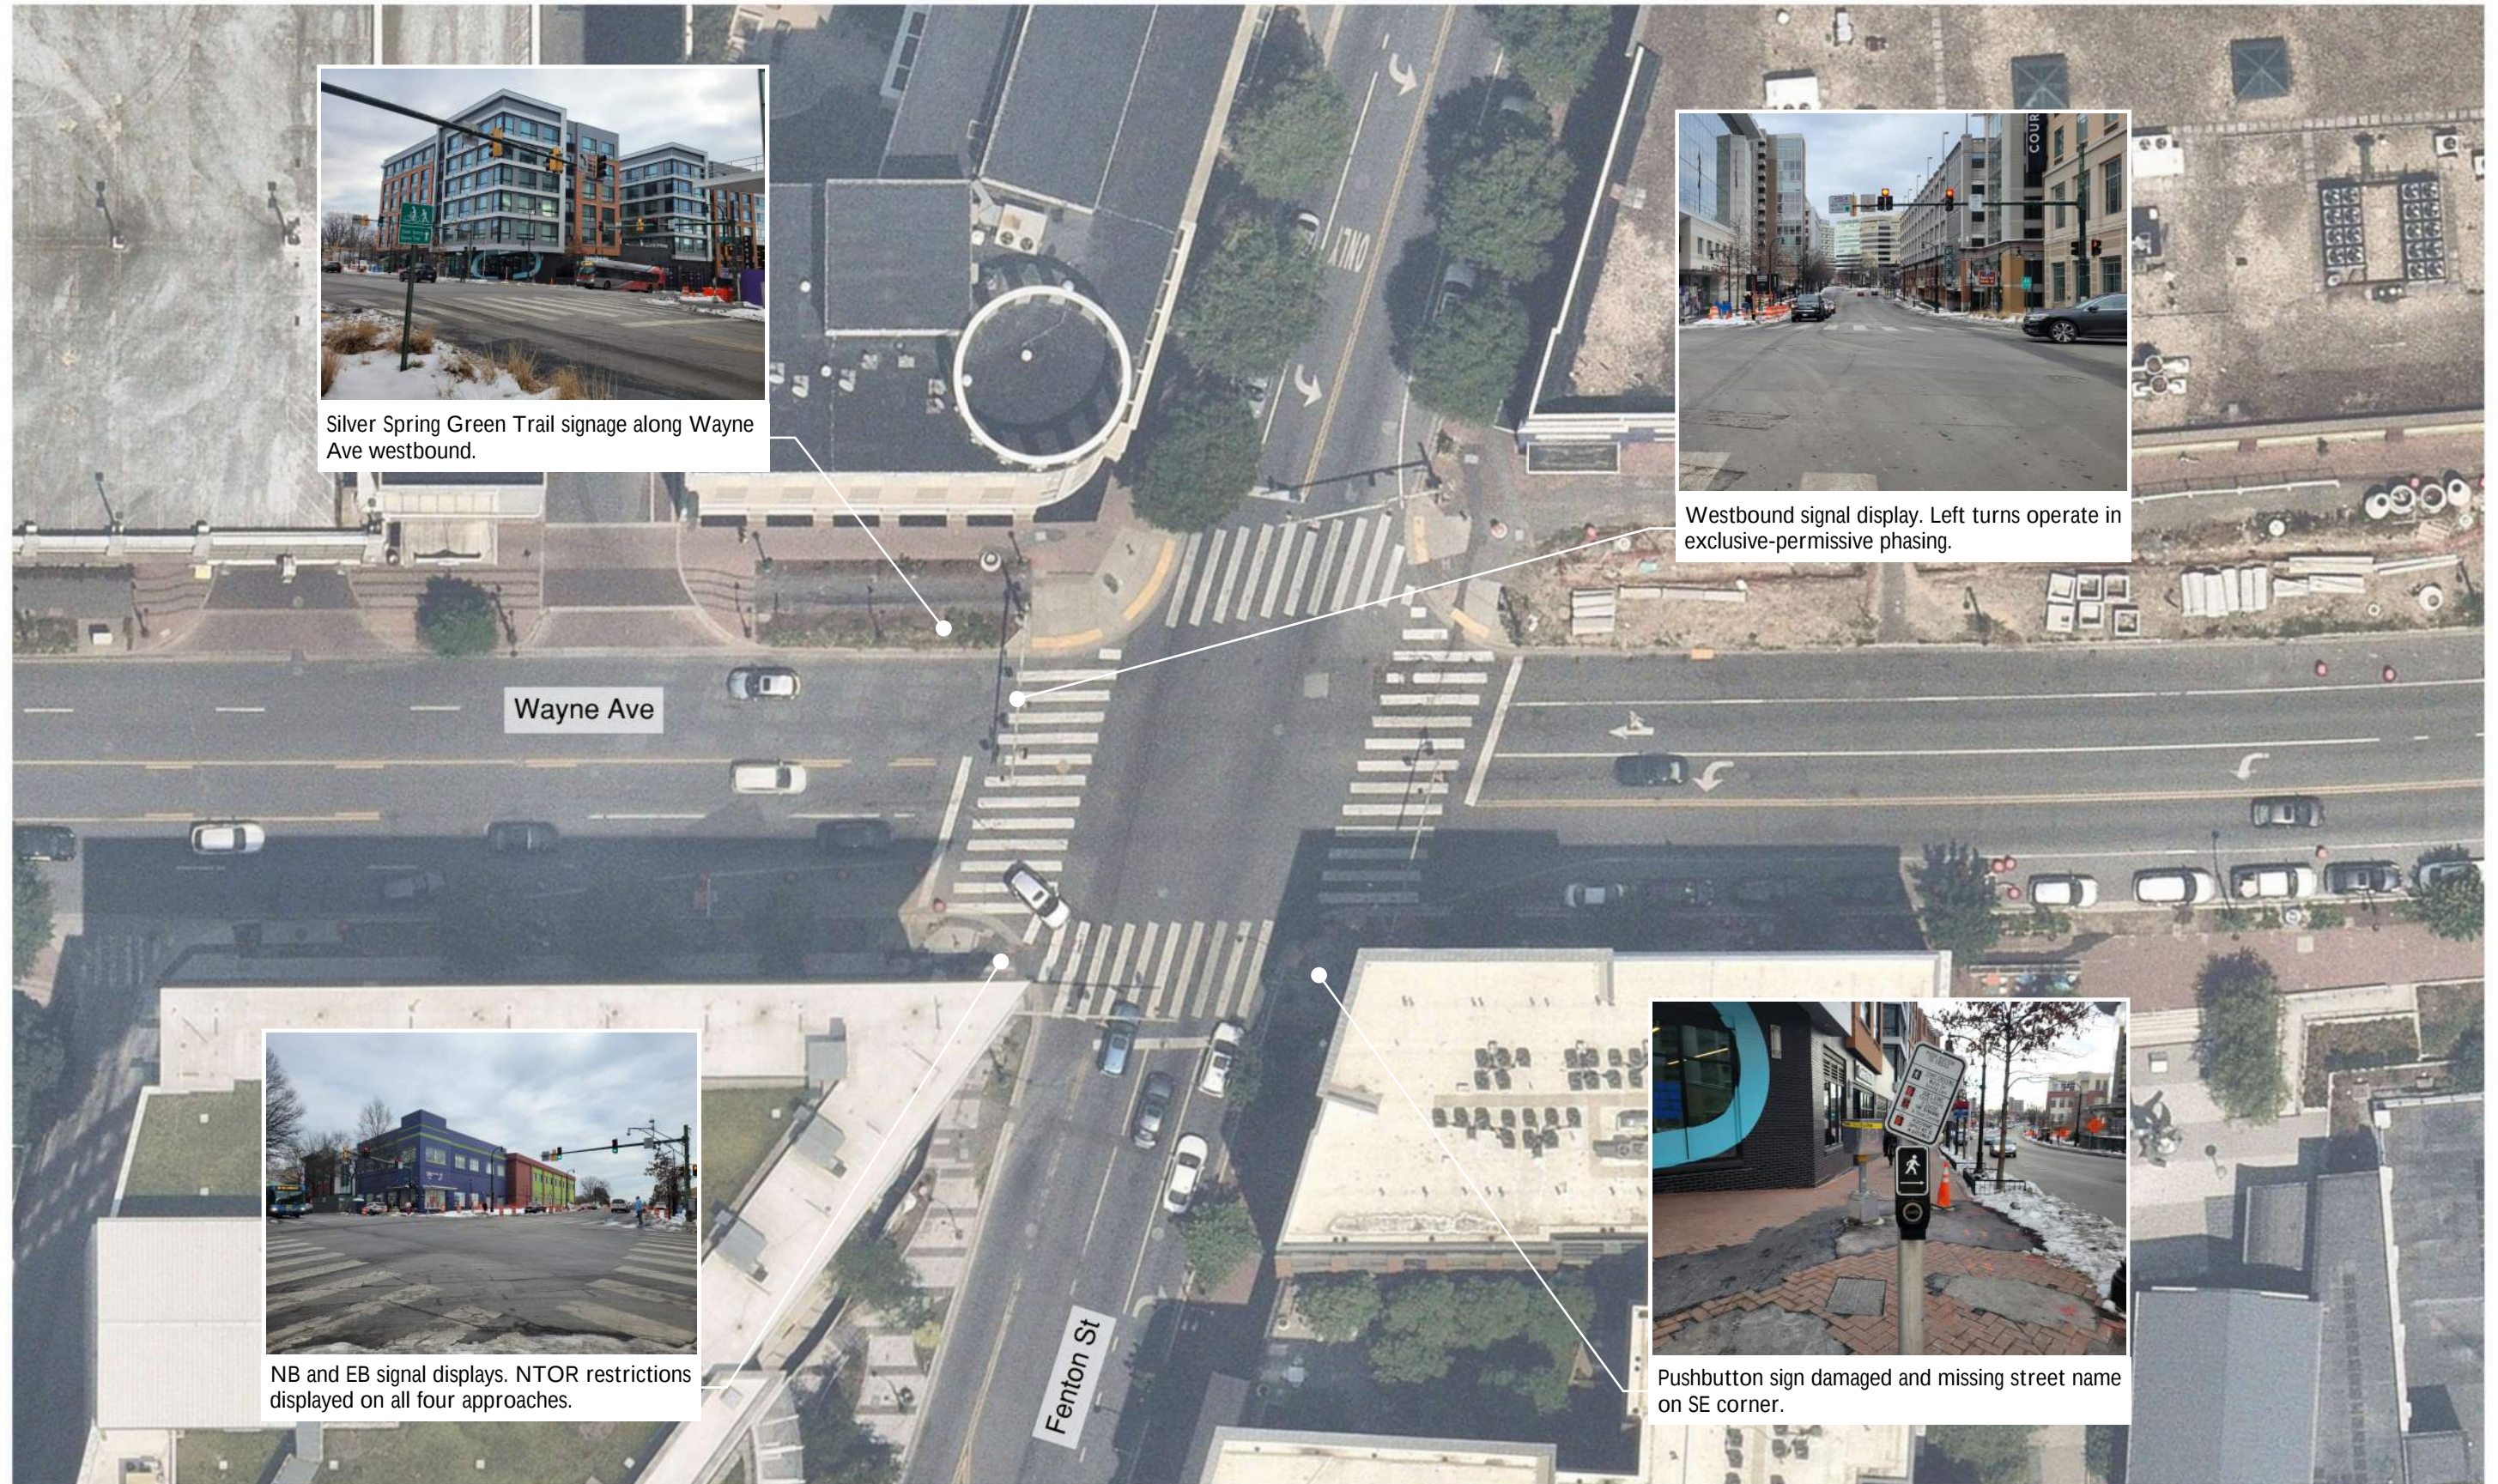
Figure 1 - Wayne Ave Corridor Observations

Wayne Avenue is classified as a downtown street, is approximately 60 feet wide, and is oriented in the east-west direction. Wayne Avenue is approximately two miles long between MD 384 (Colesville Road) to the west and terminates at Oak View Elementary School to the east. At the crash location, Wayne Avenue has unbuffered sidewalks on both sides of the street. There are no shoulders along the roadway. On the west leg of the crash location, there is a two-way turn-lane that transitions to turn lanes at the signalized intersection.

The posted speed limit along Wayne Avenue is 25 mph. A marked, two-stage pedestrian crossing exists across Wayne Avenue approximately 400 feet west of the subject intersection. Montgomery County RideOn bus stops are installed on the northbound and westbound approaches of the intersection. A “State Law Stop For [Peds] in X-Walk” sign exists in both directions while a “School” sign with a supplemental “Ahead” plaque exists only in the eastbound direction approaching Sligo Creek Elementary School.

Refer to **Figure 1** in the attachments for additional details on the Wayne Avenue segment.

The Wayne Avenue corridor was evaluated to identify potential infrastructure, maintenance activities, and road user behaviors that contribute to increased safety risk at and in the vicinity of the school-related crash location. The Wayne Avenue corridor was reviewed between US 29 (Georgia Avenue) to the west and Cedar Street to the east. Please refer to **Figure 1** for additional information.

Field observations were performed on Monday, January 13, 2025, at 9 AM. Weather conditions were clear, and the roadway surface was dry. However, conditions were cold, and snow cover remained from the previous weekend storm. Pedestrian and vehicular activity was high during the observation period. Pavement markings across the intersection are in good condition. Ongoing construction is occurring along Wayne Avenue through the subject segment and affects the sidewalks on the north side of Wayne Avenue.

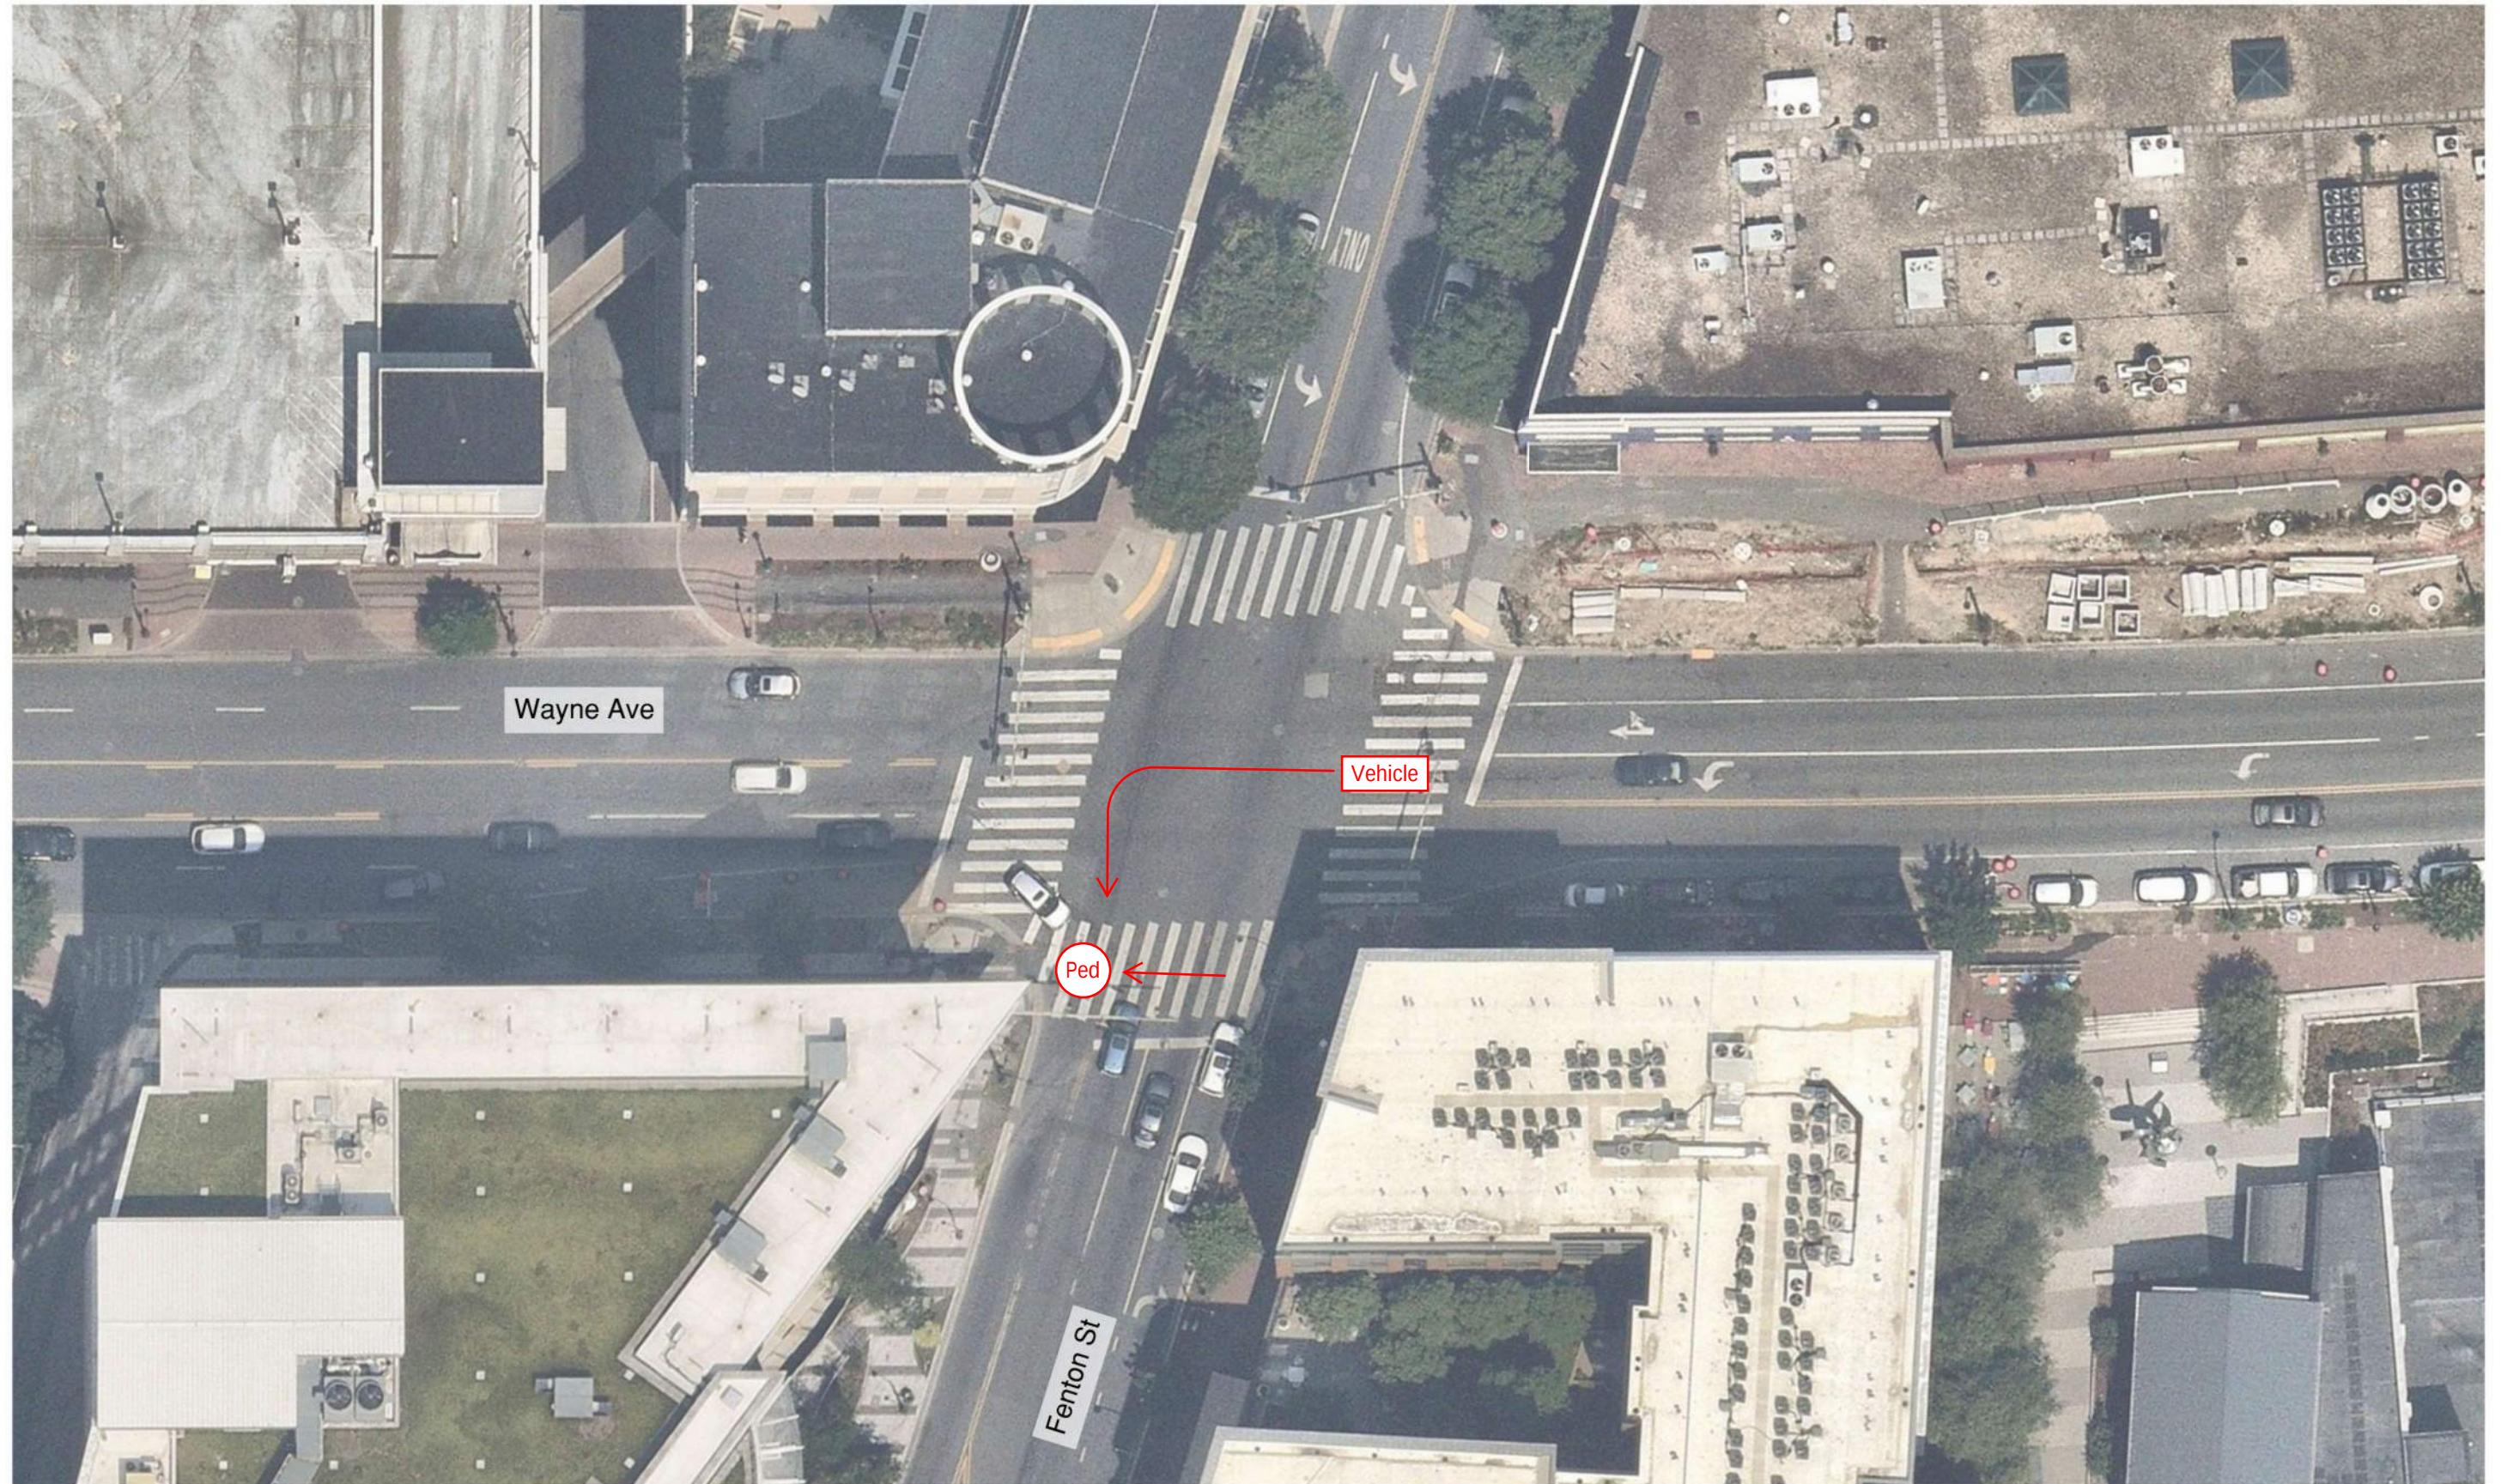
Figure 2 - Crash Diagram

On Tuesday, May 7, 2024, at approximately 4:05 PM, a pedestrian was traveling westbound across the south leg of the intersection in the crosswalk. A motorist traveling westbound on Wayne Avenue, with a green arrow indication, turned left onto Fenton Street and struck a pedestrian who was established in the crosswalk. The crash report indicated that the pedestrian suffered minor injuries. Daytime weather conditions were clear, and the roadway surface was dry.

**Figure 2** illustrates the crash location and direction of pedestrian and vehicle travel.

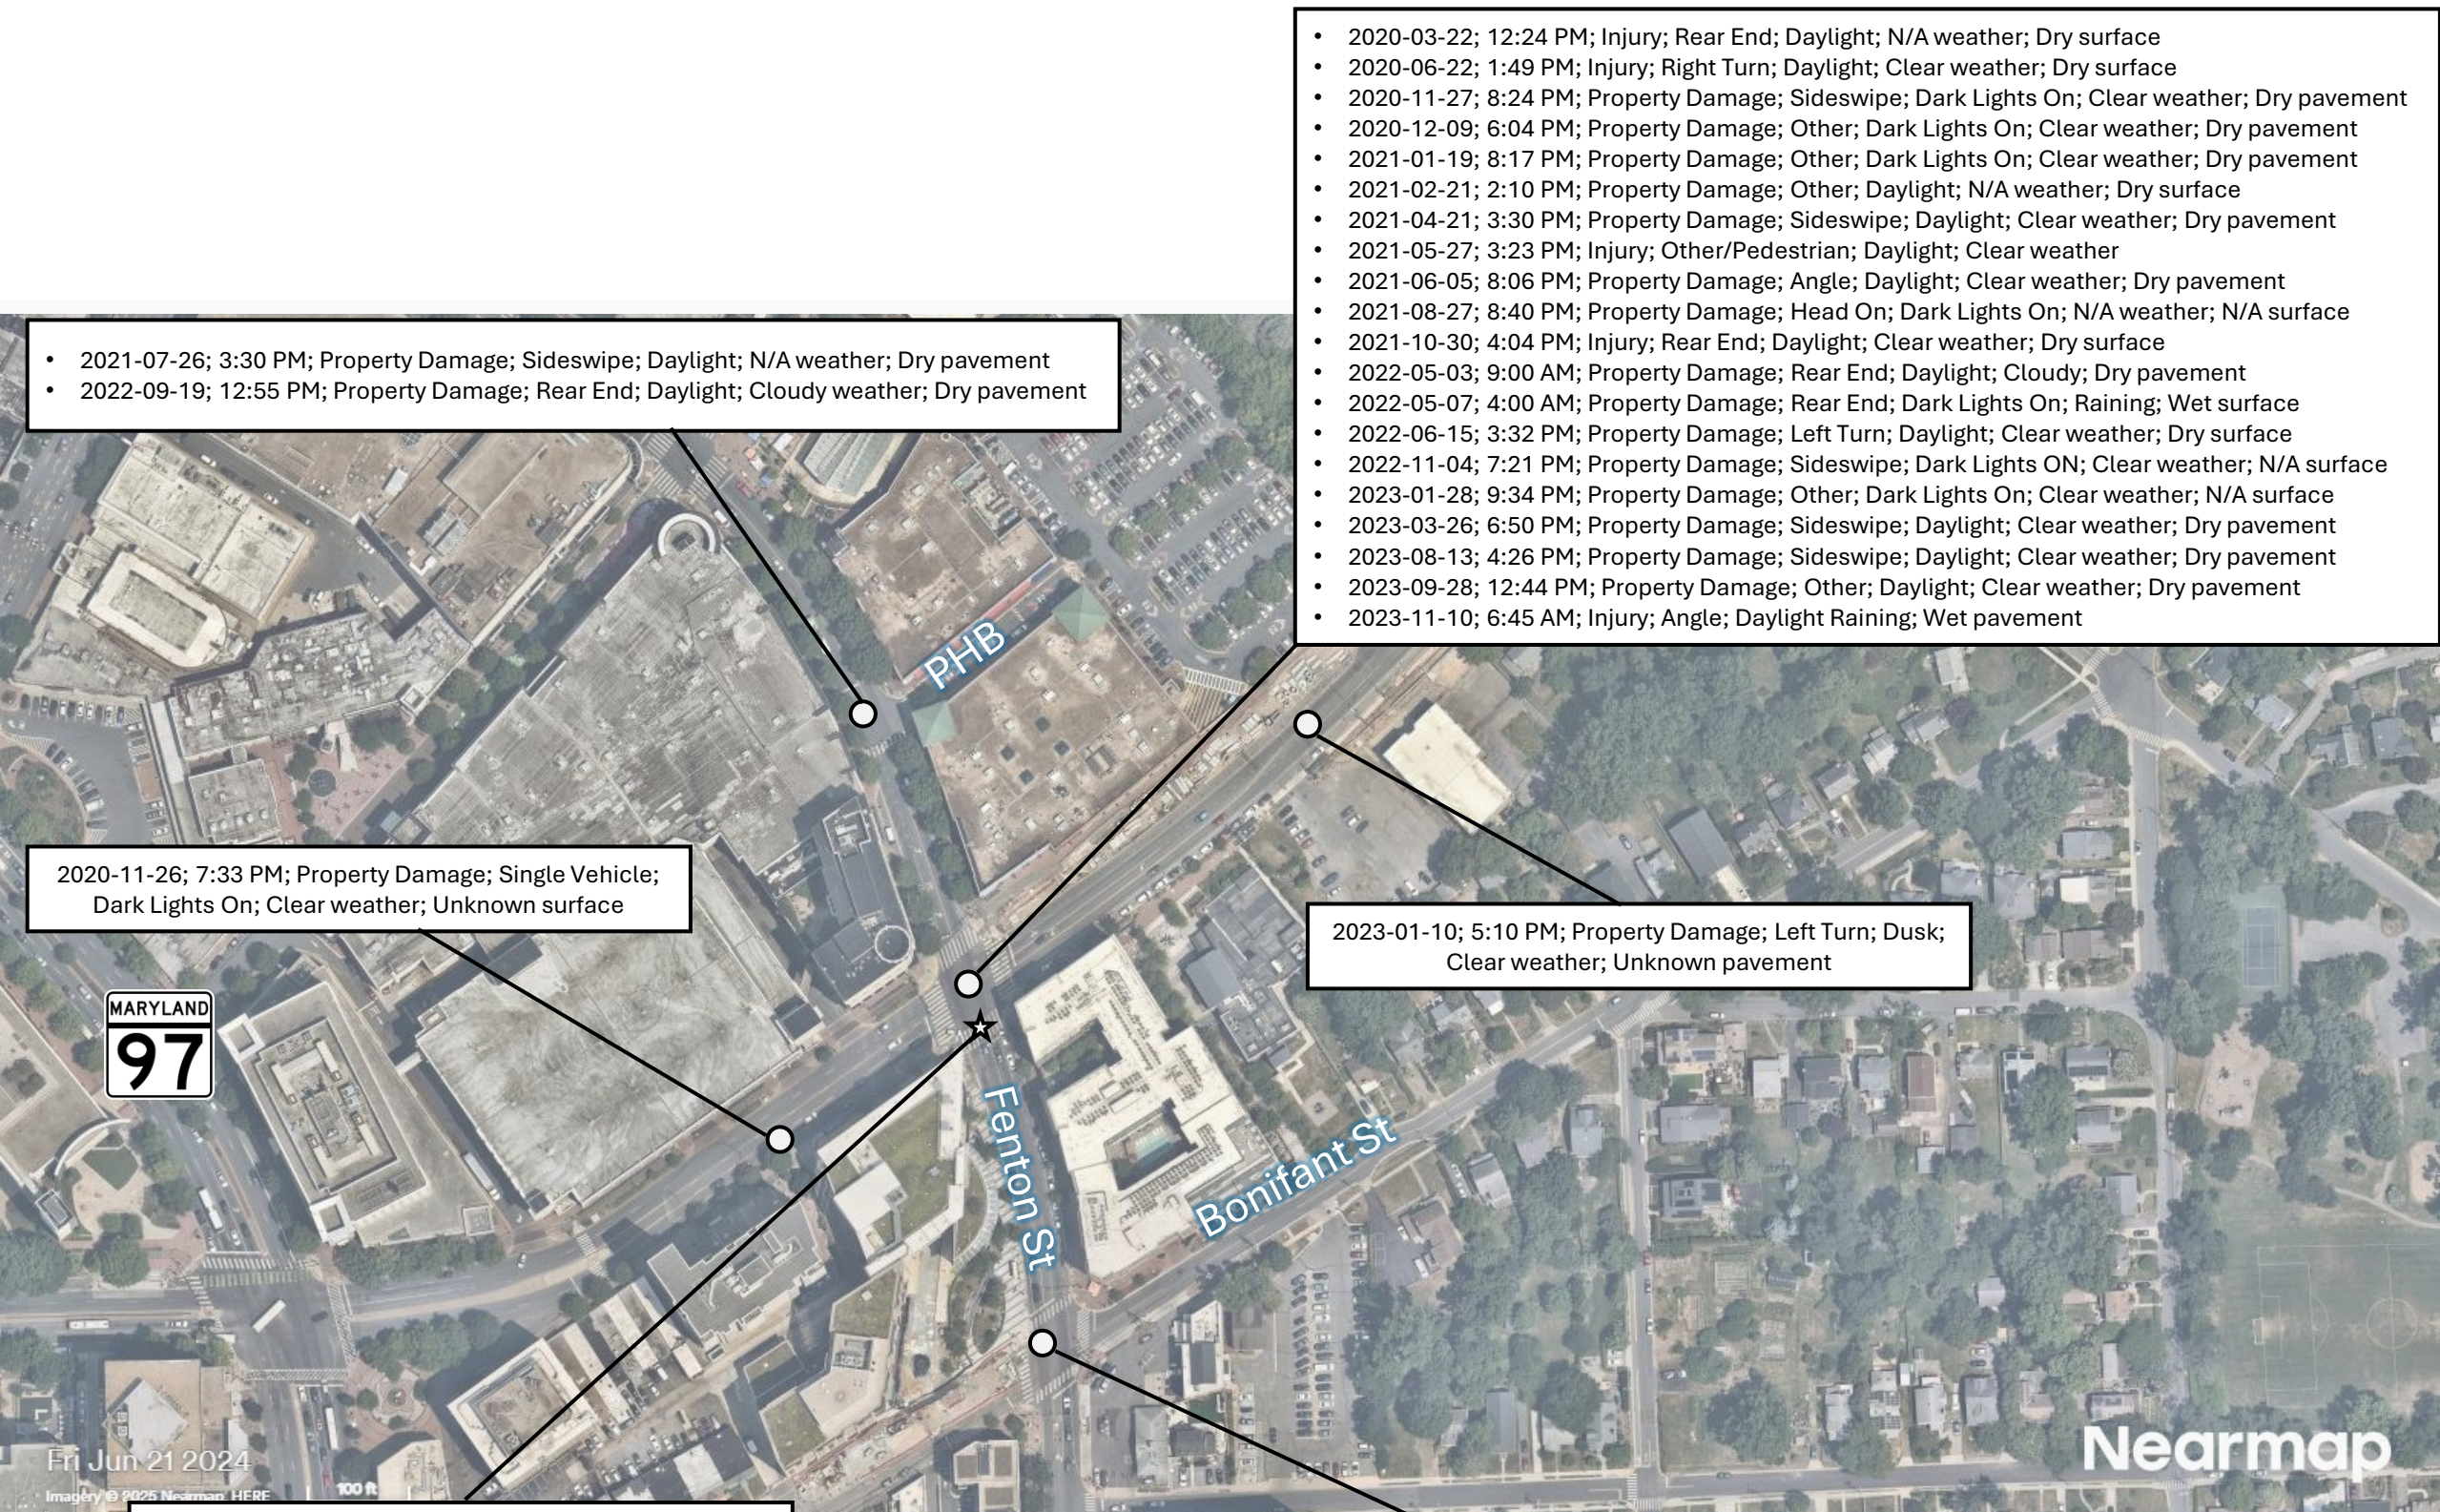
Figure 3 – Crash History (2021-2023)

Crash data obtained from dataMontgomery indicates that 31 incidents occurred within the vicinity of the crash site between January 2020 and December 2023. Of these 31 incidents, 21 crashes occurred within 150 feet of the signalized intersection of Wayne Avenue and Fenton Street, the subject crash incident. The 10 other crashes occurred at nearby intersections, which include Fenton Street at Bonifant Street, Wayne Avenue at driveways, and Fenton Street at the PHB. The 31 crashes reported included eight (8) injury crashes, 23 property damage crashes, and the crash type consisted of four (4) angle collisions, three (3) left turn collisions, one (1) right turn collision, one (1) head on collision, five (5) rear end collisions, six (6) sideswipe collisions, four (4) single vehicle collisions, and seven (7) classified as “other”. There were three (3) pedestrian-related crashes. Two (2) of the incidents occurred during wet pavement conditions, six (6) of the incidents were along an unknown surface, and 13 occurred in the dark/dusk. The incidents are illustrated on **Figure 3**.
