SCHOOL-RELATED CRASH REVIEW

Location: Rock Spring Drive west of Old Georgetown Road

Crash Date: May 24, 2024

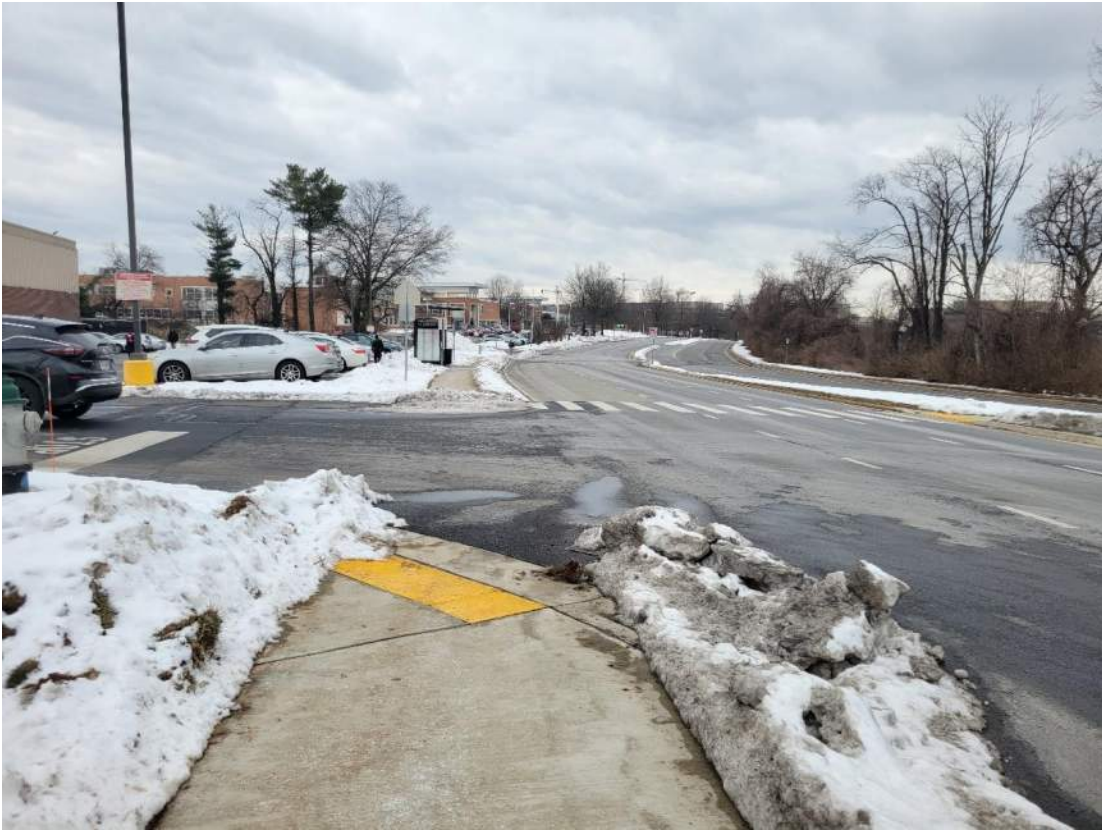
Photo 1. Looking westbound along Rock Spring Drive. Approximate crash location.

1. Install continental-style crosswalk markings across the driveway.
2. Relocate the existing stop sign at the driveway to enhance the visibility of the sign.
3. Install a mid-block pedestrian hybrid beacon (PHB) at the pedestrian crosswalk along Rock Spring Drive, approximately 400 feet west of MD 187 (Old Georgetown Road).

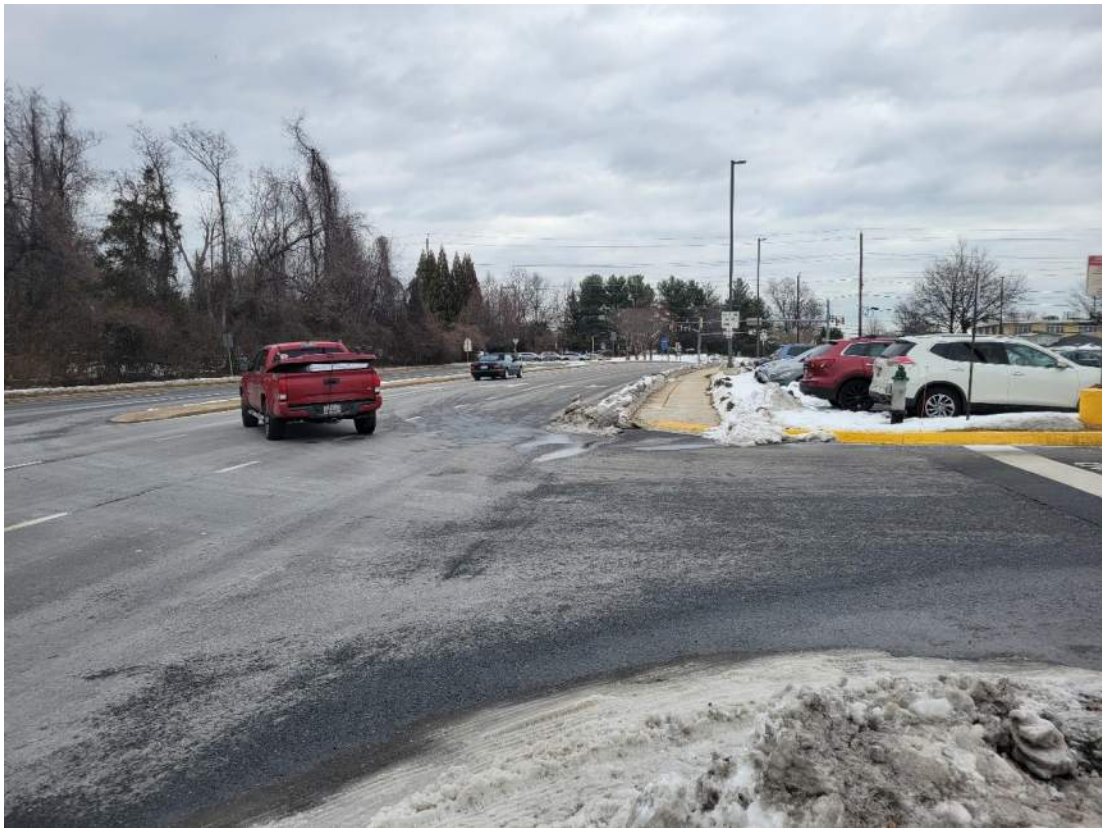
Photo 2. Looking eastbound along Rock Spring Drive. Approximate crash location.

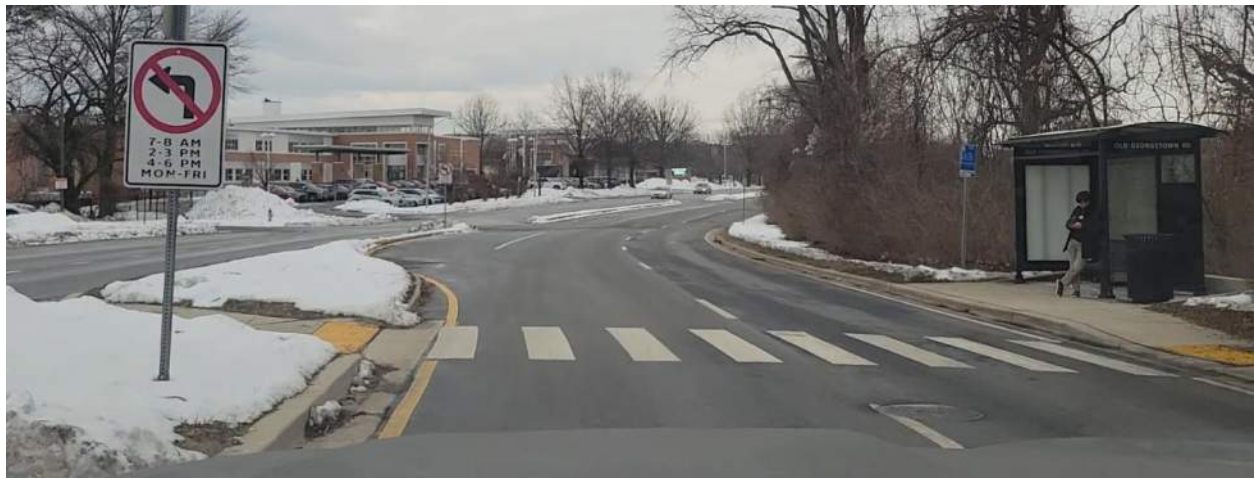
Field observations were performed on Monday, January 13, 2025, at 10:30 AM. Weather conditions were clear, and the roadway surface was dry. However, conditions were cold, and snow cover remained from the previous weekend storm. Pedestrian activity was light, with only one (1) pedestrian observed to cross Rock Spring Drive to the bus shelter within the observation period, and no pedestrians observed to cross the driveway. Vehicular activity was moderate at the intersection during the observation period, with motorists arriving and departing the shopping center. Left-turn restrictions into the parking lot from westbound Rock Spring Drive are implemented Monday through Friday from 7-8AM, 2-3PM, and 4-6 PM. This information is posted on a ground-mounted sign within the median along Rock Spring Drive, shown in Photo 3. Pavement markings across the intersection are in good condition.

Photo 3: Left Turn Restriction to Shopping Center

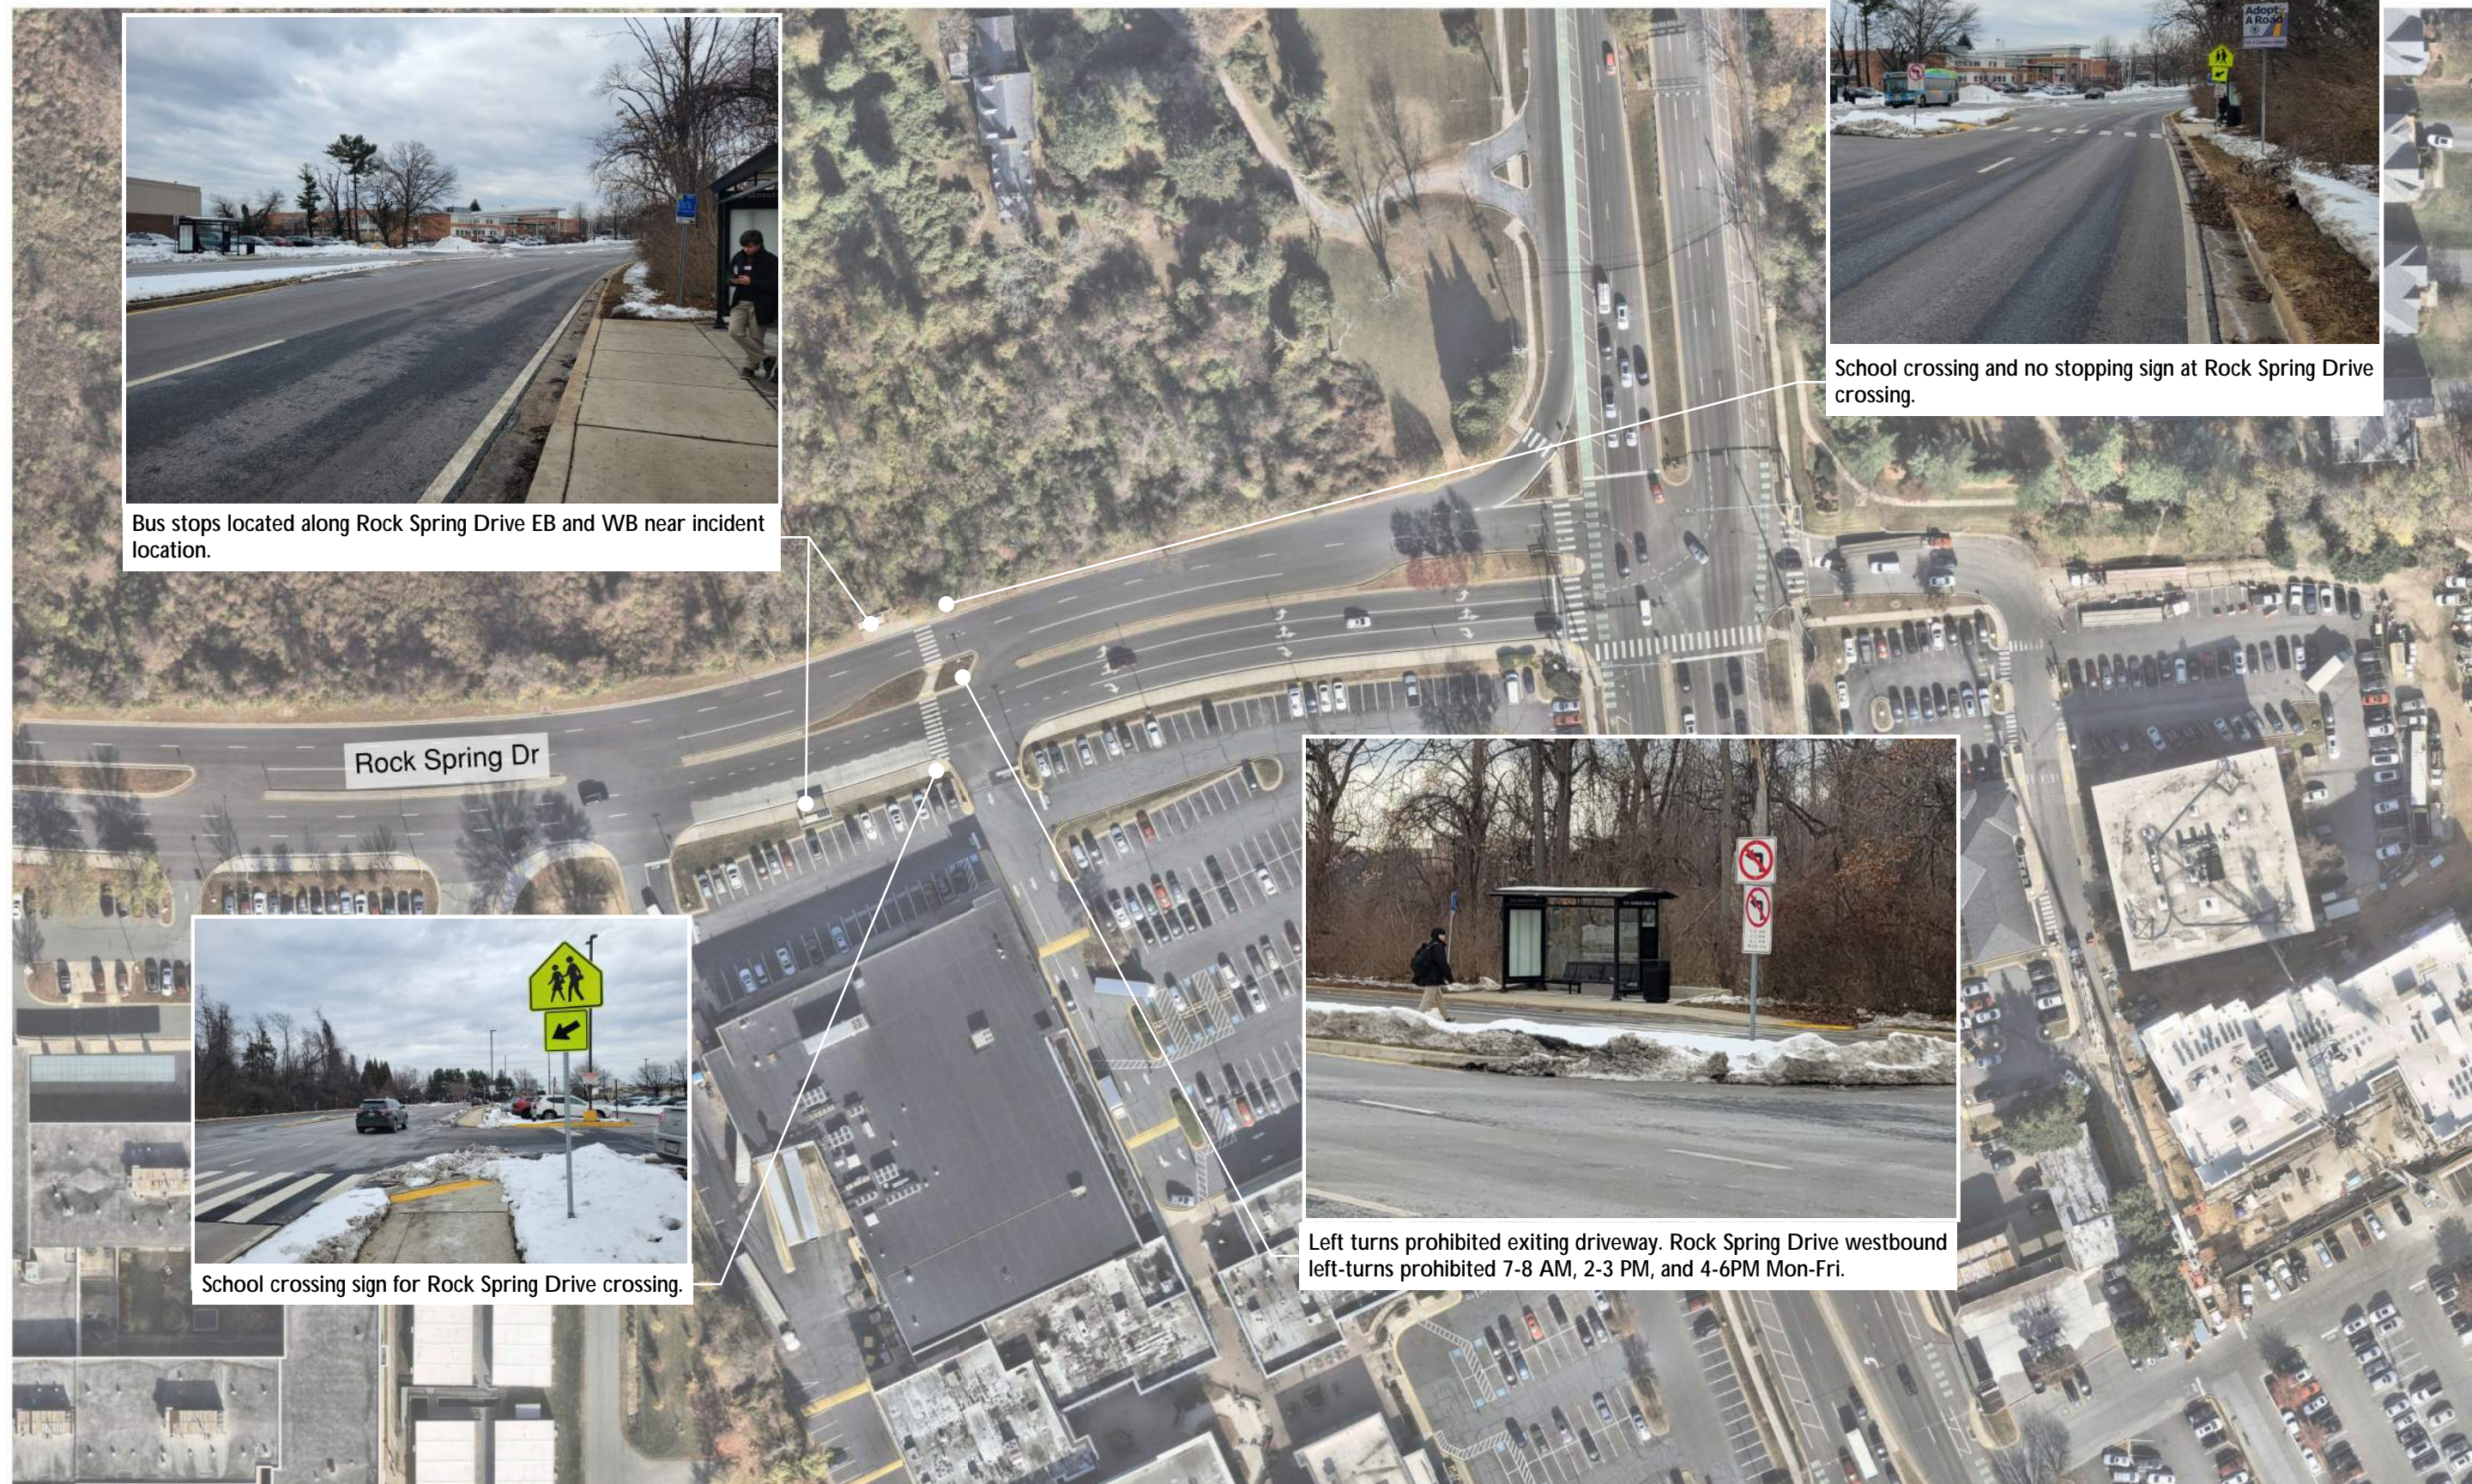
The Rock Spring Drive corridor was evaluated to identify potential infrastructure, maintenance activities, and road user behaviors that contribute to increased safety risk at and in the vicinity of the school-related crash location. The Rock Spring Drive corridor was reviewed between Rockledge Drive to the west and MD 187 (Old Georgetown Road) to the east. Please refer to **Figure 1** for additional information.

Figure 1 - Rock Spring Drive Corridor Observations

Refer to **Figure 1** in the attachments for additional details on the Rock Spring Drive segment.

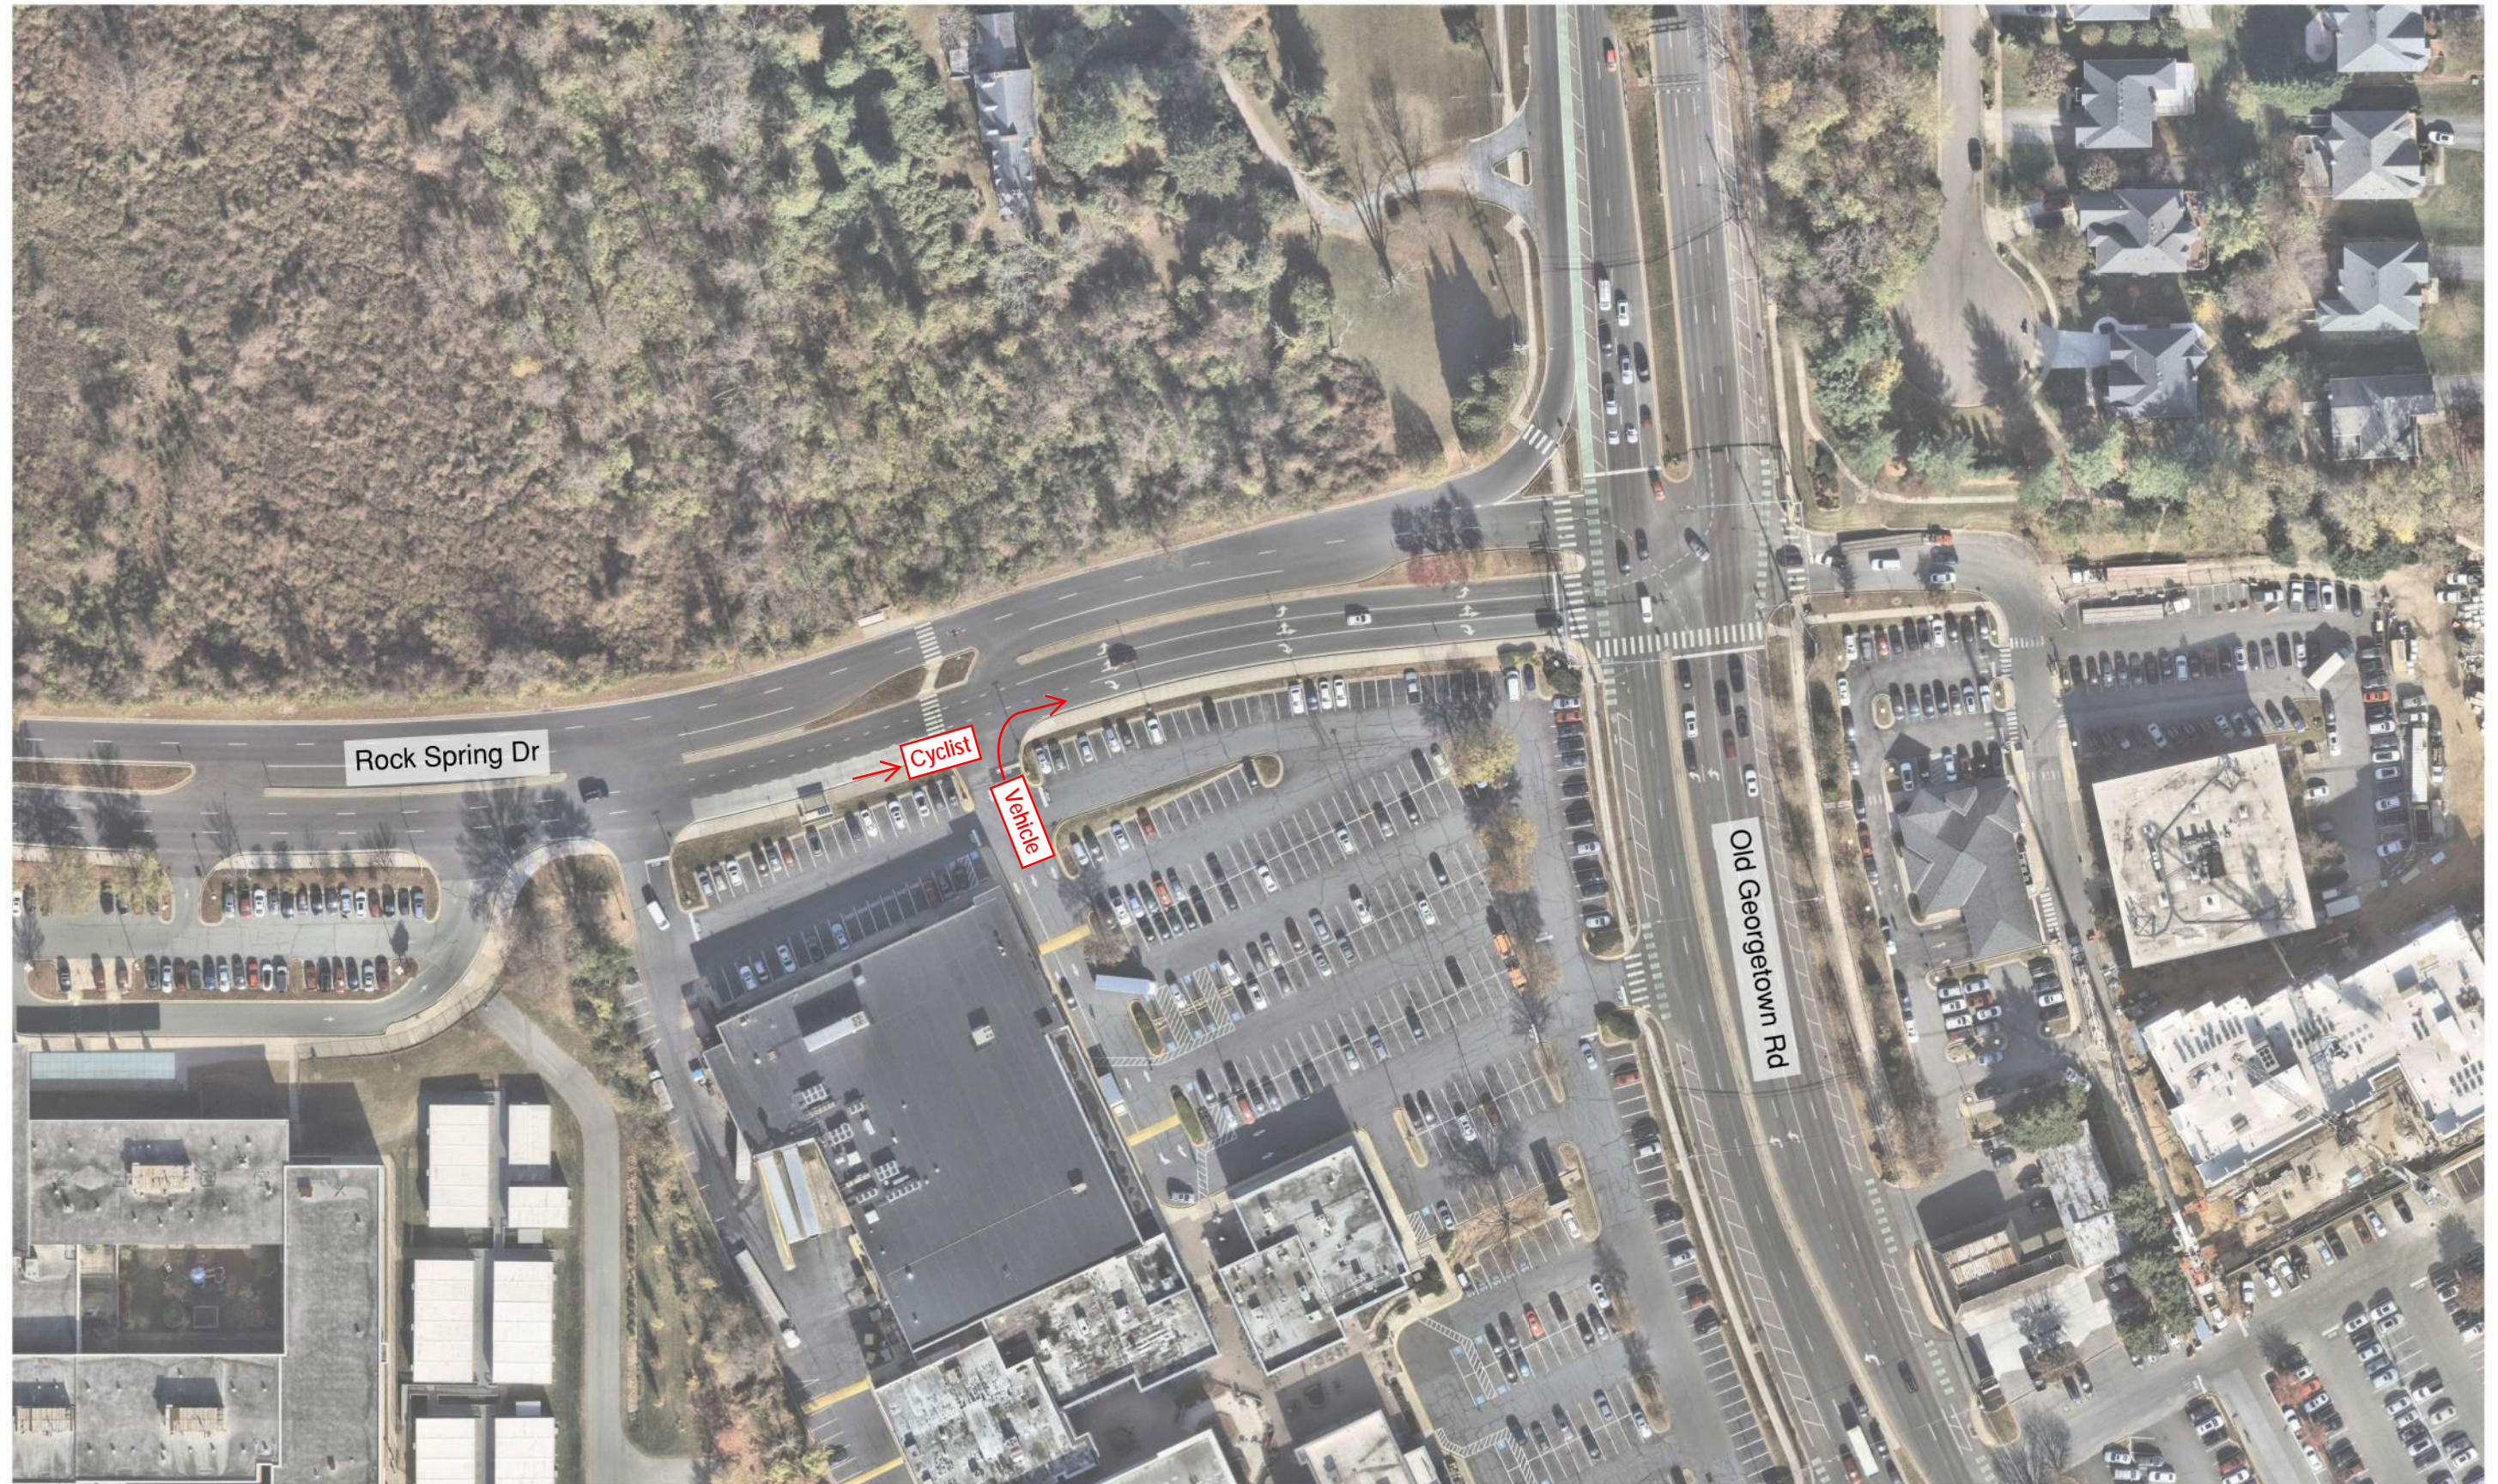
On Friday, May 24, 2024, at approximately 7:42 AM, a motorist was exiting the driveway from 10400 Old Georgetown Road and making a right turn onto eastbound Rock Spring Drive. The vehicle struck a cyclist traveling on the sidewalk, westbound along Rock Spring Drive. According to the crash report, the pedestrian suffered minor injuries. Daytime weather conditions were clear, and the roadway surface was dry.

Figure 2 - Crash Diagram

Figure 2 illustrates the crash location and direction of cyclist and vehicle travel.
