# SCHOOL-RELATED CRASH REVIEW

**Location:** Weller Road west of Greenly Street

**Crash Date:** June 11, 2024

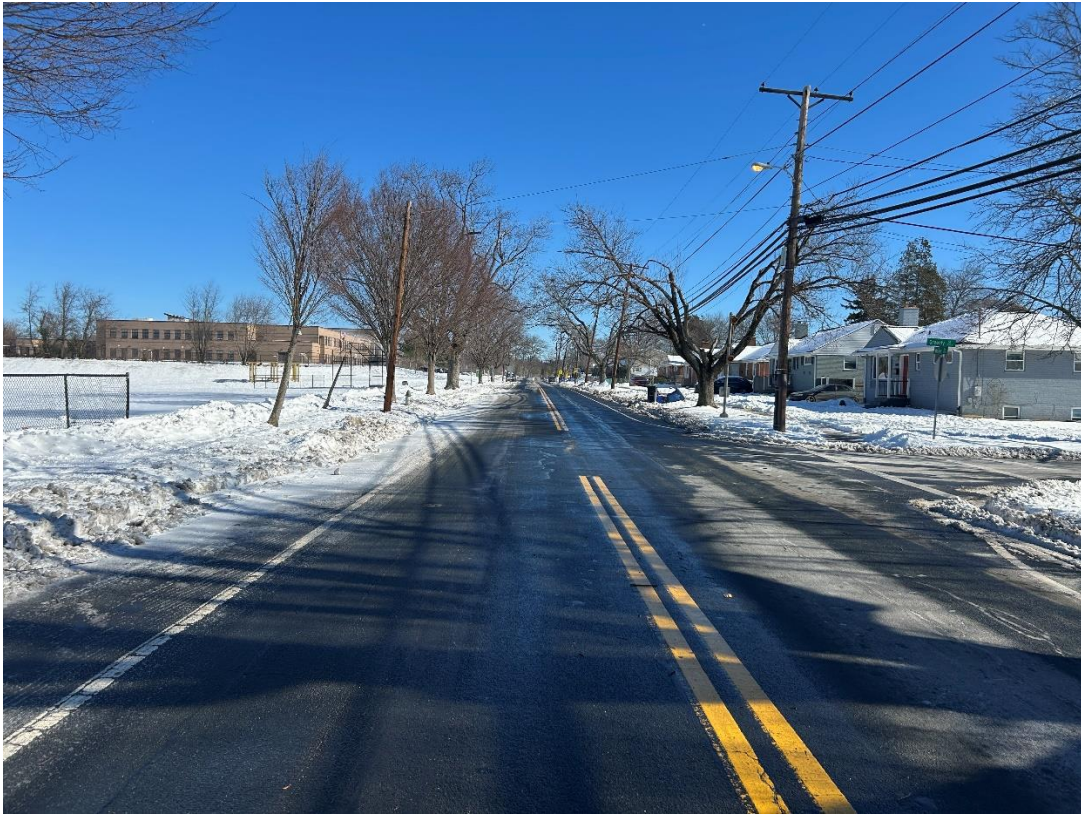
**Photo 1. Looking east along Weller Road towards Greenly Street. Approximate crash location.**

1. Consider installing a marked crossing with continental crosswalk pavement markings, crossing island, and school crossing signs at this location.
2. Consider restricting on-street parking near this crossing location in order to provide better sight lines.
3. Install missing signs for the school flasher to the east of Greenly.

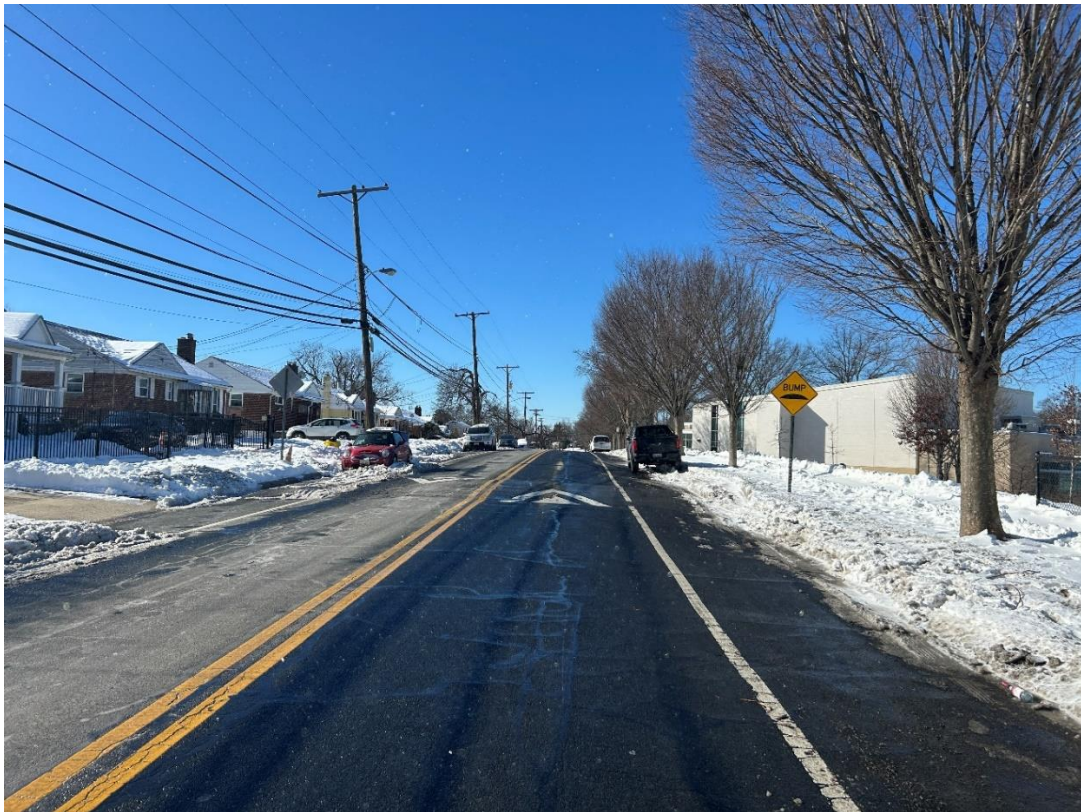
**Photo 2. Limited sightline due to crest vertical curve looking west along Weller Road towards MD 185 (Connecticut Ave). Approximate crash location.**

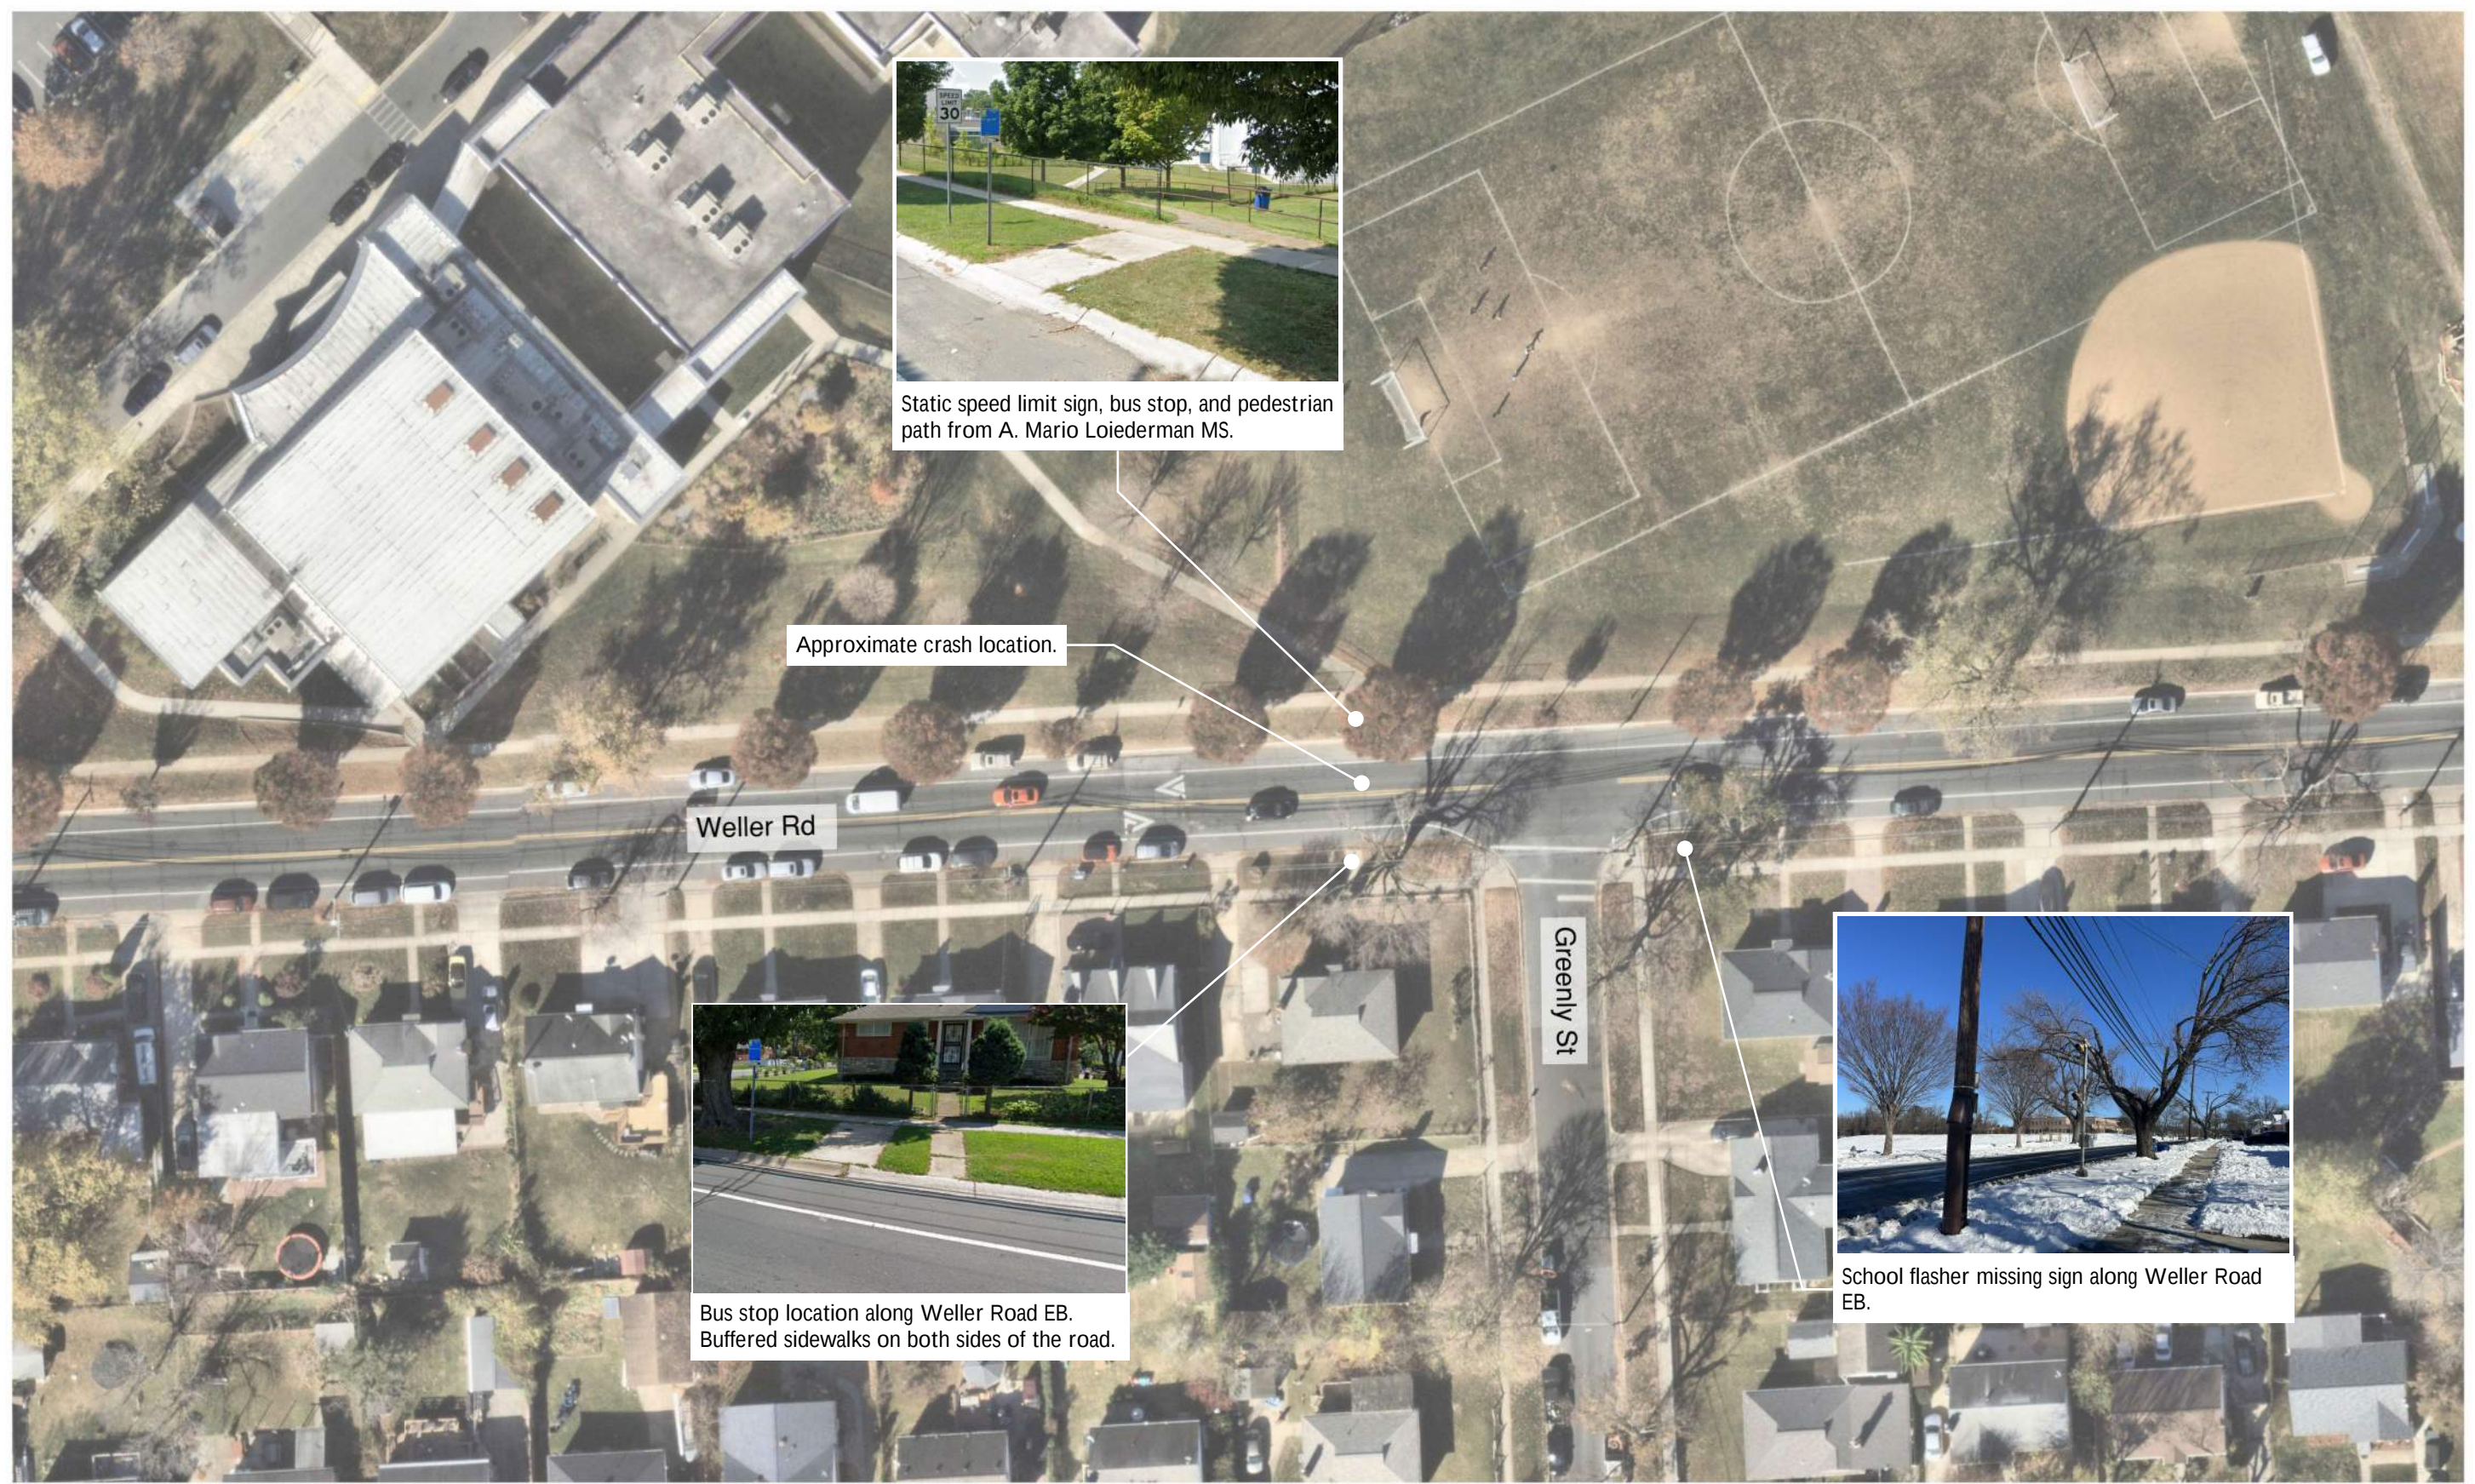
Figure 1 - Weller Road Corridor Observations

The Weller Road corridor was evaluated to identify potential infrastructure, maintenance activities, and road user behaviors that contribute to increased safety risk at and in the vicinity of the school-related crash location. The Weller Road corridor was reviewed between Goodhill Road to the west and Dean Road to the east. Please refer to **Figure 1** for additional information.

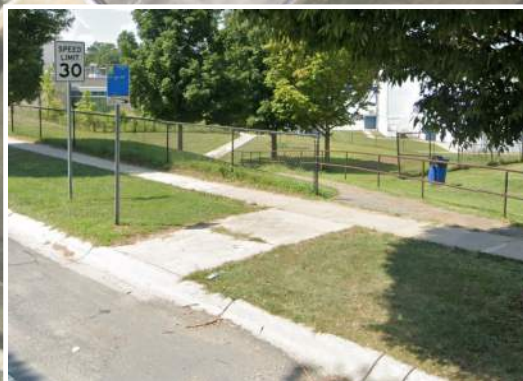
Static speed limit sign, bus stop, and pedestrian path from A. Mario Loiederman MS.

Approximate crash location.

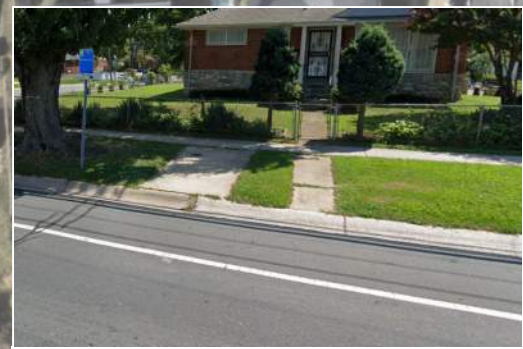
Bus stop location along Weller Road EB. Buffered sidewalks on both sides of the road.

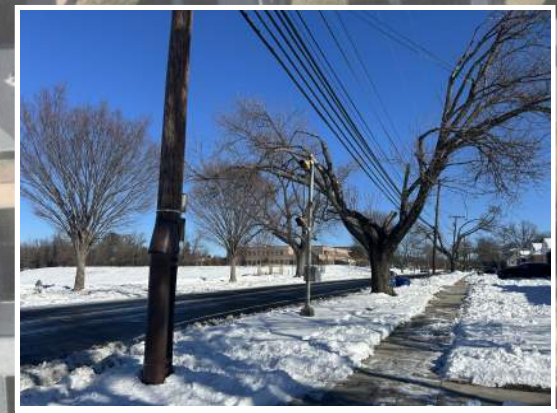
The posted speed limit along Weller Road is 30 mph with a school flasher/hazard identification beacon (HIB) just east of Greenly Street. This flasher is missing a speed limit sign. A Montgomery County RideOn bus stop exists in both directions on the west leg of Greenly Street. Multiple school-related signs exist along the corridor, including a school sign with supplemental plaques (Ahead and downward arrows at the marked crosswalk near the ES), and "State Law Stop for Peds in X-Walks."

School flasher missing sign along Weller Road EB.

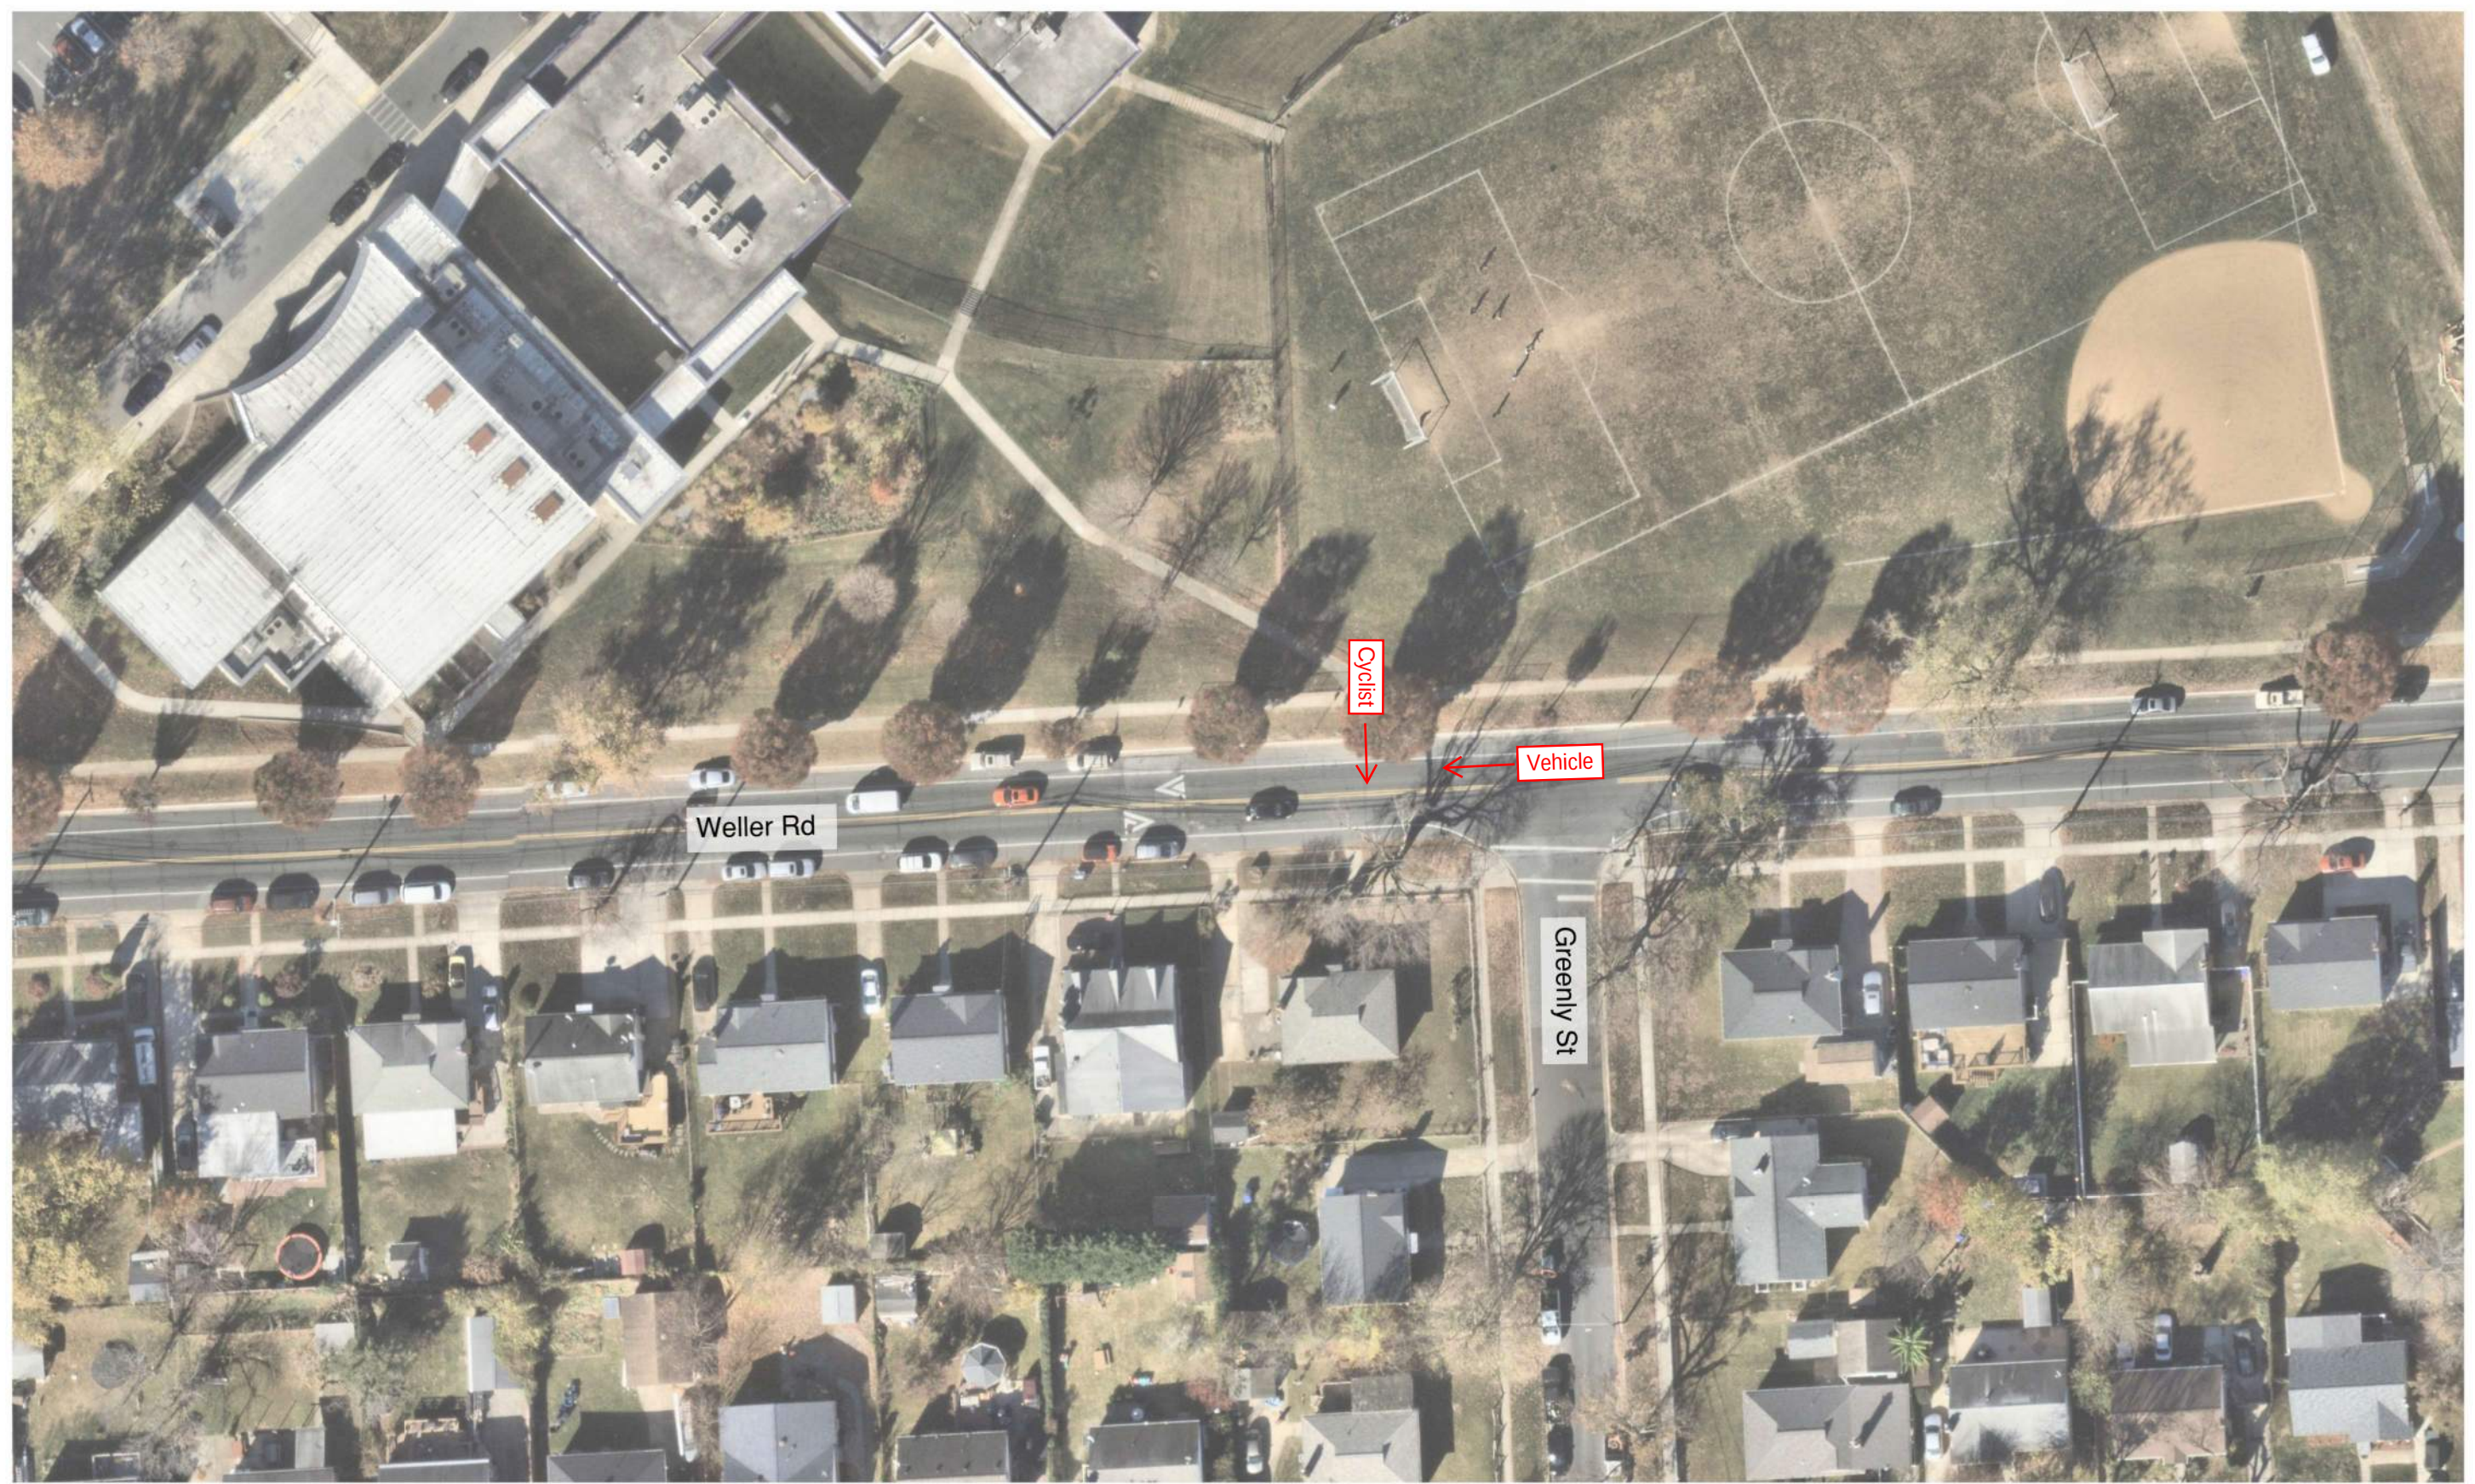
Figure 2 - Crash Diagram

On Tuesday, June 11, 2024, at approximately 6:30 PM, a bicyclist was traveling southbound across Weller Road at an unmarked location west of Greenly Street. A motorist traveling westbound along Weller Road struck the bicyclist in the roadway. The report indicated that the bicyclist suffered minor injuries. Daytime weather conditions were clear, and the roadway surface was dry.

**Figure 2** illustrates the crash location and direction of cyclist and vehicle travel.

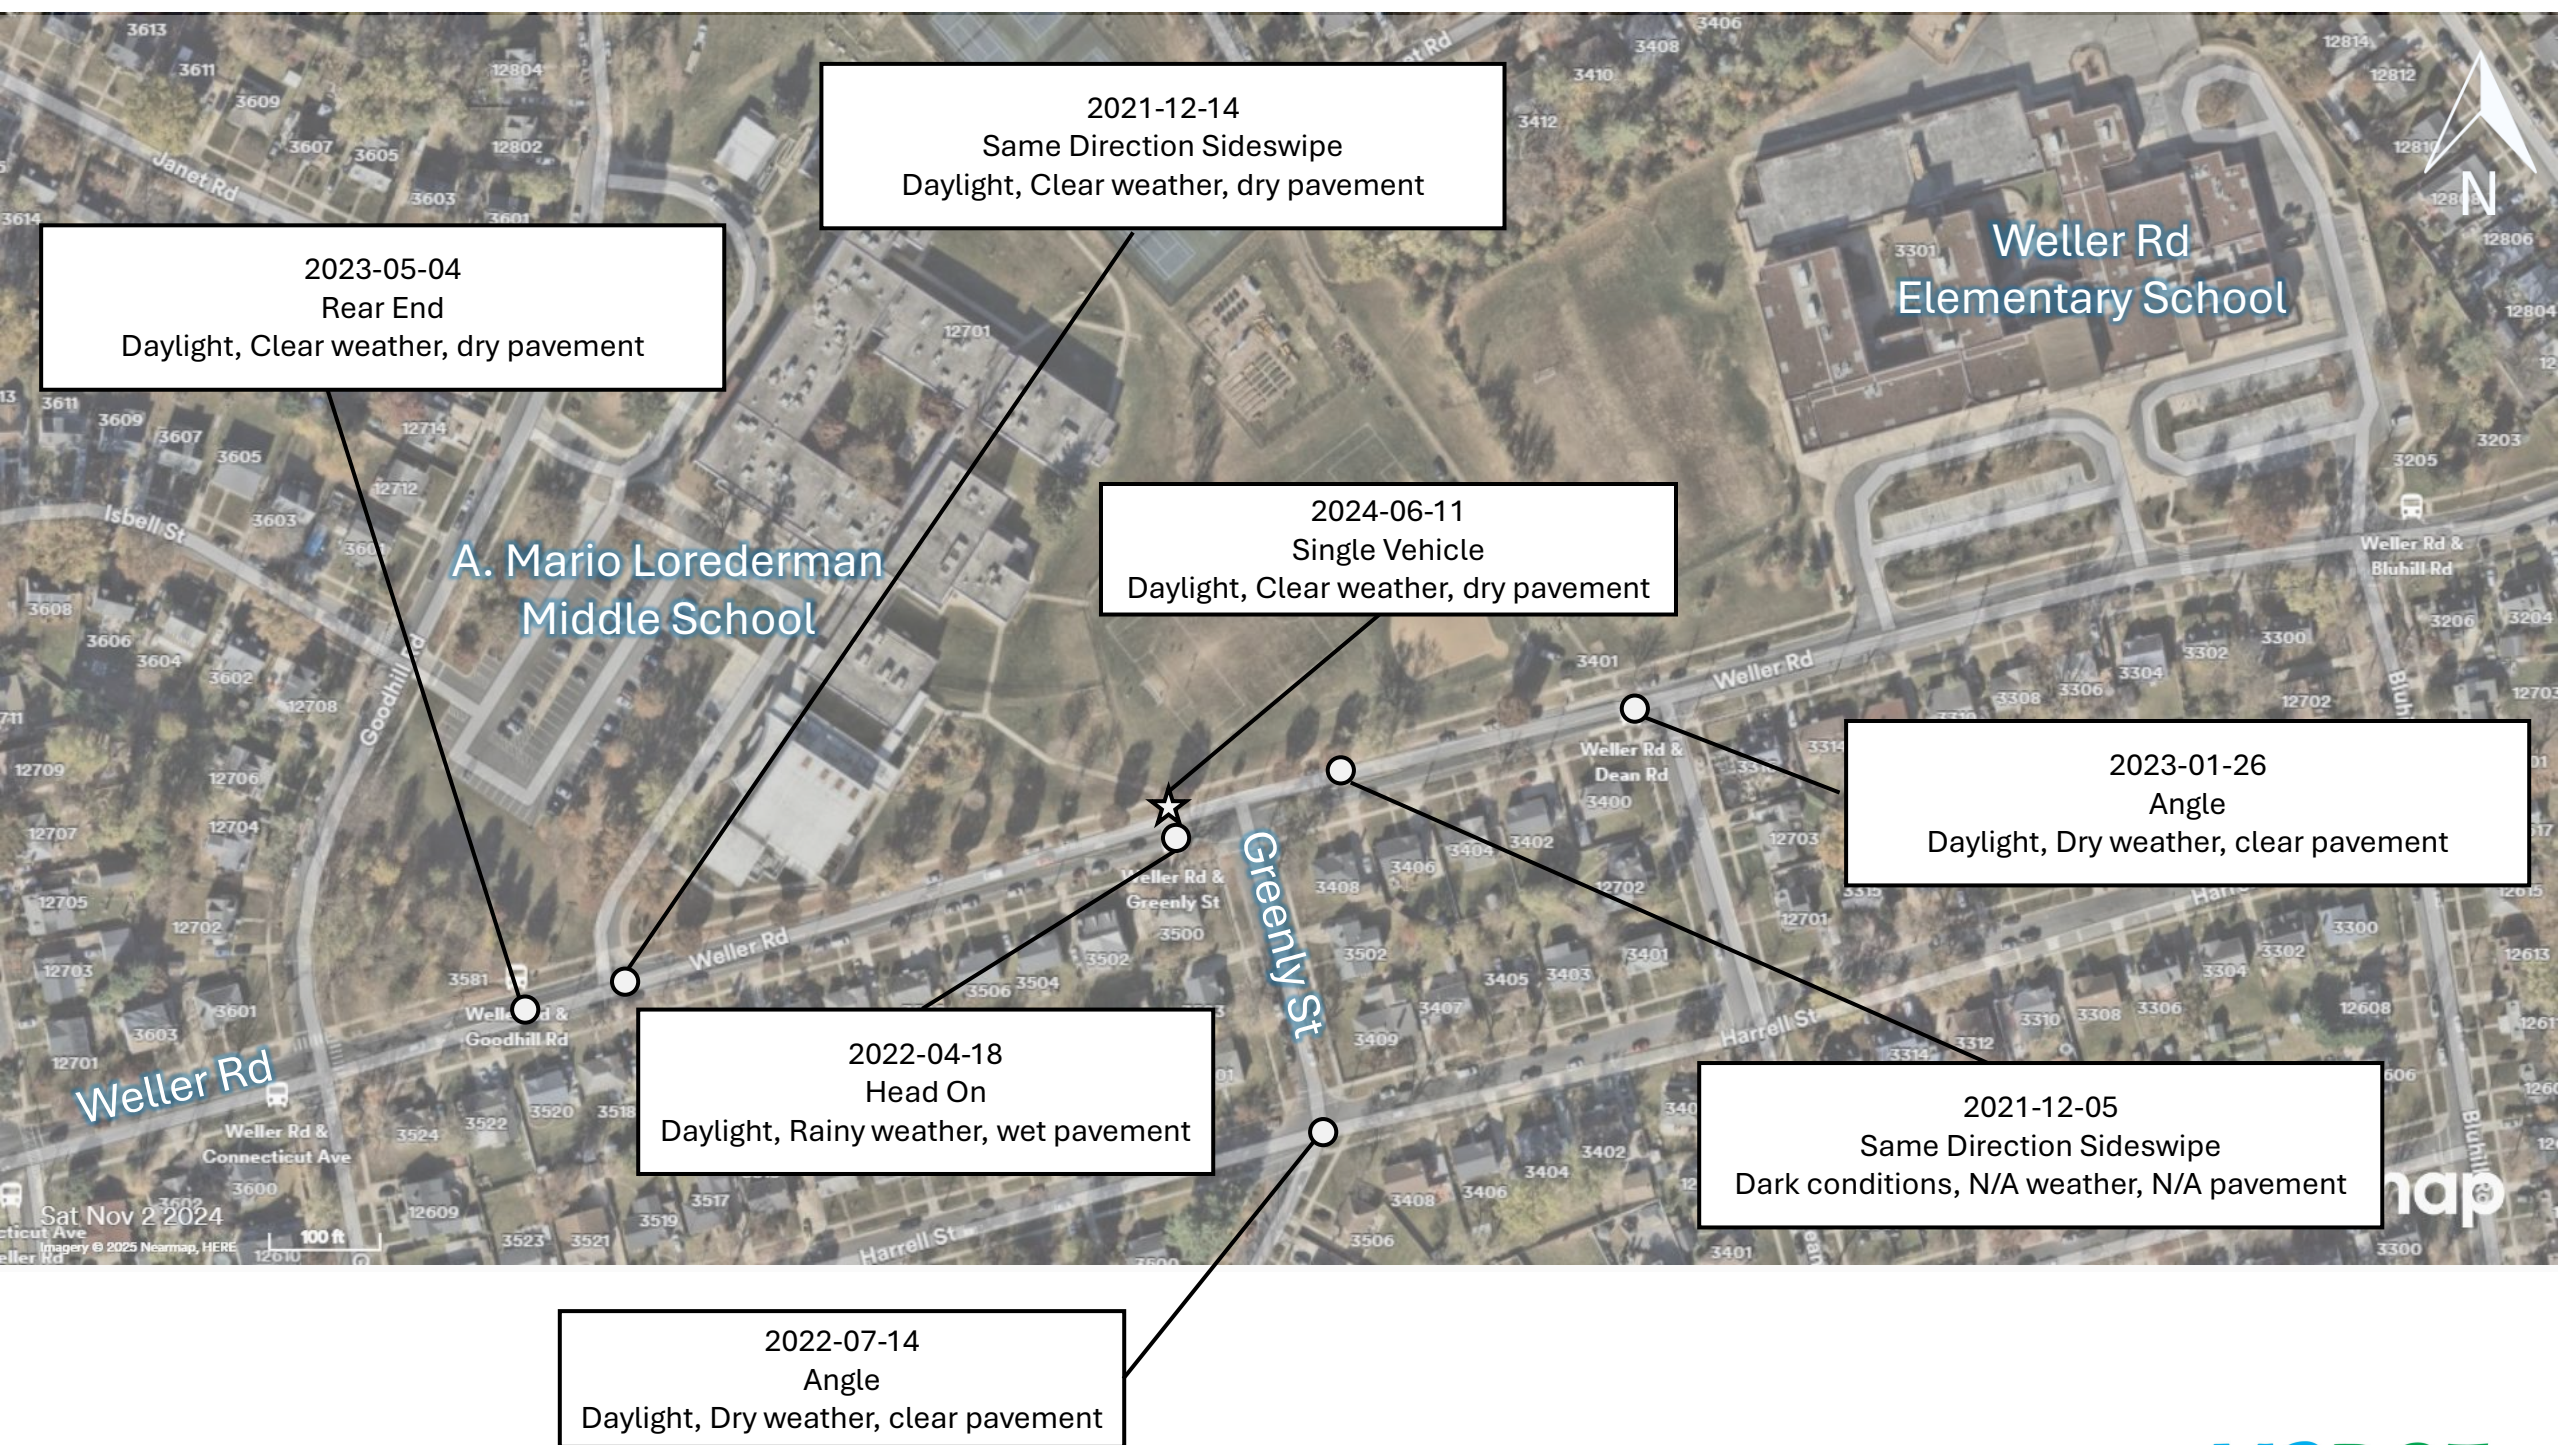
Figure 3 – Crash History (January 2020- September 2024)

Crash data obtained from dataMontgomery indicates that six (6) incidents occurred within the vicinity of the crash site between January 2020 and September 2024. Five (5) crashes occurred along Weller Road within 500 feet of Greenly Street, including one (1) at the same location as the subject incident. The other crashes include two (2) crashes that occurred approximately 650 feet to the west, near the middle school driveway; one (1) crash that occurred on the east leg of Weller Road at Greenly Street; one (1) crash approximately 375 feet to the east at Dean Road; and one (1) crash to the south at Greenly Street and the intersection with Harrell Street. The six (6) crashes reported near the Weller Road and Greenly Street intersection included three (3) injury crashes, three (3) property damage crashes, and the crash type consisted of two (2) sideswipe crashes, one (1) head on crash, two (2) angle crashes, and one (1) rear-end crash. There were no pedestrian or bicycle-related crashes. One (1) of the incidents occurred during wet pavement conditions, and one (1) occurred at night. The incidents are illustrated on **Figure 3**.
