# SCHOOL-RELATED CRASH REVIEW

**Location:** Greentree Road at Ewing Drive

**Crash Date:** June 12, 2024

**Local Case No.:** 240027904

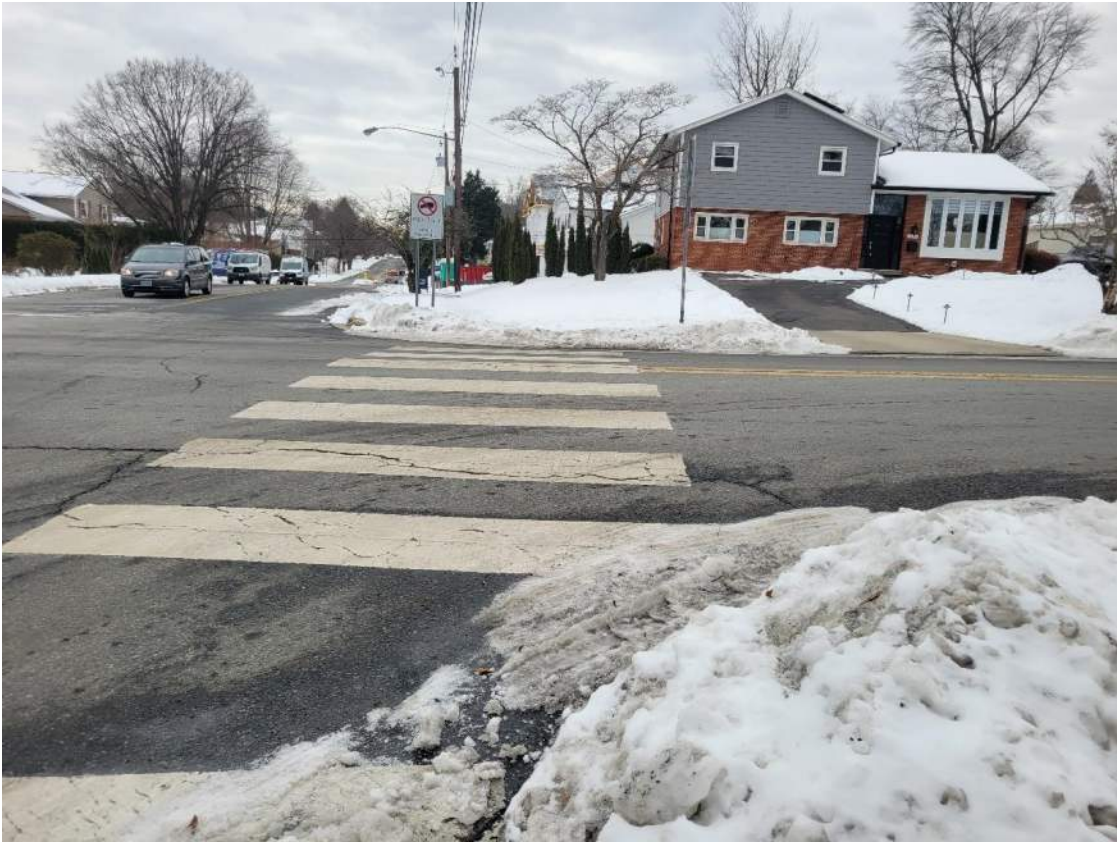
On Wednesday, June 12, 2024, at approximately 8:07 AM, a motorist traveling eastbound along Greentree Road turned left onto Ewing Drive and struck a pedestrian walking southbound along the west leg crosswalk. According to the crash report, the motorist failed to yield to the right of way of the pedestrian, and the pedestrian suffered serious injuries. Daytime weather conditions were clear, and the roadway surface was dry.

**Photo 1. Taken from the northwest corner looking south across Greentree Road. Approximate crash location.**

1. Upgrade existing crosswalk markings across Ewing Drive to continental style.
2. Refresh continental crosswalk markings across Greentree Drive.
3. Relocate the existing pedestrian crossing warning sign an additional 100 feet west from the crosswalk.

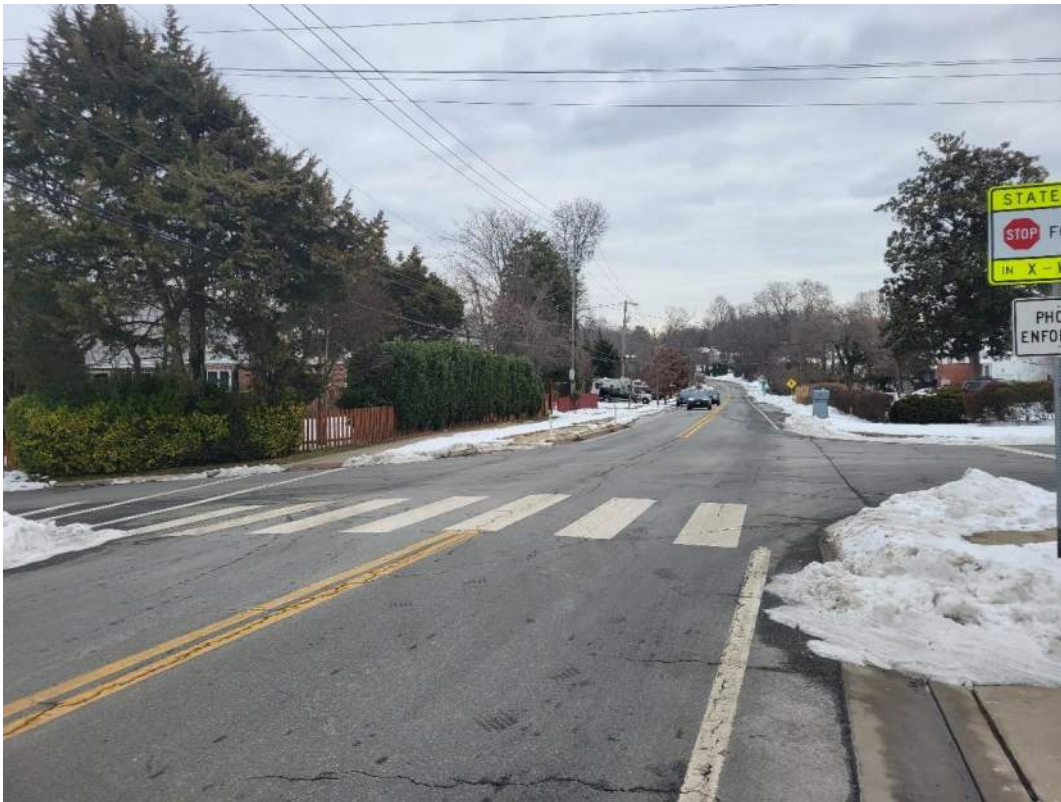
**Photo 2. Looking eastbound along Greentree Road. Approximate crash location.**

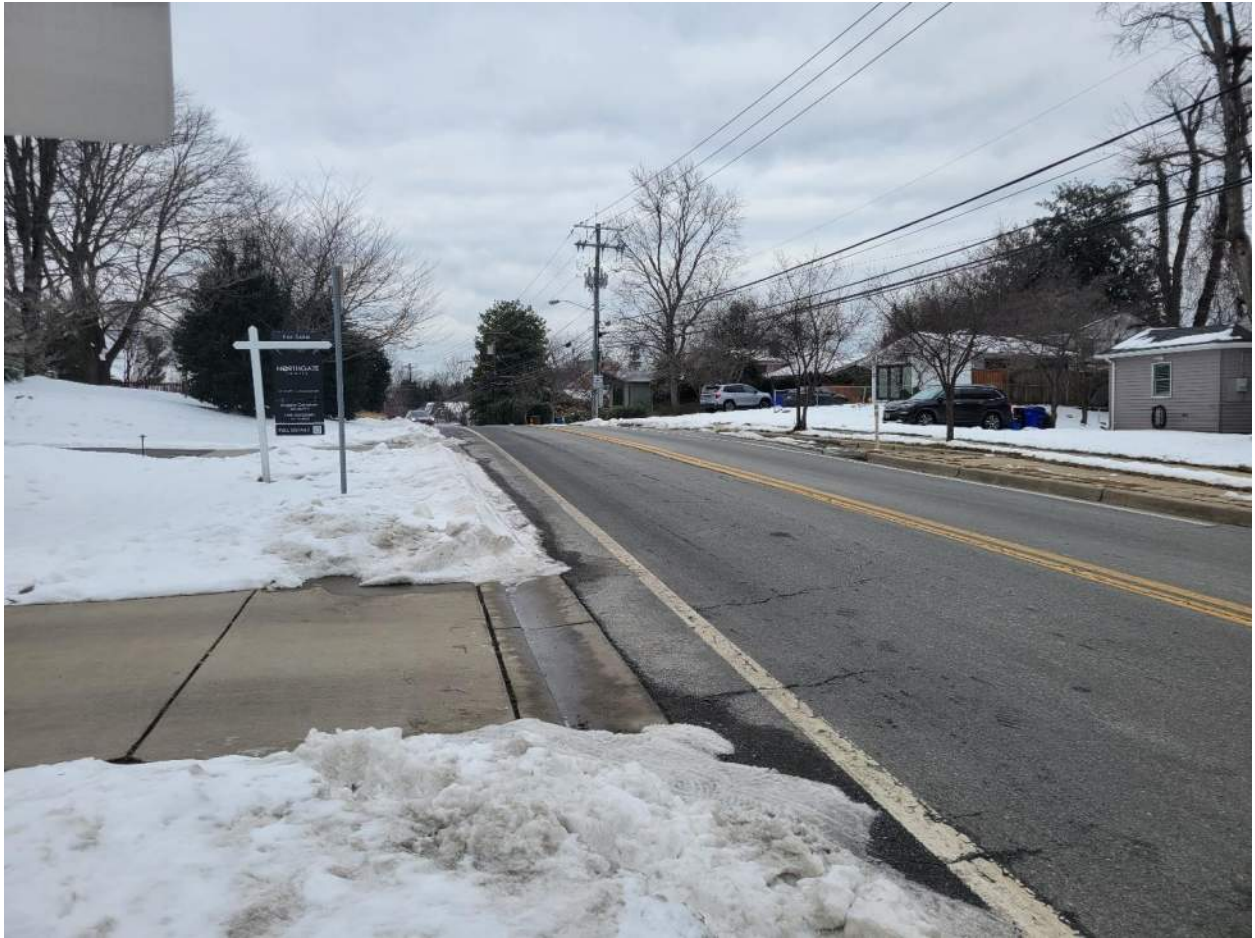
Sight distance is limited for pedestrians crossing northerly and looking to the left at oncoming eastbound traffic. The measured sight distance in the field is approximately 200 feet. AASHTO guidelines indicate that the minimum sight distance along a roadway with a design speed of 30 mph should be 290 feet. The existing pedestrian crossing warning sign (that includes a supplemental, 300 feet plaque) is incorrectly installed 200 feet from the crosswalk. See **Photo 3** and **Photo 4** for sight distance photos.

**Photo 3: Sight Distance from Southwest Quadrant Looking Left**

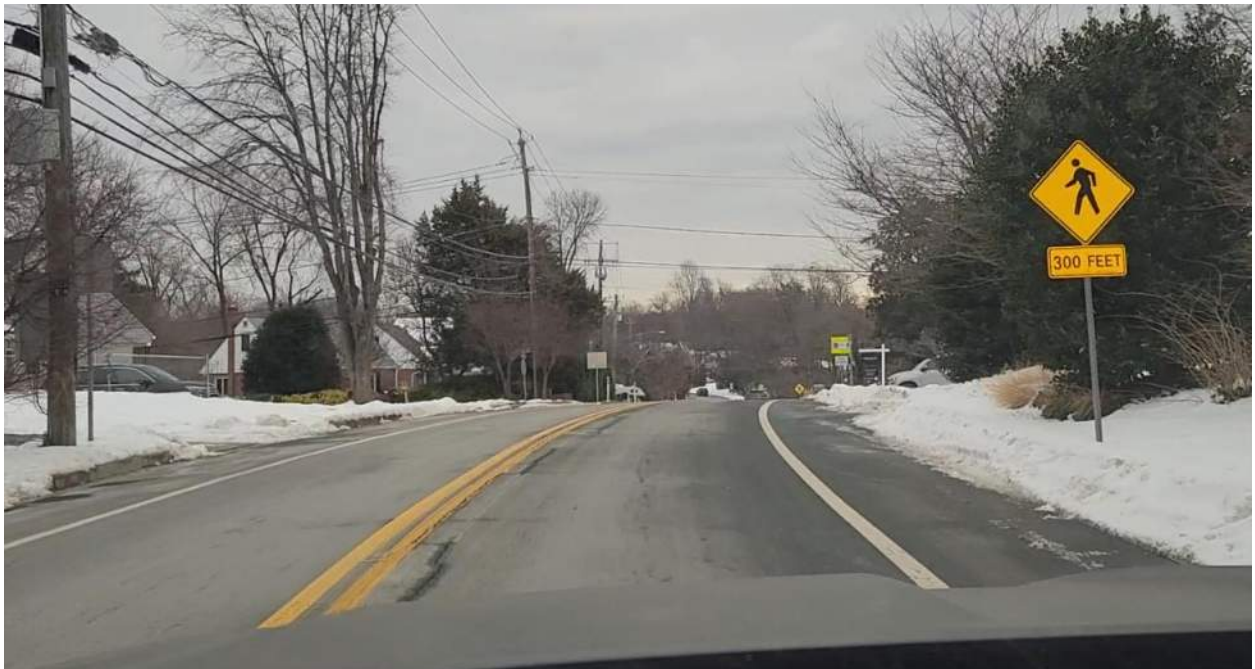
**Photo 4: Stopping Sight Distance for EB Motorist Approaching Ewing Drive**

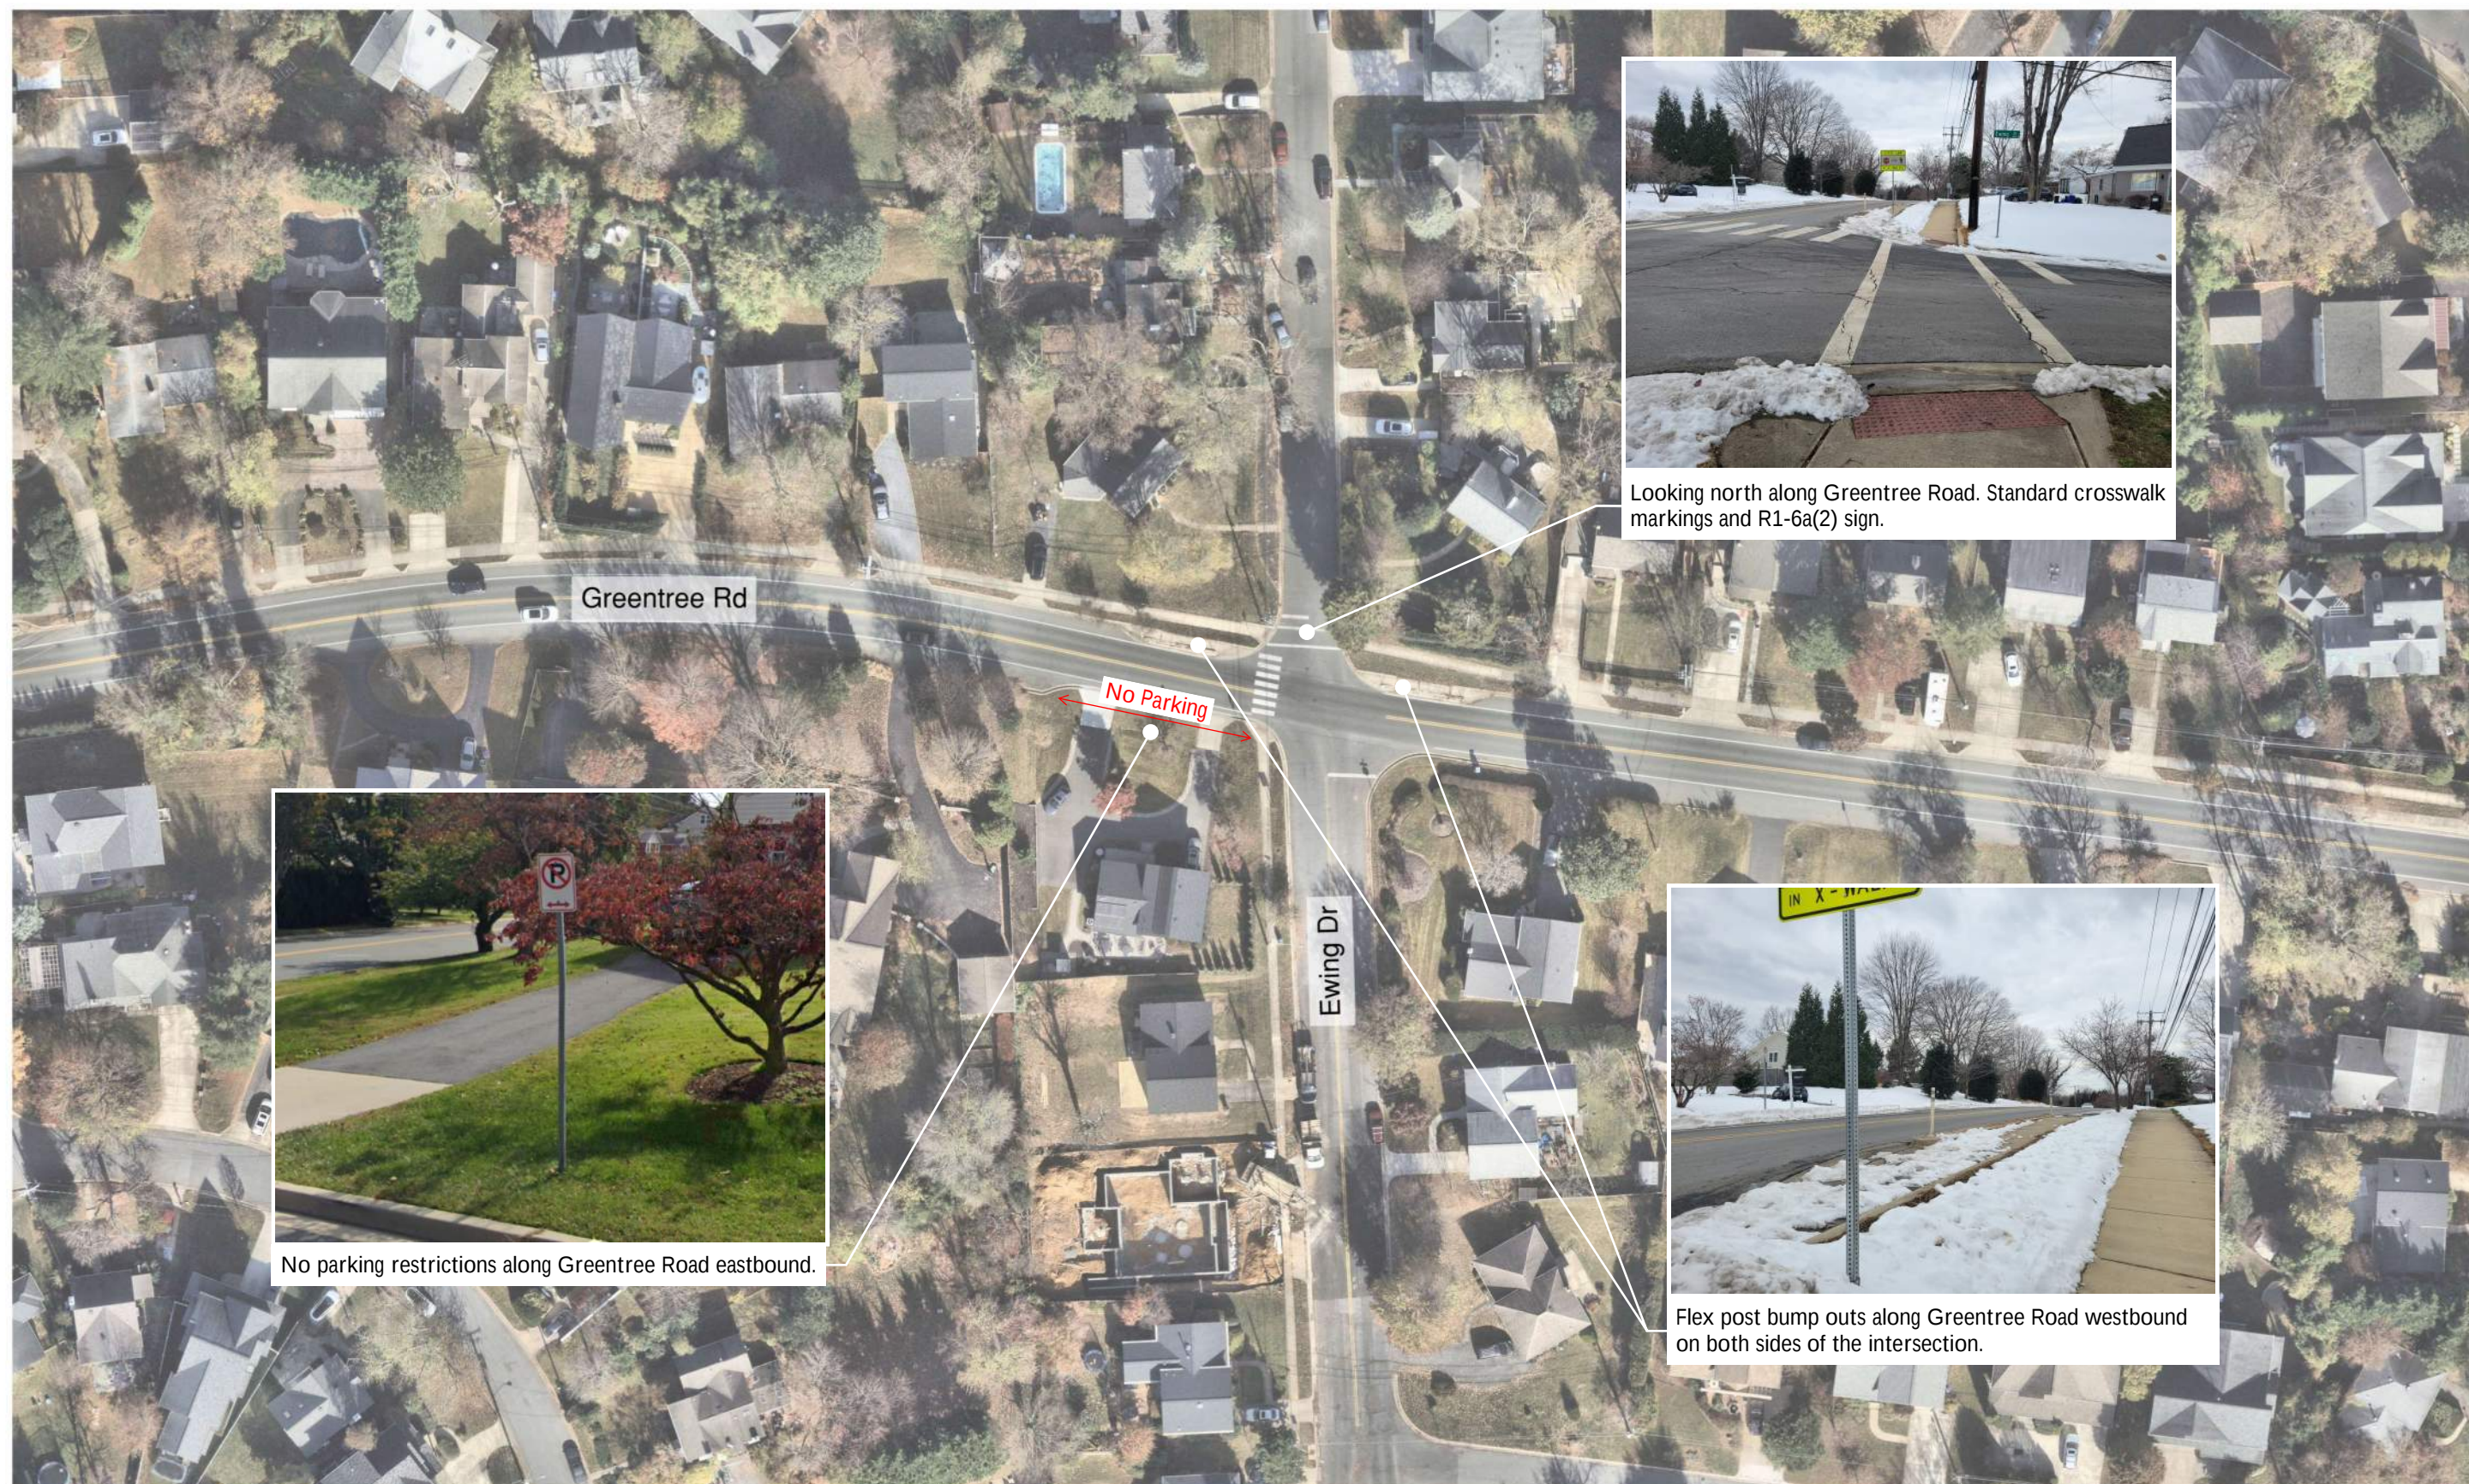
Figure 1 - Greentree Road Corridor Observations

Refer to **Figure 1** in the attachments for additional details on the Greentree Road segment.

The Greentree Road corridor was evaluated to identify potential infrastructure, maintenance activities, and road user behaviors that contribute to increased safety risk at and in the vicinity of the school-related crash location. The Greentree Road corridor was reviewed between Melwood Road to the west and Rolston Road to the east. Please refer to **Figure 1** for additional information.

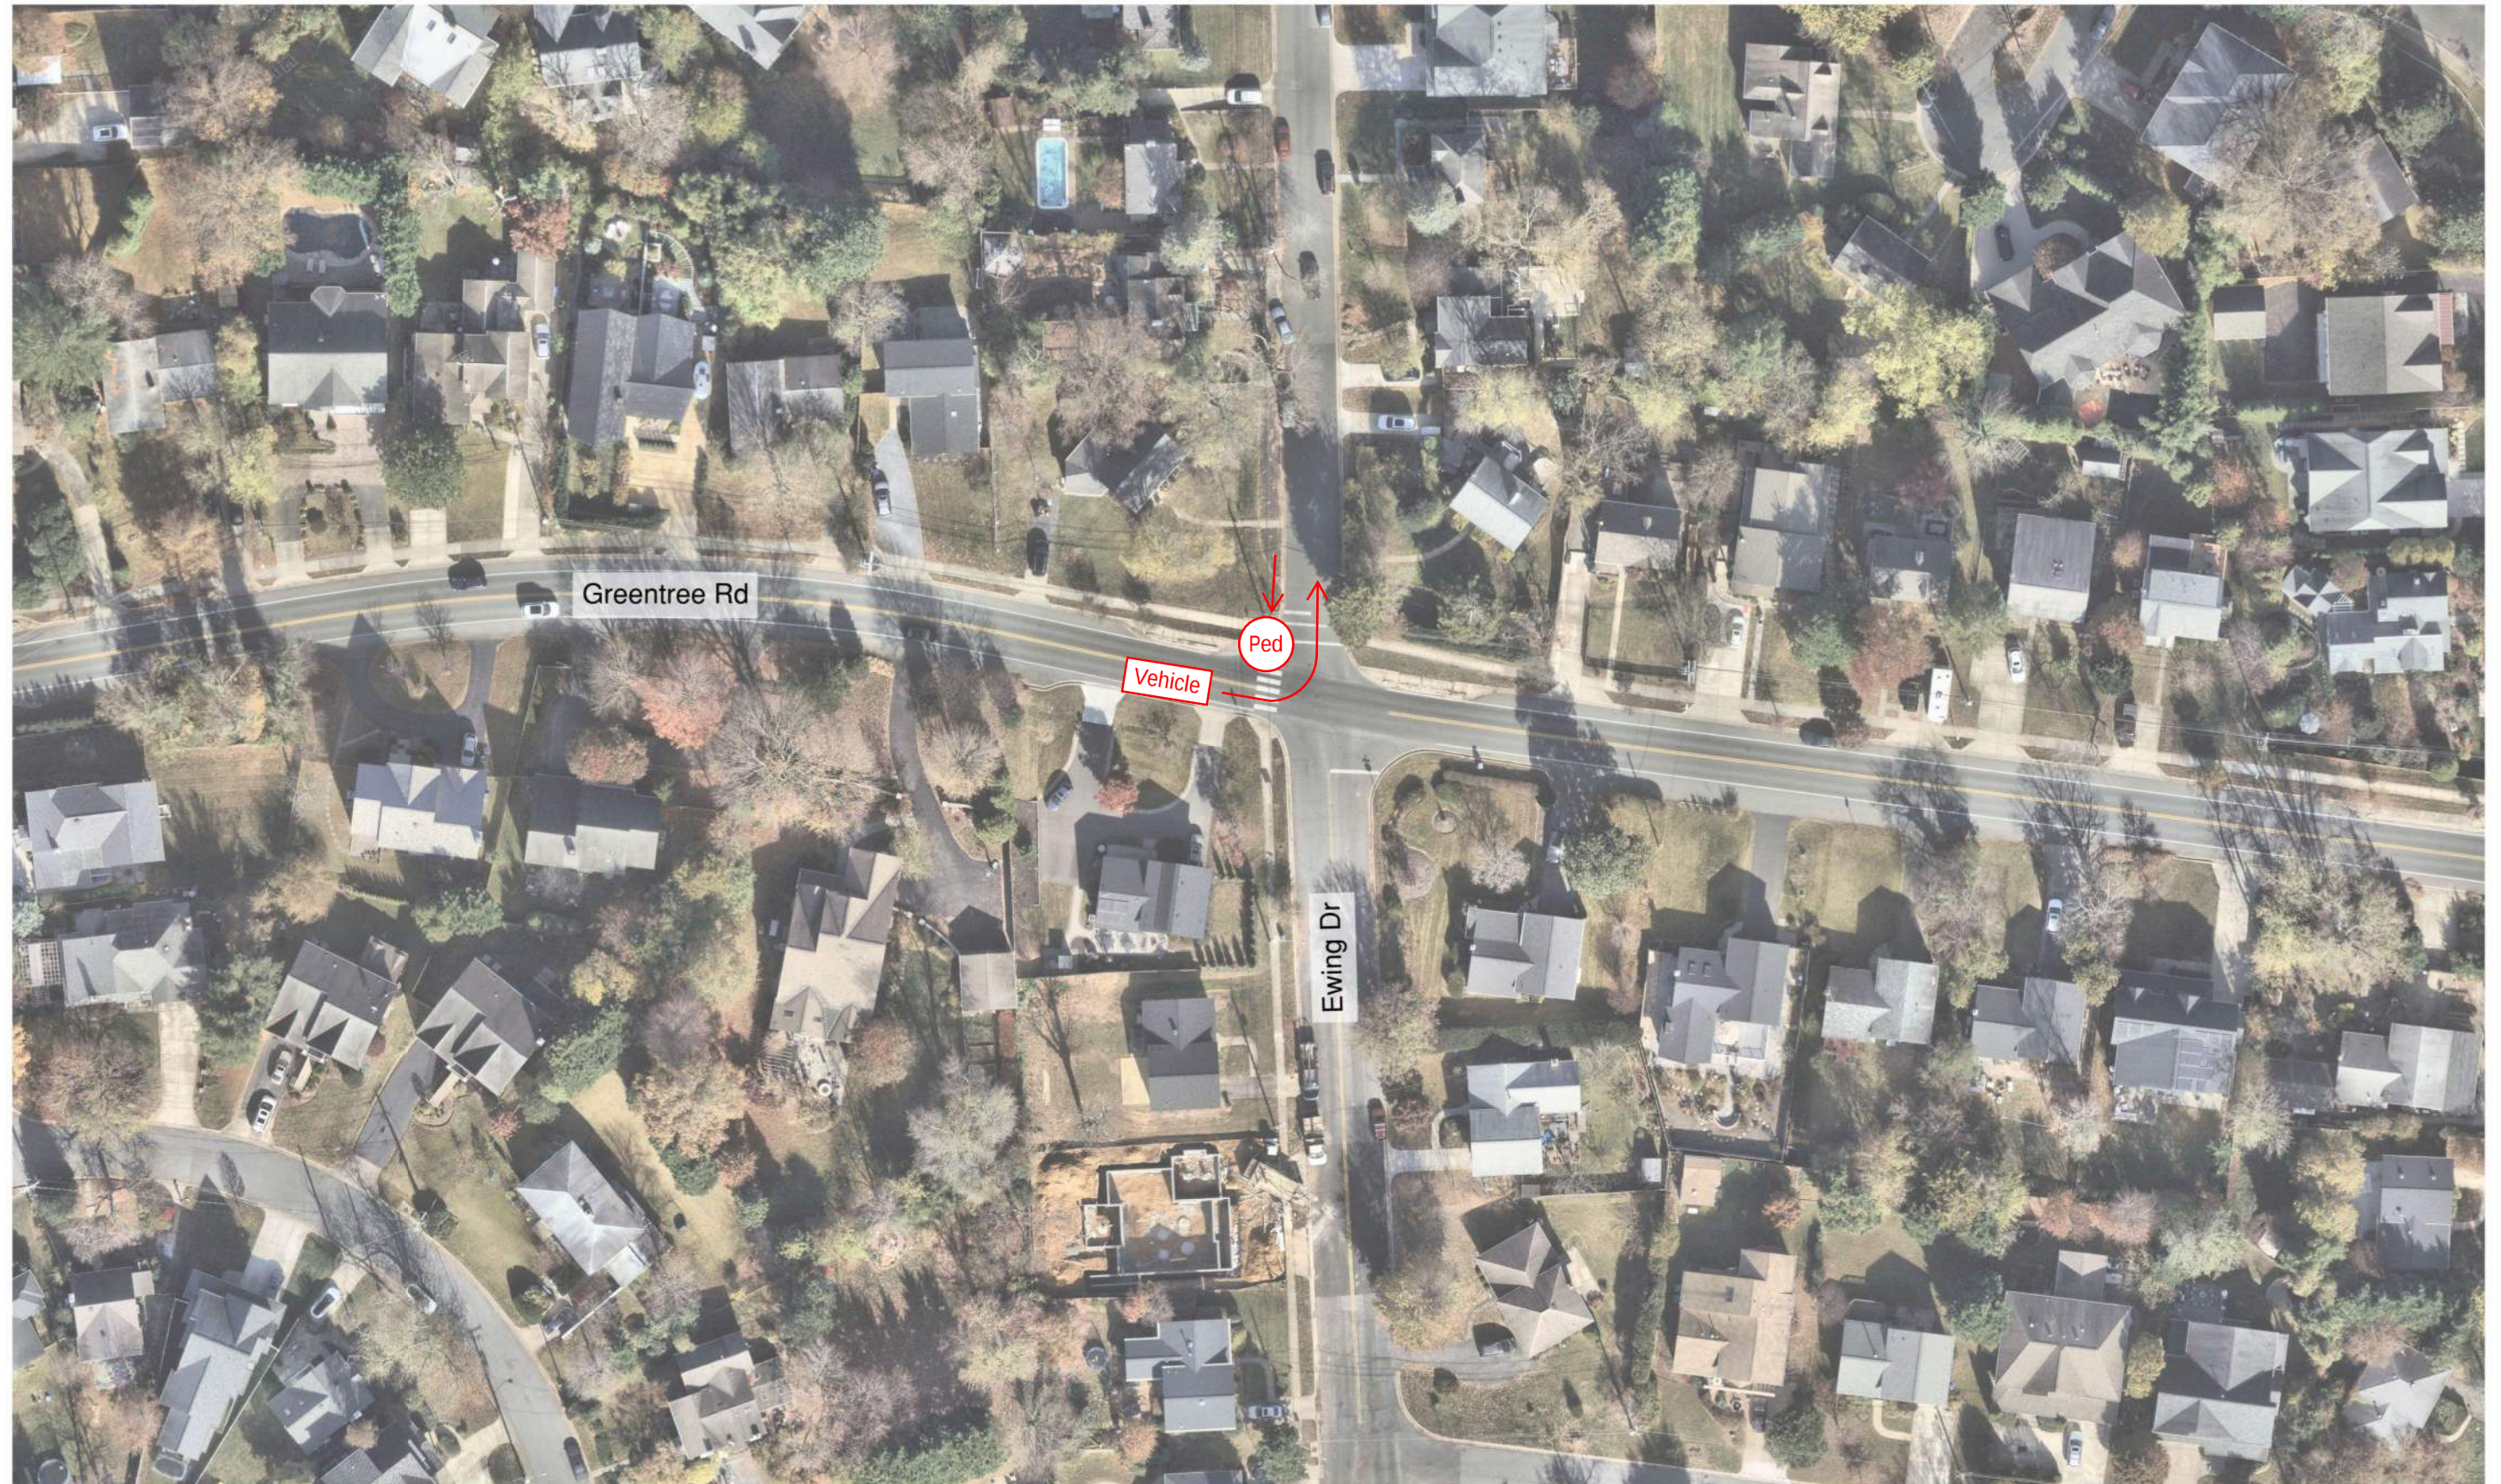
Figure 2 - Crash Diagram

**Figure 2** illustrates the crash location and direction of pedestrian and vehicle travel.

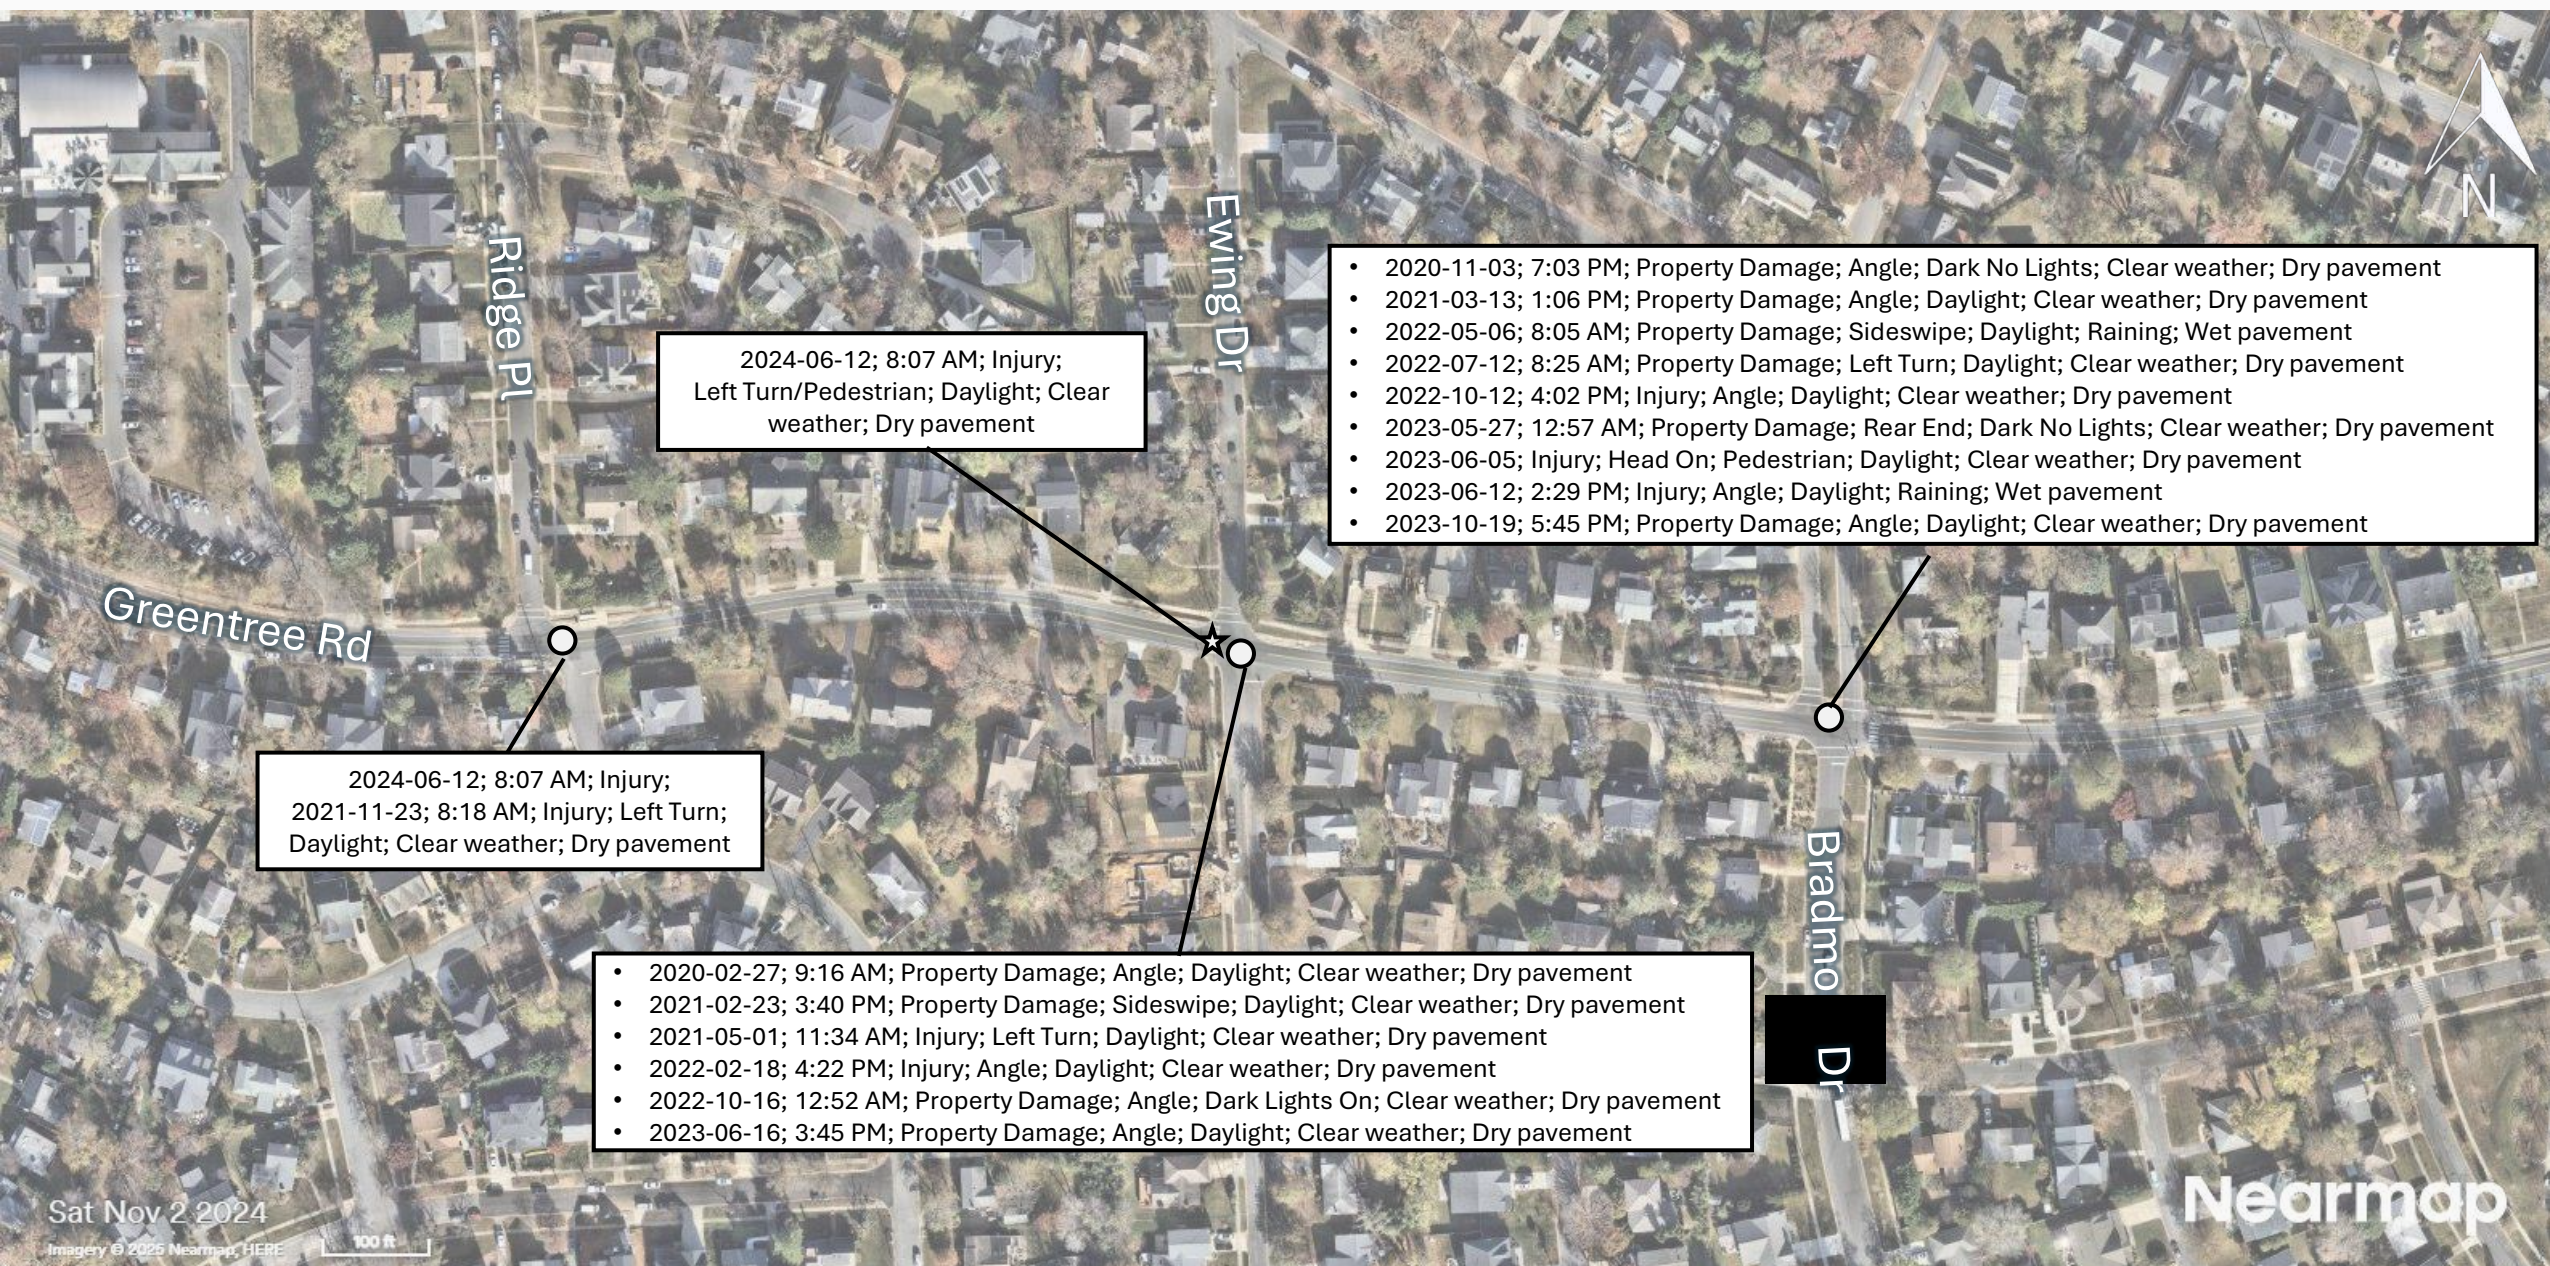
Figure 3 – Crash History (2021-2023)

Crash data obtained from dataMontgomery indicates that 16 incidents occurred within the vicinity of the crash site between January 2020 and December 2023. Of these 16 incidents, six (6) crashes occurred within at the subject crash intersection of Greentree Road and Ewing Drive. The other 10 crashes occurred at the intersections with Bradmoor Drive to the east, or with Ridge Place to the west. The 16 crashes reported included six (6) injury crashes, 10 property damage crashes, and the crash type consisted of nine (9) angle collisions, two (2) sideswipe collisions, three (3) rear end collisions, three (3) head on collisions, three (3) left-turn collisions, one (1) head on collision, and one (1) rear end collision. There was one (1) pedestrian or bicycle-related crashes. Two (2) of the incidents occurred during wet pavement conditions, and three (3) occurred in the dark. The incidents are illustrated on **Figure 3**.
