SAFE STREETS ACT 2023 - CRASH REVIEW

Location: Rock Spring Drive

Crash Date: September 9, 2024

Local Case No.: 240042790

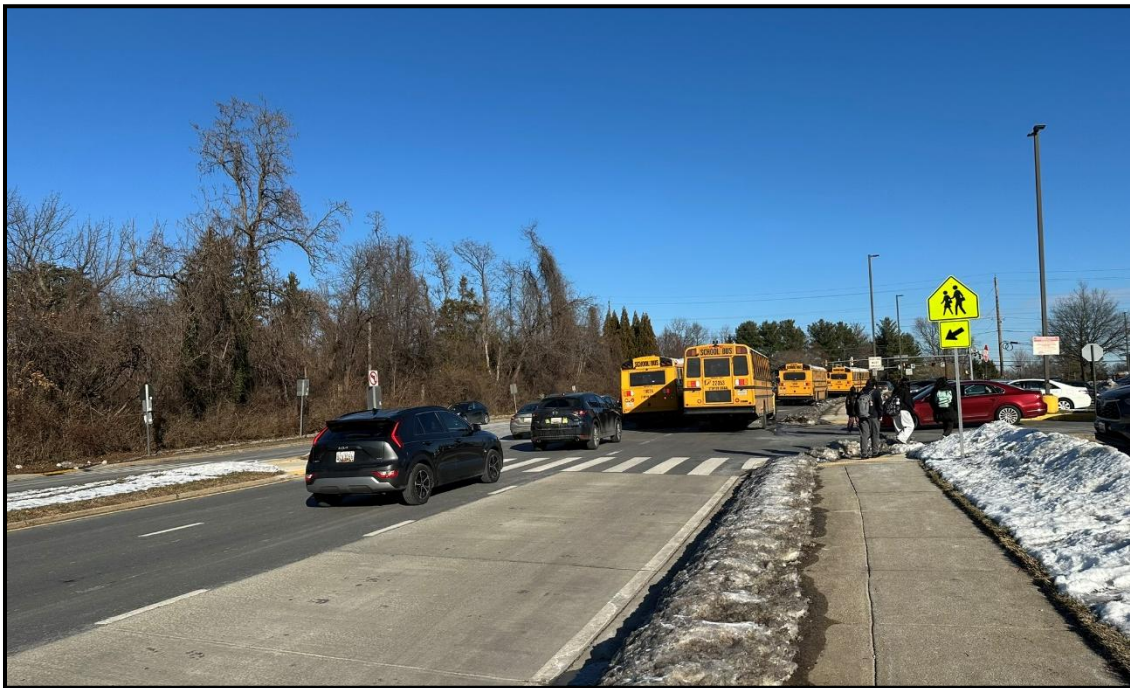
The crosswalk is located approximately 250 feet east of the Walter Johnson HS frontage. ADA-compliant pedestrian ramps provide accessible crossings between bus stops on either side of the street. A staggered ladder-style crosswalk is installed for this crossing.

Photo 1. Subject Marked Crosswalk

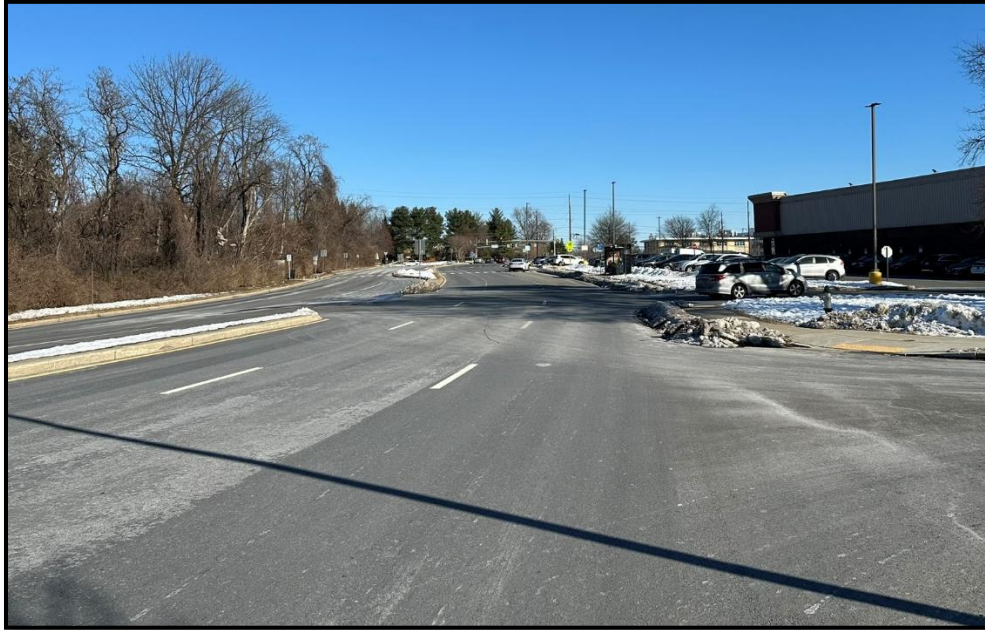
Photo 2. Eastbound Approach to the Crossing

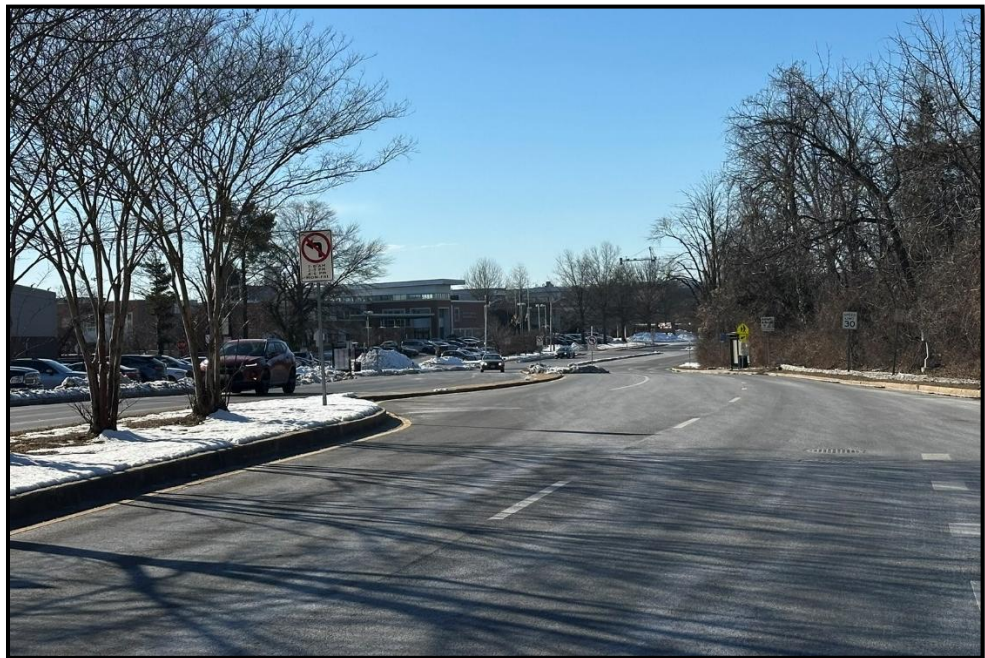
Photo 3. Westbound Approach to the Crossing

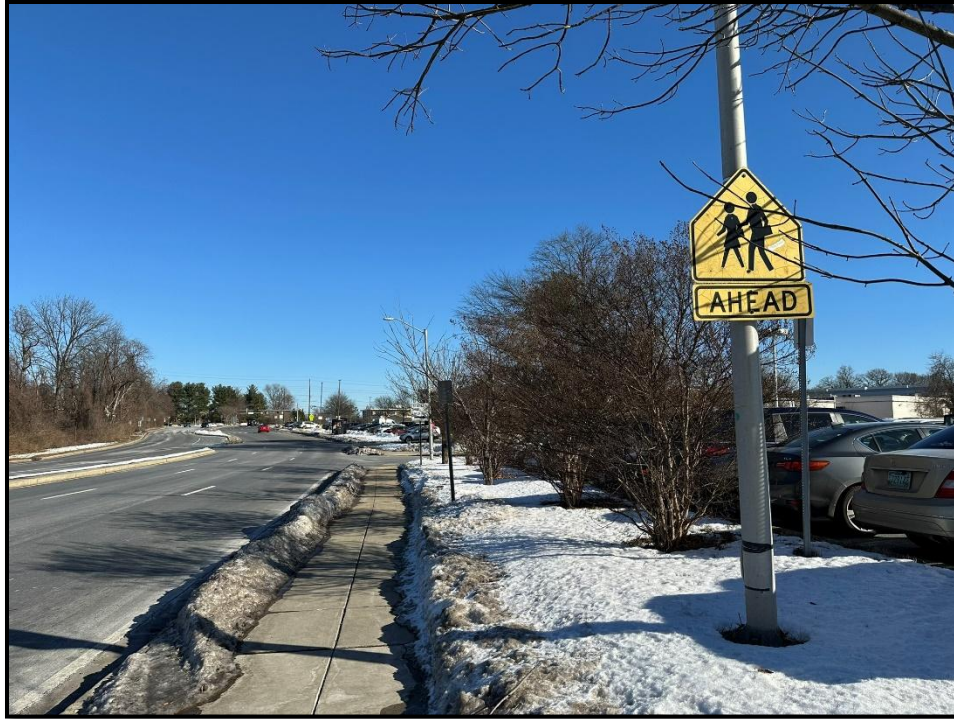
Photo 4. School Advance Crossing Assembly on Eastbound Approach

1. Install School Crossing Assemblies (S1-1 and W16-7P signs) on the median side for both eastbound and westbound approaches to improve conspicuity.
2. Trim trees to improve the visibility of the existing eastbound School Advance Crossing Assembly (S1-1 and W16-9P), located 420 feet west of the crosswalk.
3. Consider installation of a Pedestrian Hybrid Beacon (PHB) at this uncontrolled crossing. This improvement is included based on a recommendation identified by a traffic study conducted at this intersection in January 2025 (Logger ID: 90199).

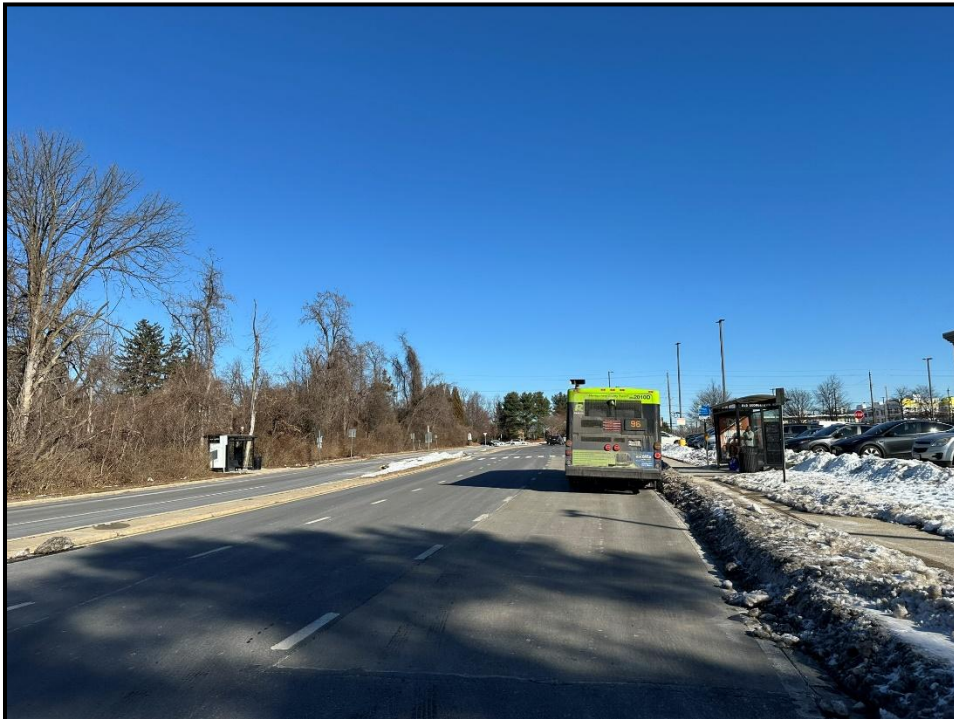
Field observations were performed on Tuesday, January 14, 2025, during the Walter Johnson HS dismissal period. Weather conditions were clear, and the roadway surface was dry. Students were observed using the crossings and sidewalks. No crossing guard was present along Rock Spring Drive. Vehicles were observed queueing along the rightmost eastbound lane, stretching from the eastern edge of the Walter Johnson HS frontage to the Rockledge Drive intersection with Rock Spring Drive, to pick up students. The queue affected the bus operations, with one bus observed stopping in the middle lane to board passengers at the Rockledge Drive bus stop.

Photo 5. Eastbound Approach to the Crossing with Bus in View
