# SAFE STREETS ACT 2023 - CRASH REVIEW

**Location:** Dalewood Drive at Dean Road

**Crash Date:** September 16, 2024

**Local Case No.:** 240044034

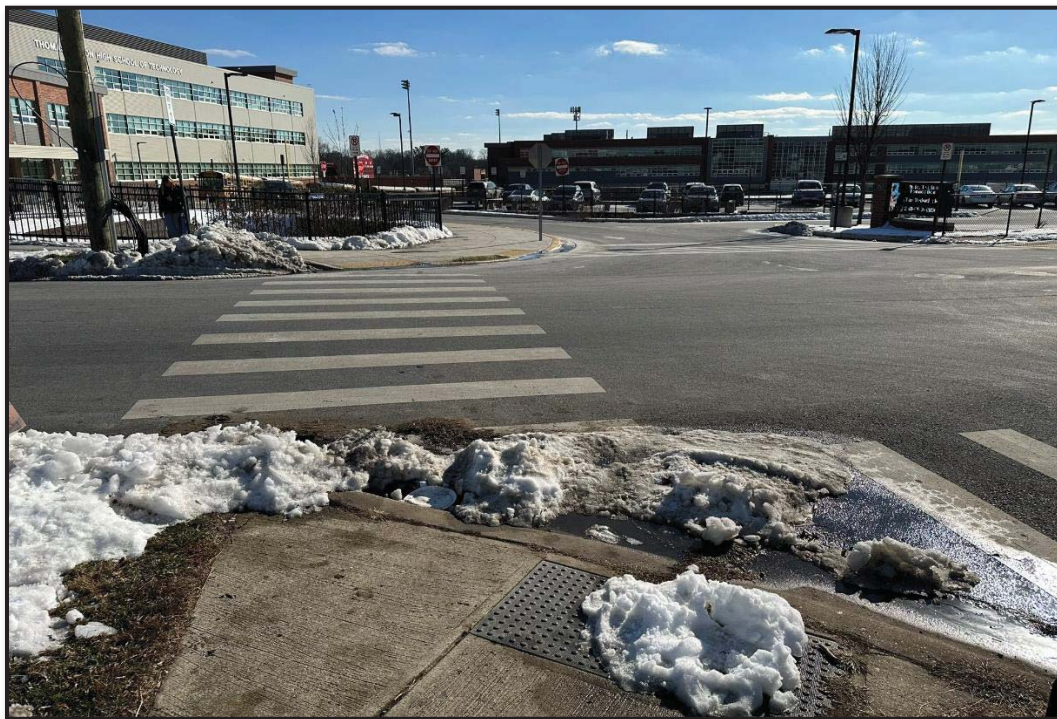
**Photo 1. Crosswalk Markings at Dean Road Crossing**

1. Consider installing School Crossing Assembly (S1-1 and W16-17P) on both left and right sides of the crossing for both eastbound and westbound approaches to improve visibility.
2. Consider installing double yellow lines in the vicinity of marked crosswalks along Dalewood Drive to discourage bypassing.
3. Coordinate with the school to educate students about the importance of safe crossing habits and encourage the use of crosswalk.

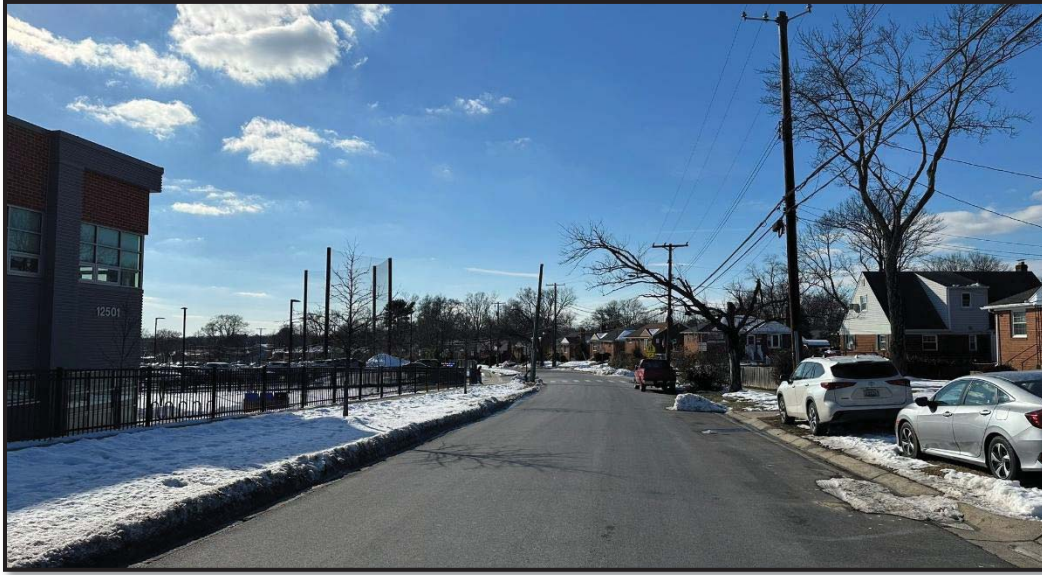
**Photo 2. Westbound Approach to Dean Road Crossing**

Based on the crash report, the motorist was bypassing the vehicles stopped for school traffic and had obstructed visibility when the incident happened. Field verification confirms that the westbound approach provides adequate sight distance, meeting the AASHTO minimum stopping sight distance requirement of 155 feet for 25 mph. The visibility obstruction is likely due to vehicles parked too close to the intersection in violation of existing parking restrictions. While there are no roadway deficiencies, visibility and pedestrian awareness could be improved through various countermeasures outlined in the recommendations below:

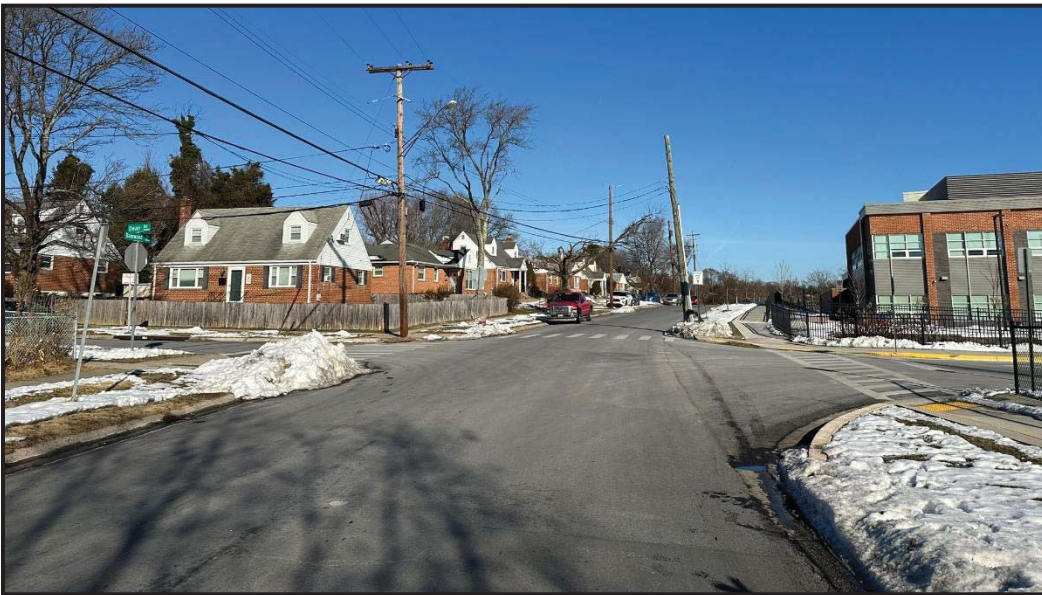
**Photo 3. Eastbound Approach to Dean Road Crossing**

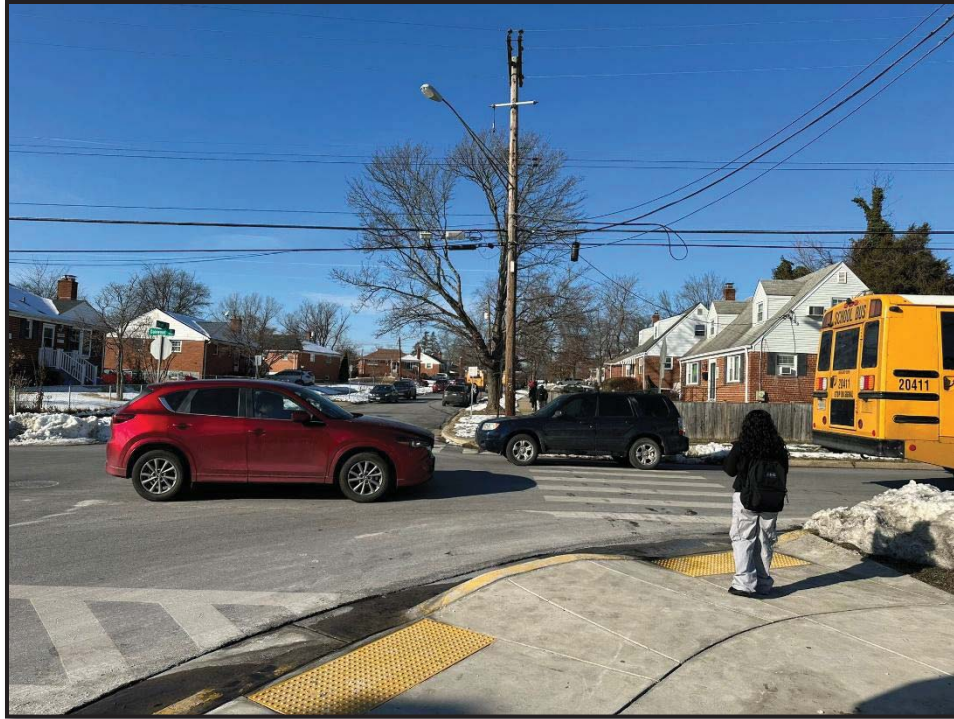
Field observations were performed on Friday, January 17, 2025, during the Wheaton HS and Thomas Edison HST dismissal period. Weather conditions were clear, and the roadway surface was dry. Many students were observed using the crossings and sidewalks. Multiple vehicles were observed parking along the roadside for student pick up. School buses leaving Thomas Edison HST and students crossing Dalewood Drive caused a significant vehicle queue in the eastbound direction, extending back to the Wheaton HS entrances.

**Photo 4. During Dismissal Period**

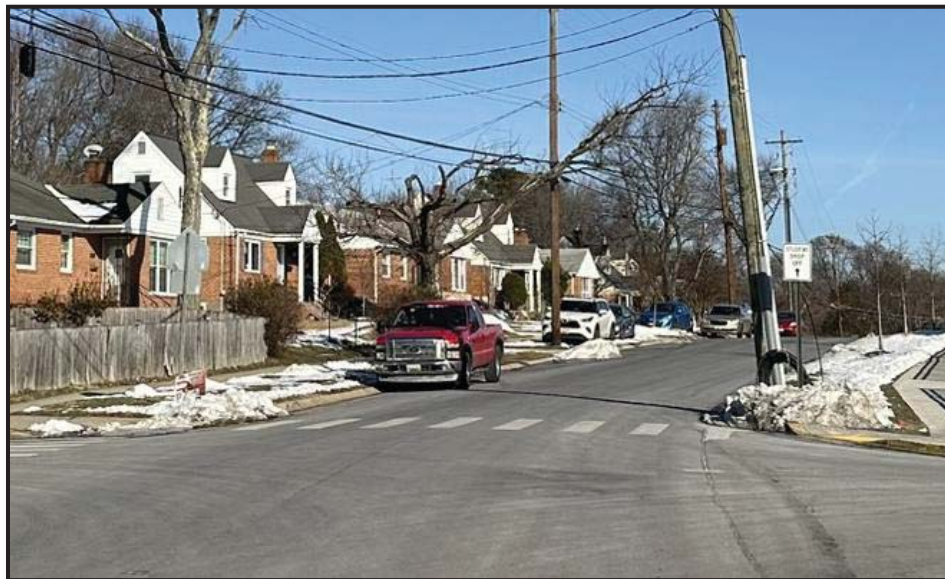
**Photo 5. Absence of School Crossing Assembly on Eastbound Approach**

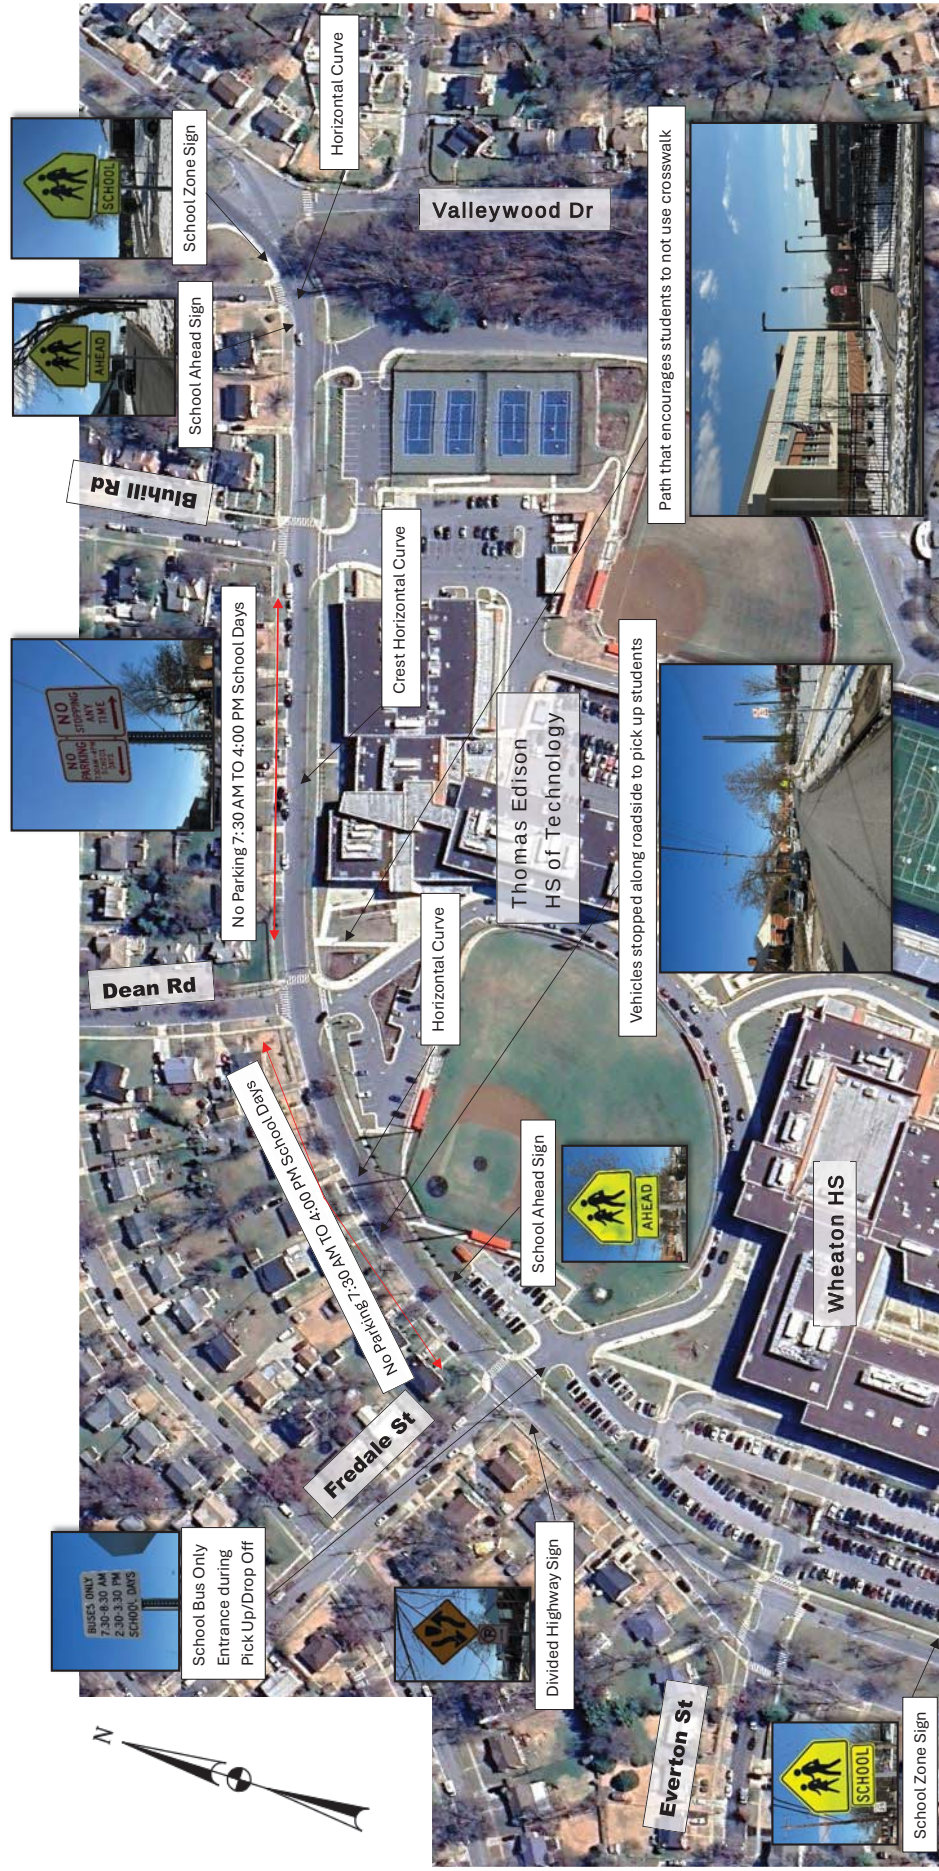
Figure 1 - Dalewood Drive Corridor Evaluation

Dalewood Drive is a two-lane neighborhood connector, which is 26 feet wide, and is generally oriented in the east-west direction. Dalewood Drive has grass-buffered sidewalks with a nominal width of four feet along the north side of the street and a nominal width of five feet along the south side. The posted speed limit along Dalewood Drive is 25 MPH. No stopping is allowed at any time along most of the segment, while no parking restrictions are in effect from 7:30 AM to 4 PM during school days on the north side between Fredale Street and Bluhill Road. Refer to **Figure 1** in the attachments for additional details of the Dalewood Drive segment.

The Dalewood Drive corridor was evaluated to identify potential infrastructure deficiencies, maintenance needs, and road user behaviors that contribute to increased safety risk at and in the vicinity of the school-related crash location. The Dalewood Drive corridor was reviewed between Valleywood Drive to the east and Everton Street to the west. There are two horizontal curves along this segment – one west of Dean Road and one near Valleywood Drive. The segment also includes a vertical curve with a crest 250 feet east of the Dean Road intersection. The horizontal and vertical curvature constrain lines of sight and observations show the grade changes result in variable acceleration and deceleration rates by motors traveling the corridor. Please refer to **Figures 1** for additional information.

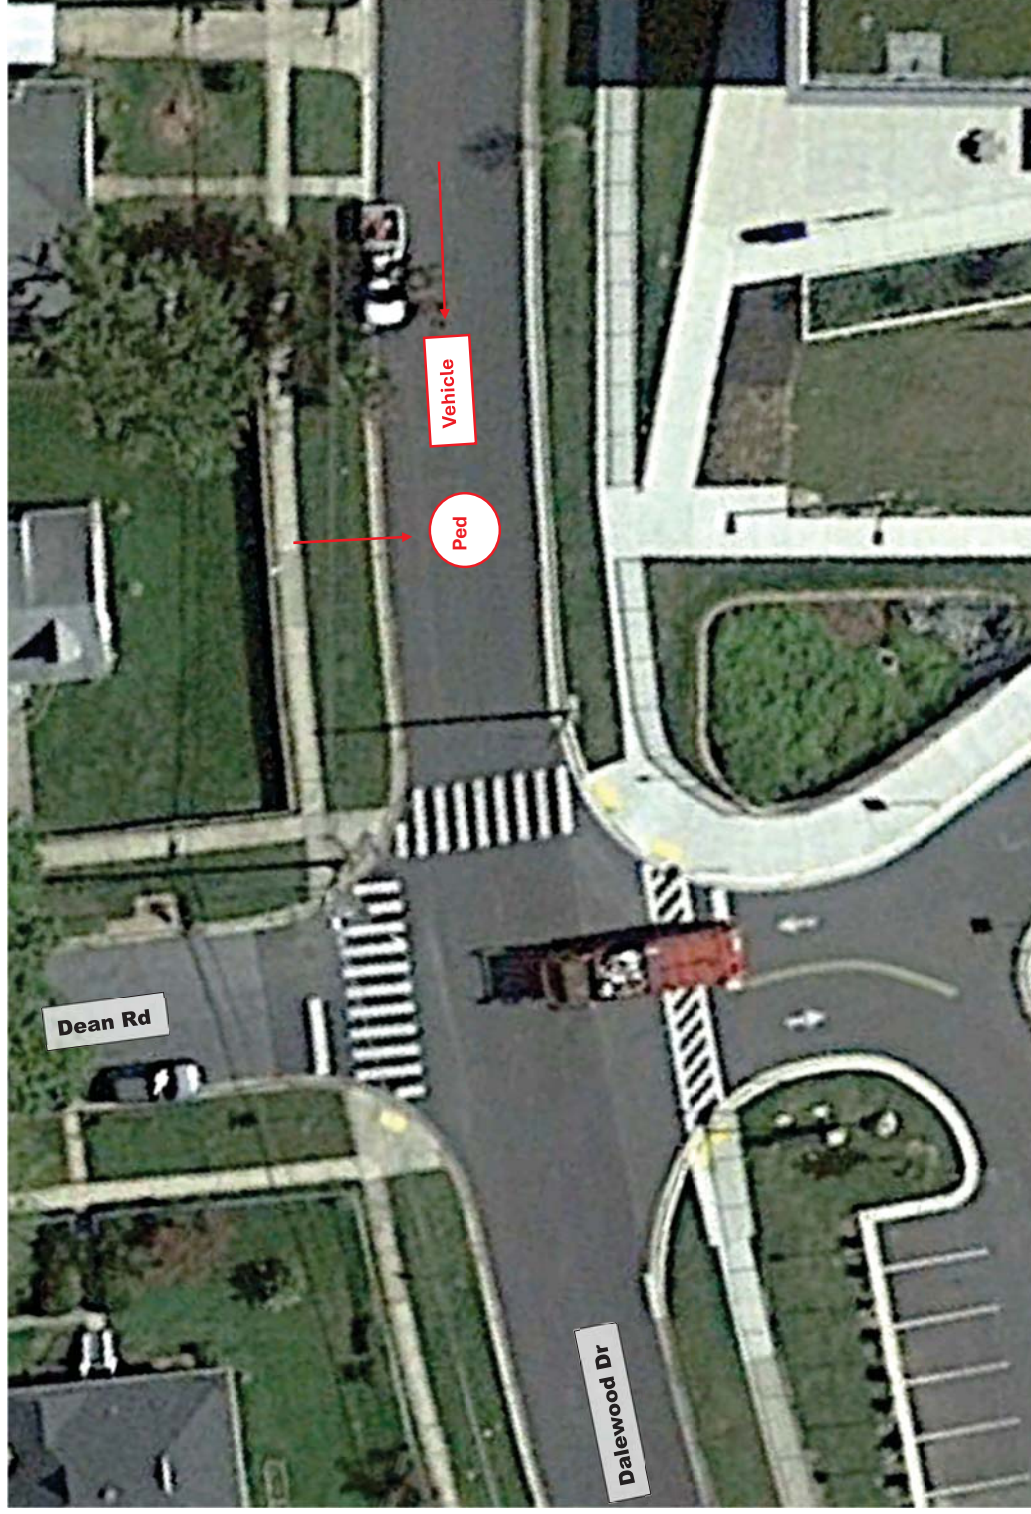
Figure 2 - Dalewood Drive at Dean Road  
2024 September 16 Pedestrian-Involved Crash

On Monday, September 16, 2024, at approximately 7:39 AM, a motorist traveling westbound along Dalewood Drive collided with a student who was crossing the street outside the marked crosswalk at the east leg of the intersection. According to the crash report, improper passing and obstructed visibility were considered as factors in the collision. Weather conditions were clear, the roadway surface was dry, and it was daylight. The responding officer reported that the pedestrian may have suffered minor injuries.

**Figure 2** illustrates the crash location and direction of pedestrian and vehicle travel.

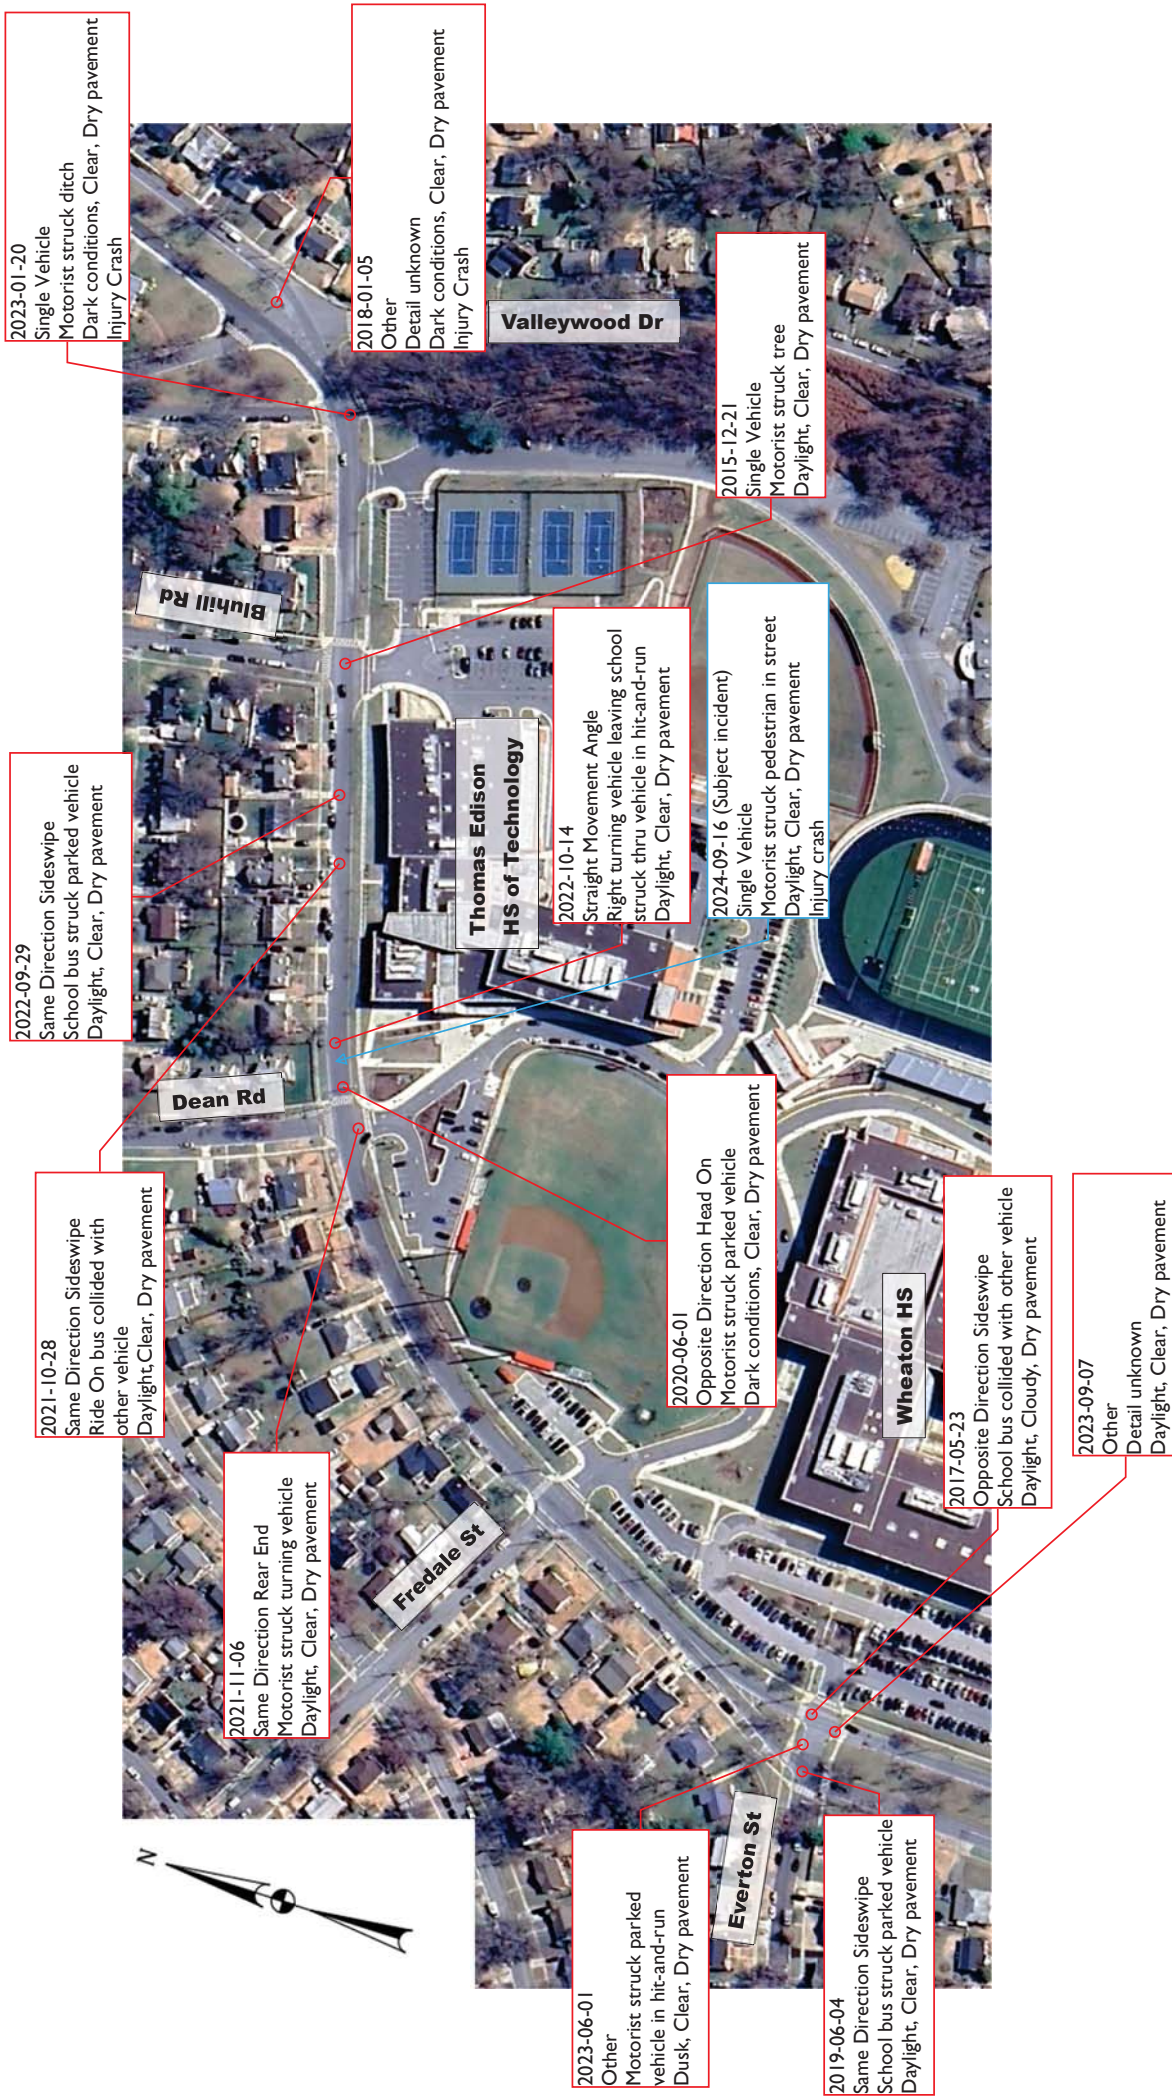
Figure 3- Crash History ( 2015-2024)

Crash data obtained from dataMontgomery provides information for thirteen (13) incidents along Dalewood Drive between January 2015 and September 2024. One (1) crash involved a pedestrian. Three (3) crashes resulted in injuries. The incidents are illustrated on **Figure 3**.
