SCHOOL-RELATED CRASH-INFRASTRUCTURE REVIEW

Location: Apple Ridge Road at Watkins Mill Road

Crash Date: October 16, 2024

Local Case No.: 240049491

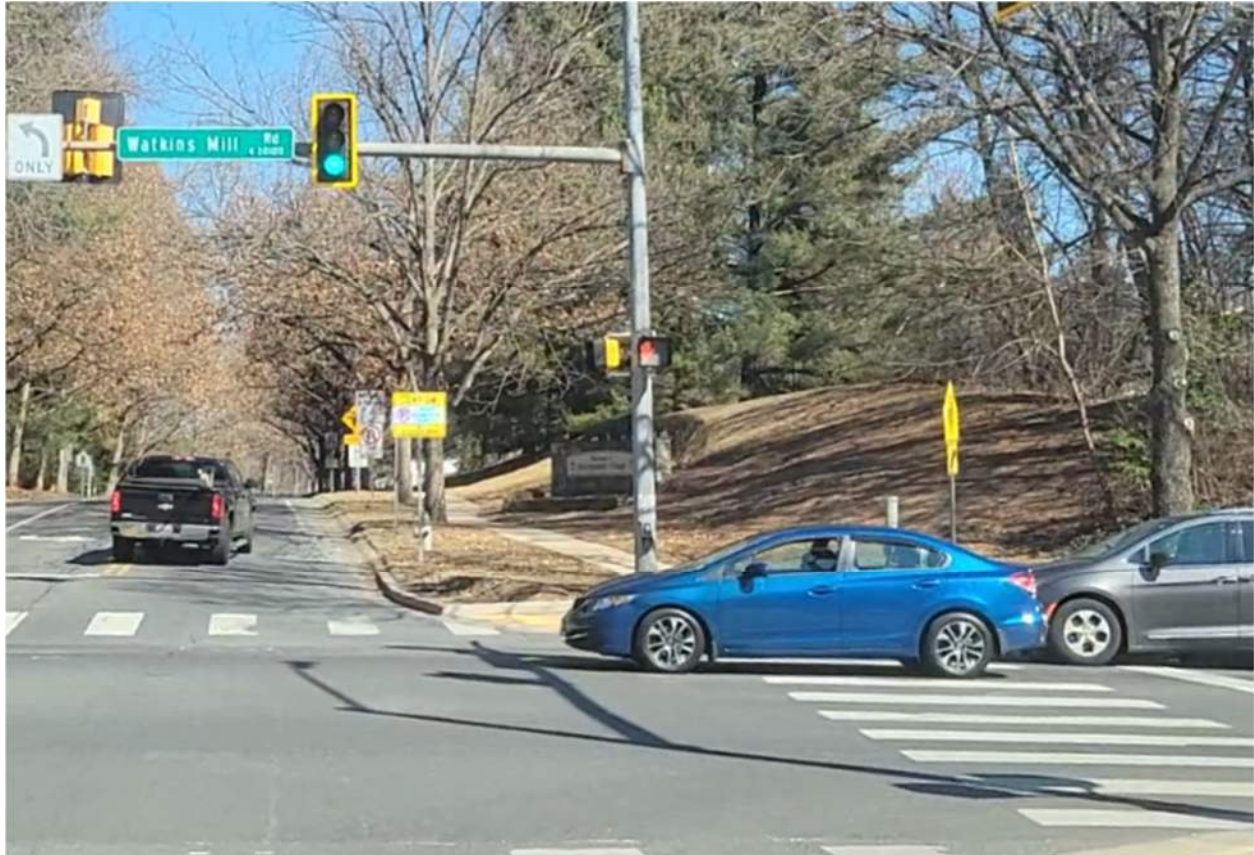
Photo 1. Taken along eastbound Apple Ridge Rd, looking east at Watkins Mill Rd. Northbound vehicle runs red light and stops past stop line within the crosswalk.

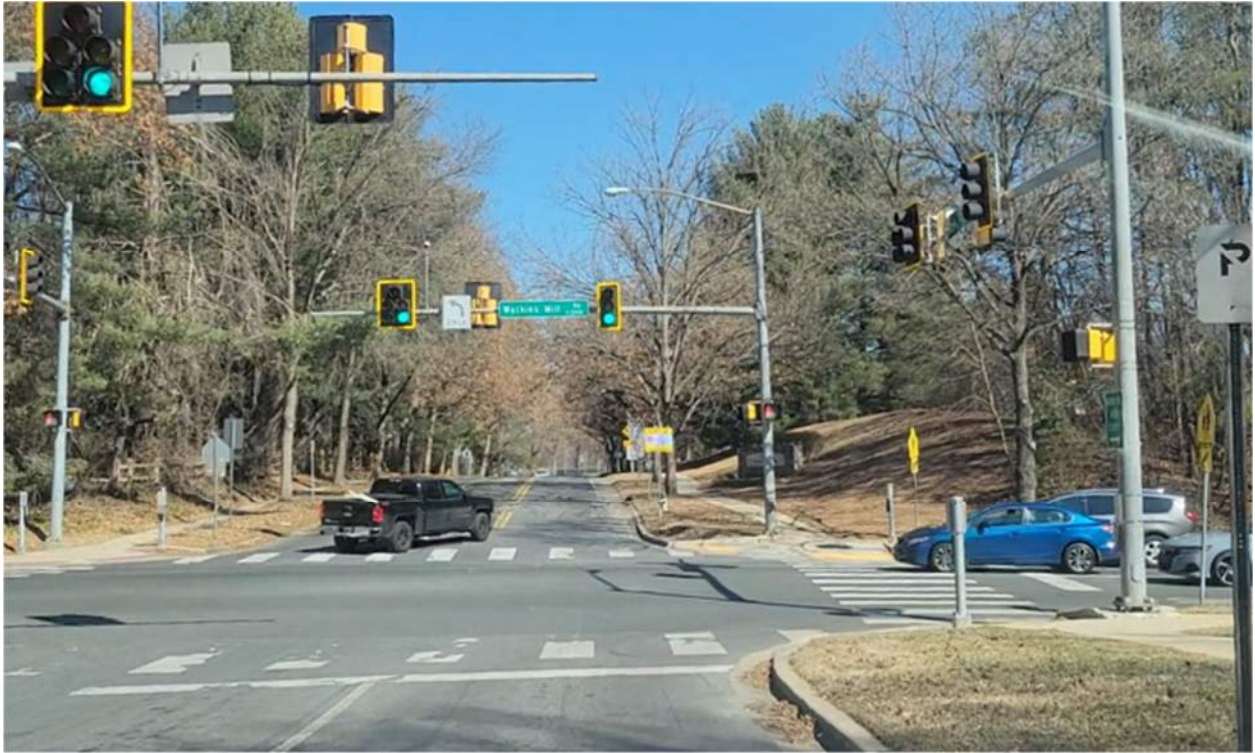
Field observations were performed on Monday, March 3, 2025, at approximately 1 PM. Weather conditions were clear, and the roadway surface was dry. Vehicular activity was consistent during the observation period, but no pedestrians or bicyclists were observed at the intersection. The west leg crosswalk is faded over Apple Ridge Road. A School sign with an “Ahead” plaque exists in the westbound direction approaching the intersection, and a “Stop Here On Red” sign is placed in the westbound direction at the stop bar. In the eastbound direction, School Crossing signs are missing on the right side of the roadway for both the west leg and east leg crosswalks.

Photo 2. Taken along eastbound Apple Ridge Rd, looking east at Watkins Mill Rd. Southbound left-turning truck oversteers across the westbound approach. Faded west leg crosswalk and missing School Crossing signs on the right side of the roadway for both crosswalks over Apple Ridge Rd.

1. Recommend refreshing the west leg continental crosswalk pavement markings.

1. Recommend installing a “Turning Veh Yield to Peds (Right)” sign on the mast arm for all right-turns.
2. Recommend installing school crossing sign assemblies (S1-1 and W16-7p) on the right side of the roadway for the west leg and east leg crosswalk for the eastbound direction.

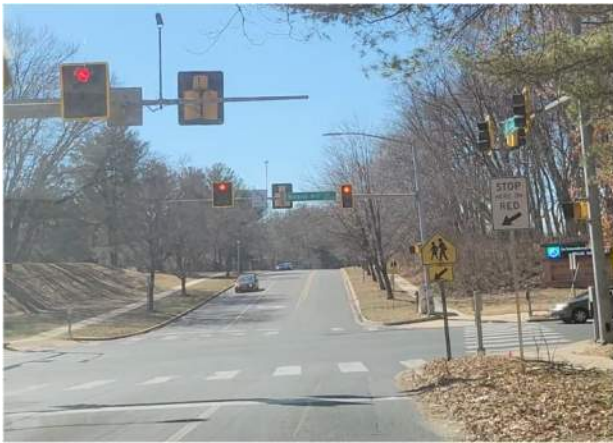
Looking westbound at Watkins Mill Rd.
School Crossing signs and continental crosswalk markings.

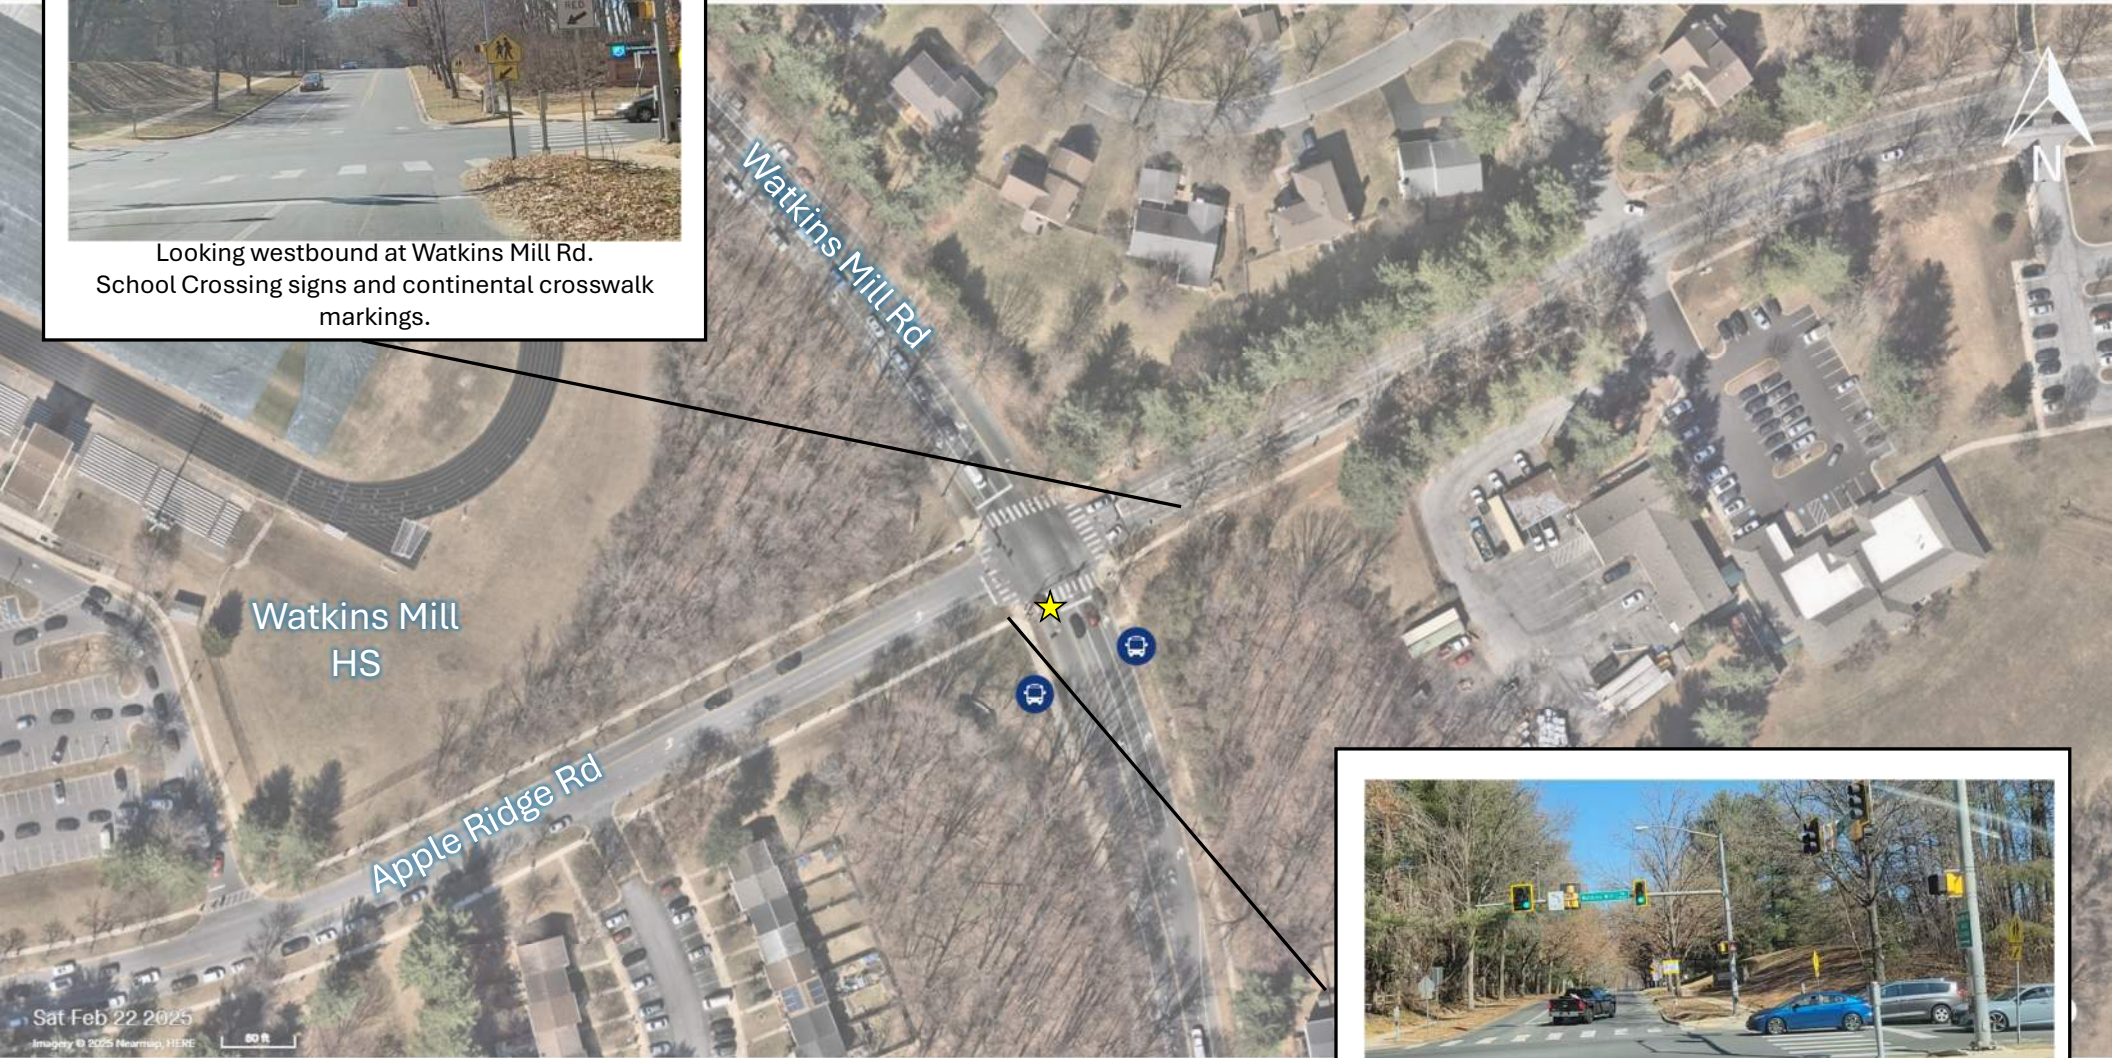
Figure 1 – Apple Ridge Rd at Watkins Mill Road Intersection Observations

★ Crash Location

Looking eastbound at Watkins Mill Rd. faded continental crosswalk markings with missing School Crossing signs

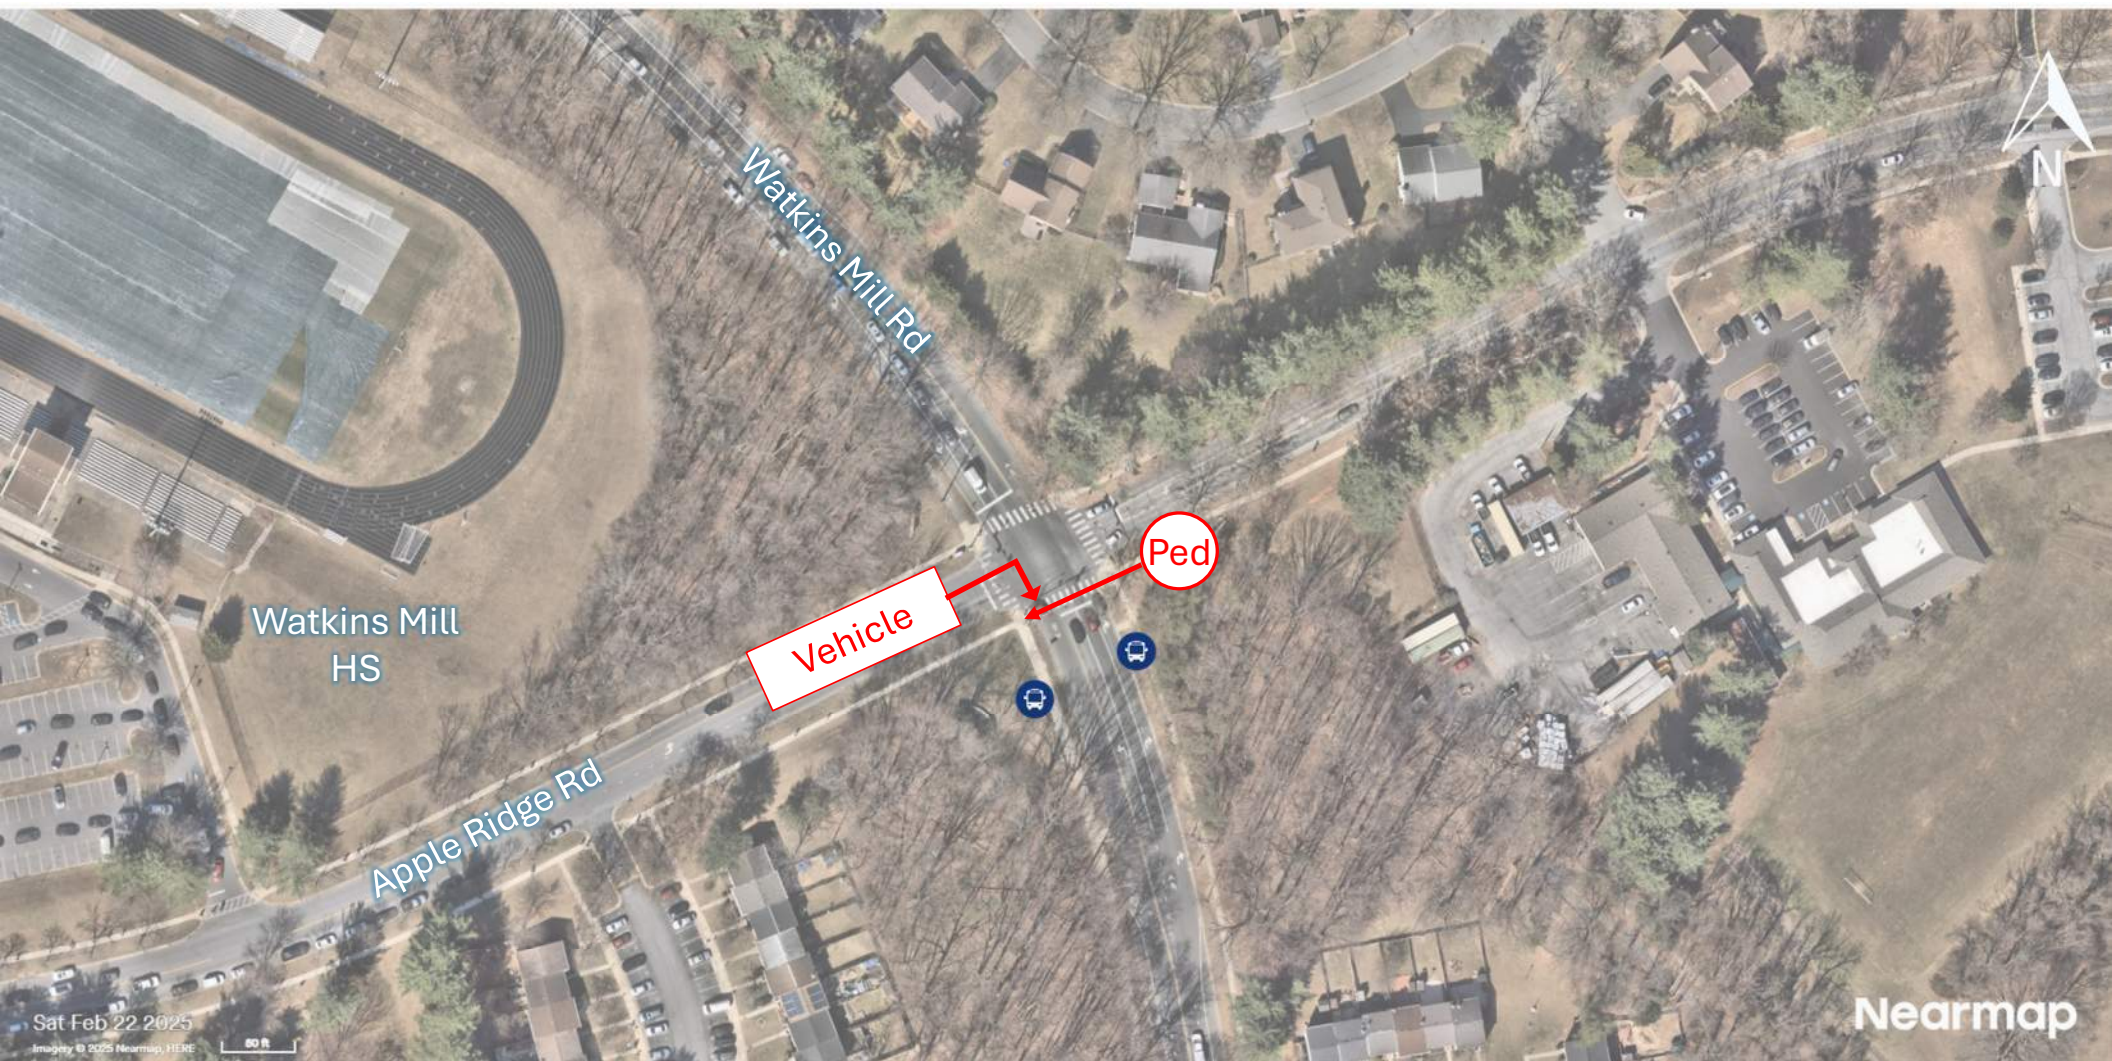
Figure 2 – Crash Diagram

On Wednesday, October 16, 2024, at approximately 4:49 PM, a motorist turning right from eastbound Apple Ridge Road turning onto southbound Watkins Mill Road struck a pedestrian crossing the south leg. The motorist turned during a green signal indication. It is not clear if the pedestrian was within the marked crosswalk at the time of contact. The crash report indicated that the pedestrian suffered possible injuries. The driver was deemed at fault and did not suffer any apparent injuries. Daytime weather conditions were clear, and the roadway surface was dry.

Figure 2 illustrates the crash location and direction of pedestrian and vehicle travel.
