# SCHOOL-RELATED CRASH INFRASTRUCTURE REVIEW

**Location:** Apple Ridge Road at Darlington Drive

**Crash Date:** December 18, 2024

**Local Case No.:** 240060396

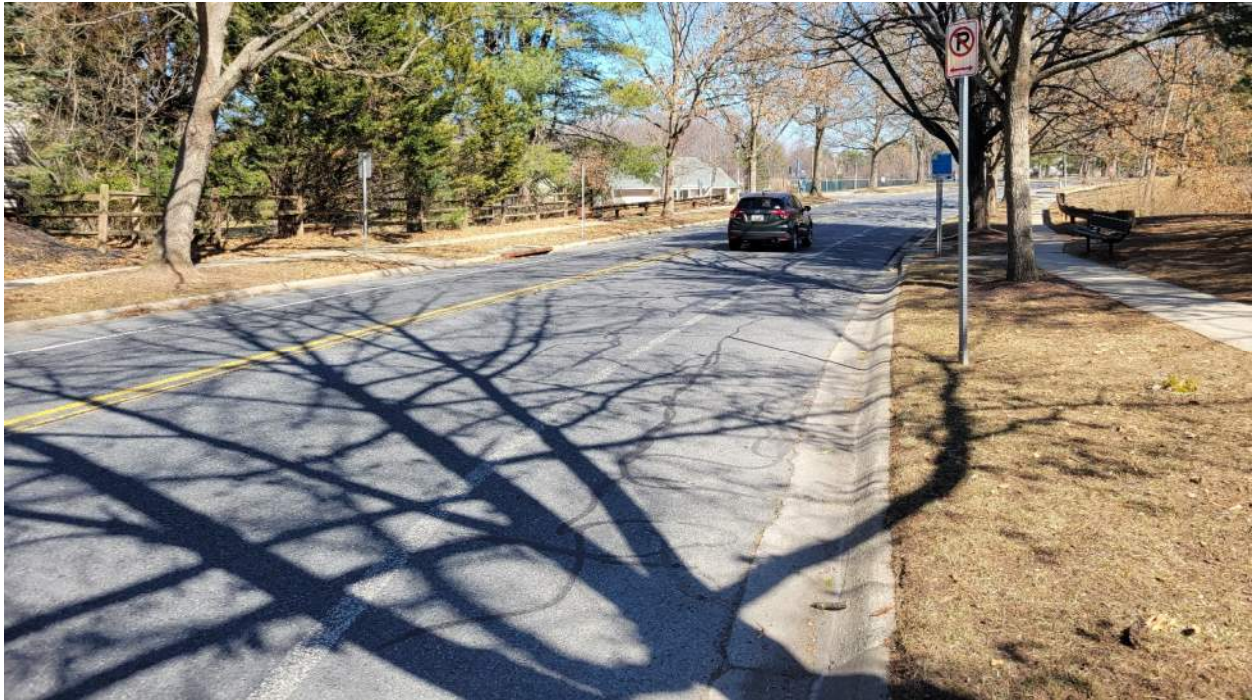
**Photo 1. Taken from east of Darlington Road, looking east along Apple Ridge Rd from south leg.  
Approximate crash location.**

**Note: W-beam placed along both sides of the street behind the sidewalks.**

1. Recommend refreshing the pavement markings along Apple Ridge Road to improve visibility and visually narrow the travel way.
2. Recommend installing new ADA ramps and marked crosswalks for all legs of the Apple Ridge Road intersections with Darlington Drive and Dellcastle Road, which are the adjacent intersections with RideOn bus stops. Install new R1-6a(2) “State Law – Stop For [Peds] In X-Walks” sign along Apple Ridge Road with the installation of marked crosswalks.

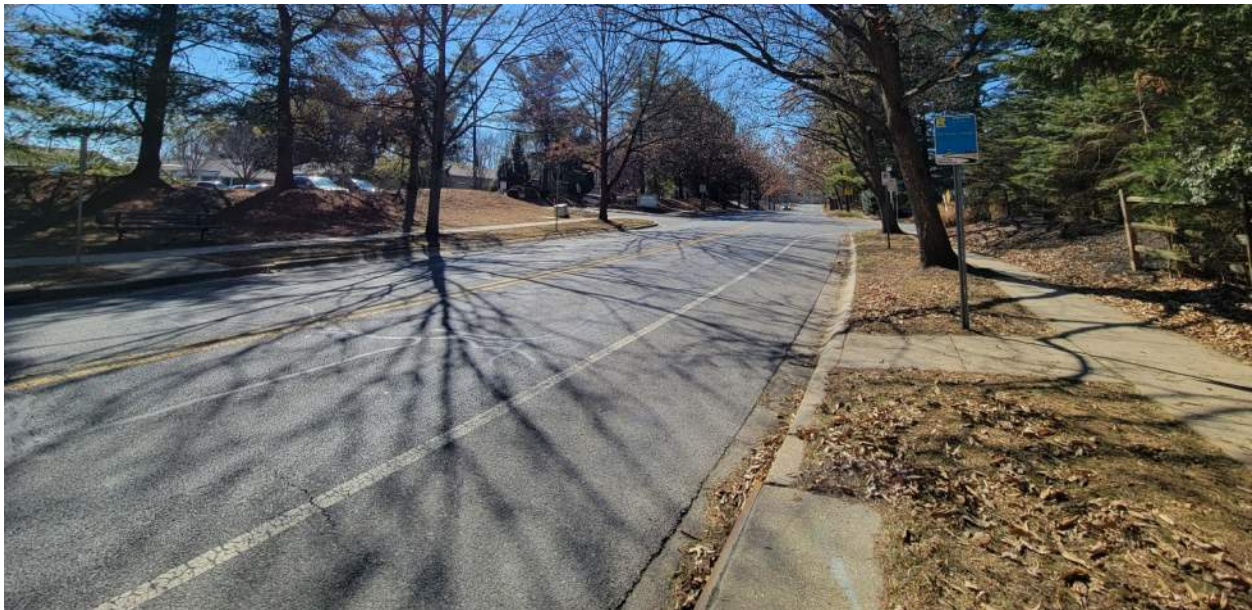
**Photo 2. Taken from east of Darlington Road, looking west along Apple Ridge Rd from north leg.  
Approximate crash location.**

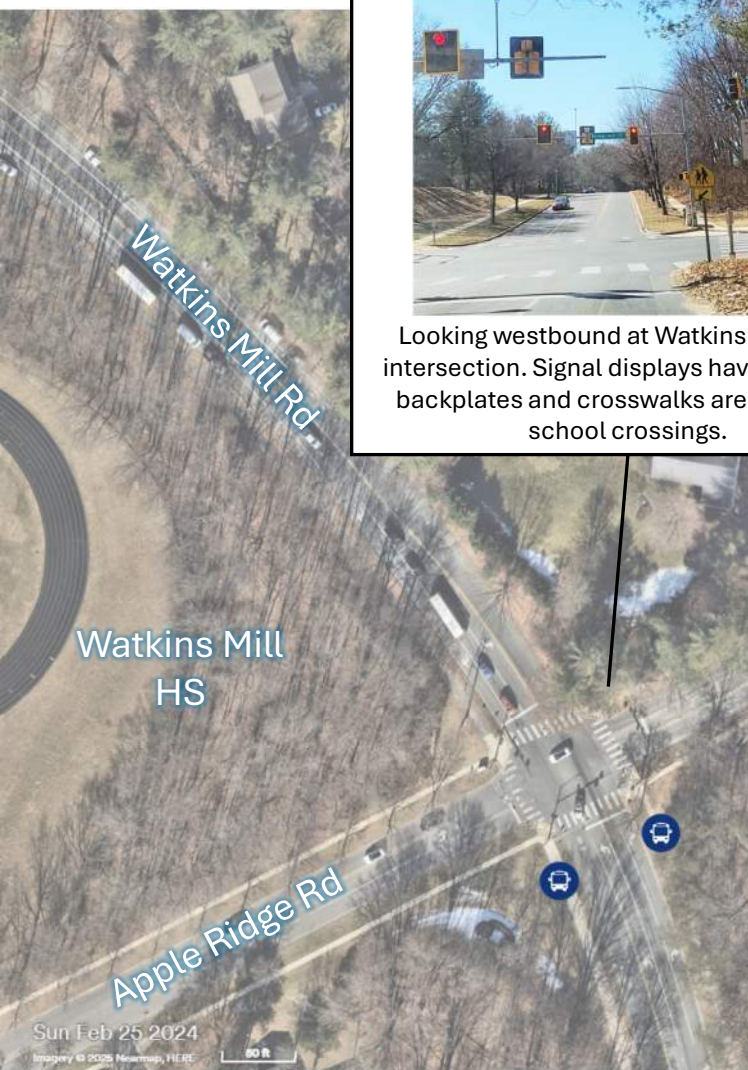
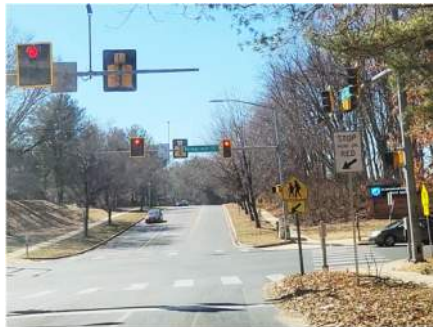
Looking westbound at Watkins Mill Road intersection. Signal displays have reflective backplates and crosswalks are signed as school crossings.

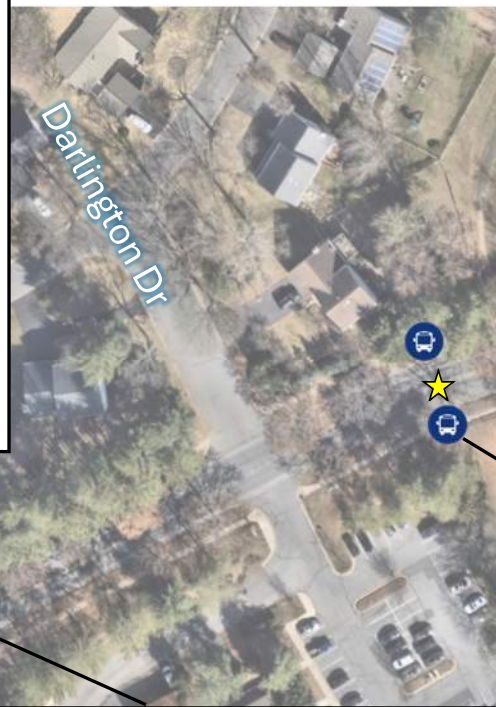
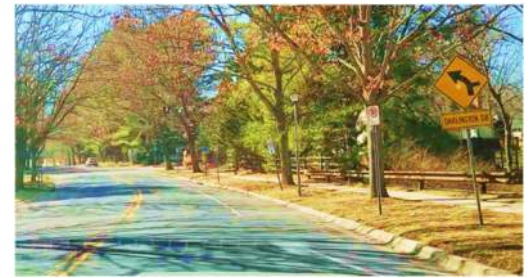
Looking westbound towards the crash location. Advance intersection along curve warning sign for Darlington Drive is visible along with No Parking signs. Colonial post top streetlights and mature street trees are placed in the sidewalk buffer.

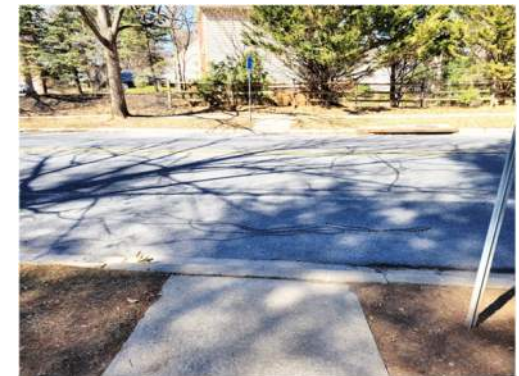
Field observations were performed on Monday, March 3, 2025, at approximately 1 PM. Weather conditions were clear, and the roadway surface was dry. Vehicular activity was consistent during the observation period, but no pedestrians or bicyclists were observed. The edge line in the eastbound direction is faded, leaving the shoulder inconspicuous. Vertical and horizontal curvature exists in the westbound direction. Advance warning signing exists, informing motorists of the Darlington Drive intersection along the curve. The sign indicates a 3-legged intersection. A “Photo Enforced” plaque exists along Apple Ridge Road as the corridor is an approved location for a speed camera. These cameras vary between a mobile camera or standalone and are not permanent.

Looking at Apple Ridge Road pavement at south bus stop. Edge lines are faded. Pavement shows fatigue crack repairs.

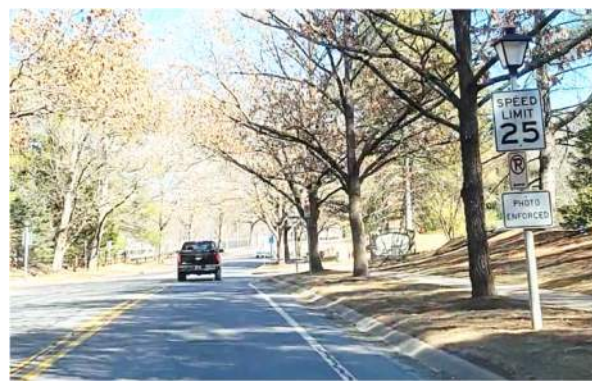
Looking eastbound towards Darlington Drive. 25-mph with Photo Enforced plaque mounted on streetlight pole.

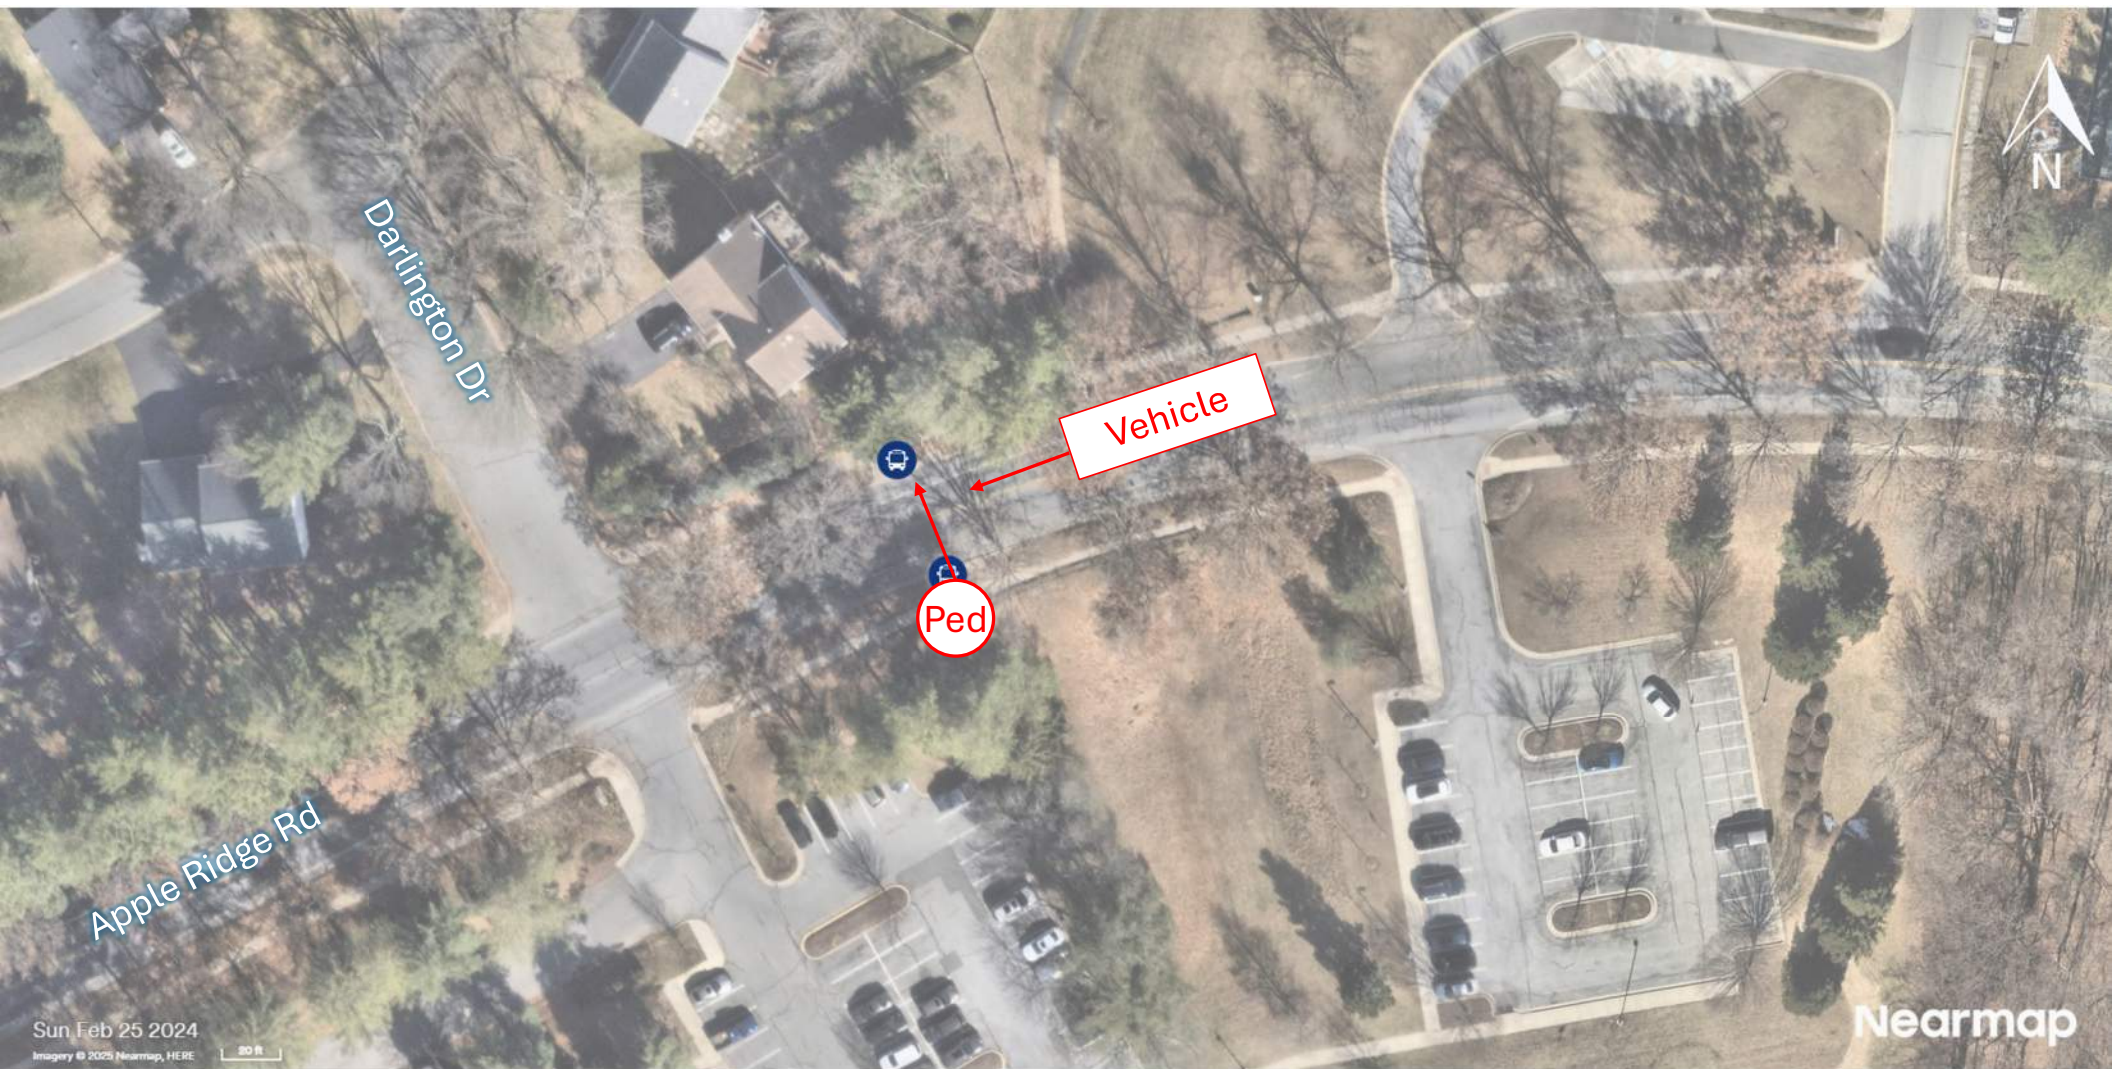
Figure 2 – Crash Diagram

On Wednesday, December 18, 2024, at approximately 7:46 AM, a pedestrian was traveling northbound between bus stops across Apple Ridge Road approximately 125 feet east of Darlington Drive. A motorist traveling westbound on Apple Ridge Road struck the pedestrian in the travel lane. The crash report indicated that the pedestrian suffered minor injuries and was at fault. Daytime weather conditions were clear, and the roadway surface was dry.

**Figure 2** illustrates the crash location and direction of pedestrian and vehicle travel.

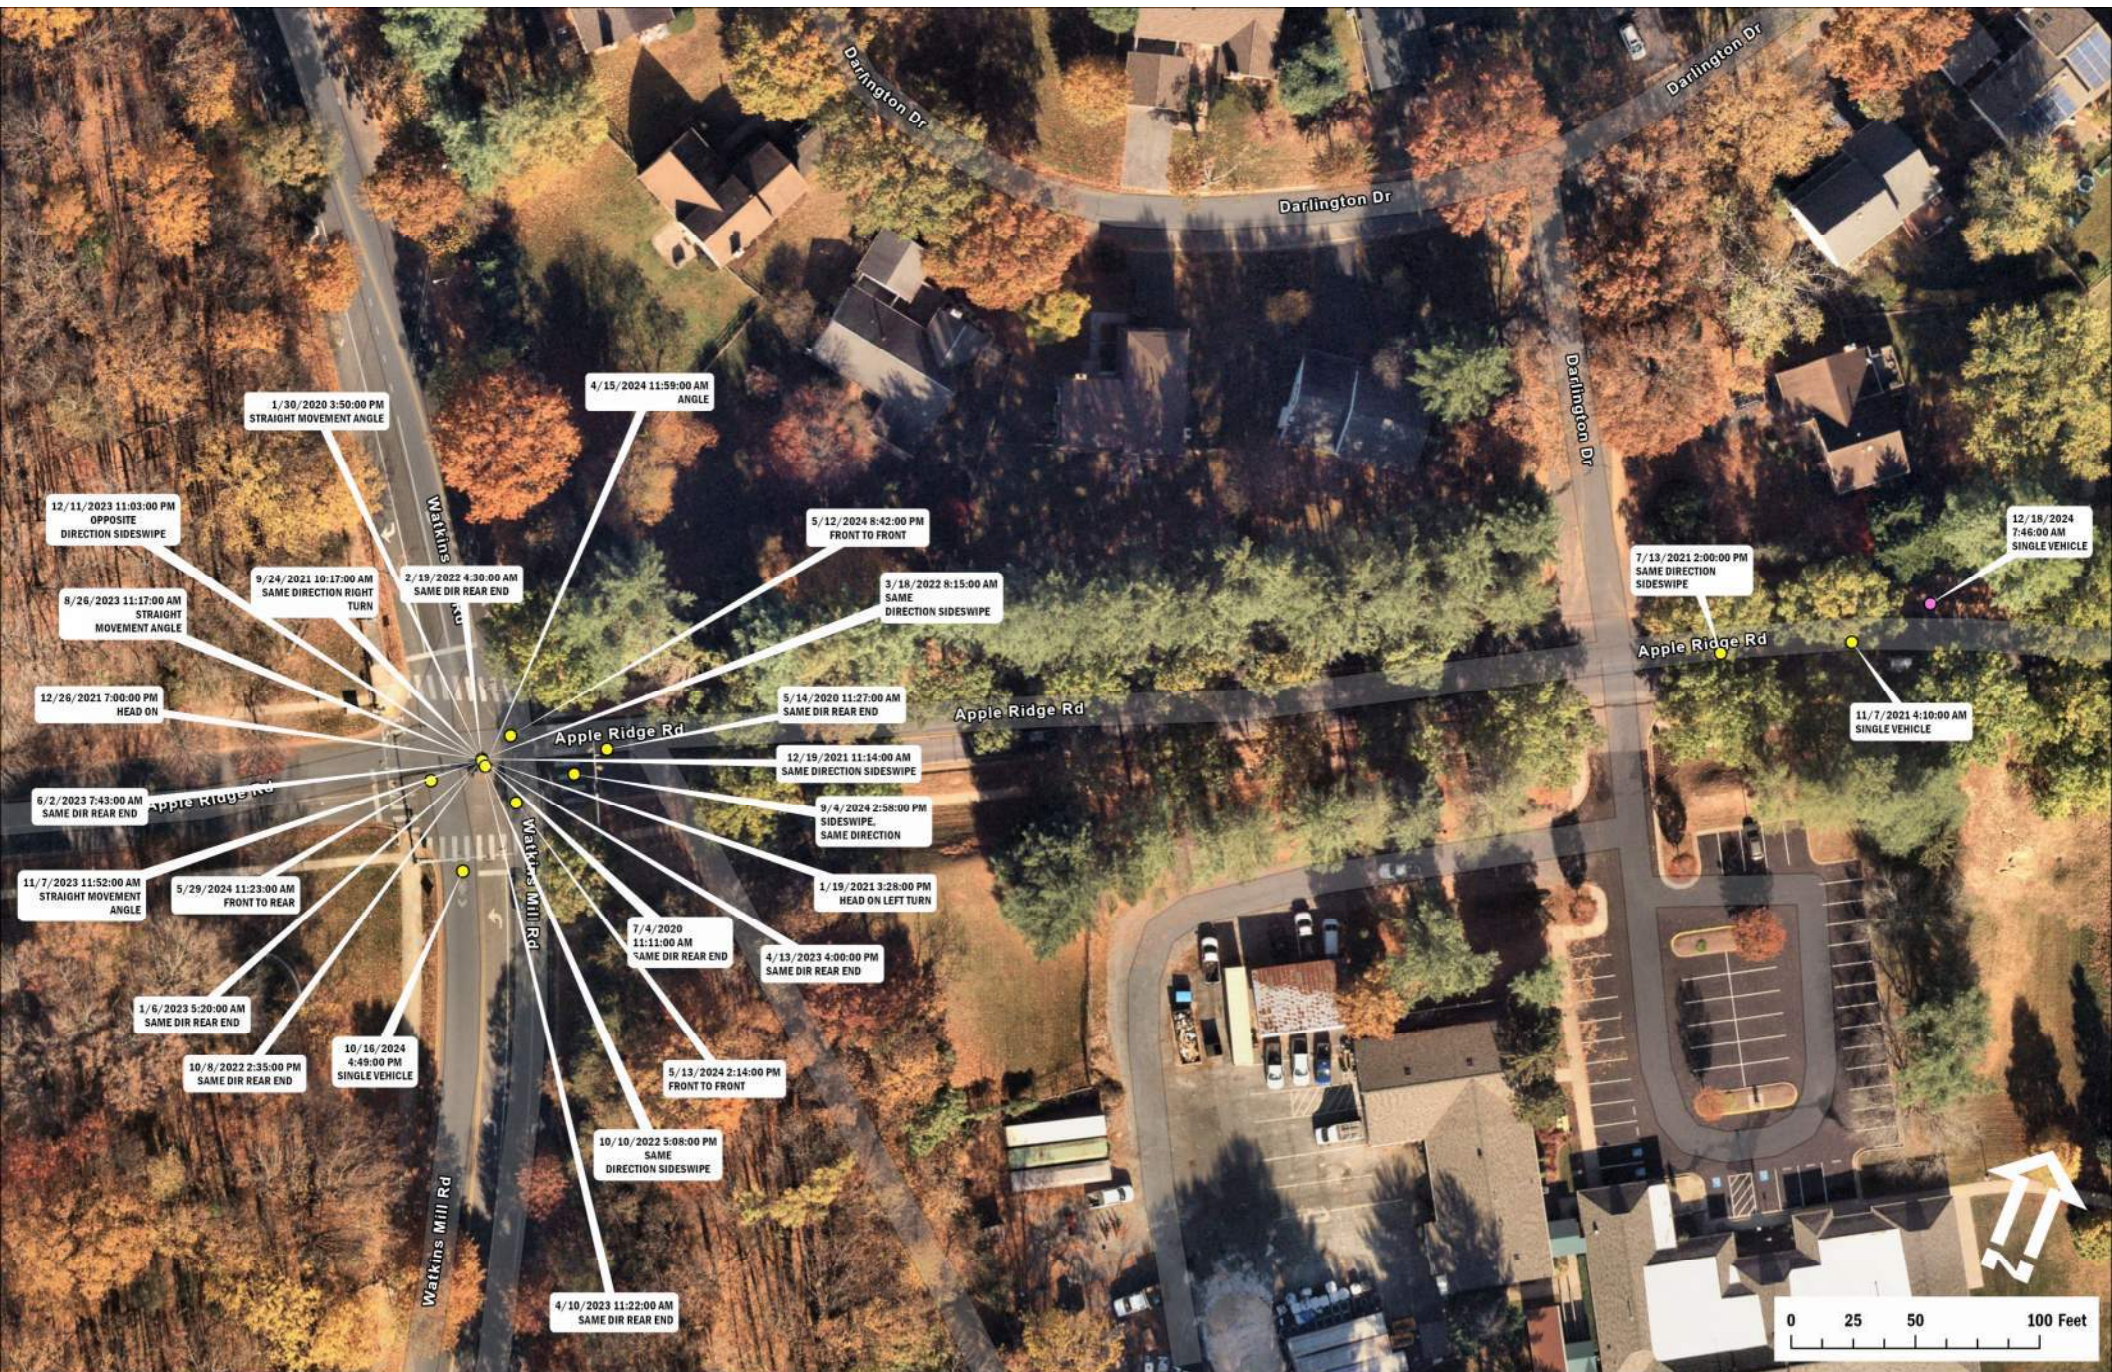
Figure 3 – Crash History (2020-2024)

Crash data obtained from dataMontgomery indicates that 27 incidents occurred within the vicinity of the crash site between January 2020 and December 2024, including the subject crash. Of these 27 incidents, 24 crashes occurred at or near the signalized intersection of Apple Ridge Road and Watkins Mill Road, west of the subject crash location. These 24 crashes include 11 injury crashes and 13 property damage crashes. The crash types consist of nine (9) rear end collision, five (5) sideswipe collisions, four (4) angle collisions, four (4) head on collisions, one (1) single vehicle collisions, and one (1) right-turn collision. There was one (1) pedestrian-related crash at this intersection.

The three (3) other crashes occurred along Apple Ridge Road near Darlington Drive, the location of the subject crash. All three (3) of these crashes were injury crashes, with one (1) sideswipe collision, and two (2) single vehicle collisions. The first single vehicle collision occurred in the dark where the motorist hit a tree. The second single vehicle collision was the subject crash, including a pedestrian. Of these three (3) collisions at the subject location, two (2) were in daylight, and all occurred along a dry surface with clear weather conditions.

The incidents are illustrated on **Figure 3**.
