## **SCHOOL-RELATED CRASH INFRASTRUCTURE REVIEW**

### **MONTGOMERY COUNTY DEPARTMENT OF TRANSPORTATION (MCDOT)**

- **Location:** Shakespeare Boulevard at Scottsbury Drive
- **Crash Date:** April 23, 2025
- **Crash Time:** Approximately 9:01 AM
- **School Name:** Dr. Sally K. Ride Elementary School
- **School Walkshed Boundary:** ☒ Inside
- **Local Case No:** 250017574
- **Review Date:** October 23, 2025

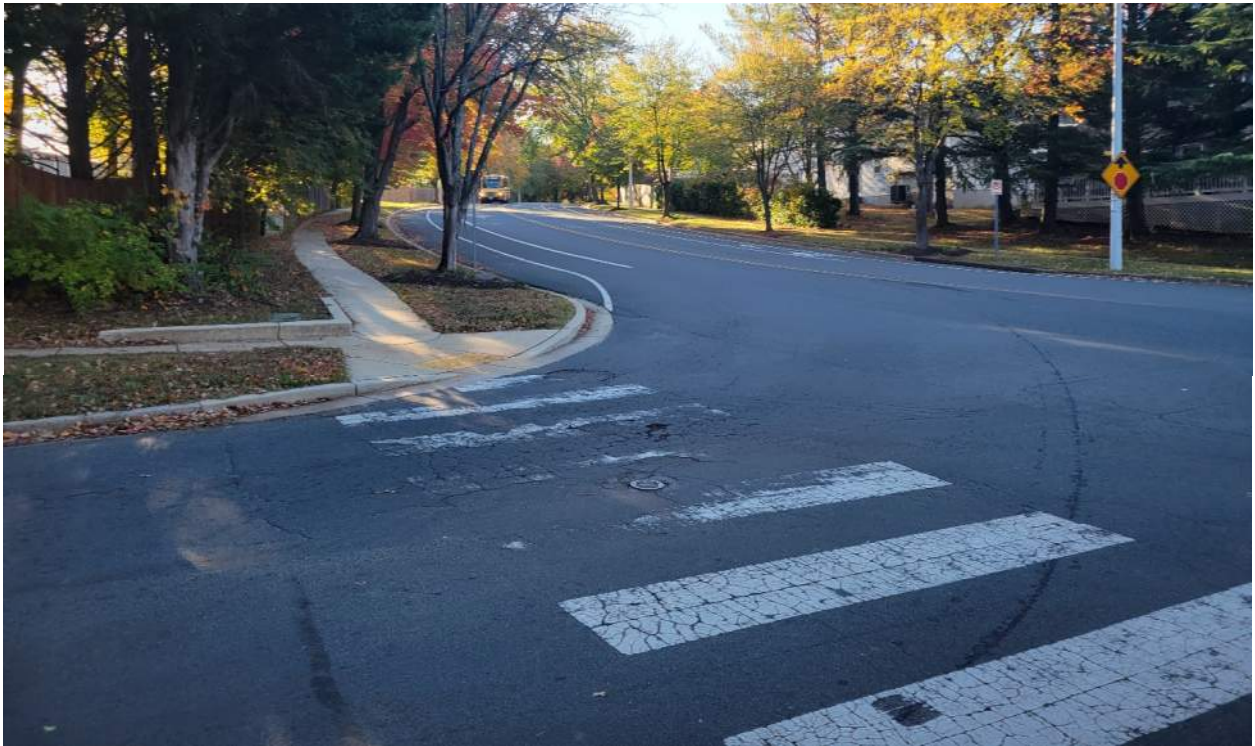
- **Crosswalk Visibility:** The continental crosswalk markings are in good condition on the south leg but are fading on the north leg. There are no marked crossings over the Shakespeare Boulevard approaches.

North leg of Scottsbury Drive at Shakespeare Boulevard

- ☒ **Maintenance:** Refresh the continental crosswalk markings over the north leg and install stop lines for the Scottsbury Drive approaches.

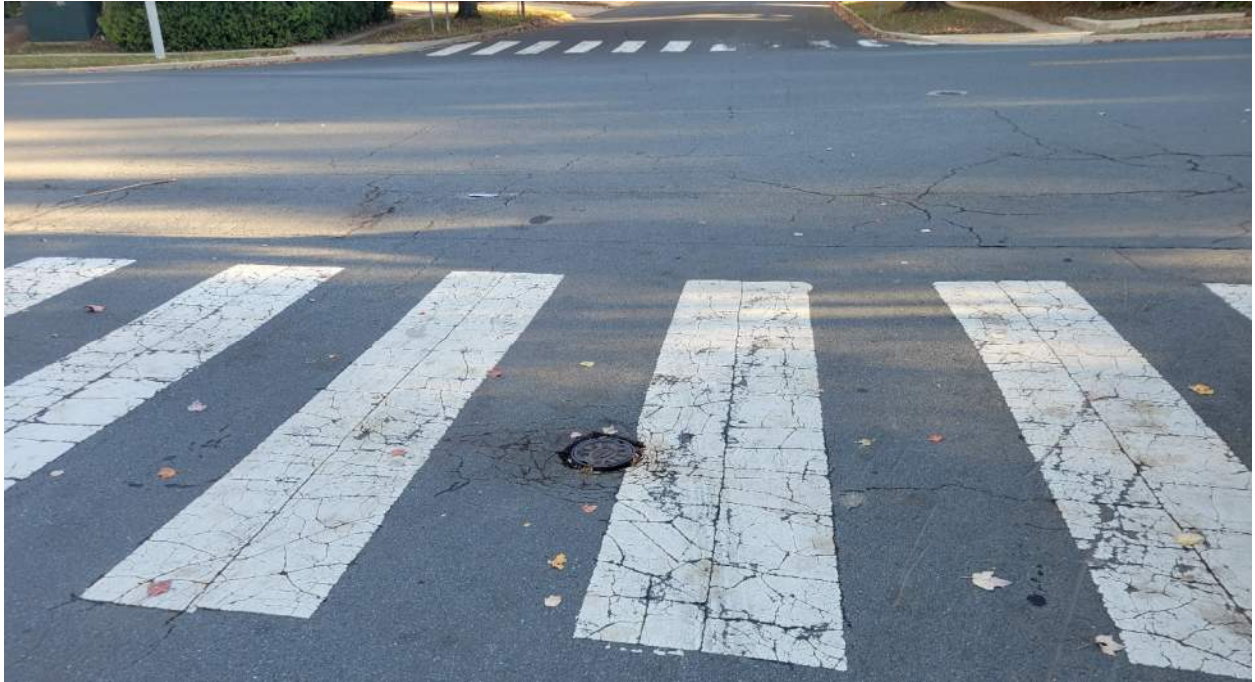
Utility Obstruction in Crosswalks

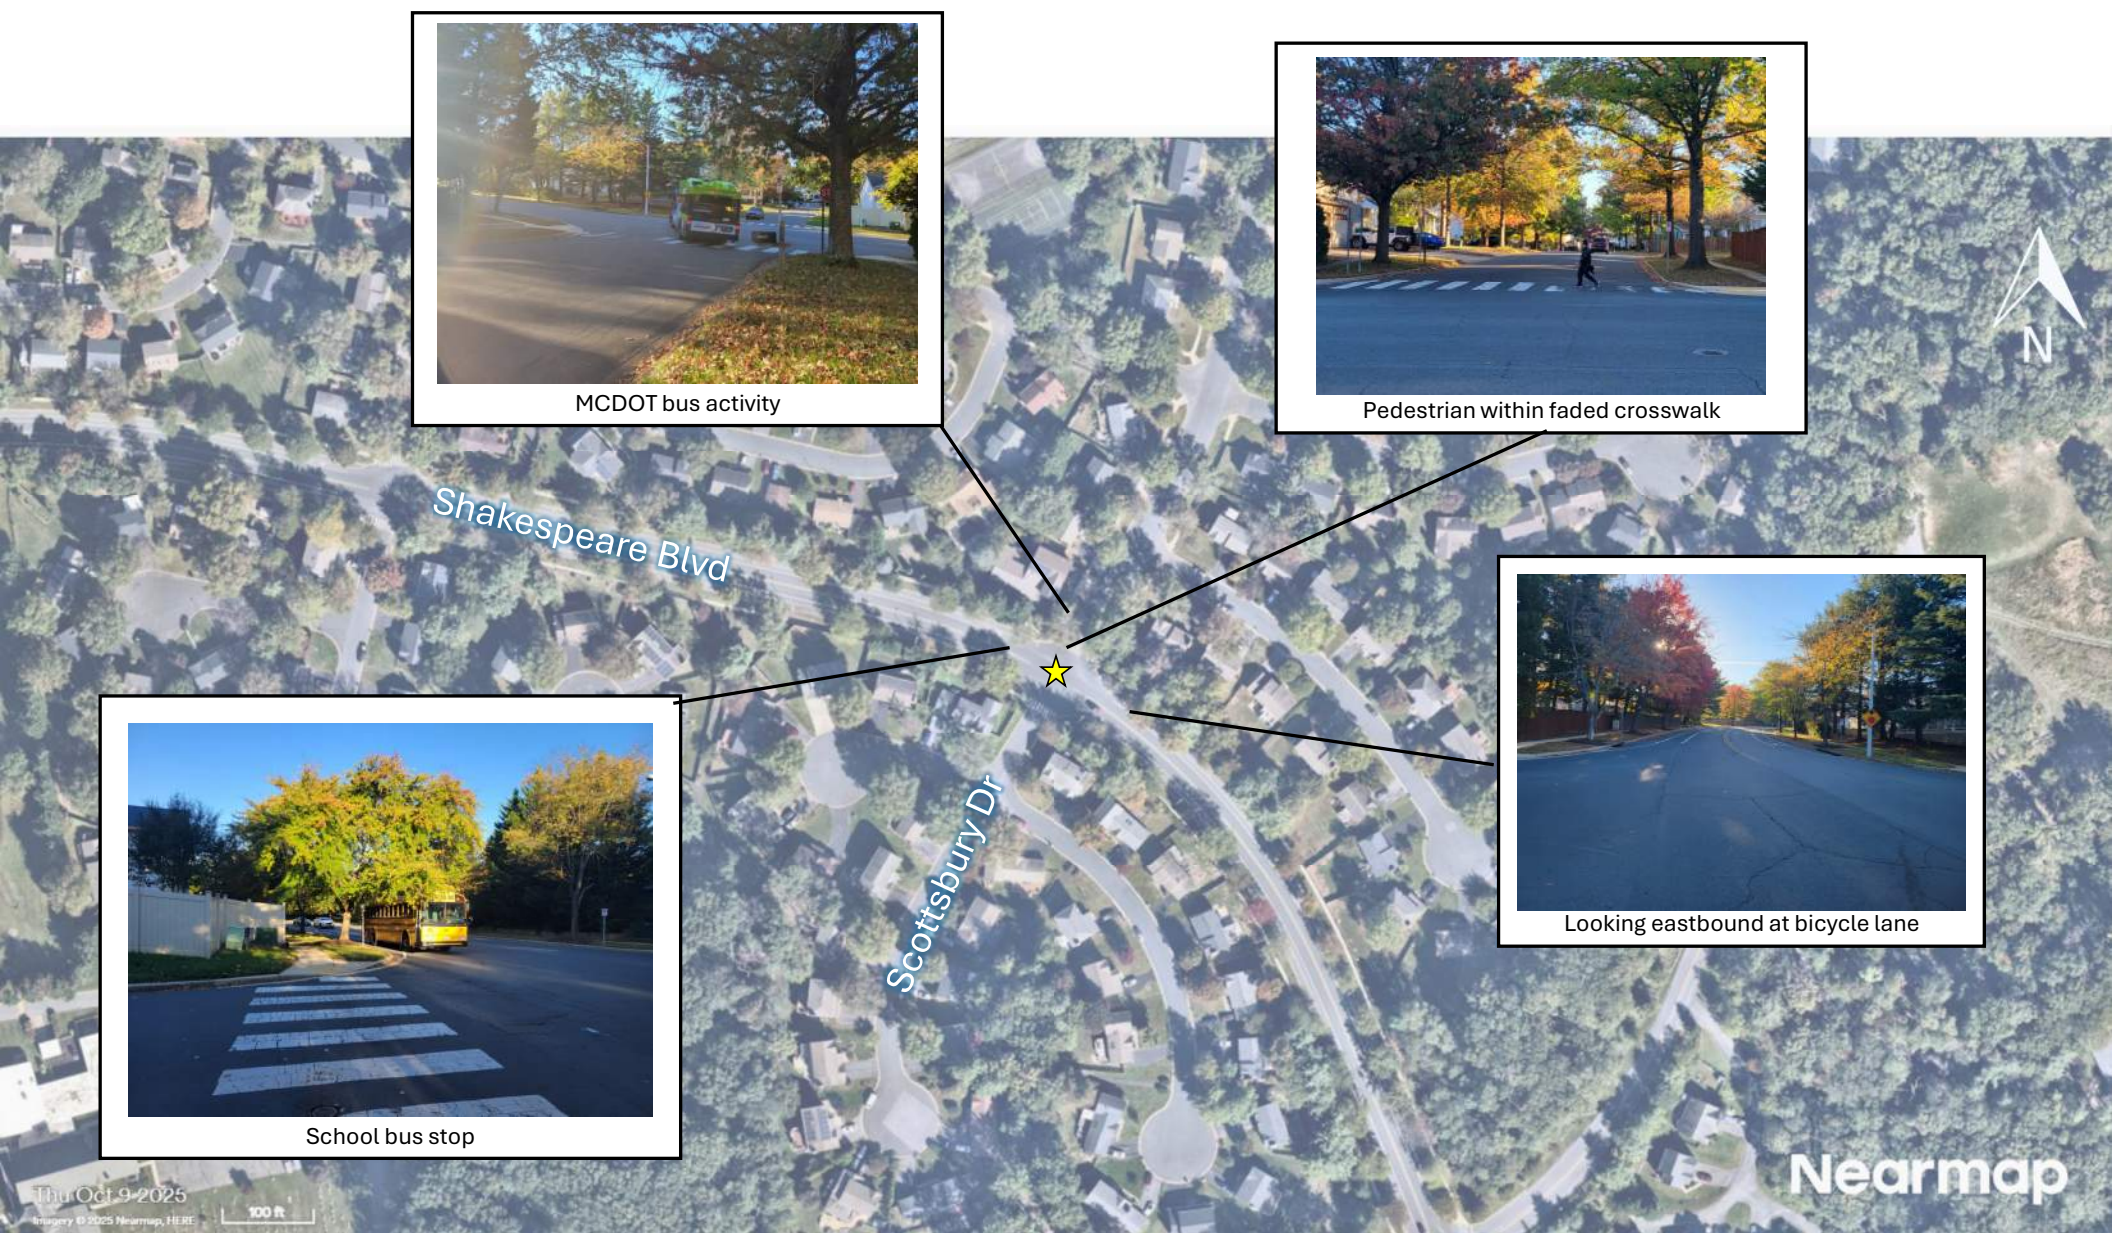
Figure 1 – Shakespeare Blvd at Scottsbury Dr

Crash Location

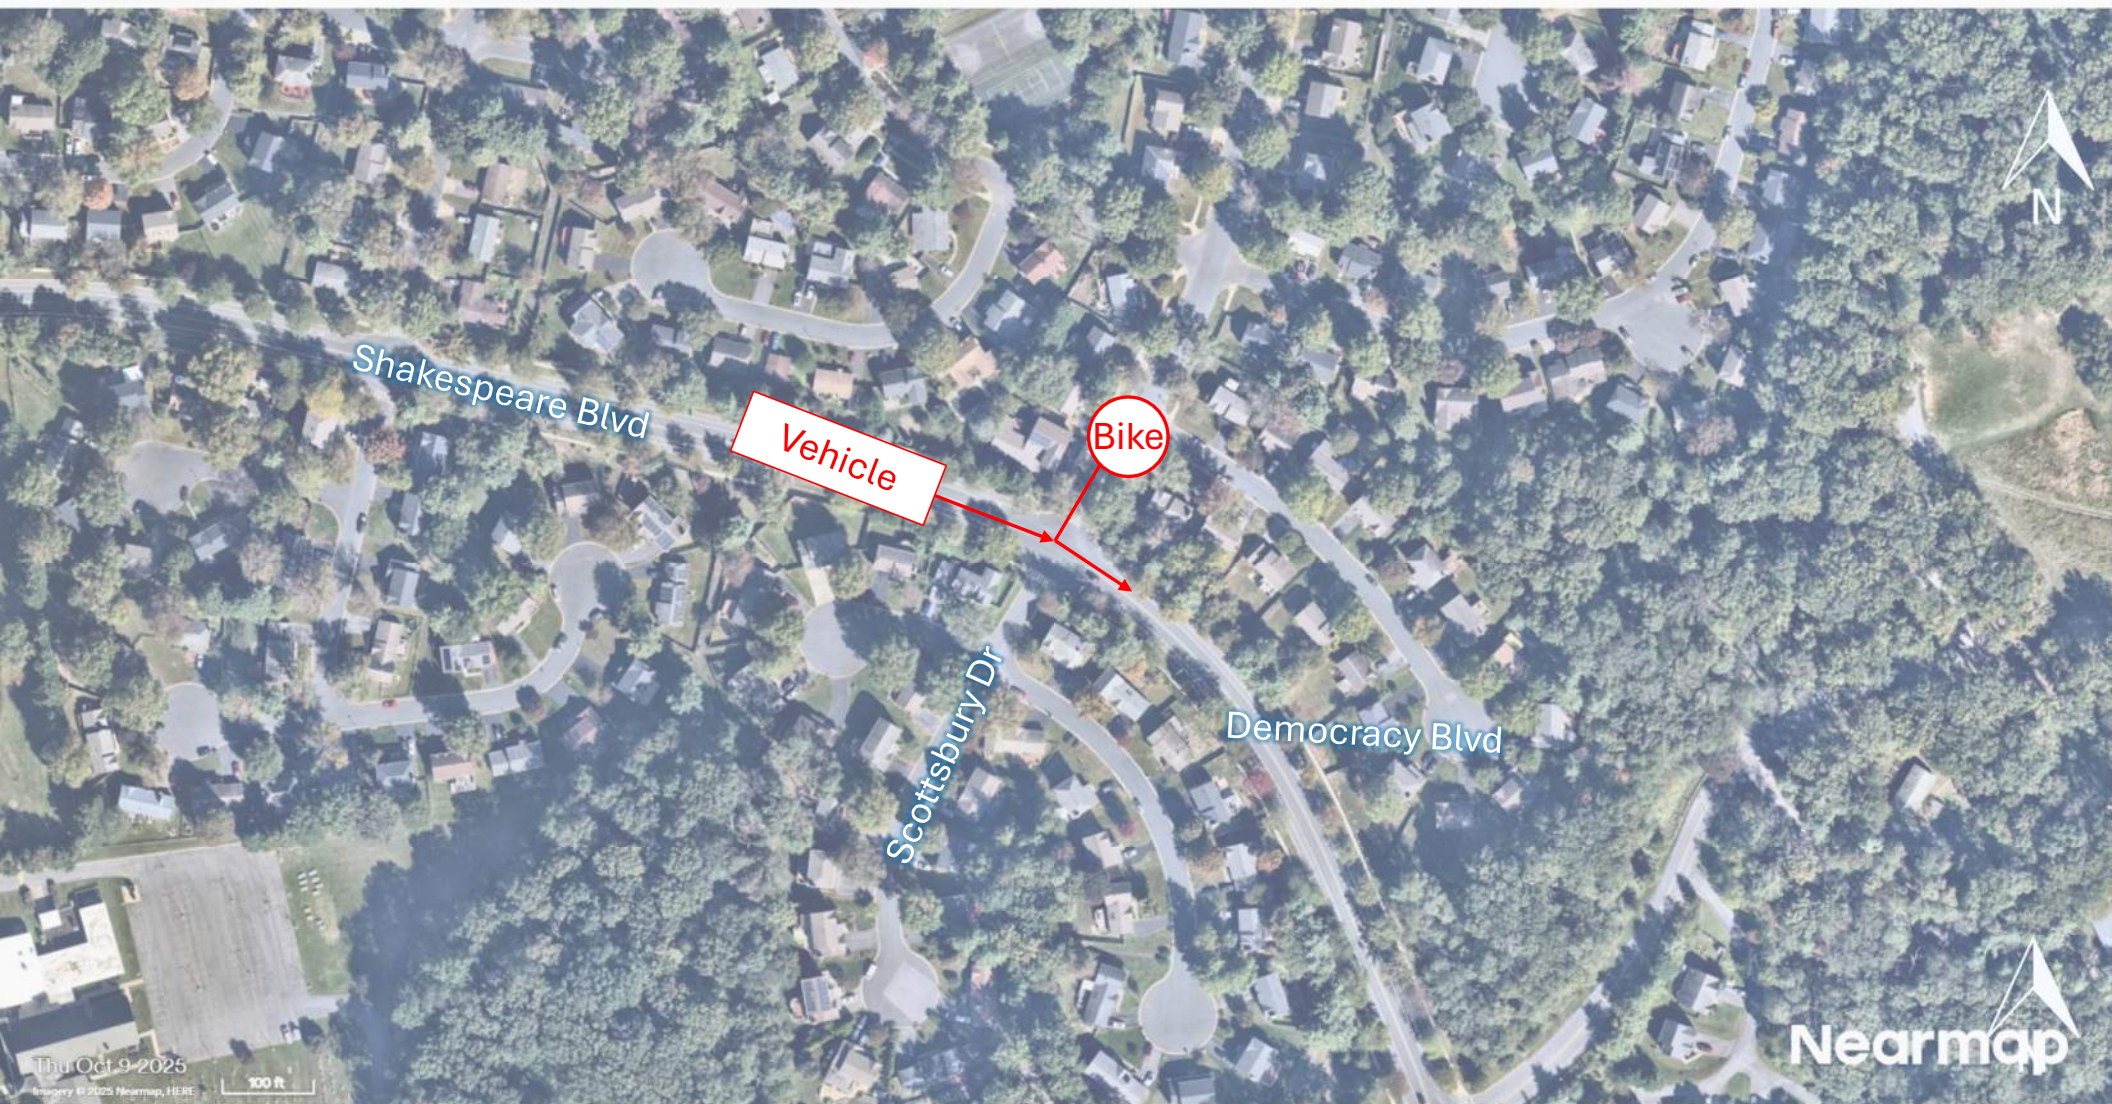
Figure 2 – Crash Diagram

On Wednesday, April 25, 2025, a bicyclist was traveling southbound along Scottsbury Drive and turned left onto Shakespeare Boulevard when an eastbound traveling motorist struck the bicyclist from behind. The bicyclist was noted to be traveling within the roadway and not within the bicycle lane. The crash report indicated the bicyclist suffered a suspected minor injury and was transported to the hospital. The weather was clear, and the roadway was dry. The circumstances contributing to the crash included glare. Figure 2 illustrates the crash location and the direction of bicyclist and vehicle travel.

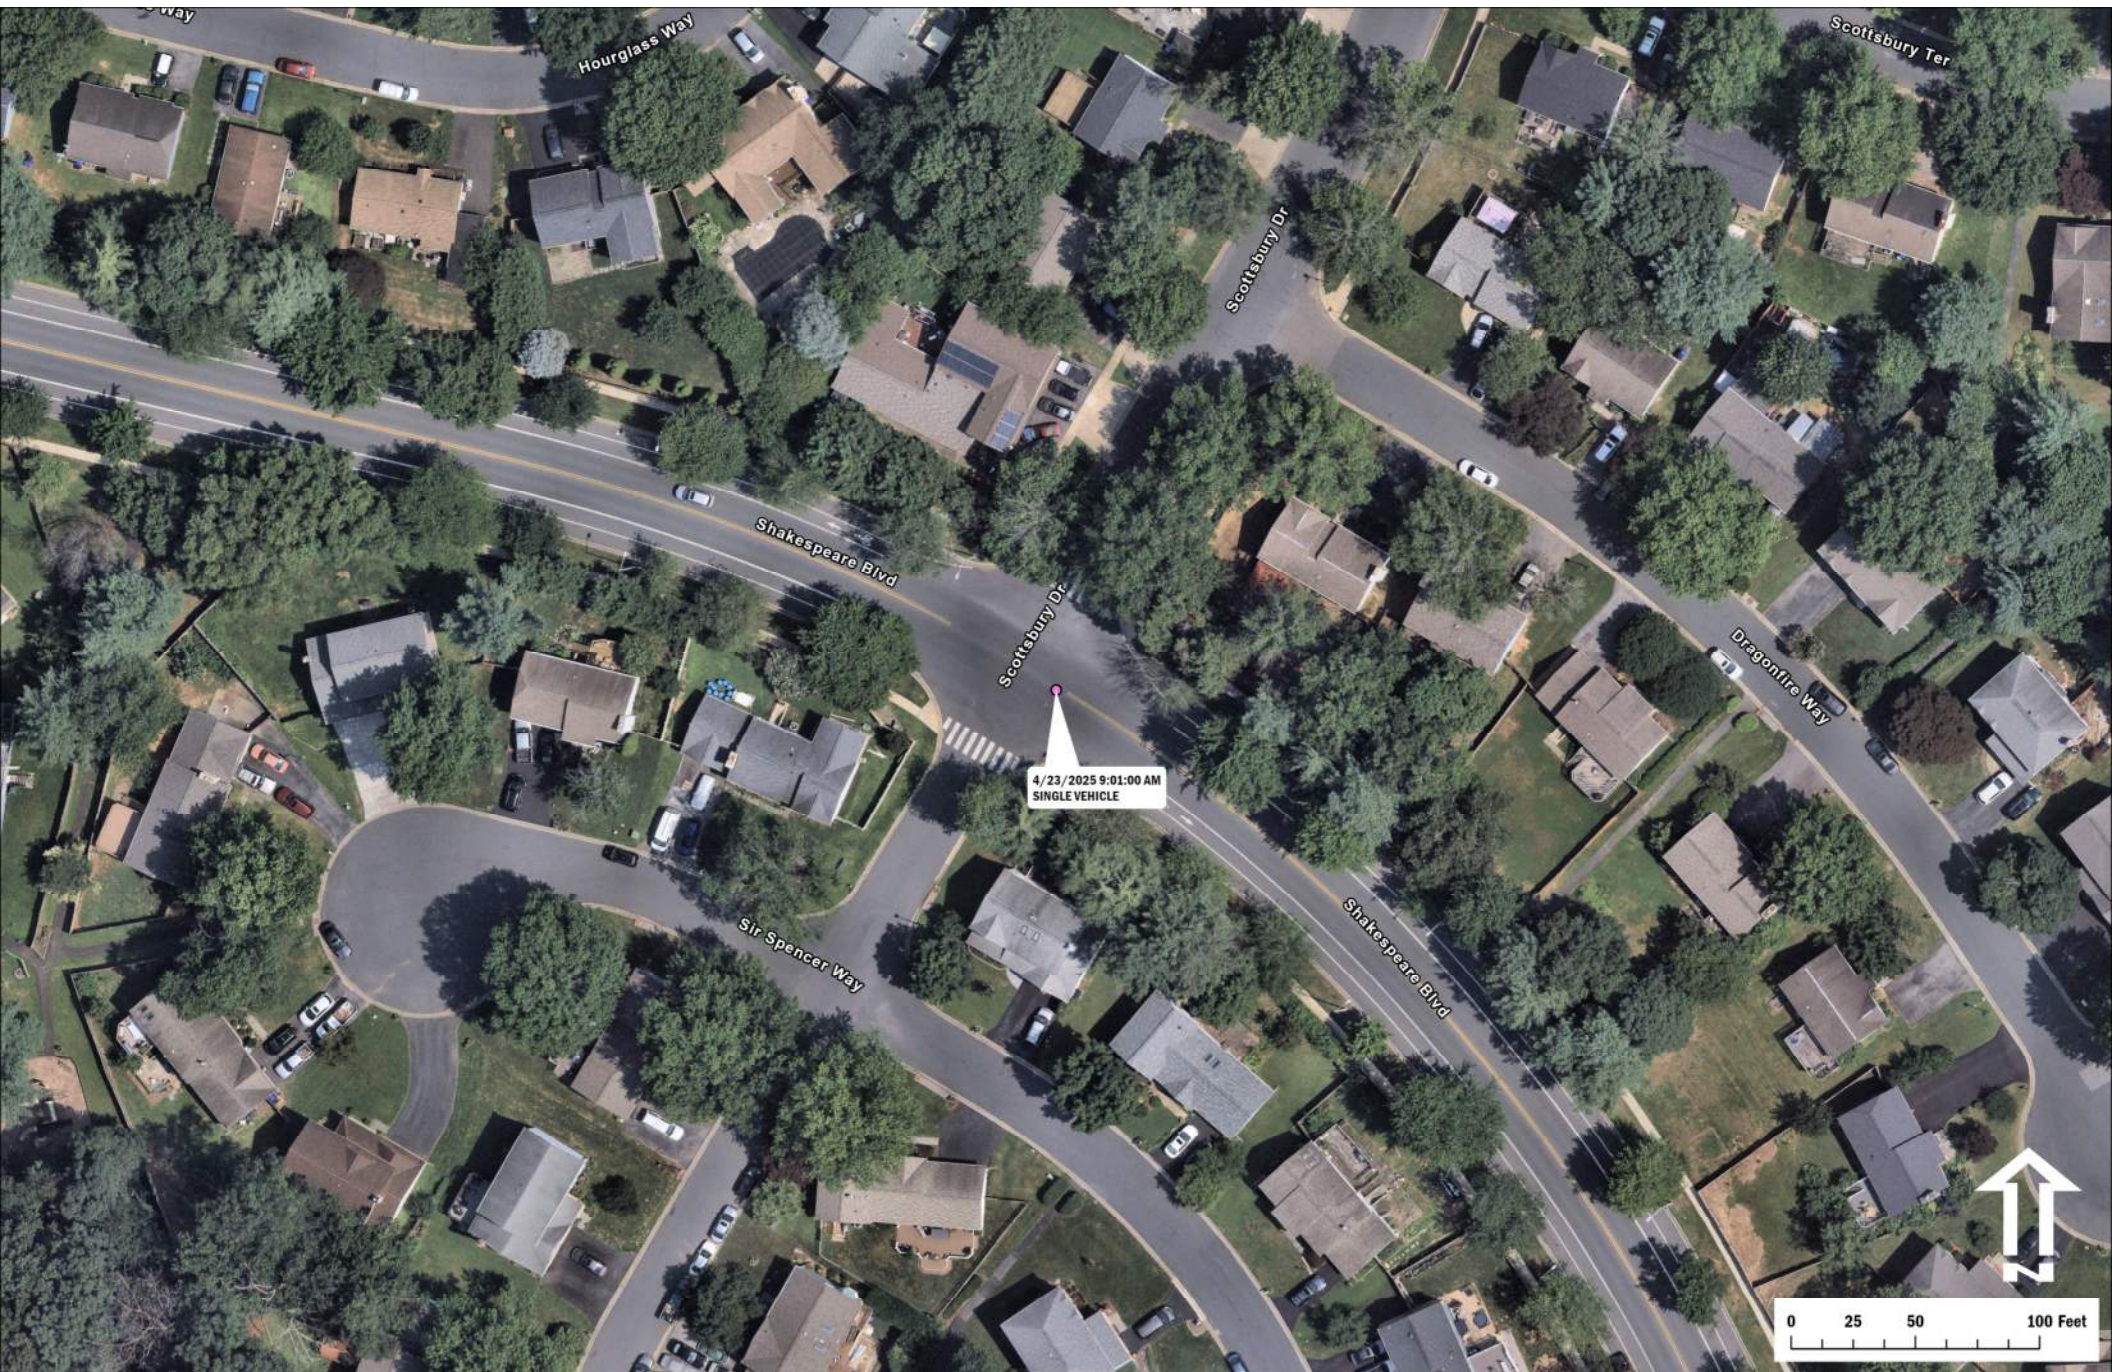
Figure 3 – Crash History (2020-2024)

- **Total Crashes (Last 5 Years):** Only one crash, the subject crash, occurred at the subject intersection between January 1, 2020 and October 1, 2025.
  - **Pedestrian/Bicycle Involved:** The subject crash involved a bicyclist.
  - **Student-Involved Crashes:** The subject crash involved a student.
  - **Crashes During School Hours:** The subject crash occurred at 9:01 AM within school hours.
  - **Recurrent Patterns (Time/Type):** Because only one crash has occurred within a 5.5-year period, there is no recurring pattern.
