SCHOOL-RELATED CRASH INFRASTRUCTURE REVIEW

MONTGOMERY COUNTY DEPARTMENT OF TRANSPORTATION (MCDOT)

- Location: Bauer Drive & Russett Road
- Crash Date: 02/05/2025
- Crash Time: 3:10 PM
- School Name: Earl B. Wood Middle School
- School Walkshed Boundary (☒ Inside ☐ Borderline ☐ Just Outside):
- Local Case No: 250005375
- Review Date: 09/10/25

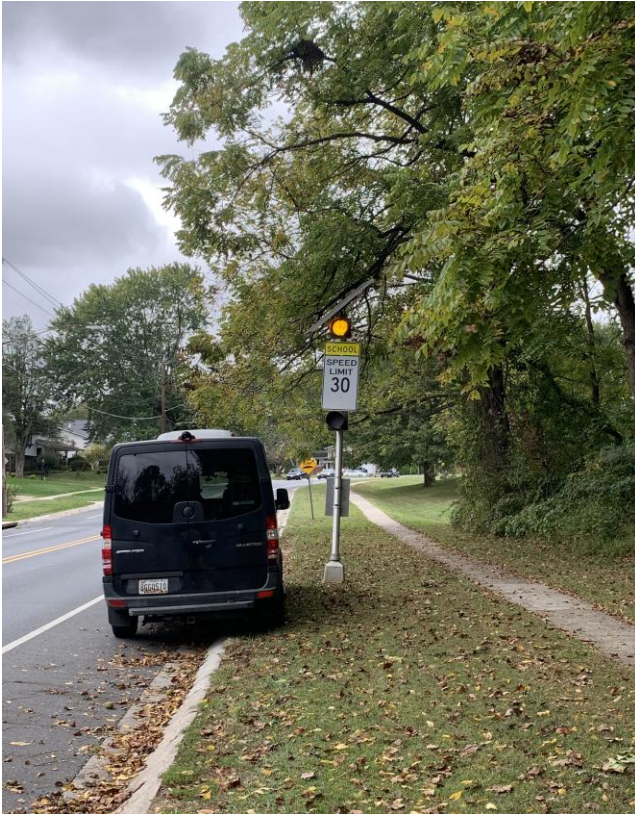
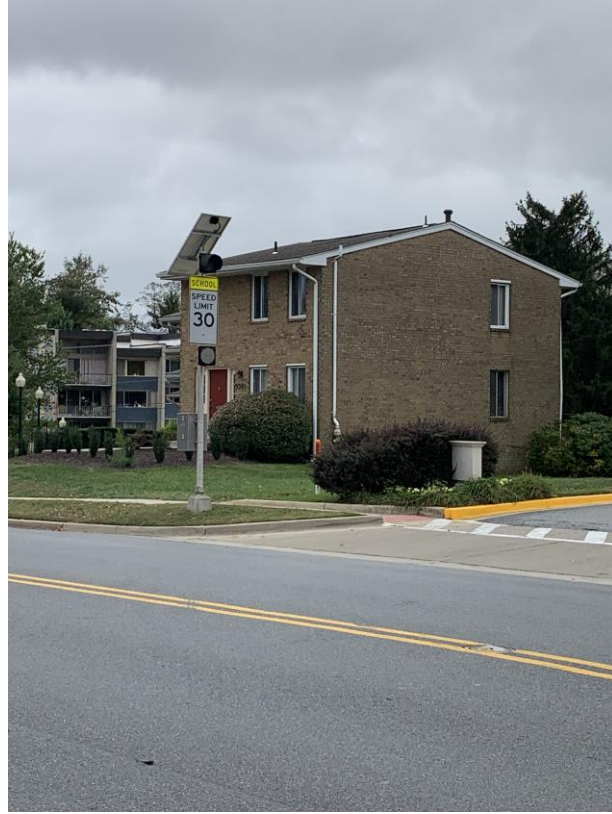
Figure 1: Bi-directional speed limit flashing sign

The posted speed limit along Bauer Drive is 30 mph. A 30-mph school speed limit sign, active when flashing, is also present along the corridor. Consideration should be given to lowering the school zone speed limit to 20 mph during school arrival and dismissal periods. This recommendation is consistent with the County's Complete Streets Design Guide (CSDG), as Bauer Drive is classified as a neighborhood connector.

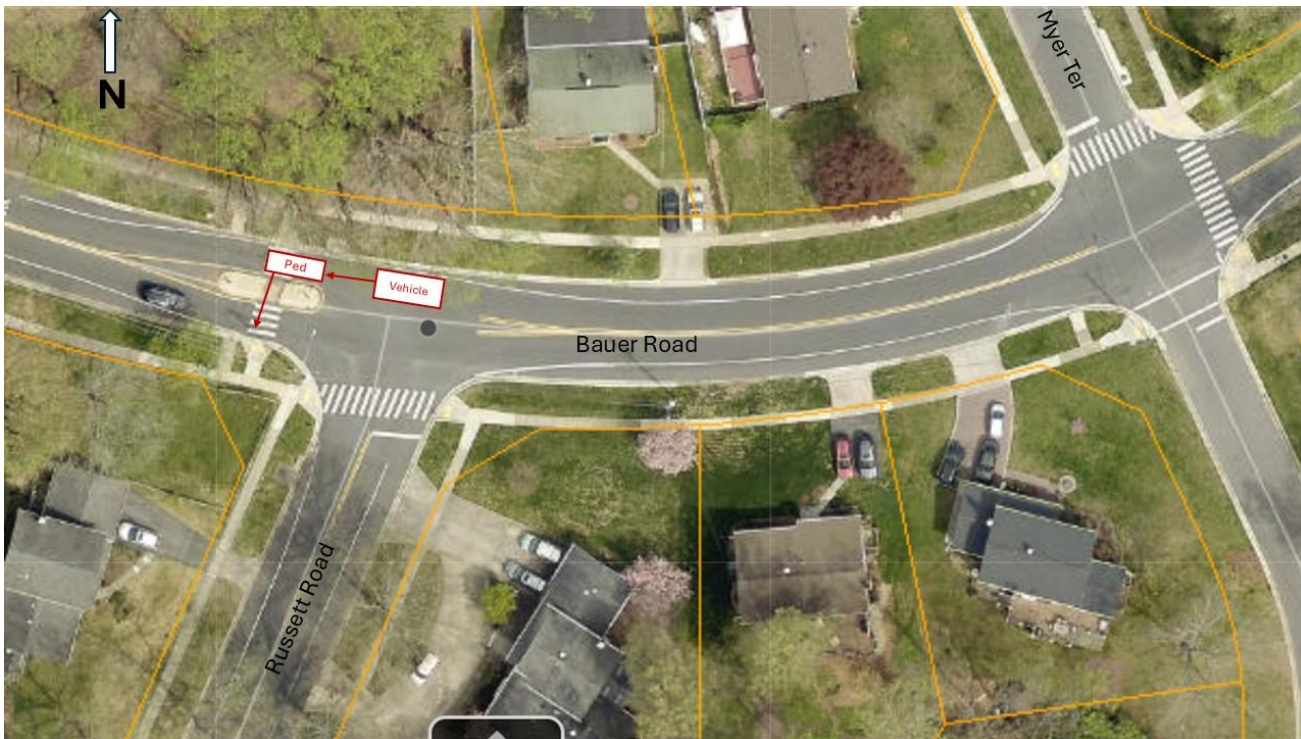
Figure 3: Crash Diagram

On Wednesday, February 5, 2025, at approximately 3:10 p.m., a pedestrian was struck while in the marked crosswalk by a motorist driving westbound on Bauer Drive. The crash report indicates that the collision occurred within a marked crosswalk. According to the crash report, the pedestrian sustained minor injuries, and the driver fled the scene. Weather conditions were clear, and the roadway surface was dry at the time of the crash. Figure 3 below illustrates the crash location and direction of pedestrian and vehicle travel.

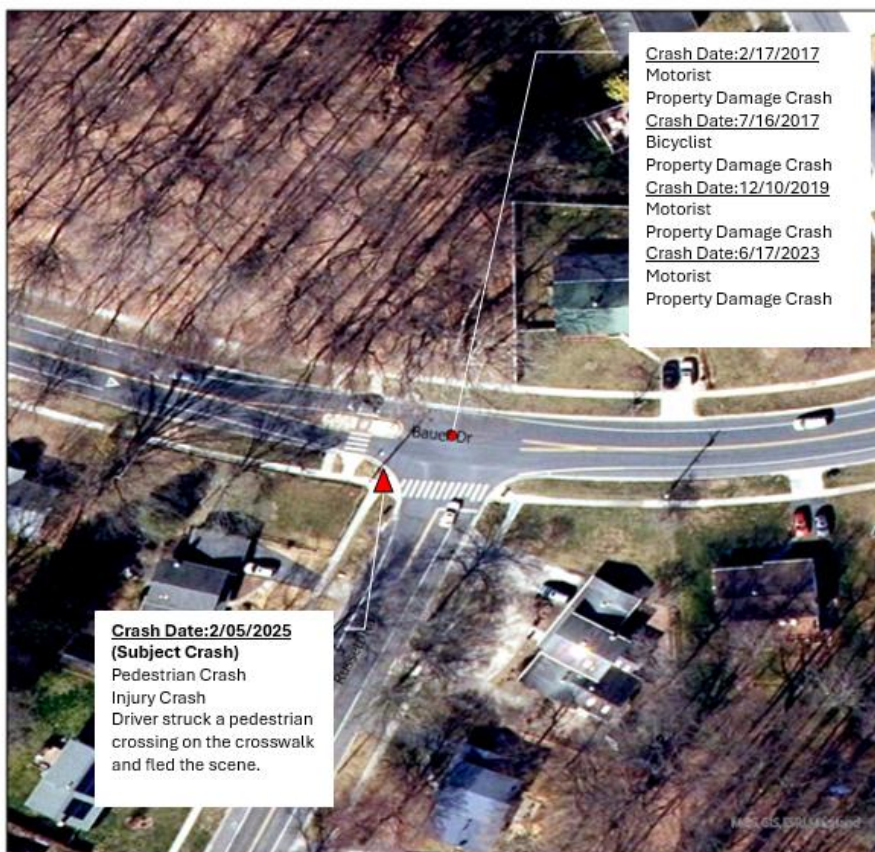
Figure 4: Crash History (2015-September 2025)

There was a total of five (5) crashes reported between March 2015 and August 2025. Four (4) crashes occurred at the intersection of Bauer Drive and Russett Road. One crash, which occurred in February 2025, involved a pedestrian who was struck while crossing at the crosswalk. The driver fled the scene after the crash.

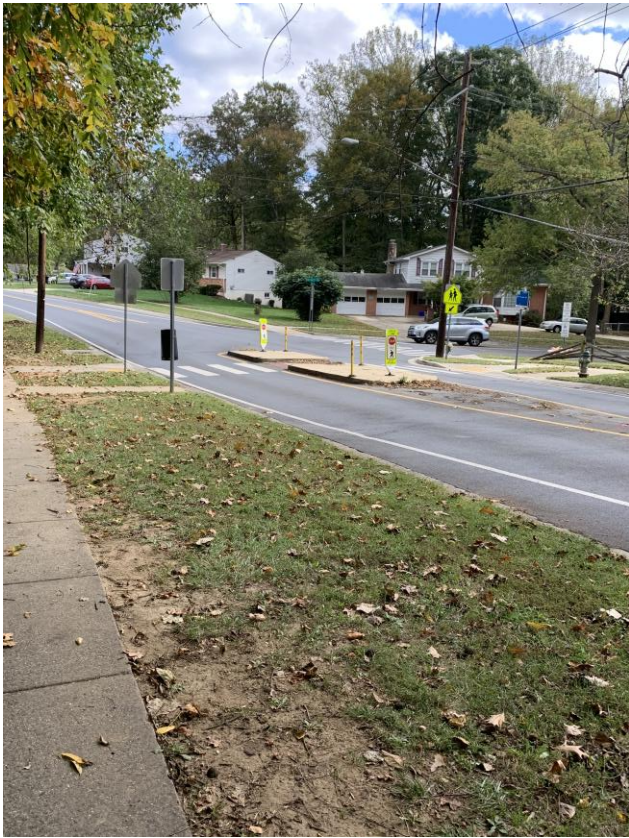
Figure 5: Existing condition of the intersection

- **Intersection Geometry**
Bauer Drive slopes downhill toward the intersection and includes a slight curve. The intersection features a marked pedestrian crossing and a refuge island located in the northeast quadrant.

The crosswalk at Bauer Dr. and Russett Road includes visible warning signs. Two pedestrian signs are installed in the center of the refuge island. There are bus stops in both directions at the intersection, and two marked crosswalks provide safe crossing points. Speed humps are also located along Bauer Drive, with one about 100 feet west of the intersection of Russett Rd. A flashing school warning sign that includes a speed posting of 30 mph is installed across from 14516 Bauer Dr., where the posted school speed limit is 30 mph.

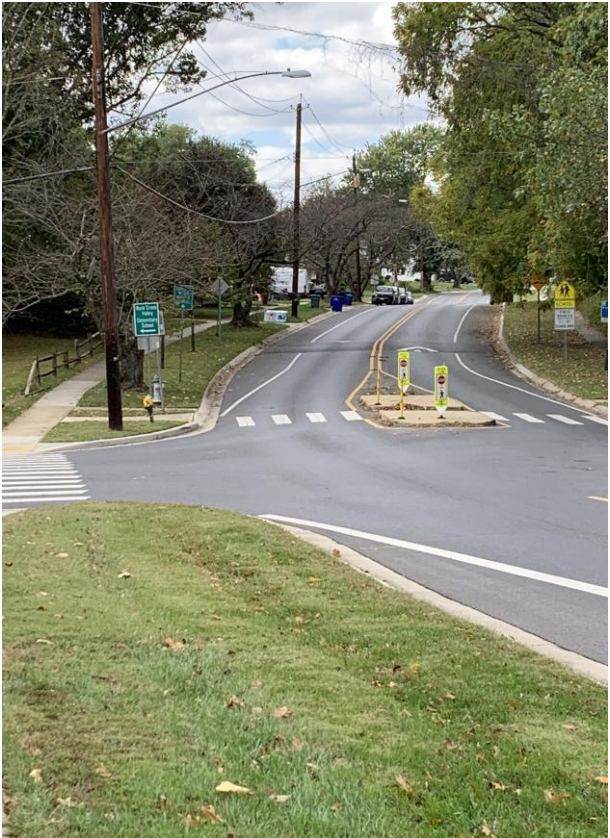
There were no visual obstructions observed at the intersection during the site visit. A downhill slope on Bauer Drive and a slight curve at Russett Road exists where pedestrians can still be seen crossing the intersection.

No infrastructure deficiencies were identified at this location.
