SCHOOL-RELATED CRASH INFRASTRUCTURE REVIEW

MONTGOMERY COUNTY DEPARTMENT OF TRANSPORTATION (MCDOT)

- **Location:** Sligo Avenue at Grove Street
- **Crash Date:** February 5, 2025
- **Crash Time:** Approximately 3:30 PM
- **School Name:** East Silver Spring Elementary School & Takoma Park Middle School
- **School Walkshed Boundary:** Inside
- **Local Case No:** 250005339
- **Review Date:** January 29, 2026

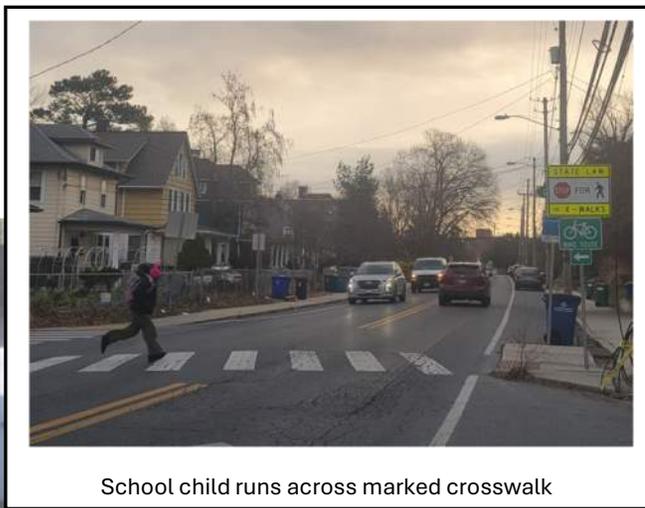
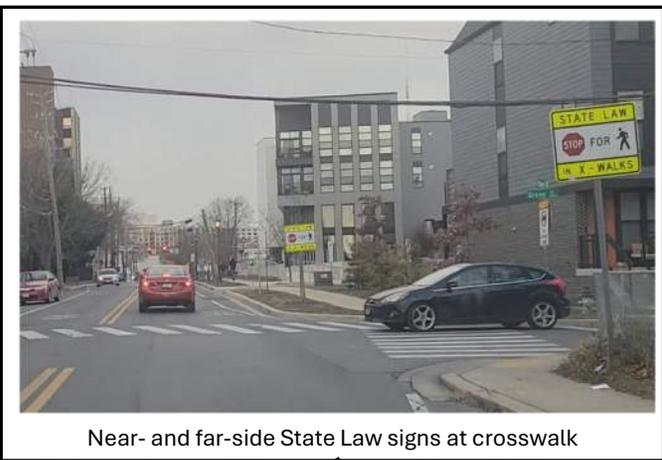
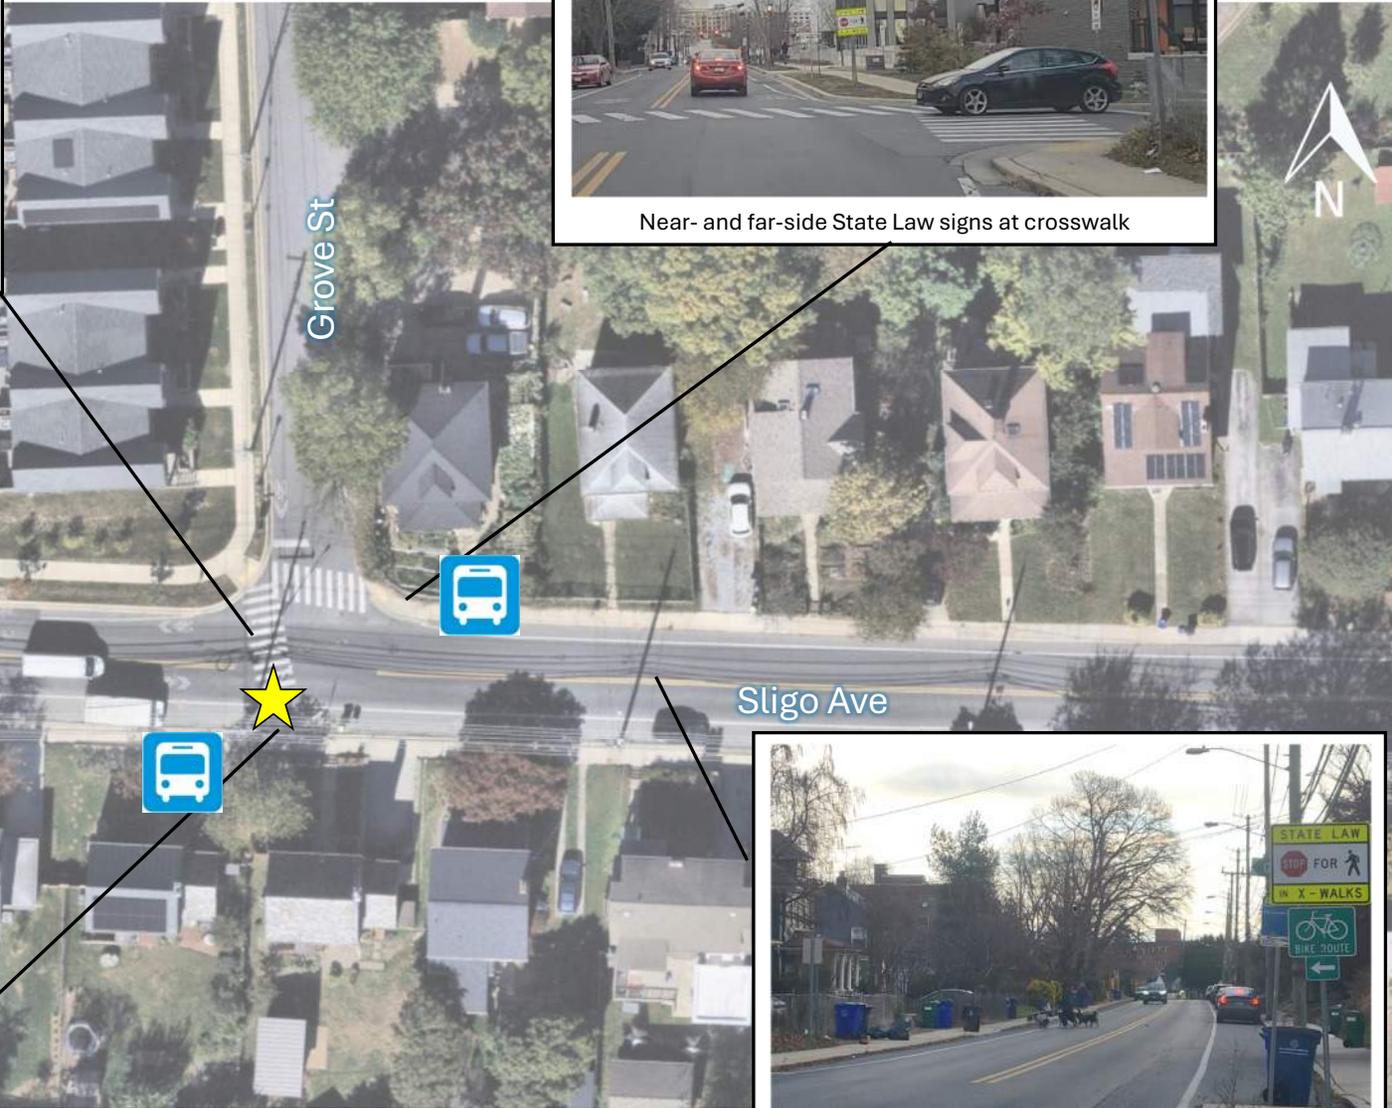
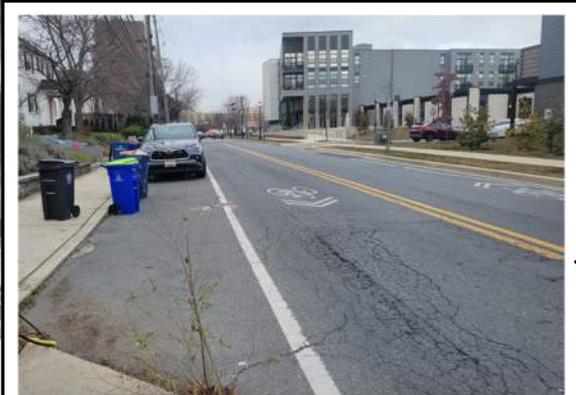
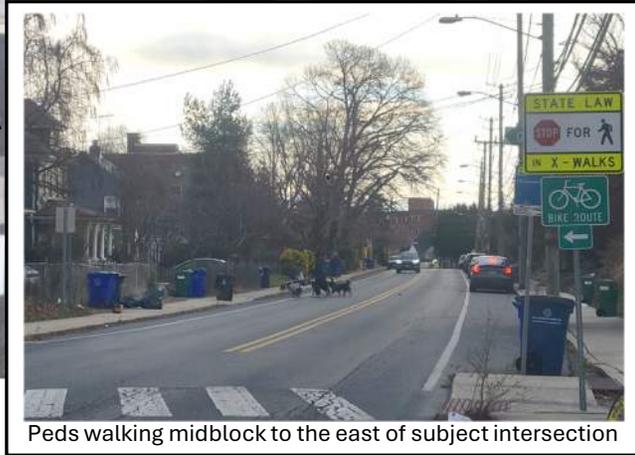
Figure 1 – Sligo Ave at Grove St

- **Sidewalk Coverage**
There is continuous sidewalk coverage on the north and south side of the road. The sidewalk is buffered to the northwest of the subject intersection.

- **Crosswalk Visibility**
The crosswalk markings are in good condition along both the west leg crossing Sligo Avenue, and the north leg crossing Grove Street.

- **Lighting at Location**
An LED street light is located in the southwest corner of the intersection over the west leg crossing.
- **Speed Limit / School Zone Limit**
The posted speed limit along Sligo Avenue is 25 mph, and the posted speed limit along Grove Street is 20 mph.

- **Intersection Geometry**
Sligo Avenue is a two-lane, two-way undivided roadway with one lane in each direction. There are shared lane markings alerting motorists as to the lateral location bicyclists are likely to occupy within the travel lanes. A 3.5-foot wide shoulder lies on the north side of the roadway, and on-street parking is permitted on the south (eastbound) side of Sligo Avenue.

- **Vehicle Activity:** Light.
- **Drop-off / Pick-up Operations**
No drop-off or pick-up patterns observed at the crash location.
- **Visibility / Obstructions**
On-street parking is available along the south side of Sligo Avenue. Pedestrian sight distance is adequate at the crosswalk ramp.

- ☑ **Maintenance:** Replace the existing crosswalk with angled continental crosswalk markings to be parallel with the vehicular approach for the west leg of the subject intersection.
- ☑ **Engineering:** Install centerline hardening along the Sligo Avenue approaches to the Grove Street intersection. This treatment will discourage the crossing of the centerline and visually narrow the travel way. Exposure of vulnerable road users will be reduced by reinforcing the requirement to not cross the centerline.

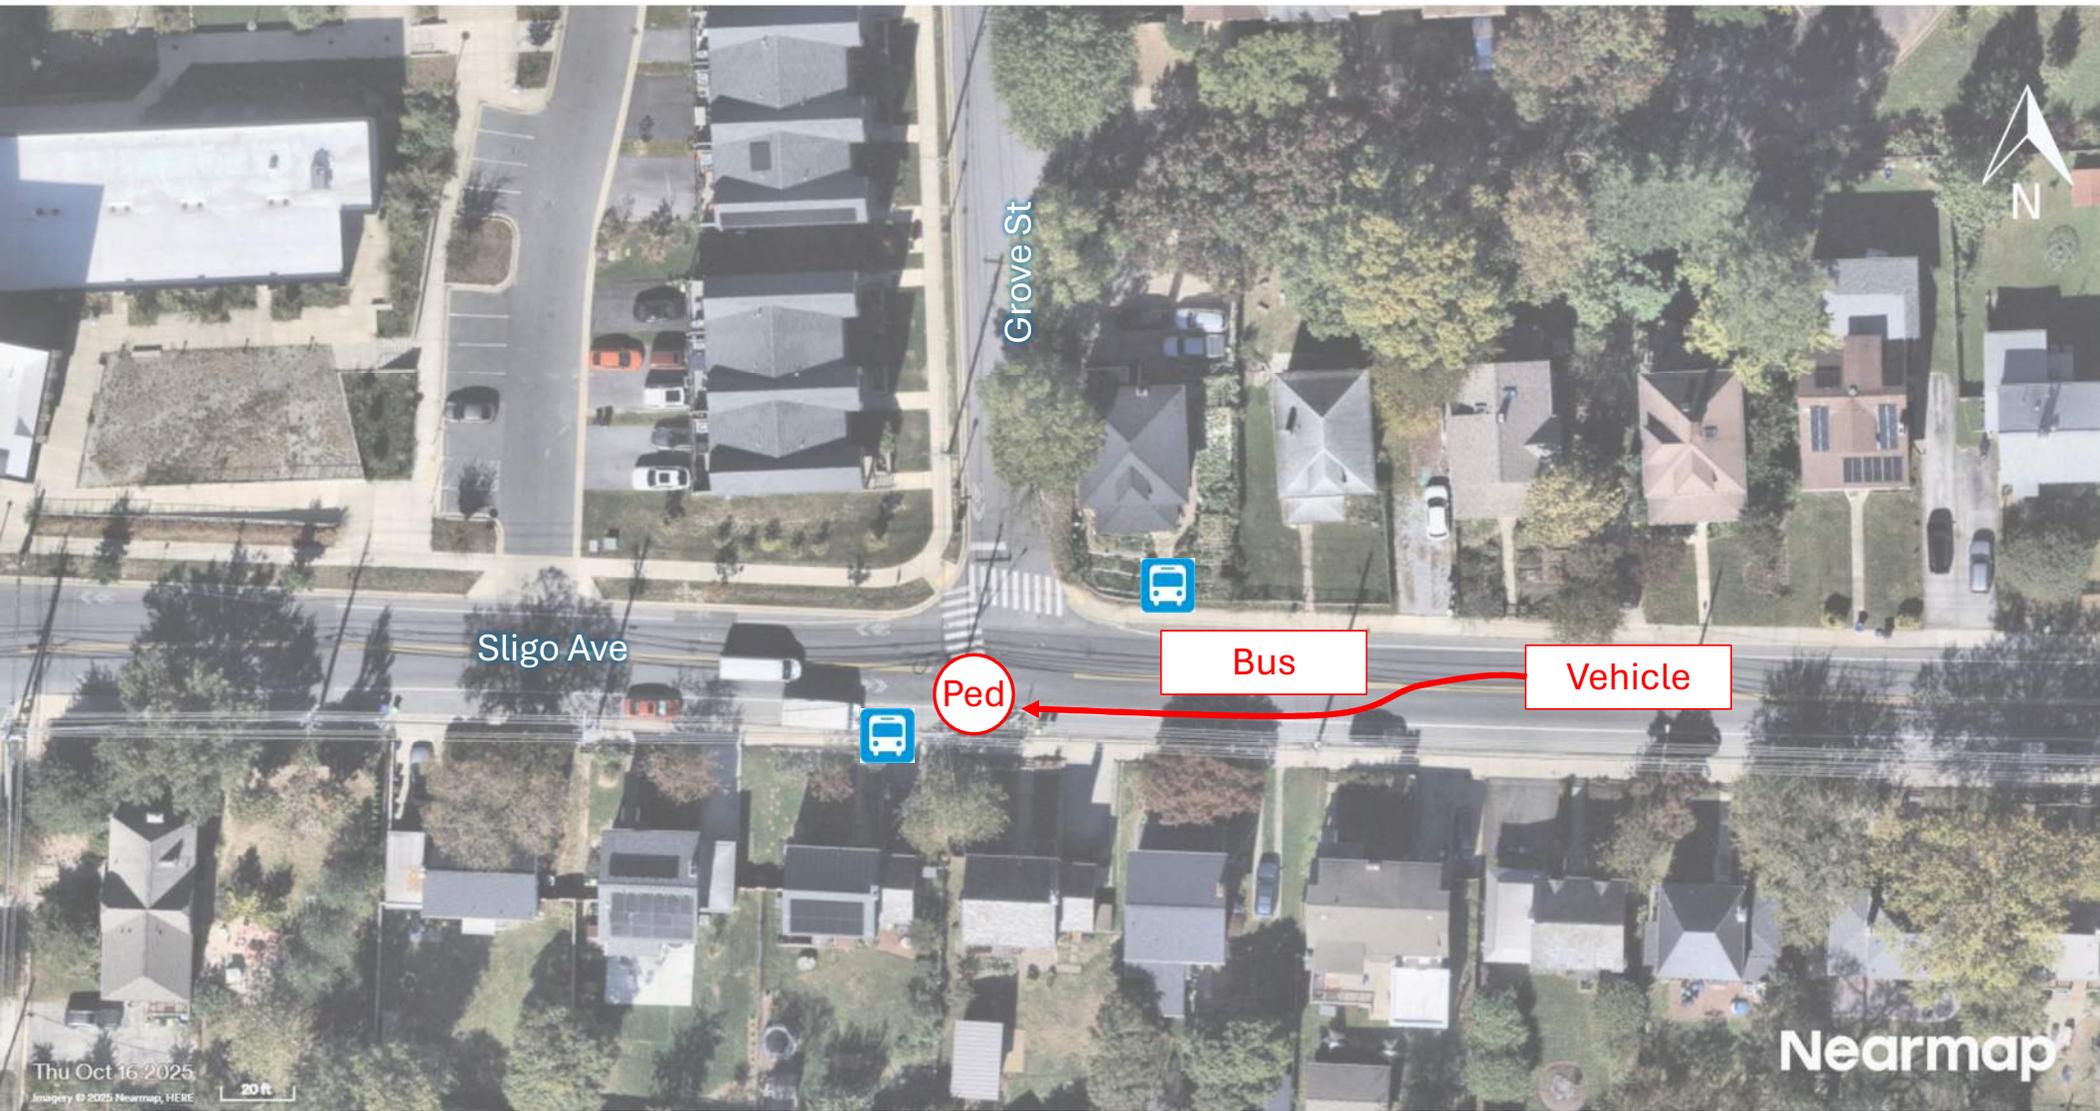
Figure 2 – Crash Diagram

On Wednesday, February 5, 2025, a pedestrian was traveling south along the marked crossing of Sligo Ave on the west leg of the intersection with Grove Street when the pedestrian was struck by a motorist traveling in the wrong lane to bypass a stopped transit bus. The pedestrian suffered a possible injury and was transported to the hospital. The weather was clear, and the roadway was dry. Figure 2 illustrates the crash location and the direction of pedestrian and vehicle travel.

There were no obvious infrastructure deficiencies that contributed to this crash. The crash occurred due to driver and failure to exercise due care approaching an uncontrolled pedestrian crossing and passing a transit vehicle.

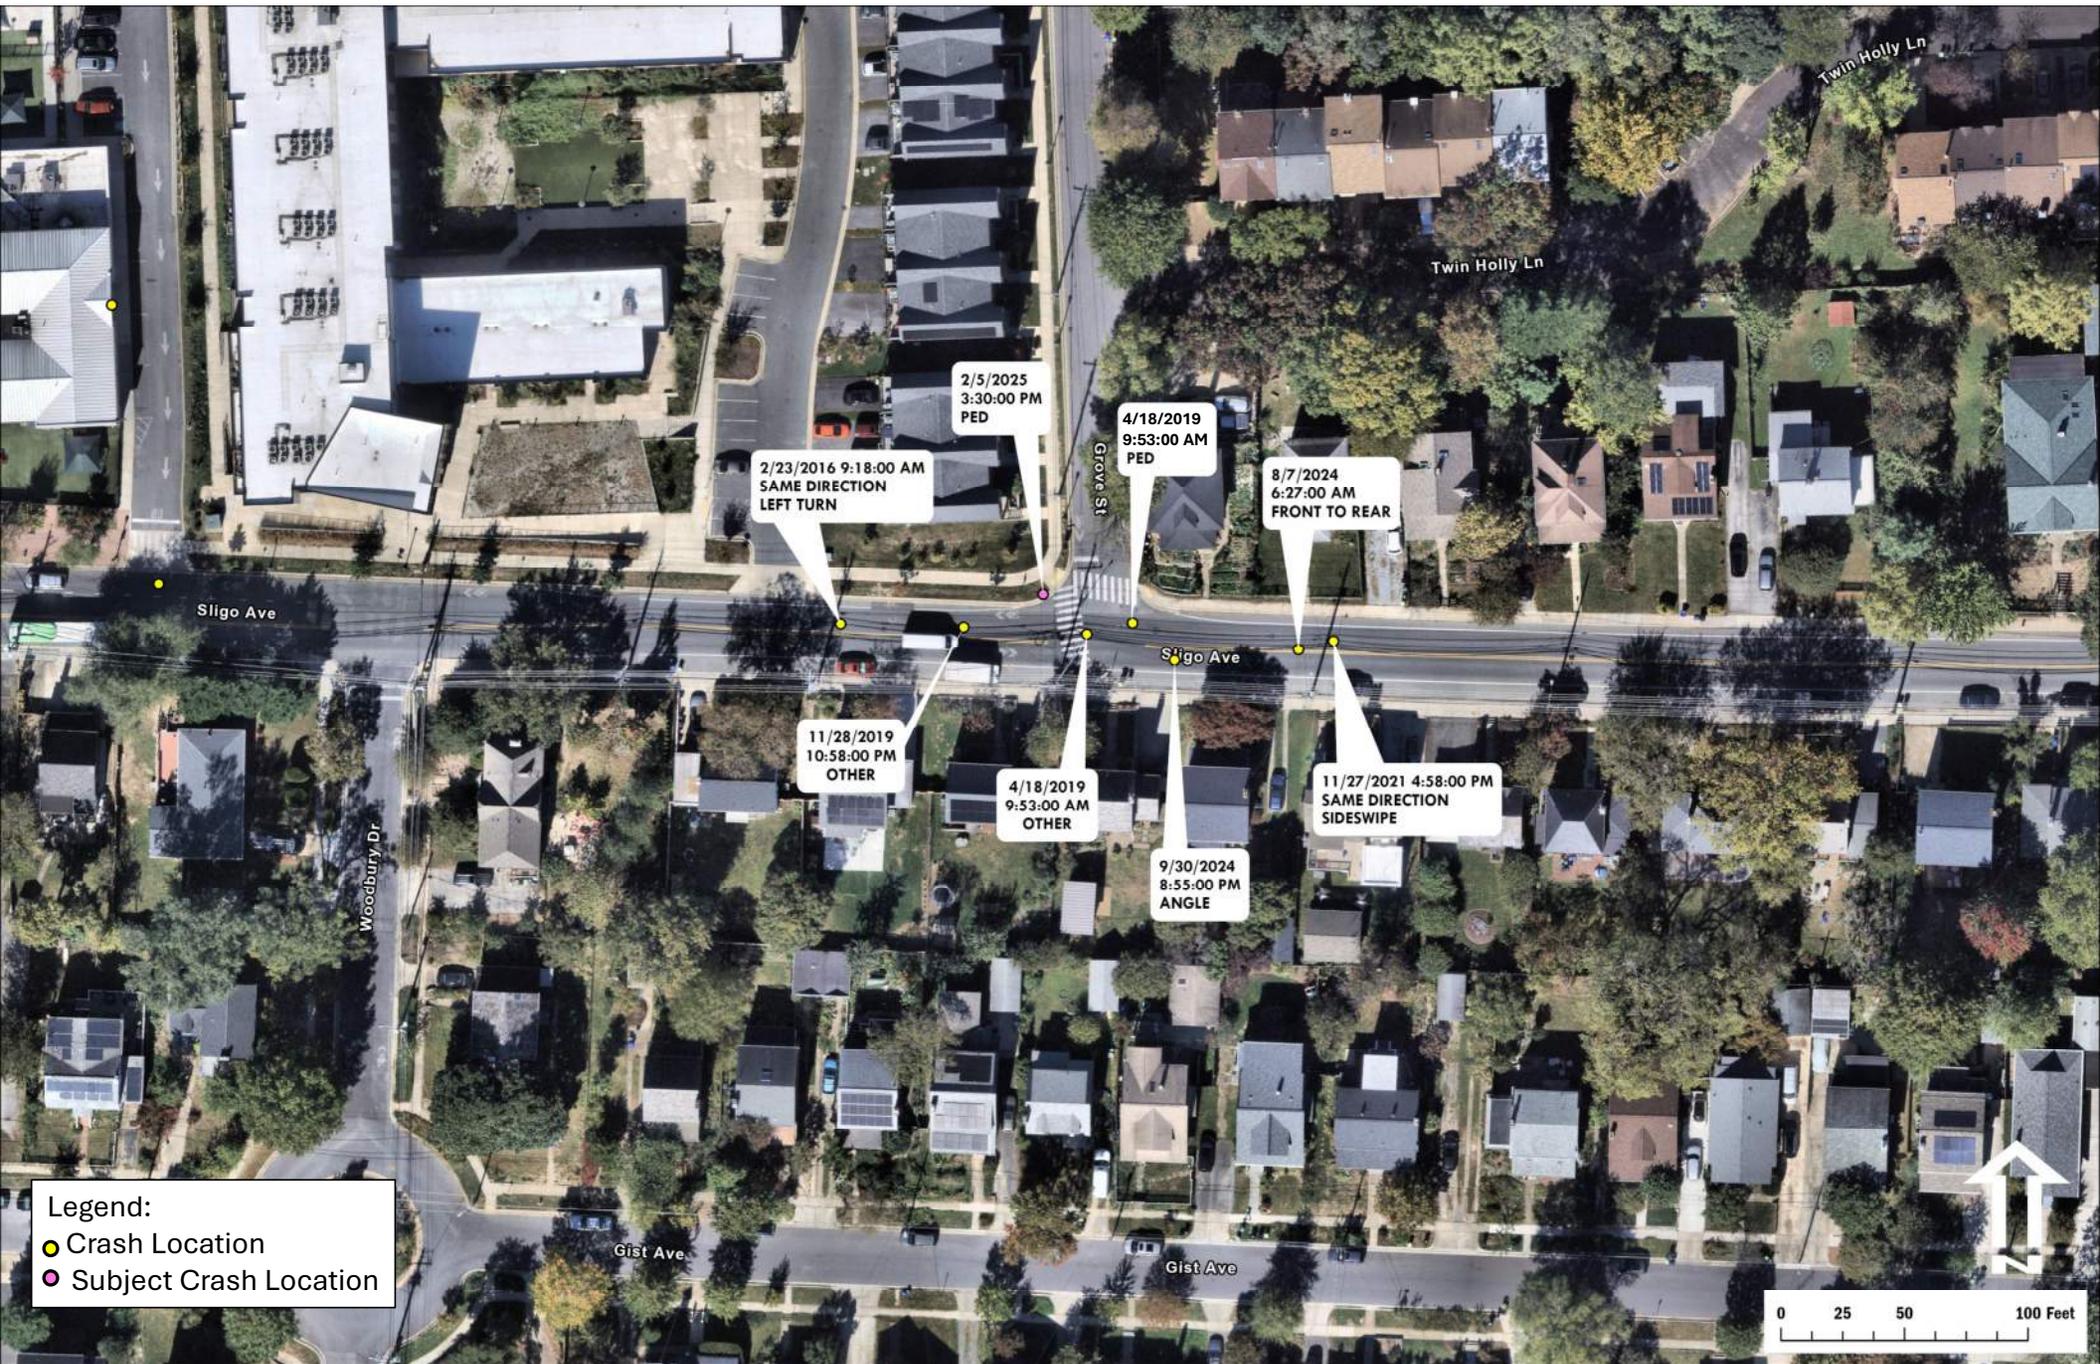
Figure 3 – Crash History (2019-2025)

- **Total Crashes (Last 10 Years):** A total of eight (8) crashes occurred at or near the subject crash location between January 1, 2016 and November 30, 2025.

- **Pedestrian/Bicycle Involved:** There were two (2) pedestrian crashes within the past 10 years; one in April 2019 at approximately 9:53 AM, and the subject crash in February 2025 at approximately 3:30 PM.

- **Recurrent Patterns (Time/Type):** There is no recurrent pattern of crashes. There have been two (2) angle collisions, one (1) sideswipe, one (1) rear end, one (1) left-turn, two (2) pedestrian, and one (1) “other” collision. Of the eight (8) crashes, three (3) involved a parked vehicle. Two (2) of the crashes occurred along a wet surface, and three (3) occurred in the dark or dusk.
