SCHOOL-RELATED CRASH INFRASTRUCTURE REVIEW **MONTGOMERY COUNTY DEPARTMENT OF TRANSPORTATION (MCDOT)**

- **Location:** Snowden Farm Parkway at Newcut Road
- **Crash Date:** May 23, 2025
- **Crash Time:** Approximately 7:05 PM
- **School Name:** Snowden Farm Elementary School, Hallie Wells Middle School, Clarksburg High School
- **School Walkshed Boundary:** Inside
- **Local Case No:** 250022932
- **Review Date:** February 3, 2026

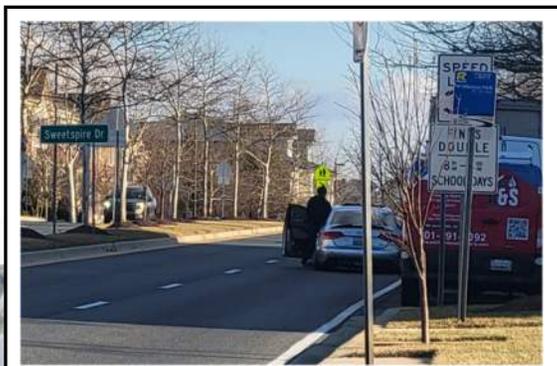
Vehicles block through lane for passenger pick up and drop off

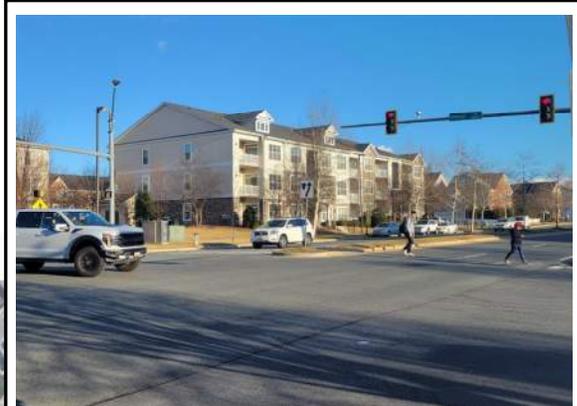
SB left turn from Newcut Rd yields to pedestrians on west leg

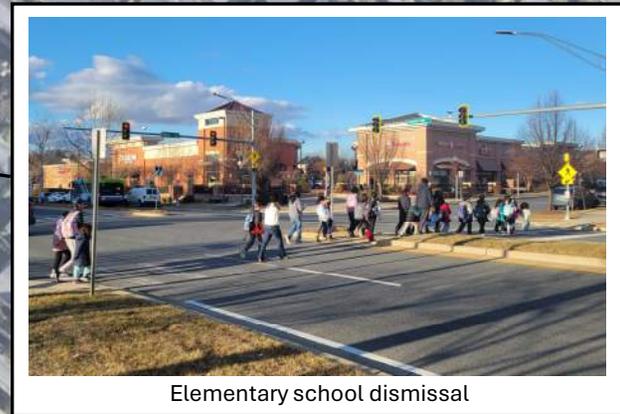
Elementary school dismissal

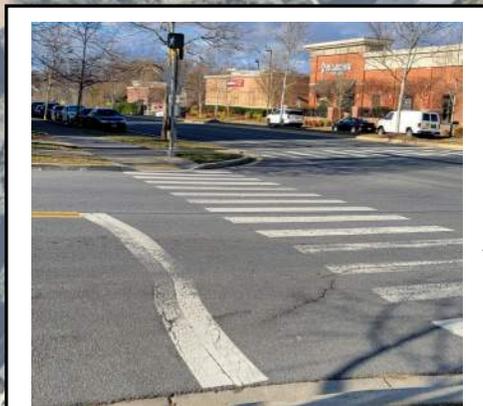
- **Sidewalk Coverage**
There is continuous, buffered sidewalk coverage along all approaches and legs of the intersection.
- **Crosswalk Visibility**
Continental crosswalks are marked over each leg of the intersection. The pavement markings over the departure lanes of Snowden Farm Parkway are fading (eastbound east leg and westbound west leg).

NB stop line uneven and fading

- ☑ **Maintenance:** Refresh faded pavement markings including crosswalks and stop lines.
Install “Turning Vehicle Yield To Pedestrian” signs on the mast arms for all approaches.
Replace “Pedestrian Crossing” signs with “School” signs.

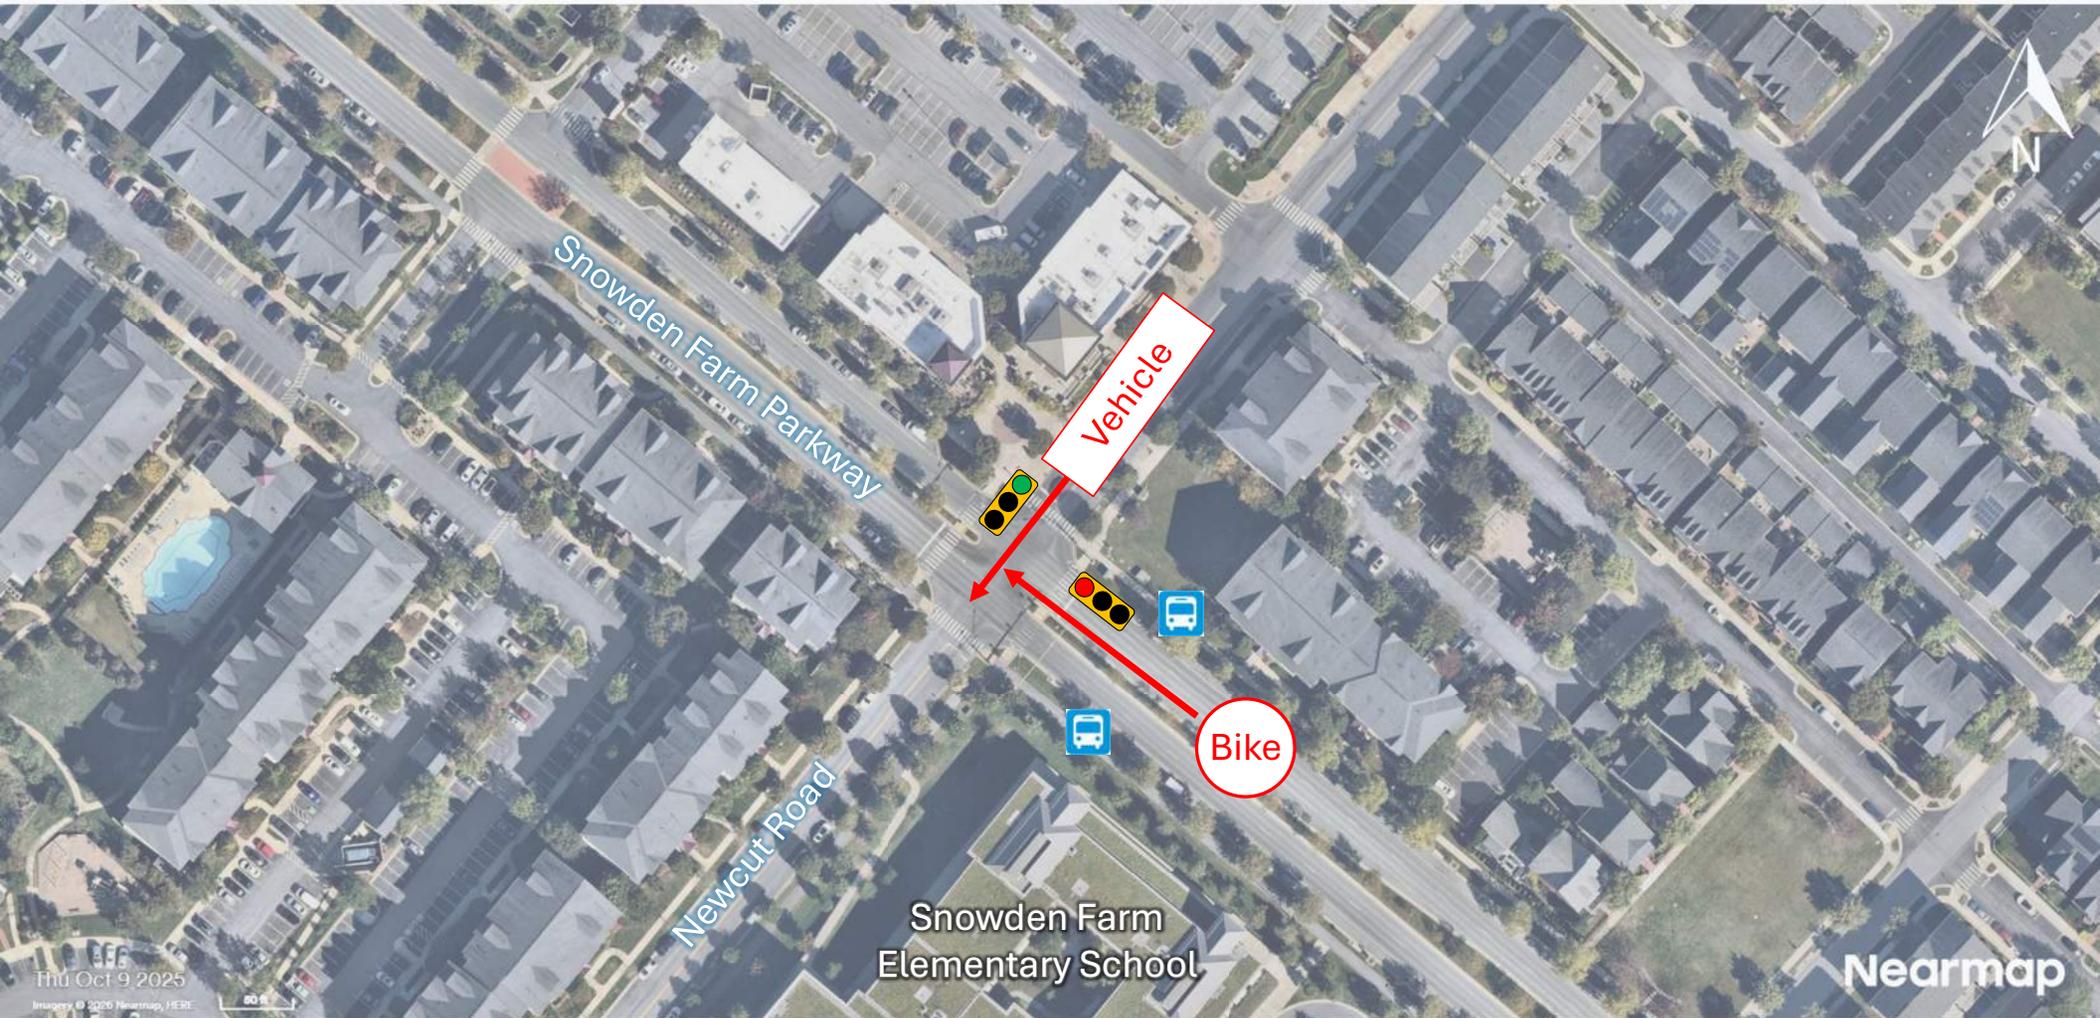
Figure 2 – Crash Diagram

On Friday, May 23, 2025, a vehicle was traveling southbound along Newcut Road and passed through the intersection with Snowden Farm Parkway while the signal was green. A bicyclist traveling along westbound Snowden Farm Parkway passed through the intersection with Newcut Road while the signal was red and was struck by the vehicle. The bicyclist suffered a suspected minor injury. The weather was clear, the roadway surface was dry, and the crash occurred in the daylight. Figure 2 illustrates the crash location and the direction of bicyclist and vehicle travel.

Crash Location

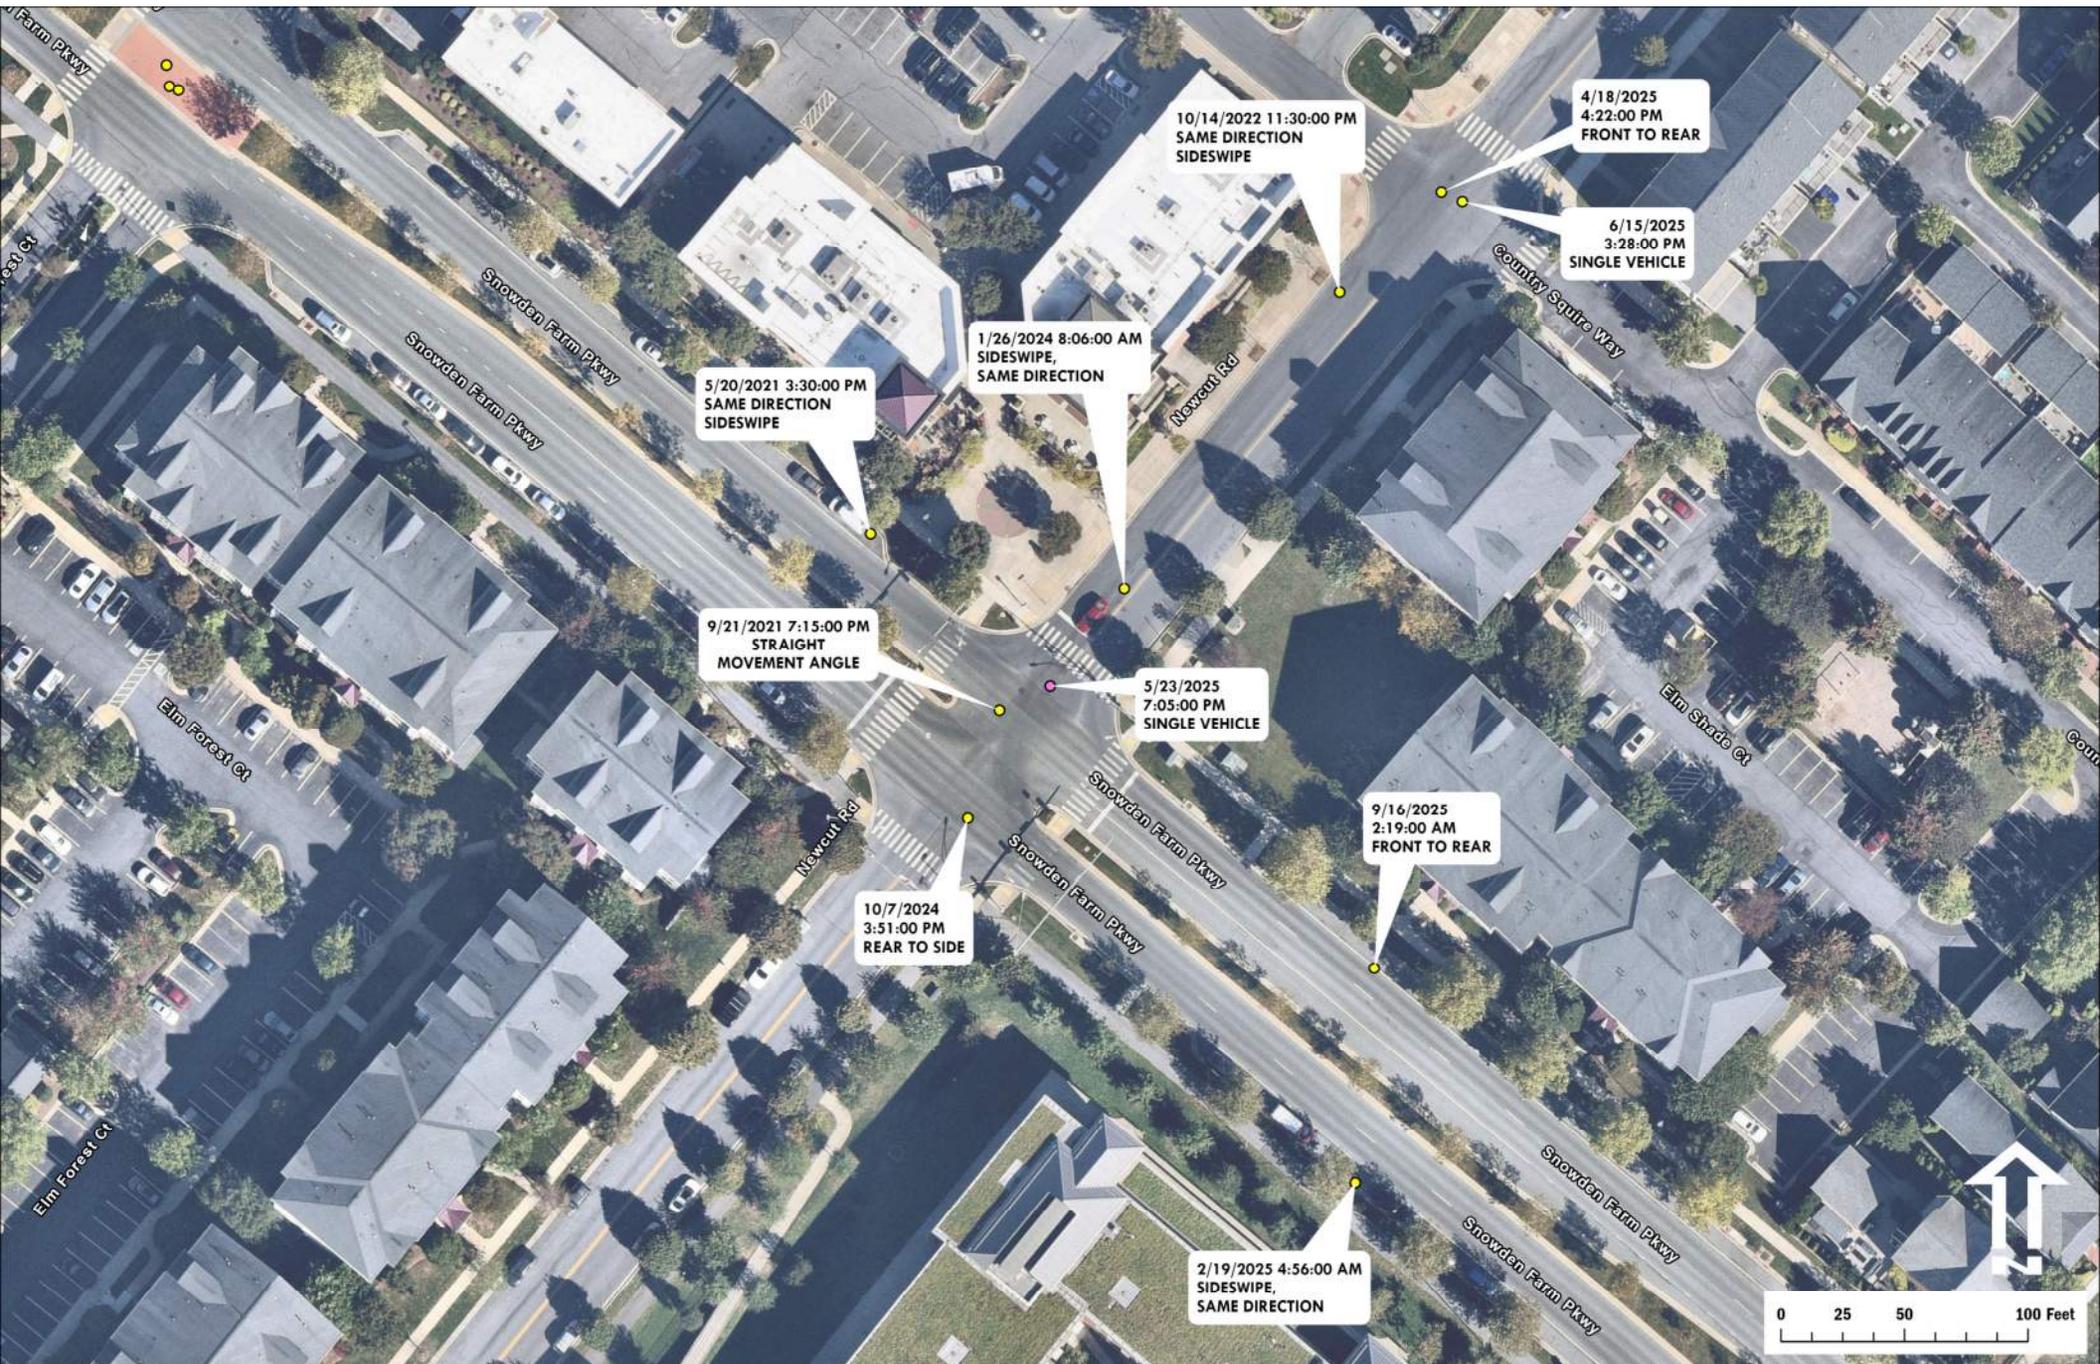
Figure 3 – Crash History (2020-2025)

- **Total Crashes (Last 5+ Years):** A total of seven (7) crashes occurred at or near the subject crash location between January 1, 2020 and November 30, 2025.
 - **Pedestrian/Bicycle Involved:** Only the subject crash involved a VRU.
 - **Student-Involved Crashes:** The only known student-involved crash included the subject crash.
 - **Crashes During School Hours:** Of the seven (7) crashes, three (3) crashes occurred within school hours or within one hour of the school bell (6:45 AM to 4:25 PM) and within the school calendar year.
 - **Recurrent Patterns (Time/Type):** There is not a recurrent crash pattern. There were three (3) sideswipe crashes, one (1) angle crash, one (1) reverse crash, one (1) pedestrian crash, and one (1) rear end crash. Three (3) crashes occurred in the dark with lights. One (1) crash occurred along a wet surface.
