SCHOOL-RELATED CRASH INFRASTRUCTURE REVIEW **MONTGOMERY COUNTY DEPARTMENT OF TRANSPORTATION (MCDOT)**

- **Location:** Independence Street at Turkey Branch Parkway
- **Crash Date:** May 8, 2025
- **Crash Time:** Approximately 3:05 PM
- **School Name:** Parkland Middle School & Wheaton High School
- **School Walkshed Boundary:** Inside
- **Local Case No:** 250020302
- **Review Date:** February 3, 2026

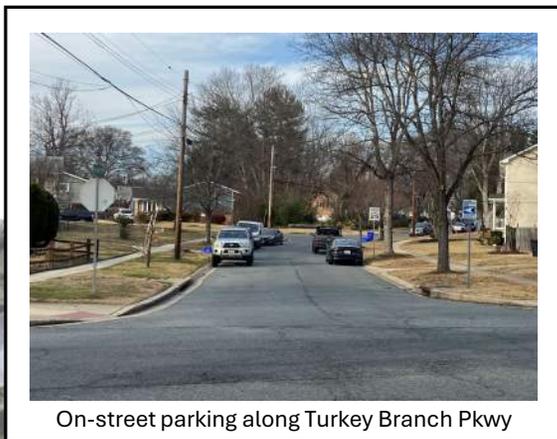
- **Vehicle Activity:** Light.
- **Drop-off / Pick-up Operations**
No drop-off or pick-up patterns observed at the crash location.
- **Visibility / Obstructions**
Vehicular and pedestrian sight lines from Turkey Branch Parkway may be negatively impacted by on-street parking. Motorists were observed to pull past the stop sign to increase their sight lines. There are not “No Parking” signs installed along Independence Street near Turkey Branch Parkway.

On-street parking along Turkey Branch Pkwy

- ☑ **Maintenance:** Paint stop lines for both approaches of Turkey Branch Parkway. Paint a crosswalk for all legs of the intersection. Provide corner clearance “No Parking” signs along the west leg of Independence Street to improve sight lines from Turkey Branch Parkway.
- ☑ **Engineering:** Considering narrowing the intersection of Independence Street at Turkey Branch Parkway using curb extensions. Vehicles travel downhill from the signalized intersection with MD 185 along a wide roadway and results in speeding vehicles. Flex post curb extensions will increase visibility and promote slower traffic operations to mitigate safety risk.

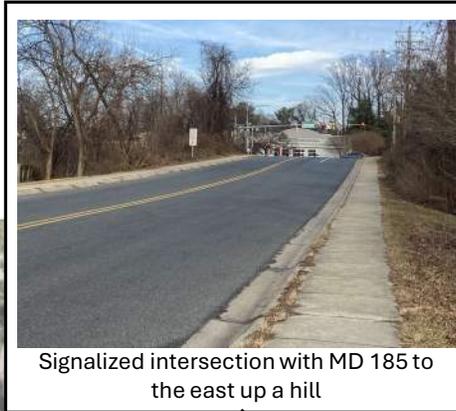
- **Additional Details**
Independence Street is a neighborhood connector providing access to detached residential houses to the west. To the east of the signalized intersection with MD 185 (approximately 375 feet to the east), the roadway becomes a parking lot into the Aspen Hill Shopping Center and Holy Cross Health Center. Turkey Branch Parkway provides access to detached residential houses.

Signalized intersection with MD 185 to the east up a hill

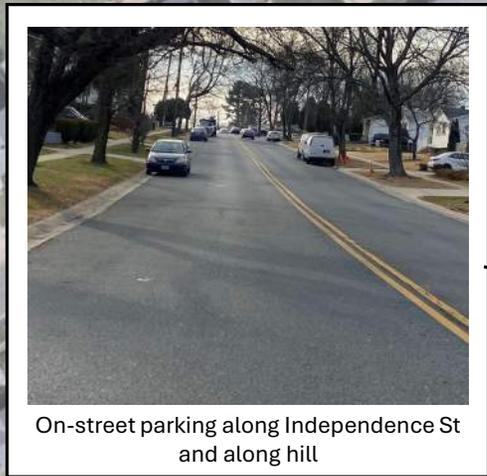
On-street parking along Independence St and along hill

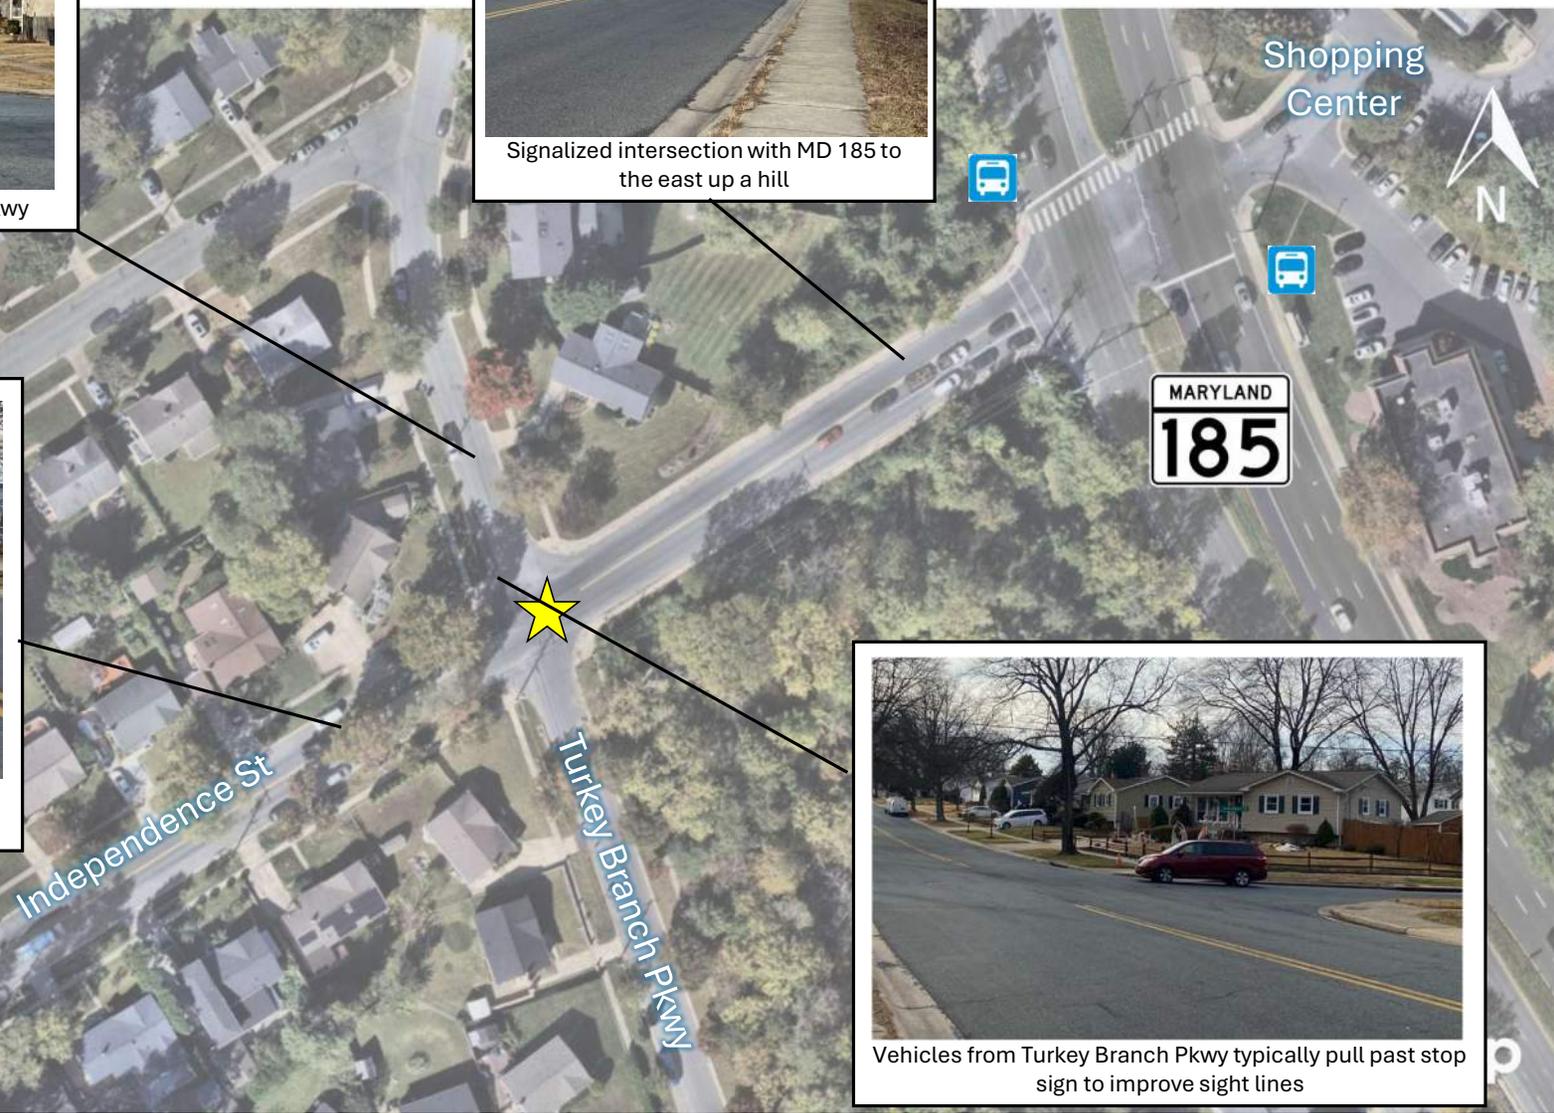
Figure 1 – Independence St at Turkey Branch Pkwy

- **Intersection Geometry**
Independence Street is a two-lane, two-way undivided roadway with one lane in each direction and no shoulders. The lanes are approximately 17-feet wide with parking permitted on both sides of the street on the west leg and parking prohibited on the east leg. Turkey Branch Parkway is a two-lane, two-way undivided unmarked roadway that is approximately 25 feet wide with parking permitted on both sides of the street.

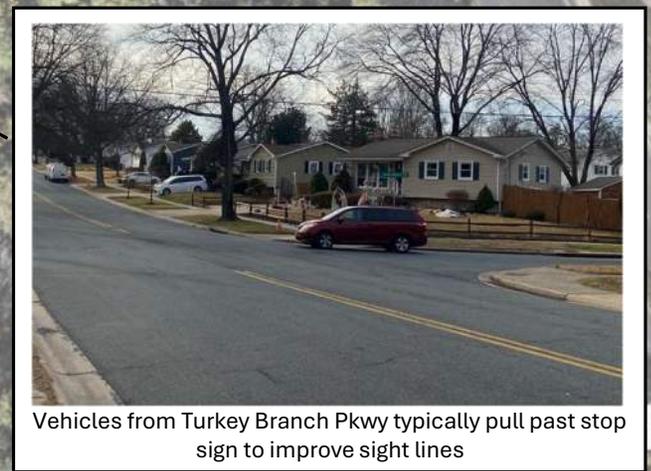
Vehicles from Turkey Branch Pkwy typically pull past stop sign to improve sight lines

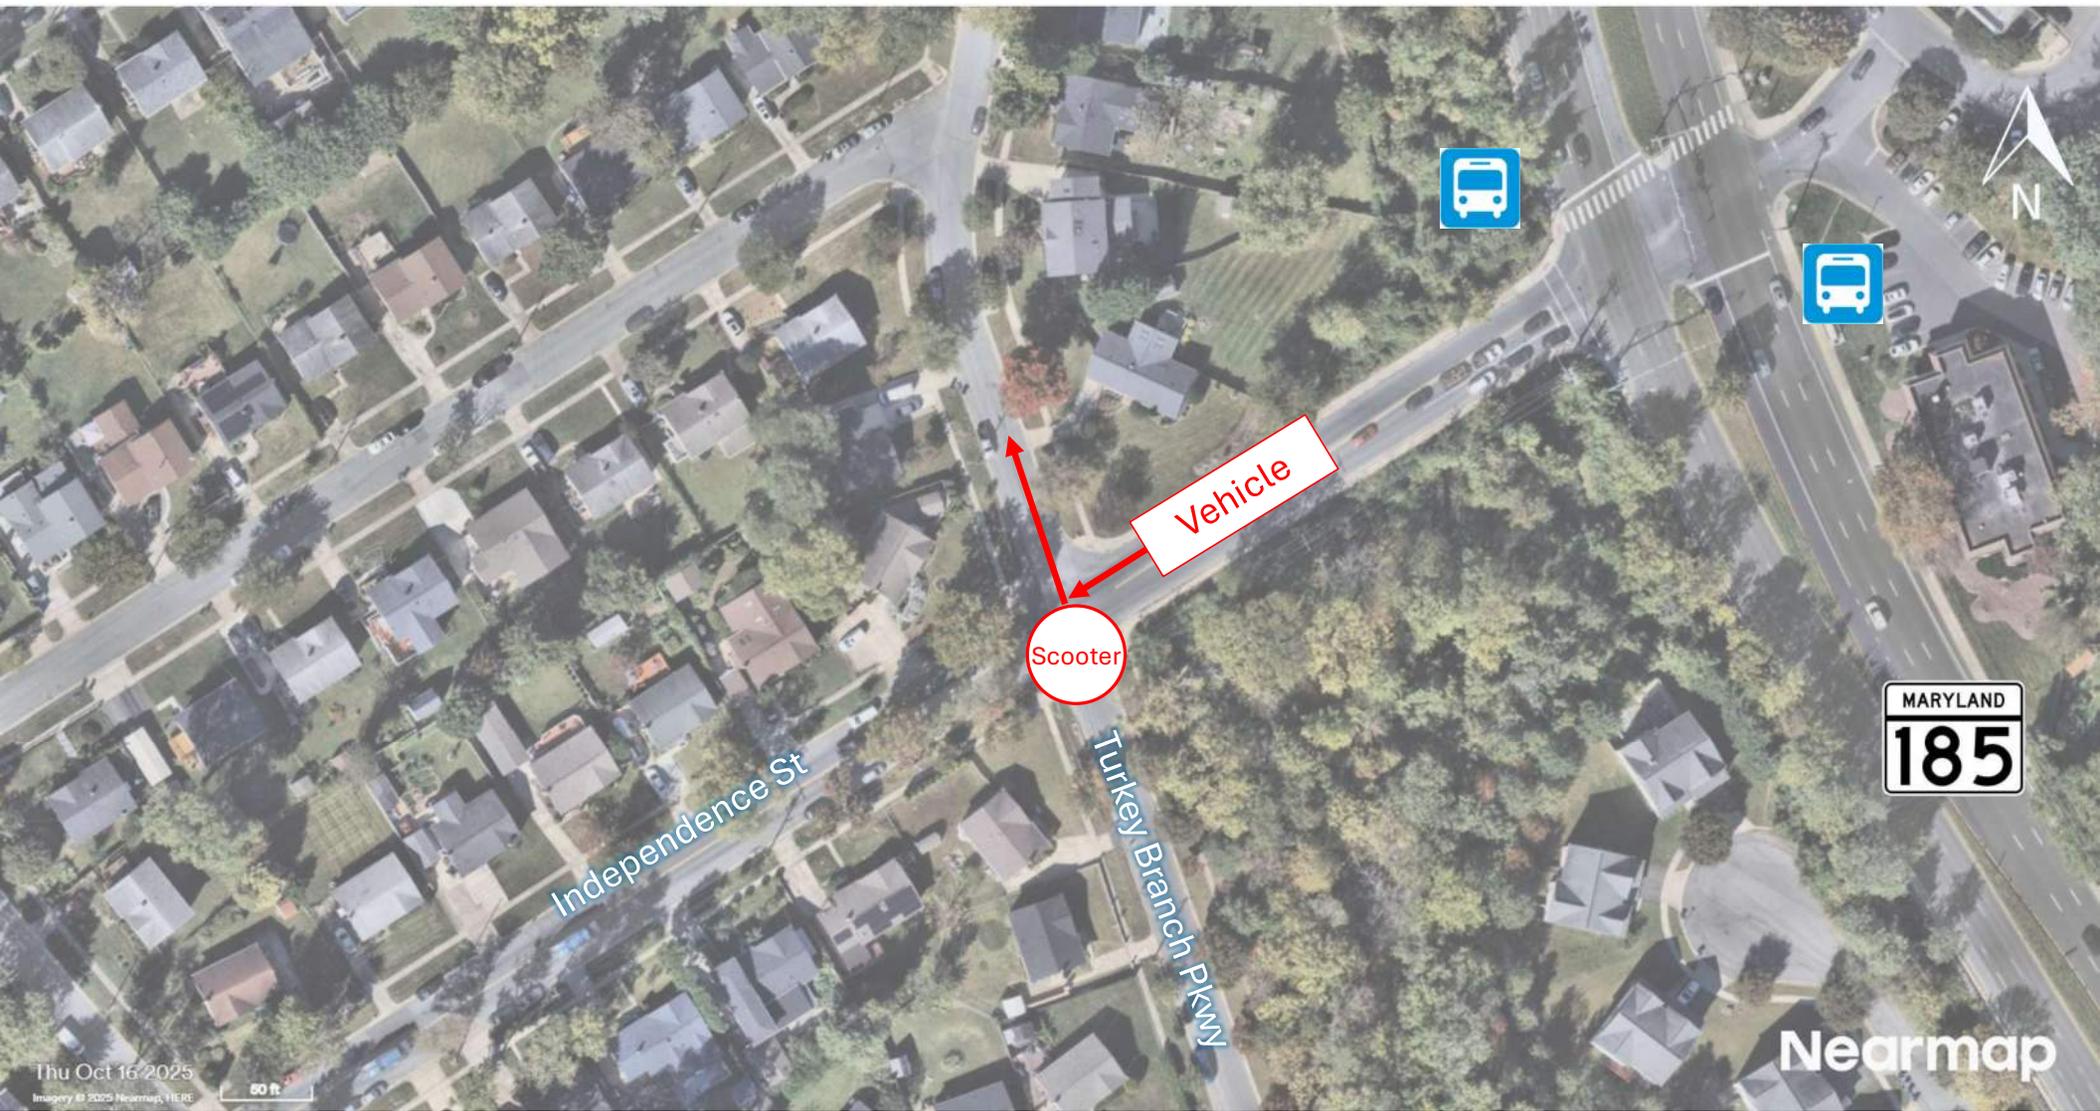
Figure 2 – Crash Diagram

On Thursday, May 8, 2025, a vulnerable road user (VRU) was traveling north on a scooter along the stop-controlled approach of Turkey Branch Parkway when a motorist along westbound Independence Street collided with the scooter. The crash report notes that the scooter did not slow. The Independence Street approaches are free flow. The scooter operator suffered a suspected minor injury and was transported to the hospital. The weather was clear, the roadway surface was dry, and the crash occurred in the daylight. Figure 2 illustrates the crash location and the direction of scooter operator and vehicle travel.

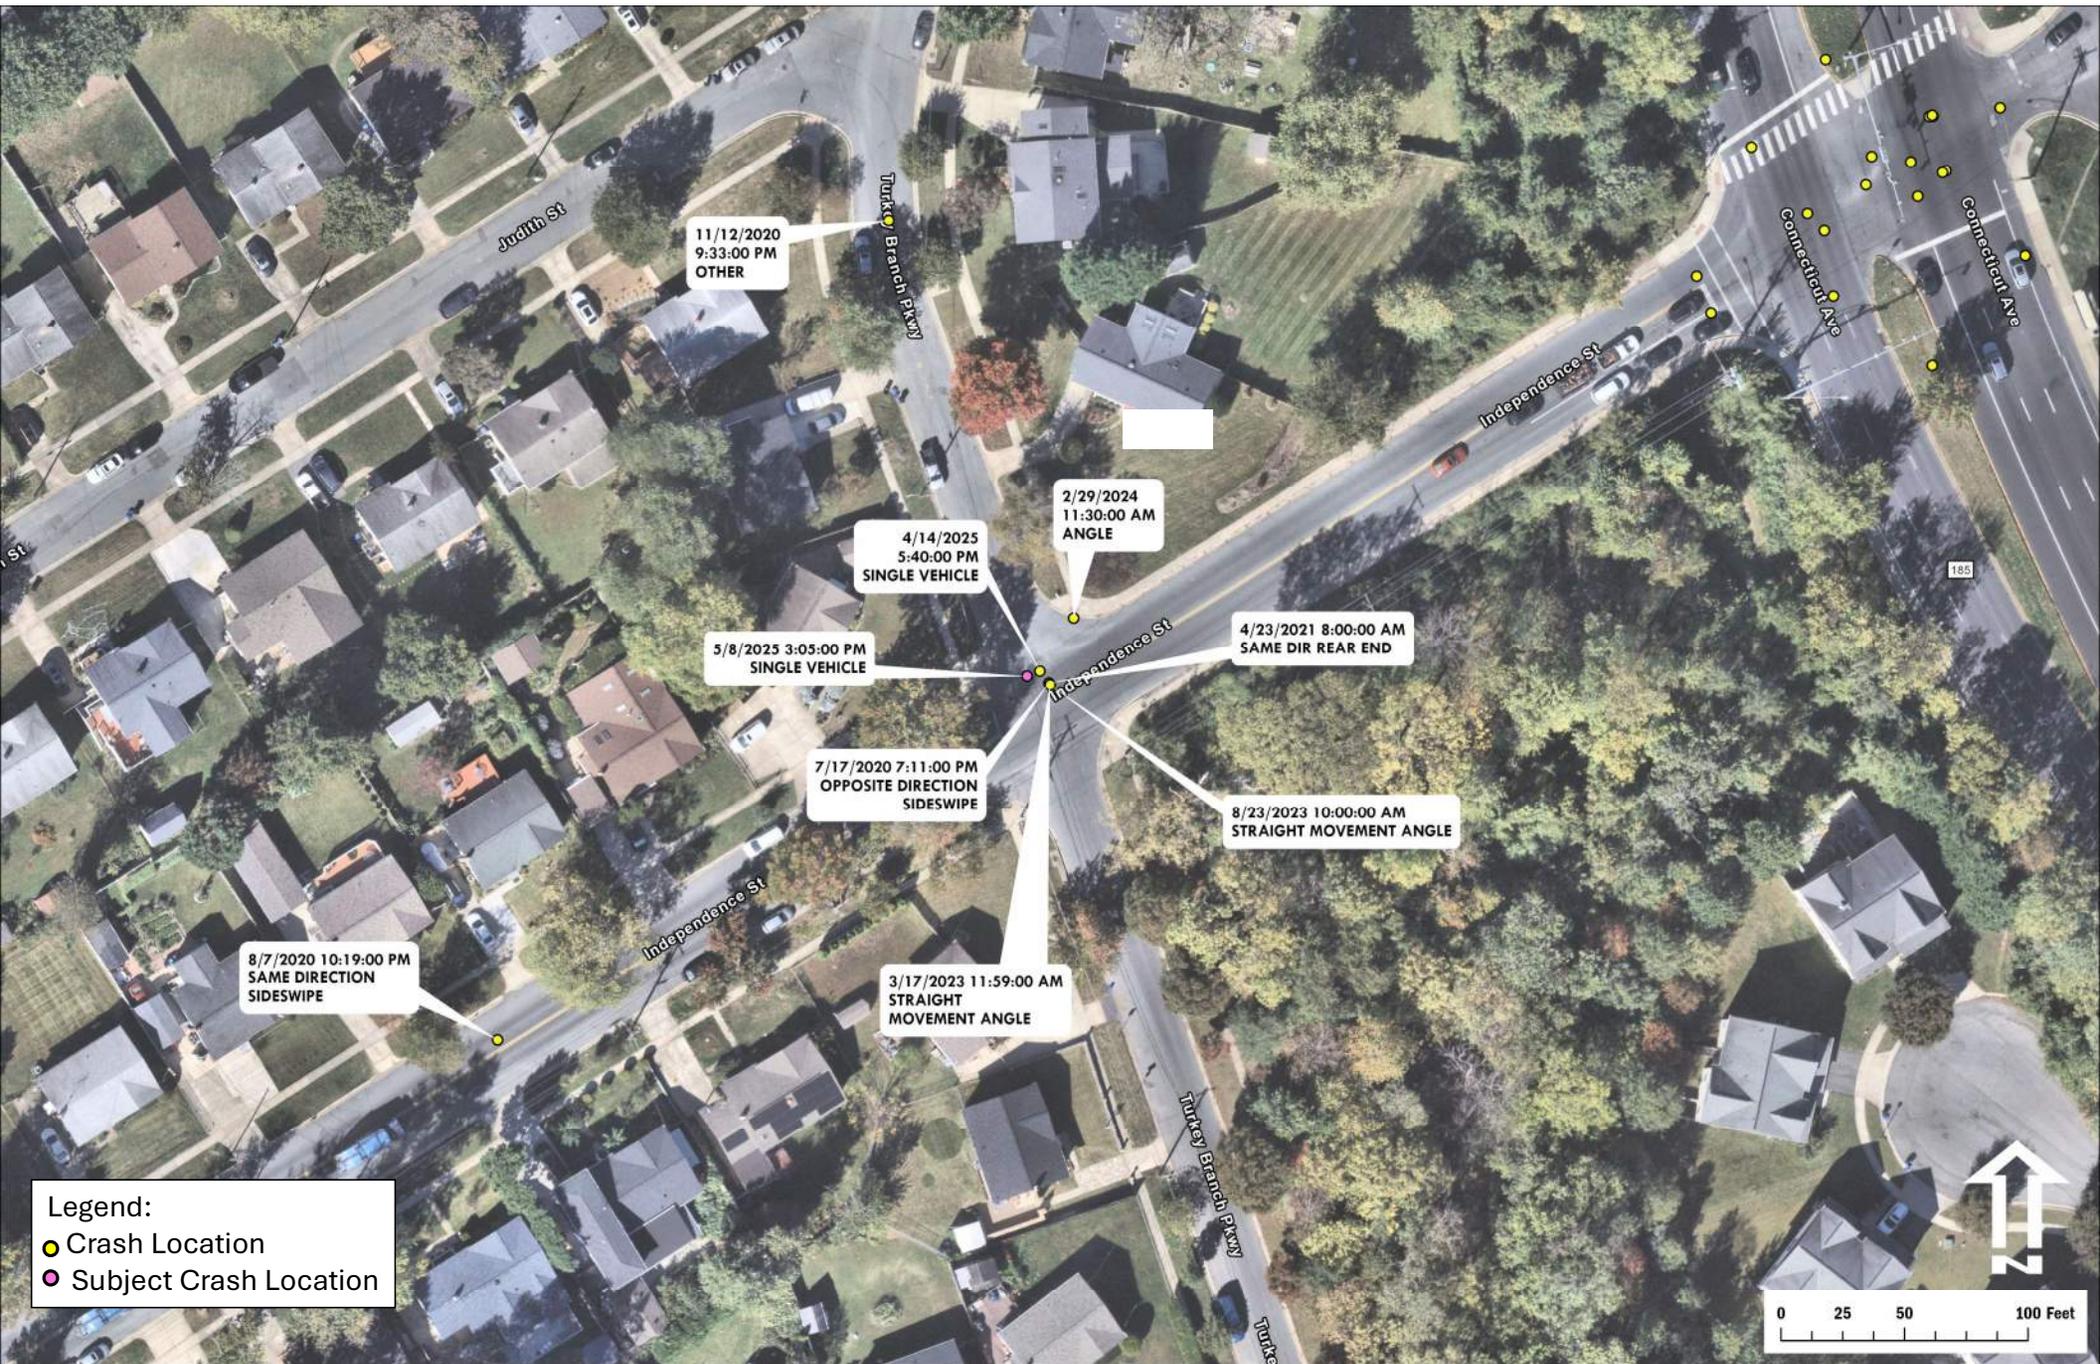
Figure 3 – Crash History (2020-2025)

- **Total Crashes (Last 5+ Years):** A total of seven (7) crashes occurred at or near the subject crash location between January 1, 2020 and November 30, 2025.
 - **Pedestrian/Bicycle Involved:** There were two (2) VRU crashes; one cyclist and one scooter (subject crash). The cyclist crash occurred in April 2025 at 5:40 PM in the daylight along a dry surface.
 - **Student-Involved Crashes:** The only known student-involved crash included the subject crash.

- **Crashes During School Hours:** Of the seven (7) crashes, four (4) crashes occurred within school hours or within one hour of the school bell (6:45 AM to 4:00 PM) and within the school calendar year.
- **Recurrent Patterns (Time/Type):** There is not a recurrent crash pattern. There were three (3) angle crashes, two (2) VRU crashes, one (1) sideswipe crash, and one (1) rear end crash. All crashes happened in the daylight. One (1) crash occurred along a wet surface, and one (1) crash occurred along an unknown surface.

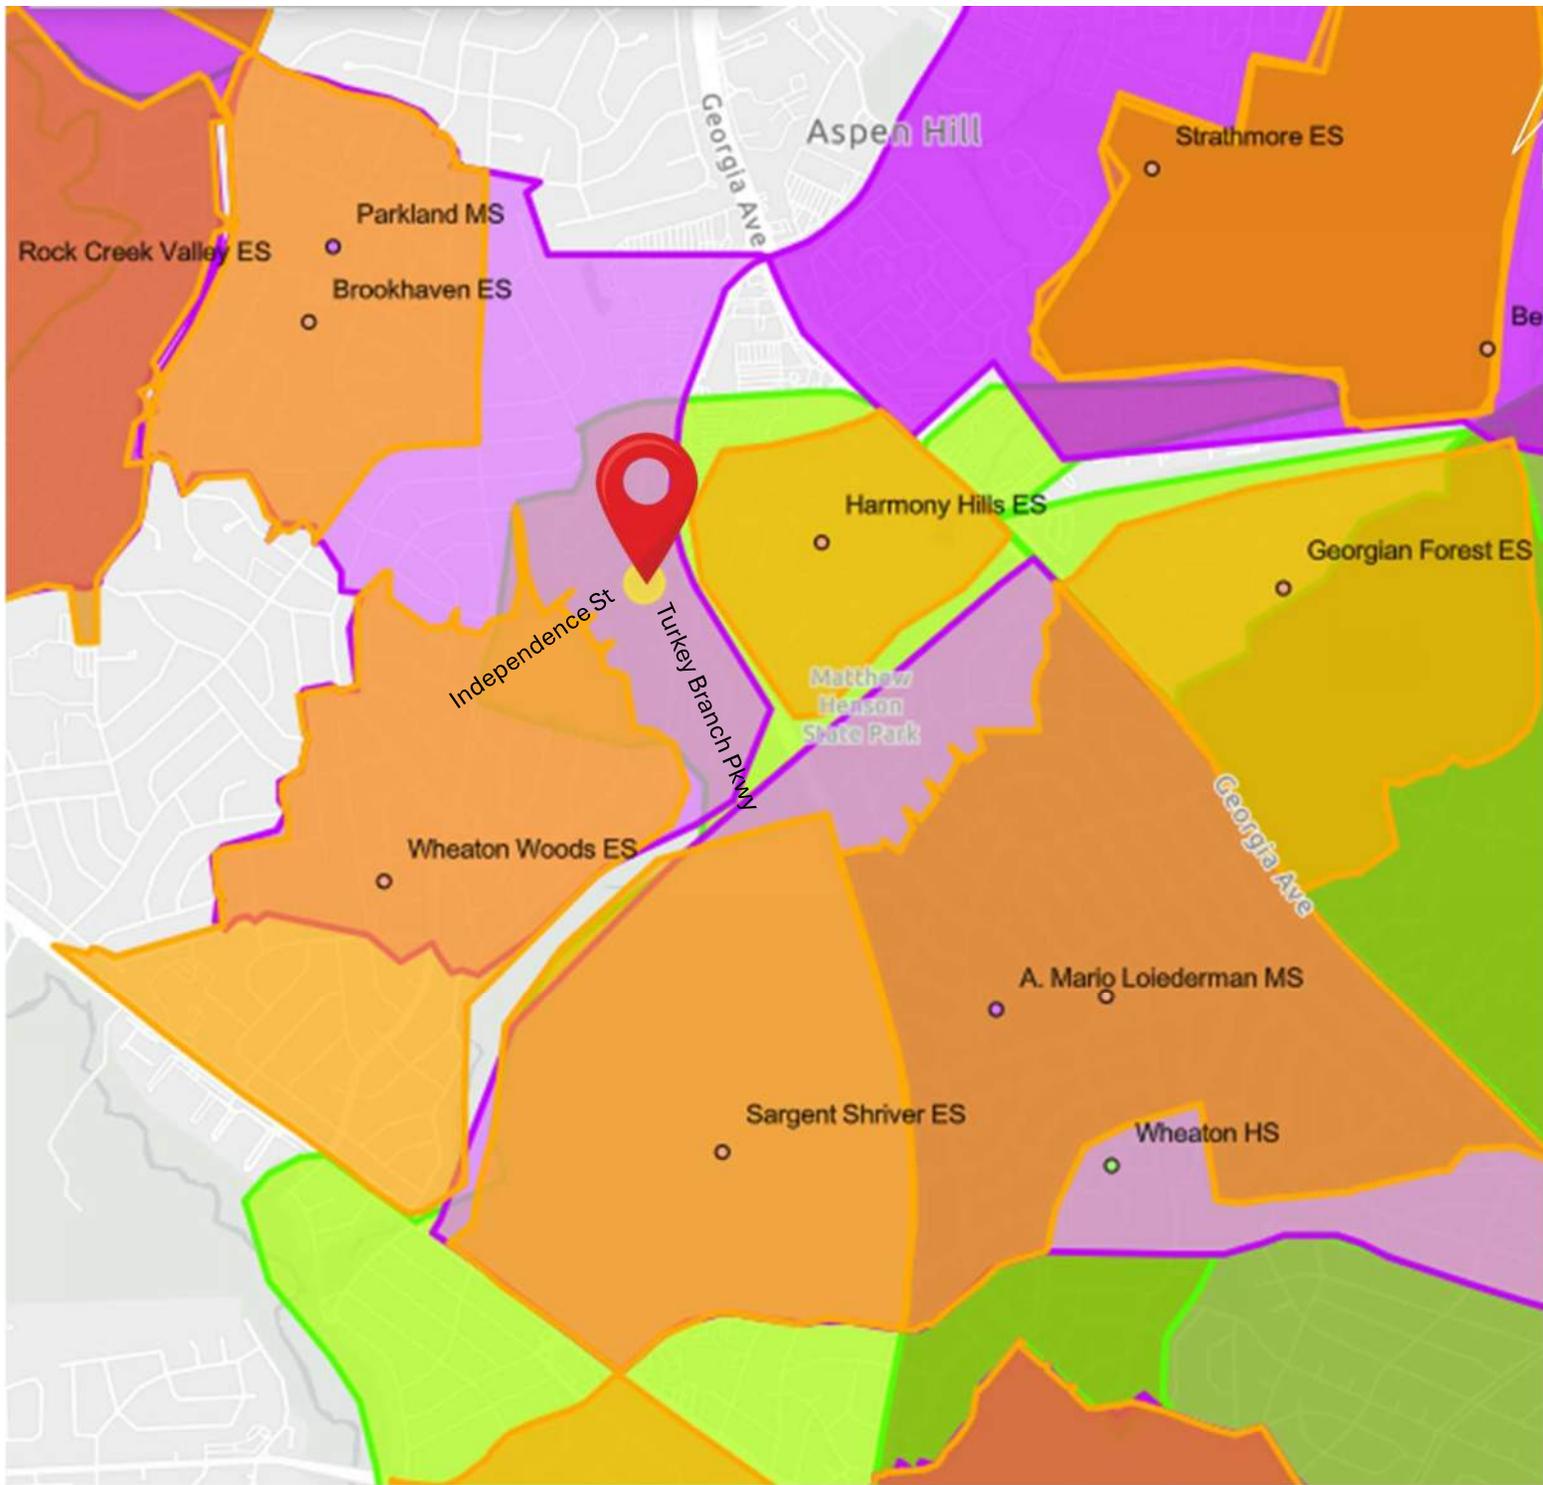
Figure 4 – School Walk Zone Map

- **Nearby Transit Stop**
Bus stops for Montgomery County Ride On exist to at the intersection of Independence Street at MD 185 (Connecticut Avenue) to the east of the subject intersection.
- **Nearby School Facilities**
The Parkland Middle School lies 1.5 miles to the northwest, with school access along W Frankfort Drive and Renn Street. The Wheaton High School lies 1.5 miles to the southeast, with school access along Dalewood Drive.
